ARCHAEOLOGICAL SOLUTIONS LTD
BROOK FARM, STATION ROAD, TILBROOK,
CAMBRIDGESHIRE
HISTORIC BUILDING RECORDING

Authors:	Tansy Collins BSc Lee Prosser PhD Peter Thompson MA Kathren Henry	
NGR: TL 08024 69389	Report No: 3629	
District: Huntingdonshire	Site Code: AS 1332	
Approved:	Project No: 3967	
Signed:	Date: August 2010

HISTORIC BUILDING APPRAISAL

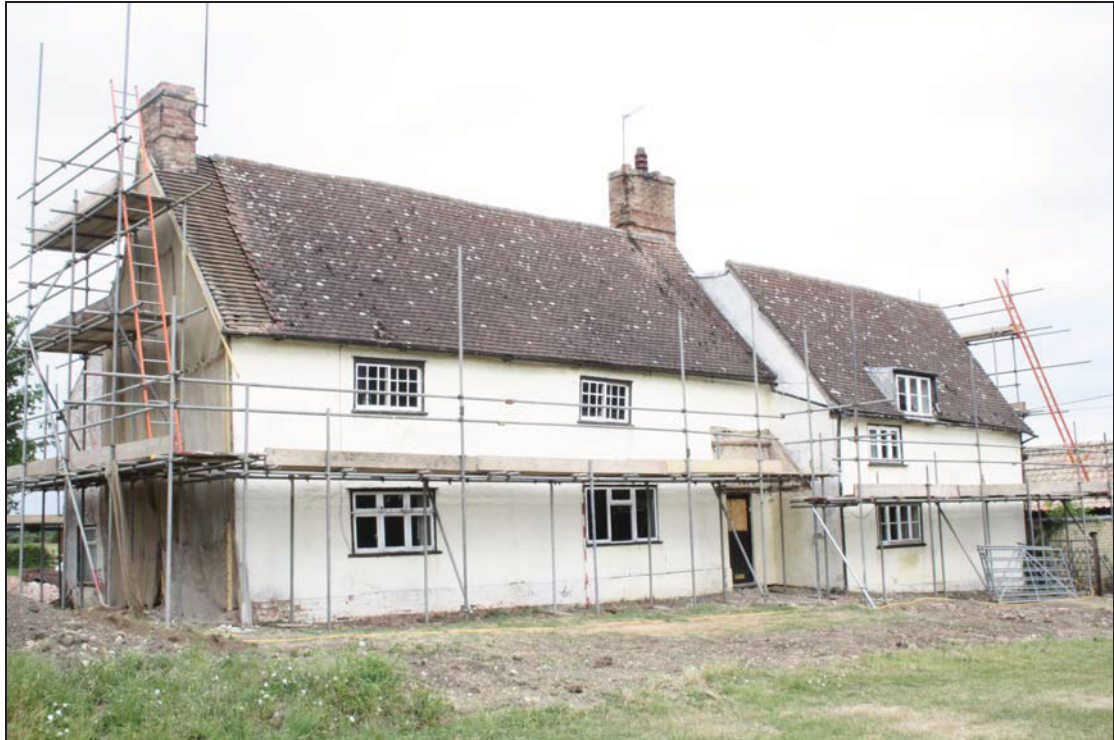
5.3 The east front is the principal elevation (Plate 1), though in common with many farms the front door was not used, the most frequently used entrance being from the working yard to the west. Where a modern porch has been removed, the original render over wattle-and-daub infill has been exposed. The south range, at ground floor level, has a modern door at the north end, formerly enclosed by the porch, and two timber casement windows. The north example is probably of 1950s date while its southern counterpart is possibly a little earlier. The north range is only lit by a single, earlier 20th century four-light casement, each light of two panes. Upper windows include two Yorkshire sashes on the south range, each with two-by-nine panes, while the north range has a three-light timber casement, each light of two panes. An attic dormer window lies slightly offset to this window and is of three lights in similar form.

Plate 1 East façade of the assessment building, taken from the south-east (7)

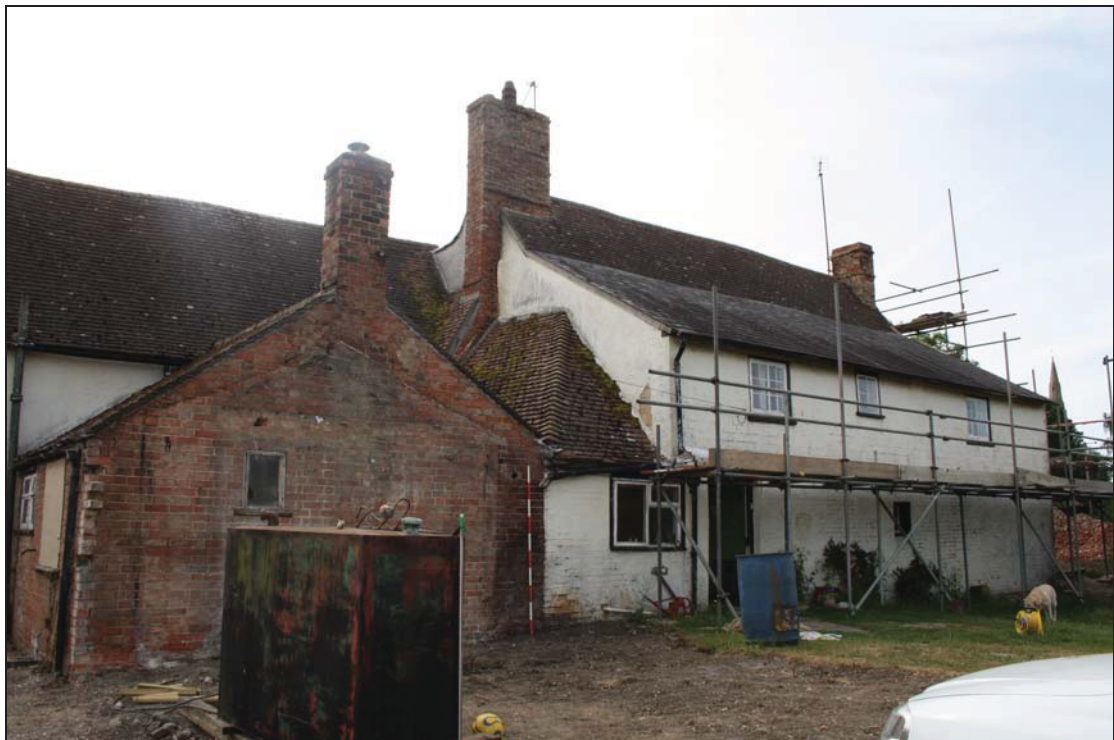
5.4 The original west elevation (Plate 2) has been augmented with a number of later extensions. The southern outshut is constructed of 19th century brickwork. The lower fabric is laid in Flemish bond which, where visible, is of the same form as the plinth visible on the east. However, the upper floor is laid in rat-trap bond. Access is given to the building through a rear doorway at the north end of the south range on this side, which is of late 20th century date. To the south this elevation is pierced by a small 19th century four-pane fixed window. The upper floor contains three windows, the outer windows of 12-pane casement form and the central window of four panes. A small hip-roofed extension has been added, extending the outshut to the north, and is possibly of contemporary date with a large late 20th century window. Above this, the junction with the main chimney stack is visible, shouldered out to incorporate the north range. The west side of the north range was latterly extended with a cross-wing and only a short section of the west elevation in this area is now visible. The wing is constructed of 19th century brick laid in Flemish bond, gabled on the west side incorporating a slender flush chimney stack and pierced by a single light.

Plate 2 West façade of the assessment building, taken from the north-west (1)

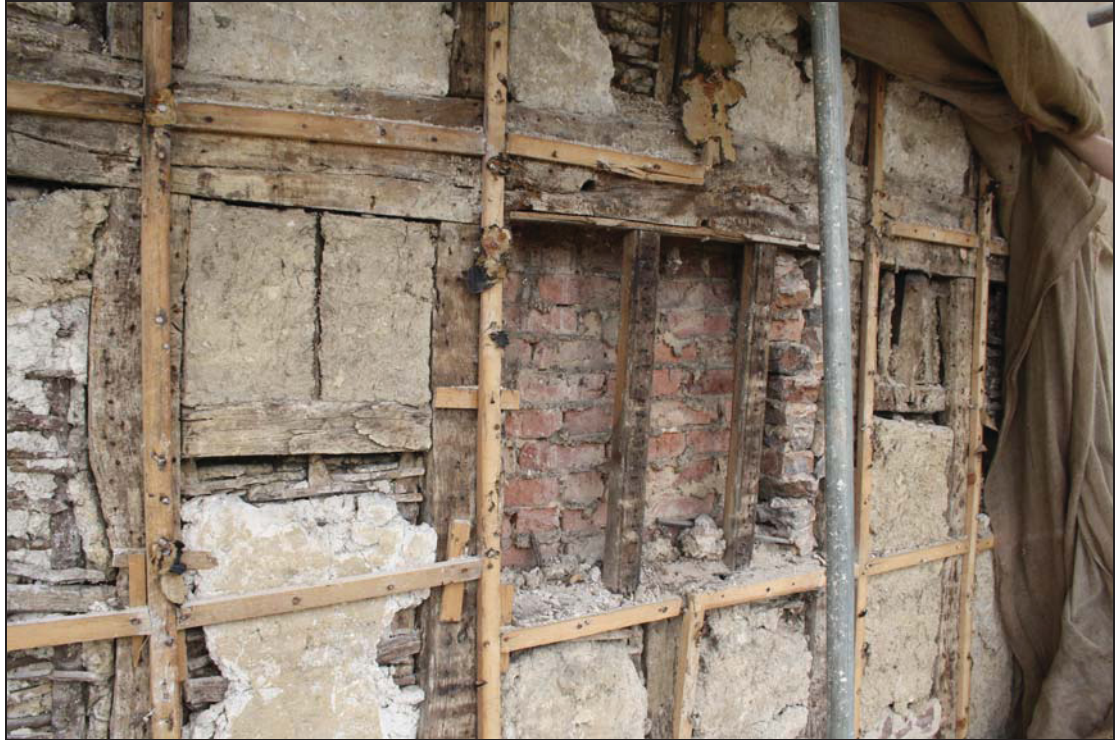
5.6 The south gable wall has been stripped of its modern render to reveal the underlying structure, framed by large, splay-cut corner posts and a badly decayed sole-plate resting on the brick dwarf wall. A mid-rail is supported by six common studs at lower level and the remains of a central window, latterly

blocked by brick when the internal chimney stack was constructed. It is possible that this is itself a later feature, as peg-holes and the stumps of two inner studs survive above and below the aperture, but the work is all clearly of some age. The sill and lintel are simply cogged into the supporting studwork, and hold rebated mullions to form a three-light window which also preserves original square holes for the original casement pintles.

Plate 3 Blocked original tri-partite first-floor window on the south wall (south range), taken from the south-west (83)

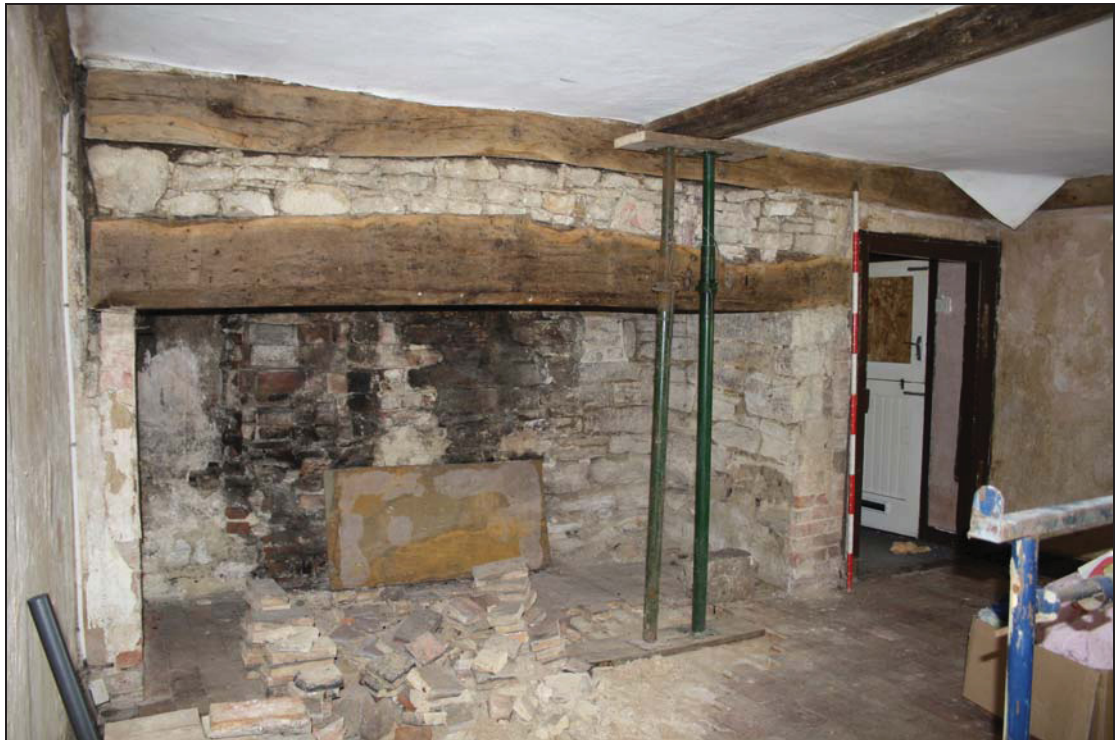
5.11 The ground floor comprises two chambers, GF01 and GF02. Room GF01 probably formed the original hall dominated by a large inglenook fireplace on the north (Plate 4). The bressumer is large and chamfered with stepped stops at both ends, while a taper mark is visible, possibly a ritual mark. Stone packing has been inserted above to the main binding joist with some discrete brick repair. A number of localised deep mortices to the east are associated with a notch in the beam above, perhaps for a shelf. The back and cheeks of the fireplace are constructed of large limestone blocks, although there is some disturbance to the west in brick, perhaps for a bread oven. The west brick jamb retains fine plasterwork with some trace of painting. Various iron hooks also survive within the aperture. A 19th century pavement floor is in overall excellent condition except for one or two areas which have been lifted near the fireplace to reveal a lime base. A thin 19th century or earlier skirting board with slight mouldings extends round the room. The principal framing elements, including mid-rails and main ceiling joist are exposed. The mid-rail has a regular arrangement of peg-holes for studs, while the west mid-rail also preserves faint traces of a painted chevron pattern, now much faded. The window on the east is a 1970s timber replacement but the pattern of peg-holes above indicates a window of smaller proportions in this location originally.

Plate 4 Inglenook fireplace on the north side of Room GF01, taken from the east (23)

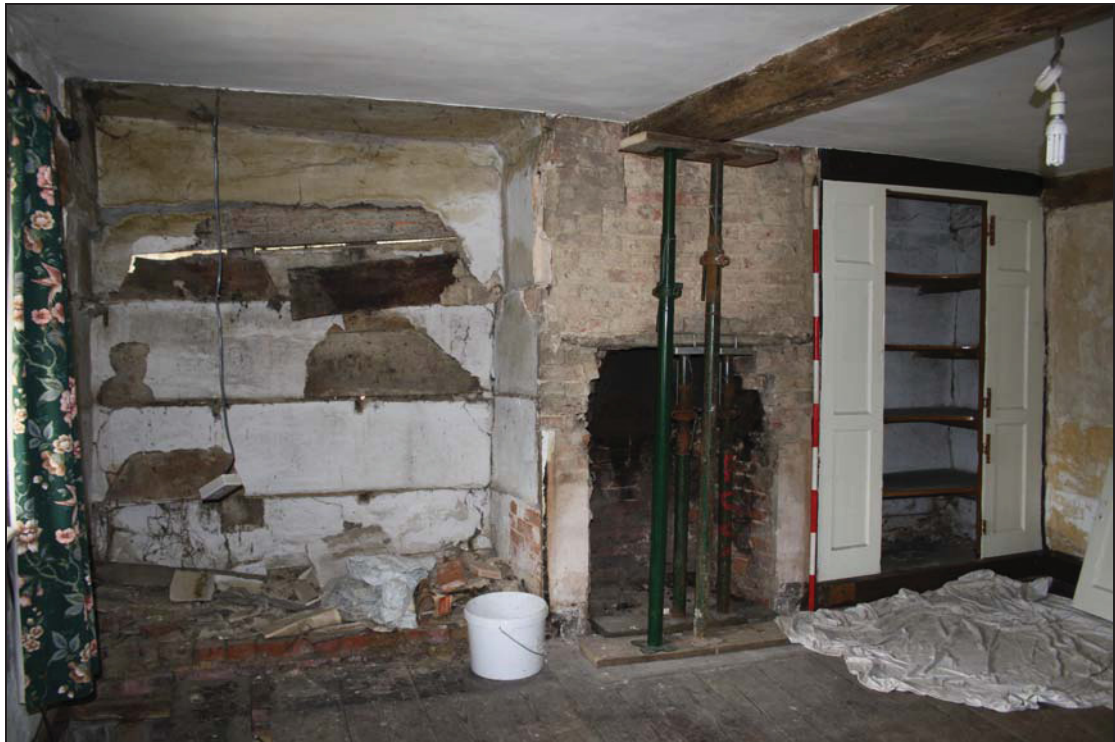
Plate 5 South side of Room GF02, taken from the north (14)

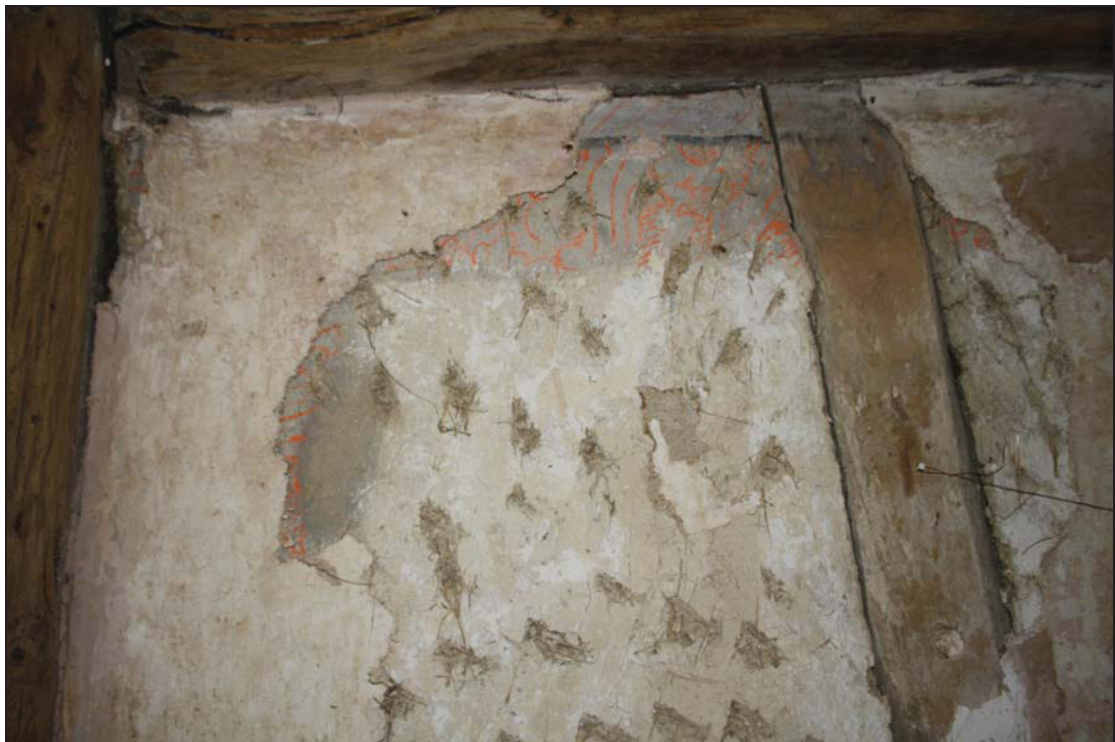
Plate 6 Detail of the exposed paint scheme on the north wall of Room GF02, taken from the south (22)

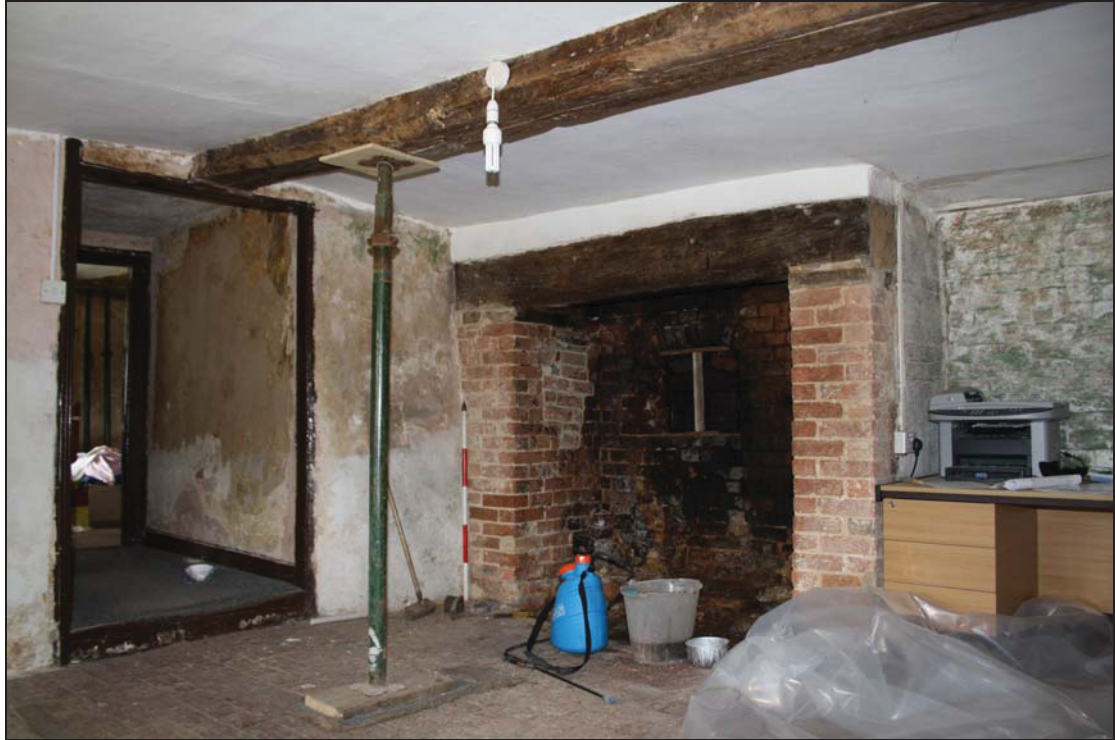
5.17 The north range is occupied by two rooms and an enclosed staircase in the north-east corner. In Room GF04, the floor is of brick and heavily worn, lying at a step down from the south range. The fireplace, piercing the rear of the main stack is constructed of 18th / 19th century brickwork with jambs and a simple bressumer (Plate 7), chamfered with wave stops and preserving evenly-spaced peg-holes for a shelf together with the burn-mark from a taper as seen in the south range. An 18th century bread oven also survives to the rear within wide chamfered reveals.

Plate 7 South-west corner of Room GF04 showing fireplace, taken from the north-east (26)

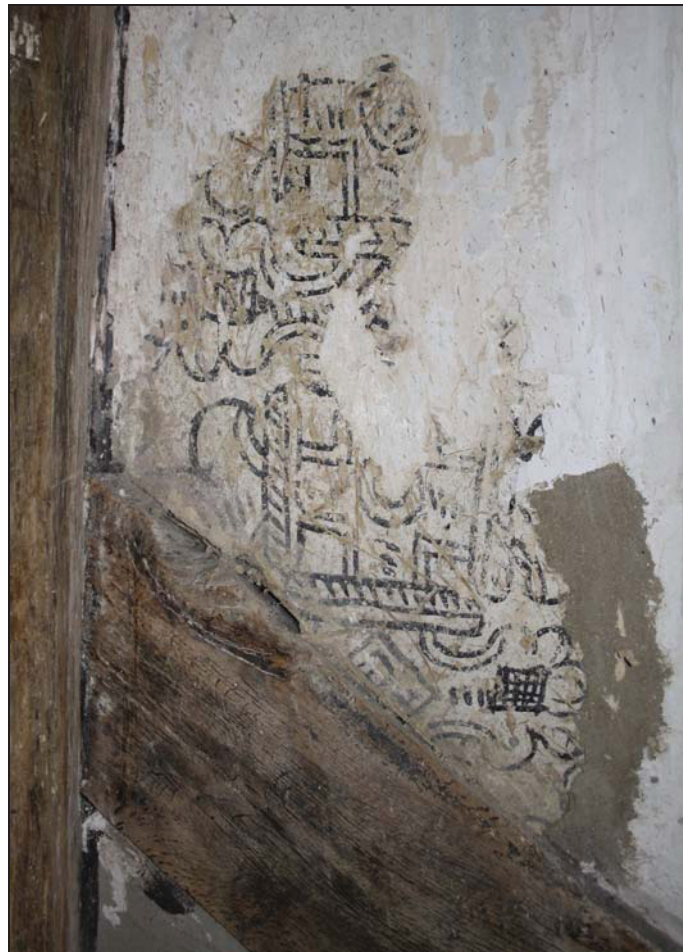
Plate 8 Detail of east wall in Room FF01 showing original decorative paint scheme, taken from the west (58)

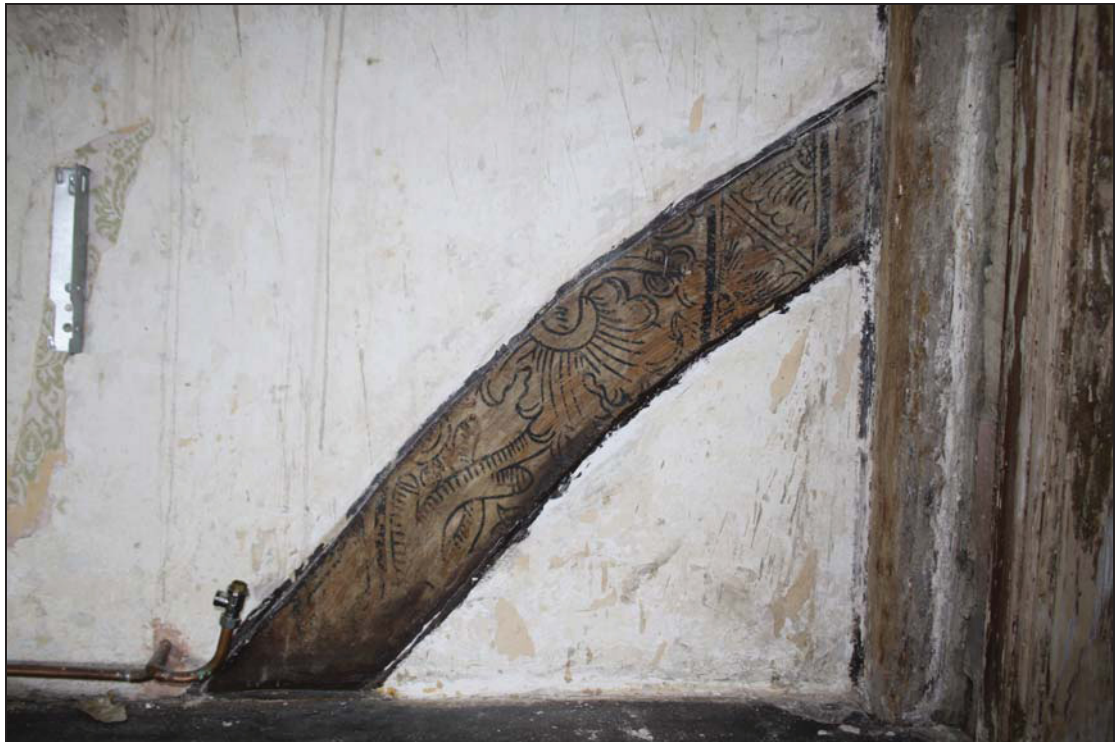
Plate 9 Downward brace on the west wall of Room FF02 showing original painted scheme, taken from the west (43)

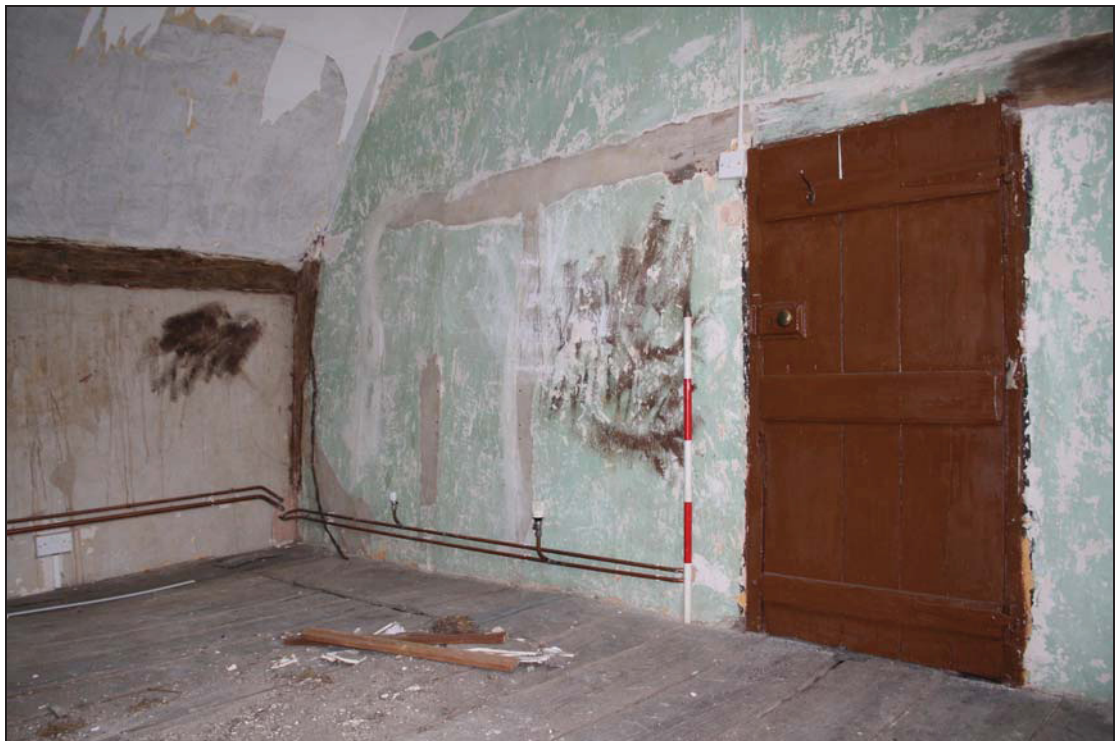
Plate 10 North wall of Room FF04, taken from the south-east (66)

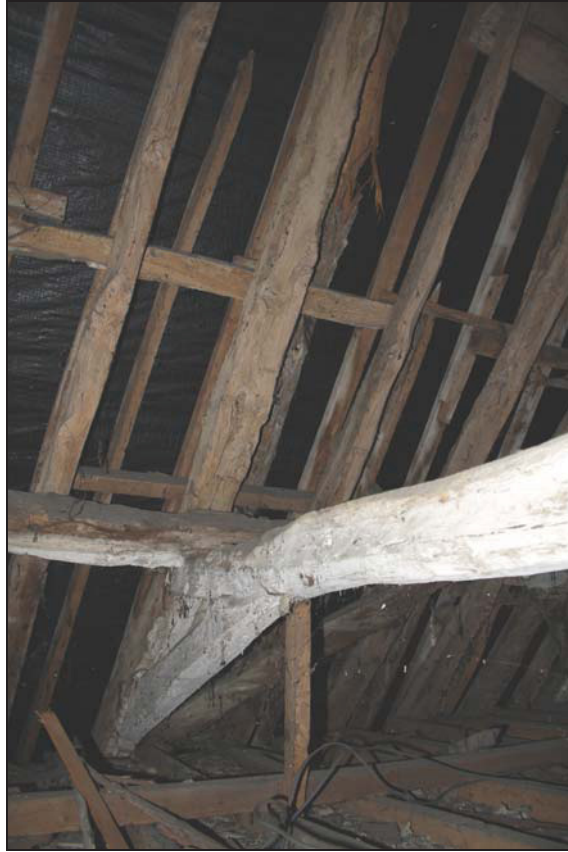
Plate 11 View in the roof space above Room FF01 (north bay, mid-bay division), taken from the north-west (88)

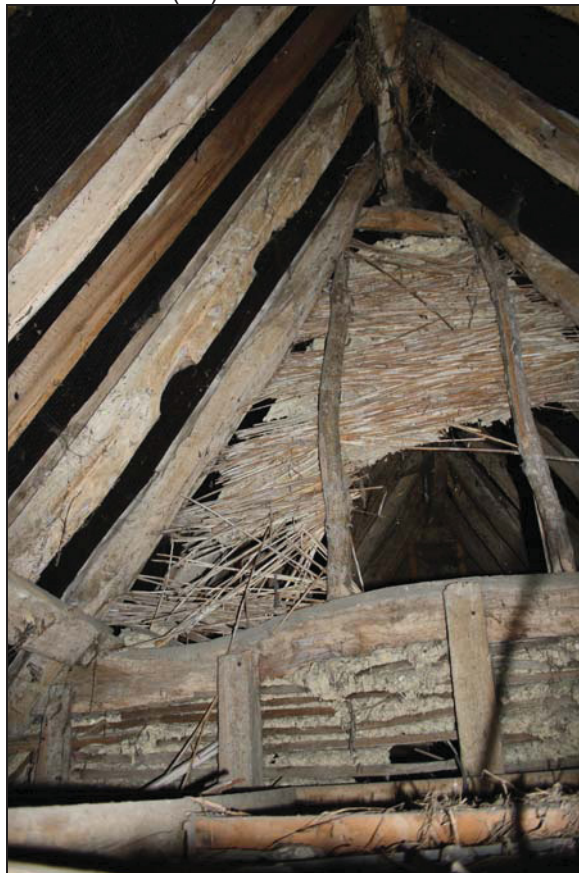
Plate 12 View of the roof space above Room FF04 showing the bay division (south bay, north range), taken from the south (39)

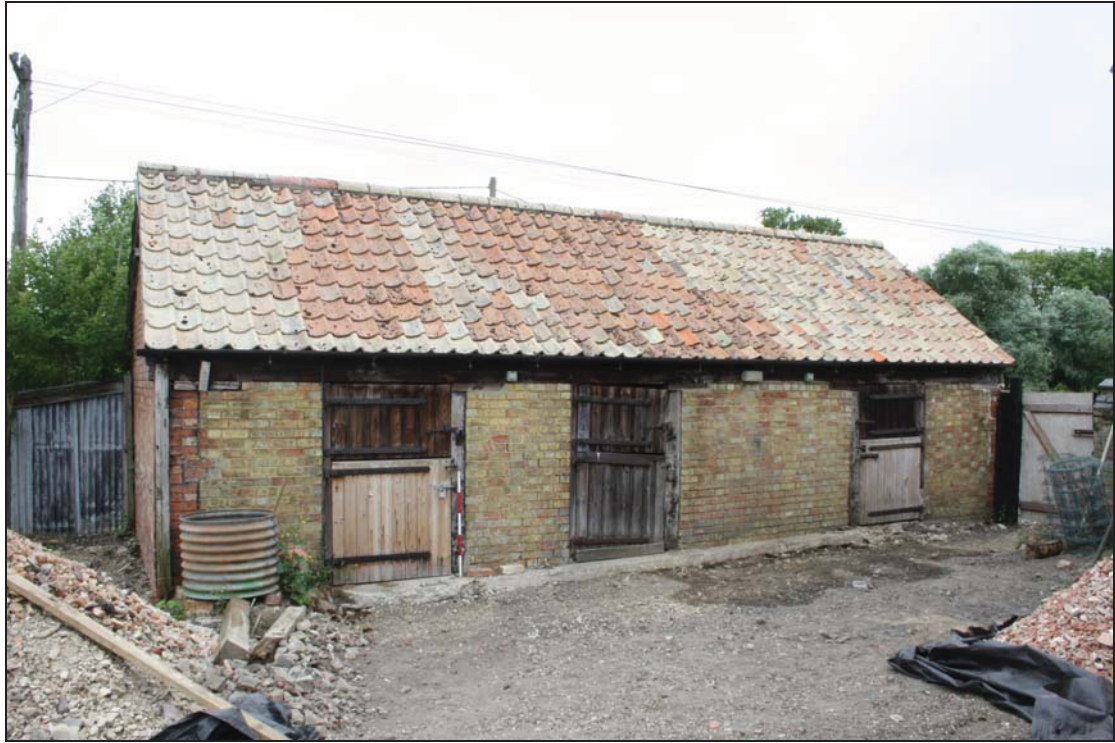
5.40 A number of outbuildings associated with the farmhouse are portrayed on historic maps, but only a single example survives to the north of the farmhouse, aligned east – west and parallel with the road. It is constructed of red brick with a pan-tiled roof, and was clearly once open-fronted to the south (Plate 13). This has now been infilled with a yellow-pink Huntingdonshire brick although remnants of the original supporting posts appear to have been incorporated into the brickwork. Split-doors have also been inserted although they are in poor condition and of limited historic interest.

Plate 13 South elevation of the outbuilding, taken from the south (09)
