BARN NORTH-EAST OF THE CHESTNUTS,
LUNDY GREEN, HEMPNALL,
NORFOLK

HISTORIC BUILDING RECORDING

LEVEL 2

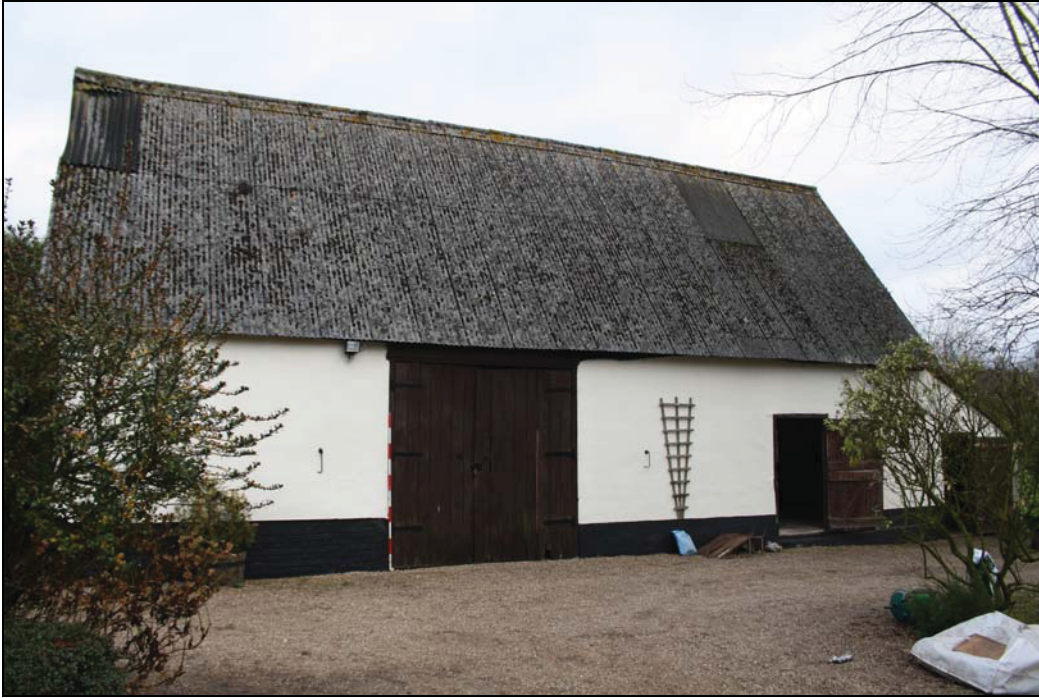
5.4 The south elevation fronting the yard sits on a dwarf brick wall of nine courses of brick laid in English bond to the west of the main doorway but thickly coated in tar. To the east of the entrance the wall is completely rendered, and has been partly replaced or reinforced in concrete.

5.5 The large double doors are vertically boarded, ledged and braced to the rear but entirely modern, together with their jambs and lintel. A second split ledged and braced stable door to the east gives access to the separated eastern bay. A third door gives access to the outshut at the far eastern end. These are likewise modern replacements of little interest.

Plate 1 South elevation of barn, taken from the south-west (DP 1)

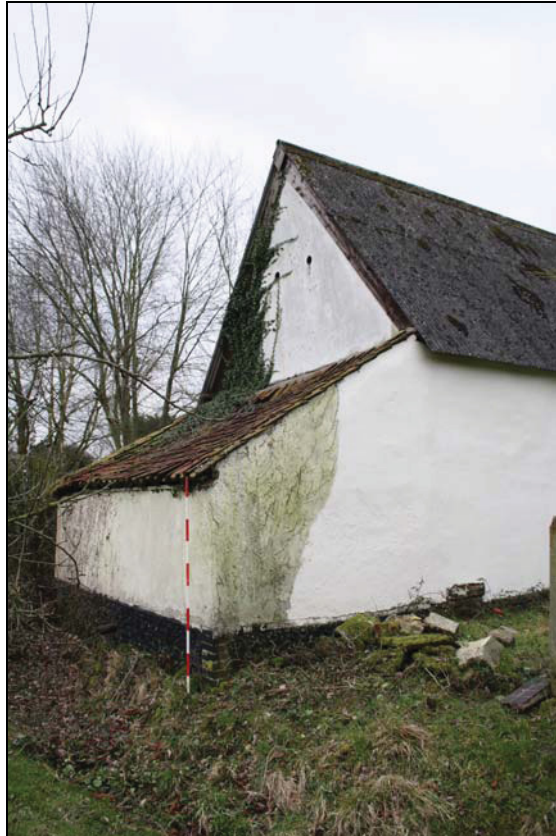
5.8 The outshut occupies the lower portion of the east elevation and is rendered over a dwarf wall of flint and brick (Plate 2). Two ventilation holes pierce the upper gable. As on the west, the barge boards have been renewed.

5.38 The outshut is fairly ephemeral in construction and clearly a later addition to the eastern end of the barn, as its rafters have been slotted crudely into the main structure and have now failed and allowed water penetration. Most

Plate 2 Outshut, taken from the north-east (DP 5)

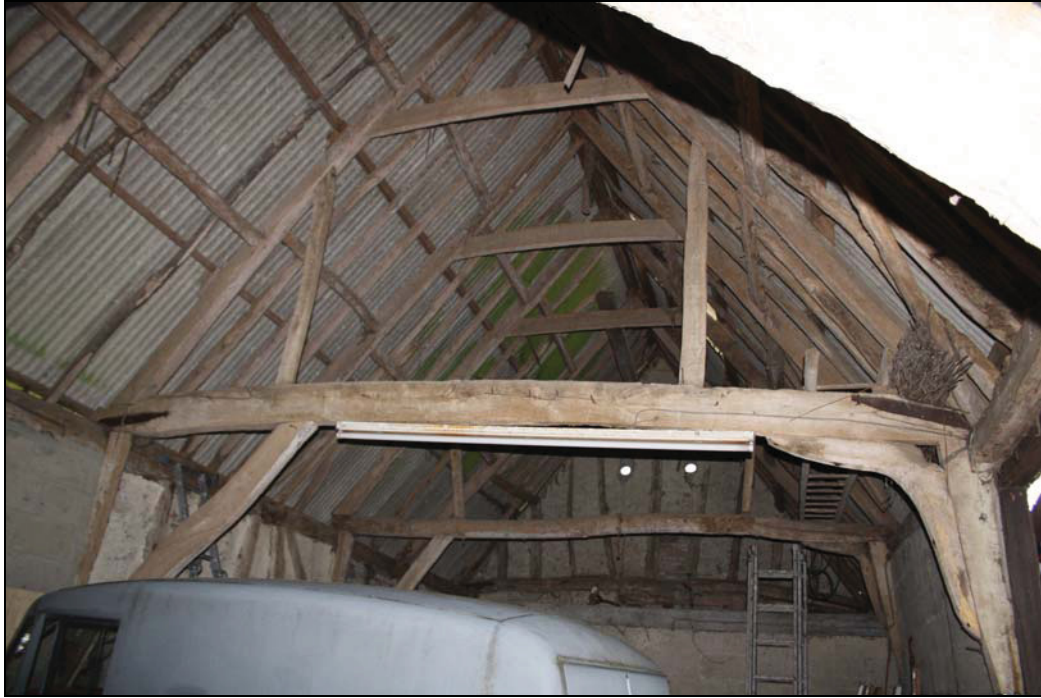
5.25 The principal-post on the north extends to full height and is slightly jowled but its southern counterpart has been truncated to accommodate the replacement of the sole-plate. An original brace survives on the north but on the south this has been replaced by a cranked elbow-brace nailed to the principals. Mortices for the earlier brace survive. The tie-beam is of good squared oak with some iron strapping used for additional support.

Plate 3 Truss 3, taken from the south-west (DP 24)

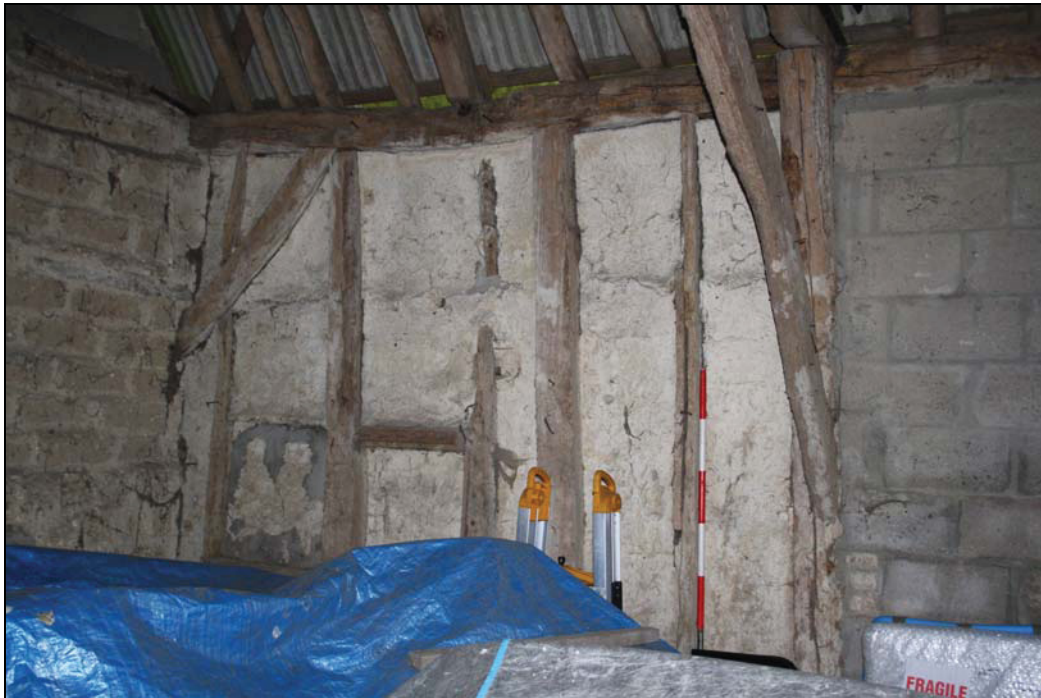
5.16 The north wall panel is likewise preserved in its original form with an intact sole-plate situated at lower level than its companion to the south, two properly pegged common studs and intermediates. A pegged upward corner brace is present as on the south. The infill is well preserved though small areas have been repaired with cement. Short nailed-on timbers form two small square

apertures in the central part of the panel. One preserves a row of 19th or 20th century wooden coat pegs.

Plate 4 Bay 1, north panel, taken from the south-east (DP 27)

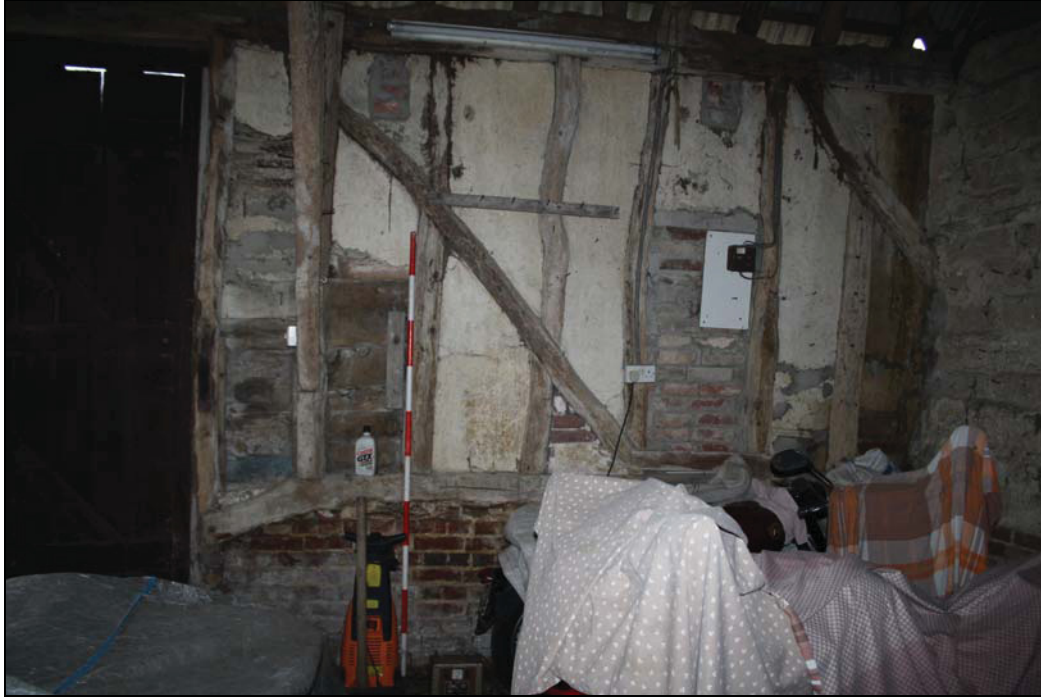
5.14 The south wall panel is largely intact though the sole-plate has been replaced; the studs are all nailed to the base and not pegged (Plate 5). The wall-plate is fairly waney on its upper edge; some decay at the junction with the first stud and the upper brace indicates water ingress at some point in the past. A primary brace extending from the principal-post to the sole-plate is probably original and marks a departure from the norm but there are, as elsewhere five waney studs.

5.15 Substantial remains of the earlier, creamy and even-textured daub infill survive, but a subtle distinction is visible with the lower areas, where repair can be associated with the replacement of the sole-plate. Some weather-boarding has also been employed.

Plate 5 Bay 1, south panel, taken from the north (DP 26)

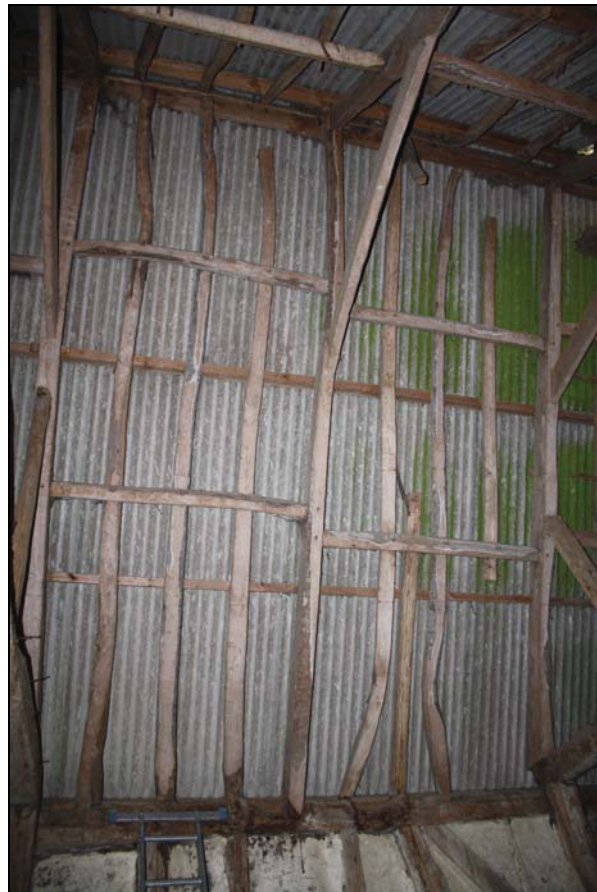
5.29 The north pitch preserves all elements though the east common rafters are waney and incomplete (Plate 6).

Plate 6 Northern roof panel, Bay 3, taken from the south-west (DP 29)

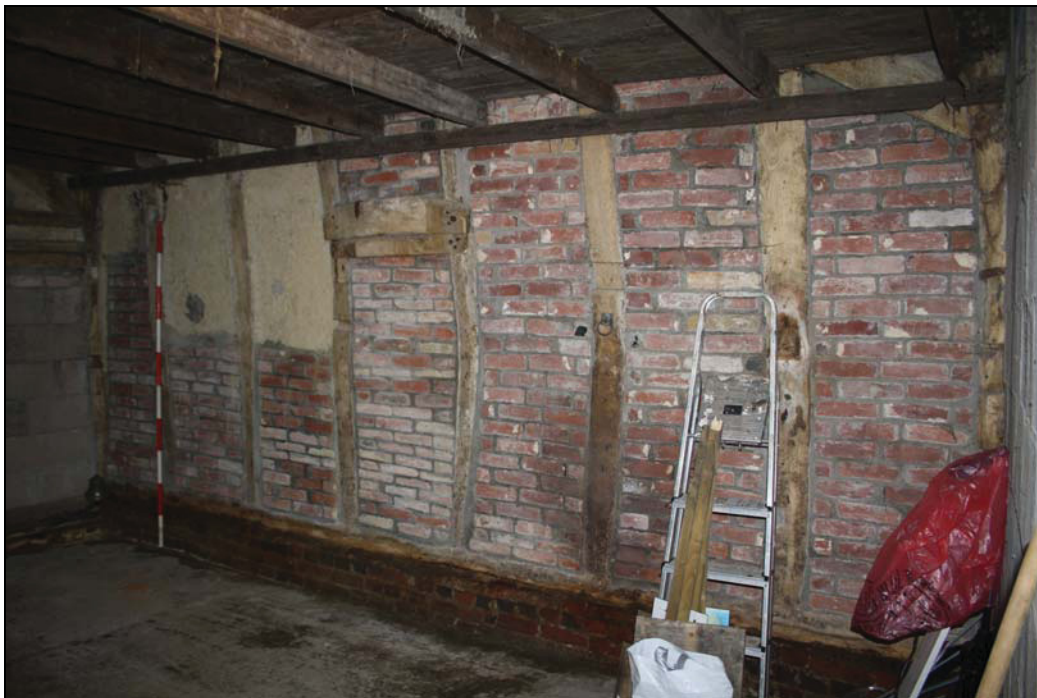
5.35 The eastern gable wall is substantially intact: its sole-plate possibly renewed and sitting on a 19th century dwarf wall (Plate 7). Principal-posts and six evenly spaced studs displaying a series of trenched mortices suggest that these are reused members but original. The two central studs are linked by short yoke pieces: function unknown. Much of the infill has been replaced by cement-pointed brickwork but substantial areas of original fabric survive on the north side.

Plate 7 Interior of the east wall of the barn, taken from the south-west (DP 11)

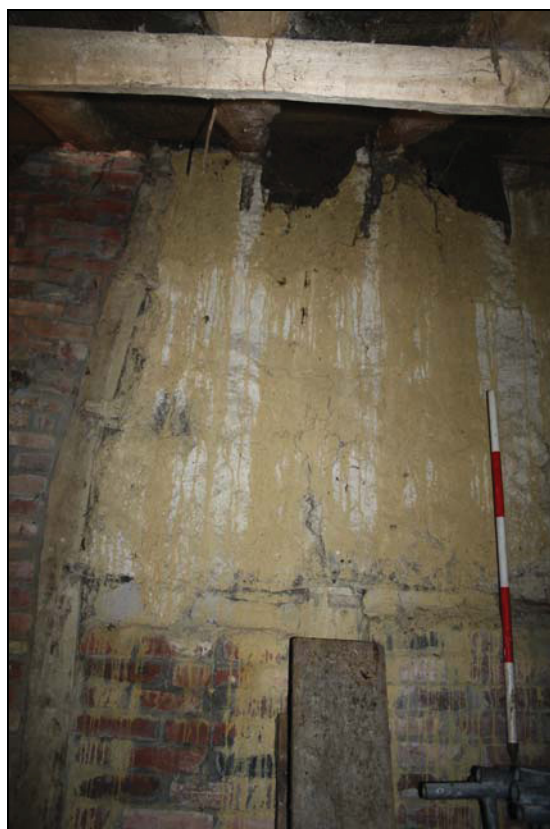
Plate 8 Wattle and daub panels preserved within the external barn wall, taken from the south-east (DP 10)
