**49 WOOLLARDS LANE,
GREAT SHELFORD, CAMBRIDGESHIRE**

HISTORIC BUILDING RECORDING

Authors:	Tansy Collins BSc Kate Higgs BA Kathren Henry	
NGR: TL 4605 5191		Report No: 3707
District: South Cambridgeshire		Site Code: AS 1377
Approved: Claire Halpin		Project No: 3385
Signed:		Date: February 2011

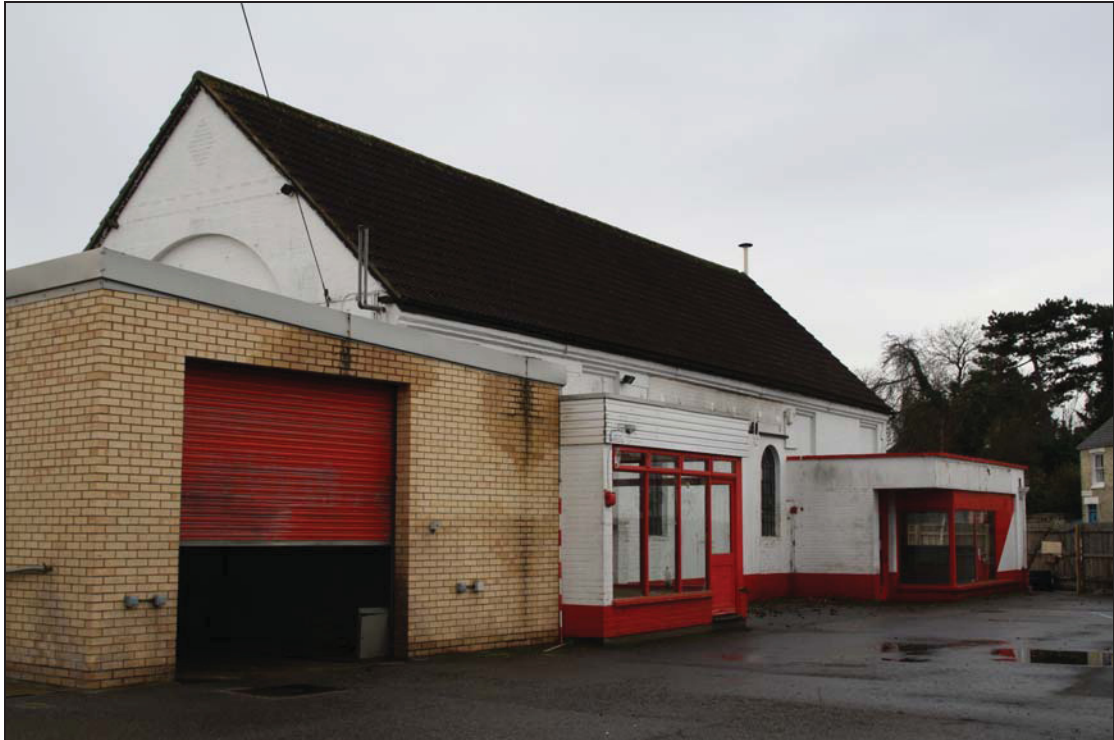
1 North side of Building 1 showing later additions, taken from the north-east (16)

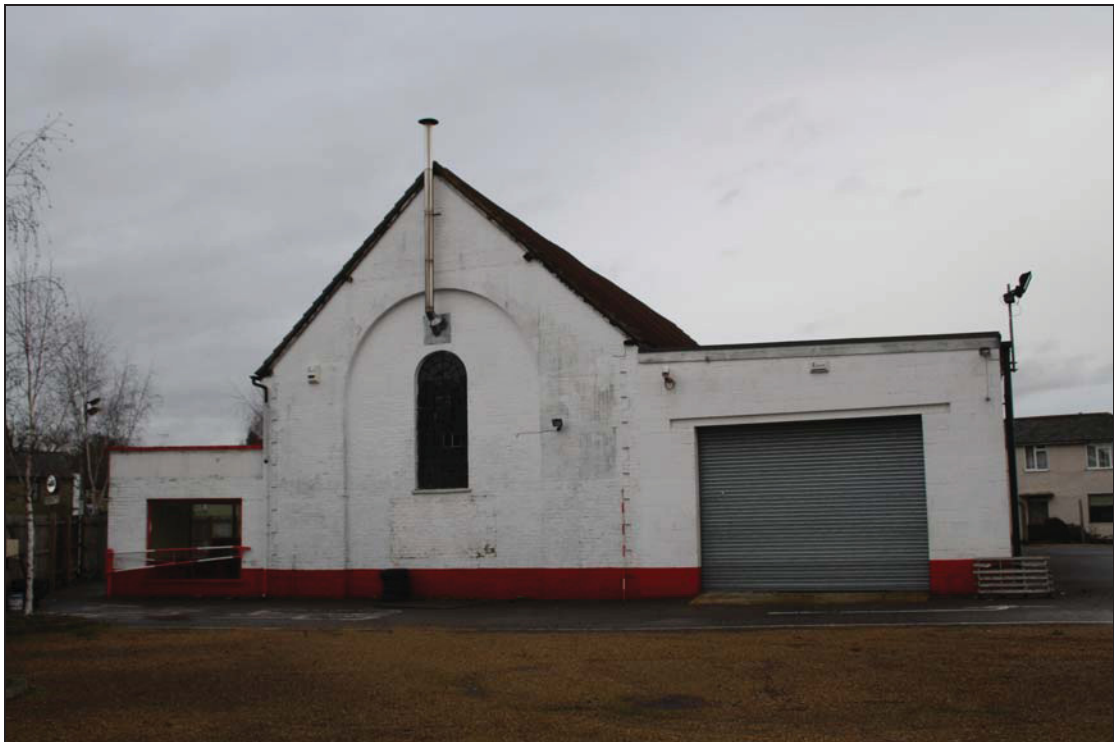
5.2.6 The west elevation is the most undisturbed (Plate 2) and comprises the gable end of the original school. This side is dominated by a large slightly recessed panel with a semi-circular arch rising to purlin level. Within the panel a large tall window is of the same form as elsewhere, the central four panels forming a pivoting casement. The gable is framed with a thin bargeboard, in poor condition, and purlins protrude slightly through the brickwork. Decorative touches include brick quoining at the corners as before, but also in the apex of the elevation bricks laid on-edge form a pattern. Two courses extend across the gable at purlin level and in the apex a diamond has been traced out with pierced air bricks. The entrance block is visible to the north and to the south, the rear range is constructed entirely of blockwork on this side and rises to the eaves level of the main range. It houses a large aperture supported by an I-girder with a modern roll-shutter door. The blockwork of this range has been tied into the brickwork of the school building causing some disturbance to the quoining.

2 West elevation of Building 1, taken from the west (11)

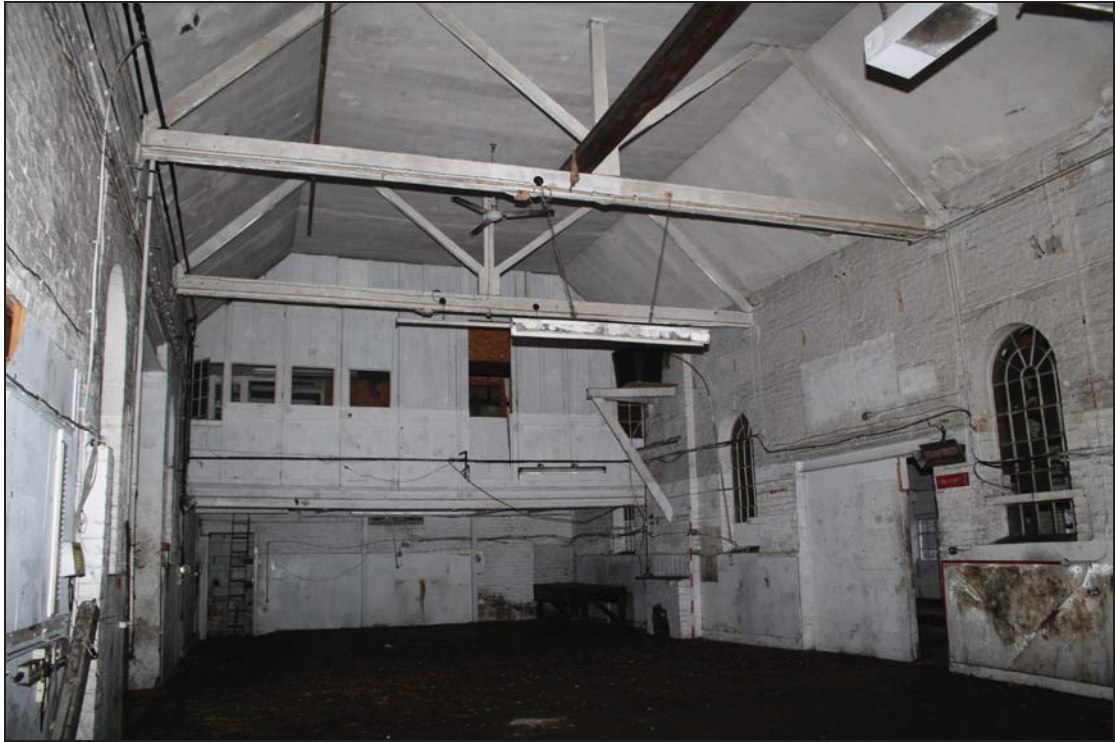
3 Interior of Building 1, taken from the west (36)

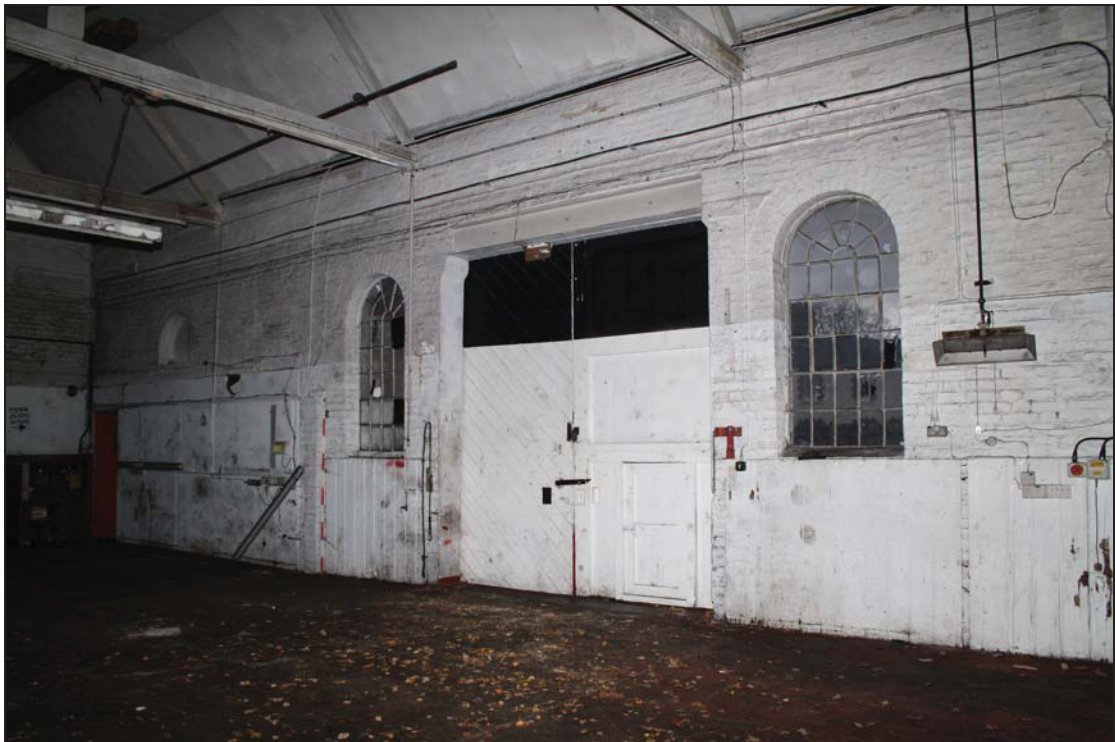
4 North wall of the main range (Building 1), taken from the south-east (41)

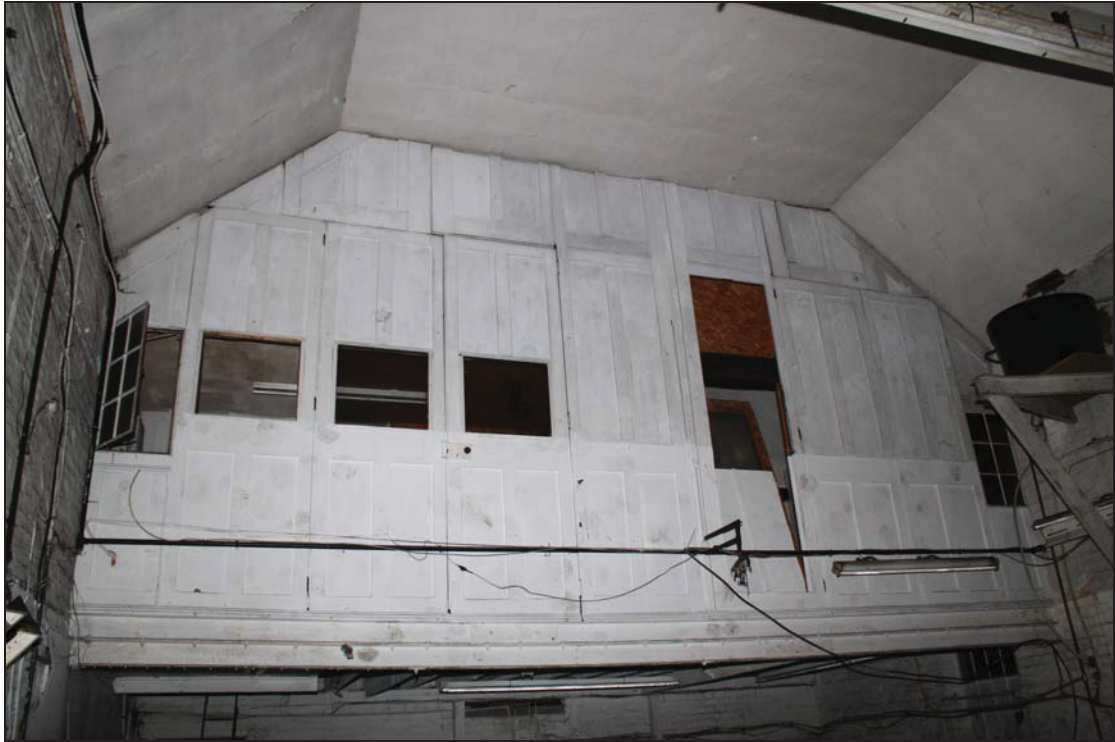
5 Panelled partition enclosing the mezzanine level in Building 1, taken from the west (38)

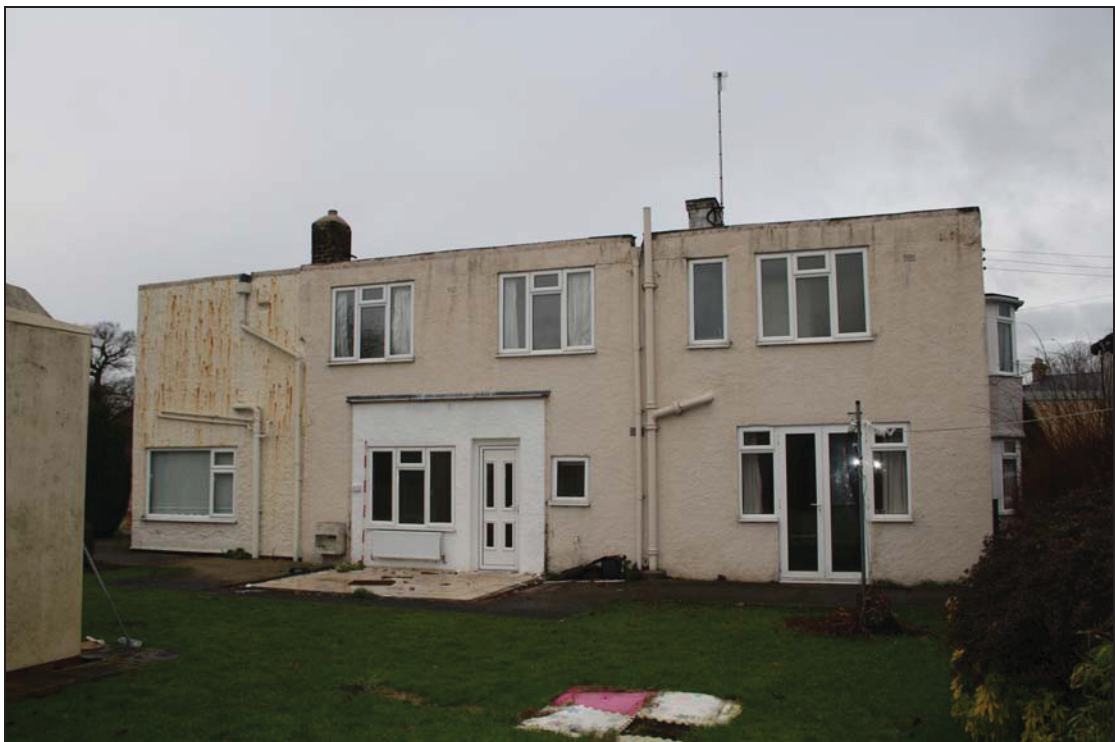
5.3.3 The principal façade faces west and frames the front door (Plate 6), offset to the south, with a series of windows. As noted these are of no interest, although their arrangement is worth describing. At lower level a two-light window lies to the north with a bay window adjacent to the south which spans both storeys to eaves level. Adjacent to the south, the front door and frame have been removed. A flat hood lies above, constructed of concrete. The final aperture to the south held a window which has been removed. A newspaper dating from 1969 used as packing around the steel mesh at the head of the window provides a useful date. At the south end there appears to have been discrete interventions or areas of repair, for example round the doorway, and cracking is visible in the render suggesting a level of structural movement.

6 West elevation of Building 2, taken from the west (8)

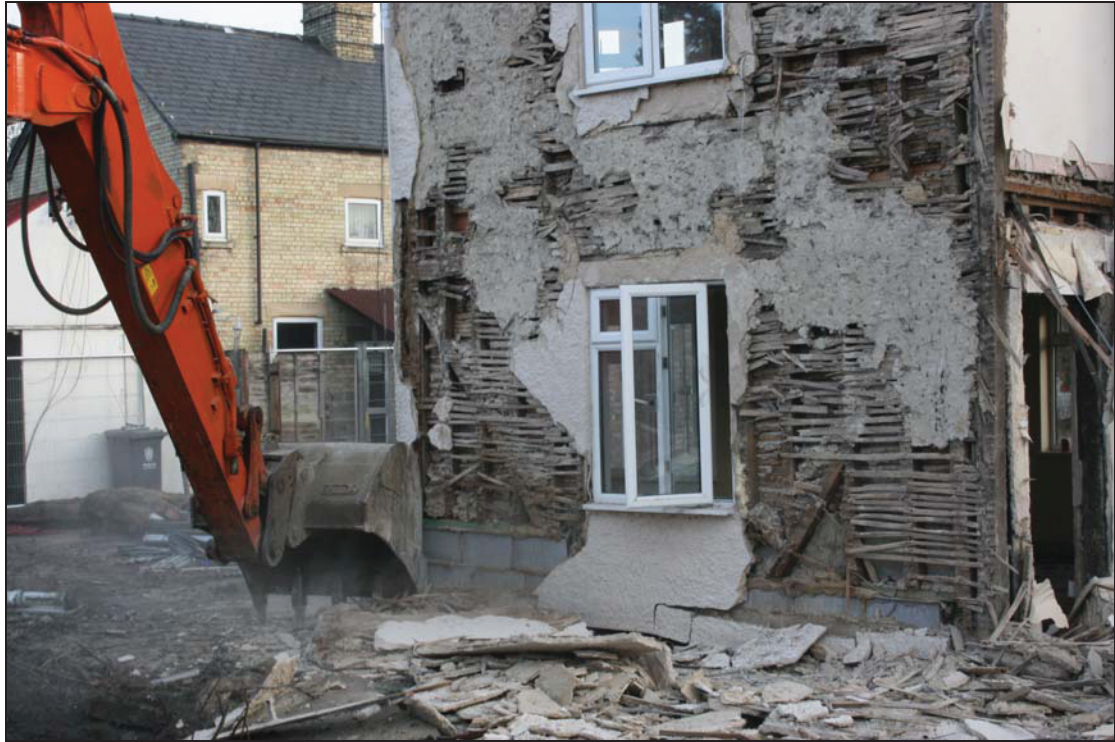
7 External west wall of Room GF01 (Building 2) showing primary-braced studwork and surviving lath and plaster, taken from the west (92)

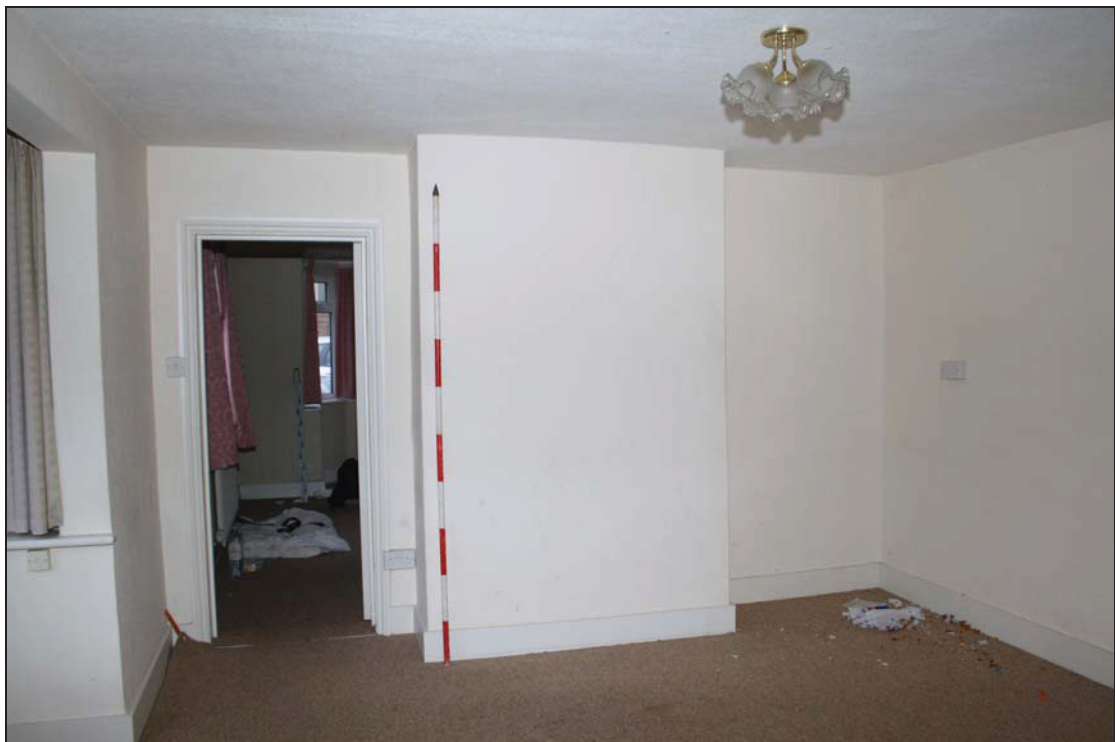
8 North side of Room GF02 (Building 2), taken from the south (24)

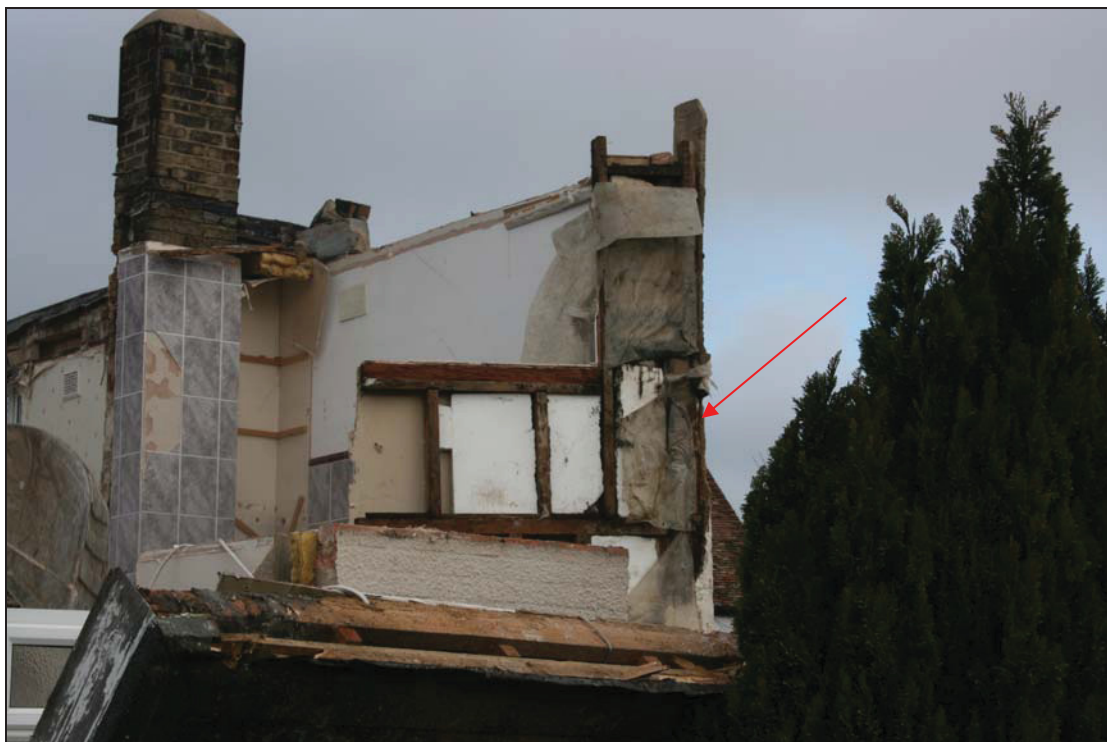
9 South end of the rear range (Building 2) during demolition showing surviving timber elements (indicated) with later timber repair, taken from the south-west (74)

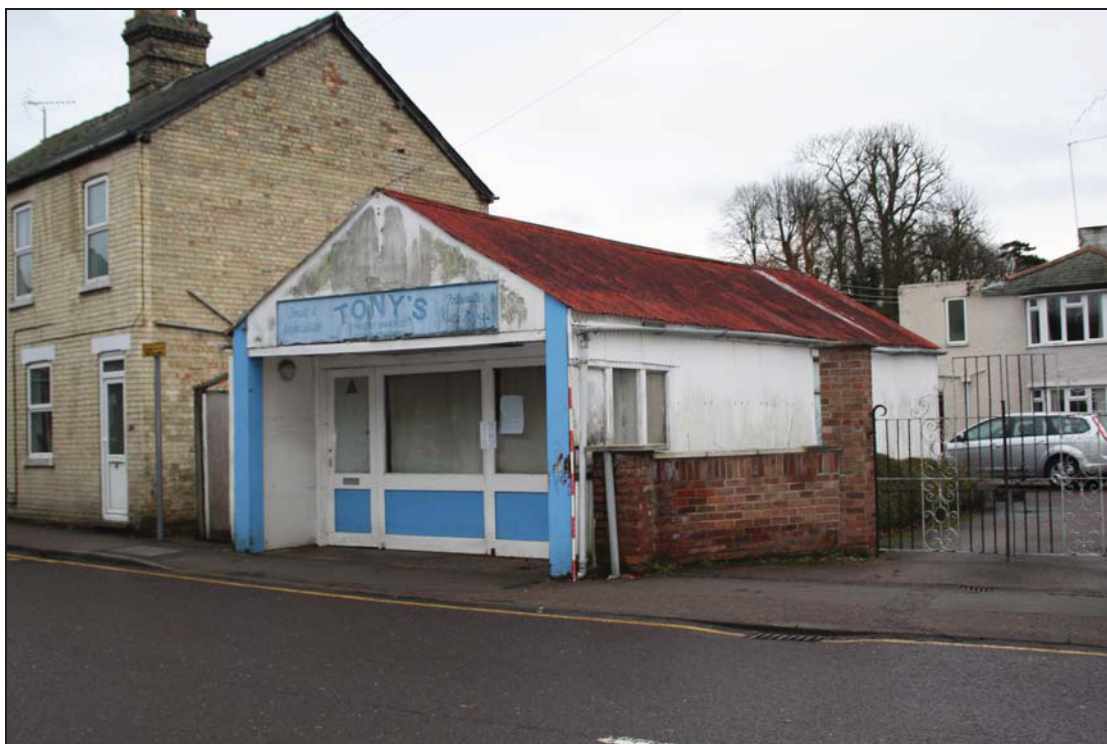
10 North and west elevations of Building 3, taken from the north-west (01)

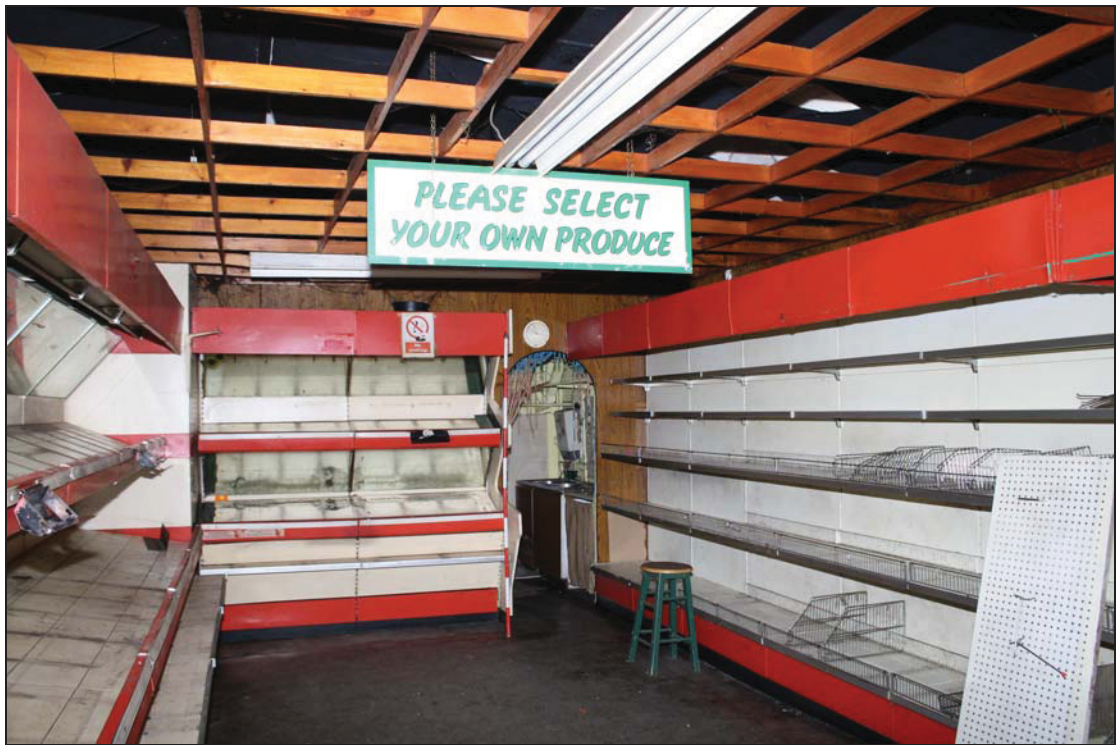
11 Shop floor area of Building 3, taken from the north (18)
