**ST MARY'S HOUSE, CLACTON ROAD,
LITTLE OAKLEY, ESSEX**

HISTORIC BUILDING MONITORING AND RECORDING

Authors:	Tansy Collins BSc Lee Prosser PhD Peter Thompson MA Kathren Henry	
NGR: TM 2120 2846	Report No: 4035	
District: Tendring	Site Code: LOSM11	
Approved: Claire Halpin	Project No: 4245	
Signed:	Date: March 2012

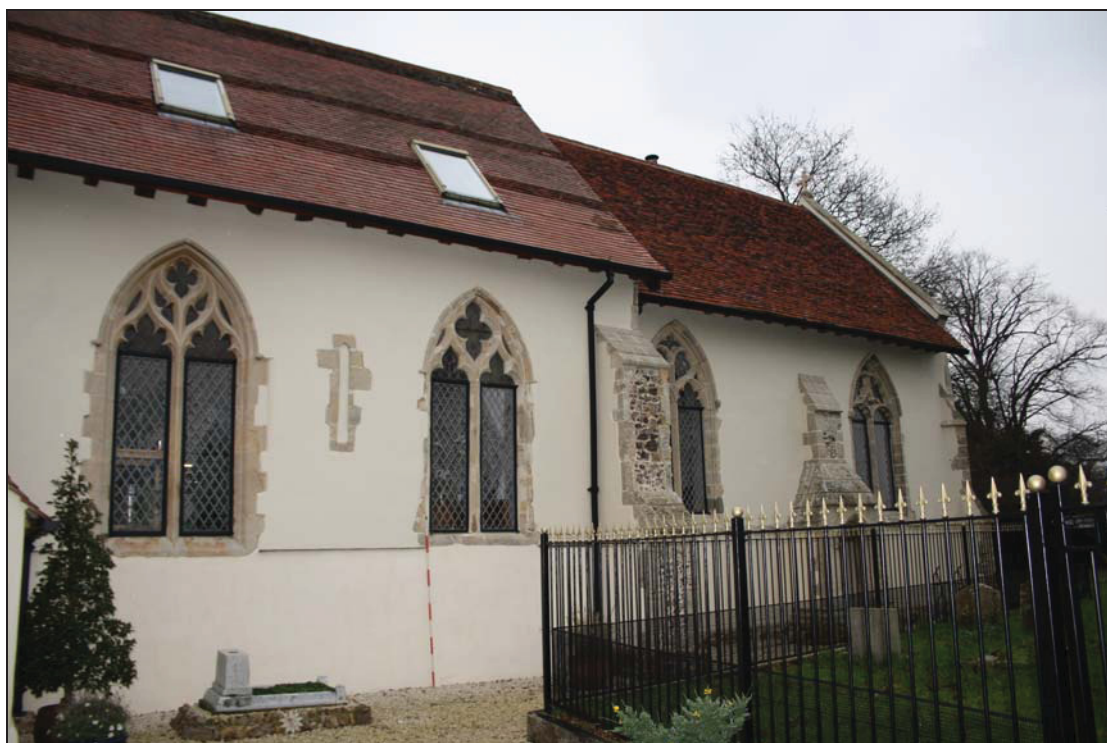
5.2 On the south elevation, the nave retains a lancet window, suggesting its 12th century date (Plate 2). This is now sandwiched between two, two-light windows with reticulated tracery, the east of probable original 14th century date though much of the stonework of the western window has been replaced. To the west, the south door is enclosed by a rendered porch, but lit by trefoil-

Plate 2 South elevation of the nave and chancel, taken from the south-west (DP 08)

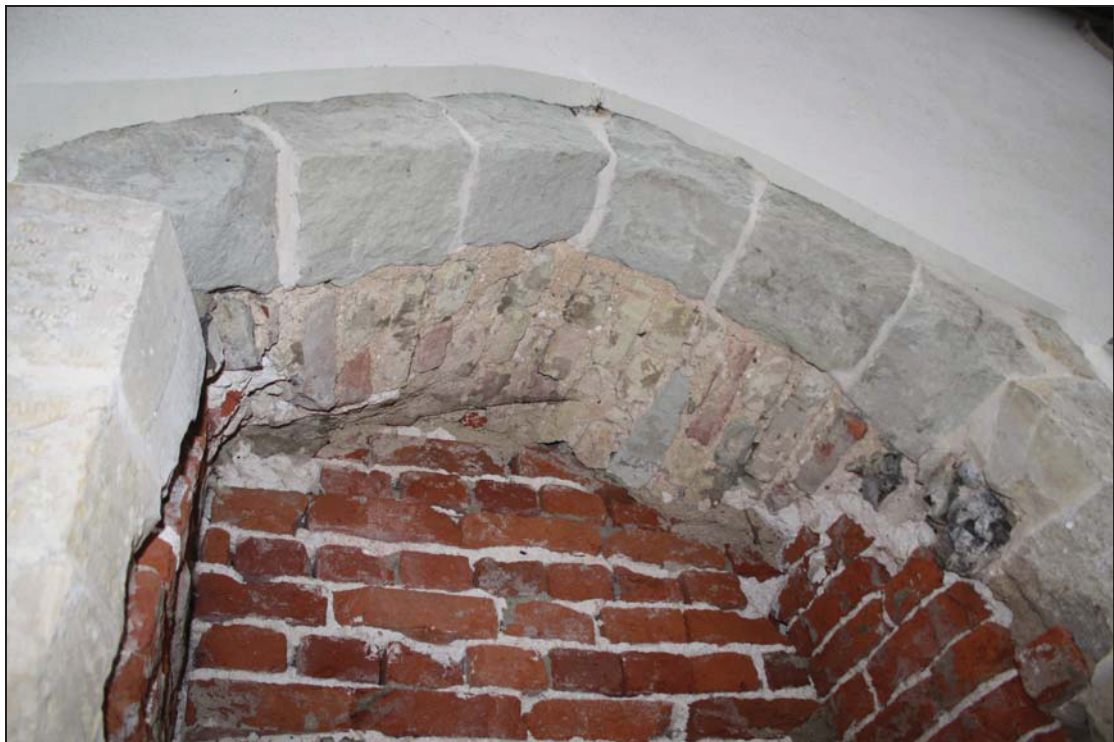
Plate 4 Arch soffit on the blocked doorway on the north side of the chancel, taken from north (DP 13)

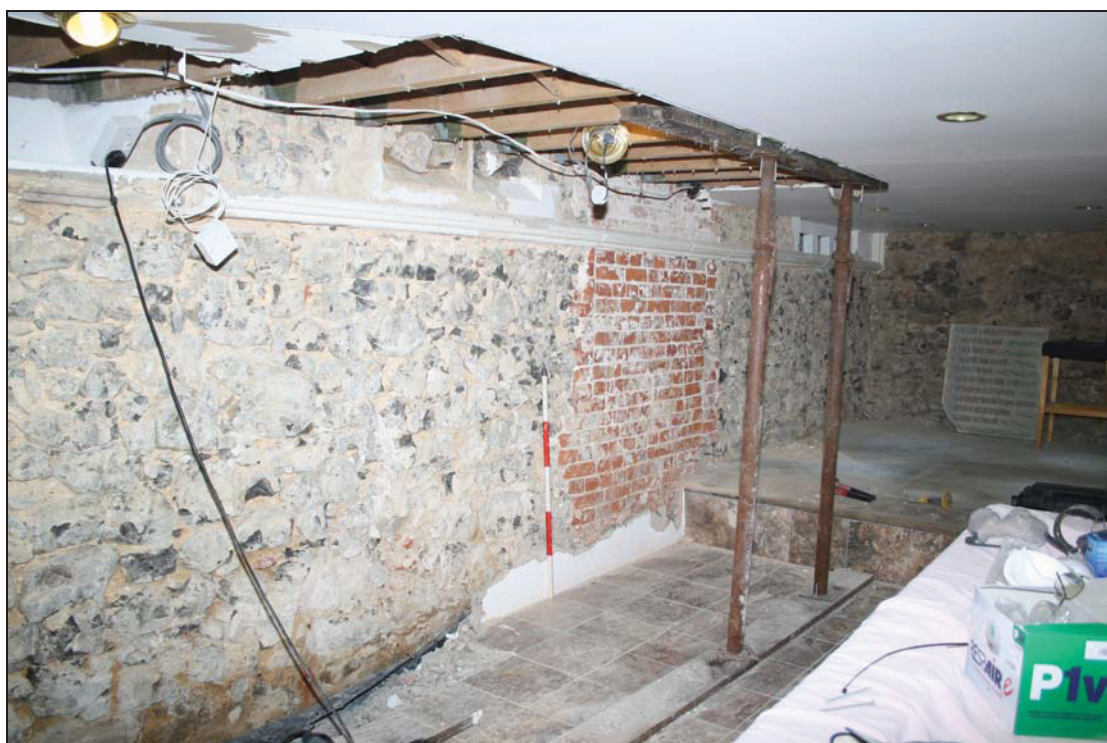
5.14 Within the former chancel, the window sill level all round is marked by a contemporary ovolo-moulded string course, built into the masonry. This survives particularly well on the north side, though has been hacked off below the north chancel window (Plate 5). Immediately adjoining, the base of a second, now-blocked window with stone jambs and a single mullion survives. This is noted in the List description as having two square-headed lights with external splays. The inner face of the former vestry door continues the English bond brickwork seen to the exterior, but here laid in a more regular fashion and formerly plastered. The outer jambs have been made good with brick, suggesting the original stone jambs were been removed when the door was blocked. The brick extends above the modern floor joisting. In addition the blocking is spanned by a stretch of moulded string course continuing the medieval form but clearly a more recent addition and perhaps contemporary with the blocking.

Plate 5 North wall of Room GF01 (chancel), taken from south-west (DP 15)

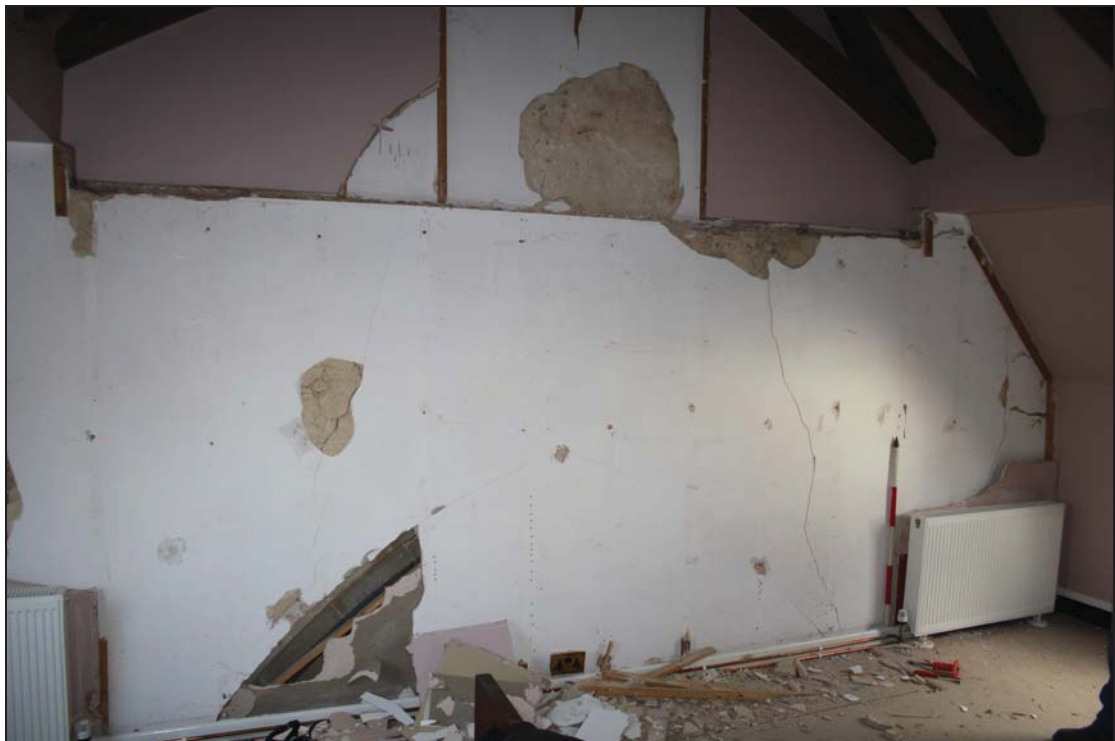
5.23 Detailed investigation and some exploration of the chancel wall within Room SF01 was carried out to determine the age and nature of the wall surface between the arch head and the apex (Plate 10). A fitted wardrobe and modern plasterboarding were removed to show that the arch survives in good condition. The masonry, by contrast rises to an offset just below soulace level, where the upper walling was found to be poorly built in small stone rubble with a few flints, bound with a buff-coloured mortar. A thin render finish survived, over which modern gypsum plaster has been applied. Several areas show structural cracks, particularly in the area to the north. Discrete scrapes were carried out in a random sample across the wall but no fine or finishing plaster surfaces were encountered.

Plate 10 East wall of Room SF01 during investigation, taken from the west (DP 75)
