GODWICK GREAT BARN, GODWICK HALL
TITTLESHALL, NORFOLK

HISTORIC BUILDING RECORDING

Authors:	Tansy Collins BSc Lee Prosser PhD Peter Thompson MA Rosanna Price BSc	
NGR: TF 9041 2208		Report No: 4029
District: Breckland		Site Code: n/a
Approved: Claire Halpin		Project No: 4610
Signed:		Date: Revised July 2012

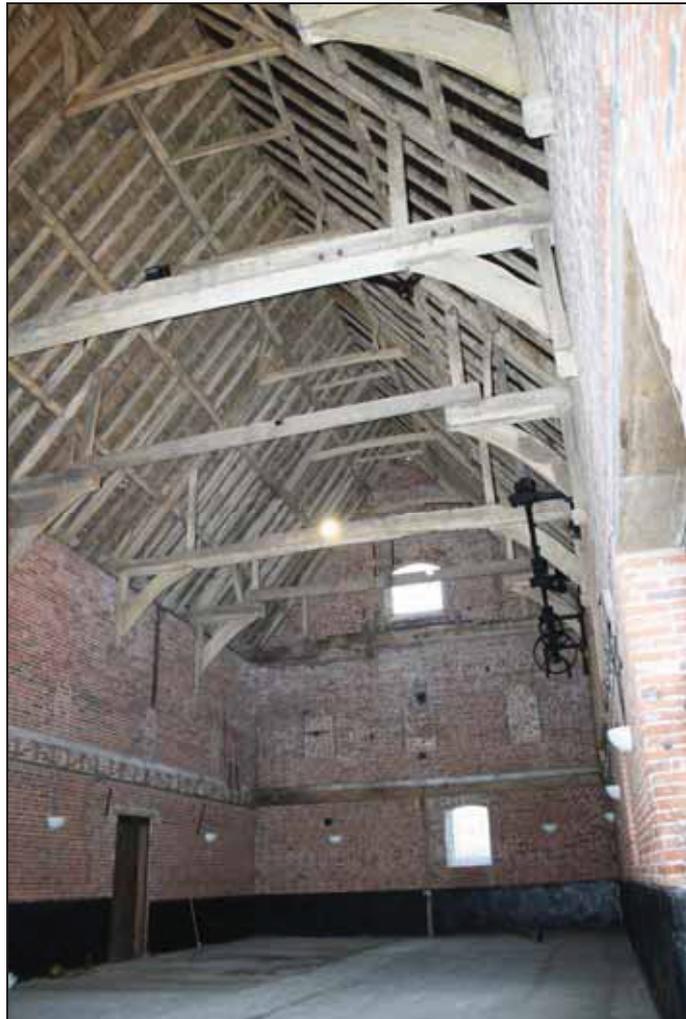
5.10 Structurally, the barn is of ten bays with conventional braced tie-beams alternating with hammer-beam trusses of similar form in eight of the bays (Plate 4). At the north end, the construction varies slightly to accommodate the domestic arrangements. The bays and trusses are noted on Fig. 10. A general description is followed by a more detailed consideration of individual areas, below.

Plate 4 Interior of the barn, taken from the north (DP 20)

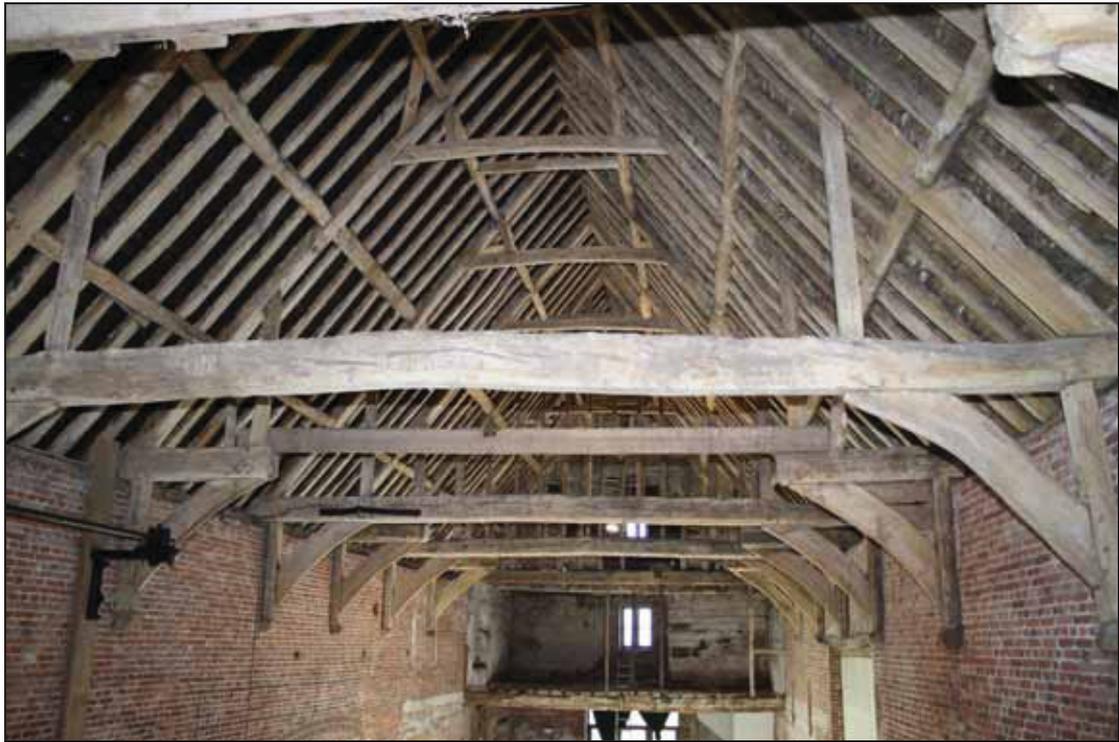
Detailed examination shows the loss of one or two, but empty mortices are not present everywhere, and there is no consistent pattern. There appears to be some replacement of rafters, and these may reflect the phase of later work demonstrated in the tree-ring analysis.

Plate 5 General view of the roof structure, taken from the south (DP 32)

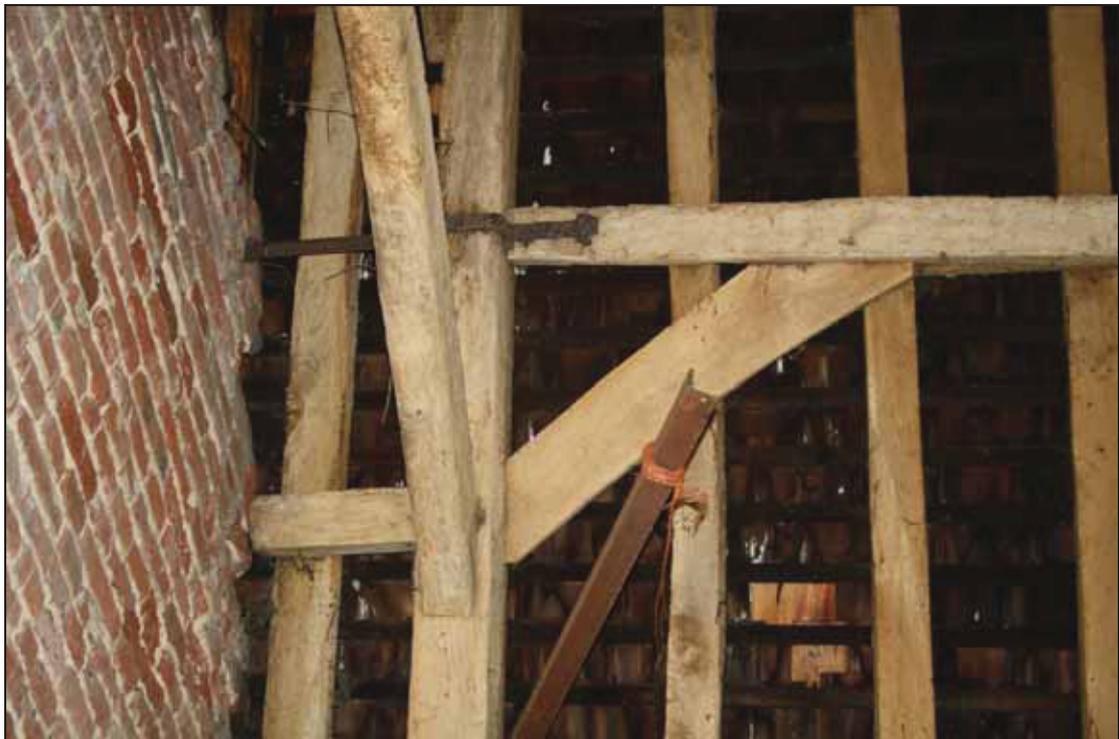
Plate 10 Detail showing west side of Truss 11 showing stub purlin and additional rafter, taken from the east (DP 36)

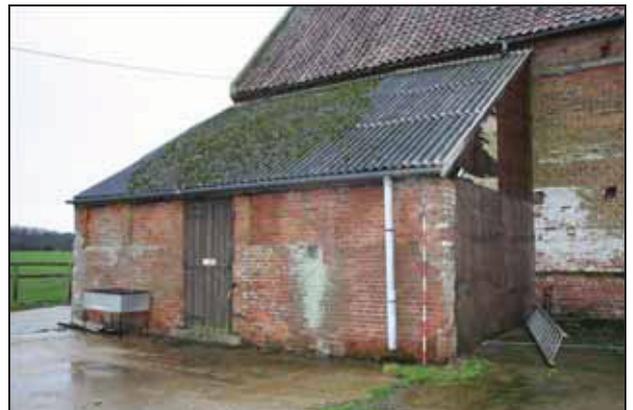
DP 6

5.29 The outshut is probably of early 19th century date and as noted has served to protect the original barn wall and pointing in this area from the elements. It is constructed of similar red brick to the main barn, laid in English bond, apart from a section of the south wall which incorporates lower panels of flintwork, suggesting that an earlier curtilage wall was raised and roofed over. The brickwork is all now whitewashed. The east wall has a blocked window with bull-nosed brick jambs. The roof is simple, having two softwood trusses with cleats supporting two purlins with wide-spaced softwood rafters to a corrugated roof. As noted above, the outshut clearly extended further north by at least two further bays, as this side is now enclosed with a flimsy boarded partition and the barn wall, now external once more, shows traces of whitewash with pockets for the ties and rafters, and also preserves original brick pointing in good condition.

Pent-roofed outshut on the east elevation, taken from the north-east

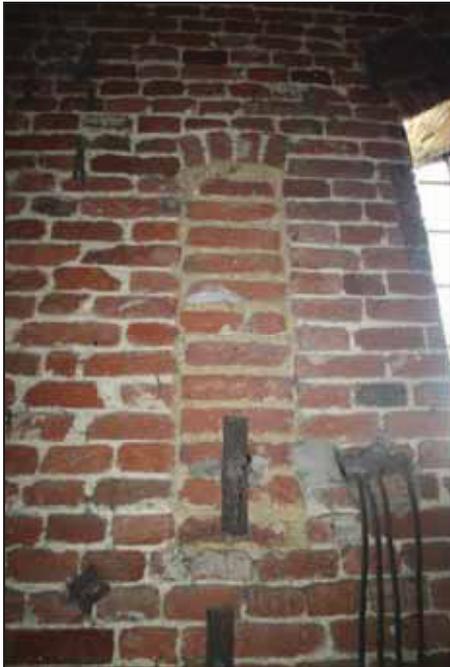
DP 35

View of blocked ventilation aperture, taken from the north

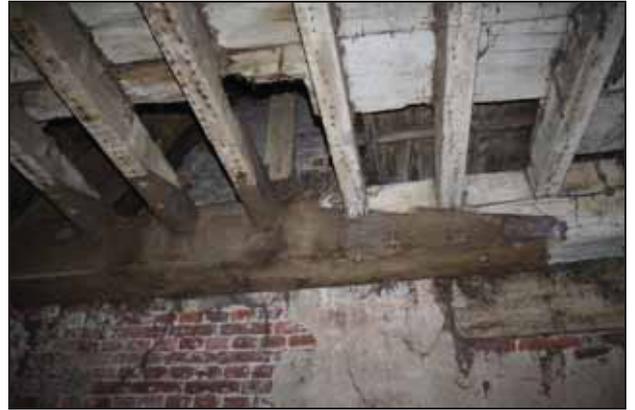
DP 68

Detail of modern repair on the north side of Bay 1 at first floor level, taken from the south

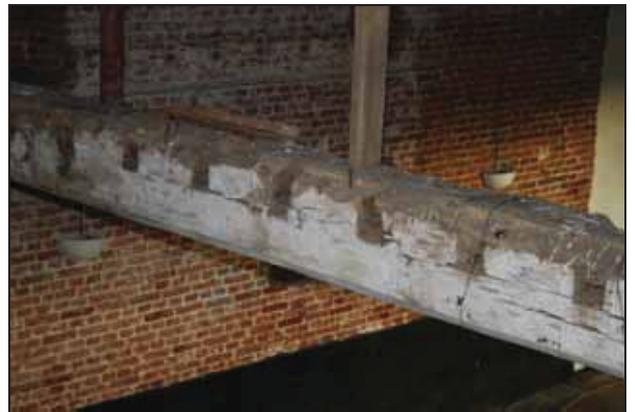
DP 70

Detail of common joist mortices in Bay 2 at first floor level, taken from the north-west

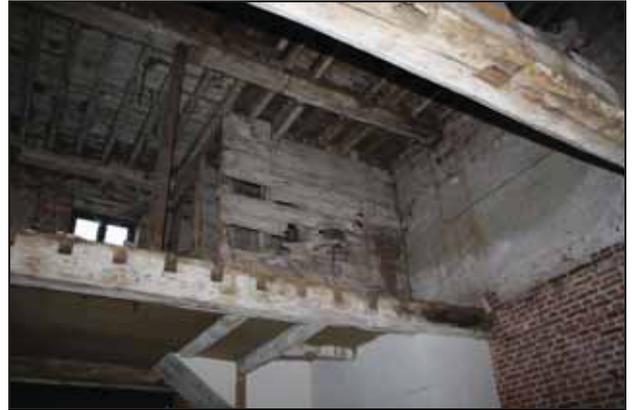
DP 78

View of the removed floor of Bay 2, taken from the south-west
