**FORMER WAGGON AND HORSES PUBLIC HOUSE,
1 HIGH STREET, WATTON AT STONE,
HERTFORDSHIRE**

**HISTORIC BUILDING RECORDING
WITH MONITORING AND RECORDING**

Authors:	Tansy Collins BSc Lee Prosser PhD Kate Higgs MA Antony Mystchin MSc (Editor)	
NGR: TL 29705 19690	Report No. 3969	
District: East Hertfordshire	Site Code: AS 1450	
Approved: Claire Halpin MIFA	Project No. 2846	
Signed:	Date: December 2011 Revised: December 2012

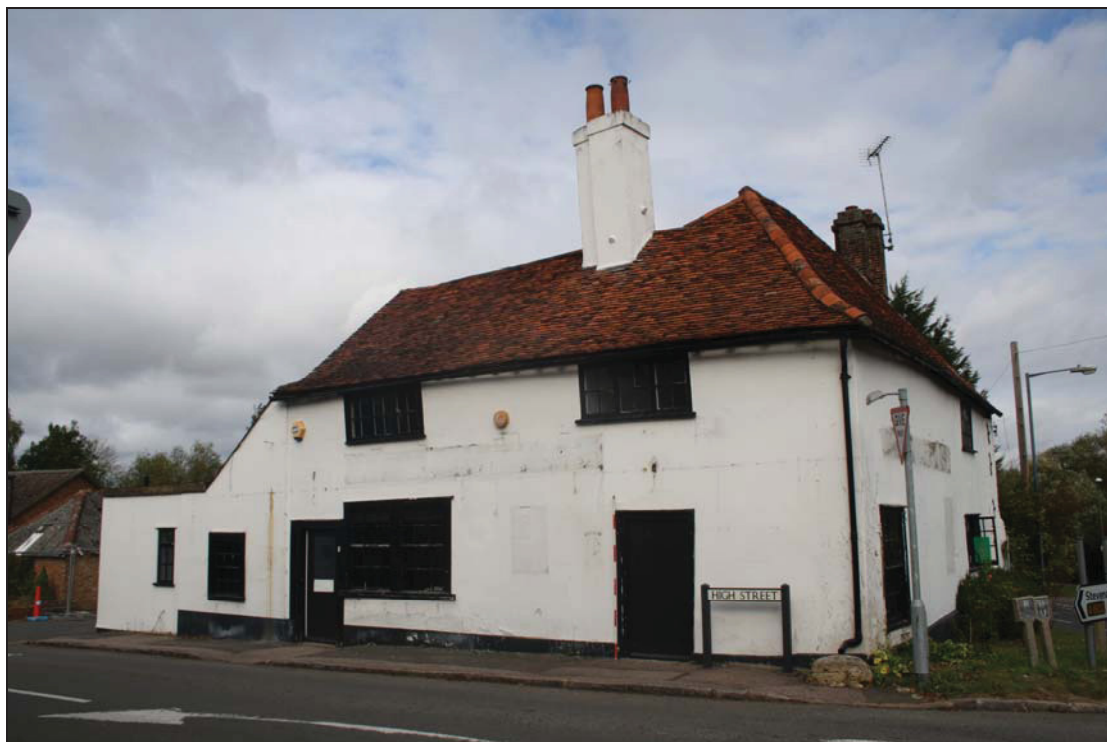
6.1.2 On the principal or south elevation, the (Plate 1) two bays are rendered and lined in fictive ashlar blocks. A multi-form, rendered chimney stack rises from the south roof pitch close to the ridge. Doors to the east and west of centre give access to the former public bars. The eastern door has a slightly moulded inner frame with a modern applied outer frame while the west door

Plate 1 South elevation, taken from the south (1)

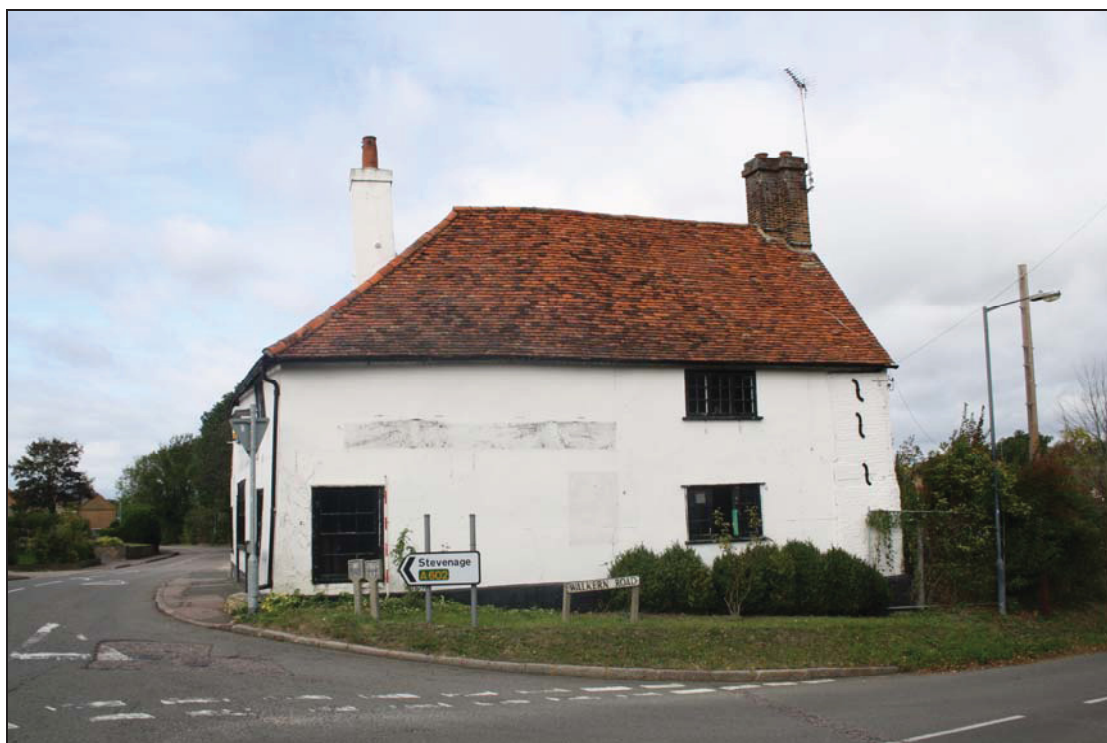
6.1.3 The east elevation (Plate 2) is timber framed, rendered and ashlar-lined as before. A double-hung sash window without horns lies to the south in an 18th / 19th century frame. To the north 20th century casement windows light the ground and first floors. Each has three lights, with six panes. The building is supported at the northern end with three iron S-braces, at the transition to painted brickwork, thus reflecting an added bay at this end.

Plate 2 East elevation, taken from the east (2)

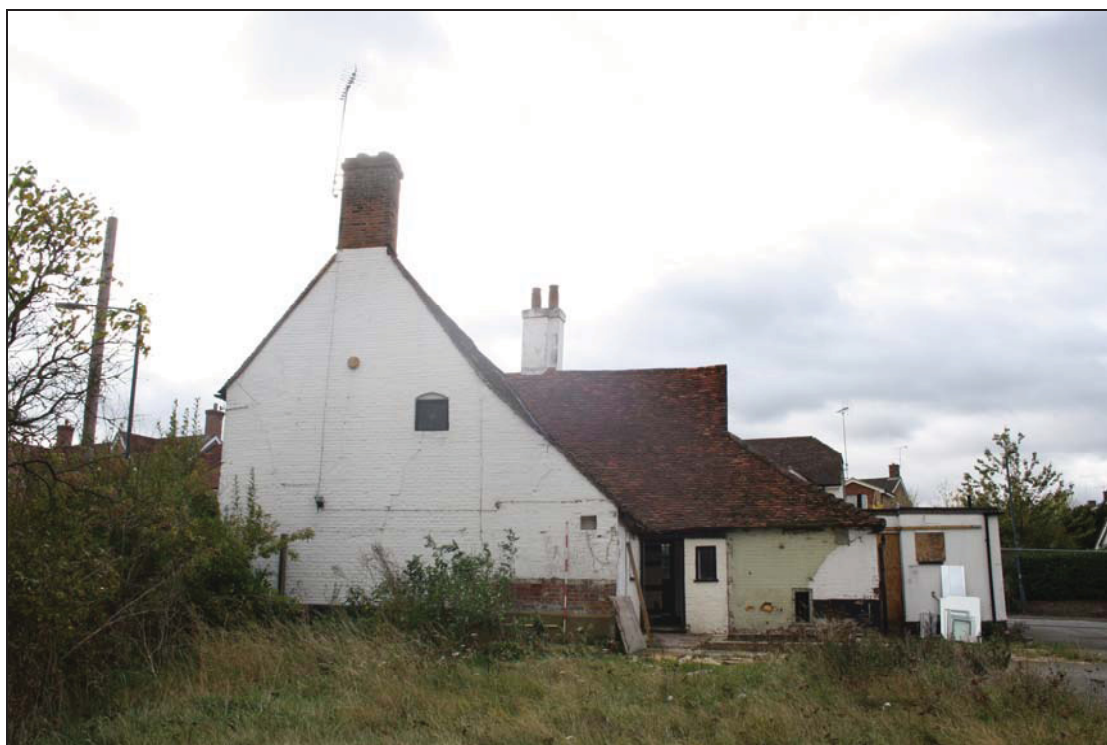
6.1.4 The north gable of the rear range comprises painted brick laid in English bond rising to an unpainted chimney stack of probable 19th century date (Plate 3). This is plain, except for a small segment-headed light at first floor level. A rudimentary brace has been fixed to the east corner, where there has been some disturbance and rebuilding of the masonry. The rest of the range is obscured by the slate pent roof of the 19th century outshut. The north elevation of the flat roofed addition to the west has a steel-framed, top-hung casement.

Plate 3 North elevation of building, taken from the north (5)

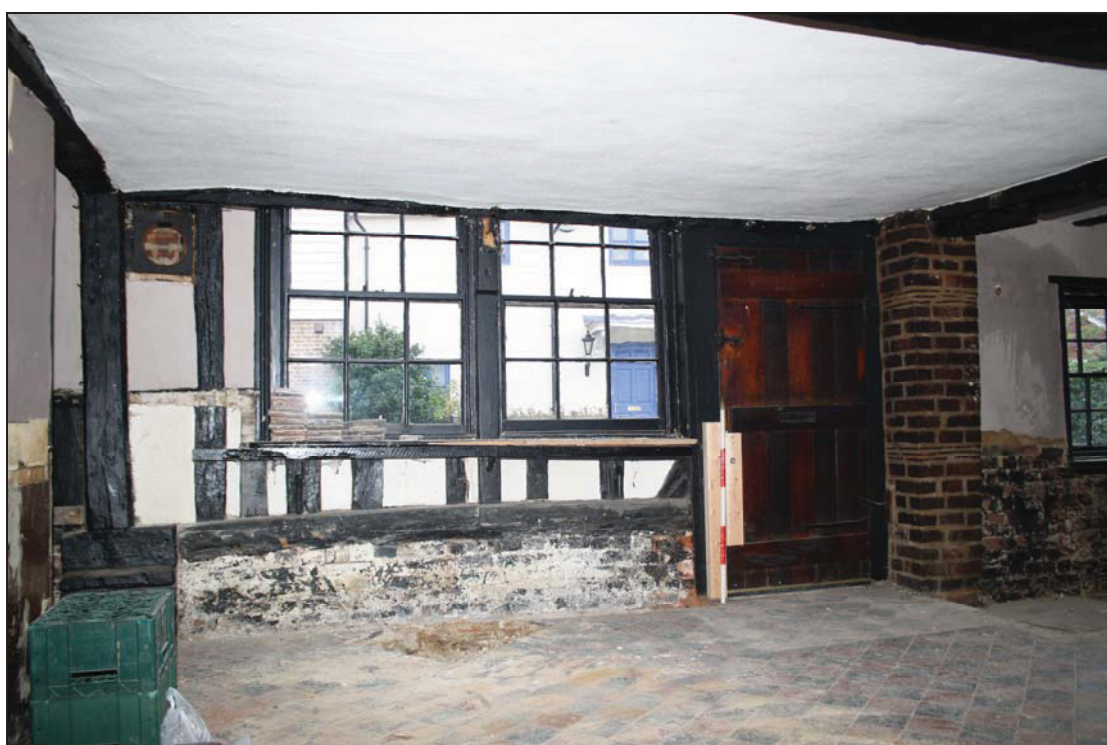
Plate 4 South side of Room GF01, taken from the north (14)

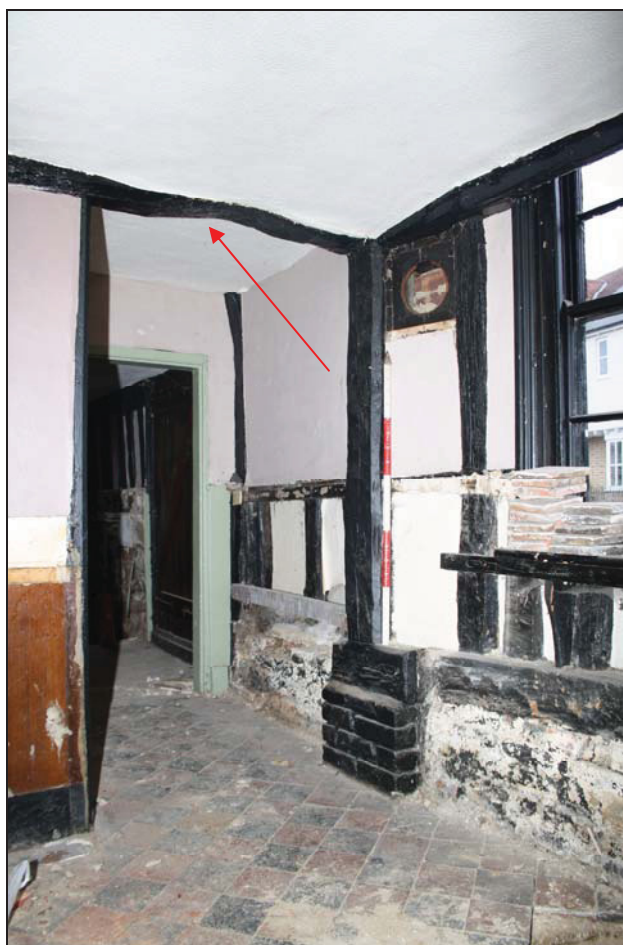
Plate 5 *Junction between Room GF01 and the lobby on the south side of the chimney stack with curved notch in the soffit (indicated), taken from the north-west (15)*

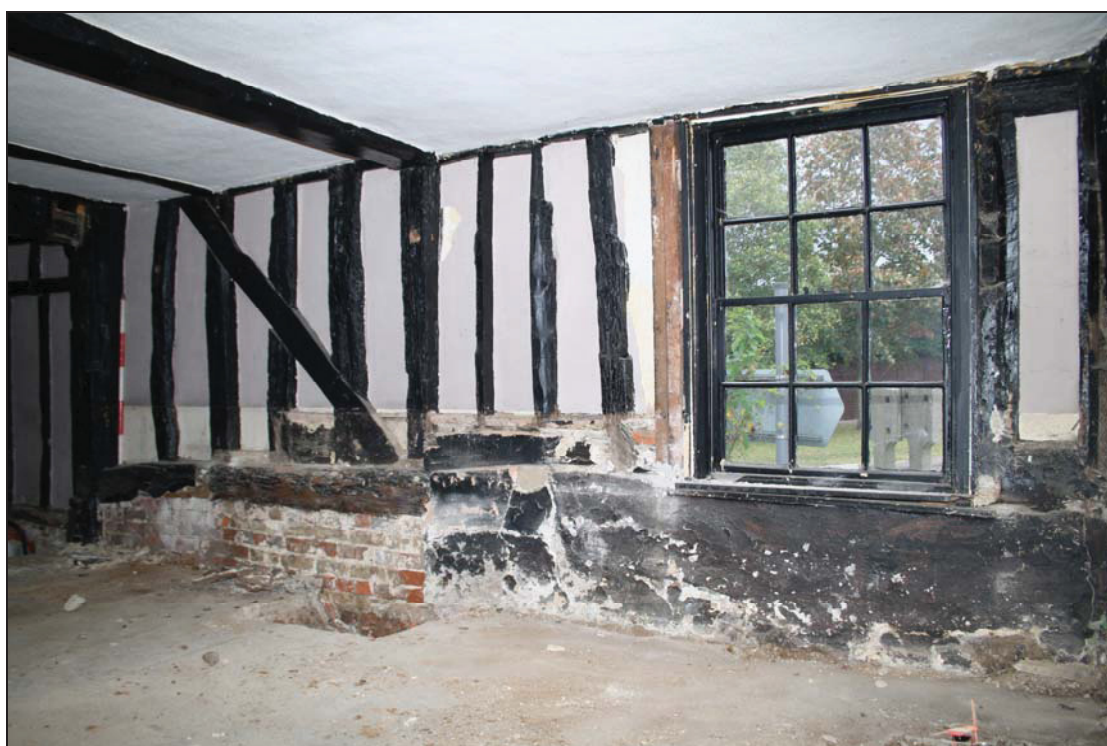
6.1.12 In Room GF03 to the east, timber framing is visible on all walls, though now smothered with black paint. The east wall (Plate 6) had a high modern match-boarded dado and shelf which obscures the lower framing, though this was removed during planned works to reveal a mixture of robust and waney studwork, some of which is clearly later and of poor quality, all resting on a solid sole-plate and dwarf wall. A tension brace is notched into the studs though appears to be a replacement. Where render has been removed the fabric of the dwarf wall is visible, comprising an orange red fabric laid in English bond with occasional overburnt headers. Both window sashes on this side have been replaced in the mid 20th century.

Plate 6 *East side of Room GF03, taken from the south-west (19)*

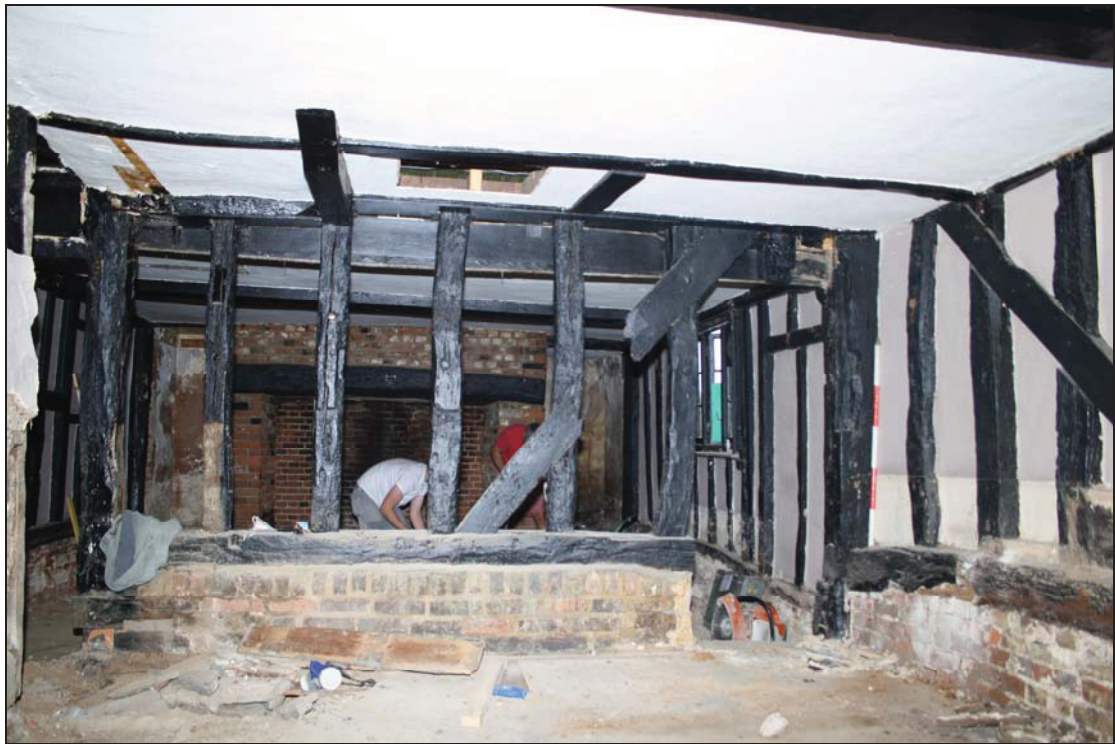
Plate 7 North side of Room GF03, taken from the south (21)

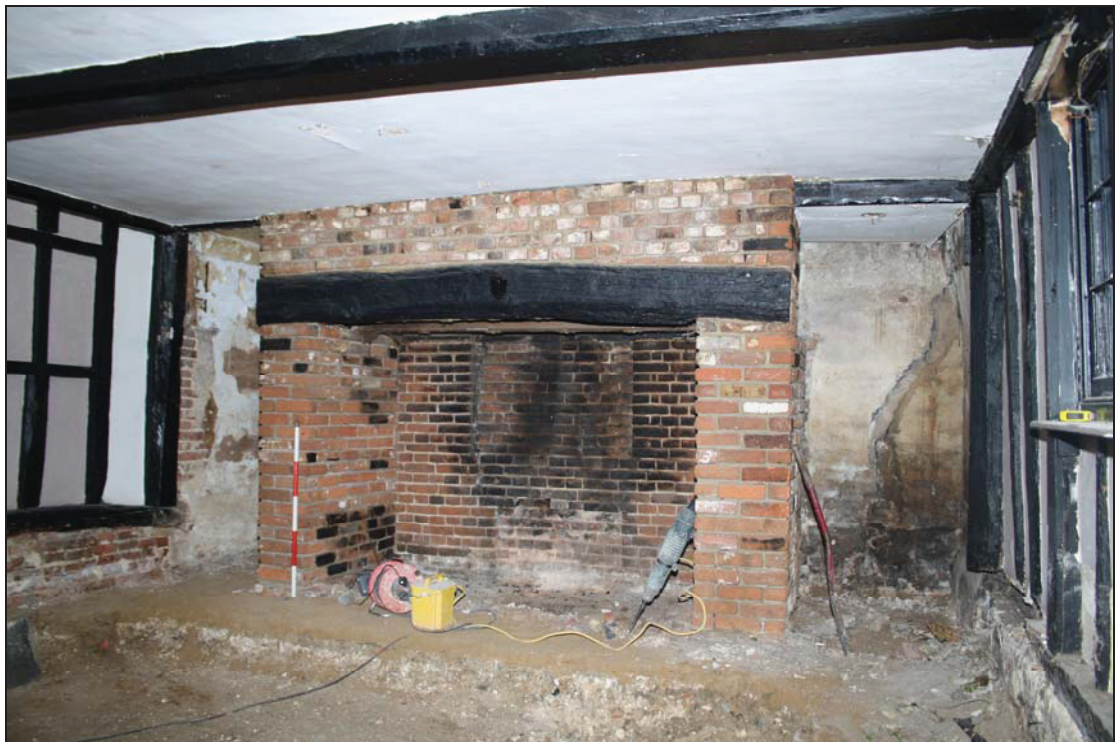
Plate 8 North side of Room GF04, taken from the south (24)

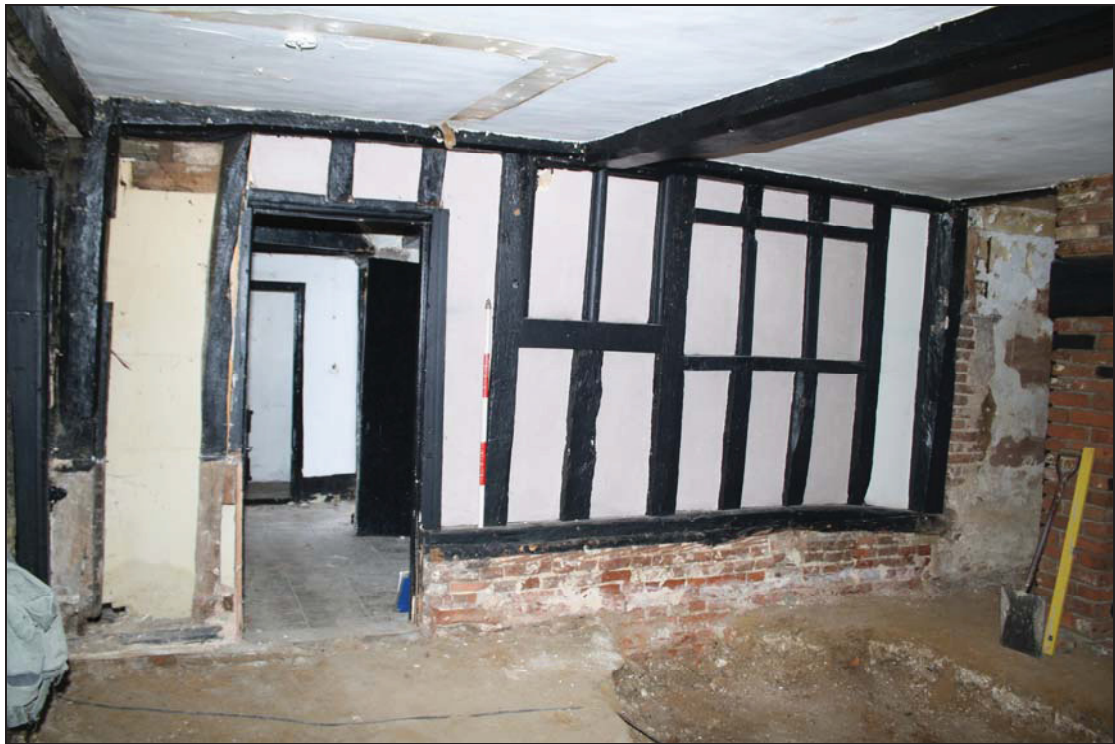
Plate 9 West side of Room GF04, taken from the east (25)

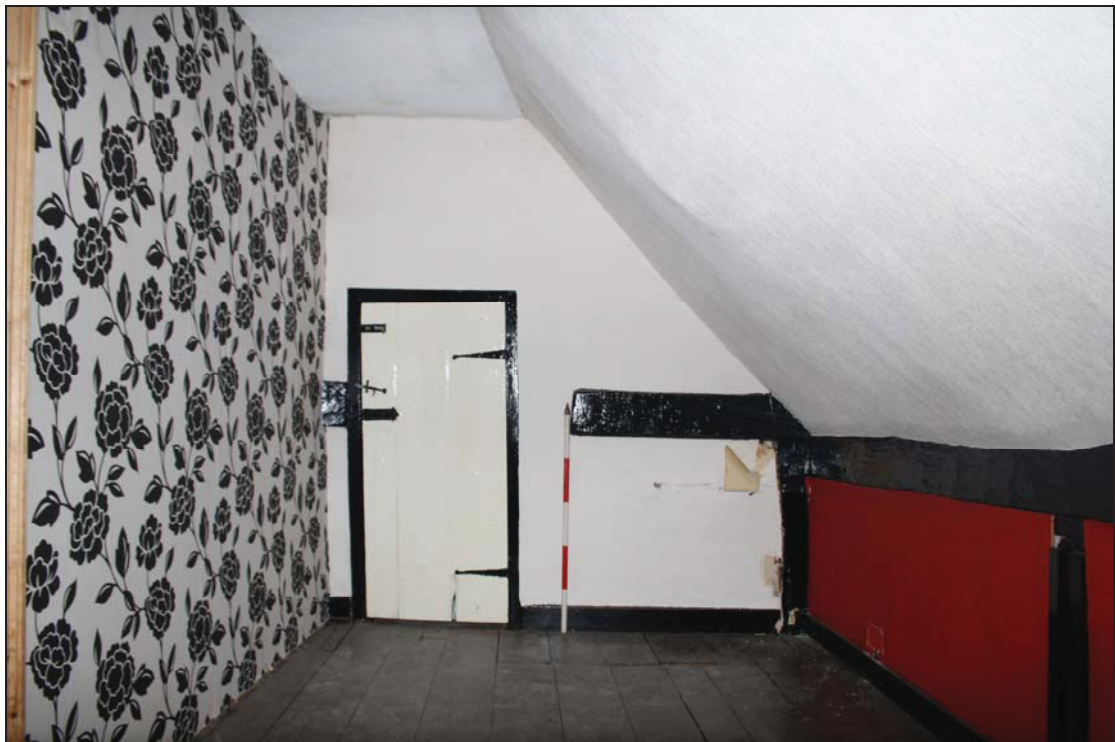
Plate 10 West side of Room FF03, taken from the east (33)

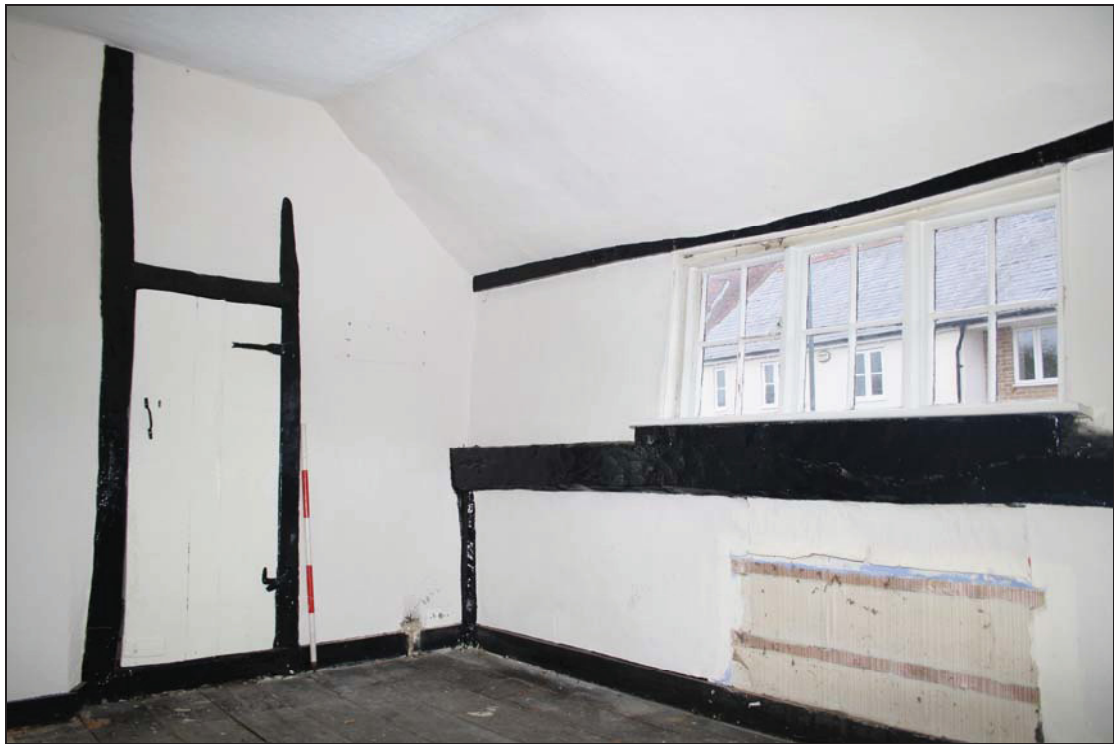
Plate 11 South and east side of Room FF04, taken from the north-west (36)

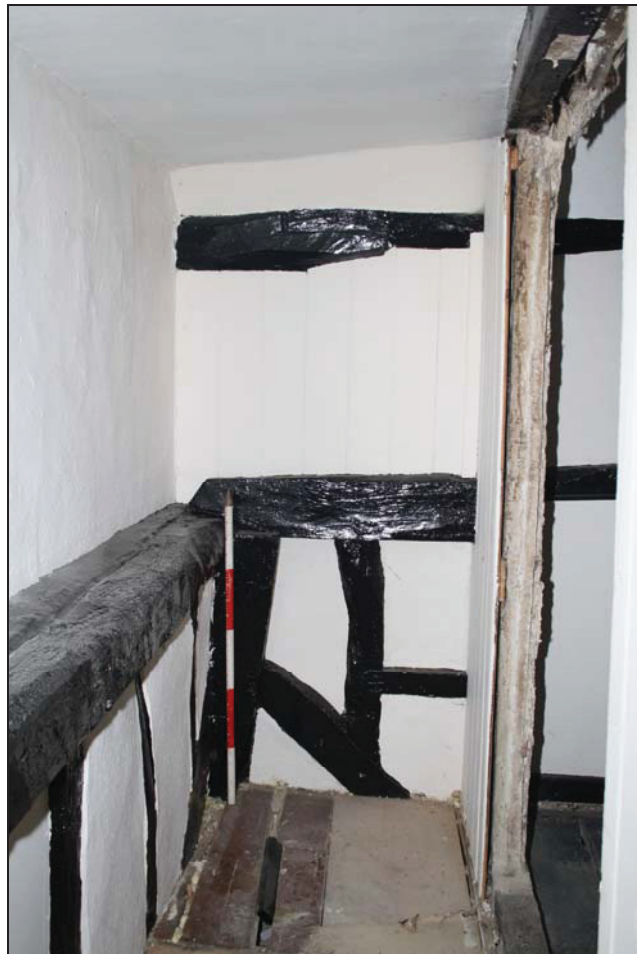
Plate 12 East end of Room FF05 showing original wall-plates with lower studwork and later inserted wall-plates above, taken from the west (42)

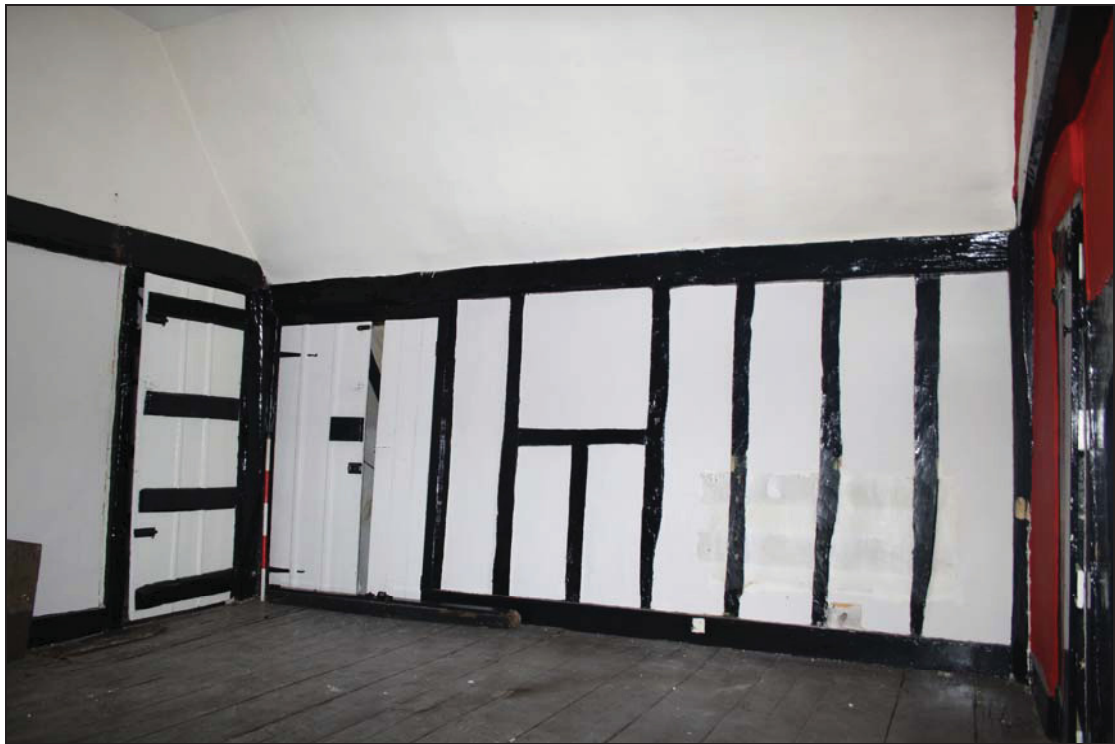
Plate 13 West wide of Room FF07, taken from the east (44)

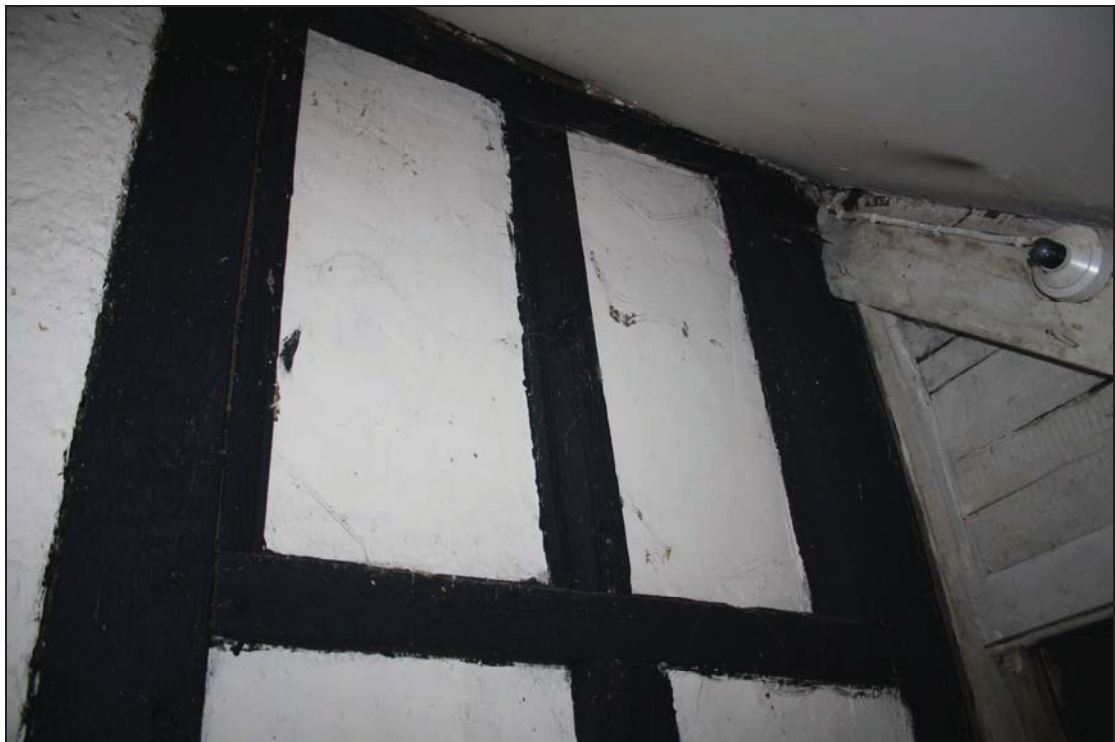
Plate 14 Blocked 17th century window of the rear wing from within Room FF08, taken from the west (44)

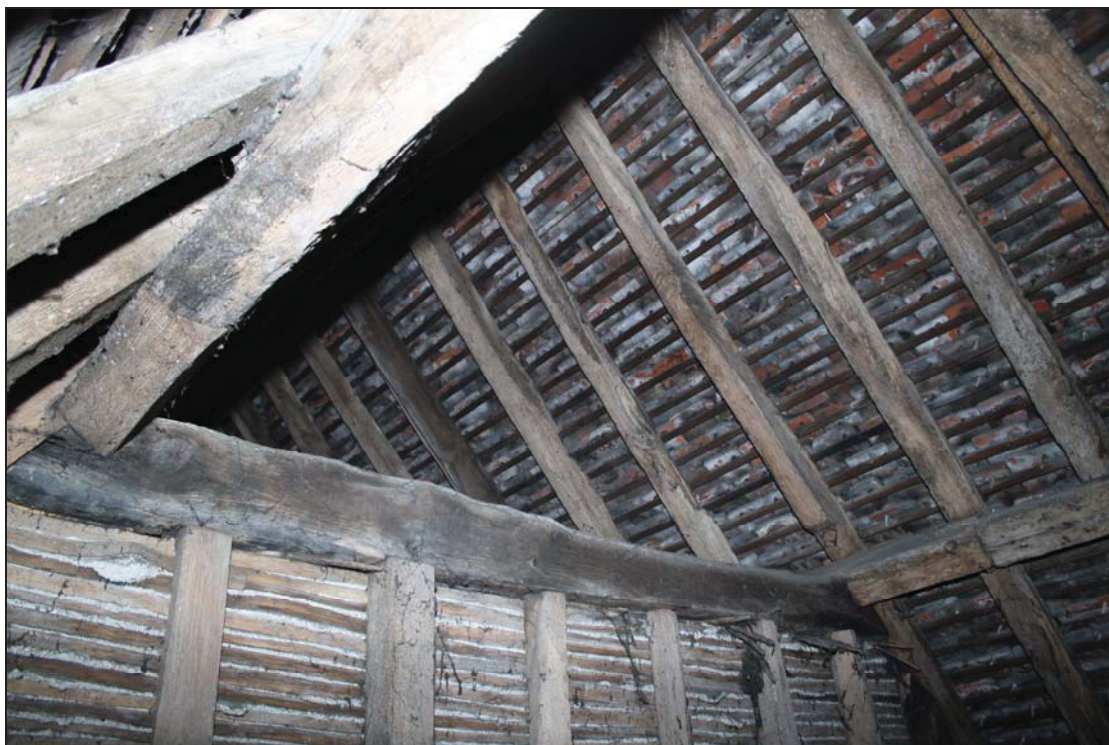
Plate 15 Roof over the rear wing, taken from the south-west (49)

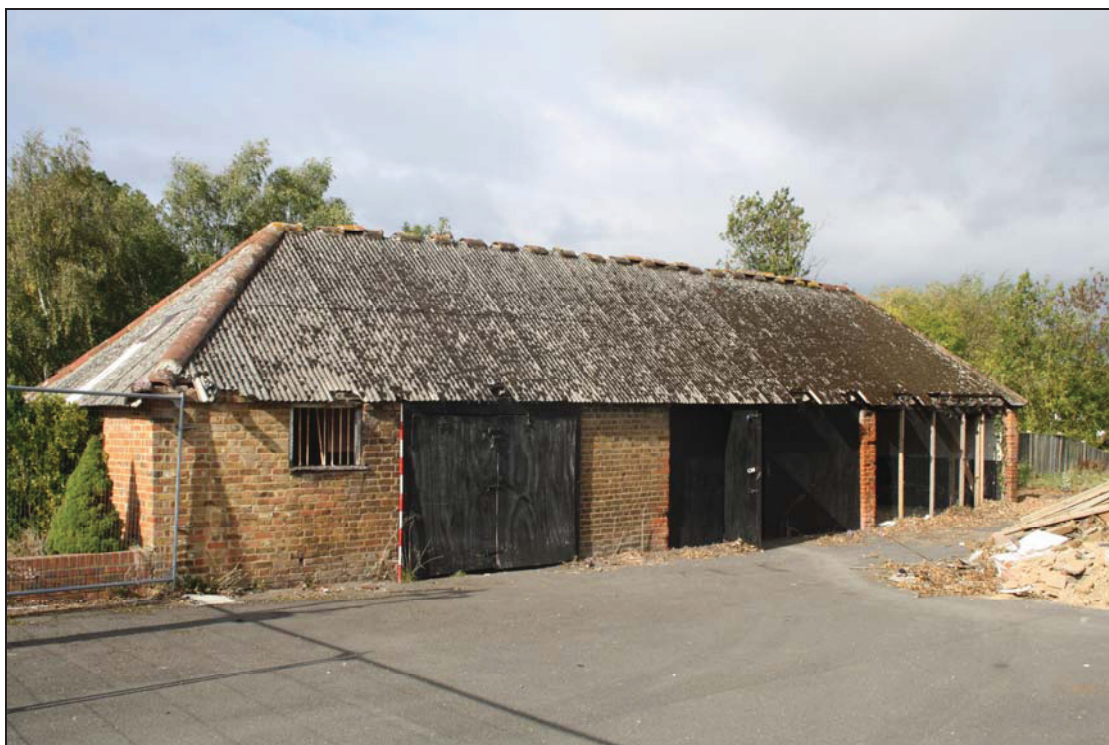
Plate 16 East elevation of outbuilding, taken from the south-east (8)

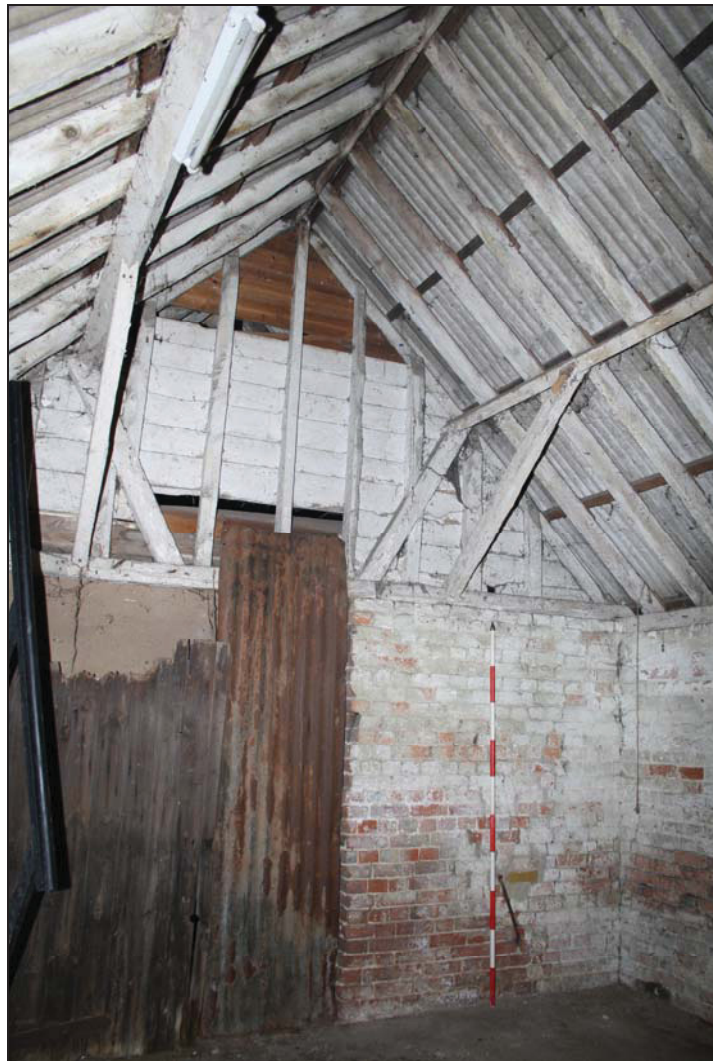
On the south wall above tie-beam level the rear face of the weatherboarded studwork is visible, all painted or lime-washed (Plate 17). Some weatherboarding appears original but there has been replacement in modern materials. The west wall is plain, relieved only by a central pilaster, though this does not support a roof truss. The east wall was originally open-fronted though now contains modern studwork of no interest, though original short diagonal ties survive in both corners from the tie-beams to the wall-plate. The wall-plate also retains a Baltic bracking mark (Plate 4).

Plate 17 South-west side of Unit 2 (outbuilding), taken from the north-east (56)
