**ST MARY'S HOUSE, CLACTON ROAD,  
LITTLE OAKLEY, ESSEX**

**HISTORIC BUILDING RECORDING  
WITH MONITORING AND RECORDING**

Authors:	Tansy Collins BSc Lee Prosser PhD Peter Thompson MA Kathren Henry	
NGR: TM 2120 2846		Report No: 4035
District: Tendring		Site Code: LOSM11
Approved: Claire Halpin MifA		Project No: 4245
Signed:		Date: February 2013

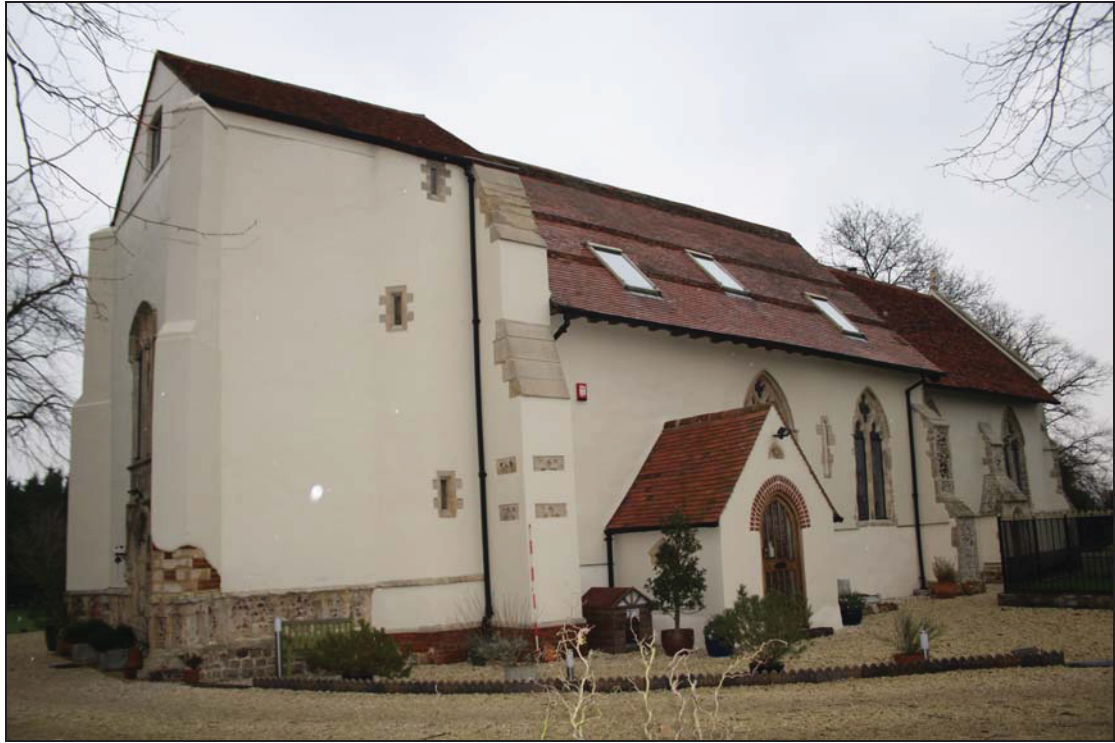
Plate 1 South elevation, taken from the south-west (DP 06)

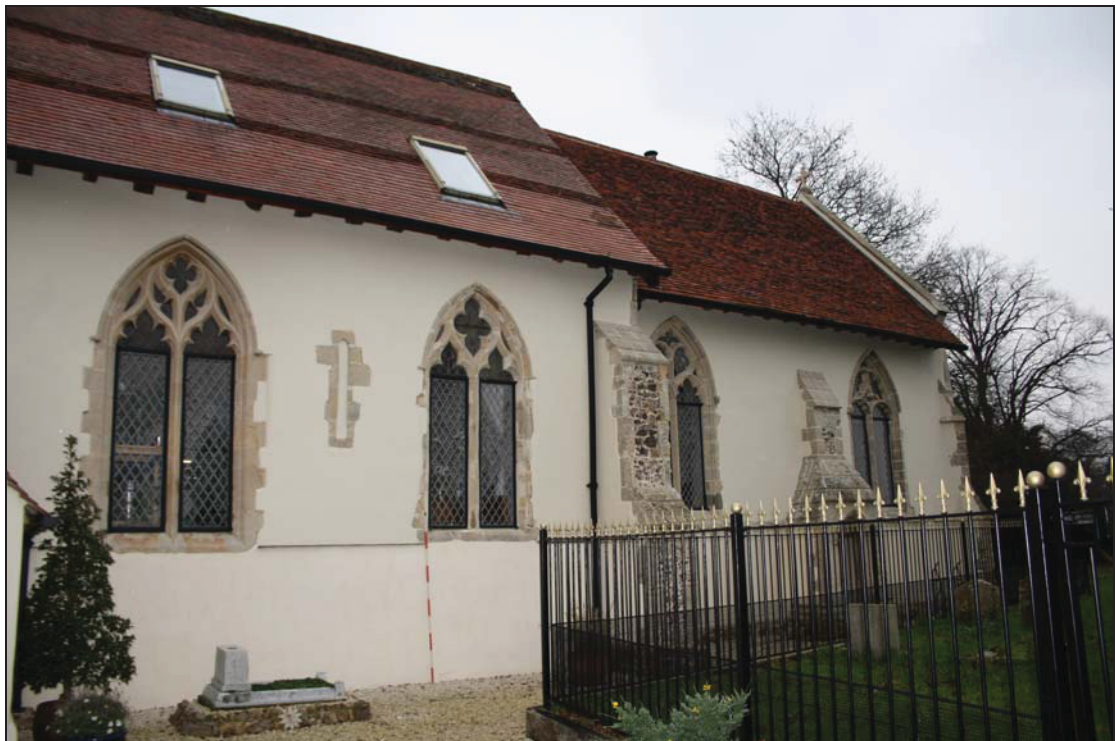
5.2 On the south elevation, the nave retains a lancet window, suggesting its 12<sup>th</sup> century date (Plate 2). This is now sandwiched between two, two-light windows with reticulated tracery, the east of probable original 14<sup>th</sup> century date though much of the stonework of the western window has been replaced. To the west, the south door is enclosed by a rendered porch, but lit by trefoil-headed windows. The tower has angled corner buttresses of brick with stone dressings set above a moulded stone plinth with empty recesses for flint flushwork. A small attached stair turret lies on the south side but appears mostly rebuilt in late 19<sup>th</sup> century brick.

Plate 2 South elevation of the nave and chancel, taken from the south-west (DP 08)

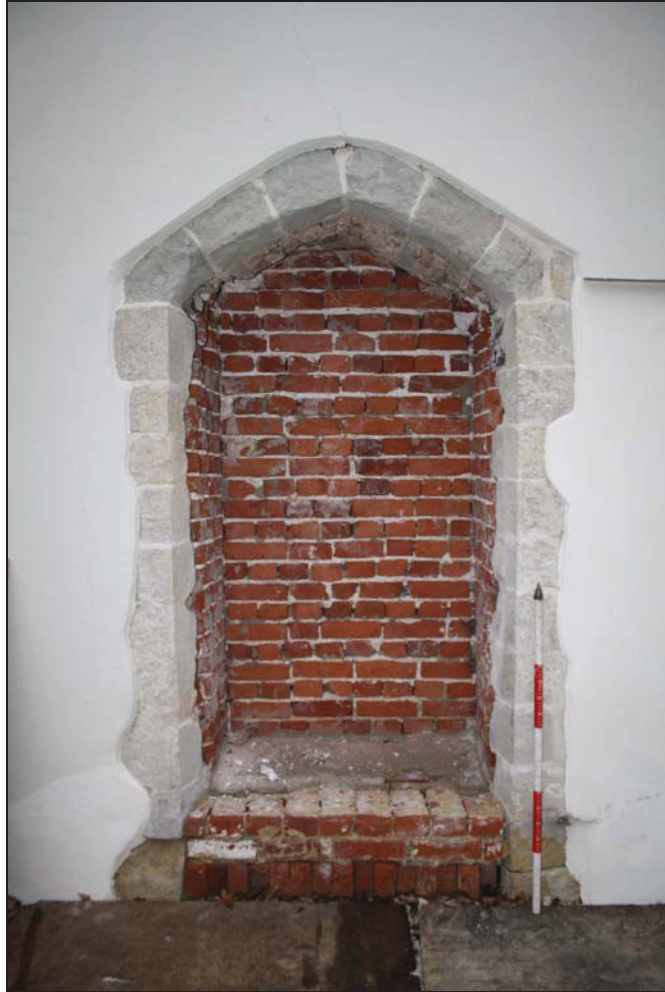
Plate 3 Blocked doorway on the north side of the chancel, taken from north (DP 12)

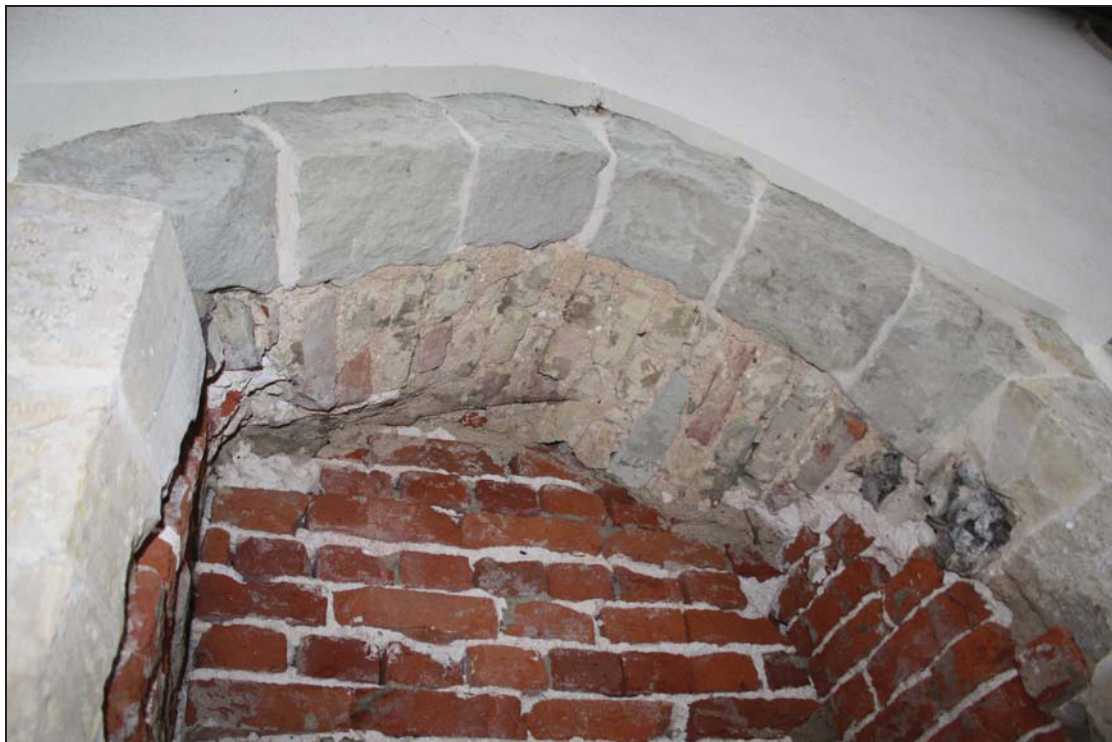
Plate 4 Arch soffit on the blocked doorway on the north side of the chancel, taken from north (DP 13)

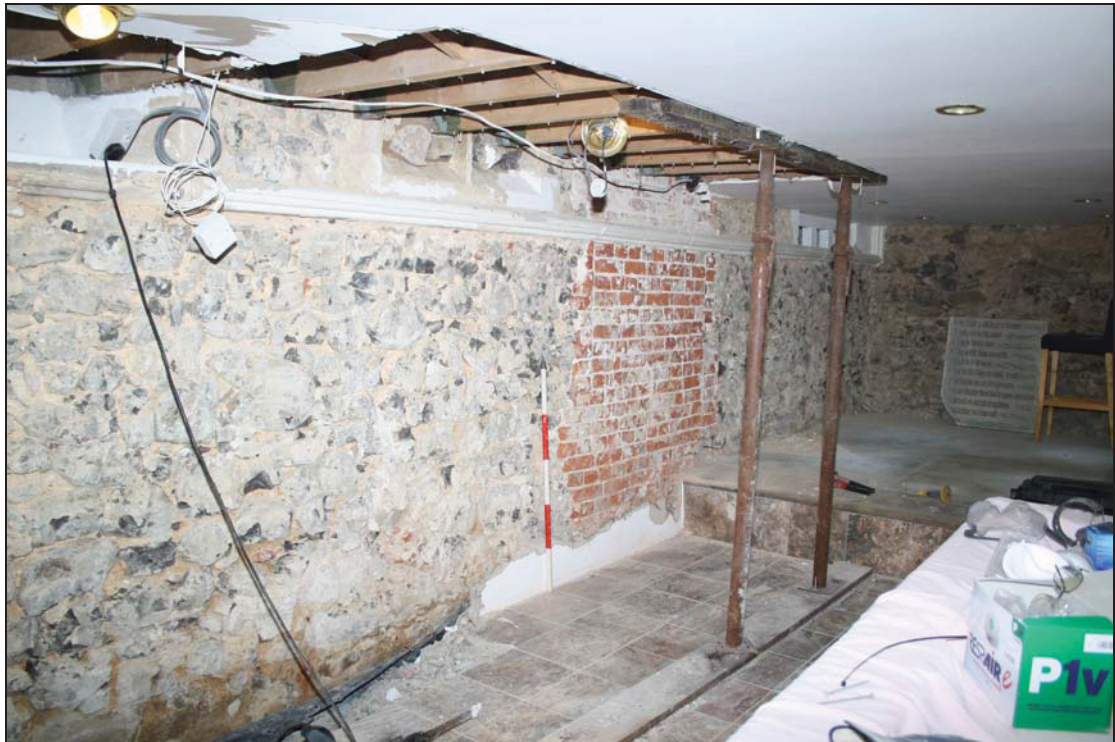
Plate 5 North wall of Room GF01 (chancel), taken from south-west (DP 15)

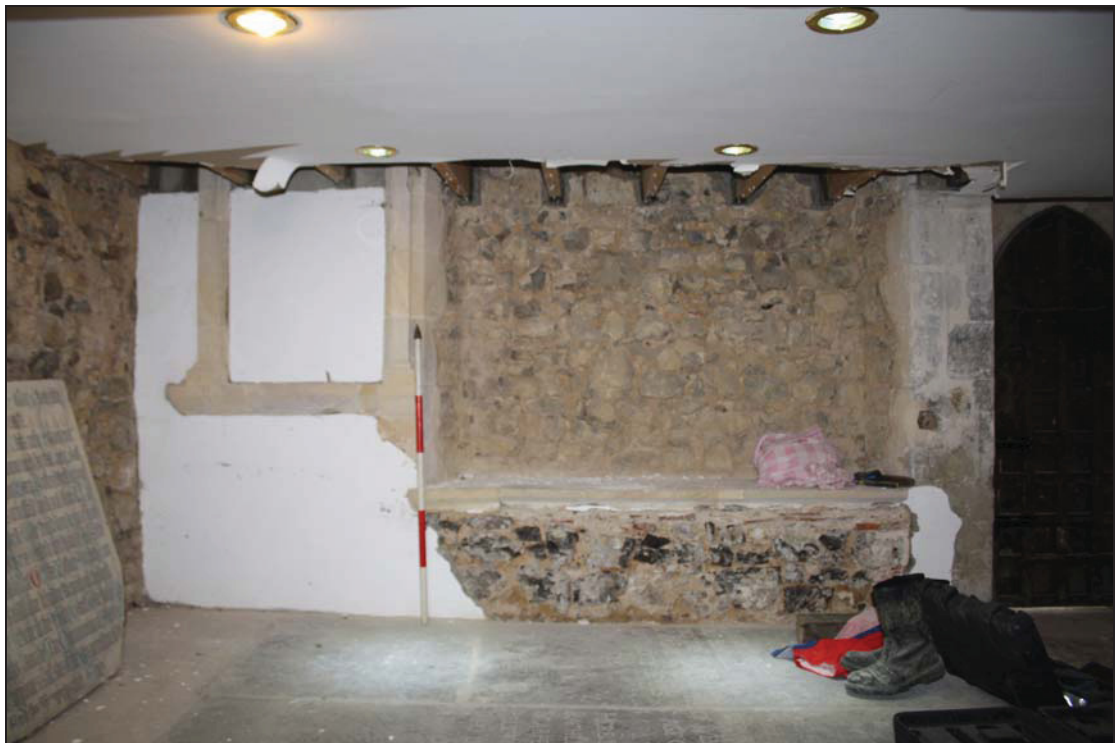
Plate 6 South wall of Room GF01 (chancel), taken from the north (DP 25)

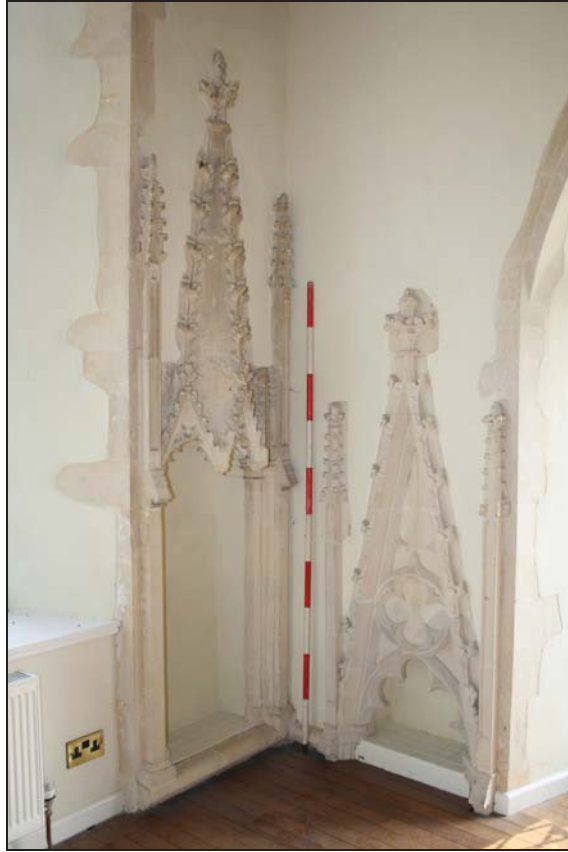
Plate 7 Hoods of image niche and piscina in the south-east corner of Room FF01, taken from the north-west (DP 46)

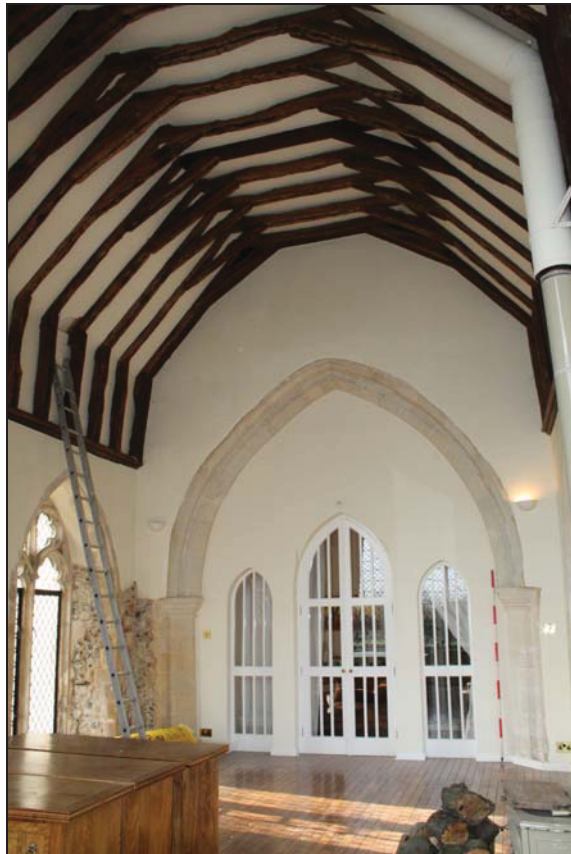
5.20 The roof structure comprises closely-spaced rafter couples with collars and double-pegged soulace-pieces (Plate 8). Ashlar pieces, some having been replaced, spring from a roll-moulded timber string or corbel course, similar in form to its stone counterpart at the base of the windows. The roof was probably once underdrawn or boarded, as distinctive nail-holes survive in the timber. This was a common 17<sup>th</sup> or 18<sup>th</sup> century modification, itself often reversed by the Victorians.

Plate 8 Room FF01, taken from the north-east (DP 42)

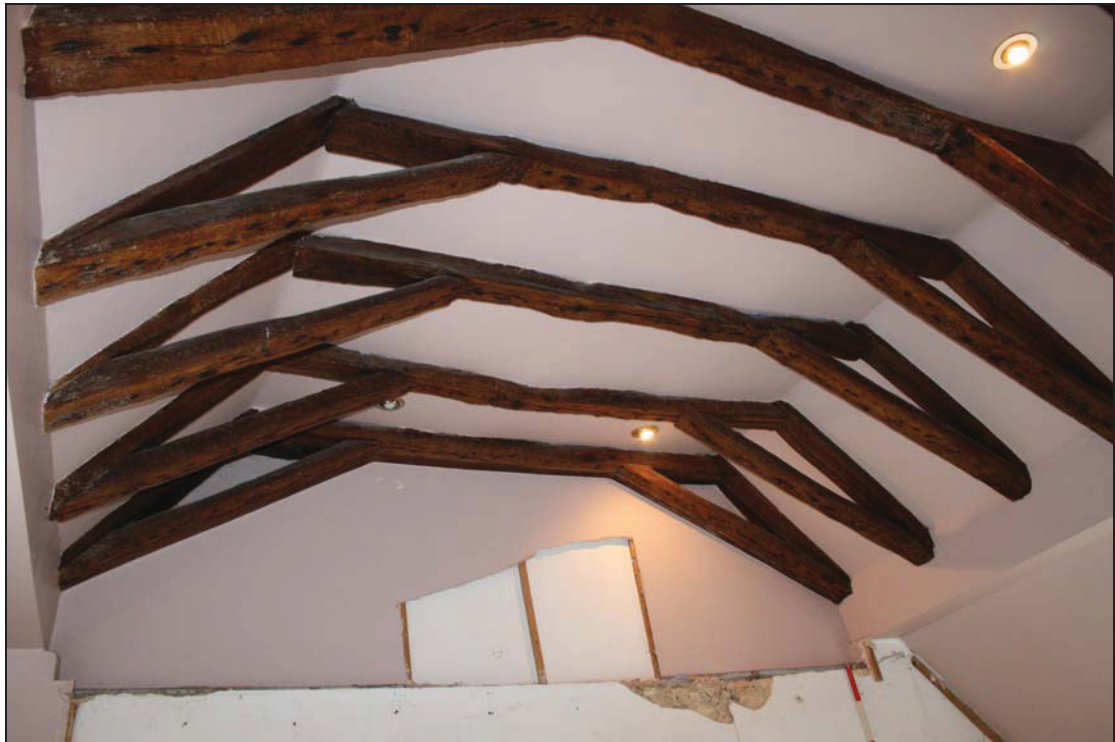
Plate 9 Roof structure in Room SF01, taken from the east (DP 36)

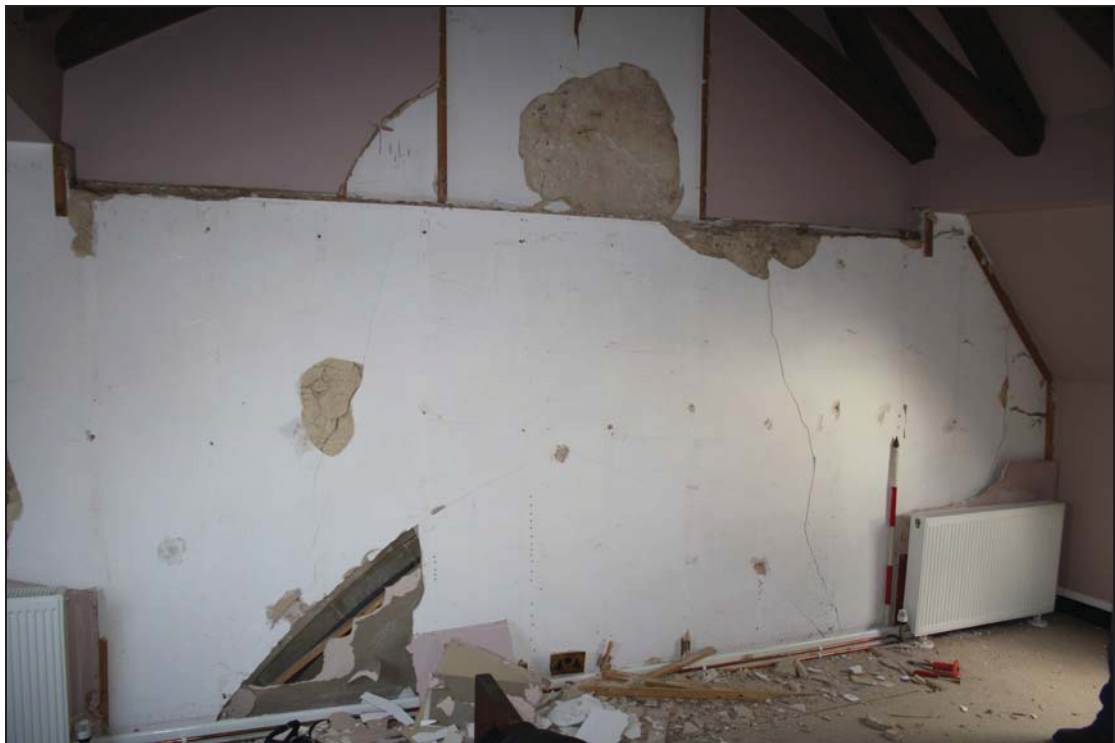
nature of the wall surface between the arch head and the apex (Plate 10). A fitted wardrobe and modern plasterboarding were removed to show that the arch survives in good condition. The masonry, by contrast rises to an offset just below soulace level, where the walling was found to be poorly built in small stone rubble with a few flints, bound with a buff-coloured mortar. A thin render finish survived, over which modern gypsum plaster has been applied. Several areas show structural cracks, particularly in the area to the north. Discrete scrapes were carried out in a random sample across the wall but no fine or finishing plaster surfaces were encountered.

Plate 10 East wall of Room SF01 during investigation, taken from the west (DP 75)

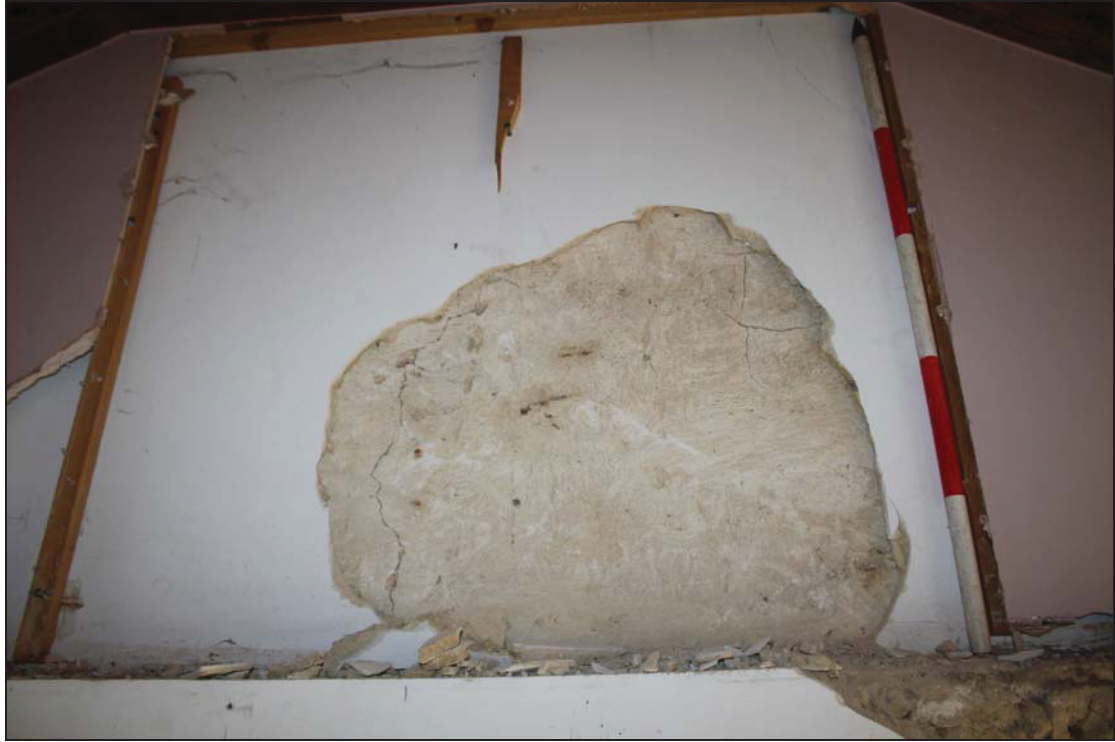
Plate 11      Detail of east wall of Room SF01 at upper level during investigation, taken from the west (DP 66)

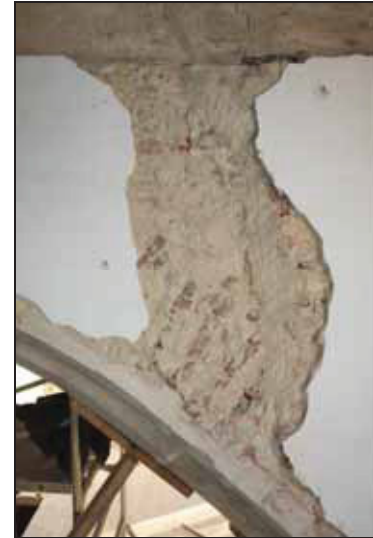
*DP 88  
Area of repair on the south side of the chancel arch showing brick repairs, taken from the west*

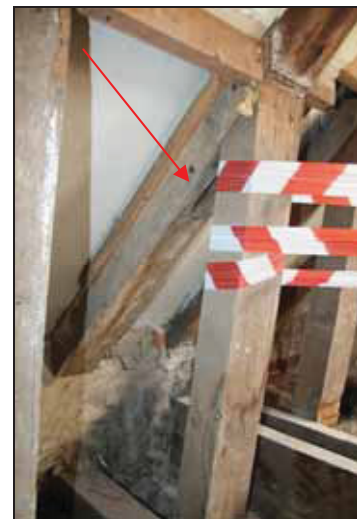
*DP 90  
North side of the nave roof showing replacement ashlar piece with empty mortice for the original (indicated), taken from the south-west*

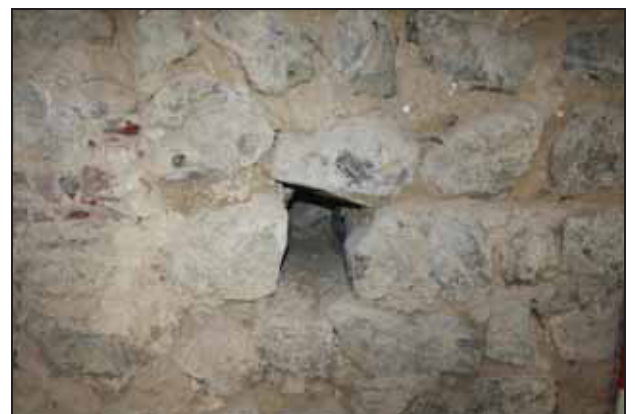
DP 96

5.22 The north wall of Room FF05 and FF06 is now exposed and there appears to be at least two distinct structural phases, to the east is a short full-height stretch of unaltered stonework consisting of fairly large coursed blocks, which continues for the majority of the wall to the west but here somewhat rebuilt and repaired. One feature of note to the east is the survival of a possible putlog hole framed with roughly squared stone blocks.

*Possible putlog hole on the north wall of the nave (FF05) exposed during the planned works, taken from the south*

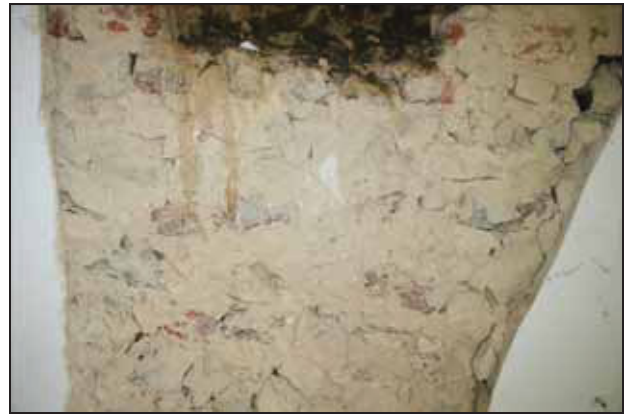
DP 106  
Detail of the construction of the nave wall to the south of the chancel arch showing later brick fabric, taken from the west

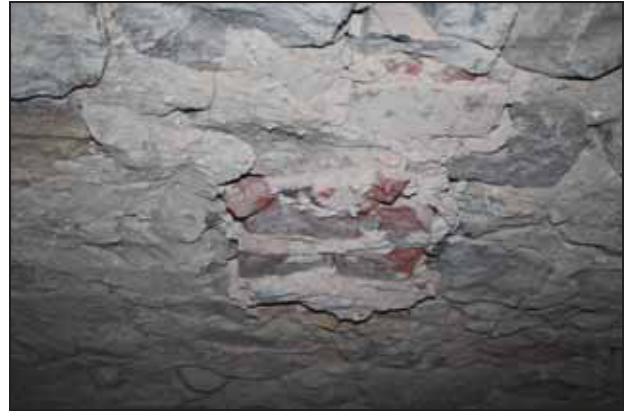
DP 110

*Possible putlog hole or area of repair on the north wall of the nave at upper level (SF06) during the planned works, taken from the north*
