**THE COACH HOUSE
DOLPHIN YARD, ST ALBANS
HERTFORDSHIRE**

HISTORIC BUILDING RECORDING

Authors:	Tansy Collins Bsc Lisa Smith BA	
NGR: TL 14712 07032		Report No: 4217
District: St Albans		Site Code: AS 1558
Approved: Claire Halpin MfA		Project No: 5050
Signed:		Date: December 2012

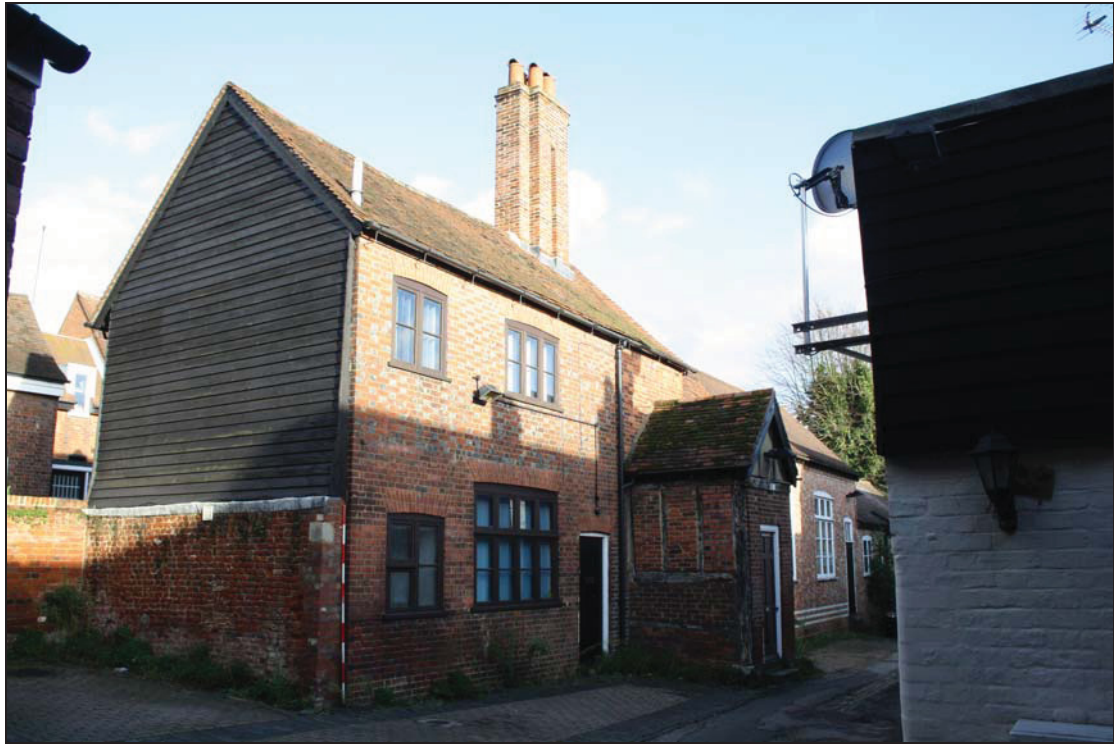
5.3 The principal south elevation faces south into Dolphin Yard and has a single-storey porch at the east end (Plate 1). No sign of the timber frame exists on this side and has been rebuilt in fine early 19th century brickwork. This is most coherent at upper level where red brick is interspersed with overburnt headers in a chequerboard pattern, but elsewhere appears to have seen phases of repair, particularly at the east end which appears to confirm the porch formerly rose to full-height. At ground floor level the main façade is pierced by a doorway and two windows of varying size with two further windows at upper level. All apertures are set beneath gauged brick arches with slightly cambered soffits. Although the existing doors and windows are modern, the apertures are all original to the re-fronting of the building. The presence of the doorway directly into the main range as well as to the porch it suggests the building was divided at an early date.

Plate 1 South side of Range 1, taken from the west (DP 1)

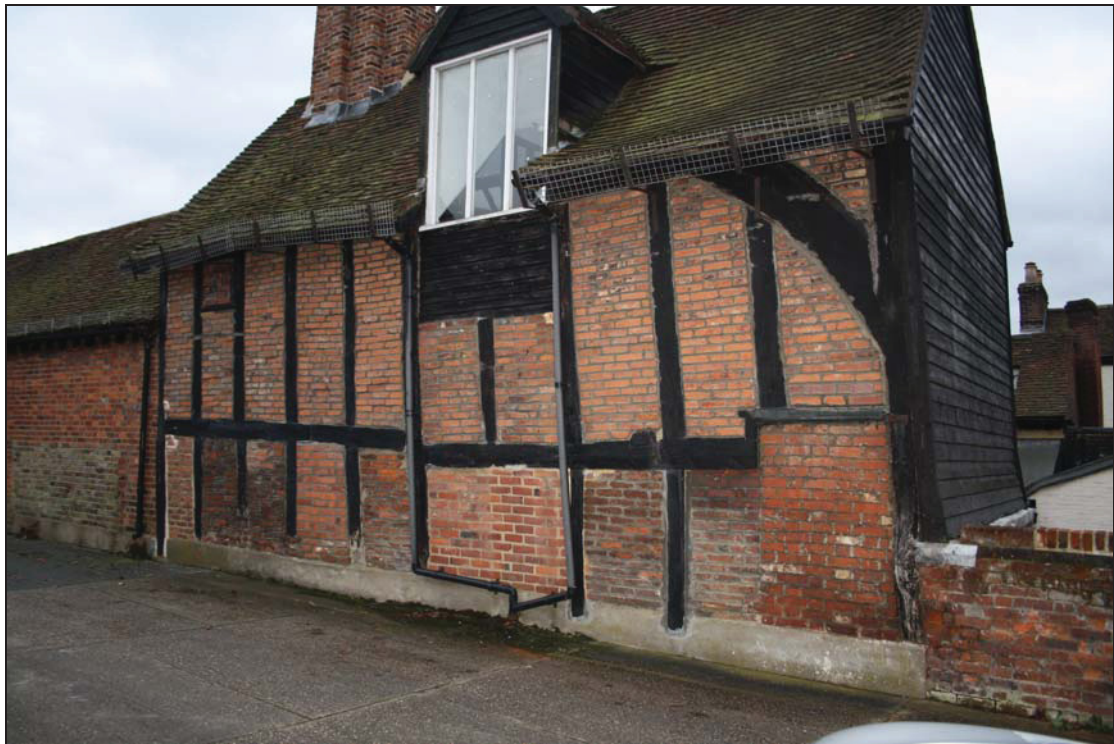
5.7 The north side of the building preserves the most historic fabric though the ground level has been substantial built up and is set approximately 1m above the ground level to the south (Plate 2). The timber framing here is of fairly robust members, apparently of oak or other hardwood, now all painted with sections of modern repair in softwood scarfed in and treated to blend in with the earlier timber. The original timber frame infill has been entirely replaced in brick of varying dates, the majority including a slender orange fabric, measuring 8-8³/₄" x 2-2¹/₄" (203-222mm x 51-57mm) with patches of repair and replacement elsewhere, while a dormer window rises above the elevation through the roof pitch. The casement is modern but a dormer window in this position may be depicted on a photograph dated 1899, noted above.

Plate 2 Northern elevation of Range 1, taken from the north (DP 7)

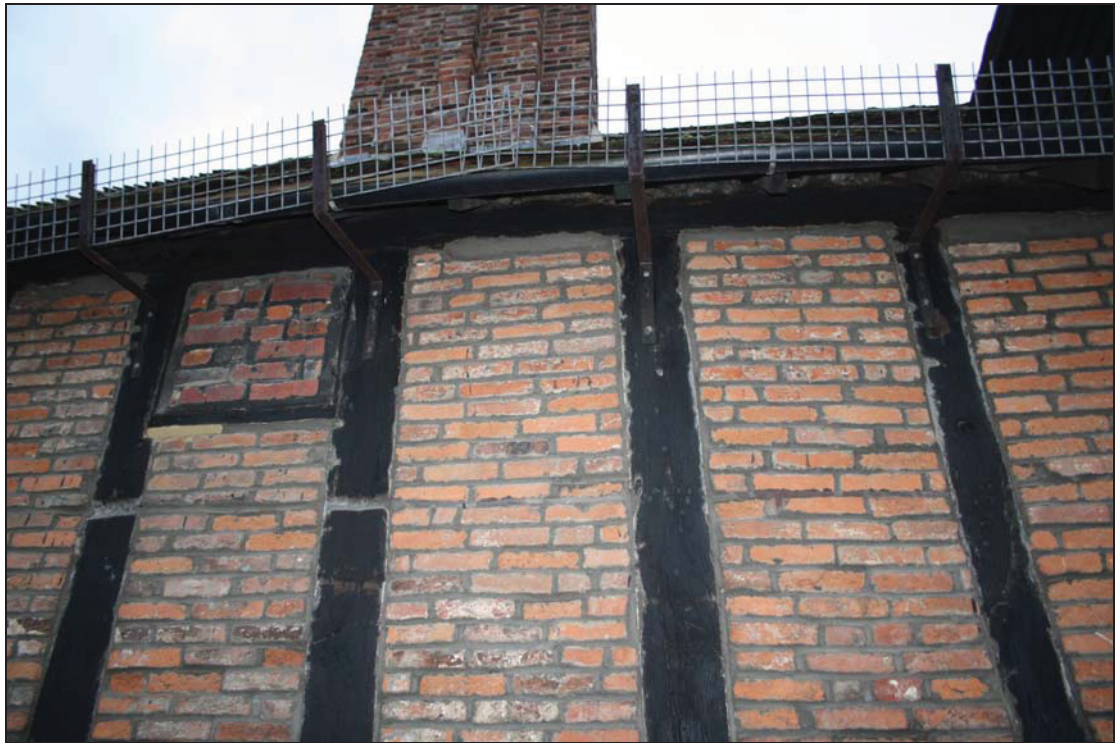
Plate 3 Position of a tripartite window on the north side of the east bay, Range 1, taken from the north (DP 28)

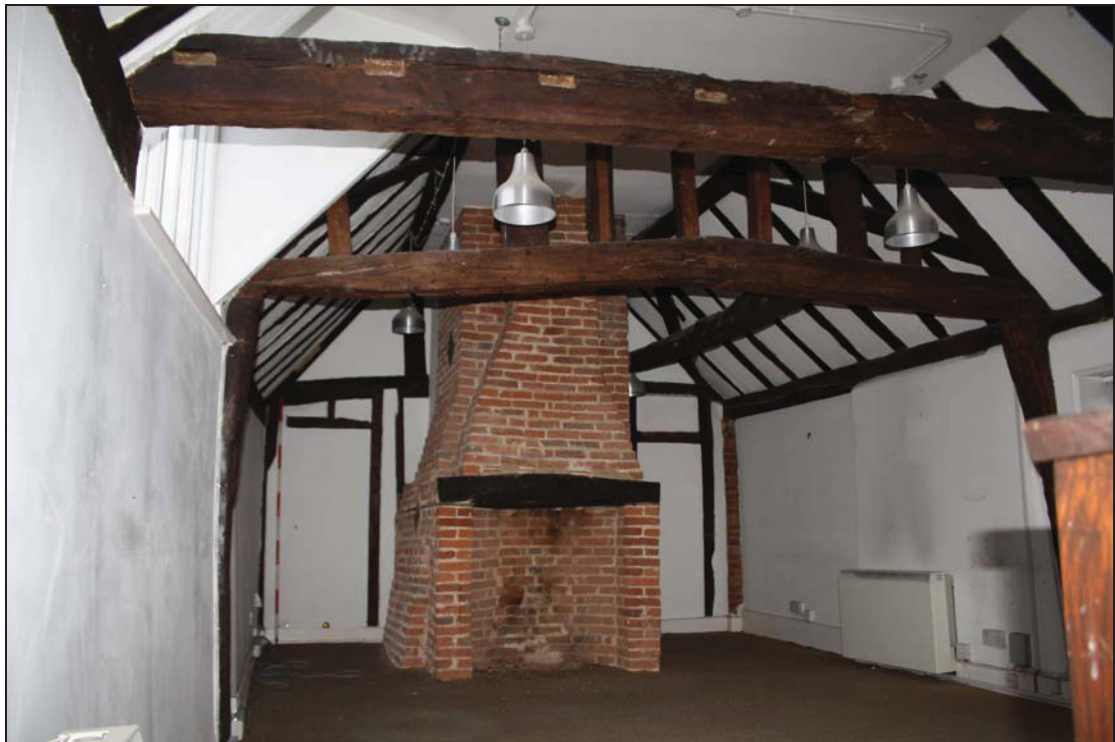
5.18 More of the historic fabric is exposed at first floor level and the form and layout of the building is more readily discernible. The principal original elements of the timber frame are exposed but there have clearly been phases of alteration with areas of loss and repair. Some of the area, the south wall particularly, is dry-lined but may preserve historic fabric and evidence for the evolution of the building. The space is divided with a truss at the bay division but otherwise comprises a single open space with the chimney stack at the east end, all ceiled above collar level (Plate 4).

Plate 4 West end of Room FF01, Range 1, taken from the north-west (DP 14)

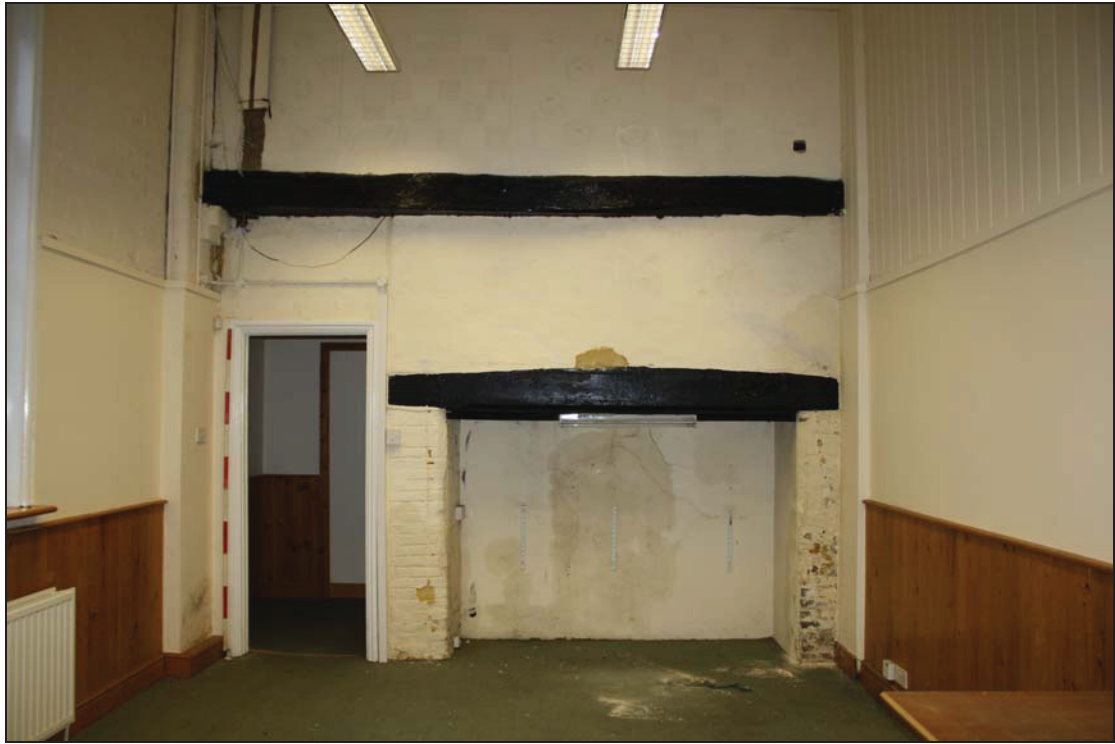
Plate 5 Former west end of the truncated bays of Range 1 from within Range 2, taken from the east (DP 19)

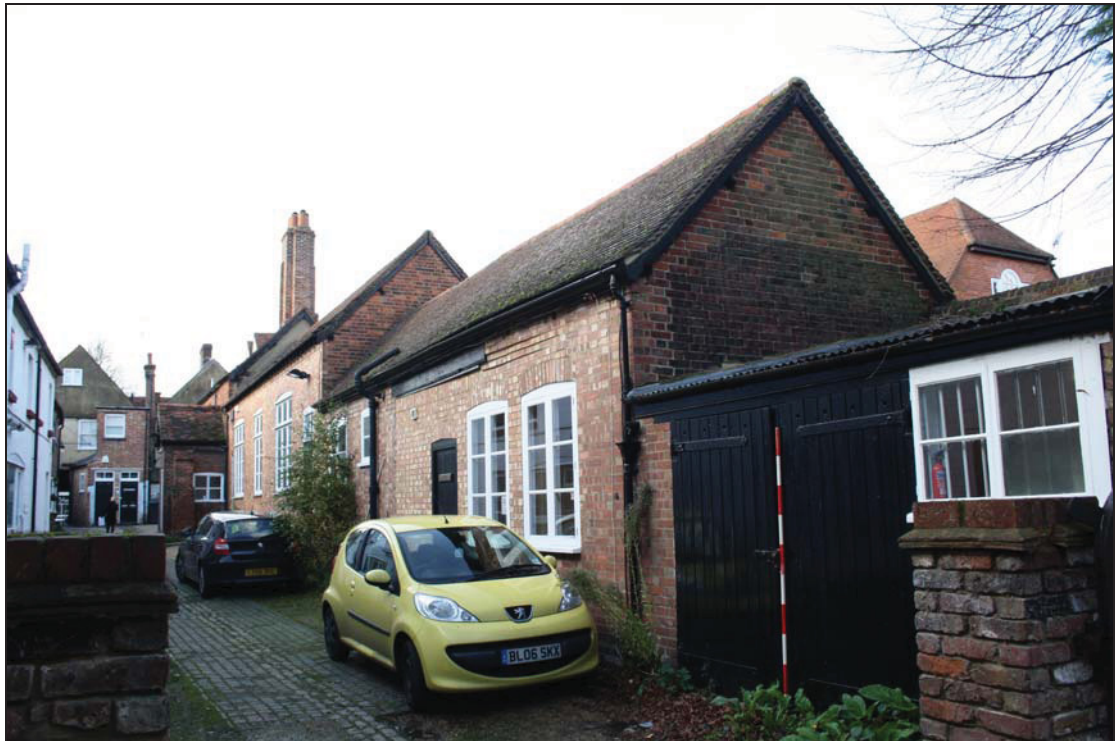
Plate 6 Dolphin yard, Ranges 1-4, southern elevation, taken from the south (DP 4)

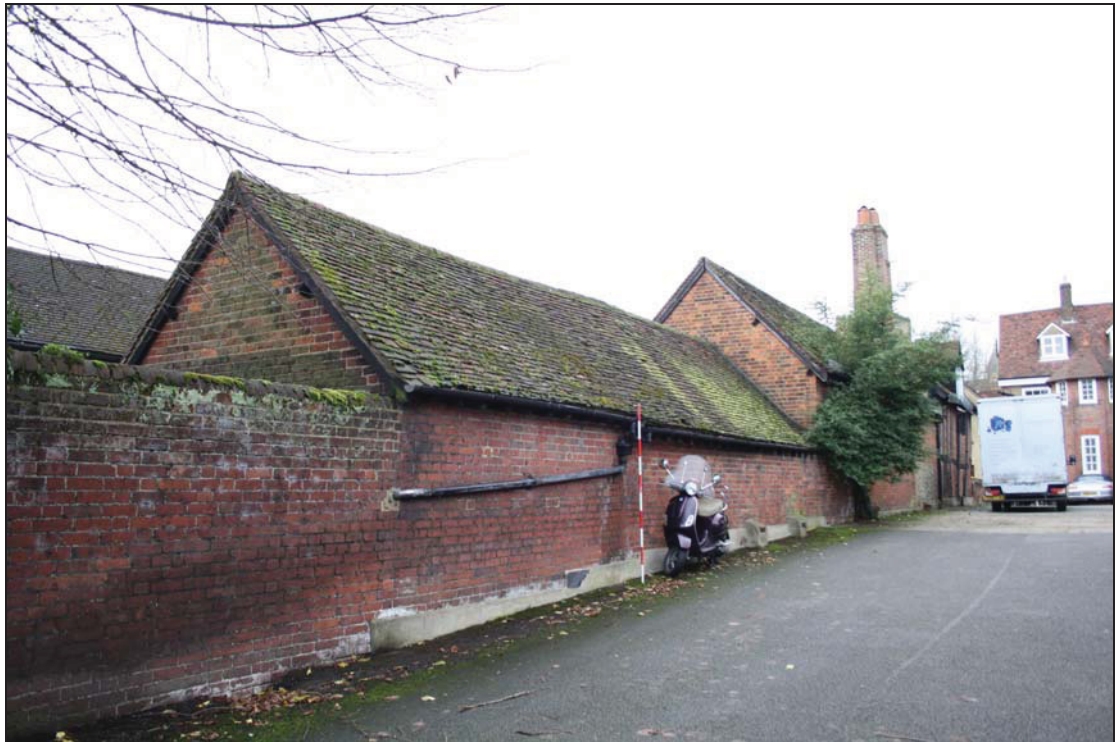
Plate 7 Northern elevations of Range 2-4, taken from the east (DP 8)

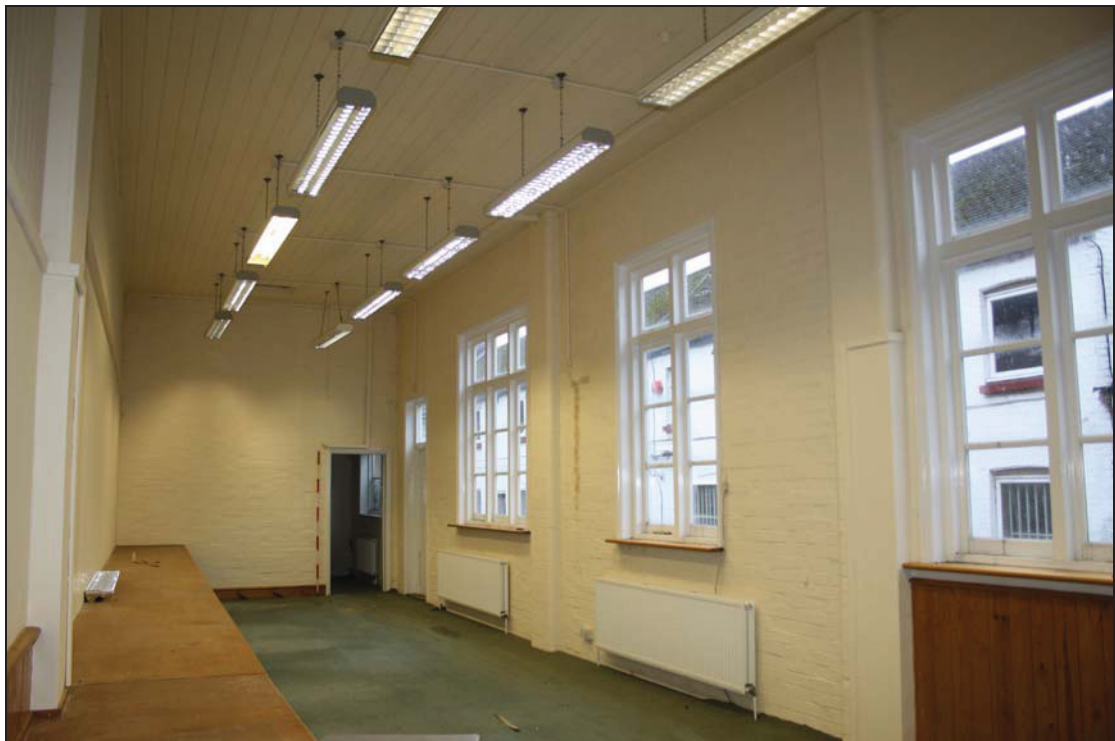
Plate 8 Interior of Range 2, taken from the north-west (DP 16)

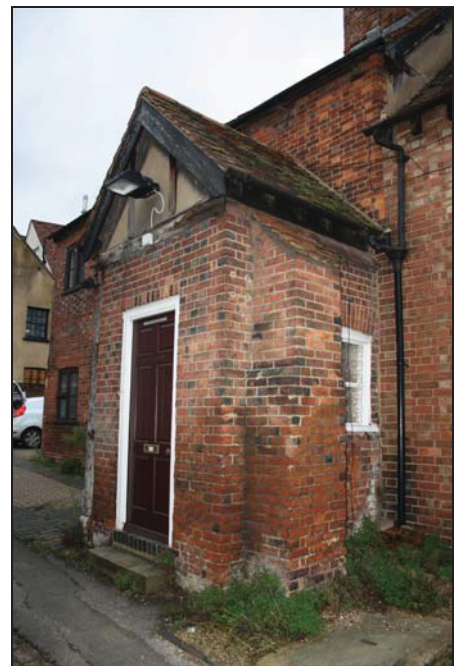
23

Substantially rebuilt elements of the porch to Range 1, taken from the south-east

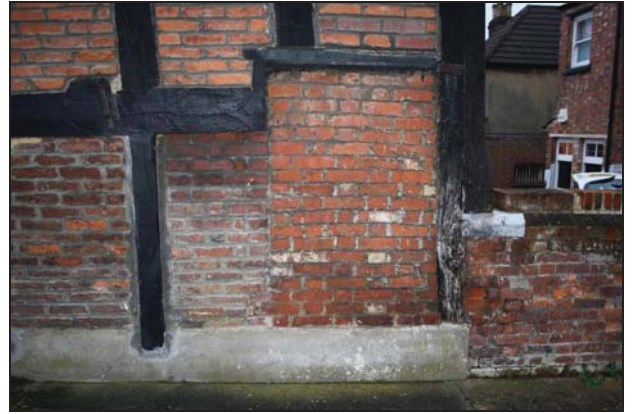
26

Inserted doorway on the northern side of Range 1, itself later blocked, taken from the north-east

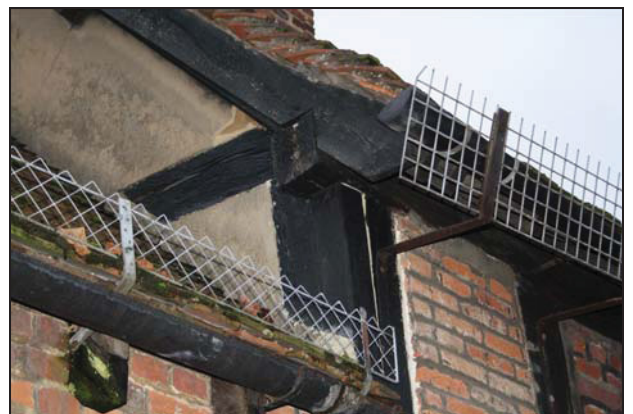
30

5.5 The east elevation is visible only above Range 2 and is all cement-rendered apart from the corner posts and a section of wall-plate. The lateral wall-plates project on both sides, where the ends appear fairly unweathered.

North-east corner of Range 1 showing unweathered wall-plate, taken from the north-east

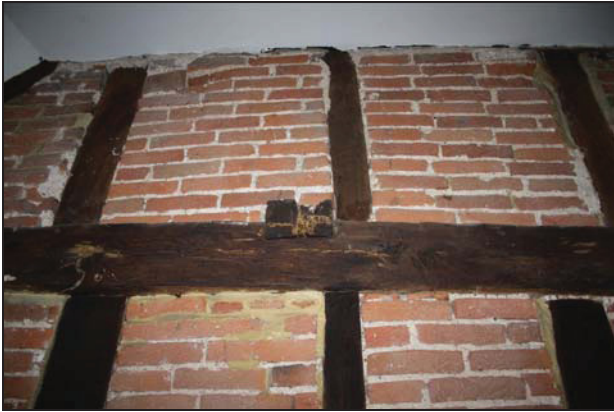
37

5.19 The west wall has been somewhat altered and the timber-frame infilled with brick as on the north, although the existing original fabric suggests this marks the original end of the building. Where the modern staircase rises the mid-rail is visible though partially plastered over, so that only to pegs are visible for studs above. Some reinforcement has been applied with metal strapping at the south end. Timber elements include the north-west corner post which has a slightly splay-cut jowl and is double-pegged to the wall-plate and reinforced with later iron strapping, probably 19th century in date. A wide curved brace is double-pegged to the post and tie-beam and corresponding peg-holes indicate a second to the south though this is lost and the corner post is either lost or hidden. There are two pegged studs which survive in good condition above, one possibly a well-executed replacement. In addition, this stud has been bisected with the application of a later downward brace from the south corner secured with ironwork. Slender intermediate members are not pegged. Above the tie-beam the gable includes queen post and a central un-pegged intermediate. Offset to the south of centre is the stump of a truncated bridging joist, simply notched over the wall-plate.

Upper section of the west wall of Room FF01 showing possible truncated bridging joist, Range 1, taken from the east

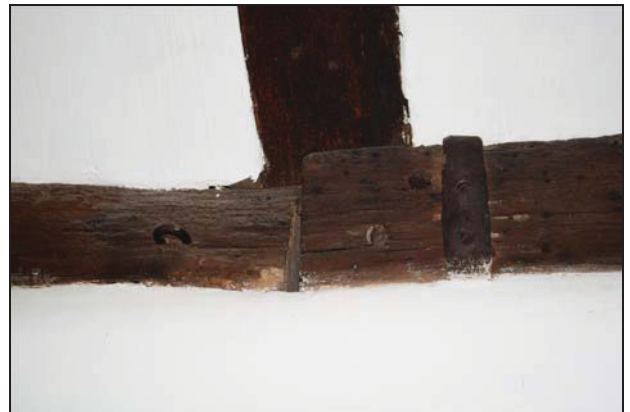
42

5.20 The south wall is all clad in modern dry-lining with no early fabric exposed, apart from the central bay post and the wall-plate above extending the length of the building. The pattern of peg-holes in the wall-plate indicates the arrangement of original studs below. The survival of the central bay post may indicate the survival of further timber elements behind the dry-lining. The wall-plate is scarfed to the west of the bay post but the form is not visible and has been strengthened with metal strapping.

Scarf joint with strapping on the southern wall-plate in Room FF01, Range 1, taken from the north
