**THE KILN AT READS BRICKWORKS  
ALDEBURGH  
SUFFOLK**

**HISTORIC BUILDING RECORDING  
AND MONITORING**

**Level 2/3**

Authors: Lisa Smith BA Kathren Henry	
NGR: TM 449 569	Report No. 4378
District: Suffolk Coastal DC	Site Code: ADB199
Approved: Claire Halpin	Project No. 4398
MIFA	Date: 25 July 2013
Signed:

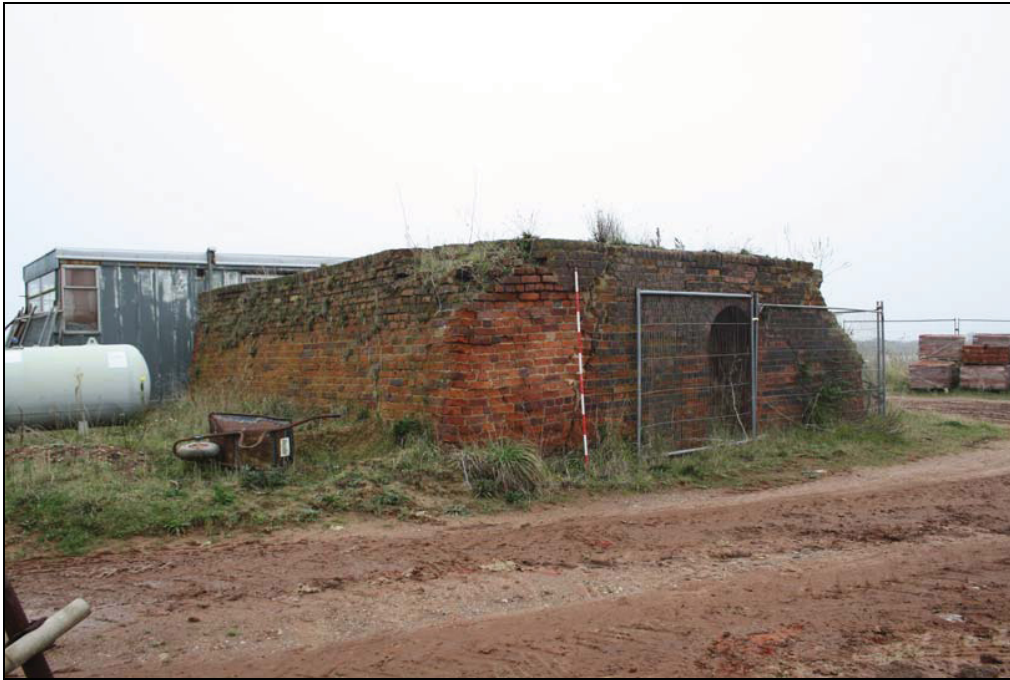
4.1 As described in the original report the kiln stands neglected and in a ruinous condition, now surrounded by the demolished remains of the brickworks (Plate 1). The above-ground remains suggest a typical 'Suffolk'-type kiln however the functional aspects of its construction were an unknown quantity until now, its excavation and subsequent demolition providing an opportunity to investigate the extent of its survival.

Plate 1 19<sup>th</sup> century Suffolk kiln, taken from the north-west (DP 1)

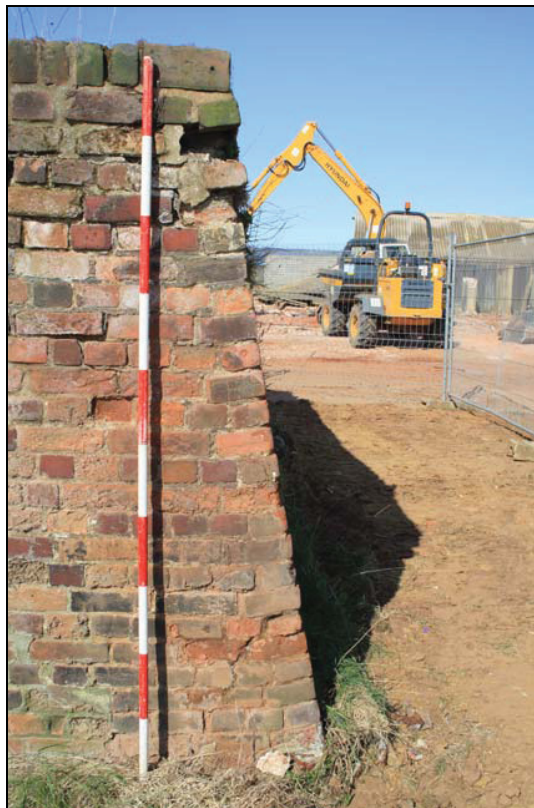
4.2 The removal of fencing has allowed a closer inspection of the structure which comprises four robust walls approximately 1.3m thick, buttressed on the north for extra support (Plate 2). The brickwork is laid in English-bond bonded by a flinty lime mortar, capped by a single course in soldier-bond with overburnt headers and stretchers throughout. The damaged south-western corner reveals a shallow rounded frog to the bricks. The outer face of the brickwork to the soldier-course is bevelled. The condition of the brickwork is poor being heavily patched and repaired across all façades and partially collapsed in the south-western corner, the upper courses disturbed by vegetation. The south side in particular has undergone accelerated decay in the form of cracks throughout with heavy spalling to the brickwork and in places continuous episodes of extreme heat have caused the walls to bow.

Plate 2 Battered northern end of eastern elevation, taken from the east (DP 5)

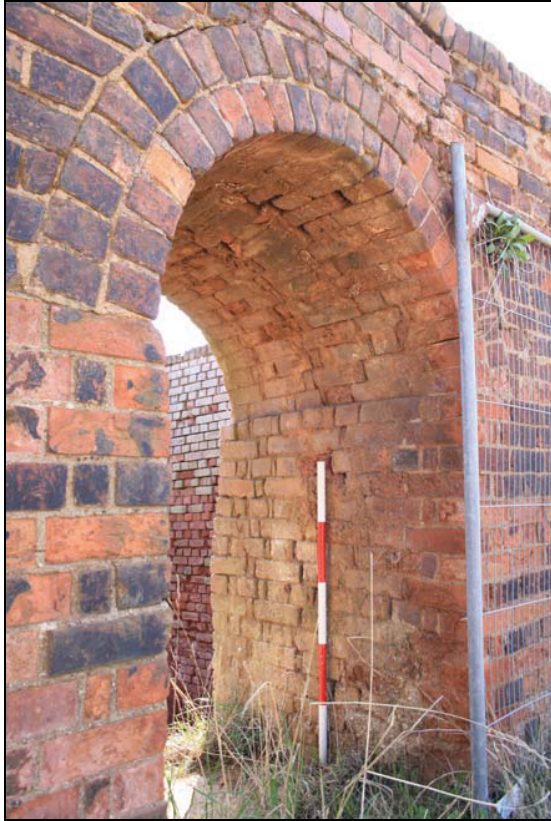
4.3 There is a single point of access on the west via a doorway or wicket off-set to the south given a semi-circular arched head framed to either side by queen closers (Plate 3). As expected the kiln is without a roof; a make-shift one would be constructed with each new firing.

Plate 3 Central wicket, internal construction, western elevation, taken from the north-west (DP 13)

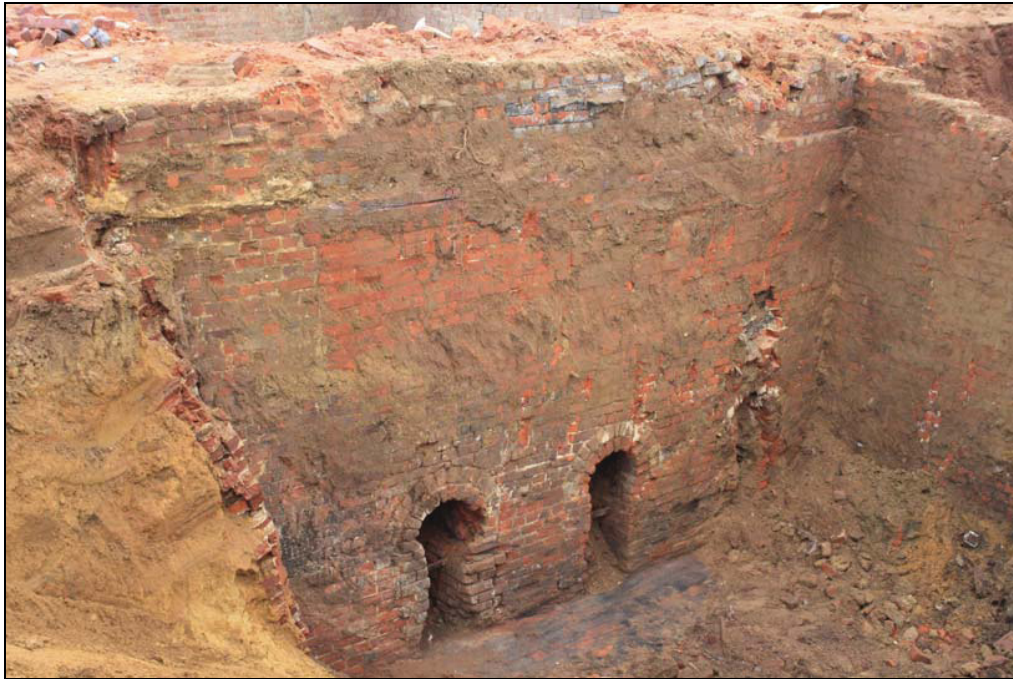
Plate 4 External archways along the south wall of the kiln, taken from the south-west (DP 61)

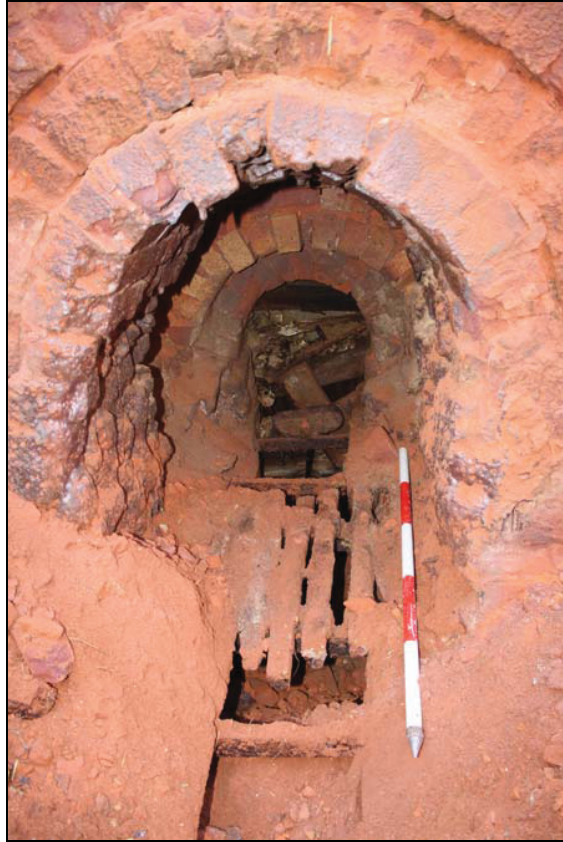
Plate 5 View through central arched aperture piercing the southern elevation with grille covered channel below, taken from the north (DP 30)

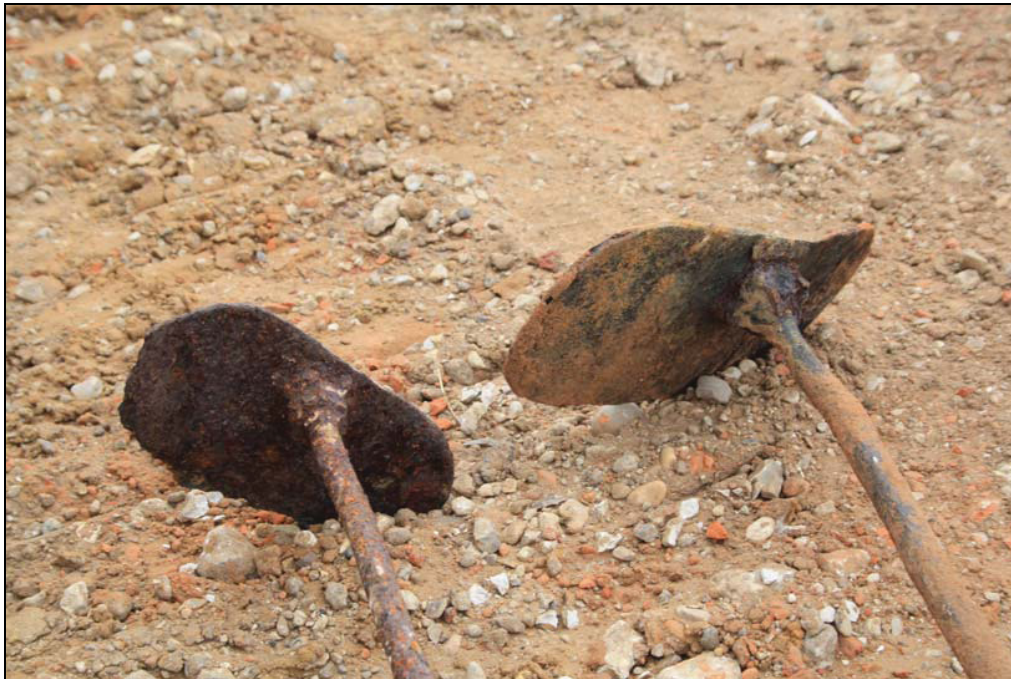
Plate 6 Fire rakes, found within the fire tunnels (DP 49)

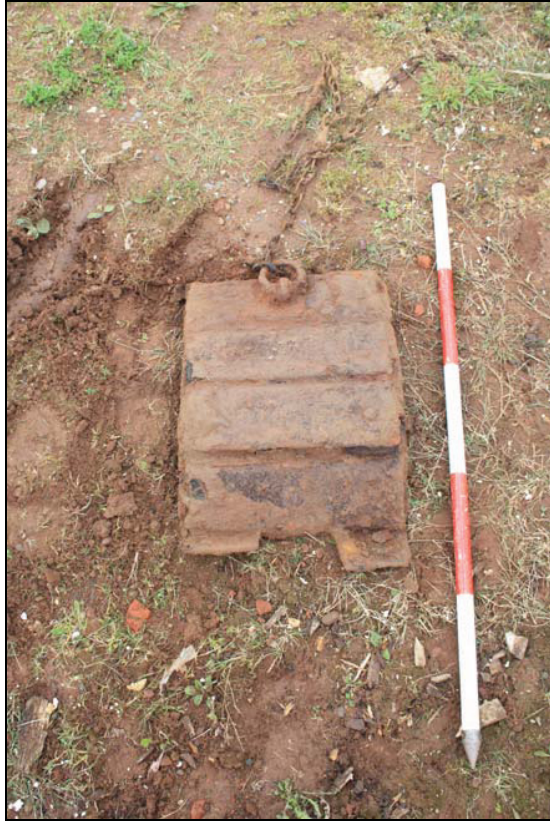
4.4 Excavations along the southern side of the building revealed most information. The wall descends four metres below the current ground surface to the base of the structure in two offsets to a brick paviour floor where three semi-circular arched apertures give access to internal fire tunnels running across the kiln (Plate 4). The central aperture is best preserved with a decorative upper arch in yellow brickwork while the eastern example has partially collapsed. Within each aperture a series of cast-iron rails supported on lateral members survive and would have carried the fuel pushed into the body of the kiln by long rake-like implements, a number of which were left *in situ* after the disuse of the kiln (Plate 5&6). The channels below the rails would then catch the spent remnants of the fire. At high level hooks embedded in the brickwork above each of the archways carried heavy cast-iron doors on chains to be raised and lowered as necessary. One example was found during the excavations (Plate 7).

Plate 7      Heavy metal door hung on a chain used to cover one of the archways  
(DP 53)

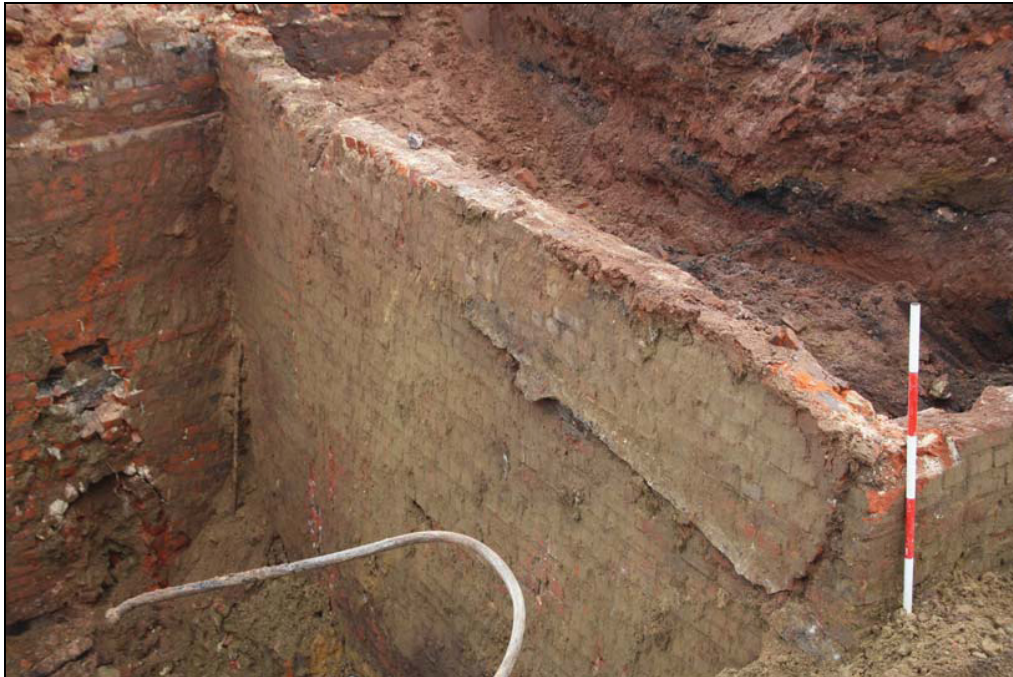
4.5 Retaining walls at the eastern and western end of the building extend five metres to the south, the eastern wall having a stubby buttress to the rear and returning to the east for a short section. Evidence of a pitched roof can be seen on the interior of the eastern wall suggesting that this side of the kiln was probably partially enclosed (Plate 8). Squared timbers and corrugated

sheeting unearthed during the excavation are likely to have formed the roof structure.

Plate 8      The remains of the roof line along the eastern retaining wall, taken from the  
south-west (DP 60)

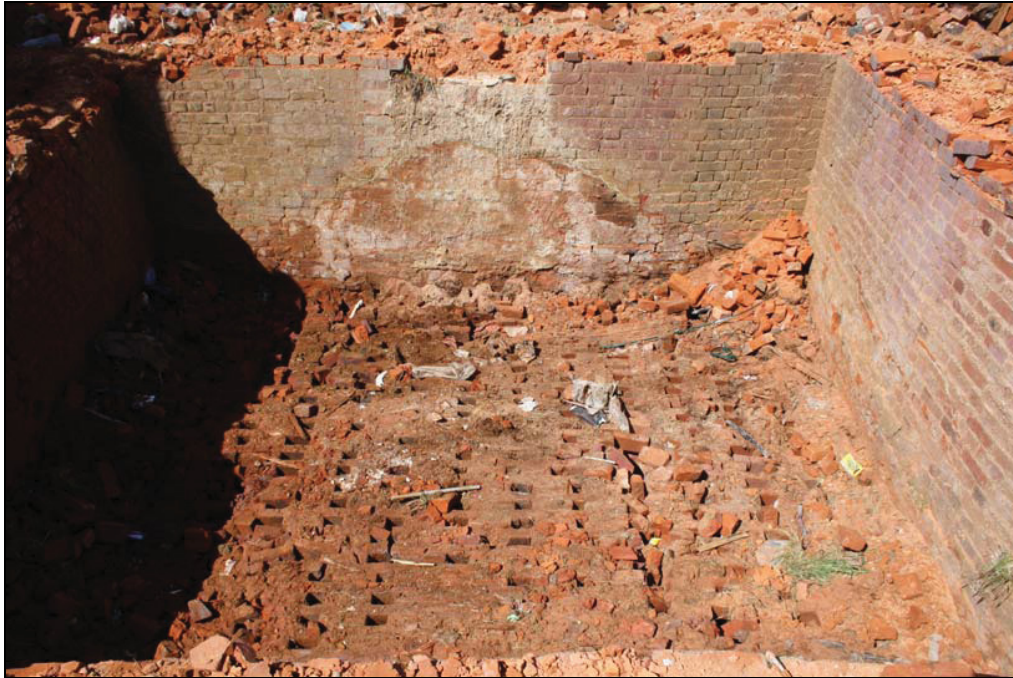
Plate 9 Kiln floor constructed in brick forming a pattern of ventilation apertures, taken from the east (DP 24)

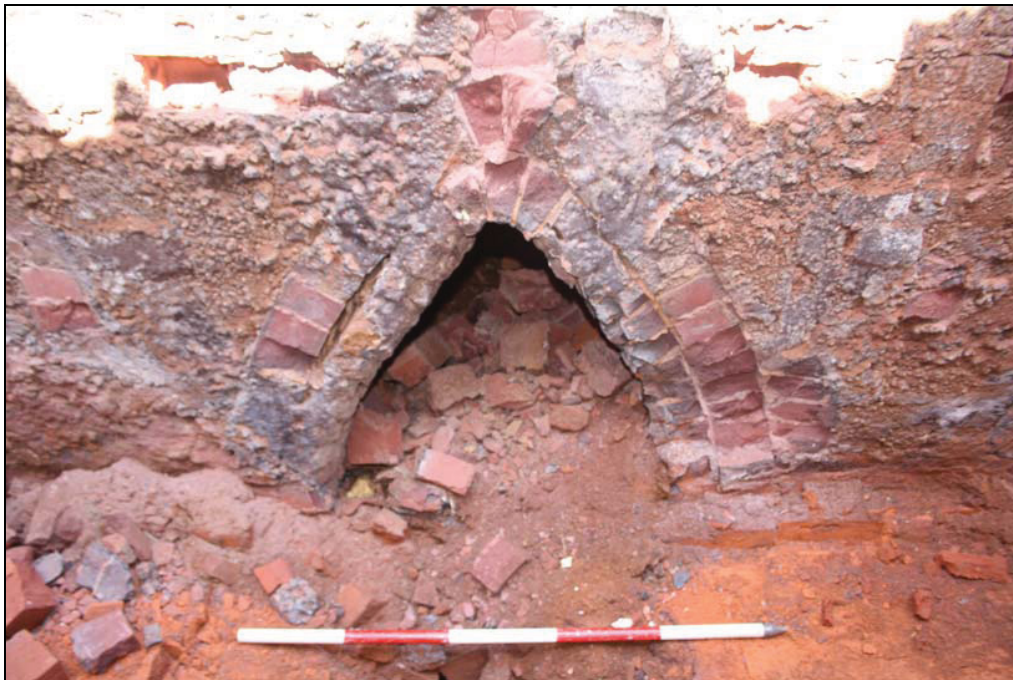
Plate 10 Detailed view of pointed arched aperture extending beneath the kiln floor, taken from the south (DP 34)

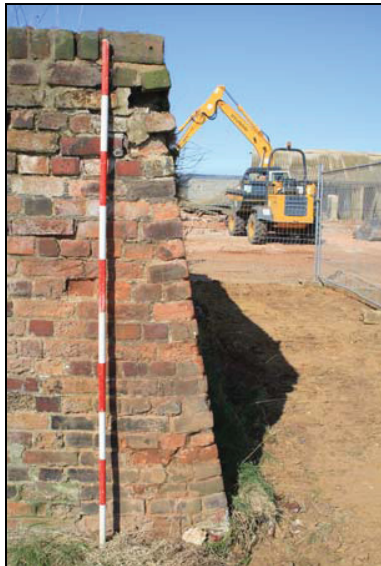
5

*Battered northern end of eastern, elevation taken from the east*

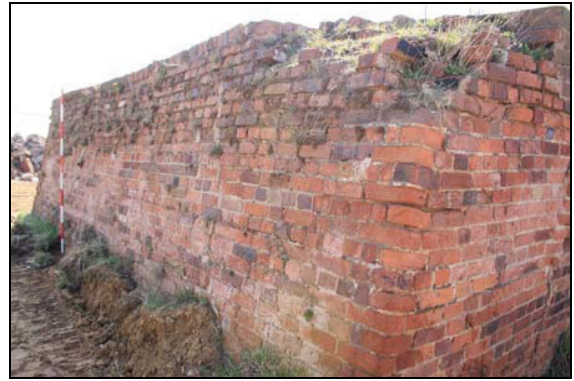
8

*Battered northern elevation, taken from the north-west*

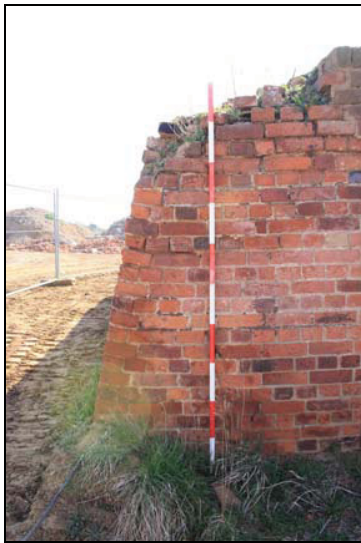
9

*Battered northern end of western elevation, taken from the west*

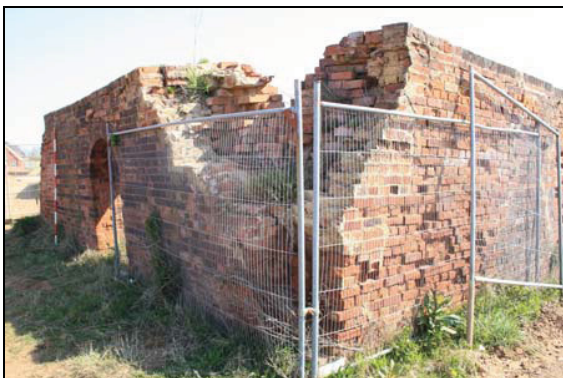
11

*Decayed south-western corner, taken from the south-west*

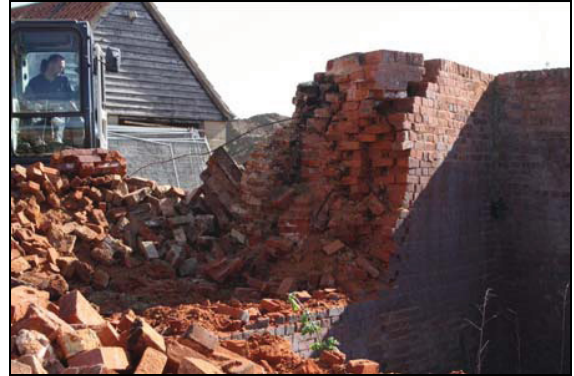
20

*Northern elevation showing battered element as a later addition, taken from the south-west*
