ARCHAEOLOGICAL SOLUTIONS LTD

HISTORIC BUILDING RECORDING AND MONITORING & RECORDING

1 BEECHTREE COTTAGES, HEMEL HEMPSTEAD ROAD, LEVER STOCK GREEN, HERTFORDSHIRE

HISTORIC BUILDING BUILDING RECORDING AND MONITORING AND RECORDING

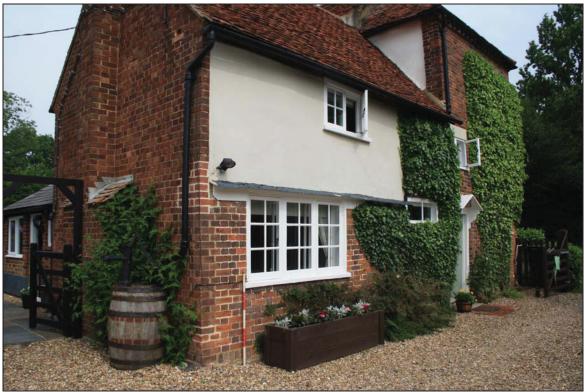
Plate 2

5.2 From the exterior little timber-framing is exposed, although the presence of plain render on the east and west elevations at upper level suggests at least partial survival (Plate 2). The lower framework on the east has been replaced with a variable orange 19th brick. This is laid in Flemish bond and the original penny-struck pointing survives in places. The range rises to a steeply-pitched roof covered in peg-tiles and below the eaves on the east, the wall-plate and a tie-beam end is visible.

East elevation of the rear wing, taken from the south-east (DP 10)

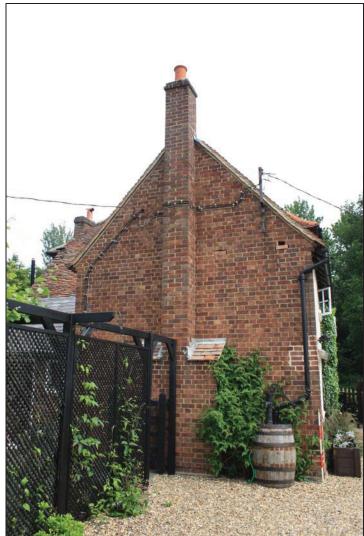
5.3 The south gable end has been entirely clad in 20th century Fletton-type bricks laid in Flemish bond (Plate 3). This comprises a brick skin, indicated where the wall-plate is set in from the visible brickwork but removal of this during the planned works reveals

that the brickwork continues for a further brick depth infilling the surviving elements of the timber frame.

South gable end of the rear wing, taken from the south (DP 13)

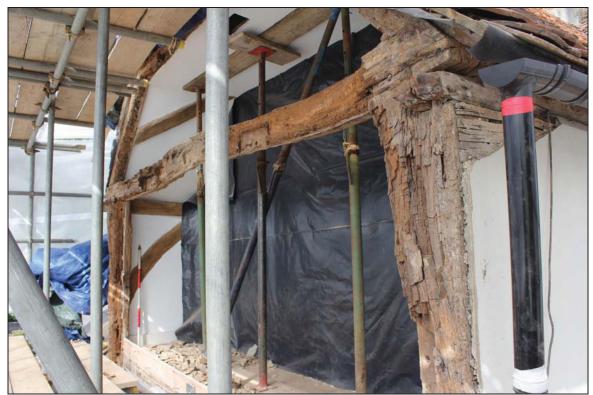
5.5 What survives of the gable end includes the principal structural members, such as those visible from the interior. These include the corner posts which survive at upper level, tie-beam, collar and rafters (Plate 4). The corner posts have gently swelling jowls, while the tie-beam is fairly waney and slightly cambered extending over and dovetailed to slightly protruding wall-plates. The mid-rail is lost although mortices in the outer posts mark its position as does a bridging joist from the interior which retains a tenon with two peg-holes. Timber framing infill of the upper register is mostly lost although truncated fragments and the pattern of peg-holes allows the original form to be reconstructed (Plate 5). The posts were braced to the tie-beam and double-pegging survives with the truncated stumps of the braces which were presumably slightly curved as seen elsewhere. A peg in the tie-beam indicates a lower central stud, while the opposing north wall of the range bears marked similarities and suggests a pair of outer studs where the braces met the tie-beam.

Surviving principal timbers at first floor level, taken from the south-east during monitoring (DP 44)

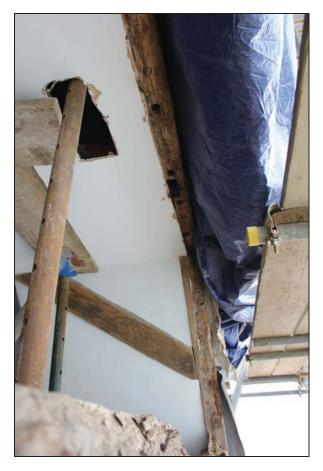
5.7 A pattern of holes in the soffit of the collar and tie-beam as well as the presence of continuous grooves in the face of these members indicates that the original infill was of wattle and daub (Plate 6). Despite damage caused by the application of brickwork, it appears that this gable comprised the external end of the range as the timber is weathered, while the wall-plate ends are slightly shaped. Fig. 13 shows the form of the gable end with surviving timber elements as well as extrapolated lost members at upper level.

View of the collar soffit showing wattle stave holes, taken from the west during monitoring (DP 50)

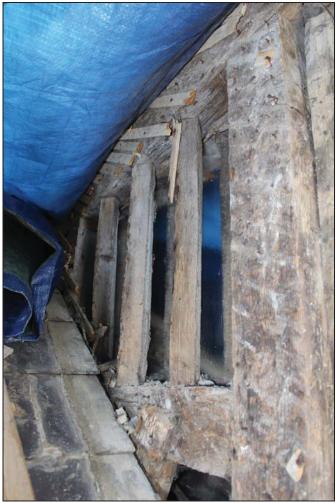
Plate 7 Original mullion window on the west elevation exposed after the removal of lath and plasterwork, taken from the south-west during monitoring (DP 59)

5.9 Of interest on this side is the survival of an original mullioned window which utilises two studs to the north and has a horizontal pegged sill with three diamond mullions, all surviving (Plate 7). This was clearly made redundant, possibly at a fairly early date, by the addition of the adjoining outshut as the roof line extends across the window. Nail marks are visible across all members for the later lath and plasterwork and slender vertical members were also added, simply notched and nailed to the wall-plate above.

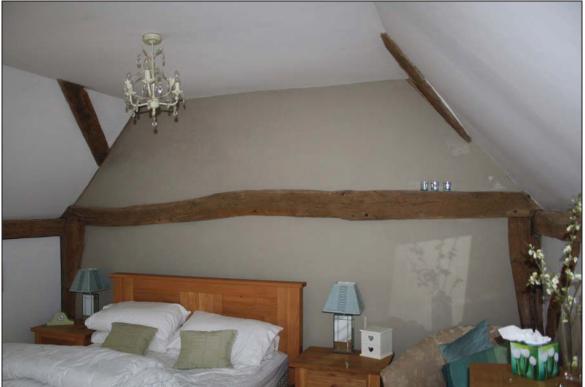
Plate 8

5.14 In general the exposed fabric at upper level is consistent with that seen on the south gable end so that the trusses include jowled corner and bay posts with slightly cambered tie-beams (Plate 8). The timber here is well preserved and as noted from the exterior the posts are braced to both the tie-beams and wall-plates with slightly curving

First floor room of the rear wing (Bedroom 3) showing the gable end, taken from the north (DP 21)
