**THE SWAN PUBLIC HOUSE
HIGH STREET, WHEATHAMPSTEAD
HERTFORDSHIRE**

**HISTORIC BUILDING RECORDING
Level 3**

Authors: Dr Lee Prosser BA PhD Lisa Smith BA Kathren Henry	
NGR: TL 17706 13915	Report No. 4458
District: St Albans	Site Code: AS1640
Approved: Claire Halpin MiFA	Project No. 5485
Signed:	Date: 14 November 2013 (Revised 15 th November 2013)

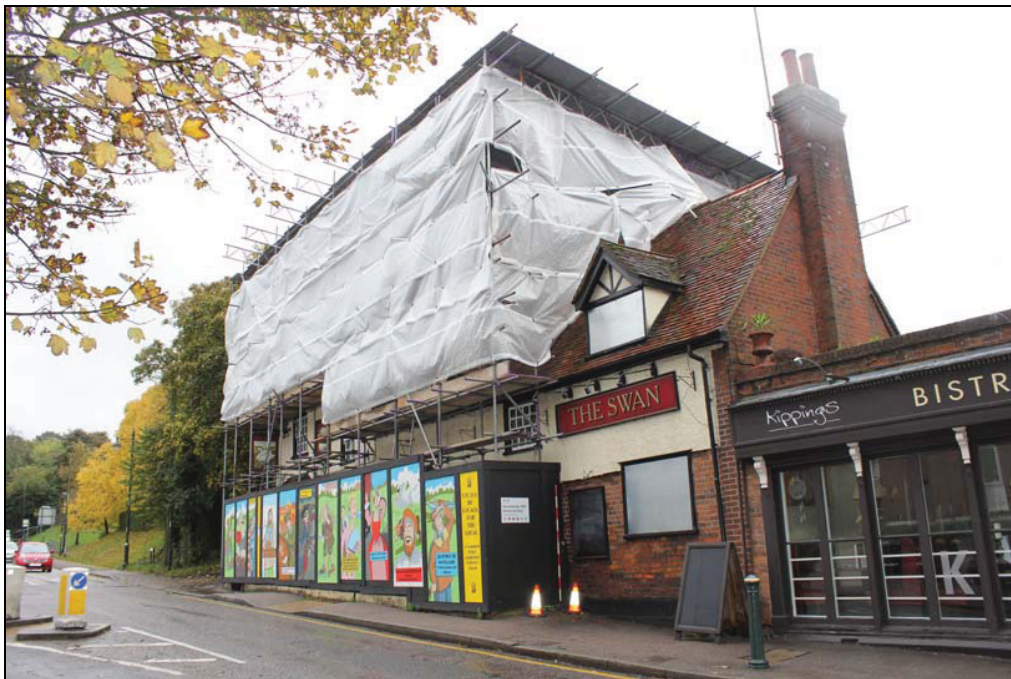
Plate 4 The Swan, (post-fire) taken from the north-east (DP 4)

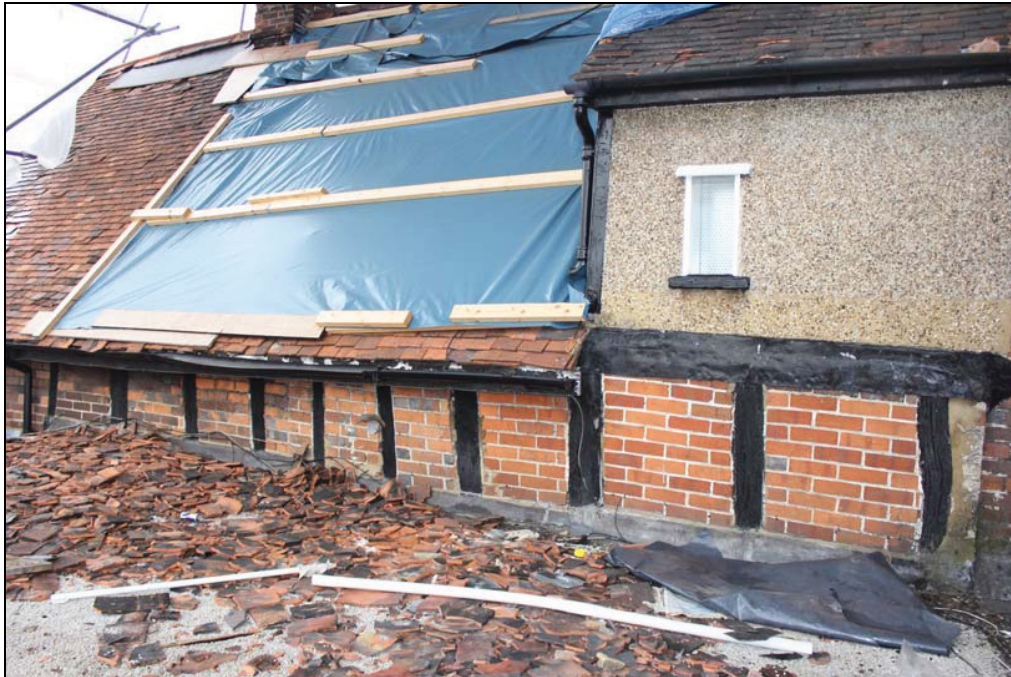
5.7 The phasing of the main range can best be appreciated in the area below the eaves, where the two original bays are well expressed (Plate 6). The south bay retains a pattern of slender but regular studs infilled with 18th century orange brick – these preserve their original struck-pointed joints. The roof in this area was partly destroyed by fire though within the uncleared rubble it is clear that the tiles were modern and machine-made. The main internal chimney-stack, constructed in its upper stages in late 18th or 19th century brickwork rises though the apex of the lower range to the north of the bay division, which is marked here by a thicker principal post.

Plate 6 Upper portions of west elevation of main building, taken from the south-west (DP 12)

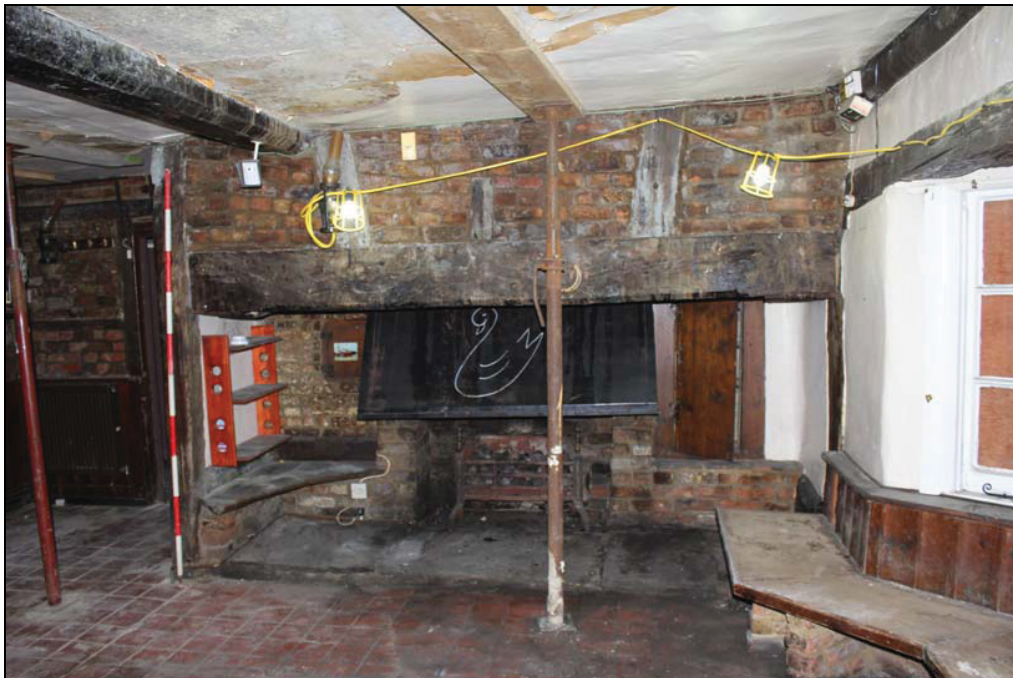
5.16 The northern bay is the southern bay of the former open hall, and was most seriously damaged by the fire of July 2013. Here, the floor is modern laid in terracotta tiles while a large inglenook fireplace, essentially bisecting the former hall, occupies the north-east corner (Plate 8). As elsewhere, a large bay window on the east preserves slightly different details to its companions with four, fixed, six-light panes and casements to the cants. The frames are chamfered and stopped in the later 19th century manner.

Plate 8 Large inglenook fireplace, GF01, taken from the south-east (DP 30)

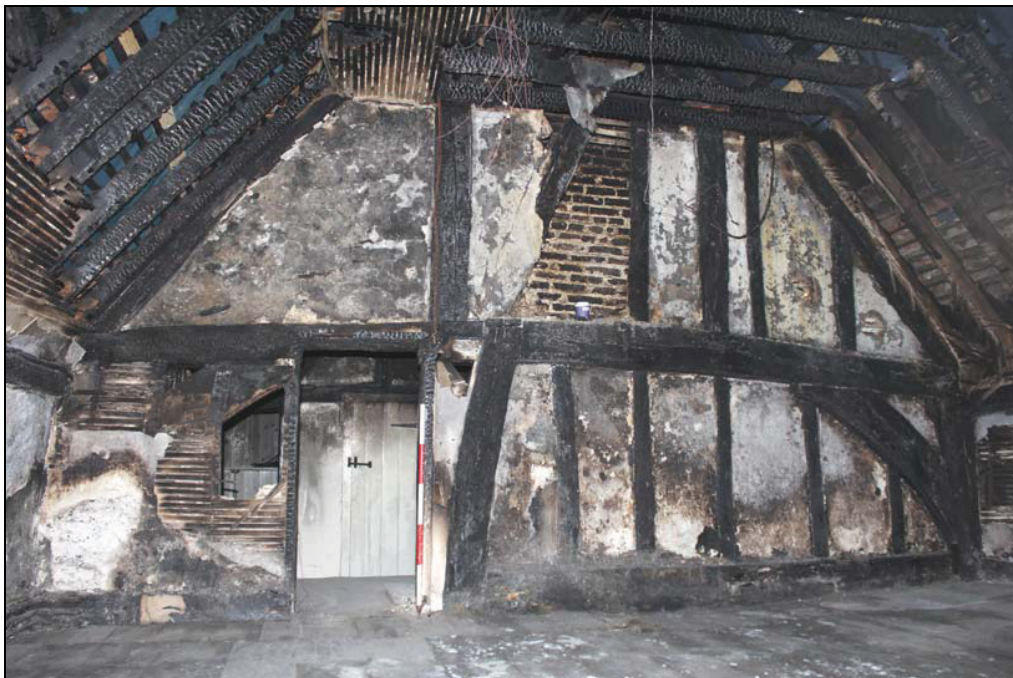
5.32 FF03 formed part of the upper area of the original medieval open hall, and was also the seat of the recent fire. Despite the damage, the fire has served to expose the underlying fabric, including timber-framing. The principal medieval timbers of the flanking trusses to the side walls appear to be intact though the boarded floor, possibly of 17th century date has been rendered extremely fragile and soft by water and heat.

Plate 12 North elevation, FF03, taken from the south (DP 71)

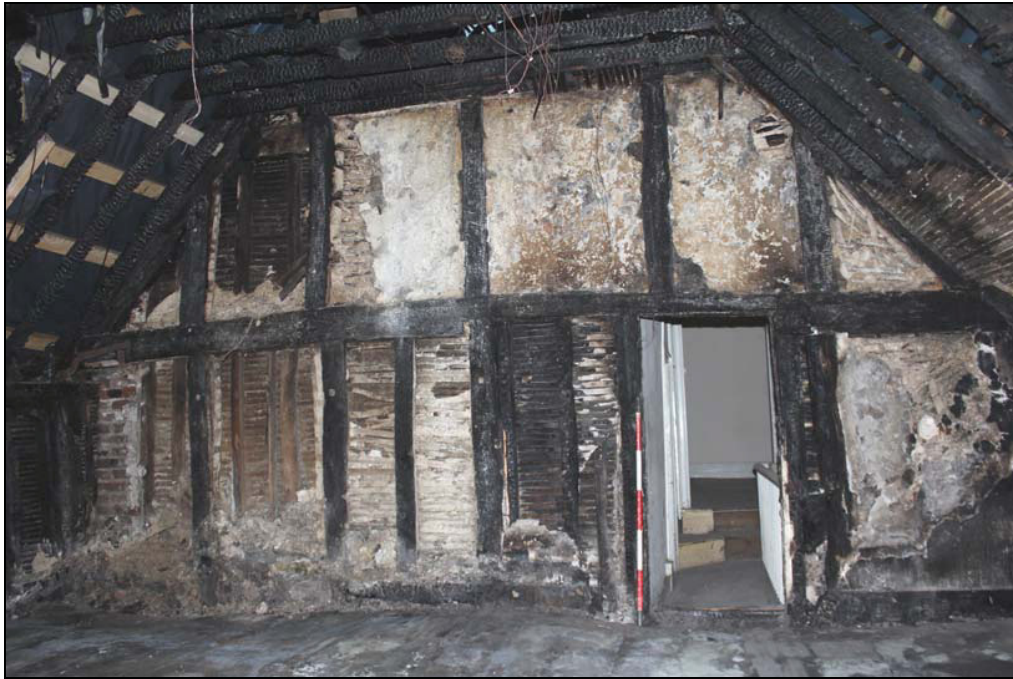
Plate 13 South elevation, FF03, taken from the north (DP 67)

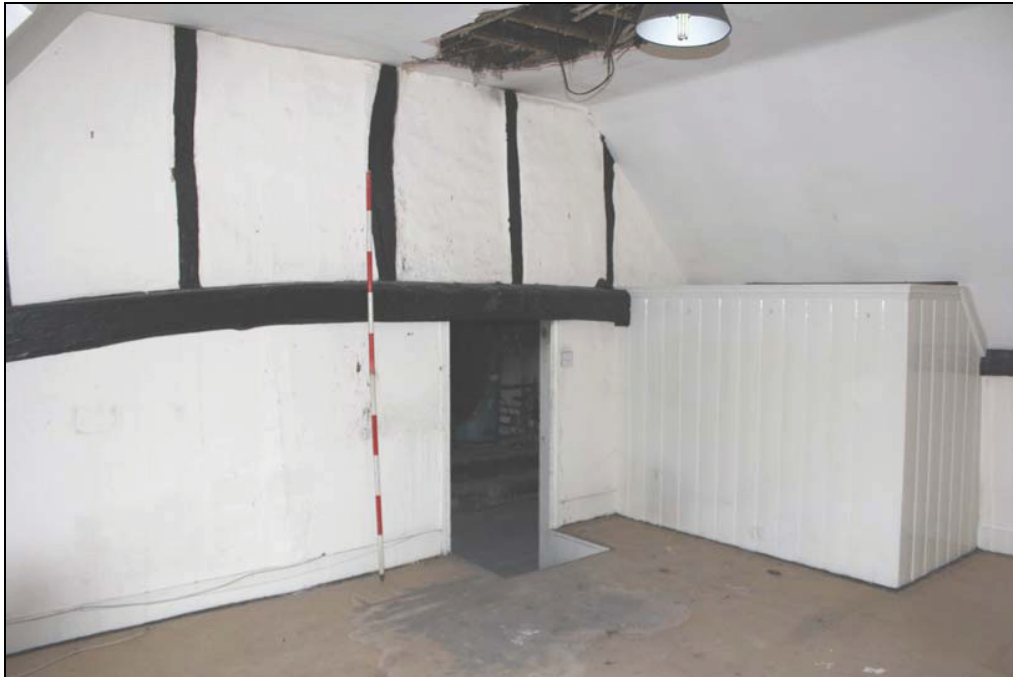
5.40 At the bay division the tie-beam is well expressed along with the queen-posts and a number of studs rising to collar level (Plate 16). The wall-plate is also visible on the east. The room is ceiled at collar level but a hole caused by fire damage provided an opportunity to view the roof at this end of the building. The timber elements directly above FF06 are softwood and early 20th century in date, but to the south, an original primary timber in the form of a single king-strut rises from the collar to the apex of the early frame. The original common rafters partly visible at lower level are present on both pitches, some retaining notches for collars.

Plate 16 Timber framed partition between FF05 & FF06, taken from the north-east (DP 84)

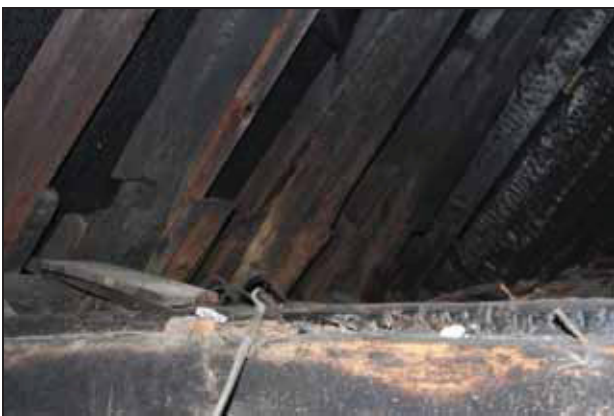
95

Original medieval rafters retaining mortices for intermediate collars, taken from the north-west

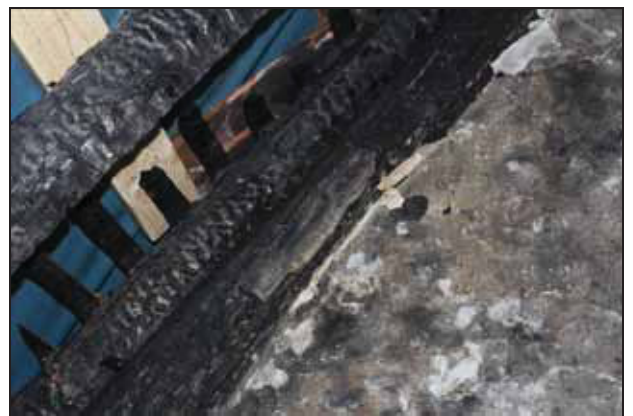
96

Redundant mortices to the principal rafters possibly for windbraces, FF03, taken from the south-east
