**42 MAIN STREET, EAST HADDON,
NORTHAMPTONSHIRE**

HISTORIC BUILDING RECORDING

Authors:	Tansy Collins BSc Antony RR Mustchin MSc (Editor)	
Illustrations:	Kathren Henry	
NGR: SP 6689 6817		Report No. 4403
District: Daventry		Site Code: AS 1591
Approved: C. Halpin MIFA		Project No. 5263
Signed:		Date: 6 September 2013 Revised: 27/09/2013

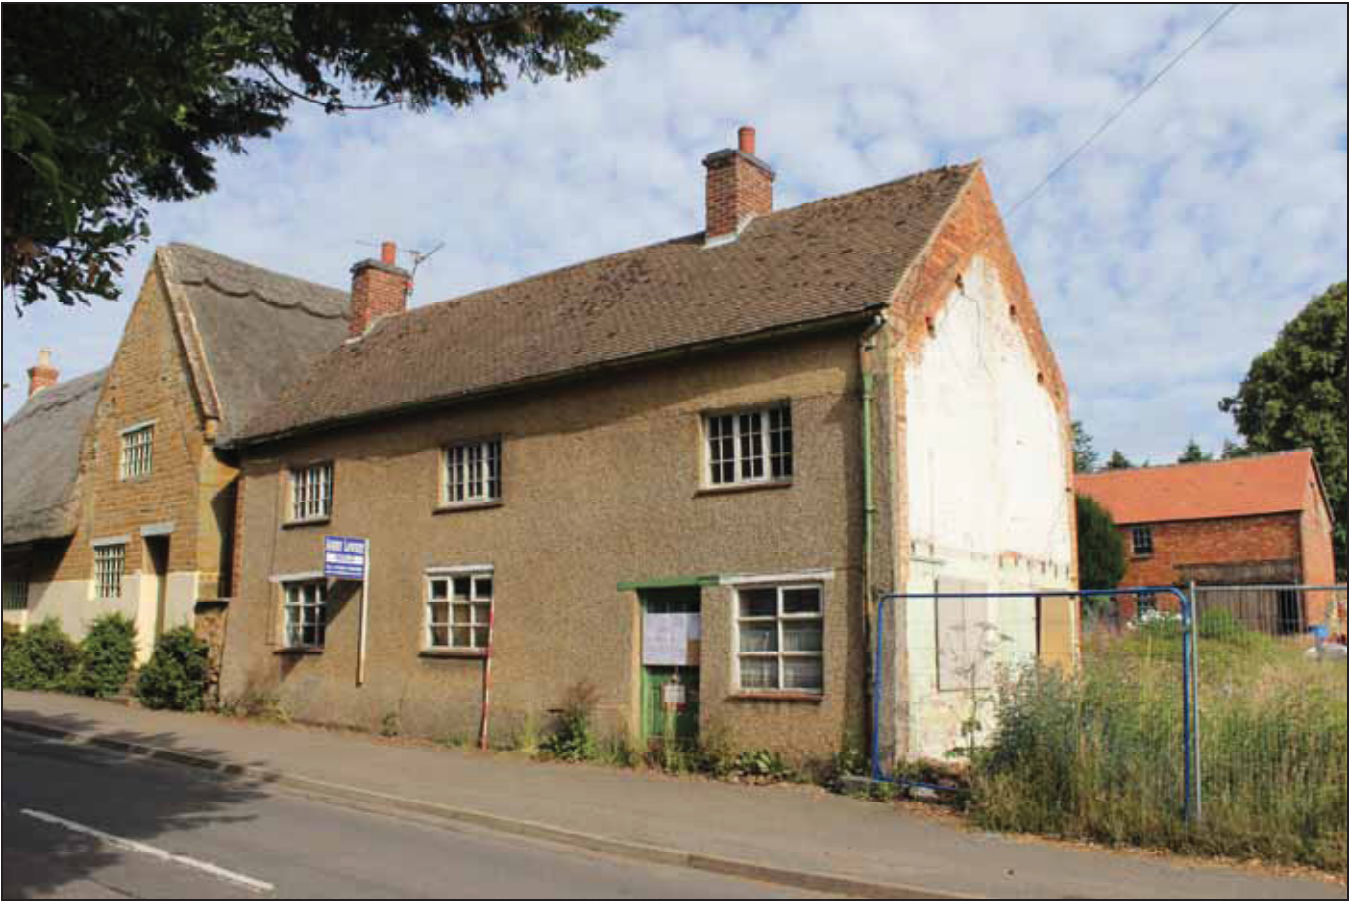
5.1 The house is aligned east – west with the main façade fronting the road (Plate 1). It is of three-cell form rising over two storeys to a pitched roof covered in peg-tiles. The south elevation is all cement rendered and covered in pebble-dashing, though the east and west gable ends are of brick as are two chimney stacks rising through the apex of the roof, with one at the west end and the second principal stack rising between the second and third cells. Both stacks have been rebuilt above apex level in rustic Fletton bricks.

Plate 1 South elevation of the house, taken from the south-east (DP02)

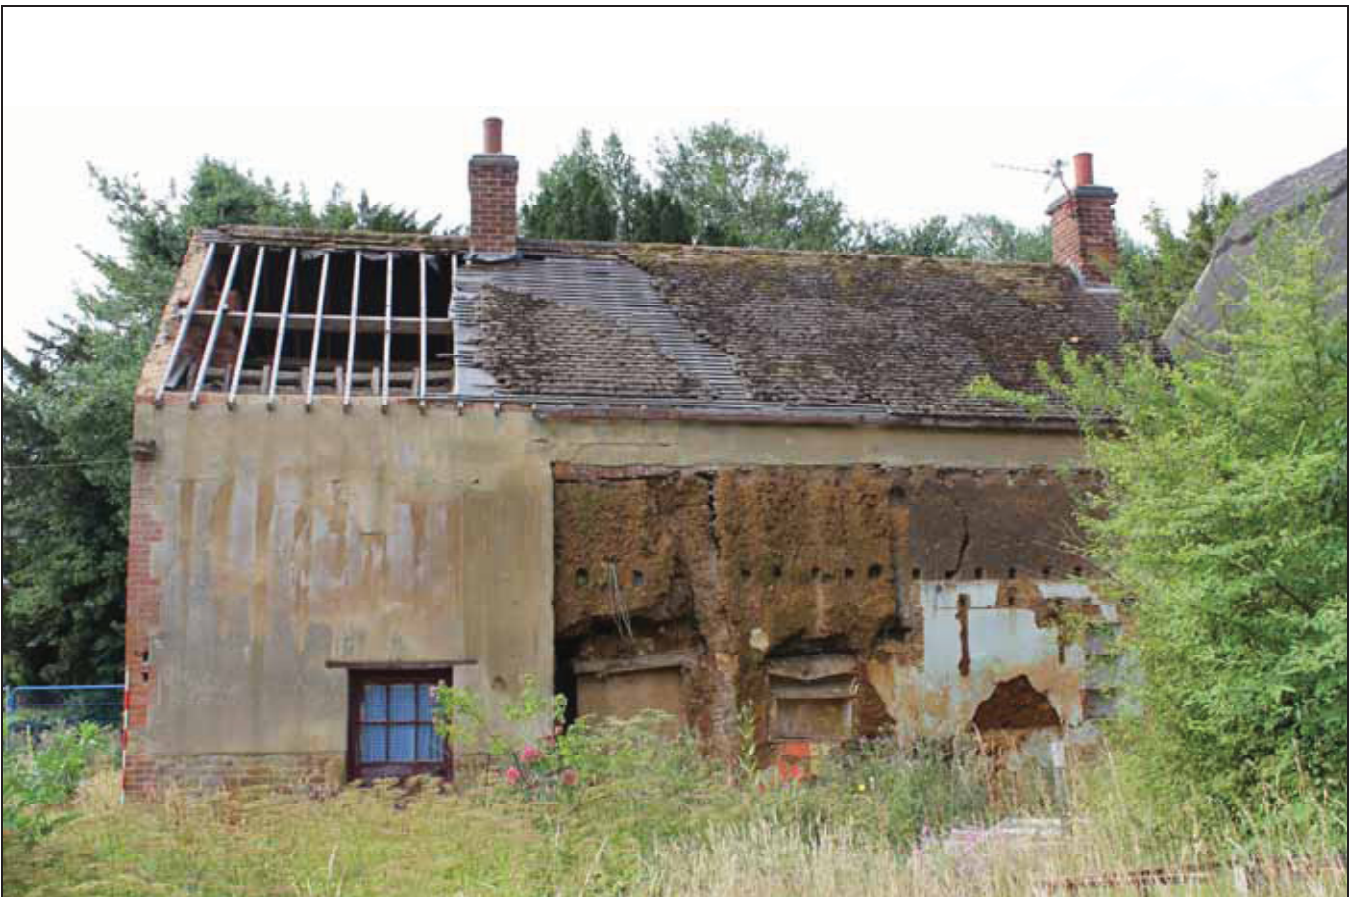
5.6 The rear north elevation reflects the phases of development as seen elsewhere but here the structure is deteriorating and areas have collapsed (Plate 2). This has, however, exposed the construction of the building. Although not clear from this side, evidence within suggests the east bay is a later addition although of similar construction and perhaps added only a short time after initial construction. The general construction is of lias stone walling to approximately 1m height. Where visible on the historic core to the west this is of fairly large blocks laid in courses with larger blocks framing apertures. This alters to the east where more slender blocks are used, these well-coursed with larger blocks again marking the corners and apertures. Above this, the construction is of cob walling, a fairly buff-coloured clay matrix with a high straw content and frequent rounded and angular small pebbles and stones. This is now exposed in the western two bays which was formerly enclosed by a kitchen/bathroom lean-to extension which has been previously removed. Some internal plasterwork survives in this area but has fallen away in places and the upper area in the roof space of the lean-to appears to have always been exposed cob, between which there are empty sockets for lost floor joists. There is no evidence at upper level for any original window apertures.

Plate 2 North elevation of the house, taken from the north (DP11)

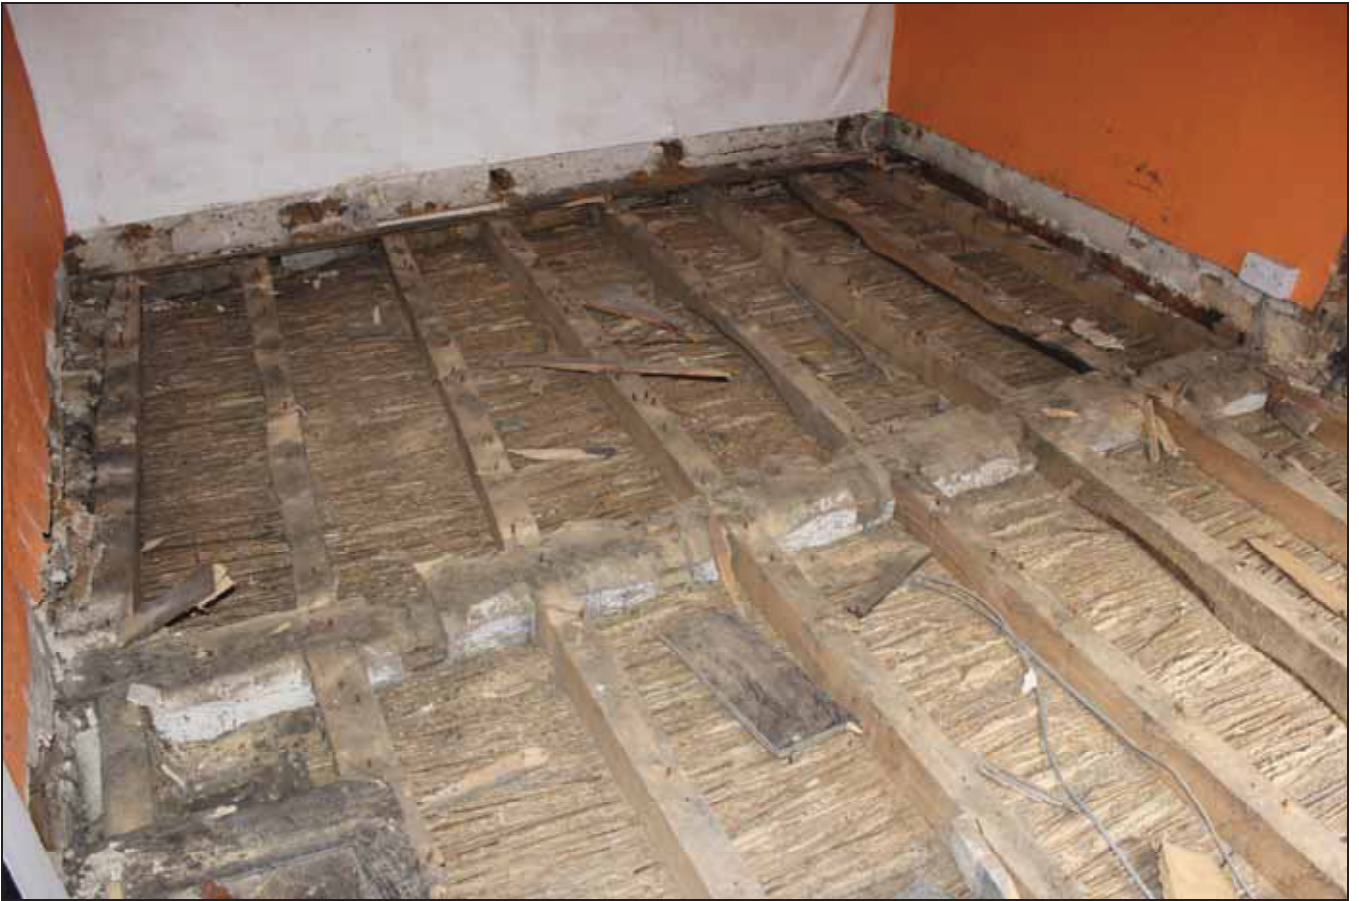
Plate 5 Exposed floor structure in Room FF02, taken from the south-east (DP62)

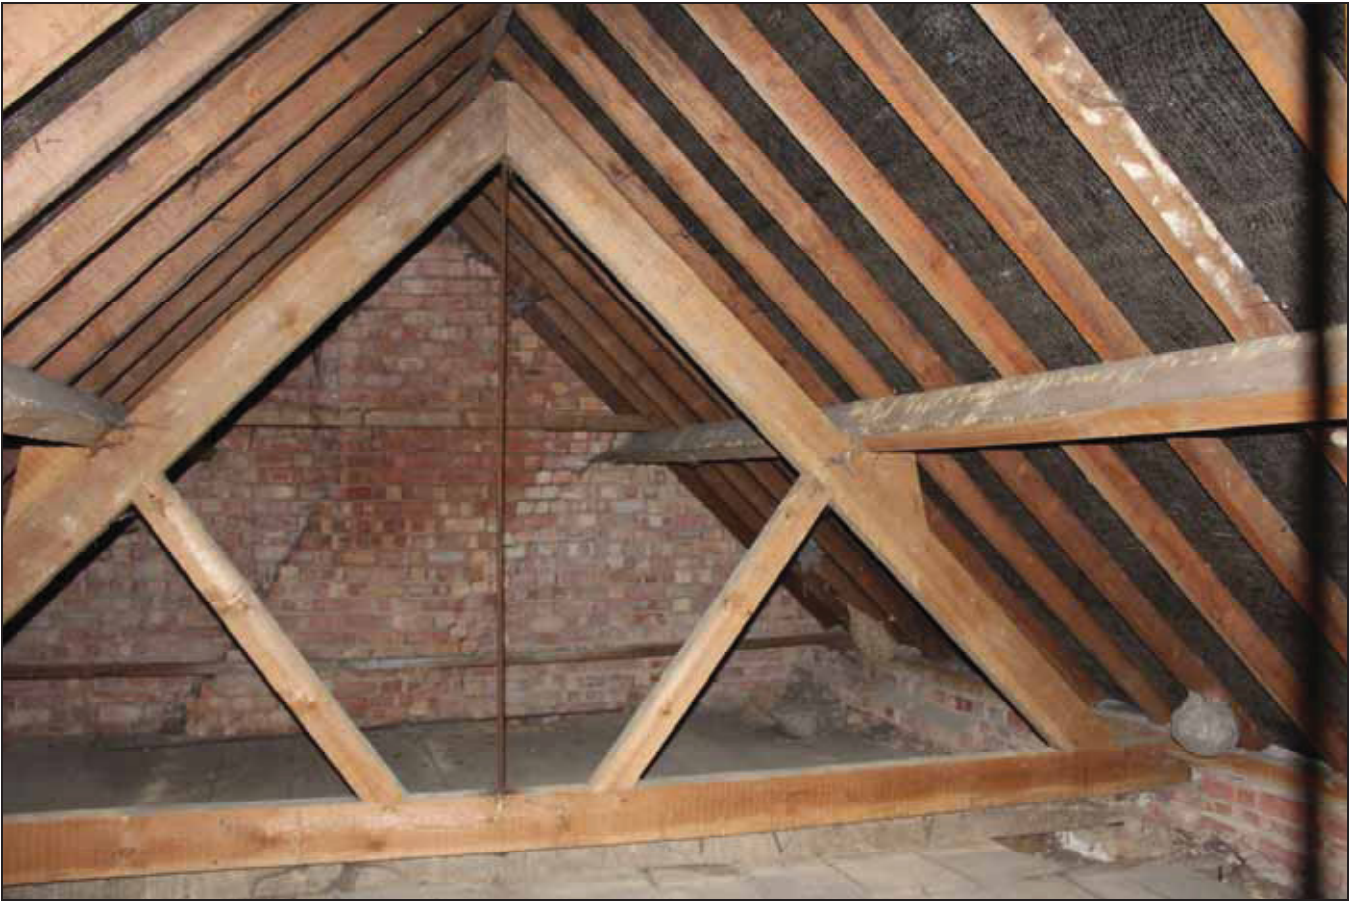
Plate 9 Later double-framed roof structure, taken from the east (DP78)

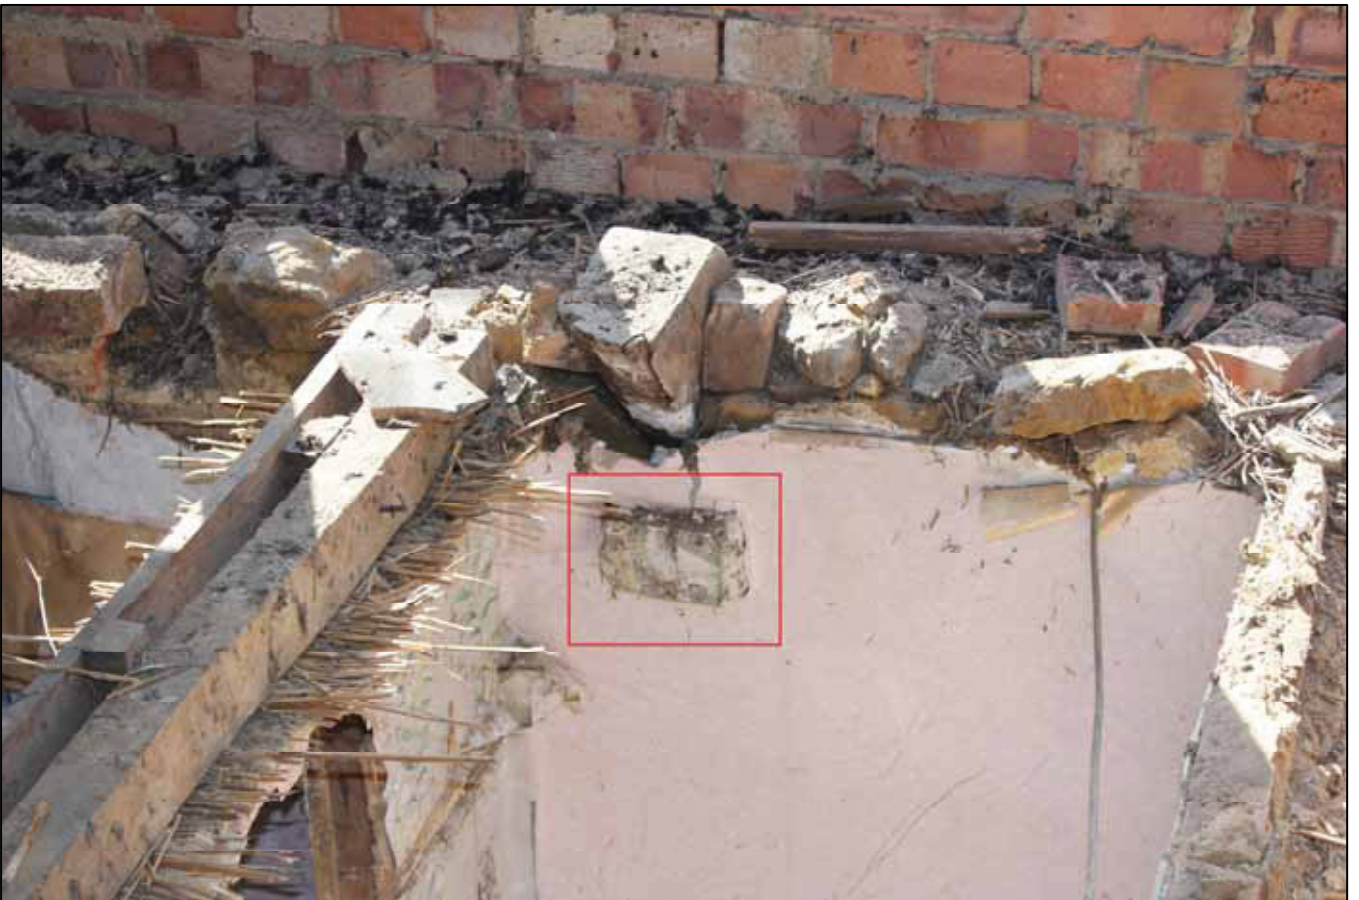
Plate 10 Evidence in the cupboard (FF03) showing stumps of the original tie-beam (indicated) and principal rafter, taken during demolition from the north

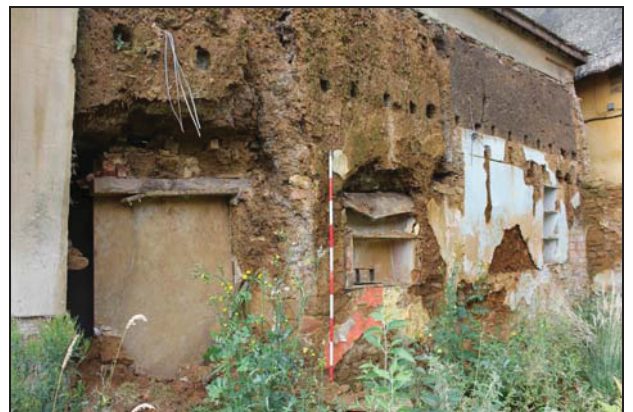
Detail of the north elevation in the area of the removed pent-roofed extension, taken from the north-east

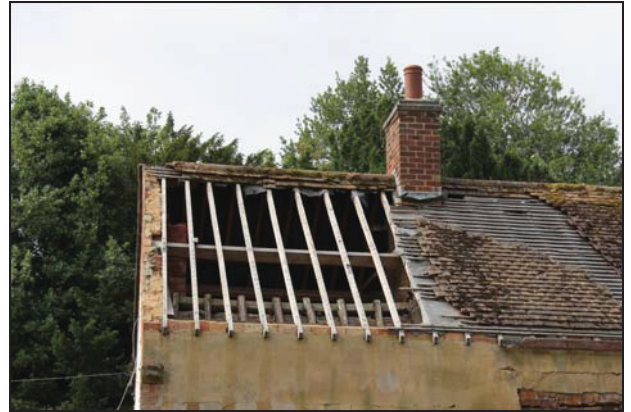
DP 20
North roof pitch of the house showing area of removed tiles, taken from the north

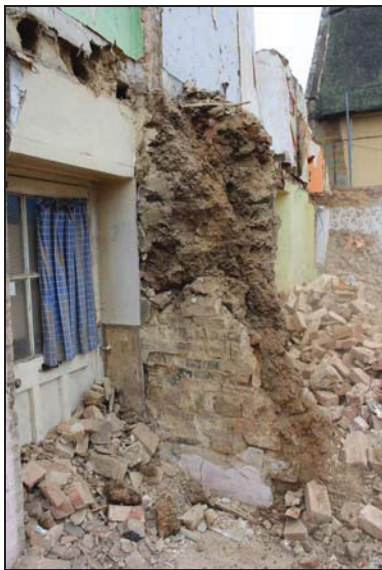
DP 101
Area adjoining the south doorway showing original cob walling with areas of brick repair below, taken during demolition from the east

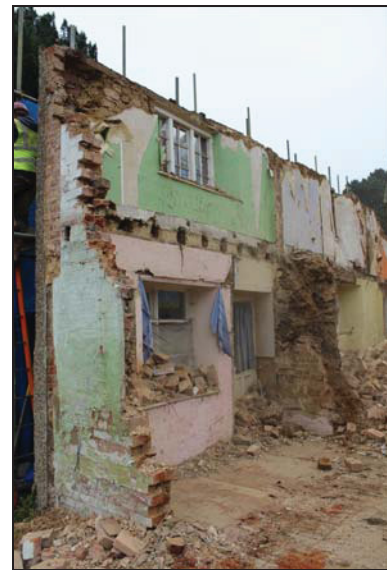
DP 102
South wall exposing mixed cob and stonework construction with later brickwork, taken during demolition from the north-east
