THE BLACK HORSE PUBLIC HOUSE
7 POTTERS CROSS, WOOTTON
BEDFORDSHIRE

HISTORIC BUILDING RECORDING AND MONITORING

Level 3

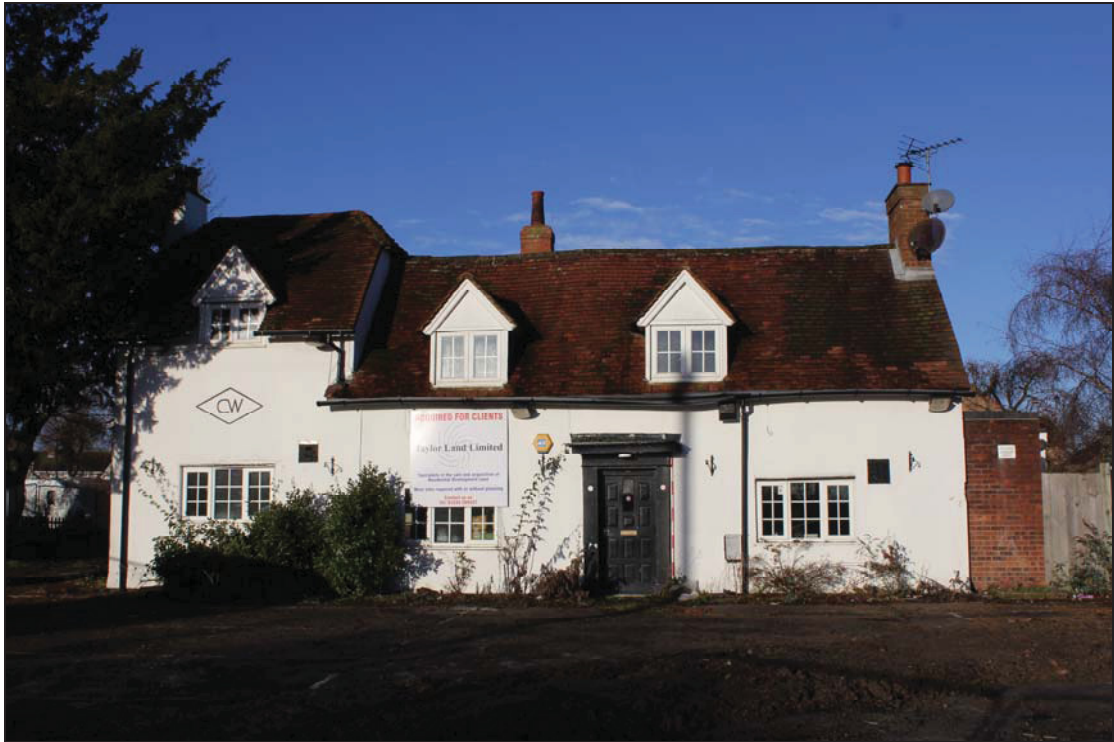
Plate 1 The Black Horse, south-east elevation, taken from the south-east (DP 1)

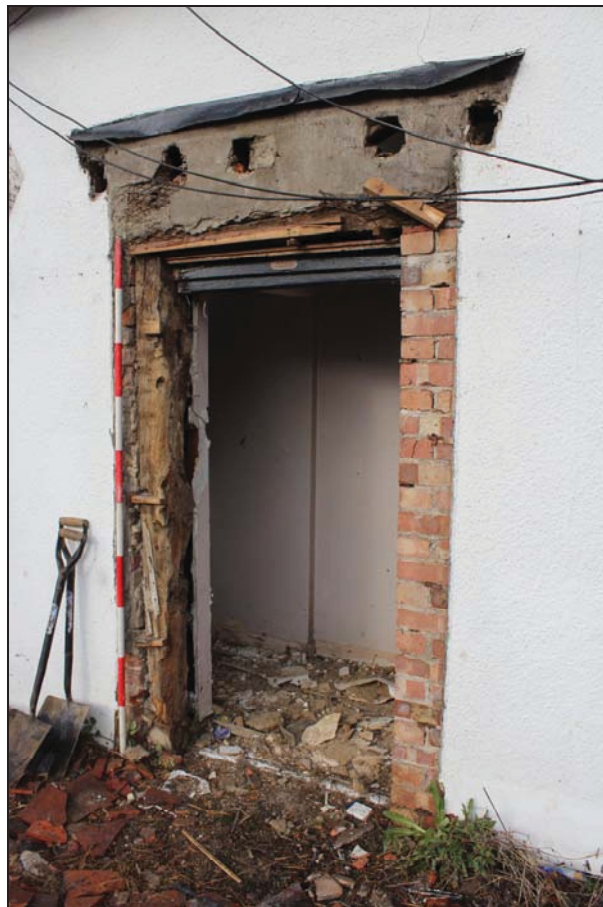
Plate 4 Original timber at the bay division acting as door jamb, south-east elevation, taken from the east (DP 68)

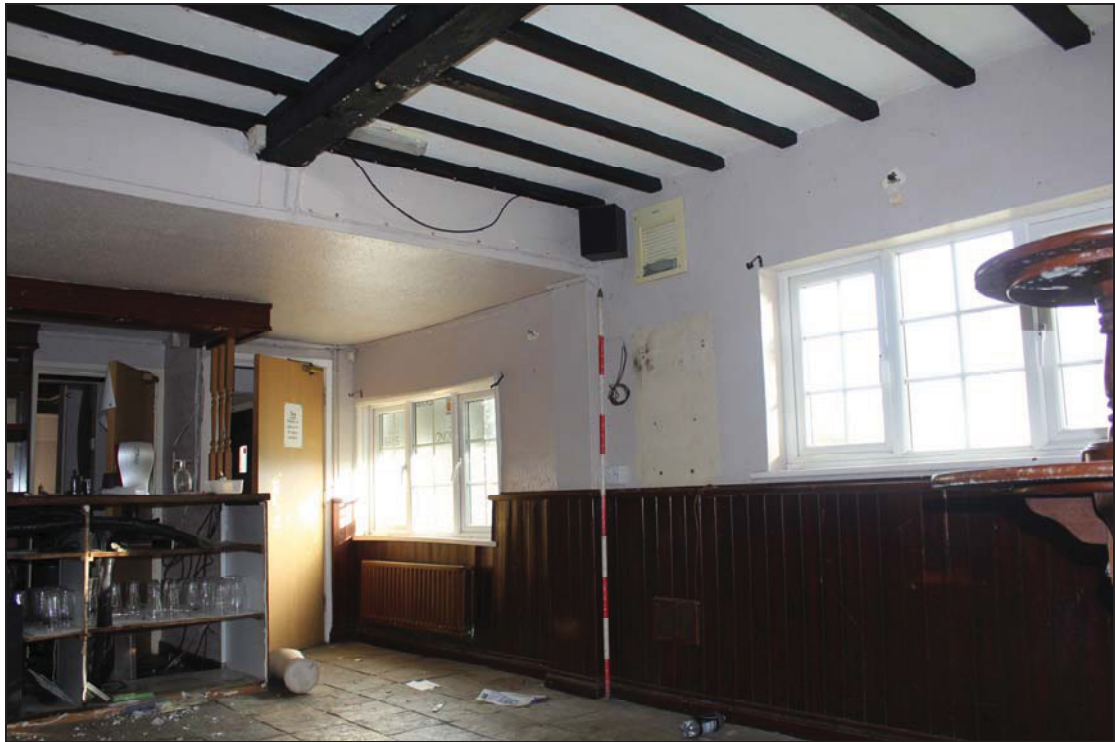
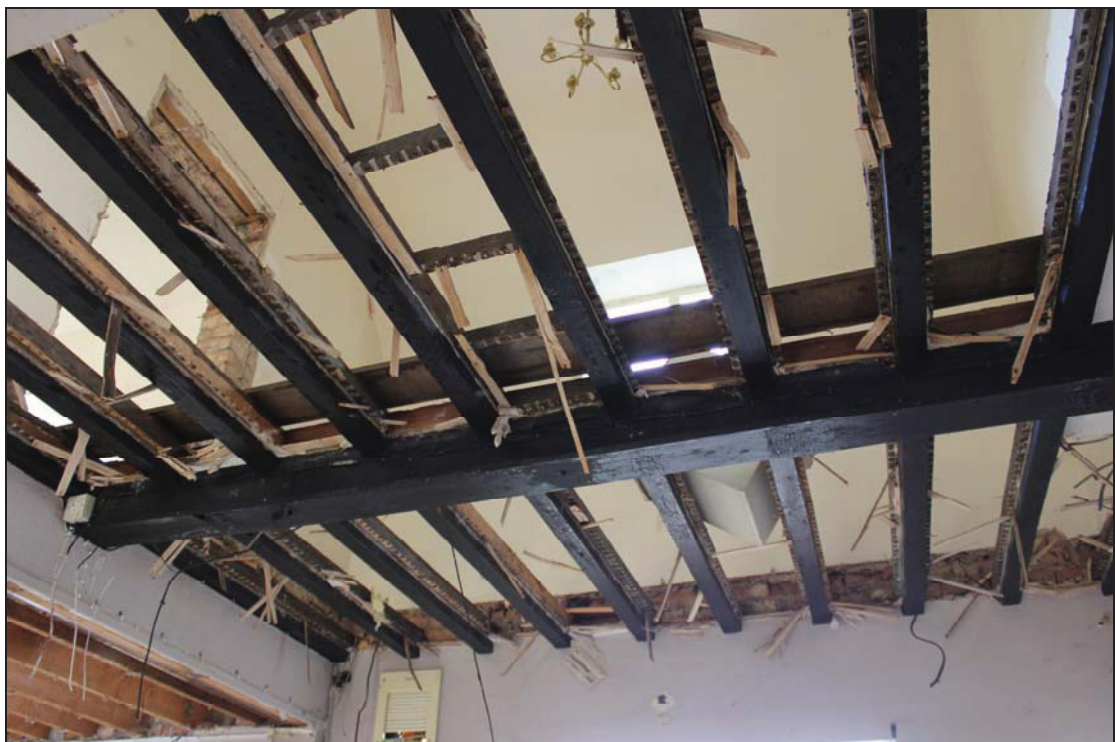
5.15 The different phases are well expressed here at ceiling level. In the southern range, the ceiling is somewhat higher than that of the historic core and comprises a large bridging joist with slender square common joists (Plate 5 & 6) supported at the junction between the two elements by inserted steel I-girders. The lower ceiling of the historic core is all underdrawn and nothing is visible, however the removal of the ceiling during the stripping revealed the joisting to have been completely replaced throughout the historic core with modern softwood members secured with x-bracing. Curiously here the common-joists rest on the original mid-rail on the east though are notched in to its companion on the west. A large aperture framed by a large steel I-girder has been cut through the rear wall of the south range giving access to the modern ranges, where a small seating area continues the form of the adjoining area with fictive ceiling joisting around boxed-in joists which mark the earlier divisions.

Plate 5 Public bar, GF02, taken from the south-west (DP 16)

Plate 6 Floor joisting to south bay, GF02, taken from the north-west (DP 74)

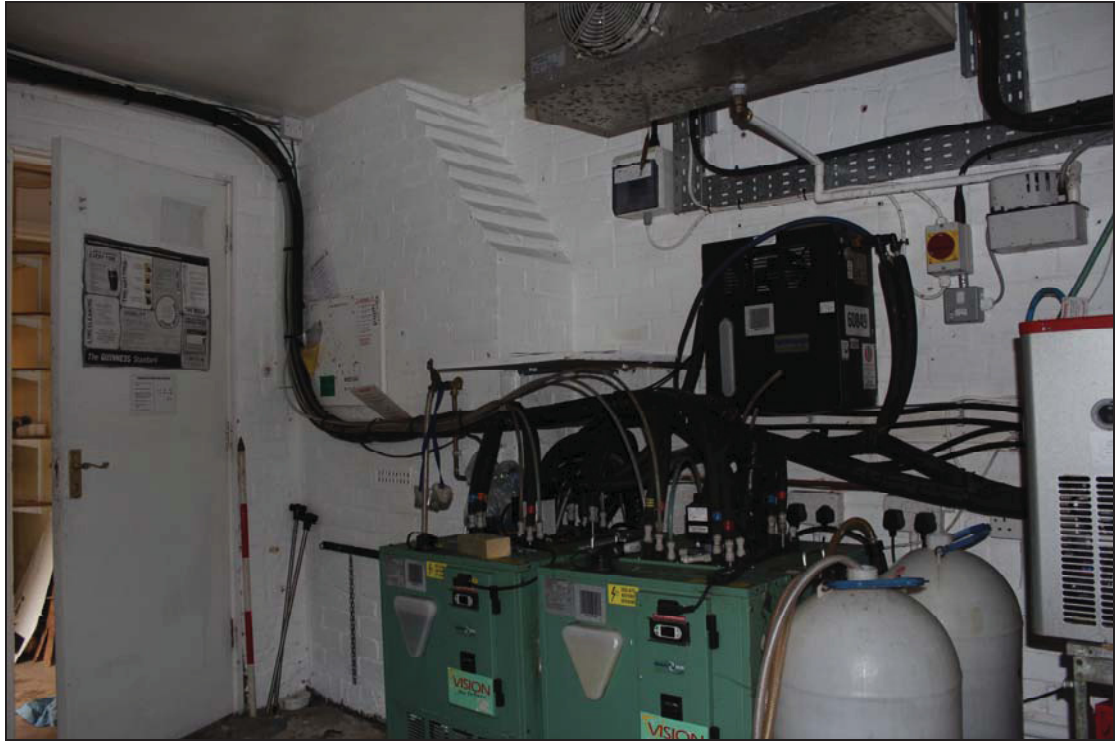
5.23 The beer store is entirely modern. It does however obscure lower sections of the northern gable where, as noted above blockings are visible infilling former apertures, here preserving a brick arch, as well as the projecting base of a chimney which is shouldered and now capped at upper level (Plate 9).

Plate 9 Beer store, GF09, taken from the north (DP 33)

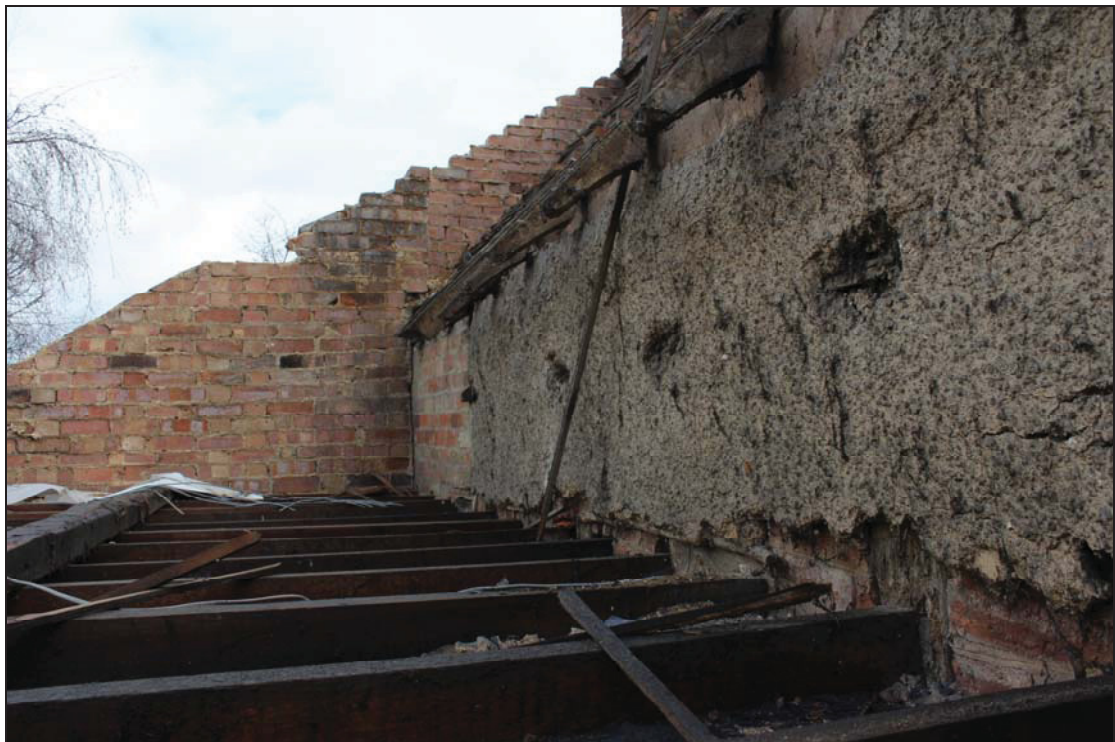
Plate 10 Sections of external render to north-west elevation, south-west (DP 81)

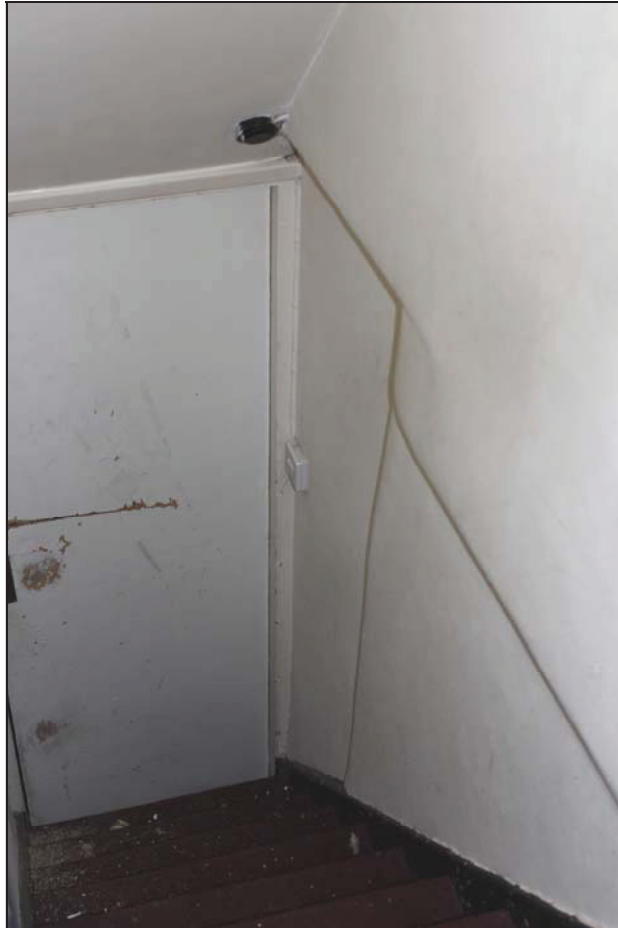
Plate 11 Stair vestibule, the junction between historic core and rear pent-roofed extension visible in the wall, FF01, taken from the south-east (DP 43)

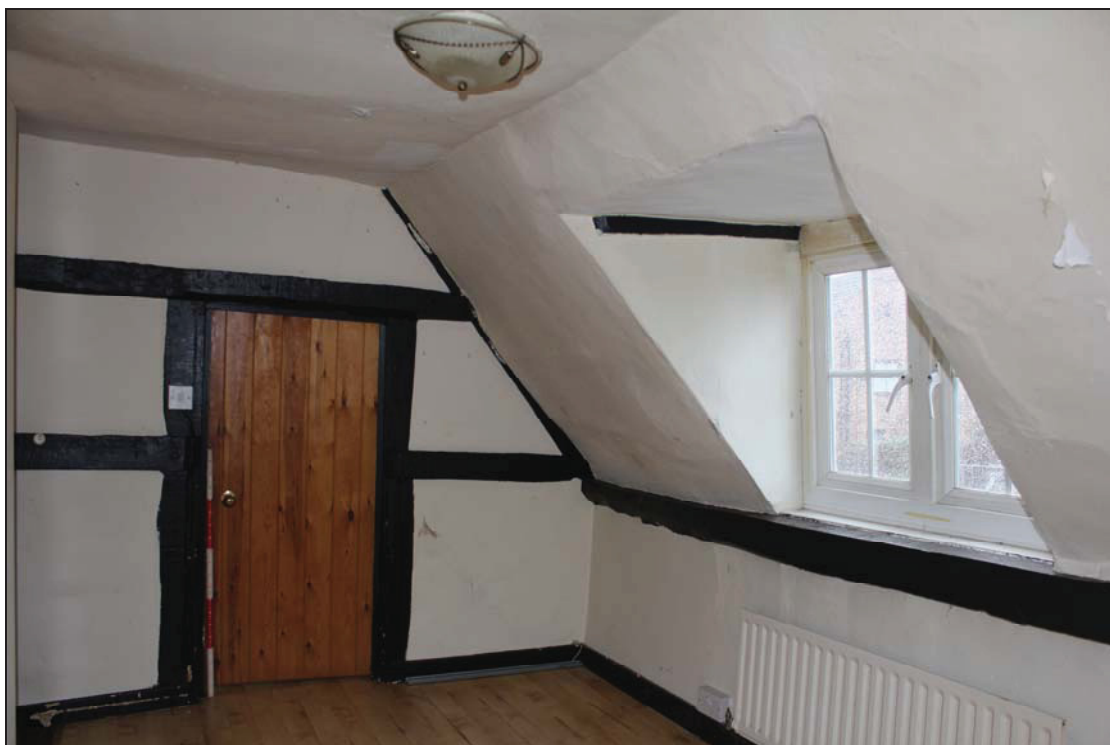
5.27 FF01 now forms an upper landing, partitioned on the west to create a bathroom (FF05). The floor is modern and both doors on the north and south have been replaced though are set within pegged timber frames. The room is lit on the east by a small dormer window (Plate 12).

Plate 12 FF01, taken from the south-west (DP 44)

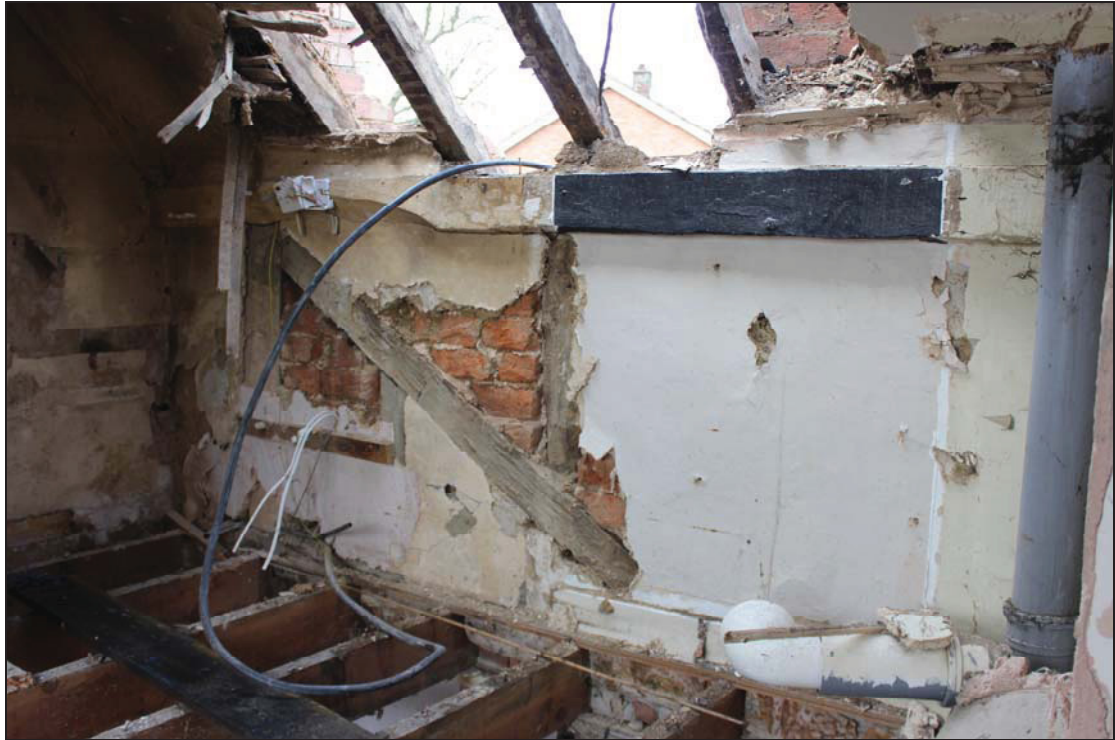
Plate 13 Primary braced studwork with brick infill to north-west elevation, FF01, taken from the north-east (DP 83)

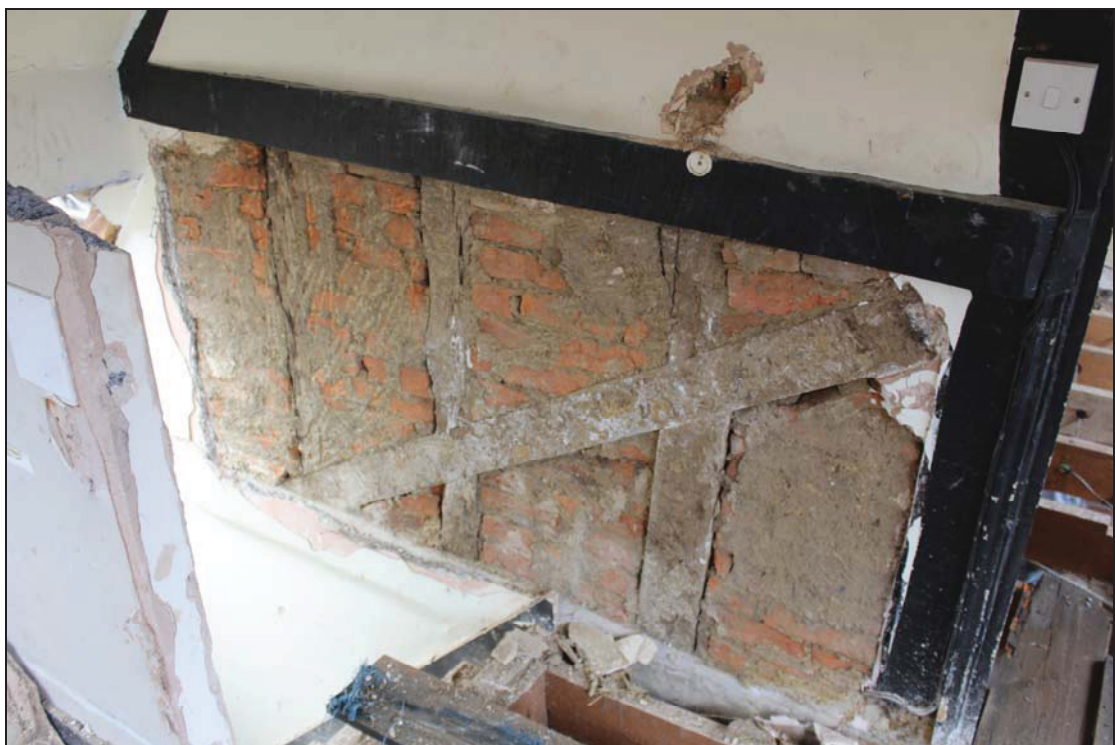
5.30 On the north the bay division is constructed in the same manner as the outer walls and retains all of its main components below the tie-beam (Plate 14). Here the studwork is bisected by downward primary braces extending either side of fairly robust door jambs which rise to an intermediate piece or collar, notched over the principal-rafters for extra support, and forming the door head. The tie-beam, as before, has been bisected for the insertion of the doorway. Above the tie-beam, any earlier studwork has been replaced with brickwork.

Plate 14 Timber-framing infilled with brick at the bay division, FF01, taken from the south-east (DP 93)

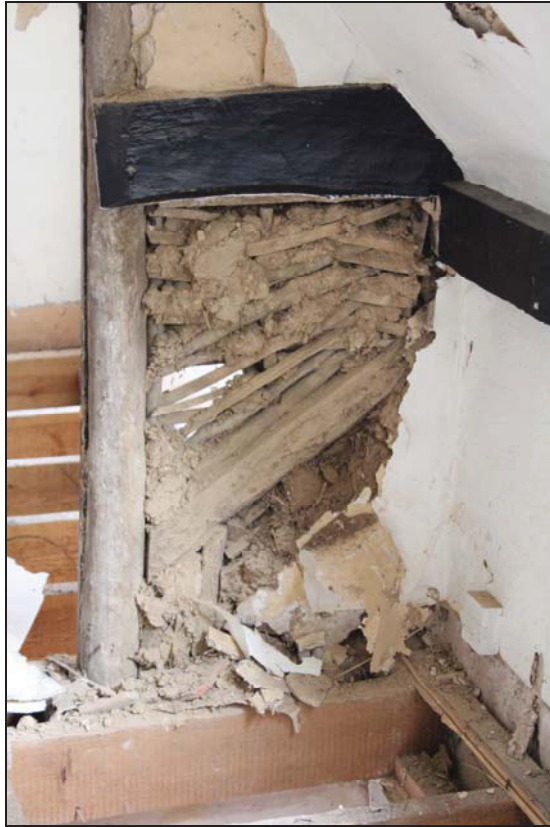
Plate 15 Wattle and daub infill around a brace, north gable, FF02, taken from the south-west (DP 85)

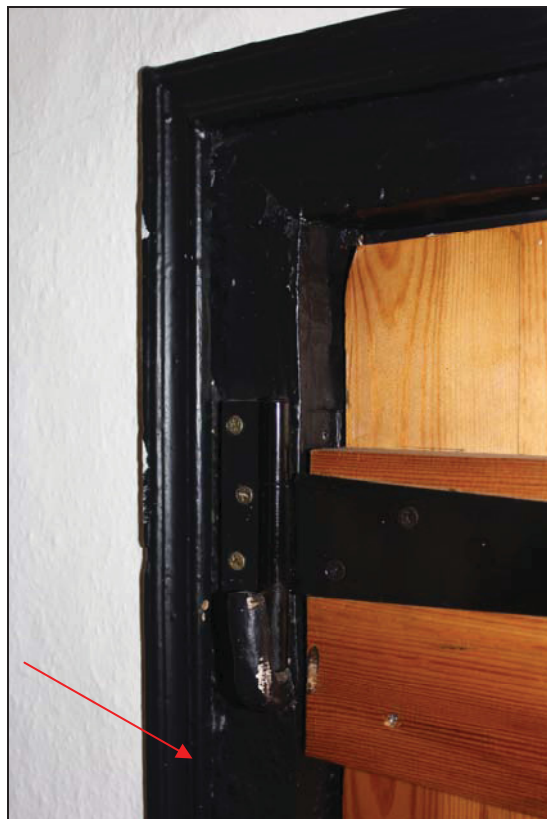
5.33 On the south the door frame retains pintels attached to a pegged frame, though as noted the existing door is modern (Plate 16).

Plate 16 Surviving pintel to door frame, FF02, taken from the north (DP 42)

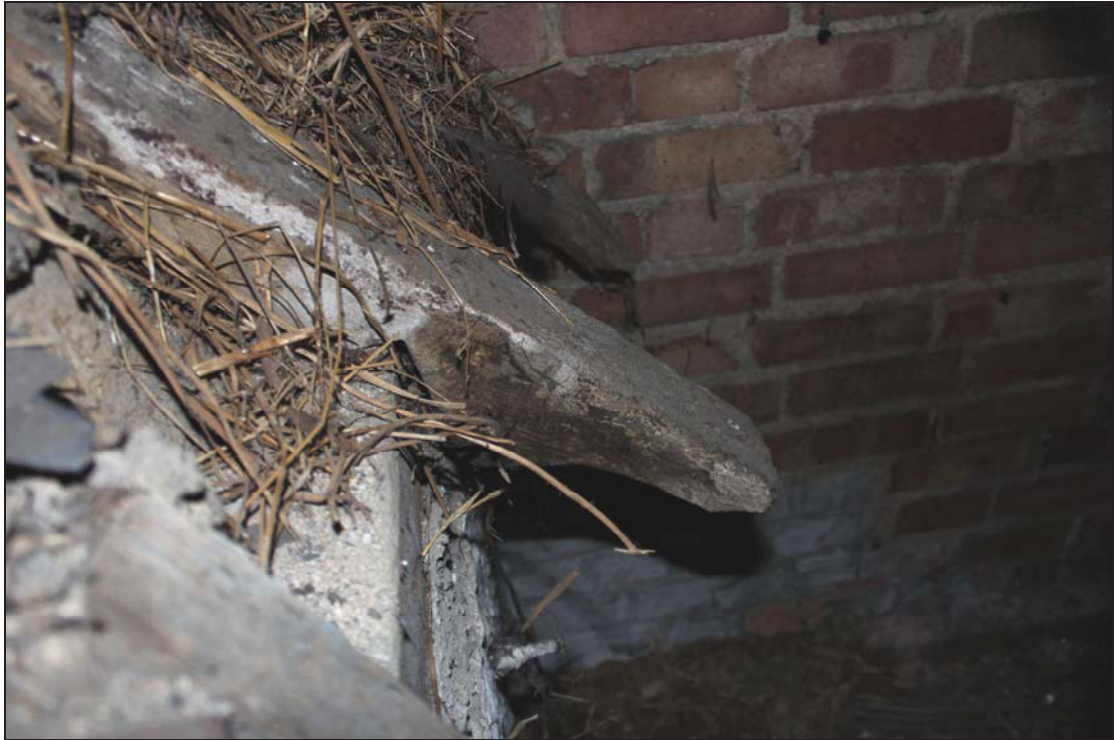
Plate 19 Original rafter feet preserved within pent-roofed extension seen from FF05, taken from the north-east (DP 55)

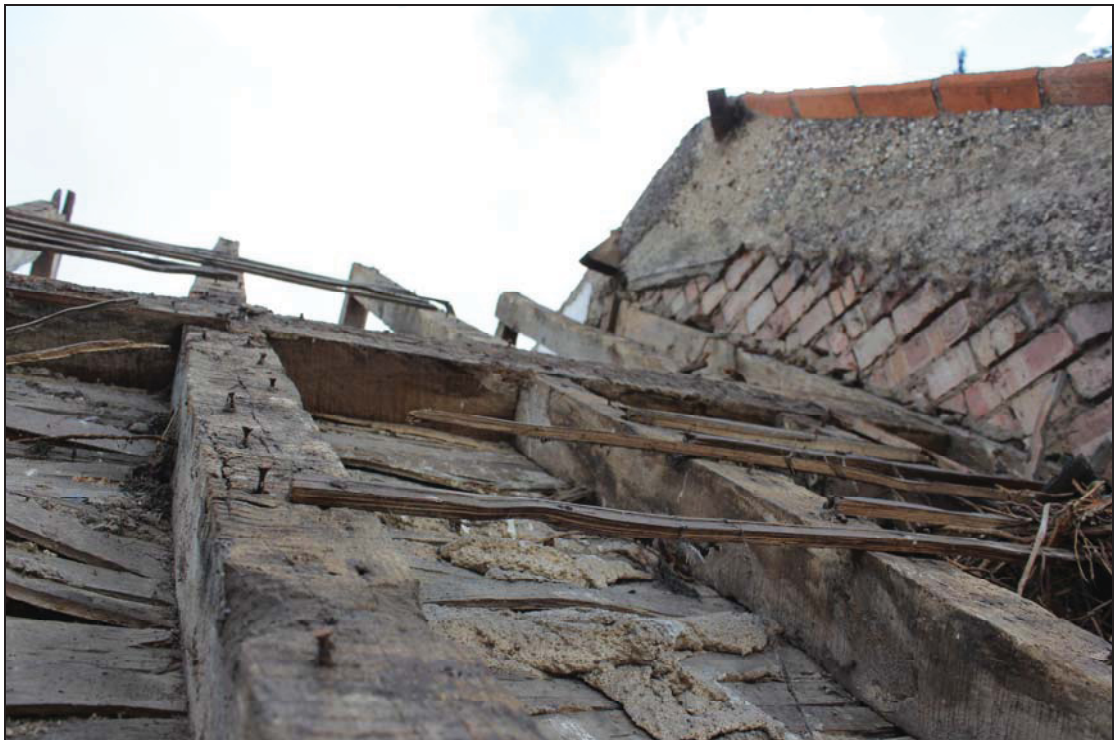
Plate 20 Common-rafters rising above and below the purlin, north-west pitch, taken from the north-west (DP 92)

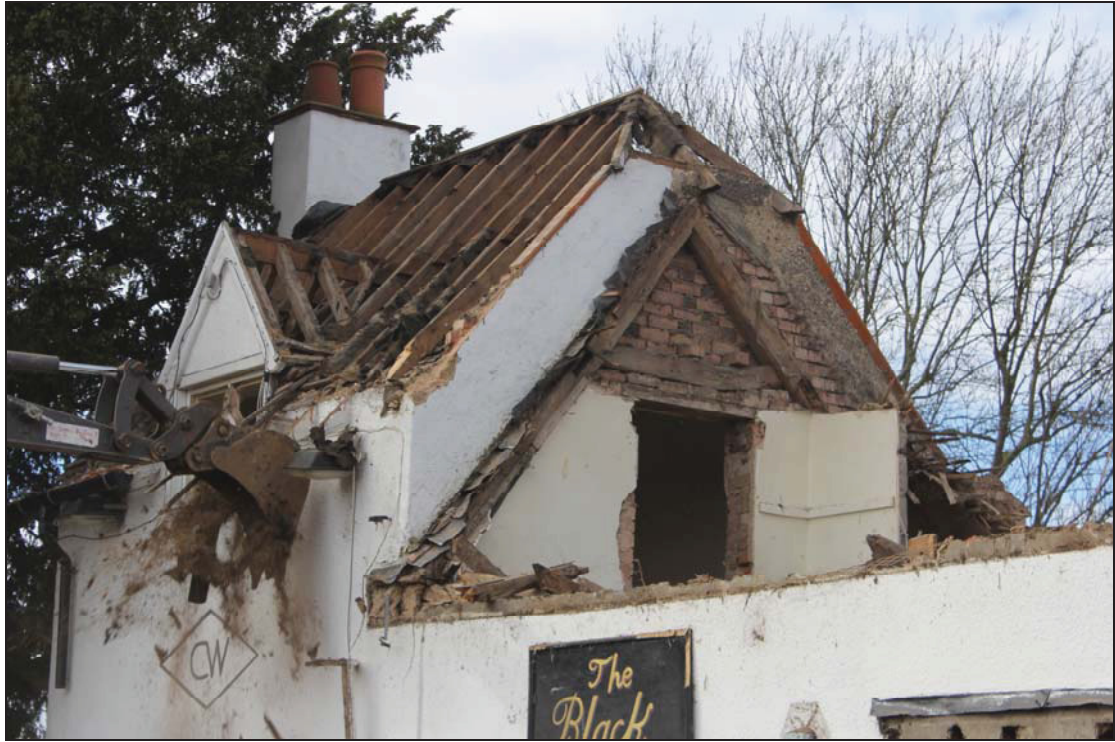
Plate 21

Original southern end truss to historic core against later 20th century brick addition, taken from the east (DP 105)

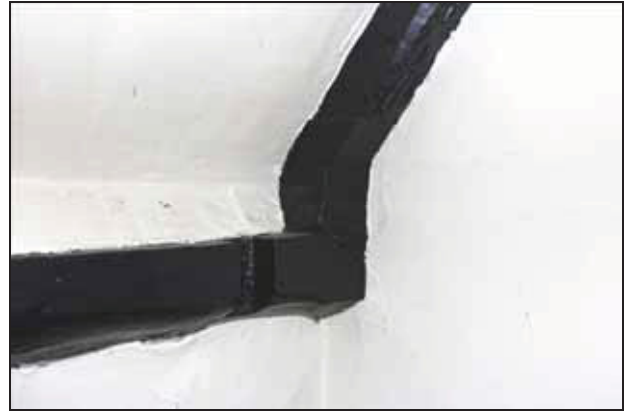
50

Tie-beam cut through to accommodate early 20th century extension, FF01, taken from the north

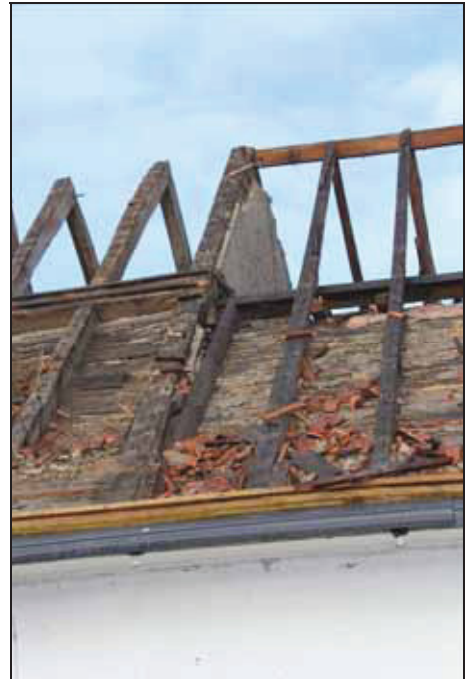
66

Section of external render surviving above collar level to historic core, taken from the east
