THE POND HOUSE,
BUGBY'S FARM, GREAT MUNDEN,
HERTFORDSHIRE

HISTORIC BUILDING
MONITORING AND RECORDING OF BUILDING
INVESTIGATION WORKS (PHASES 1 & 2)

Authors: Dr Lee Prosser BA PhD Lisa Smith BA Kathren Henry	
NGR: TL 3475 2392	Report No. 4549
District: East Herts	Site Code: AS1431
Approved: Claire Halpin	Project No. 3692
MIFA	Date: 22 April 2014
Signed:

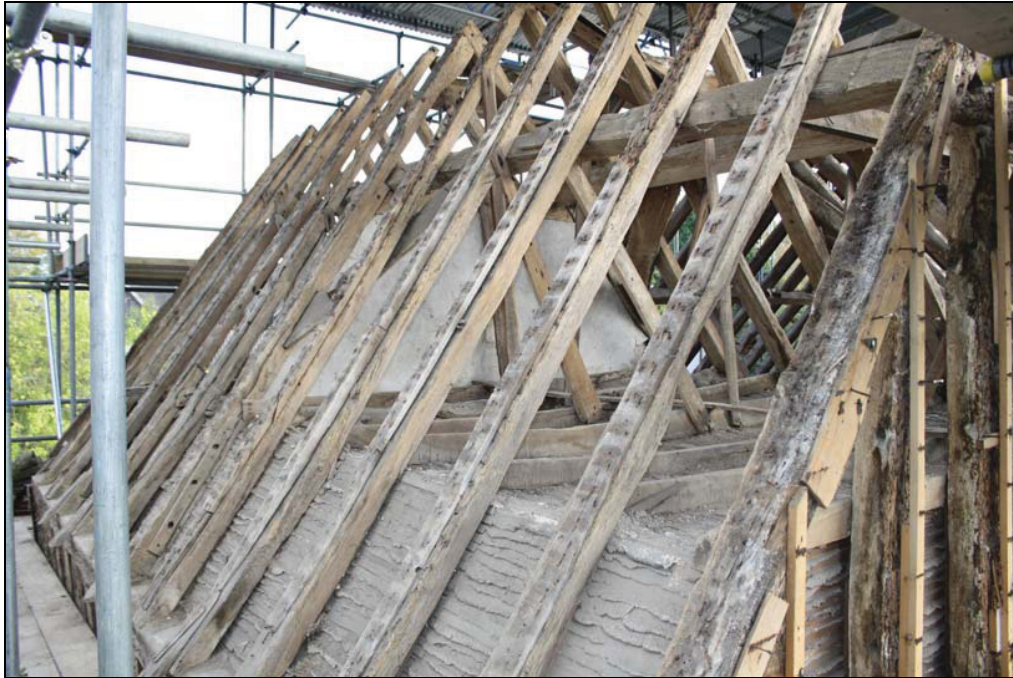
5.10 The clasped-side purlin roof survives in excellent condition, retaining virtually all its original timbers, the principal members being of good squared oak (Plate 5). The purlins are carried by collars at the gables and bay division with slender slightly curved wind-braces spring from the principal-rafters at the bay division. Braces also once existed in the end bays but these are now lost. A regular arrangement of common rafters rides over the backs of the purlins, pegged at the apex and notched into the wall-plate, where nailed-on spurs carry the roof over the eaves.

Plate 5 Western pitch of the cross-wing, taken from the west (DP 78)

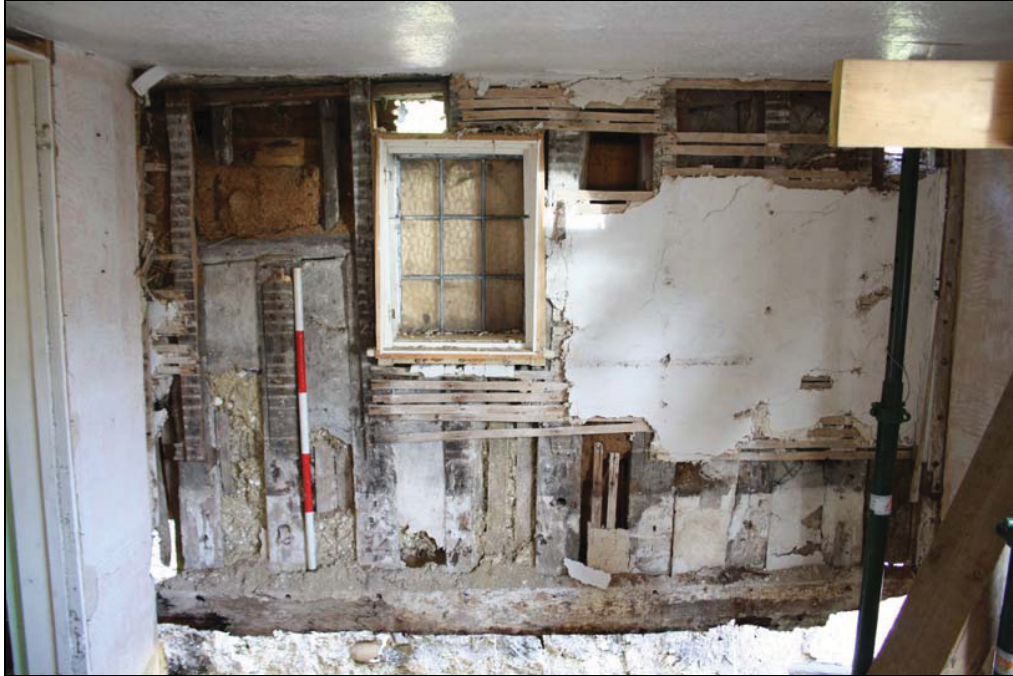
Plate 7 Soft stripping of the walls in Room 3, revealing early 17th century window and timber-framing, taken from the south-east (DP 21)

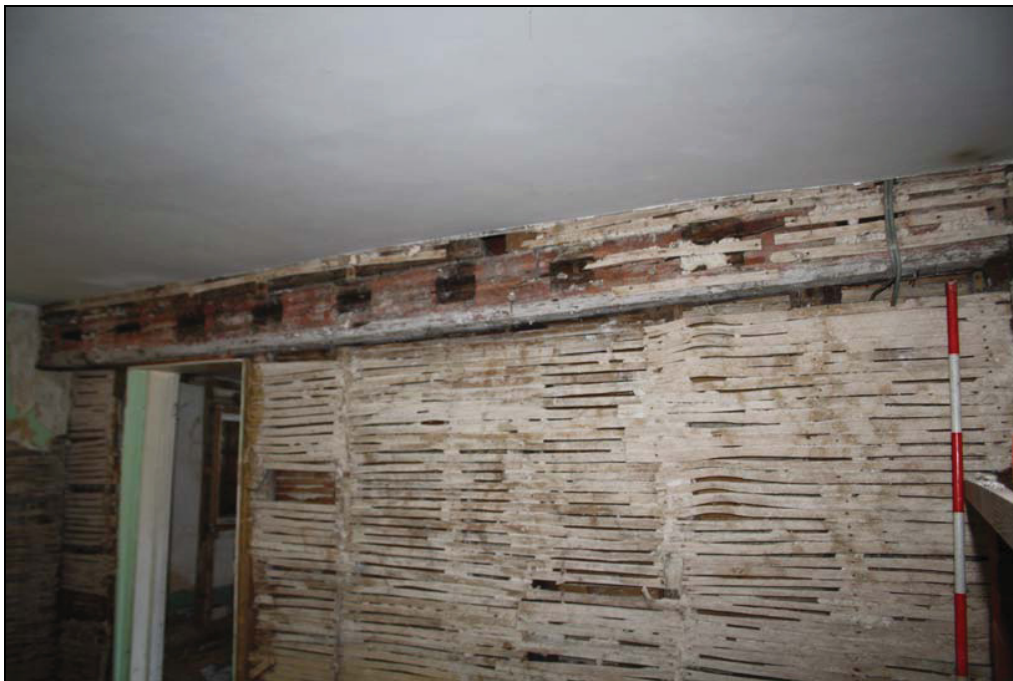
Plate 8 Central joist between Rooms 3 and 4 covered in red pigment with redundant mortices for common-joists, Room 4, taken from the south (DP 18)

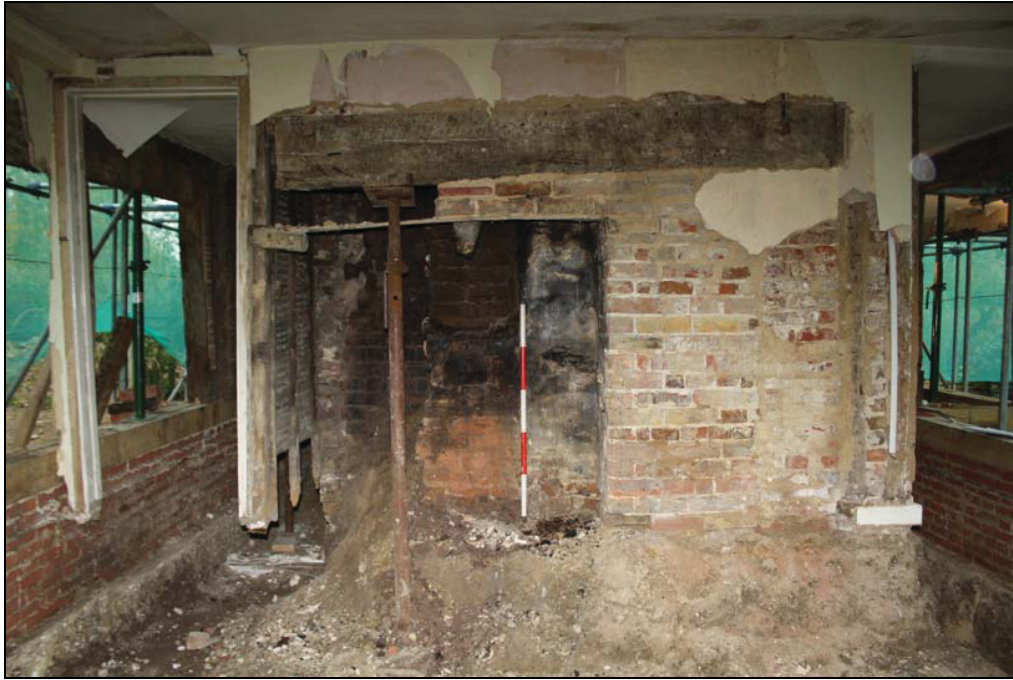
5.24 The fireplace is fully exposed at both levels and is in poor condition. At ground floor level a large inglenook is framed by a large timber bressummer, now partially infilled with brickwork (Plate 11). The southern end is barely supported and the rear of the stack has undergone a number of repairs. Above, a smaller aperture with rough brick arch has been blocked with modern brickwork while a flue on the south appears to be supported only by two sections of joisting and does not extend to the ground floor (Plate 12). The studwork to either side has been inserted in the 18th century. The original tie-beam remains *in situ*, strapped to the principal-rafters. The ceiling has been raised with pine collars inserted and covered in lath and plaster.

Plate 11 Chimney stack, fully exposed, ground floor, Room 1, taken from the south-east (DP 90)

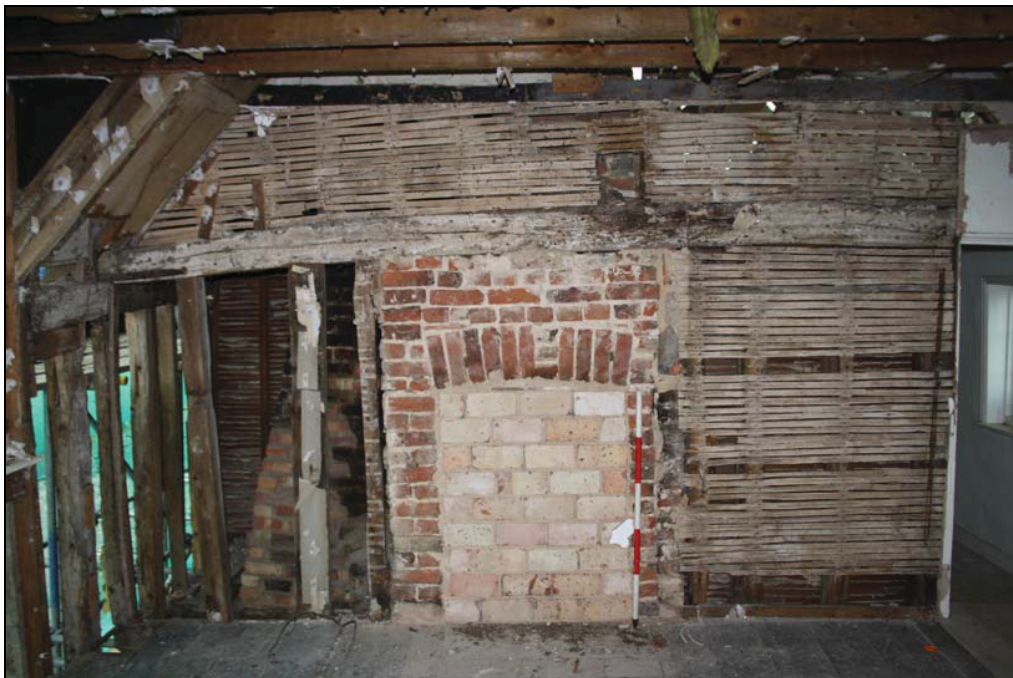
Plate 12 Blocked fireplace, Room 7, first floor, taken from the south-east (DP 88)

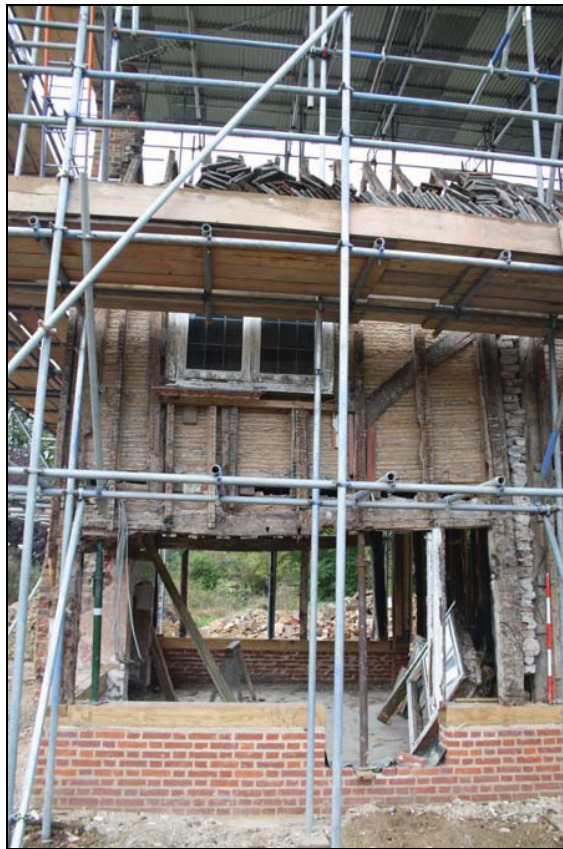
5.26 The kitchen bay comprises a single bay, but its framing appears to stand separate from the central hall-range, with the junction between the two nogged in a fairly crude manner with brick (Plate 14). The frame is in much poorer condition than elsewhere with the loss of the studwork at lower level and severe decay in the north-eastern corner-post at lower level. The principal-post is splay-cut and the mid-rail is slender and has no wattle groove but does retain peg-holes for a regular arrangement of studs. The upper studs are decayed but most are present, being in-line with their lower companions. Braces, one of which partially survives, were trenched over the inner face of the studs but were never meant to be seen.

Plate 14 The kitchen bay, north elevation, fully exposed, taken from the north-east (DP 34)

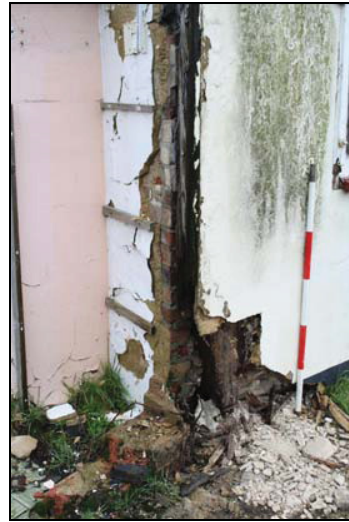
4

Render removed to reveal corner post in a poor condition, south-east corner of the building, taken from the east
