ARCHAEOLOGICAL SOLUTIONS LTD

PEARSE HOUSE,  
PARSONAGE LANE, BISHOP'S STORTFORD,  
HERTFORDSHIRE,

HISTORIC BUILDING RECORDING  
AND MONITORING

Authors: Dr Lee Prosser PhD Lisa Smith BA Tansy Collins Bsc Kate Higgs MA (Oxon.)	
NGR: TL 50355 21665	Report No. 4500
District: East Hertfordshire	Site Code: AS1644
Approved: Claire Halpin	Project No. 5506
MIFA	Date: 30 January 2014
Signed:

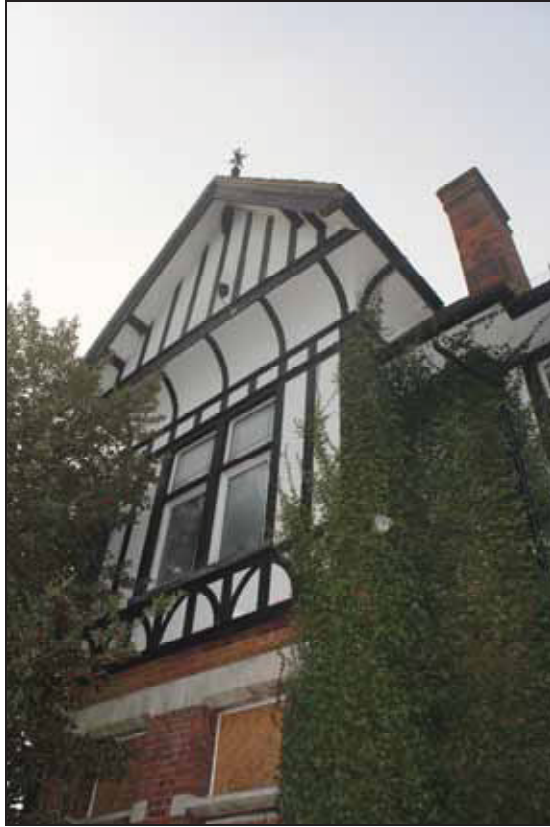
Plate 3 Upper decorative timber framing with jettied gable to south-east elevation, taken from the east (DP 74)

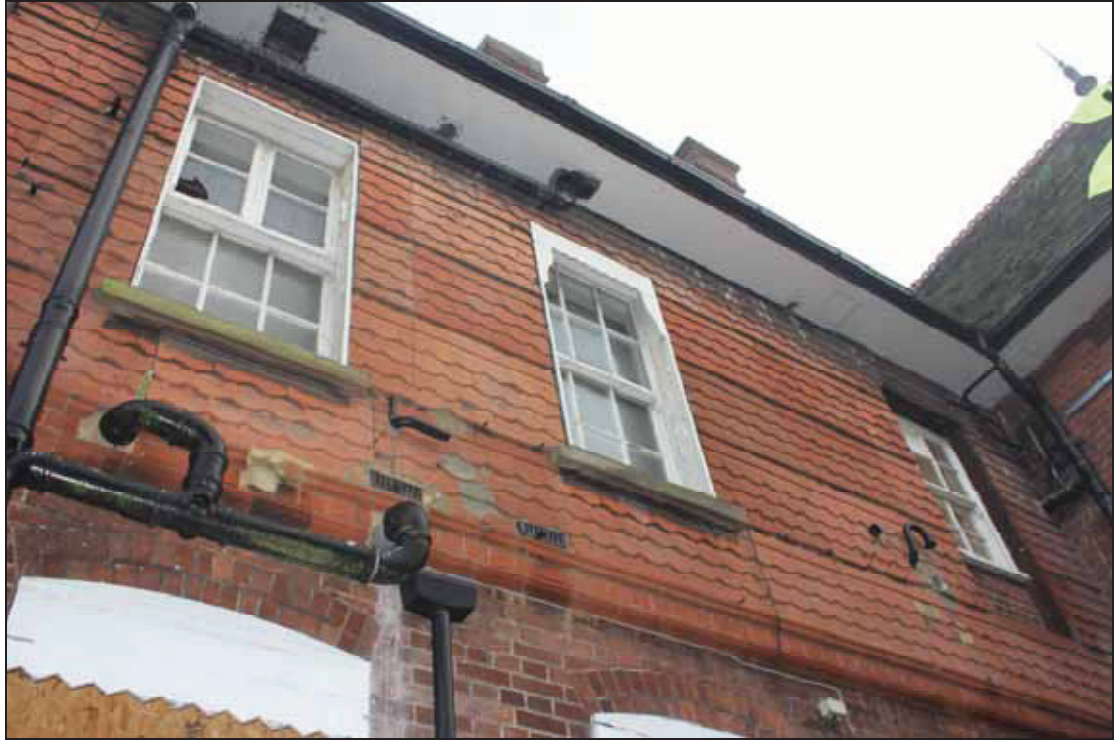
5.16 The service wing is similar in design to the eastern façade in outline, with the lower parts of the structure in brick, and tile-hanging to the upper elevations (Plate 7). Two of the four lower windows retain the original boxes for sun-awnings. The upper storey has three windows of varying form. The central window is the best preserved and is a six-over-six sash with a sun-awning box, differing slight from its counterparts below. The two other windows have been altered. To the north the upper sash has been replaced by a four-light casement while that to the south has been reduced in size. At attic level various dormer windows break through the roof line though the original fenestration has all been replaced with modern plastic materials.

Plate 7 Upper tile-hung portions of the north-west elevation of the service range, taken from the north (DP 90)

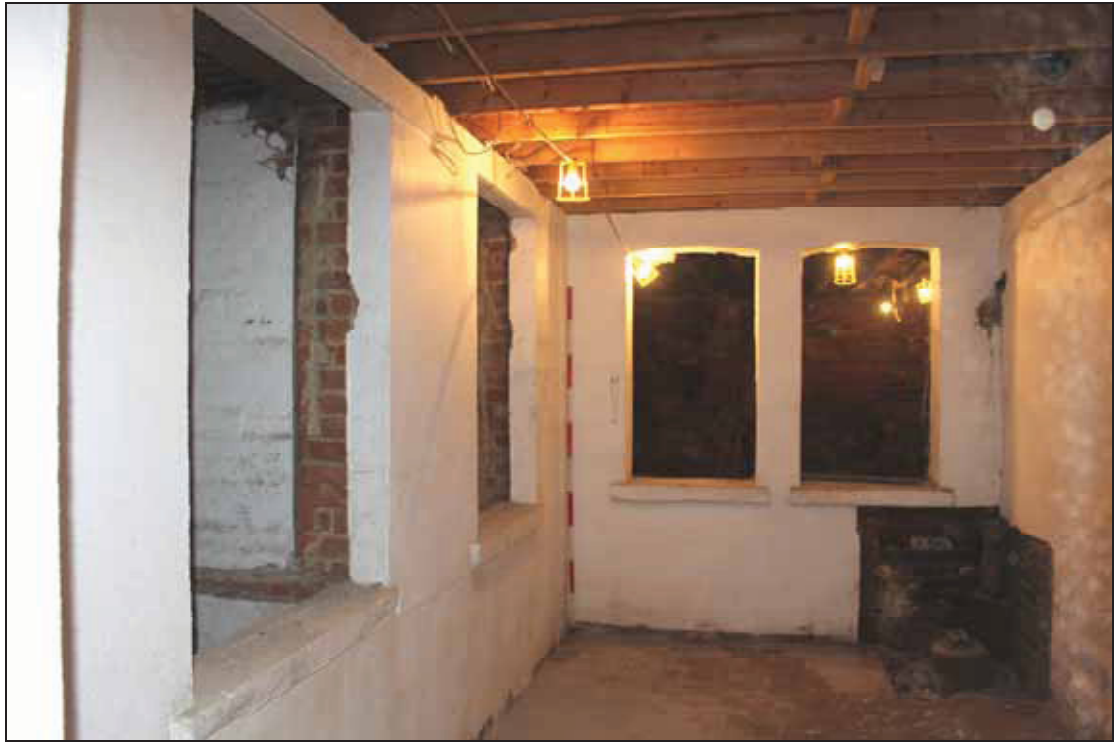
Plate 9 Original external space now boxed in and floored over, BF02, taken from the south (DP 112)

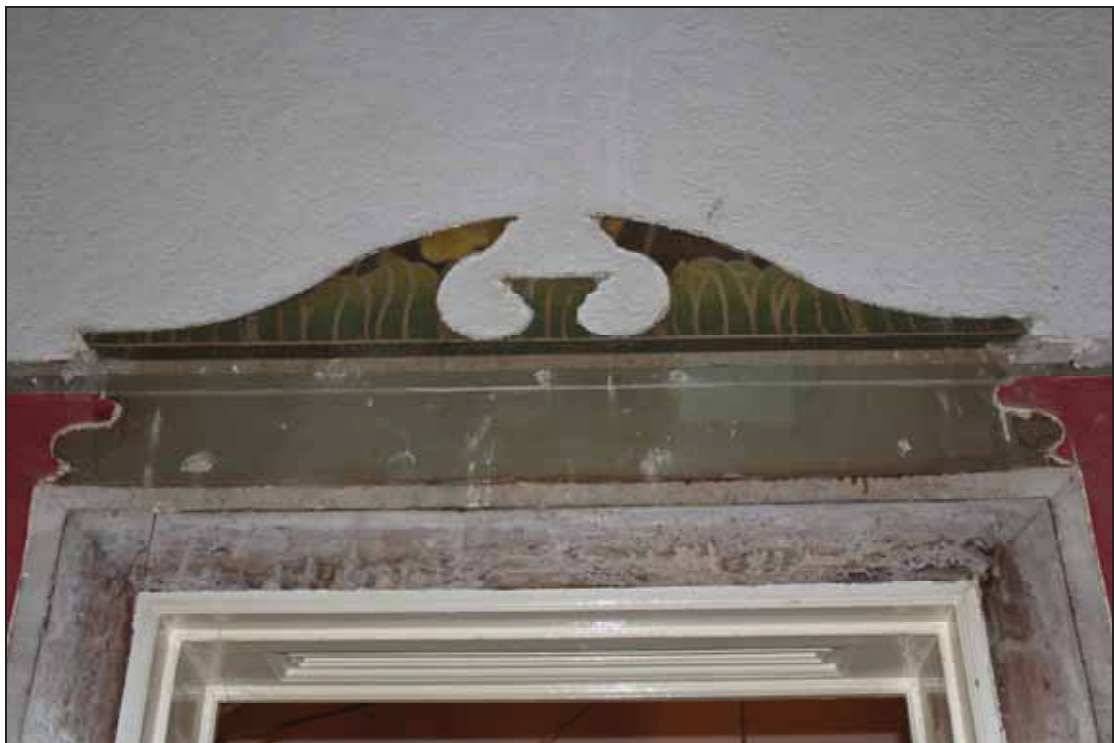
Plate 14 Wallpaper preserved beneath door case, GF05, taken from the north-east (DP 365)

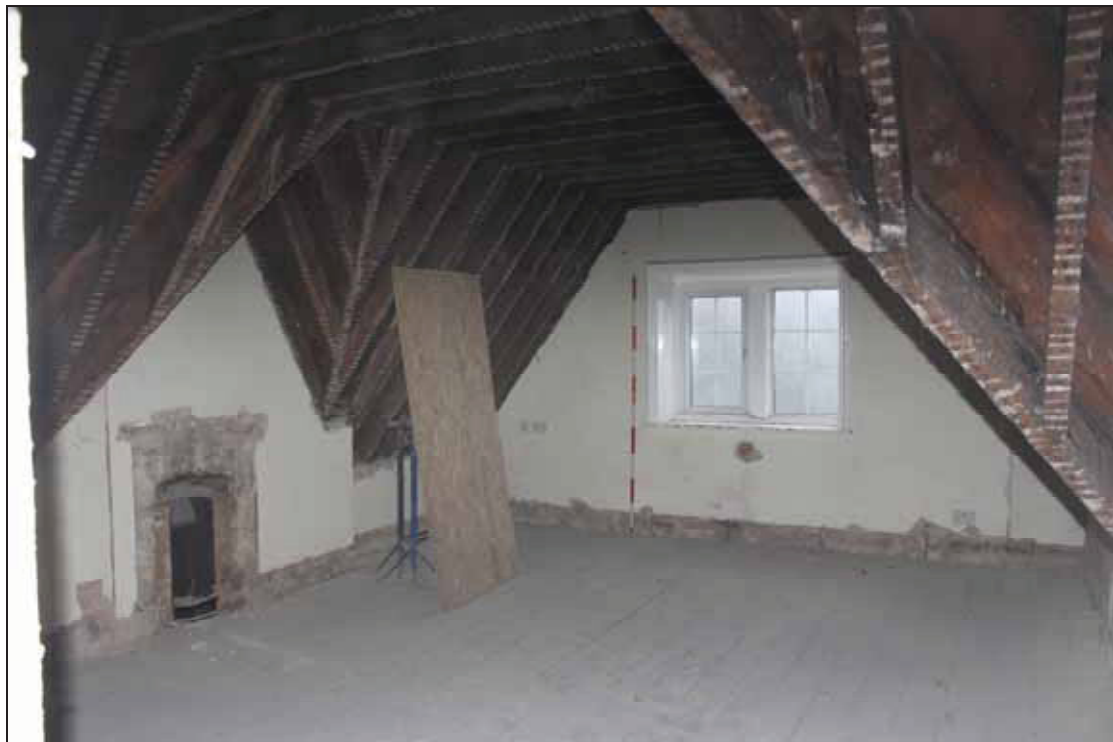
5.105 SF04 occupies the gable end return to the main frontage though with few features surviving (Plate 26). A gable window on the east has been replaced with a casement window. The fireplace has been removed. A small window has been inserted to the north of the door on the east.

Plate 26 SF04, taken from the west (DP 308)

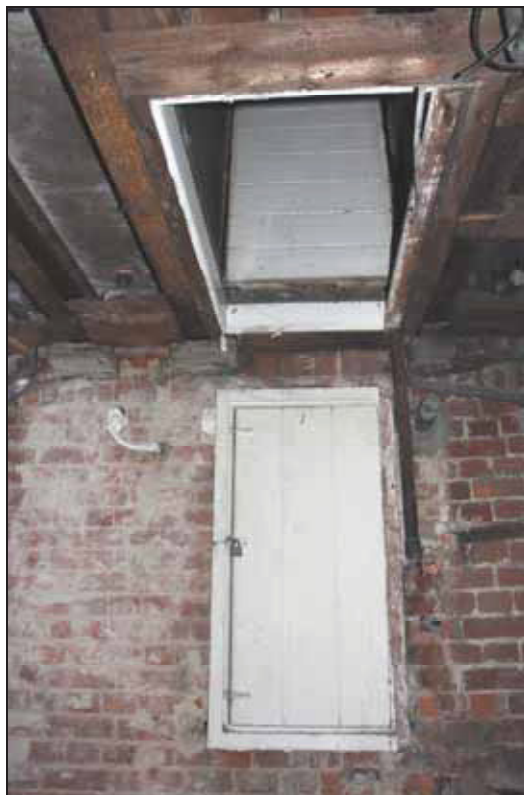
Plate 28 Small door to exterior with loft hatch above for access to water tanks, TF01, taken from the north-east (DP 303)

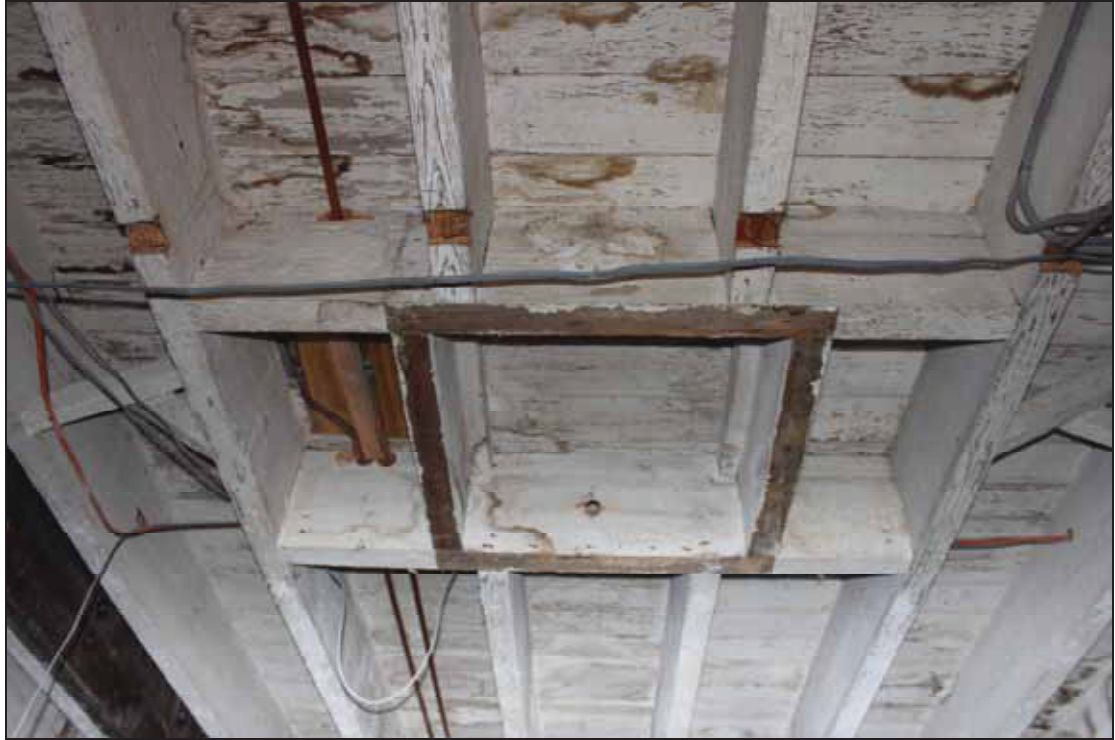
5.129 Here, the ceiling is exposed featuring a series of closely set joists given extra support with cross-bracing and supporting narrow floorboards above. Two centrally placed trimmers indicate the position of a loft hatch (Plate 31) while a longer trimmer and area of disruption in the north-western corner indicates the position of a staircase; a second loft hatch survives in the south-eastern corner. All have now been infilled with short sections of joisting. Elsewhere an original two-over-two sash flanked by a fixed three light window to the ground floor of the north-elevation and as noted above, a two-light casement to the central bay are all that remain of the original joinery.

Plate 31      Original loft hatch, GF06, north-east block, taken from the south-west (DP 381)

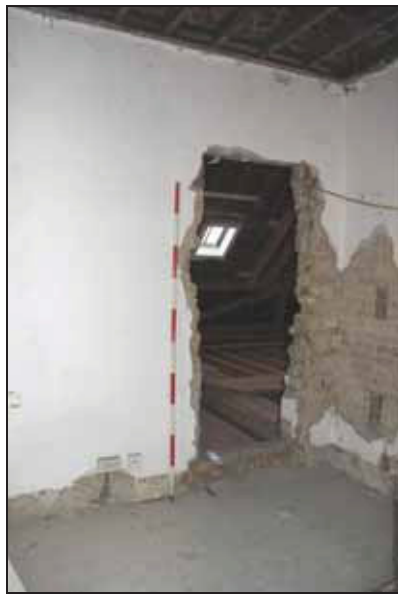
321

*Wall broken through to access roof space, SF08, taken from the north-west*
