**THE RED HOUSE
84, HIGH STREET, BUNTINGFORD
HERTFORDSHIRE**

HISTORIC BUILDING MONITORING AND RECORDING

Authors: Dr Lee Prosser PhD Lisa Smith BA Kathren Henry	
NGR: TL 36119 29765	Report No. 4377
District: East Herts	Site Code: n/a
Approved: Claire Halpin	Project No. 4586
MIFA	Date: 24 July 2013
Signed:

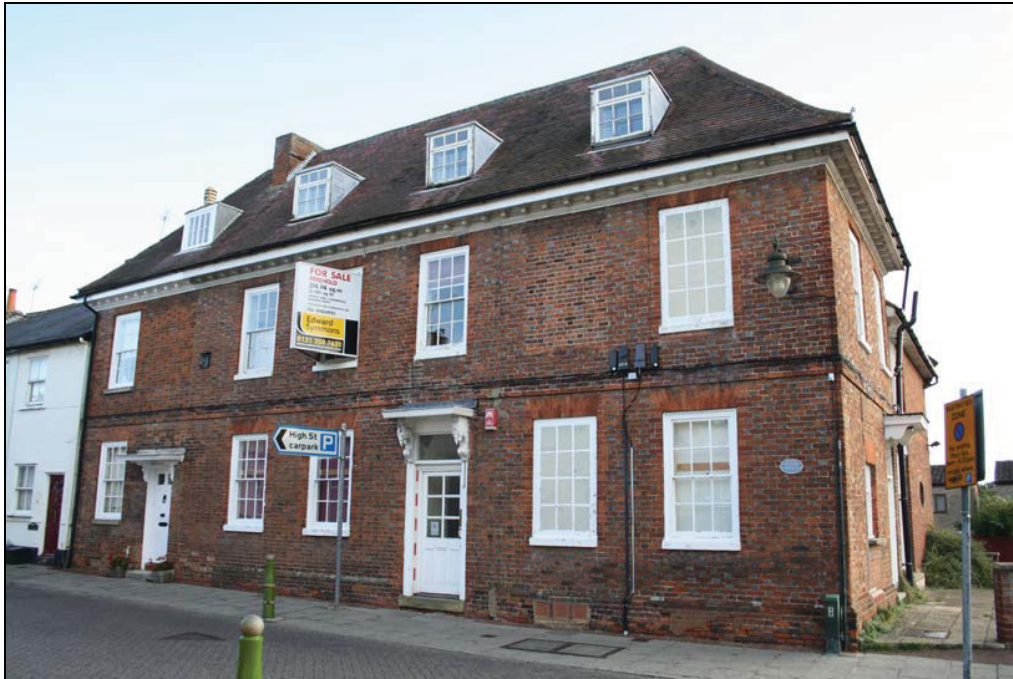
4.1 The Red House is of two-storeys in brick, with a steeply pitched roof covered in machine-made peg-tiles, pierced by modern dormer windows (Plate 1). The building is stylistically contiguous with the adjoining number 86, known as North End Cottage, but analysis shows it to be a separate dwelling constructed or refaced carefully in like style and manner. The main frontage is arranged in five, generally symmetrical bays defined by tall sash windows and a central door. A window to the right of the door is blind while blank brickwork at upper level preserves slight evidence of an earlier recess or window which has been blocked. A second window at first floor level is also blind. As part of the refurbishment the brickwork has been cleaned and given a refreshed look with all extraneous services removed from the façade (Plate 2). The blind window at ground floor level has also been renewed. New windows have been inserted to the dormers replacing their modern counterparts.

Plate 1 Main façade (west elevation), taken from the south (DP8)

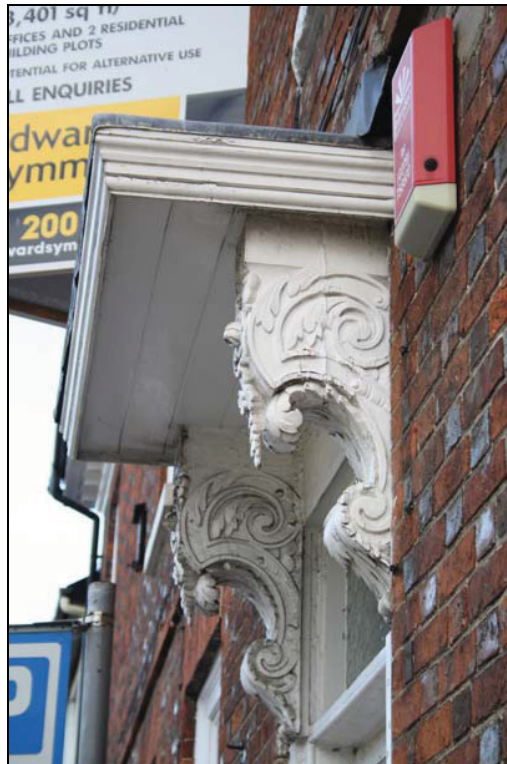
4.3 The entrance has a plain over-light (described as a fan-light in the listing, but this is not present) flanked by fine carved scrolled brackets supporting a hood (Plate 3). Some modification is apparent. The hood appears renewed and the brackets have been stripped and repainted, giving sharp, new profiles to the carving. The door has three lower panels and six glazed upper panels, probably of modern date but set in an original surround. A surviving threshold of York stone is set above disturbed brickwork, suggesting that a projecting step once existed on the pavement.

Plate 3 Detail of the decorative scrolled brackets supporting the hood above the main entrance, west elevation, taken from the south (DP11)

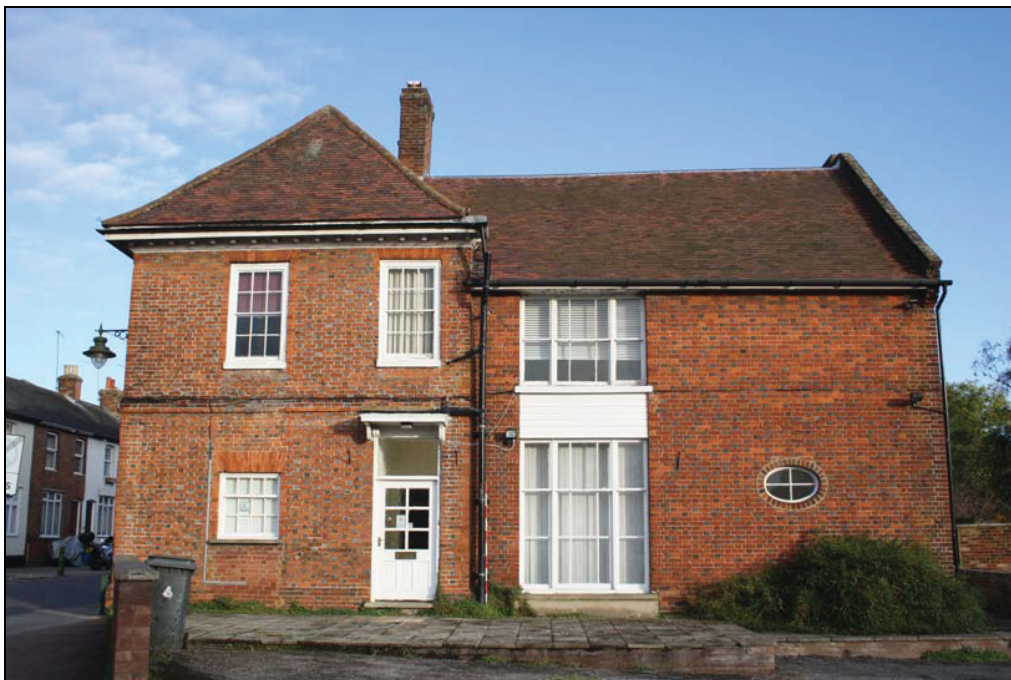
4.5 The southern elevation appears also to have been a fine façade, probably once overlooking an ornamental garden, as it returns in similar brickwork for two bays (Plate 4). Secondary access is given by a door with projecting hood supported on simple shaped brackets. Both door and over-light have been renewed, probably in the 1960s, and now again replaced during the latest of alterations. A brick set at high level to the left of the door has been carved with the initials and date 'I.E. 1713' in apparently genuine letter-forms. A short, four-over-eight window adjacent is clearly modern. The aperture was originally filled by a sash in the same form as those on the frontage, but the arch then appears to have been dropped to form a door, and subsequently bricked up to create the existing window. Subsequently, the original window opening has been restored and the arch lifted to its original position just below the string course in keeping with the style of the fenestration (Plate 5). The window has, however been left as a blind example. At upper level there are two six-over-six sashes. The cornice continues along this façade, returning on the rear face for a short stretch before abutting the rear range.

Plate 4 The Red House, south elevation, taken from the south-east (DP2)

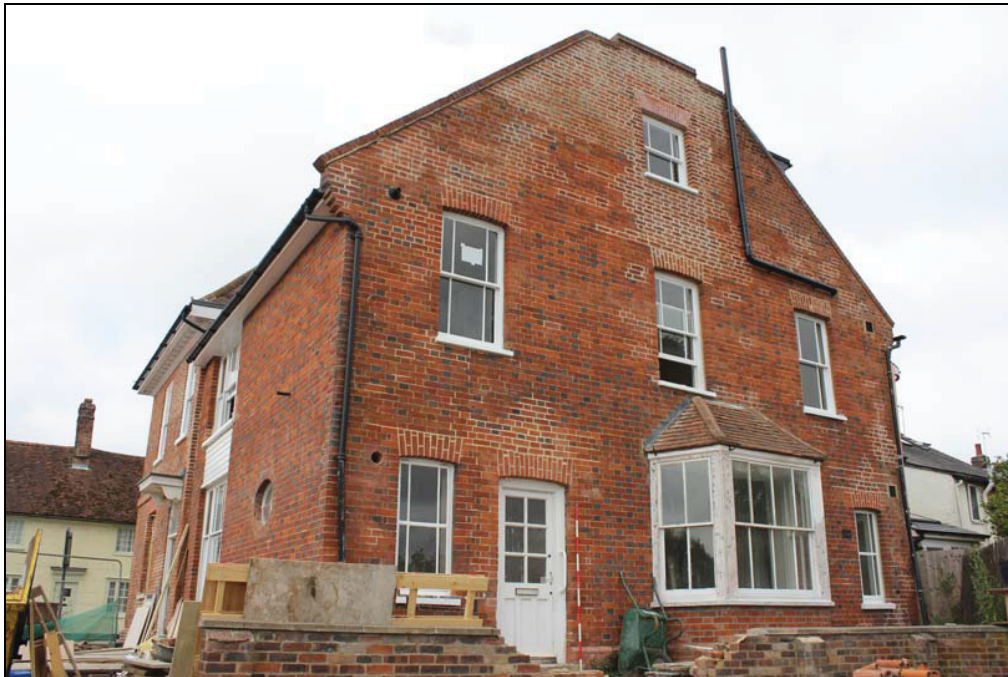
4.8 Here, the rear has undergone slightly more change than elsewhere with the removal of pipework and other services as well as the hood above the door (Plate 7). Upper sections of the parapet have been rebuilt and the large second floor window has been foreshortened and given a gauged arch as elsewhere. The central first floor window has been replaced with a similar example matching its counterparts on either side.

Plate 7 East elevation, taken from the south-east (DP78)

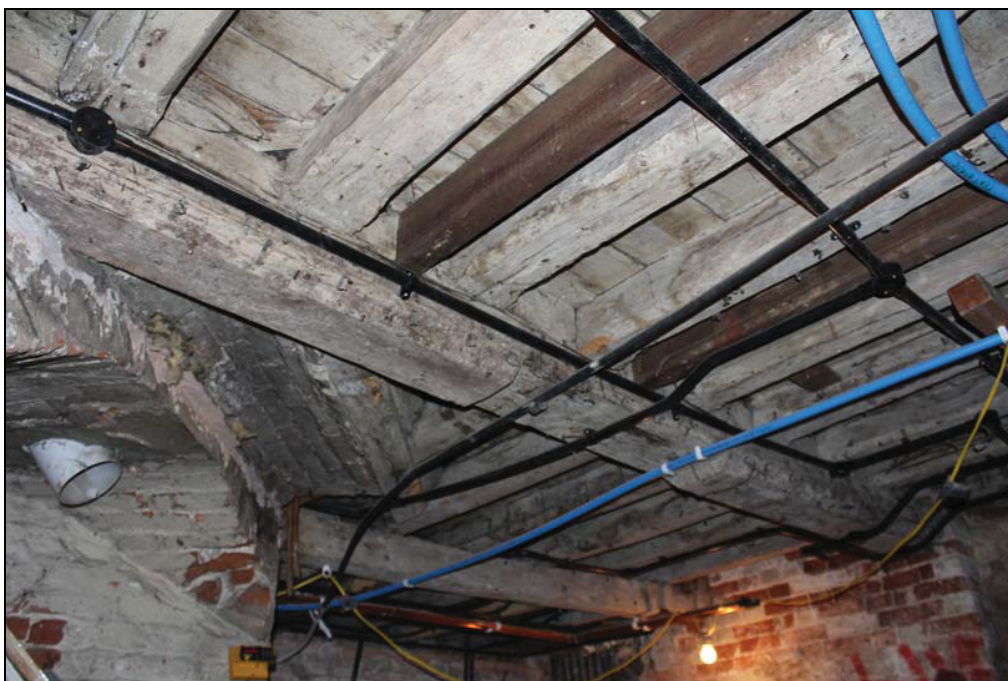
4.14 Removal of modern linings to the ceiling revealed a curiously robust and decorative floor structure comprised of a large chamfered joist extending NW/SE with in-line common-joists either side supporting the floor above (Plate 8). All the common-joists are chamfered with delicate lambs-tongue chamfer stops (Plate 9).

Plate 8 Ceiling to the basement formed of large chamfered central joist and chamfered common-joists with lamb tongue chamfer stops, BF01, taken from the west (DP103)

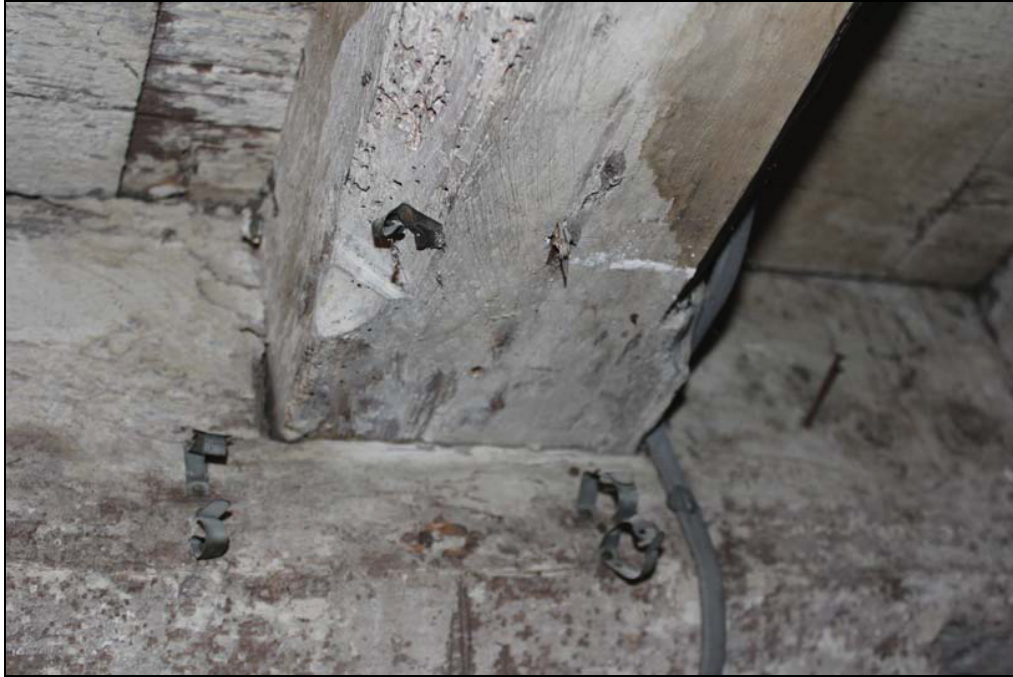
Plate 9 Lambs tongue chamfer stops to the common-joists, BF01, taken from the south-west (DP104)

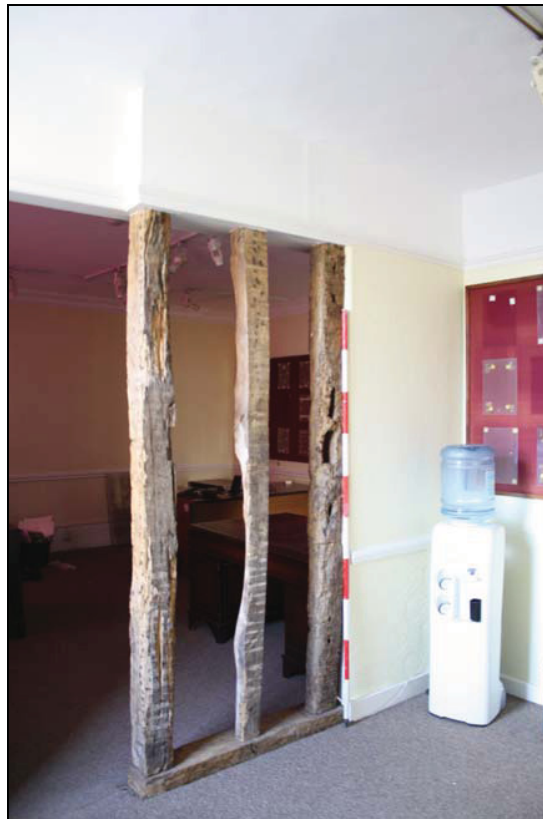
4.16 Three studs forming the dividing wall to GF02 were formerly exposed as a feature (Plate 10). One was a re-used horizontal member with empty mortices for studs and a continuous wattle groove suggesting a medieval origin. These studs were latterly enclosed while the modern partition to the rear has been pushed back and a modern wall inserted to create a bathroom and a cupboard.

Plate 10 GF01, taken from the south-west (DP13)

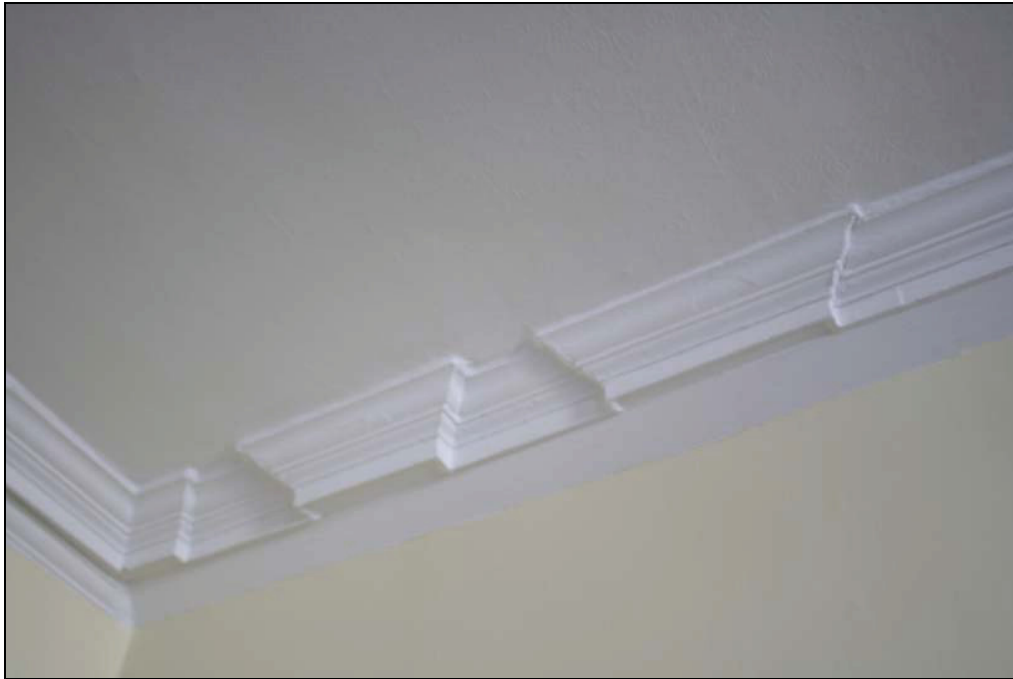
4.19 A notable feature is seen in slight articulation of the cornice to the rear of the room (Plate 11), suggesting the presence of pilasters or other architectural features.

Plate 11 Curious decoration to the cornice, GF02, taken from the south-west (DP23)

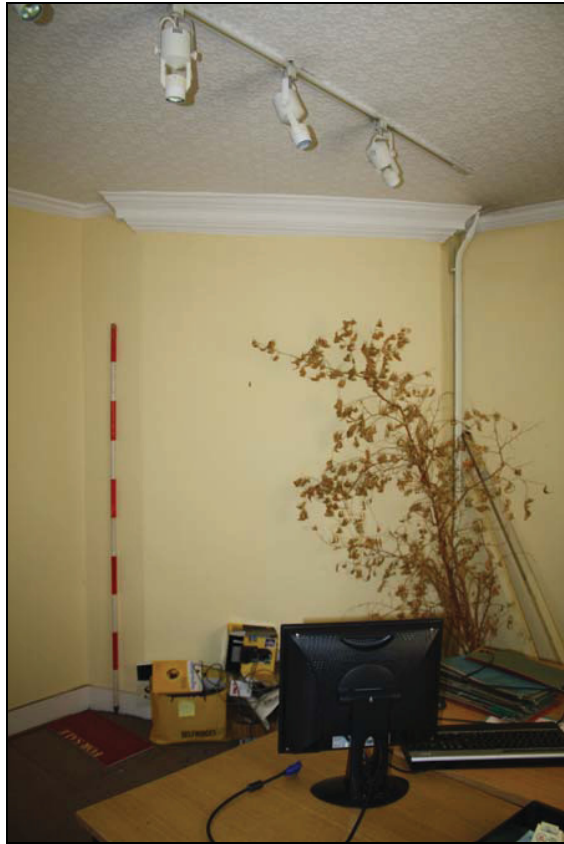
4.21 The room preserves its original box-cornice, with slight elaboration of the mouldings above the position of the original fireplace, which was set in a canted, internal corner stack (Plate 13). The listing of 1984 describes a good fireplace, but this is no longer present. The exposure of the chimney stack revealed sections of panelling and walls plastered on either side. The western sash window is a 19th century example, but set in splayed reveals with surviving 18th century shutters, until recently fixed open, but latterly eased to reveal the locking bar to the rear. The south window, noted above is modern and of no interest and has since been blocked.

Plate 13 Blocked canted corner fireplace, GF03, taken from the south-west (DP17)

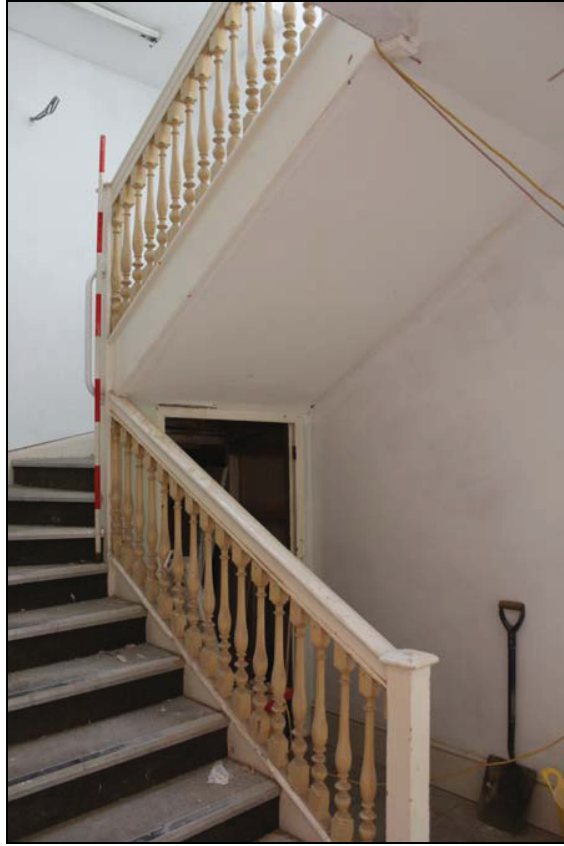
4.27 The staircase appears to have risen originally only to first floor level. It is of dog-leg form, but has been extended latterly into the attics. The lower portion of the balustrade preserves its original handrail of characteristic toads-back profile, with square newels and shaped caps (Plate 16). It is of closed-string form, and preserves its original turned vase balusters, though these were latterly hidden behind flush boarding (Plate 17). Two examples were seen during the original survey, and are of typical, if fairly advanced form for c.1710 but certainly 18th century in date.

Plate 17 Main staircase, GF08, taken from the south-west (DP95)

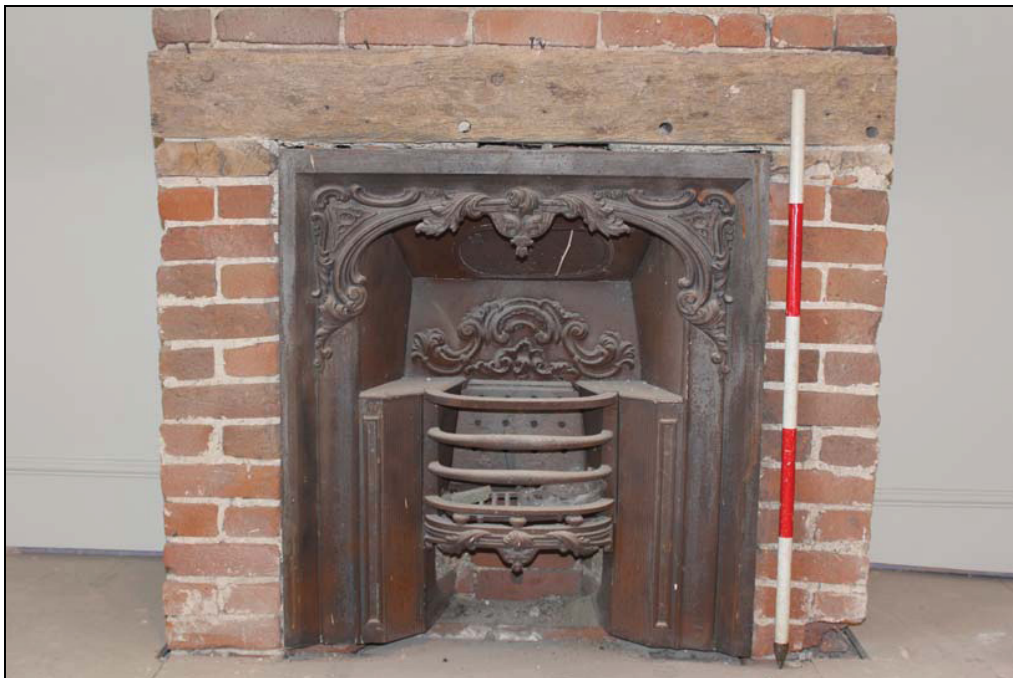
Plate 24 Cast iron hob grate, SF04, taken from the south-east (DP115)
