**POLLARDS FARM, THE COMMON, HARPENDEN,
ST ALBANS, HERTFORDSHIRE, AL5 3PE**

**BUILDING RECORDING & BUILDING /
ARCHAEOLOGICAL MONITORING AND RECORDING**

Author: Lauren Wilson MA (Research) Zbigniew Pozorski	
NGR: TL 1078 1589	Report No: 4802
District: St Albans	Site Code: AS1732
Approved: Claire Halpin	Project No: P5714
Signed:	Date: 2 June 2015

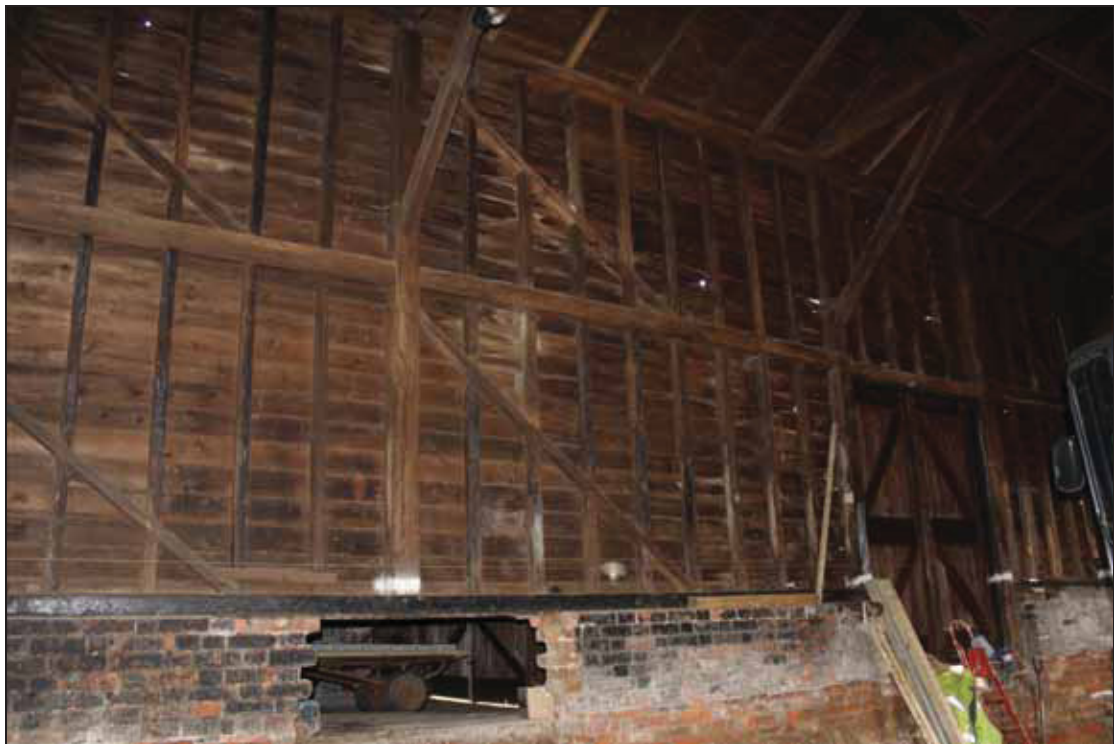
5.7 The east side has an intermediate post with a redundant brace mortice, which frames a loading door (Plate 2). The upper register is braced from the north but there are no braces in the lower register. The west upper register is braced from both sides, the lower register, partly removed, is braced the same way.

Plate 2 East side of the building showing loading door in Bay 3, taken from the north-west (DP 13)

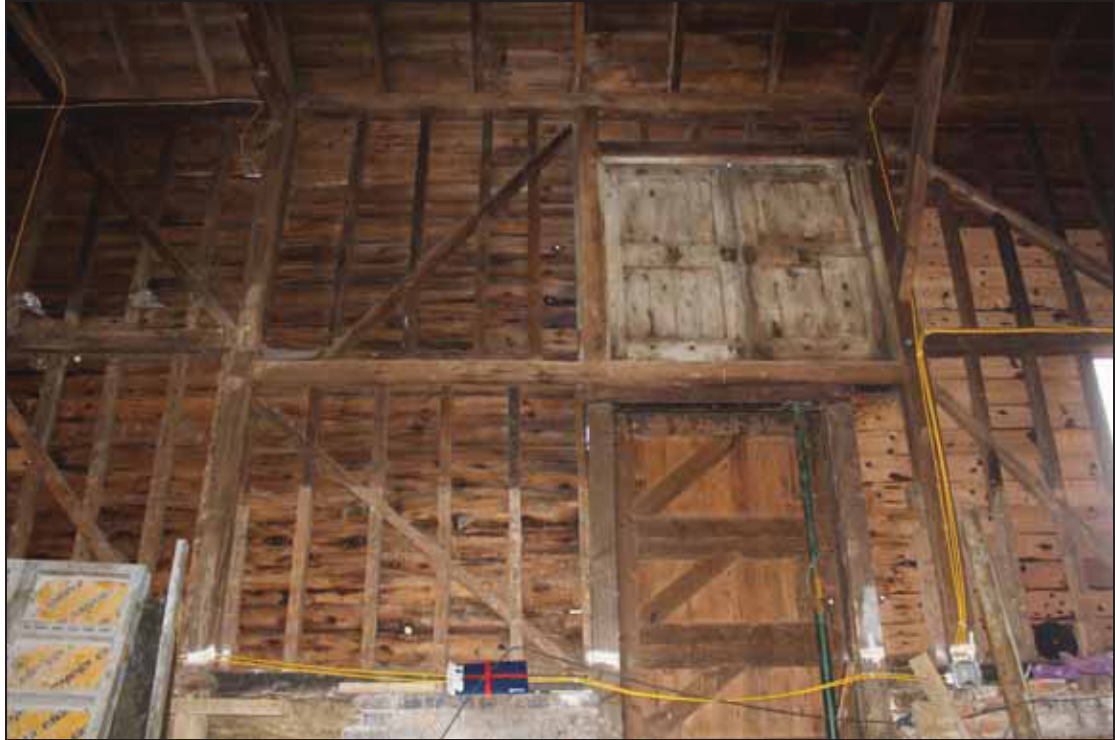
5.8 On the east side both registers are braced from the south. The west side has an inserted post which frames a conventional door, with a pitching door above. This side braced from the north in the upper register and from the south in the lower studwork (Plate 3).

Plate 3 West side of Bay 4 showing the conventional door in the lower register and pitching door in the upper (DP 04)

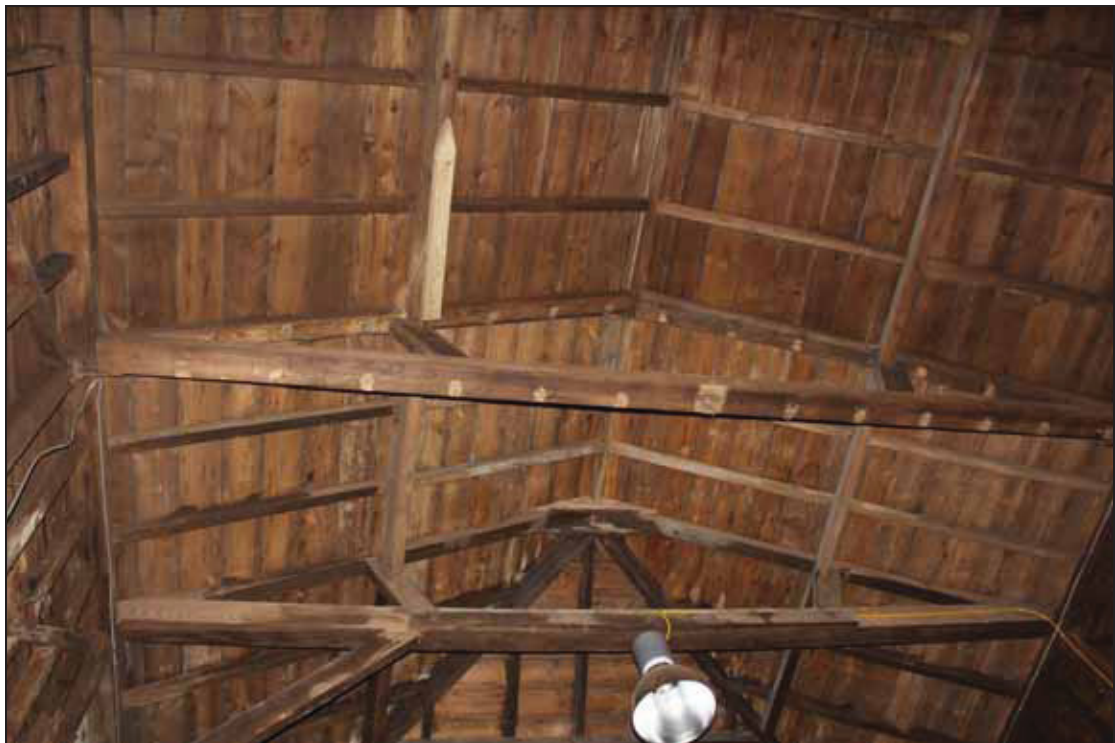
5.9 Bay 5 (including an extra half-bay) was probably partitioned as the tie-beam retains redundant mortices for a pegged central post (Plate 4), and six original studs on either side; these are off-set to the south, suggesting that the southern side was weatherboarded. The principal rafters also preserve impressions for studwork, suggesting that the partition was full-height. The principal posts either side are disturbed but evidence of a mid rail remains. On the east side the central door is framed by an intermediate post. The north post supports an extra truss for additional strength but is braced only on the east side, whereas the tie which supported the partition had no need of bracing and so these are absent. The lower door is ledged and braced, of some age, with a single upper pitching door (Plate 5). Studwork to the north in the half-bay is much disturbed and fragmentary having lost its mid-rail, lower brace and much studwork. To the south the end bay registers are well preserved with three studs. The west side is well preserved with all registers braced from the south. The south end wall has a central prick-post pegged top and bottom, with mid-rails, but the studs are now obscured behind plywood cladding.

Plate 4 Roof of Bay 5 showing redundant mortices in the tie beam and principal rafter, which was once partitioned (DP 06)

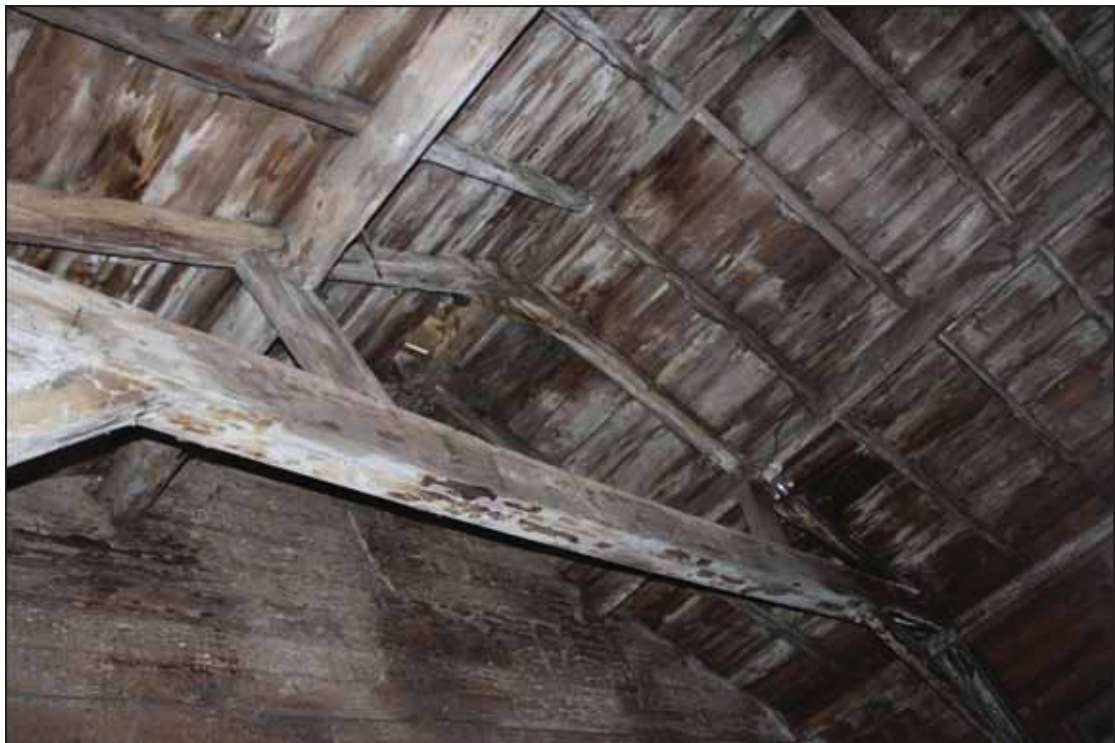
5.12 The roof comprises two trusses with raking struts clasping the purlins, as in the barn. The east truss is fairly conventional with morticed and nailed braces, and a tie-beam formed of two members for additional strength. A central truss is unbraced and retains redundant mortices for a possible earlier partition. A single purlin supports the roof in each pitch, with common rafters and ridge board present as in the barn. Either end displays a small louvre in the roof at the apex; these located above traces of small stall partitions for livestock (Plate 6).

Plate 6 Roof structure in the Garage showing the louvre at the east end over the original animal pens, taken from the west (DP 22)

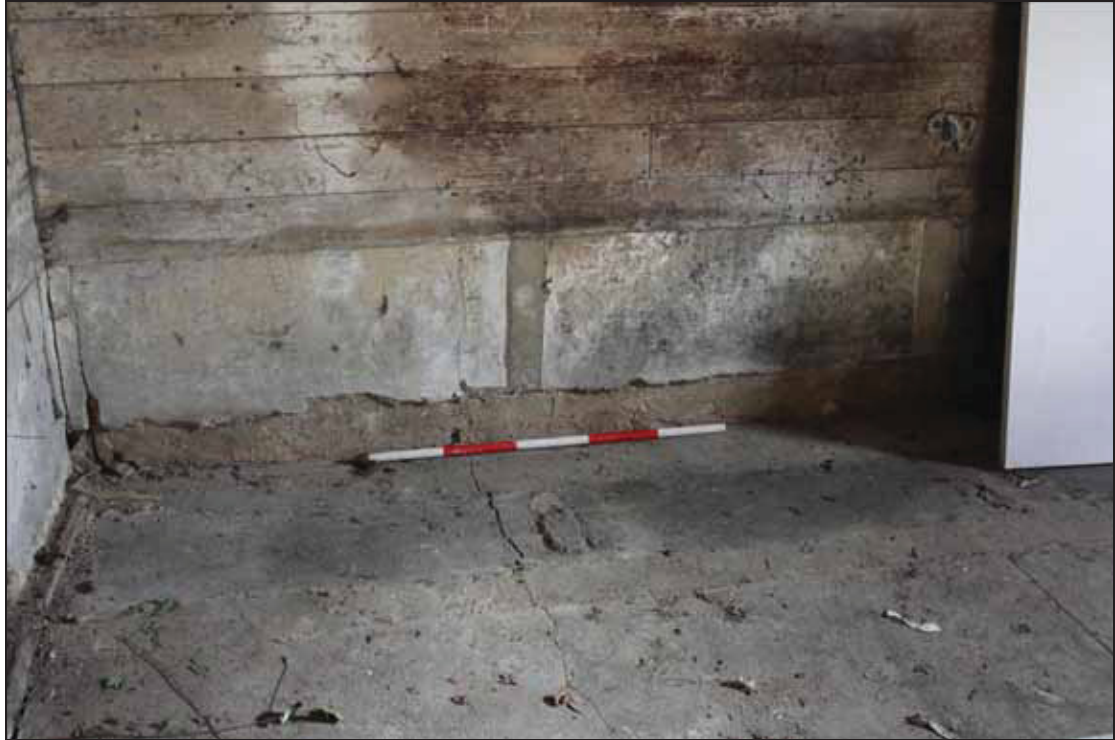
5.13 The low stalls appear to have existed from the outset. They are well preserved on the east where a rendered panel abuts the boarding in a way which suggests that the two are contemporary (Plate 7). Other ephemeral traces of troughs and partition walls remain. On the west side a similar arrangement is less well preserved, but used the dwarf wall of the barn as a backing for the render. On the north wall a studded panel possibly replaces an earlier door; this new timber has been treated with preservatives and is marked in contrast to the older fabric (Plate 8). There is a tiny original window with ledge and brace shutter on north wall (Plate 9). On the south, double garage doors have been inserted within new frames.

Plate 7 Original stall partitions on the east wall of the Garage, the cement infill represents the partition and the concrete dwarf wall would have once supported a trough, taken from the west (DP 16)

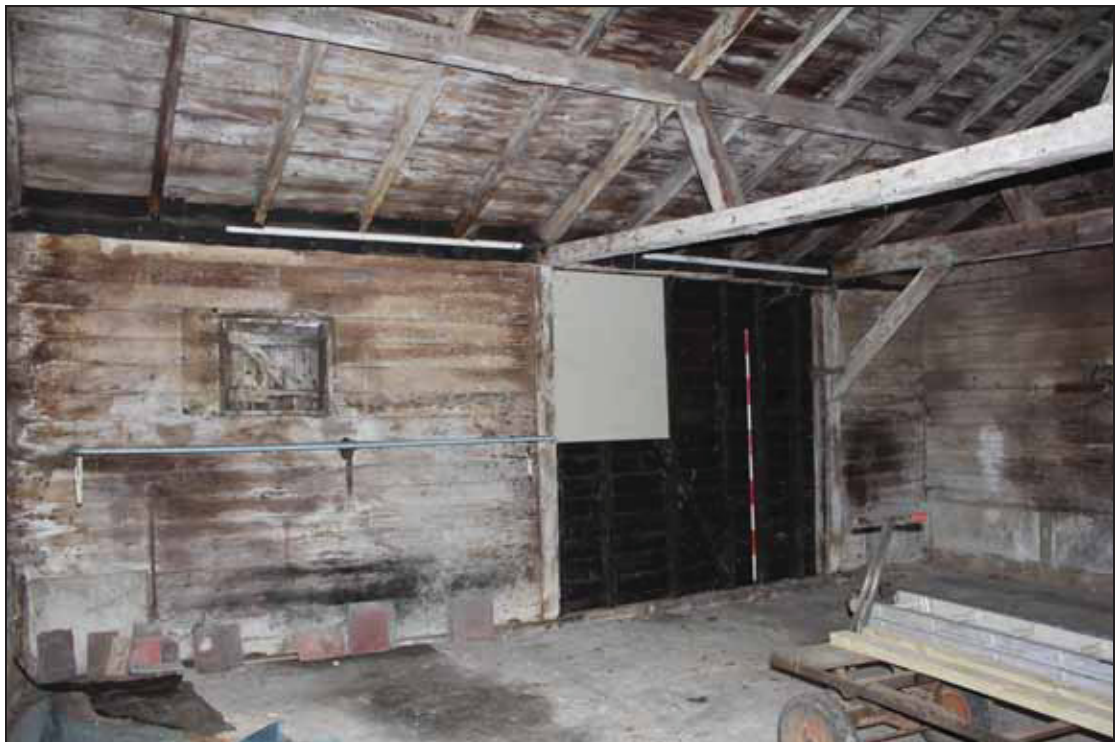
Plate 8 North wall of the Garage showing later inserted panel, perhaps once a door, now painted with black preservative, taken from the south (DP 20)

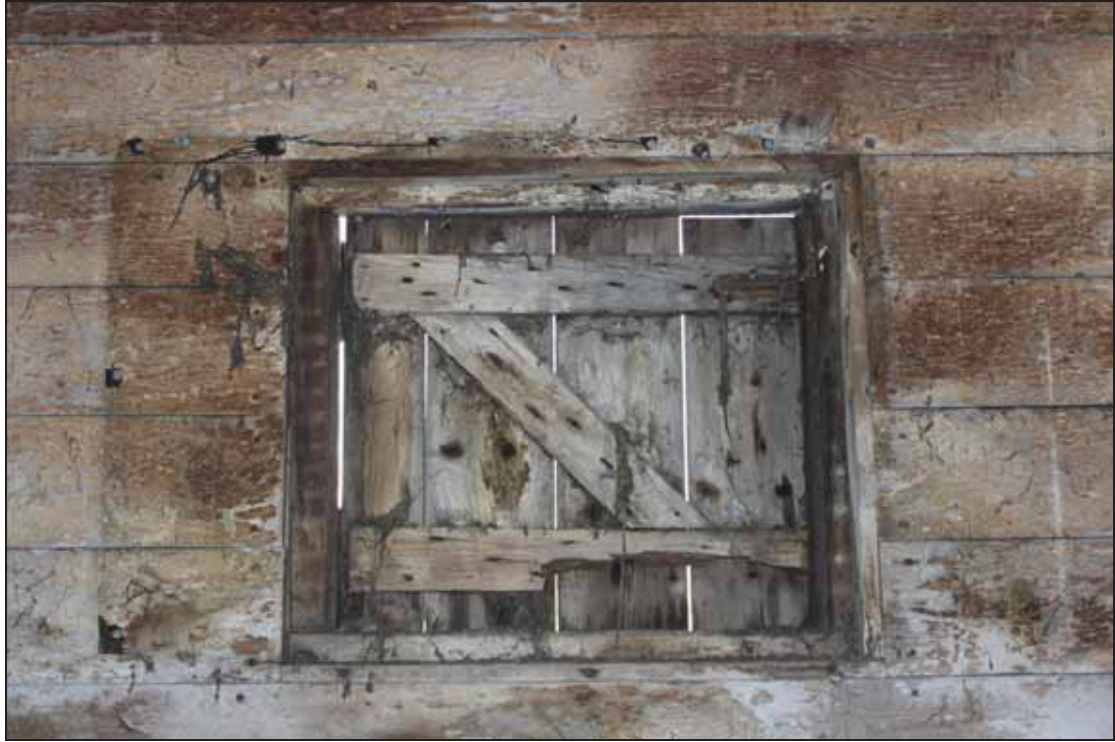
Plate 9 Small ledged and braced shutter on the north wall of the Garage, taken from the south (DP 15)

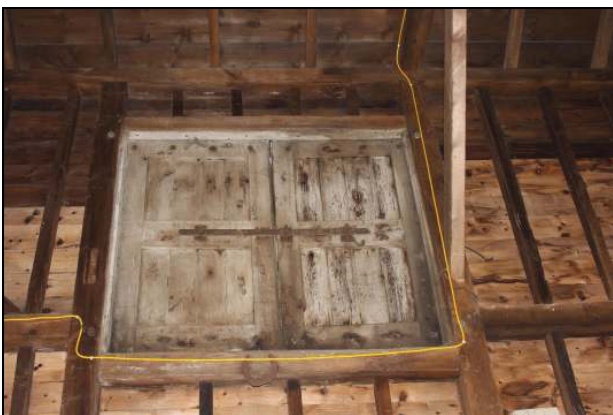
DP 11

5.6 Here eight studs are primary-braced from the north. The western upper register is interrupted by a pitching door with original iron swivel locking bar and pin. Above are empty mortices in the wall plate which appear unused. The studwork is braced from the south in the upper register to accommodate the door.

West side of Bay 2 showing pitching door with original swivel locking bar, taken from the east.

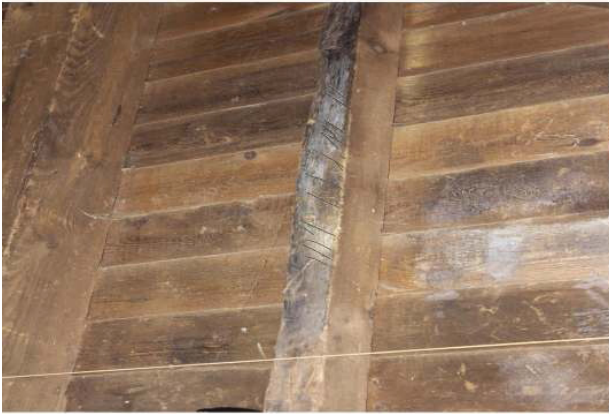
DP 25

7.2 The timber is all consistent, mostly circular-sawn with one or two members, as noted above yielding Baltic markings, which suggests a Prussian origin for the wood.

Baltic marks on the east side of Bay 2, taken from the west.

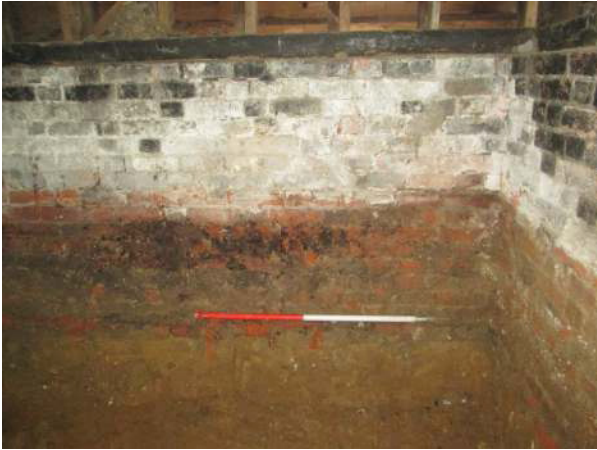
DP 31

<i>Sample section 1</i>		
<i>0.00 = 135.52m AOD</i>		
0.00 – 0.40m		Dwaft brick wall
0.40m+	L1000	Natural. Mid yellow, compact, clay with frequent sub angular flints.

*North-east corner of the barn. Sample section 1.
Taken from the south.*

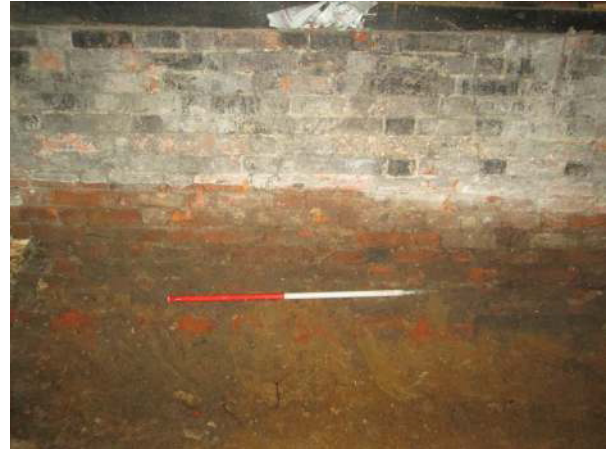
DP 32

<i>Sample section 2</i>		
<i>0.00 = 135.47m AOD</i>		
0.00 – 0.38m		Dwaft brick wall
0.38m+	L1000	Natural. As above.

*North-west corner of the barn. Sample section 2.
Taken from the east.*

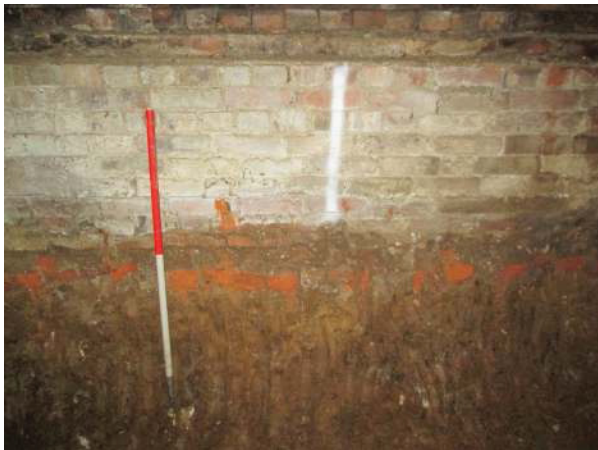
DP 33

Sample section 3 0.00 = 135.52m AOD		
0.00 – 0.40m		Dwaft brick wall
0.40m+	L1000	Natural. As above.

*South-east corner of the barn. Sample section 3.
Taken from the north.*
