**THURSTON GRANARY, STATION HILL, THURSTON,  
SUFFOLK**

**HISTORIC BUILDING RECORDING**

Level 2

Authors:	Tansy Collins BSc (Fieldwork & report) Lauren Wilson MA (Research)	
NGR: TL 91913 65063		Report No: 4936
District: Mid Suffolk		Site Code: AS
Approved: Claire Halpin MCIfA		Project No: 6272
Signed:		Date: September 2015

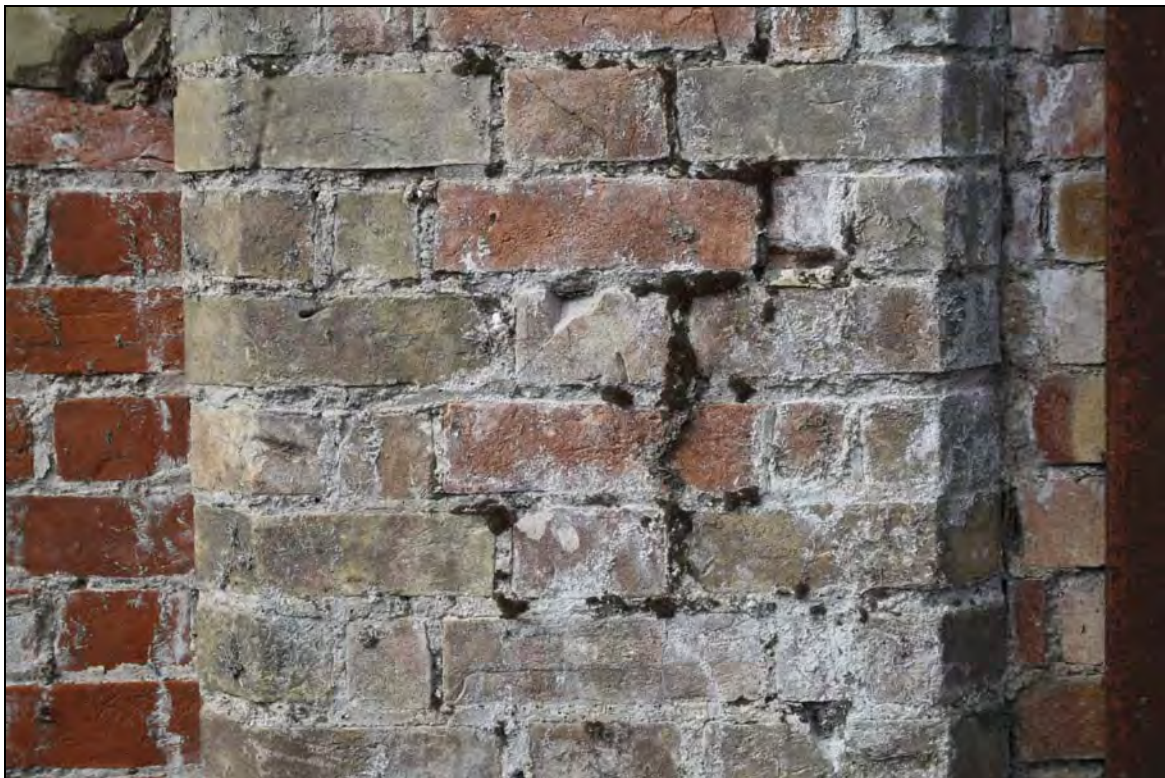
Plate 2 Detail of the north elevation (Range 1) showing original brick pilaster with chamfered gault brick corners, taken from the north (DP 59)

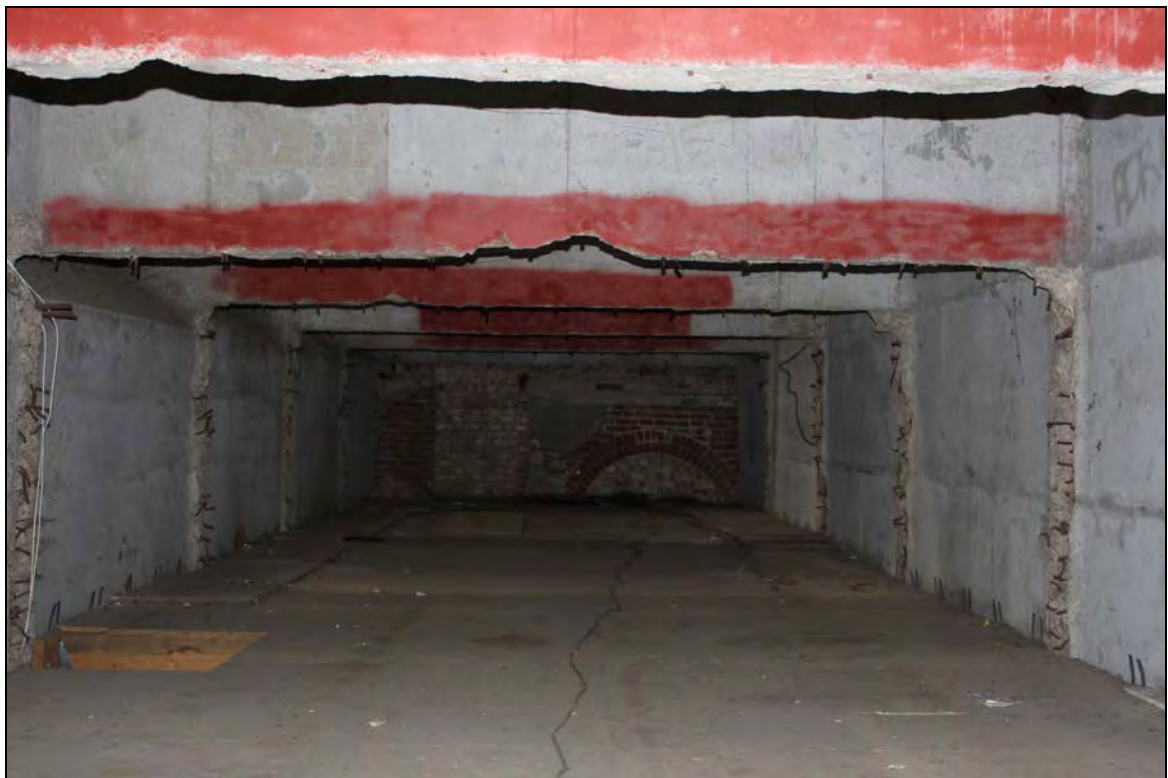
Plate 6 First floor of Range 1 (FF01) showing removed lower concrete structure of the silos, taken from the west (DP 120)

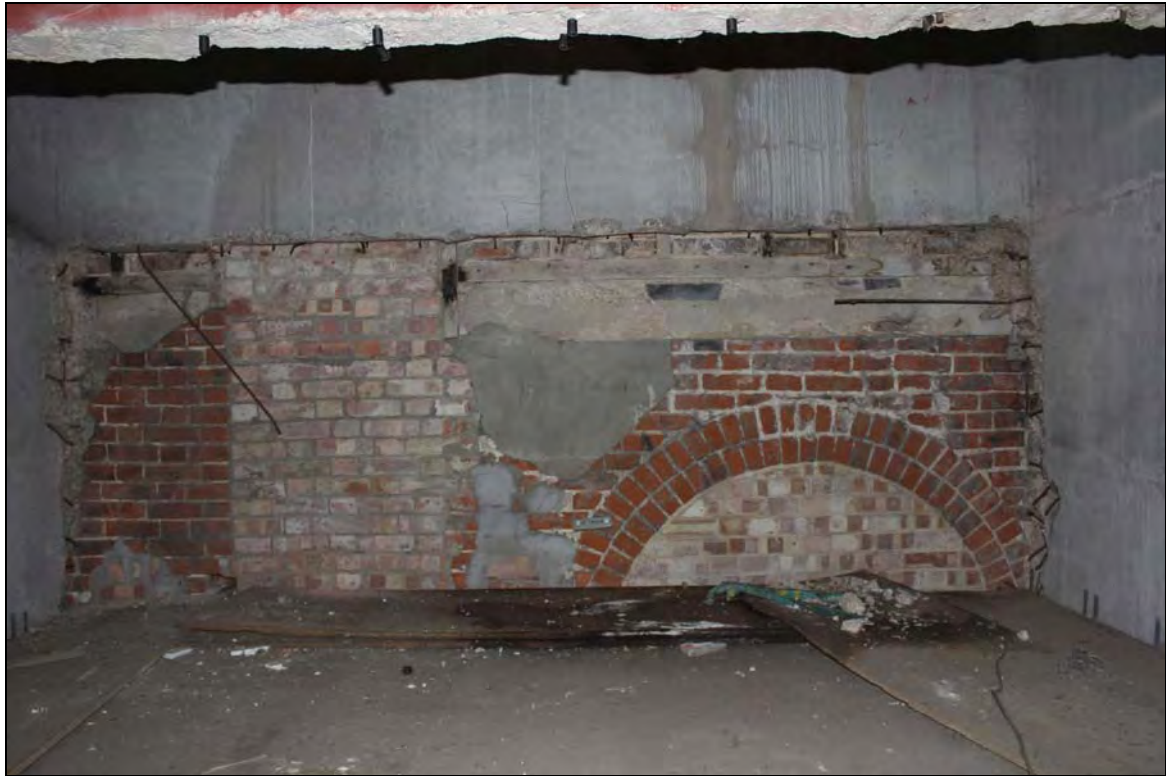
5.16 At the east end of the range, further historic fabric survives. Here a single red brick arch is visible with 19<sup>th</sup> century red brick above and to the north, though there has been much replacement in Fletton brickwork, and above slender timberwork is infilled with Fletton brickwork (Plate 7).

Plate 7 First floor of Range 1 (FF01) showing east wall with earlier brick arch infilled and much rebuilt in Flettons, taken from the west (DP 127)

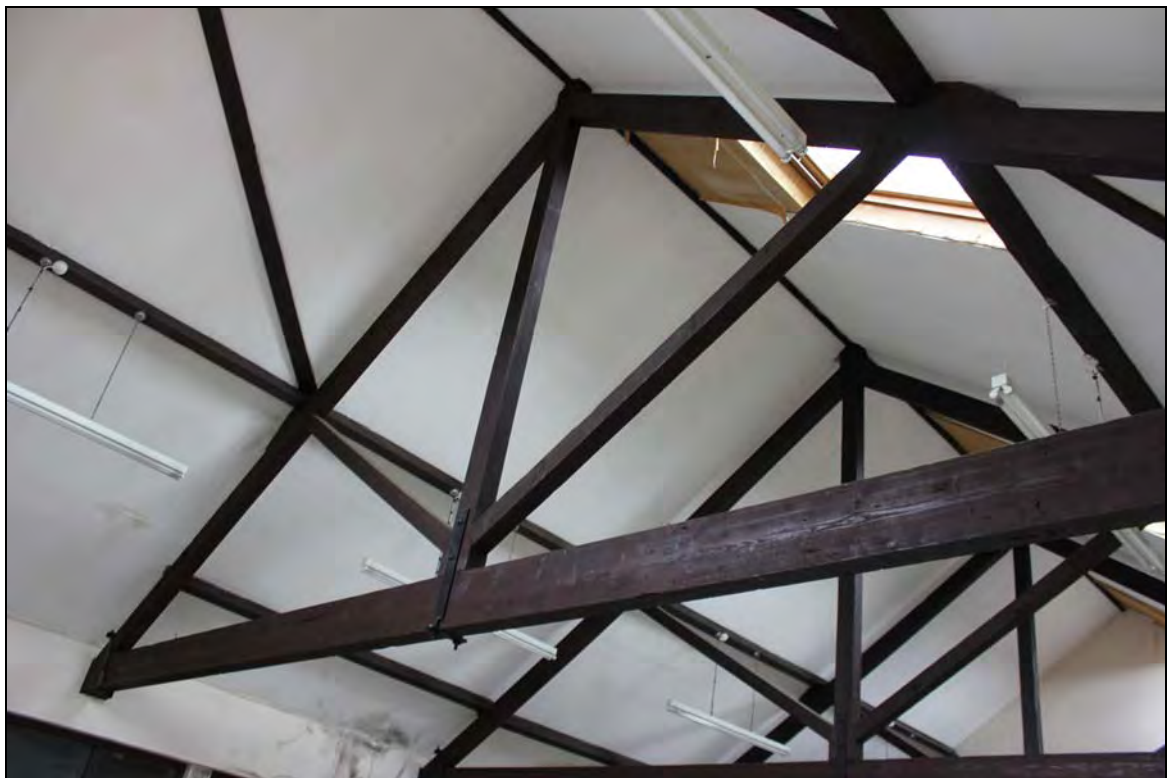
5.25 The roof structure itself is of very similar form to that over Range 1 and survives in very good condition, here spanning five bays (Plate 10). The trusses follow the double-framed king post system noted above, but here the shouldered heads are nailed instead of pegged. The tie-beam is strapped and bolted to the king-post, and the principal rafters and tie-beams are similarly strapped. There is a single purlin in each pitch supported on cleats, and although the roof pitches to the rear are lined, the common rafters must ride over to a ridgeboard at the apex.

Plate 10 Second floor of Range 3 (SF01) showing the king post roof trusses, taken from the south-west (DP 182)

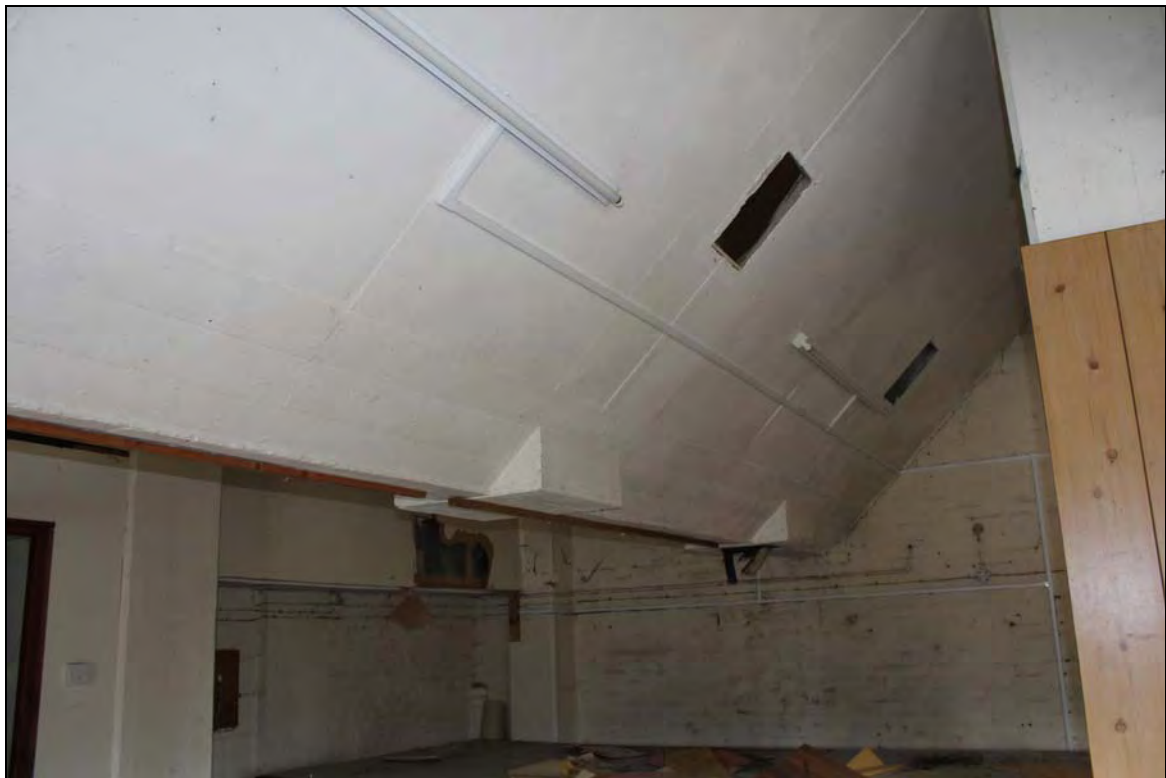
Plate 12 First floor of Range 4 (FF13) showing the underside of the concrete hoppers supported on large concrete columns, taken from the south-east (DP 163)

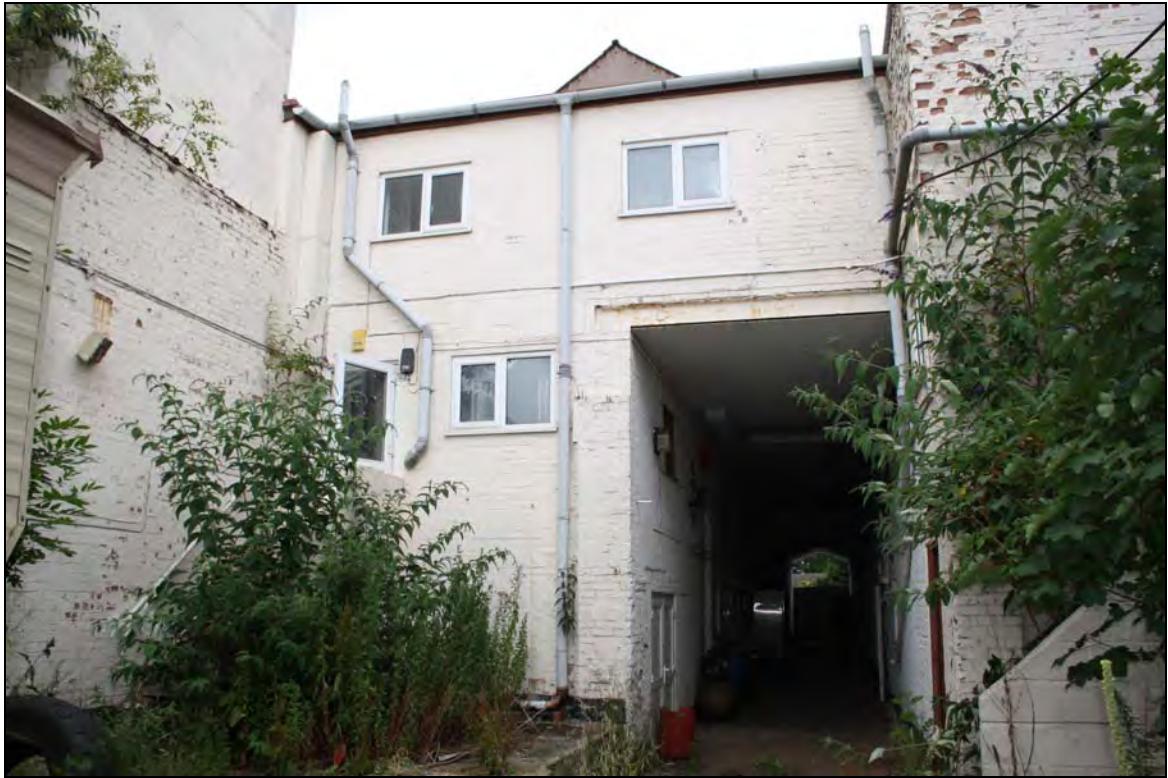
Plate 13 East side of Range 6 showing the tunnel and replacement uPVC windows, taken from the east (DP 31)

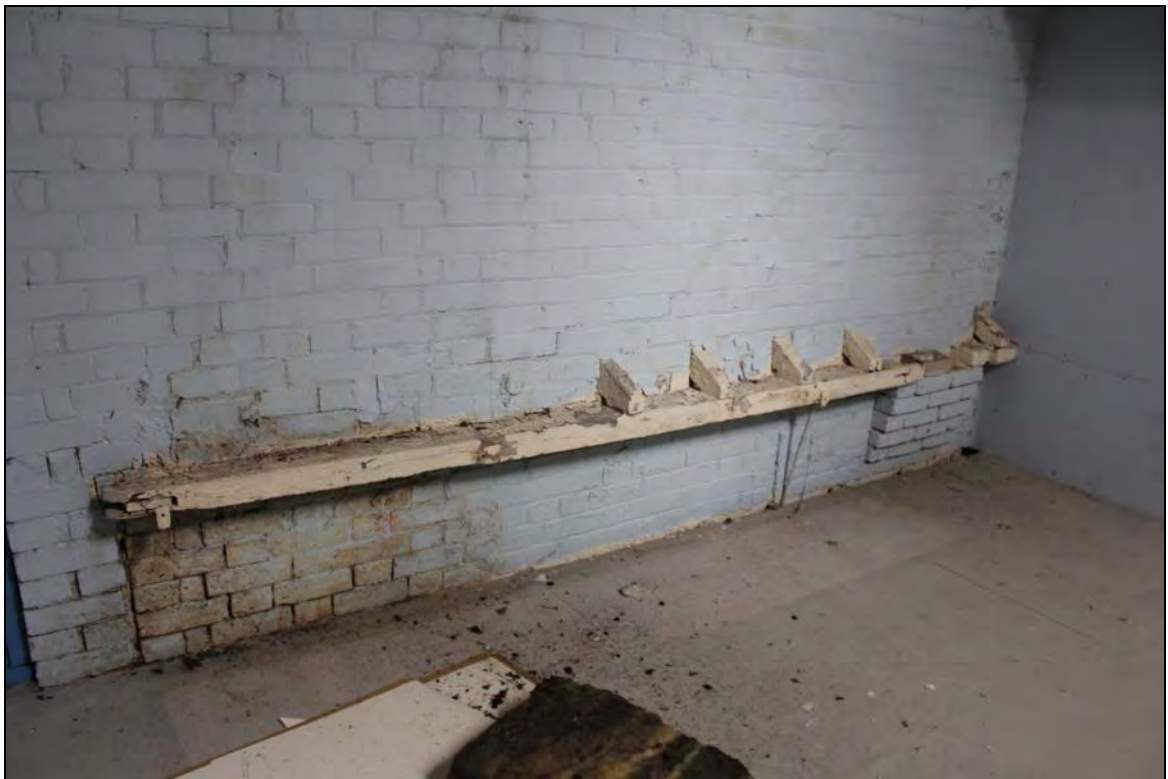
Plate 14 Second floor of Range 6 (SF04) showing the south wall (west end) where the stumps of rafters survive from a lost adjoining roof structure, taken from the north-east (DP 190)

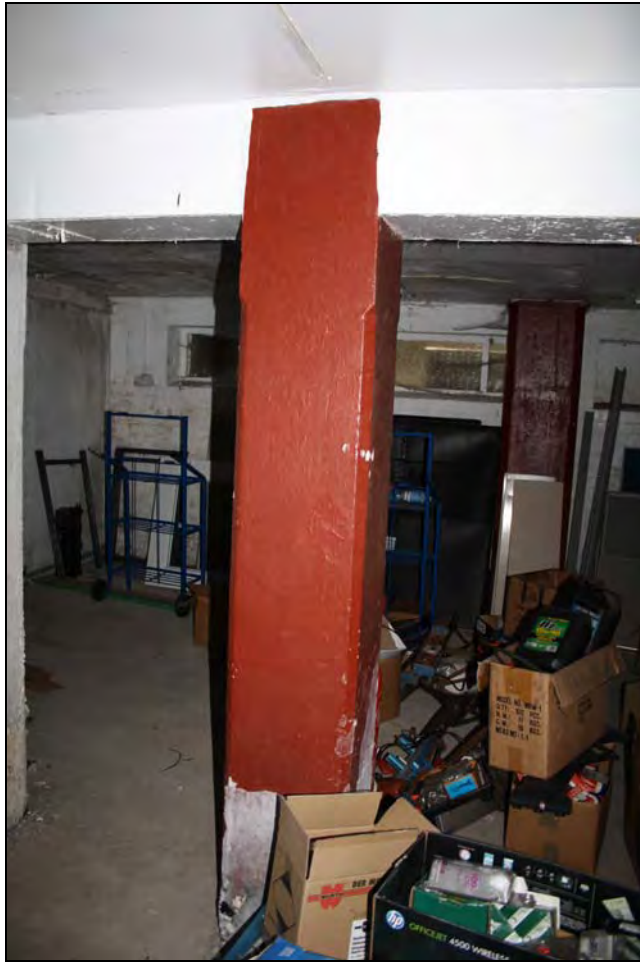
Plate 17 Detail of an original pre-cast concrete column in Range 9 (GF21), taken from the south (DP 97)

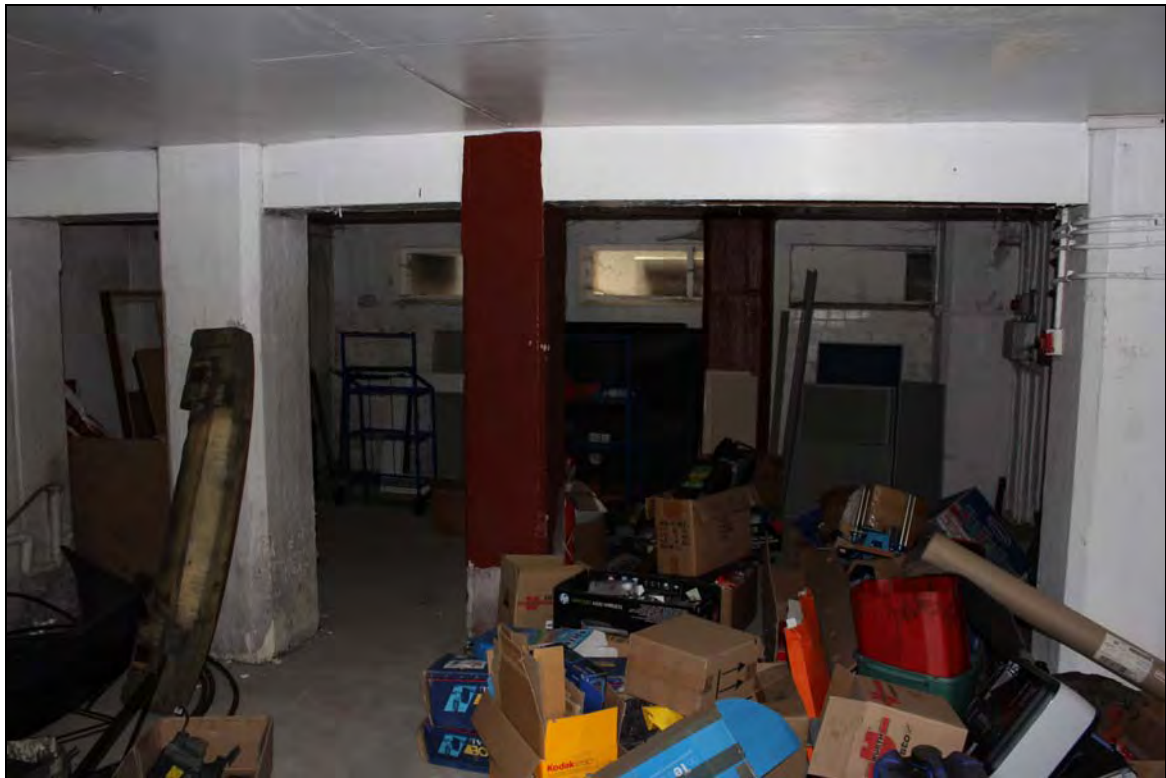
Plate 18 Interior of Range 9 showing pre-cast concrete pillar system supporting the structure above as well as concrete columns of larger profile inserted at the east end (GF21-22), taken from the south (DP 96)

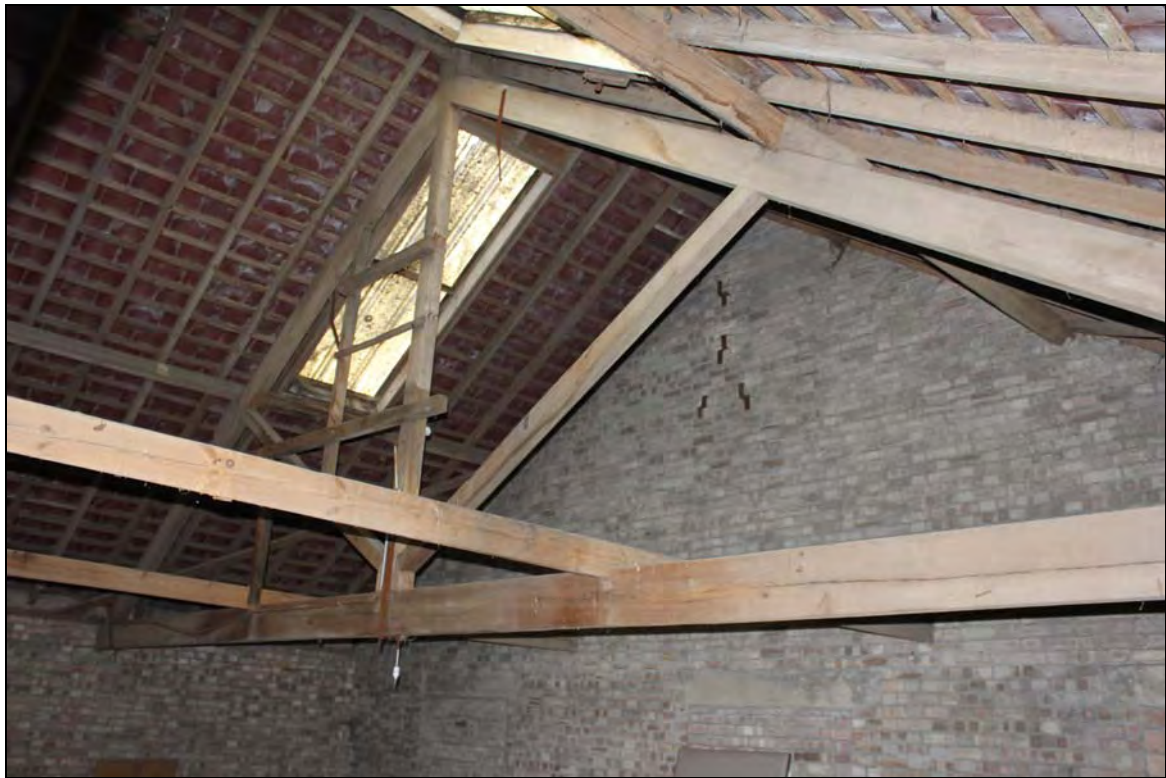
5.51 This range rises higher than any other range within the complex and the final, third floor is open to the roof structure. The outer walls are of exposed Flettons with the blocked apertures noted from the exterior visible, while the silo continues in the east bays at this level with the concrete clearly poured around the timberwork of the roof structure. As with the roof structures over Range 3 and 6, the roof here is of double-framed slender king-post form, with four trusses dividing the space into five bays and here the common rafters are exposed and not underdrawn as elsewhere (Plate 19).

Plate 19 Third floor of Range 9 (TF01) showing king-post roof truss, taken from the north-east (DP 154)
