DANE FARMHOUSE, BOWER HEATH LANE,  
HARPENDEN, HERTFORDSHIRE

HISTORIC BUILDING MONITORING AND RECORDING

Author:	Lee Prosser PhD Lisa Smith BA Tansy Collins MSt Kathren Henry	
NGR: TL 14846 17321	Report No: 4973	
District: St Albans	Site Code: AS1791	
Approved: Claire Halpin	Project No: 4240	
Signed:	Date: 26 <sup>th</sup> October 2015

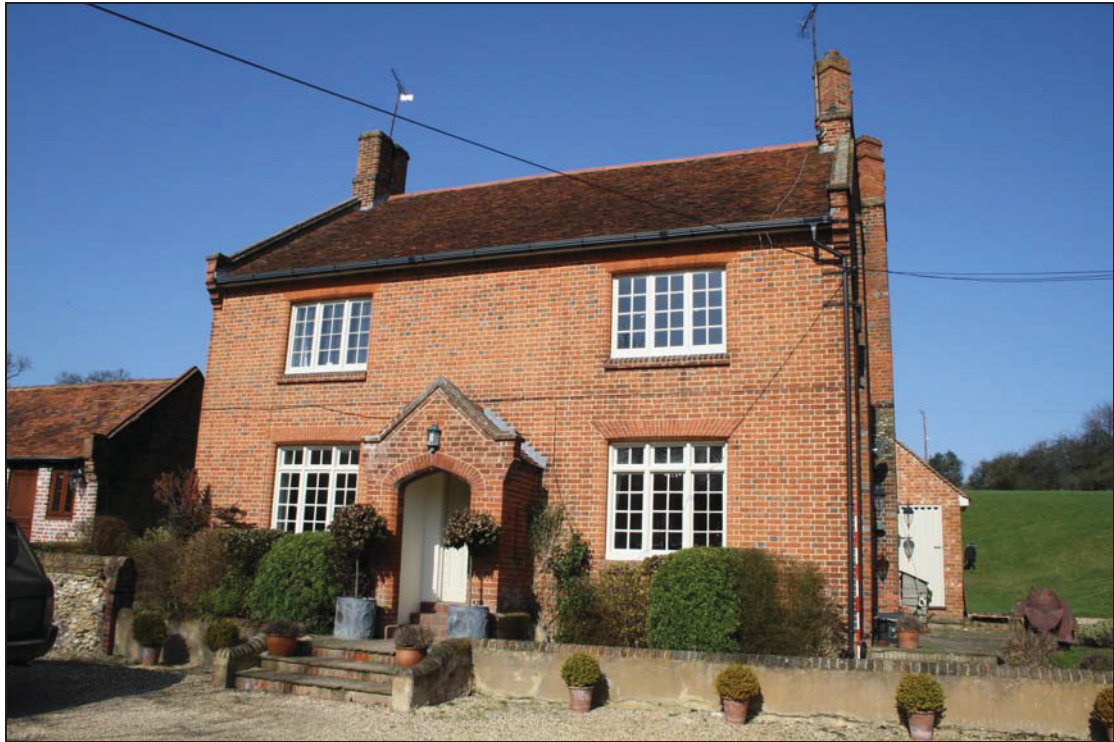
4.2 The house is a modest, two-storey Victorian block of orange brick with a peg-tile roof framed by gable-end chimneys (Plate 1). The brick is fairly homogenous on the south face, where the brick has been more carefully selected and laid in Flemish bond,

Plate 1 Dane Farmhouse, south elevation, taken from the south-east (DP 1)

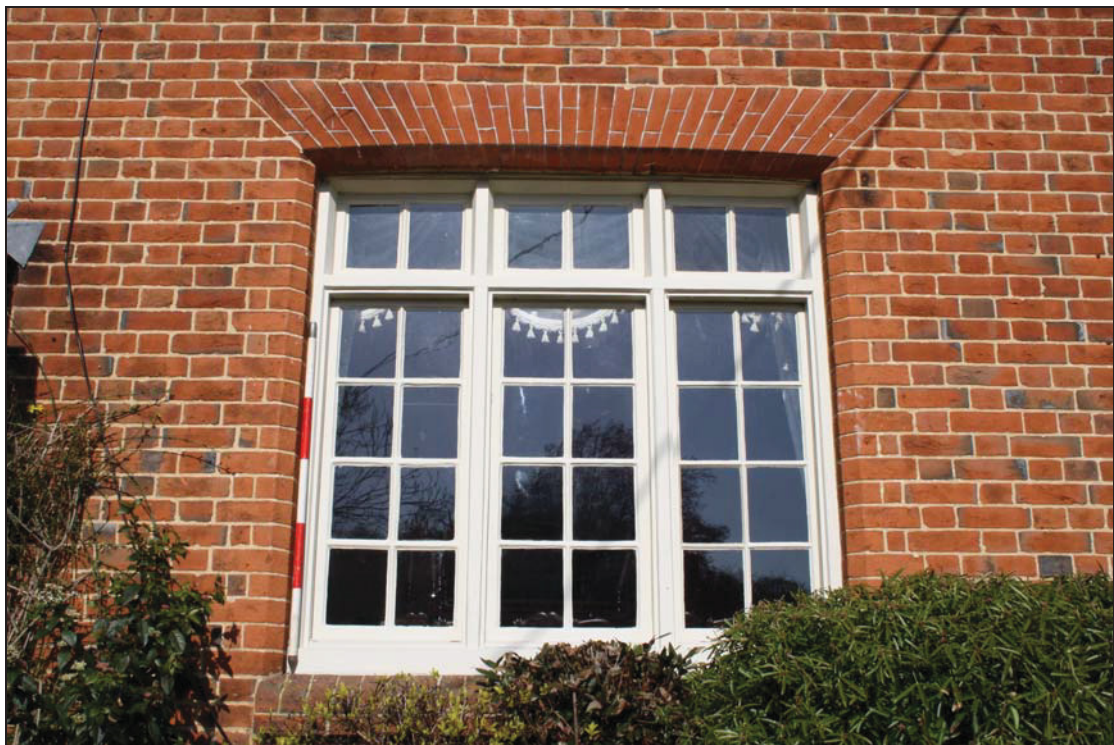
4.4 As noted above the principal windows are three-light casements, each of eight panes with two-light over-lights divided by heavy transom and mullions (Plate 2). At the head, widely splayed gauged arches are chamfered to the soffit and the jambs. The voussoirs to the upper windows lie directly below the eaves and retain almost invisible jointing, having escaped any modern repair.

Plate 2 Ground floor window with wide gauged arch, south elevation, taken from the south (DP 4)

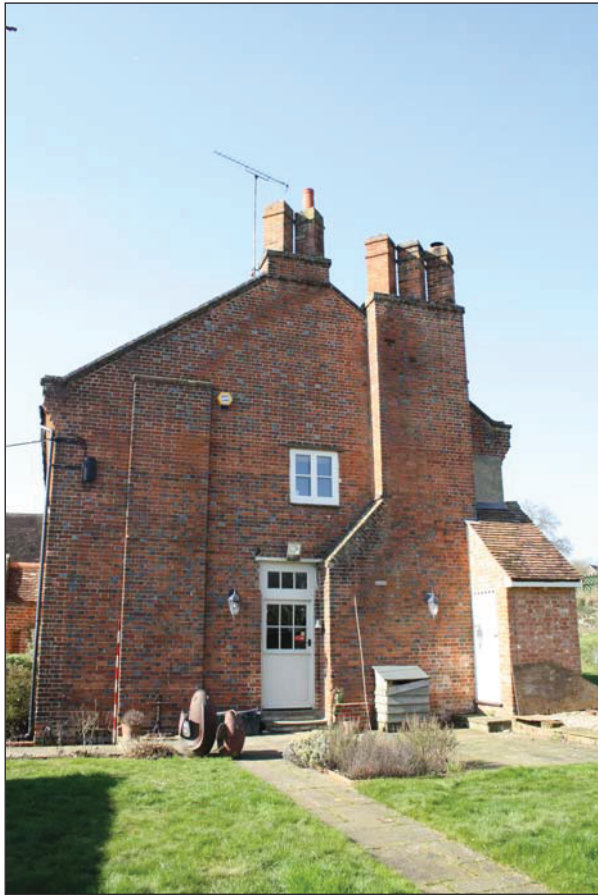
4.6 The east elevation has two chimney stacks extending either side of a central kitchen door with a window at first floor level, all framed by corbelled out kneelers to the gable in the same style as the porch (Plate 3). The southern stack is shallow, rising to first floor before disappearing and re-emerging from the apex where two chimney pots rise in diagonal profile. A larger stack to the north serves the kitchen hearth and shouldered, with tumbled-in brickwork. A partly-glazed split door gives access to the kitchen. This has a three-light overlight, all set in a heavy frame.

Plate 3 East elevation, taken from the east (DP 5)

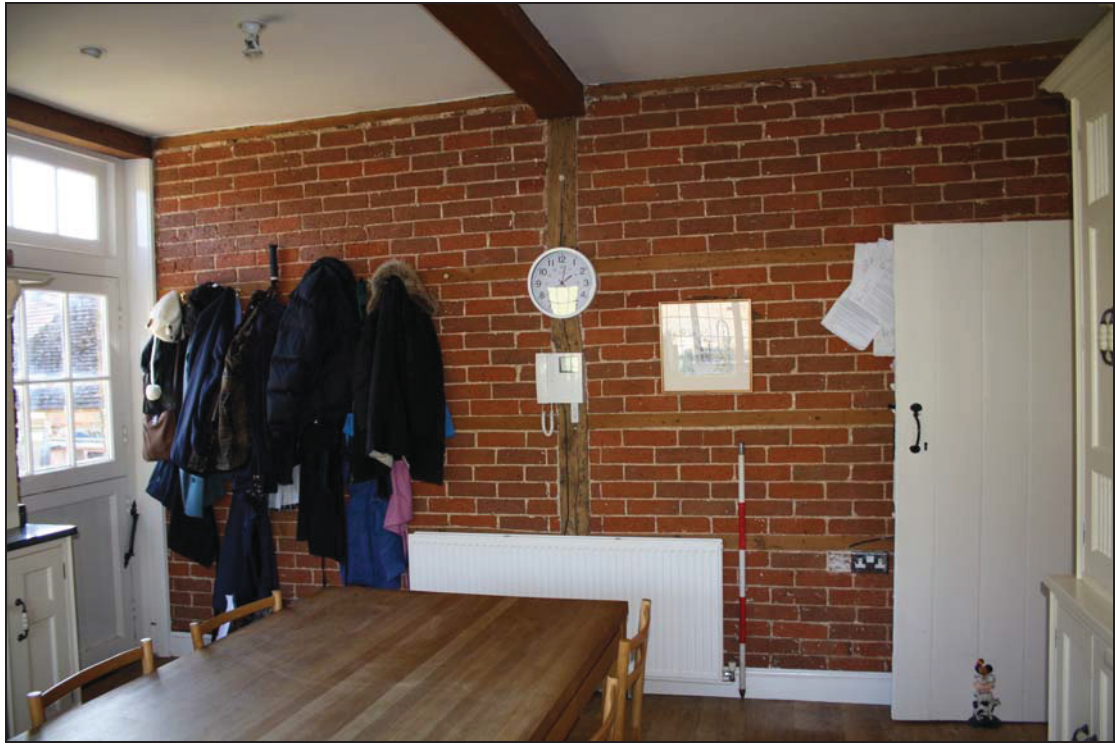
4.16 The room has been completely stripped back to the structural brickwork and sand-blasted (Plate 5). Various timber bearers in the wall probably provided a matrix

for lath and plaster. A single large chamfered joist with run out stops is exposed in the ceiling, and preserves various hooks.

Plate 5 Kitchen, GF03, taken from the north (DP 11)

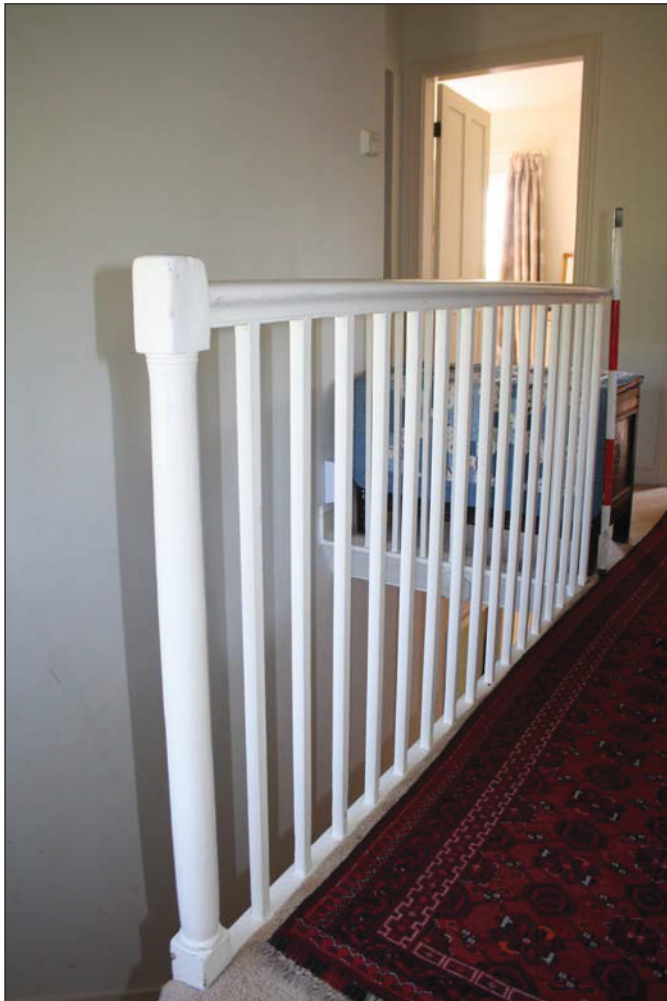
4.20 The staircase retains its original upper balustrade of a simple slender newel with a moulded handrail and stick balusters, all painted (Plate 6). Four bedrooms are given access from the landing through four-panelled Victorian doors, while a bathroom occupies the space above the kitchen. A small casement window with early 20<sup>th</sup> century catches and scrolled stay bars lights the stair from the north.

Plate 6 Upper balustrade, first floor, taken from the north-west (DP 28)

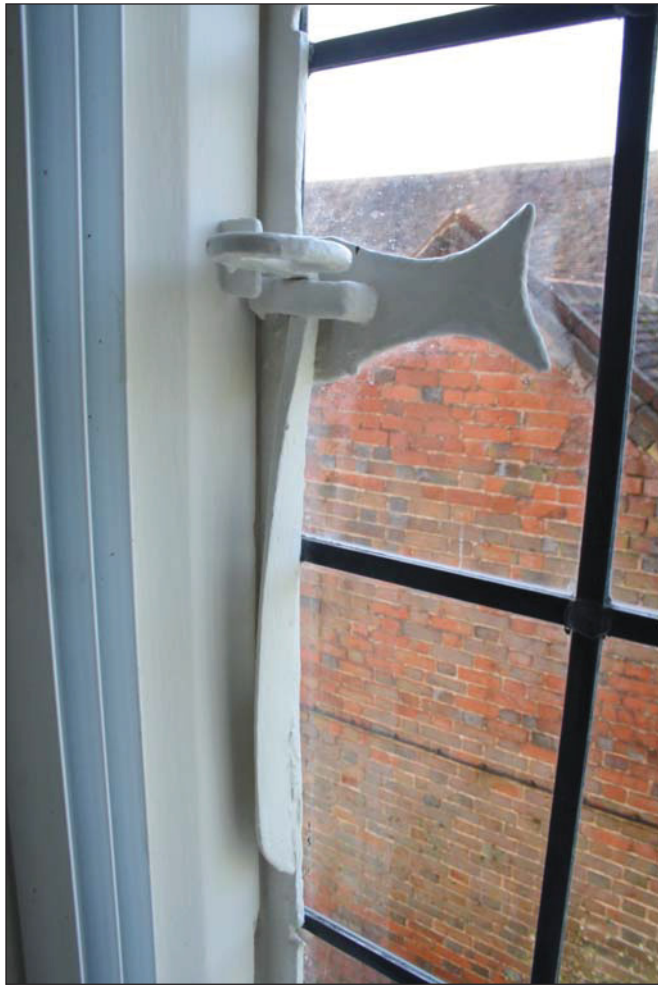
4.22 The window on the west is of some interest preserving an early 19<sup>th</sup> century window catch (Plate 7). Nothing else of note survives.

Plate 7 Window latch, FF02, taken from the north-east (DP 34)

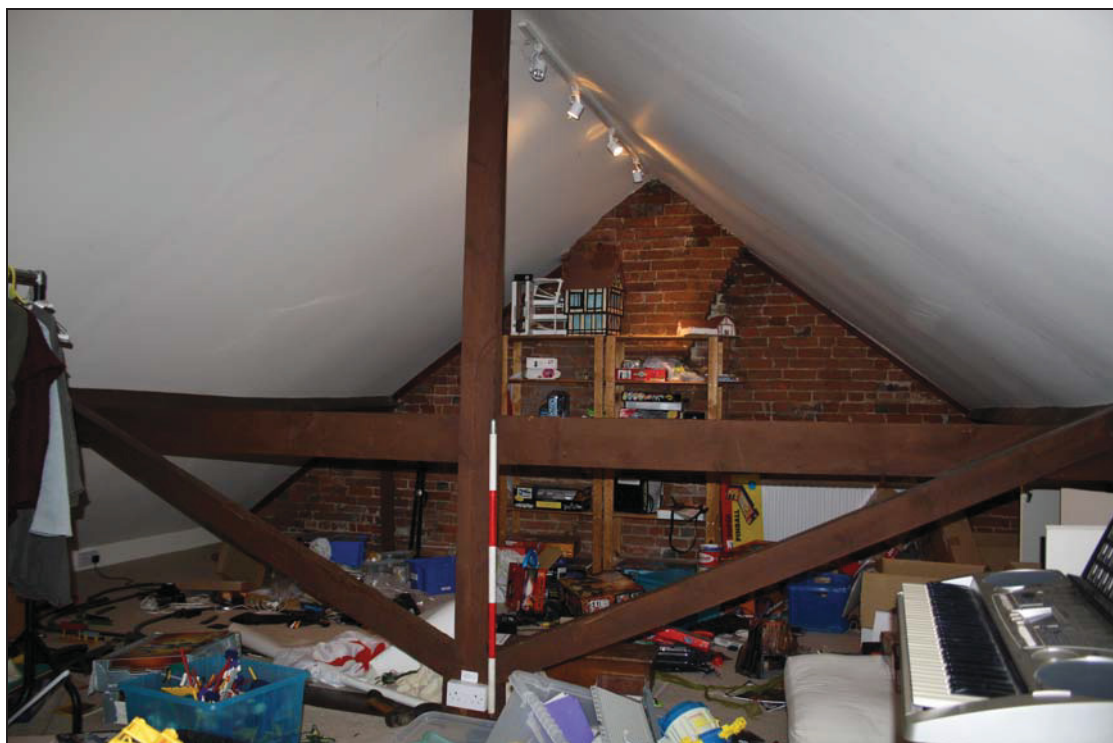
4.26 The attic has been converted into a single modern storage space but the main structural elements of the roof remain exposed. Two slender king-post trusses have raking struts bird-mouthed to a single purlin in each pitch (Plate 8). Secondary planking has been added across the trusses for extra support.

Plate 8 King post roof truss, attic, taken from the north-east (DP 41)

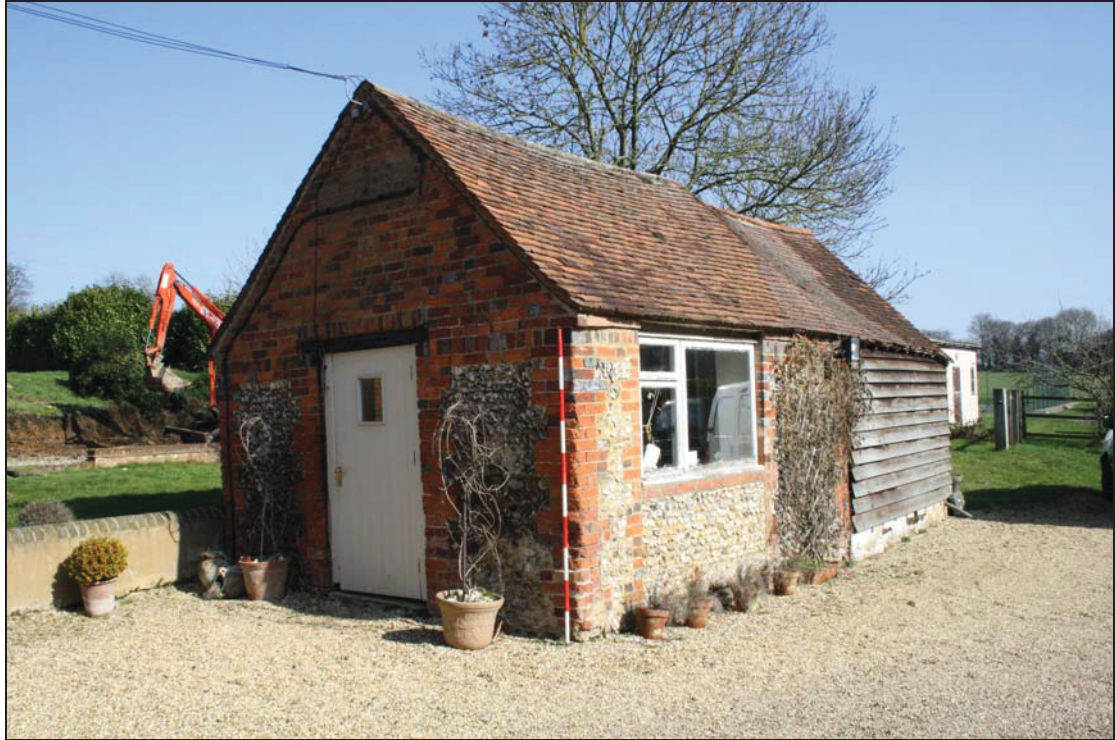
4.31 The small out-building lying to the south-east of the house has been constructed in two phases (Plate 9). The eastern bay, though much modified is weather-boarded,

Plate 9 Outbuilding, south and west elevation, taken from the south-west (DP 45)

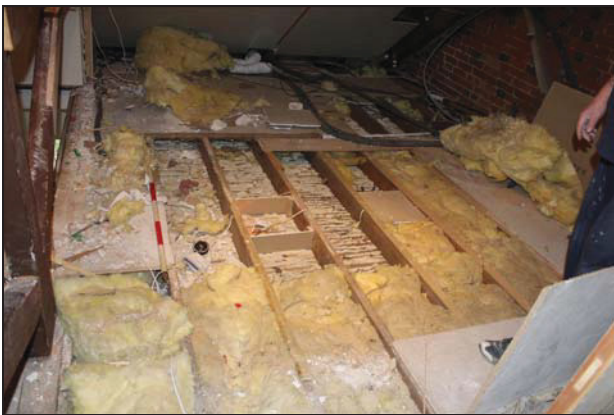
51

4.29 During the planned works involved in the conversion of the loft space, the modern closet in the north-east corner was removed exposing the floor joisting in the area to the east of the staircase as well as the east side of one strut, the north purlin and a number of rafters that all remain unvarnished. The rafters ride over or are slightly notched over the purlin.

4.30 Both the fabric forming the truss and the floor joists are of softwood, and the floor joists themselves are of fairly thin-section. Inspection of the newly exposed timber elements, however, revealed no assembly markings, graffiti, or trade marks as might be expected. Occasional floor joists may have been replaced and the lath and plaster of the ceiling below is visible. Otherwise, little of any particular historic interest was exposed during the planned works.

*View of the floor structure in the roof space following the removal of the modern enclosed closet, taken from the north-west*

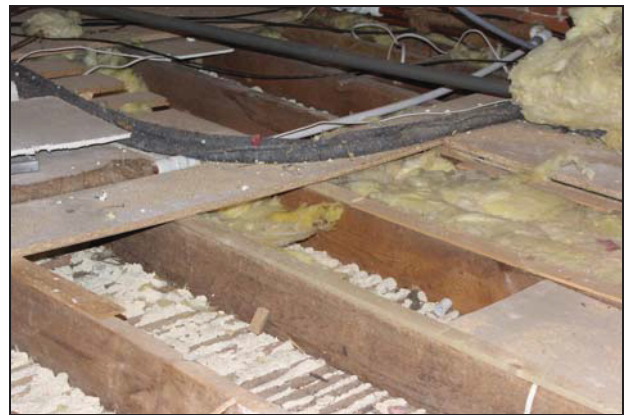
52

*Detail of the floor joists in the roof space following the removal of modern boarding, taken from the south-west*
