HISTORIC BUILDING RECORDING AND BUILDING
MONITORING & RECORDING

Authors: Tansy Collins MSt Lauren Wilson MA PCIfA	
NGR: TL 3359 2202	Report No: 5084
District: East Hertfordshire	Site Code: AS1817
Approved: Claire Halpin MfA	Project No: 6561
Signed:	Date: 8 th April 2016

ORCHARD COTTAGE, GREEN END, DANE END, WARE, HERTFORDSHIRE, SG12 0NS

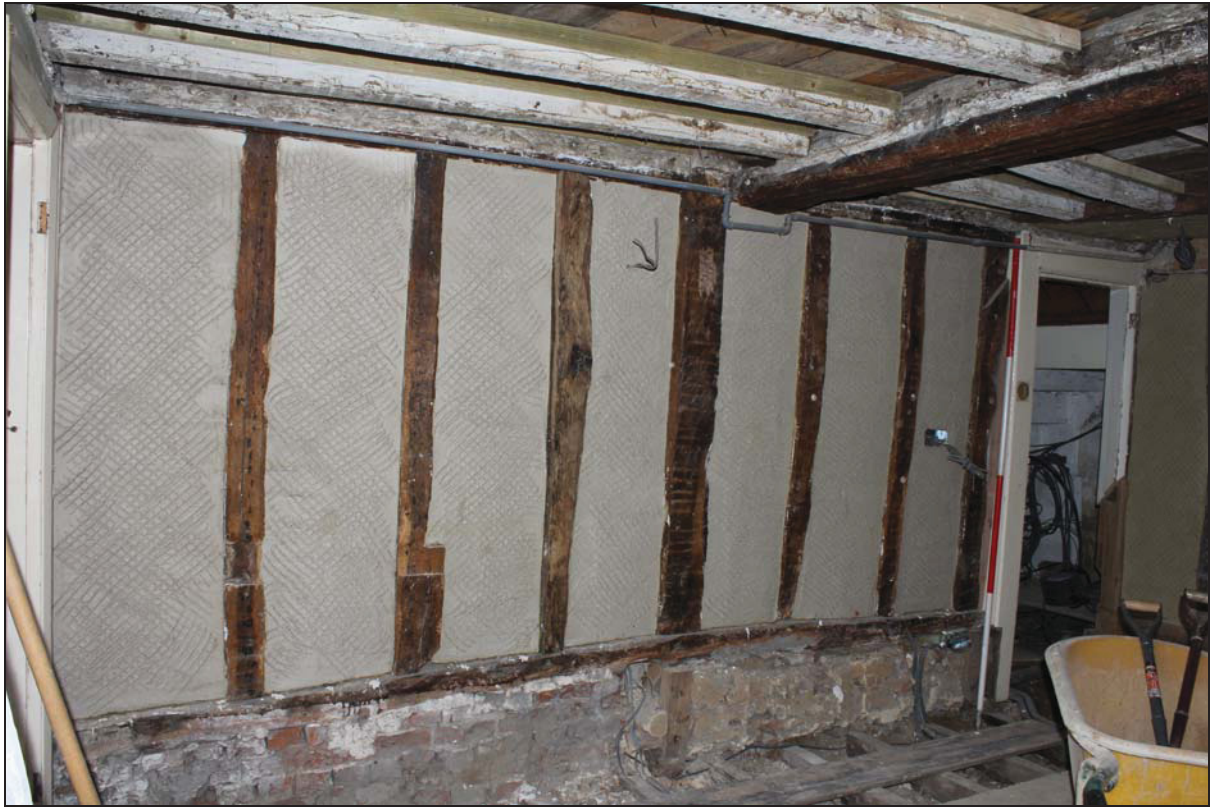
5.11 The north-west wall retains a degraded sole-plate with pegged studwork above including a large central post measuring 6¼" (159mm) and common studs to either side, one repositioned, that measure an average of 4" (102mm) (Plate 5). A doorway has been inserted at the north-east end leading to Unit 2, though there is no door and the corner post is partially visible. This post is original, and has had its rotten lower portion repaired as part of these works with a new piece scarfed in. On this wall, nine large peg-holes, evenly spaced in three rows, suggests the presence of shelves or other piece of fixed furniture.

Plate 5 North-west wall of Room GF01 (main range), taken from the south (DP 32)

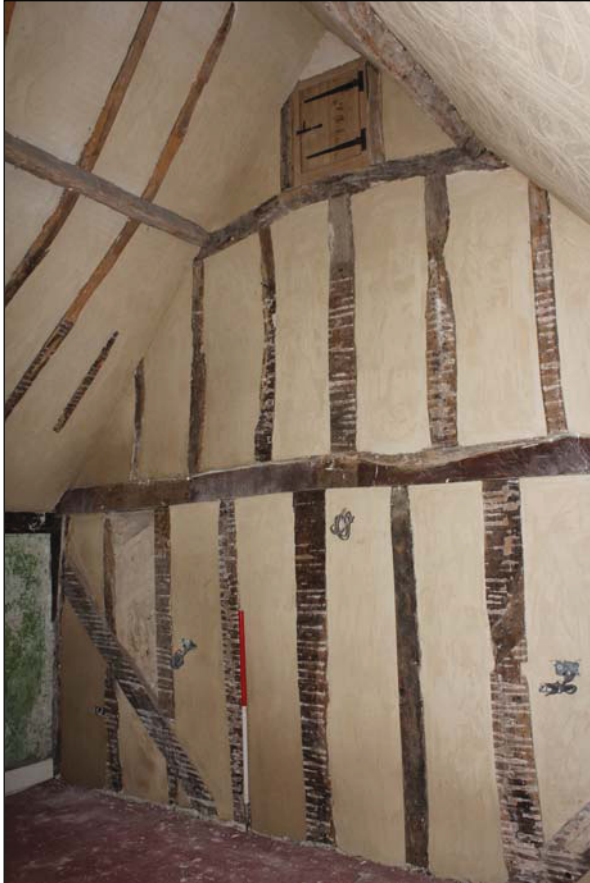
5.19 The historic core (FF01) is now given access through Room FF02. This is the most recent change of route into the room and replaced the inserted staircase, which itself superseded a doorway leading from Lordship Cottage. Before the planned works, the outer walls were all plastered leaving only the principal timbers exposed. This is still true on all walls apart from the on the north-west where the studwork is now exposed (Plate 10). The floor is carpeted and there is a plain skirting board.

Plate 10 Timber-framing on the south-west wall of Room FF01 (main range), taken from the north (DP 54)

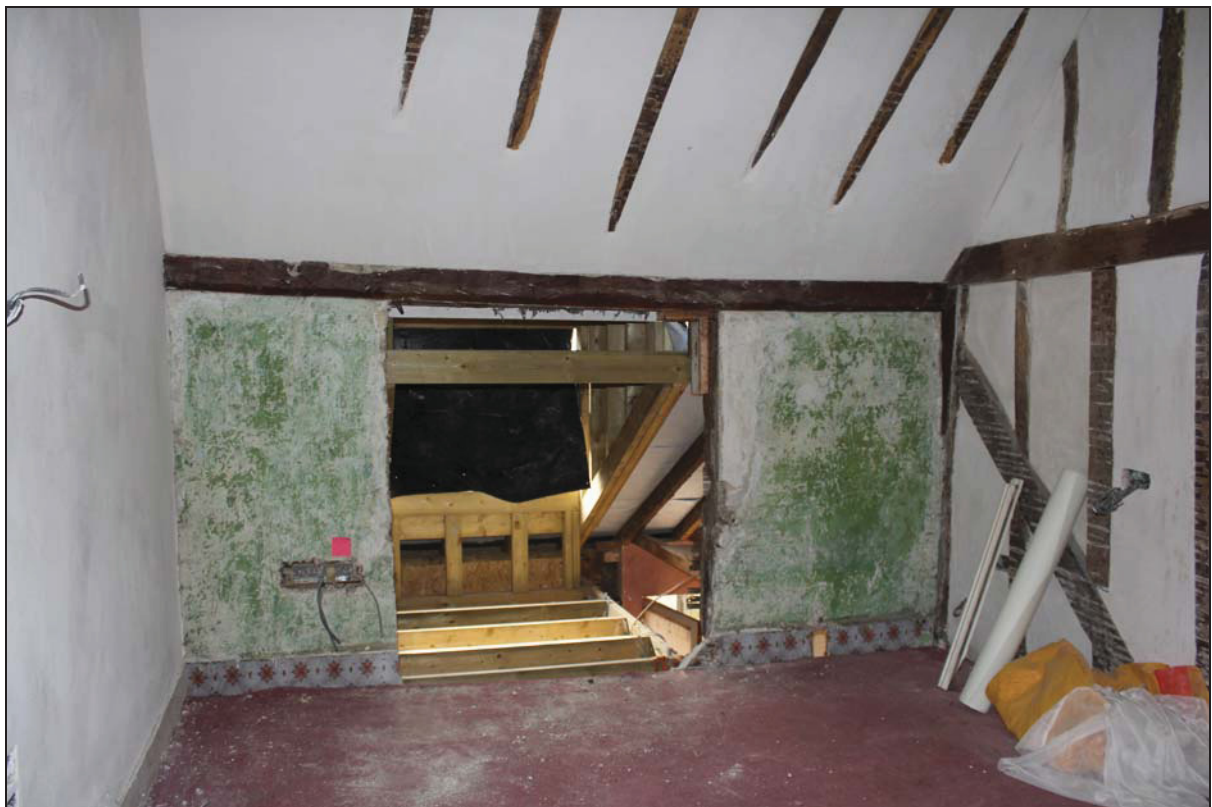
Plate 11 South-west wall of Room FF01 following removal of the window, taken from the north-east (DP 93)

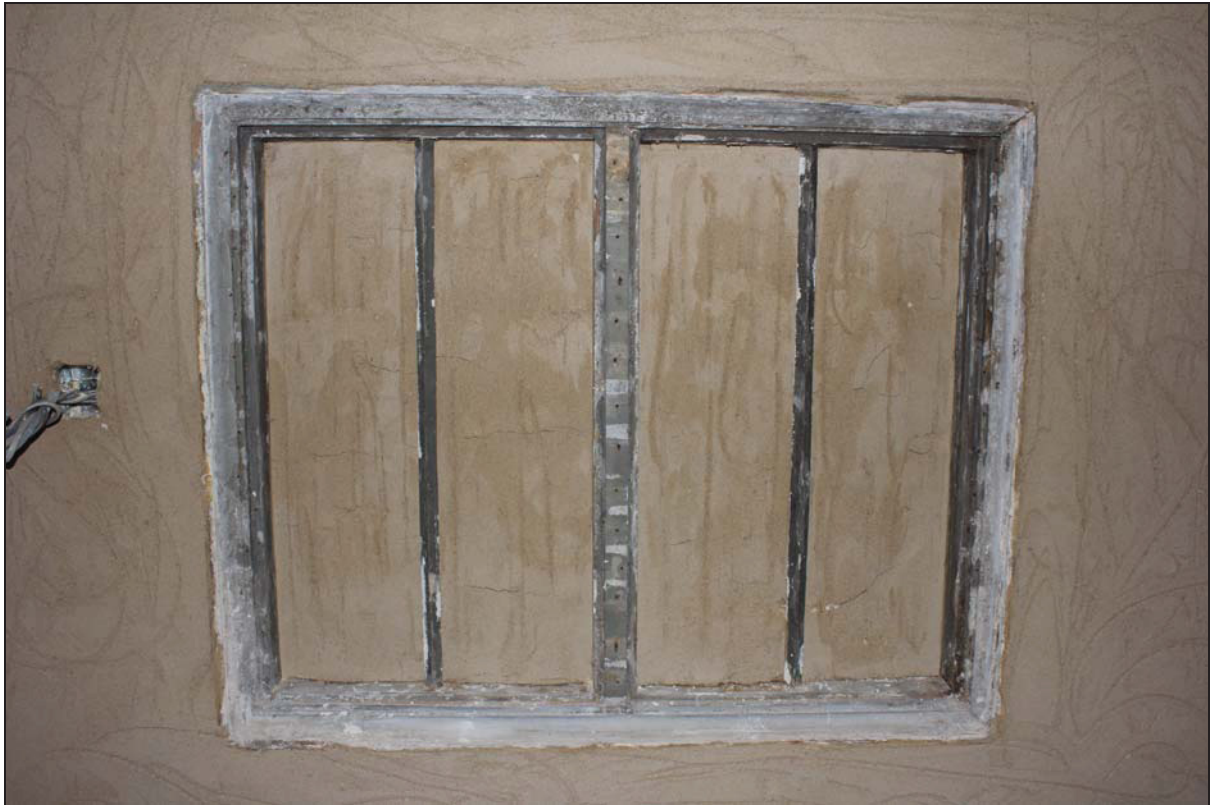
Plate 12 External face of the mullion window on the south-east side of Room FF02 (Unit 2) taken from the north-west (DP 50)

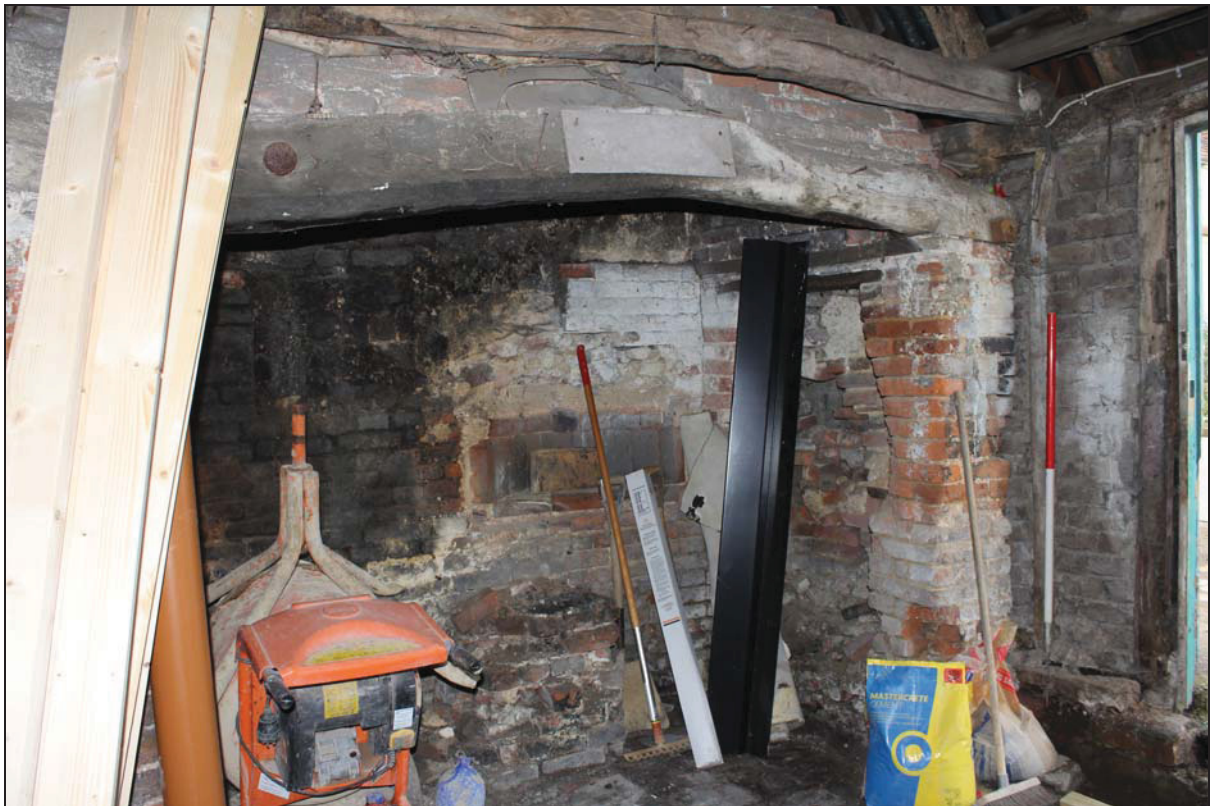
Plate 13 Massive inglenook fireplace at the north-east end of the outbuilding, taken from the west (DP 64)

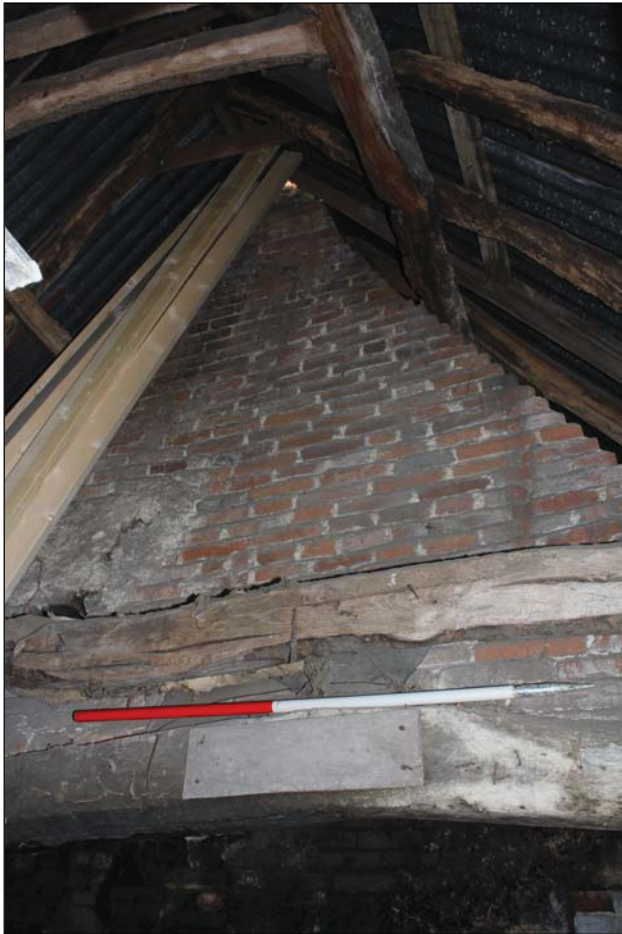
Plate 14 Detail of the chimney stack in the outbuilding showing brickwork of the stack with roof structure over, taken from the south-west (DP 66)

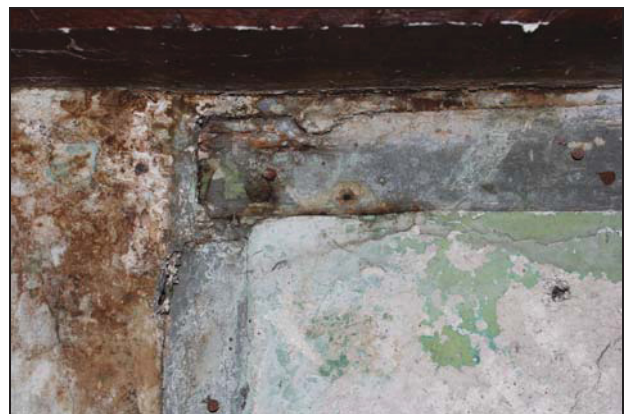
North-east wall of Room FF01 (main range) showing outline of formerly external window, taken from the south-west

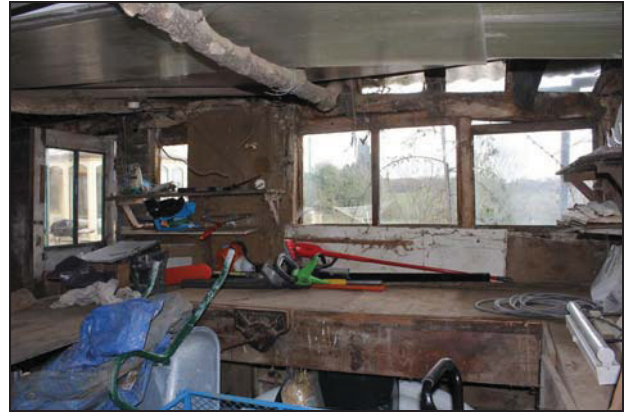
North-west wall-plate of the outbuilding showing empty mortices for removed studs, taken from the south
