KITCHENER'S MEADS, 59 FISHPOOL STREET
ST ALBANS, HERTFORDSHIRE

HISTORIC BUILDING MONITORING AND
RECORDING

Author:	Tansy Collins BSc Lee Prosser PhD Kathren Henry	
NGR: TL 14141 07165	Report No: 5011	
District: St Albans	Site Code: FPS15	
Approved: Claire Halpin	Project No: 6100	
Signed:	Date: 11 th December 2015

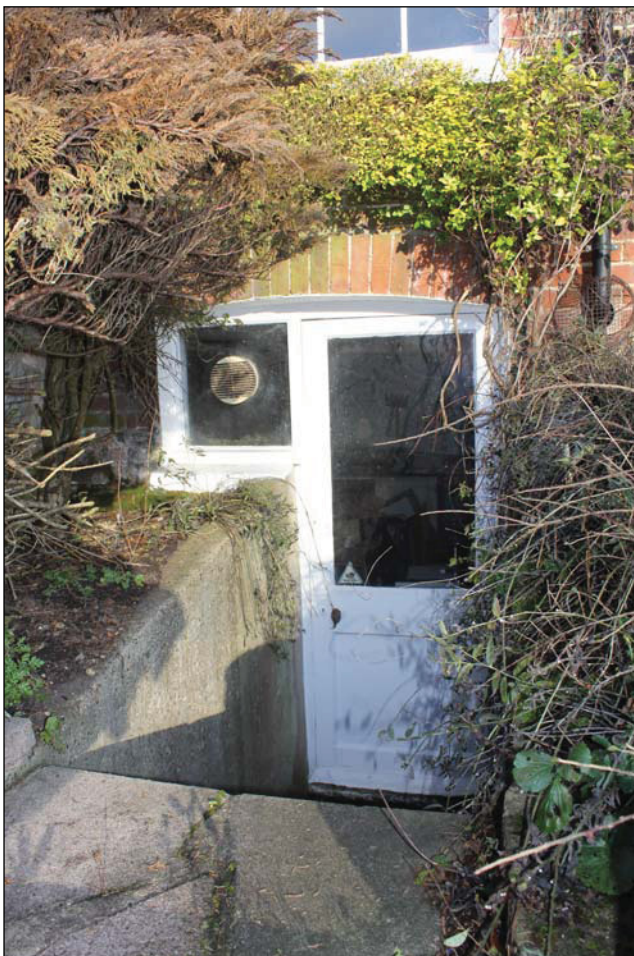
Plate 4 Reconfigured probable original window converted to a doorway on the south elevation at basement level, taken from the south (DP 12)

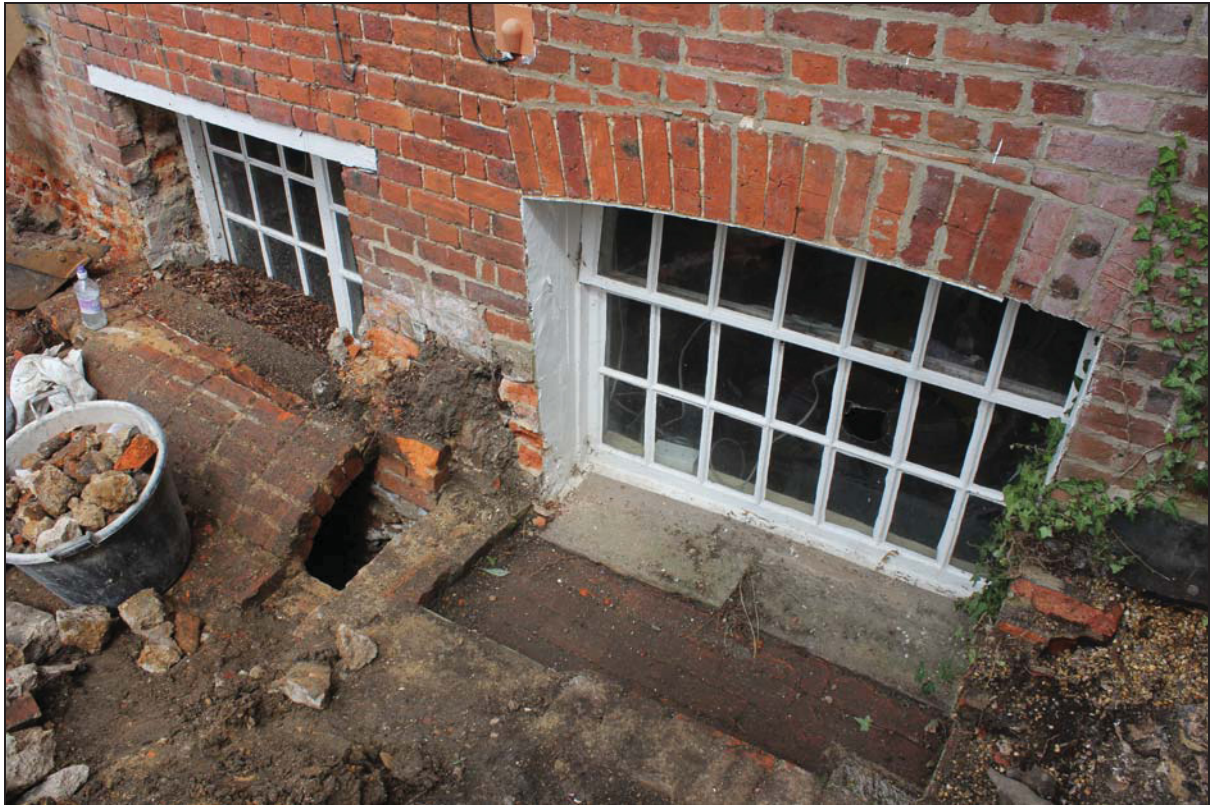
4.11 Of interest during this phase of work was the exposure of evidence relating to the original terrace construction, and although altered during subsequent phases of work, there is enough fabric surviving to elucidate the changes and original form. This current phase of work saw the removal of the central external steps leading from the terrace to the ground floor of the building, as well as the kerbing around the existing eastern basement windows. The lowest step comprises the large curtailed step noted above, while other stone pieces are broken down from larger elements, either former kerb pieces or steps (Plates 5 and 6). These retain small square mortices (some iron stained) for railings or iron attachments. Otherwise, tooling marks are visible on those faces that would have been hidden, while the visible faces display a fine finish.

Plate 7 View of the south side of the building (east end) showing original brick retaining structure keeping the fabric of the terrace away from the house, taken from the south (DP 119)

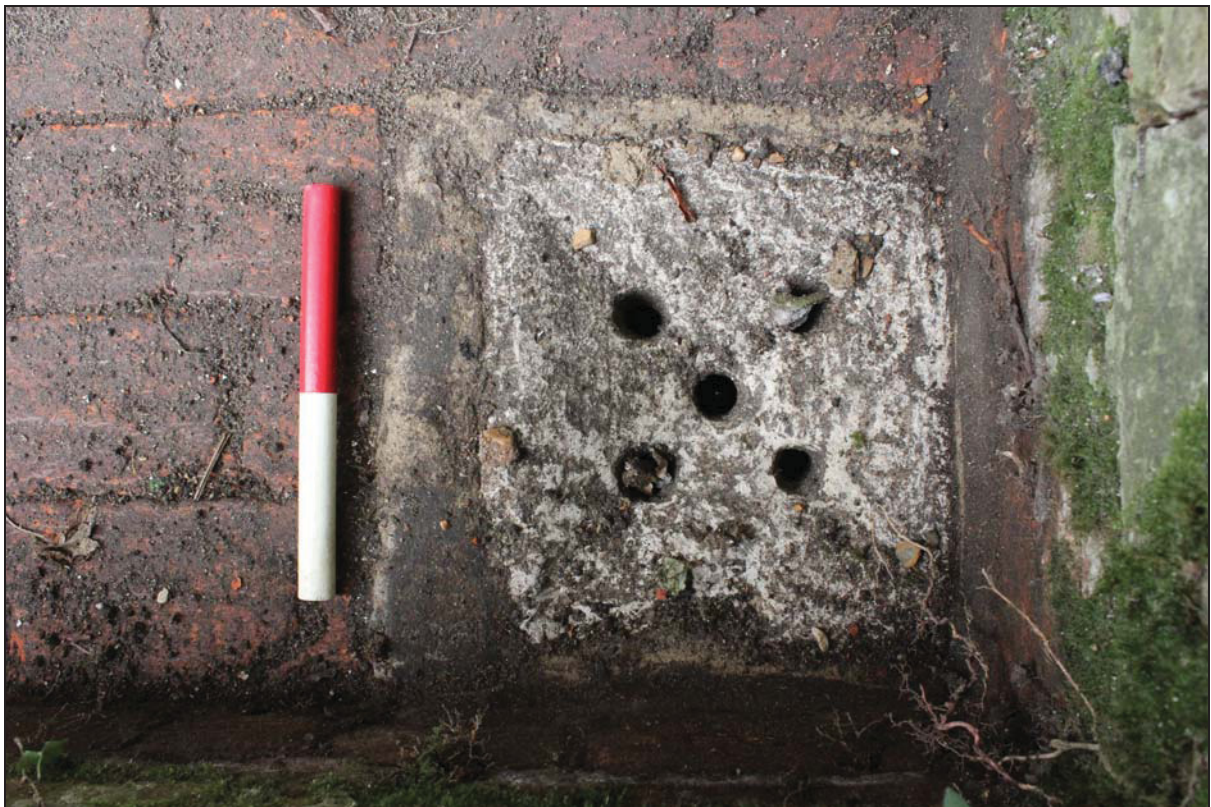
Plate 8 Detail of the stone drain within the brick retaining structure on the south side of the building (east end), taken from the south (DP 126)

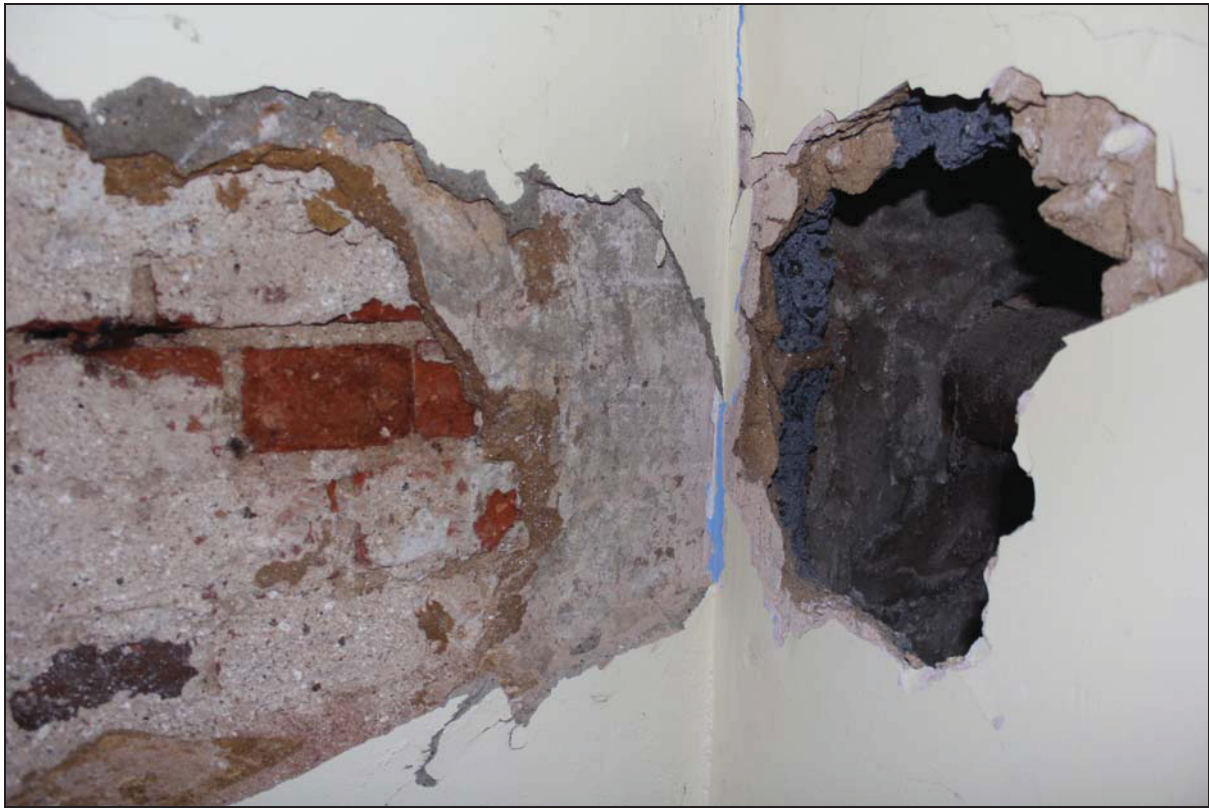
4.32 In the south-west corner, a small area of plasterwork was removed to determine the nature of the underlying fabric and establish whether there was an original opening into the garden from this space. Three layers of plaster/render were encountered, the most recent being hard cement render. Below this, a sand and cement layer overlies the earliest fabric which comprises a lime plaster with a fairly high number of chalk inclusions (Plate 21). The underlying brickwork is all of the same date indicating there was no doorway in this position. To the west a pier was also investigated and found to be of modern blockwork construction enclosing a waste pipe of no interest.

Plate 21 Detail showing the south-west corner of Room BF01 showing brickwork on the left and block work of the attached pier to the right, taken from the north (DP 72)

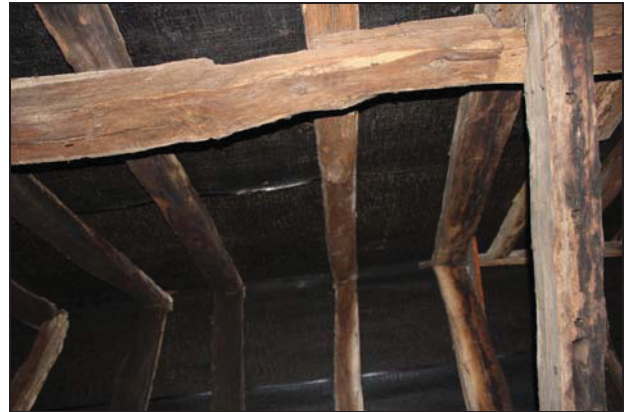
DP 16

Detail of the east roof showing smoke-blackened timbers and mortice in the purlin for a lost wind brace, taken from the north

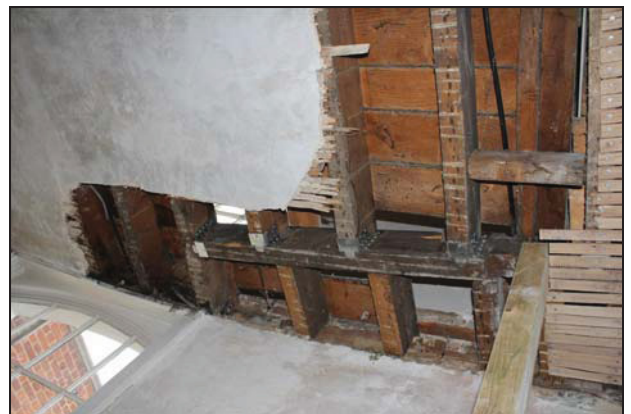
DP 114

View of the ceiling in Room GF04 during the planned works showing disturbed fabric, taken from the north
