**HELPESTONS MANOR, HOLLOW ROAD,  
FELSTED, ESSEX**

**HISTORIC BUILDING RECORDING**

Level 3

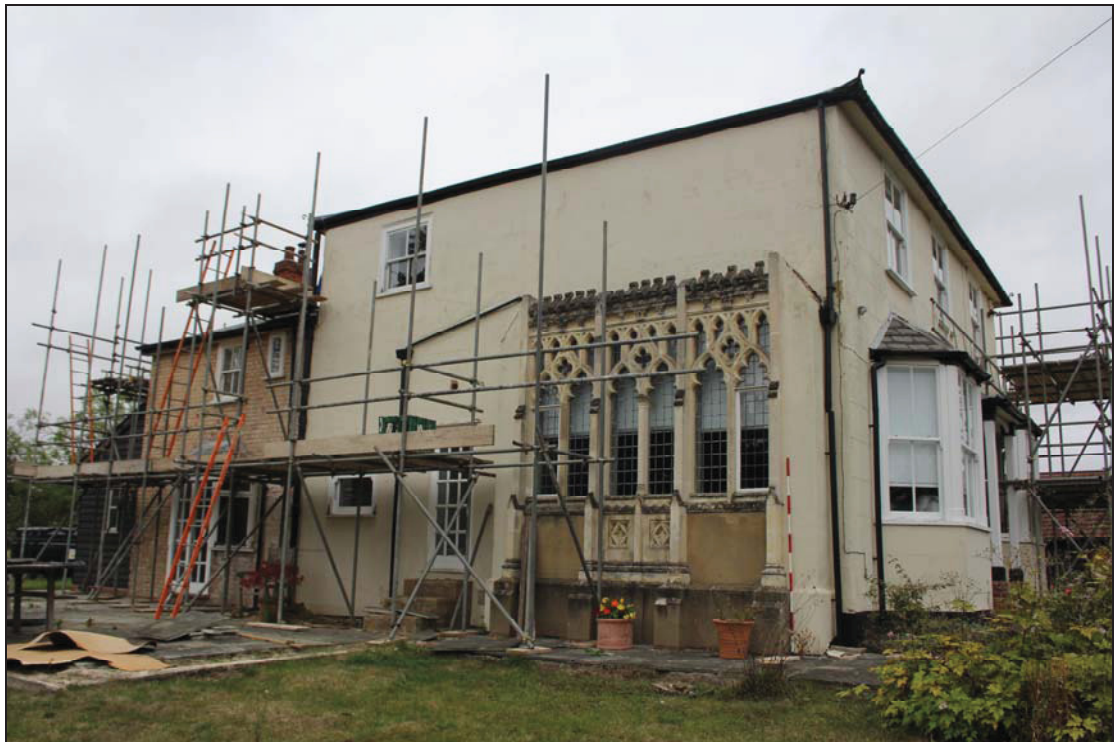
Plate 2 Side elevation of Building 1, taken from the south (DP 05)

5.2 The west elevation gives a view of the lower, rear service block, now stripped of render to reveal underlying yellow brick in English bond (Plate 2). The south end is dominated by the partial remains of the screen, all in fine limestone and now suffering from decay due to its ongoing exposure to the elements. The structure was erected against the existing external wall and is supported by crude buttresses and lifted above the plinth on a rendered base. It comprises panels of decorative tracery above a solid lower dado in the 14<sup>th</sup> century style. Tablets in the outer panels record a list of owners of the manor from the 14<sup>th</sup> century to 1914 (Plates 3 & 4), while a central tablet records the erection of the screen at St Giles's, Cripplegate in 1866 and its removal in 1915. The traceried lights are now infilled with leaded, square panes, with Crittal-style steel casement windows in the two outer lights. The remainder of this façade is fairly plain with modern windows and a garden door.

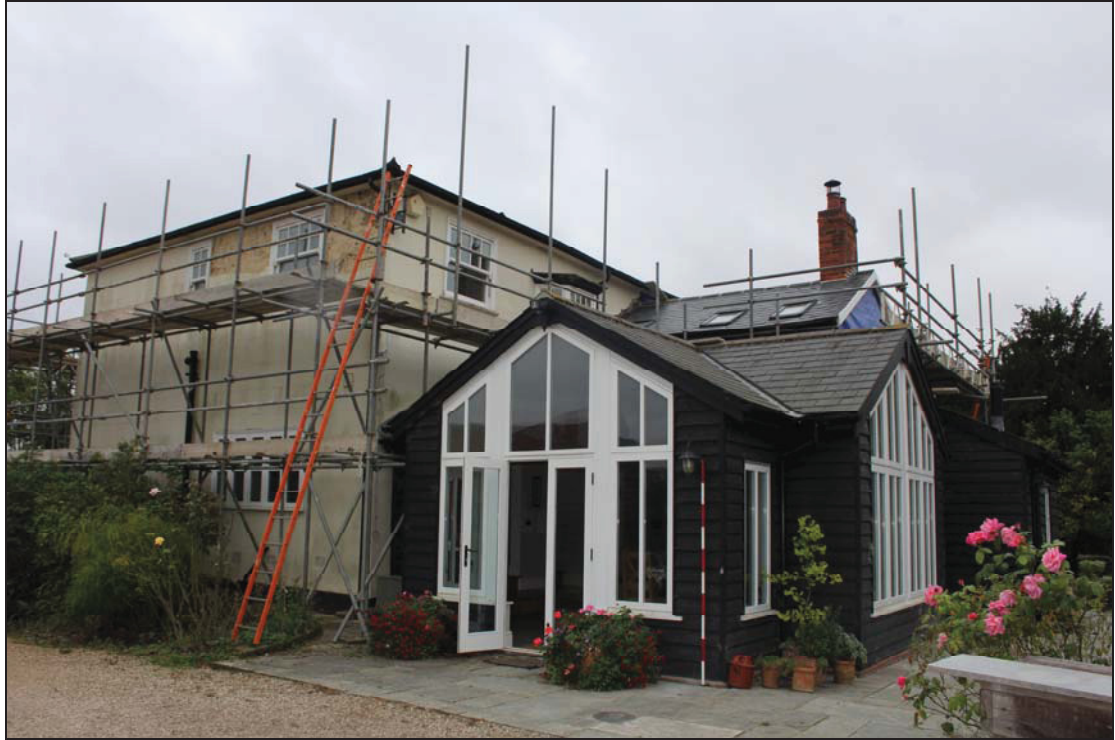
Plate 5 Exterior view of Building 1, taken from the north (DP 10)

5.3 The east elevation is comparatively plain, pierced only by a five-light window at lower level and sashes above, but all have been replaced with modern materials (Plate 5). The rear return between the main house and service range has been infilled with a 20<sup>th</sup> century extension of weather-boarding with a slate roof. The back of the service range has also been extended by a pent-roofed

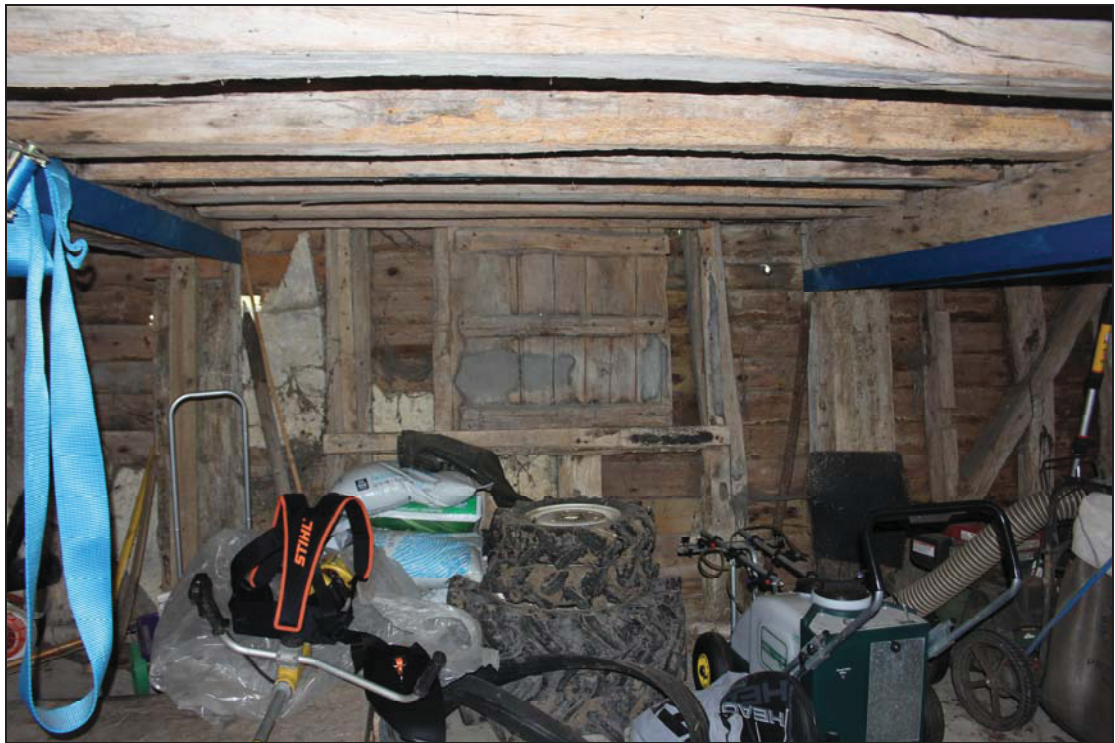
Plate 16 North wall of the central bay in Building 2, taken from the south-east (DP 60)

5.11 The north wall of the central bay has substantial studs, and as is commonly found, no bracing (Plate 16). A central stud has been truncated for the insertion of a sliding shutter of probable 17<sup>th</sup> century date. This was added by means of a nailed-on cill and upper runner. The shutter itself is fairly crude, boarded, with three nailed-on ledges.

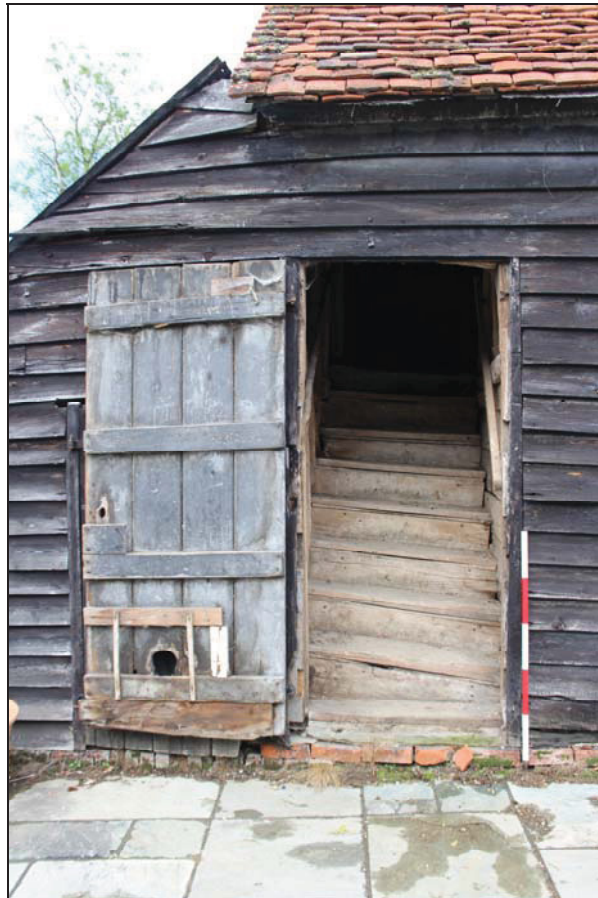
Plate 20 Staircase giving access to the first floor of Building 2, taken from the south-east (DP 65)

5.16 The staircase is given access from the exterior door (Plate 20), as noted above and comprises simple thick oak treads with nailed-on risers with a hedgerow pole as a handrail to the west. It is enclosed with simple horizontal boarding and rises directly against the sole surviving grain bin at the top which doubles as an additional handrail.

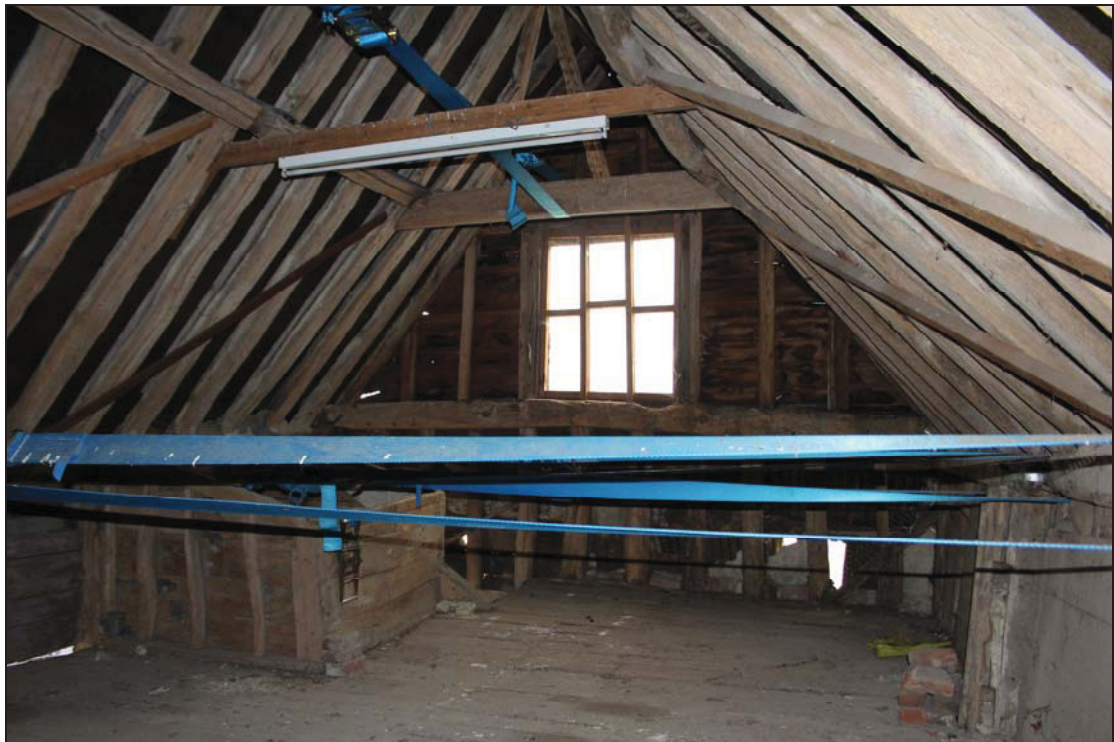
Plate 22 First floor of Building 2, taken from the north (DP 49)

5.18 The roof has no tie-beams, except to the gable ends (Plate 22). This may be the source of the current structural instability. In the west gable, the tie-beam preserves upper pegs for studwork. This member is reused, and retains mortices for earlier bracing at either end. Pegging is also partly present to the east though there has been some replacement.

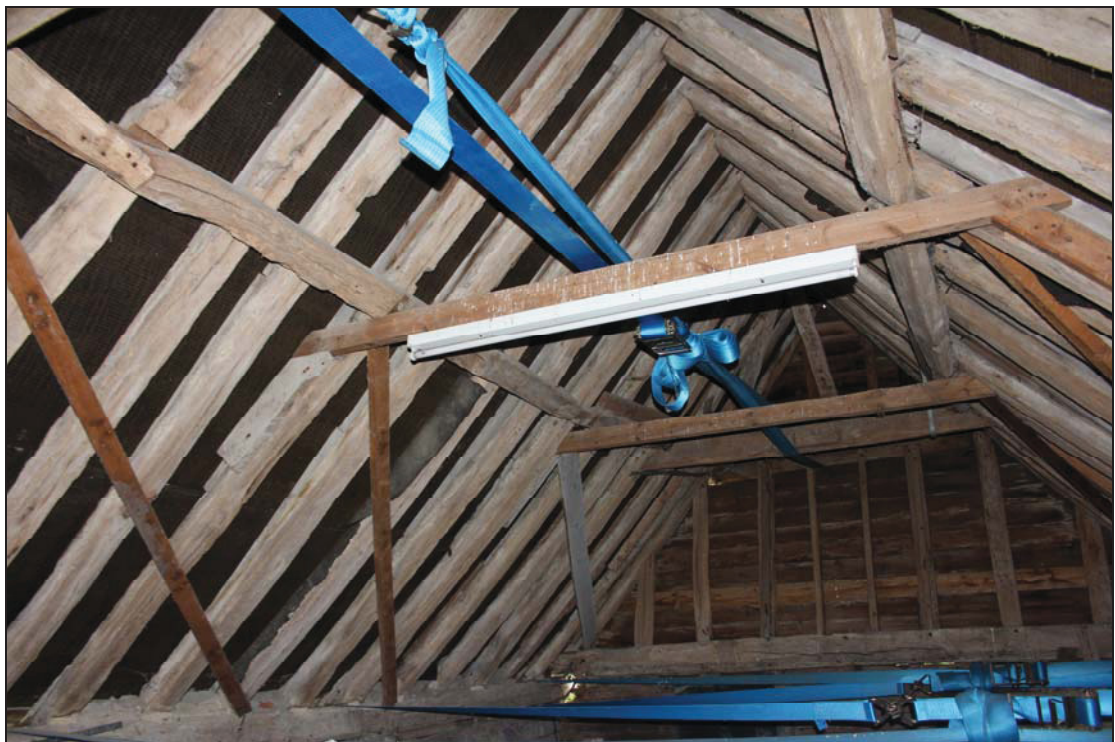
Plate 24 Roof structure in Building 2, taken from the south (DP 53)

5.20 Various modern additions can be noted, mostly as supports (Plate 24). These include nailed-on slender wind-braces, additional collars, modern metal strapping and most recently, the temporary measures in woven nylon to prevent further distortion of the structure.

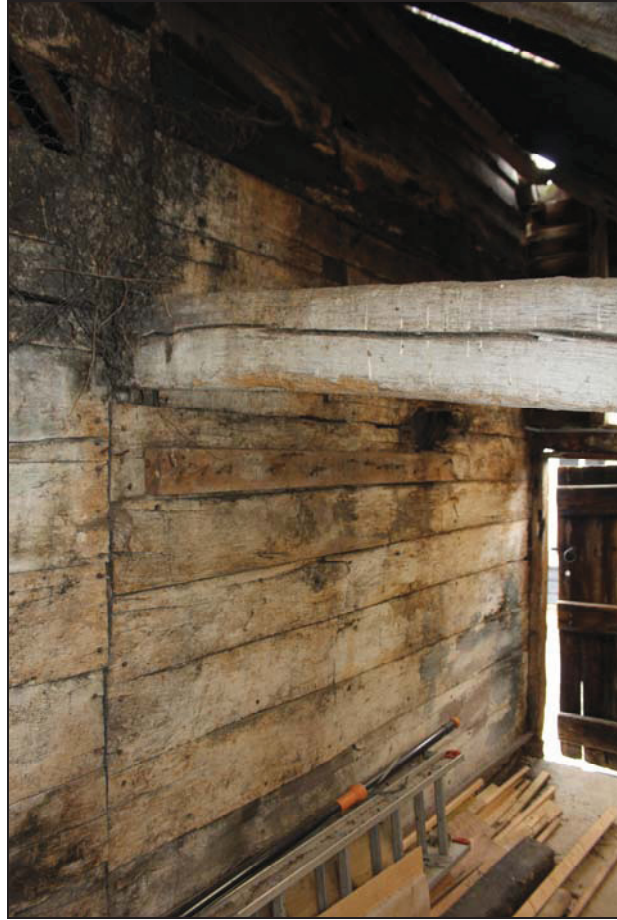
Plate 25 Weather-boarding along the original external wall of the main barn in Building 2, taken from the west (DP 59)

5.21 Within the outshut, flush boarding of some age survives to the main structure, though repaired at upper level and much decayed (Plate 25). A cement floor has partly submerged the sole-plate whilst simple studwork all round is partly pegged. A central tie and principal rafter support a flimsy modern roof (Plate 26). A few fixtures and fittings such as timber hooks survive (Plate 27).

6.5 Modern interventions are few, apart from the detrimental use of concrete for flooring, which will accelerate decay of the sill beams, and some rudimentary repair or supporting measures.
