**BARN AT BENINGTON PARK FARM,
BENINGTON, HERTFORDSHIRE**

HISTORIC BUILDING RECORDING

Authors:	Tansy Collins MSt	
Illustrations:	Kathren Henry	
NGR: TL 3088 2354	Report No: 5366	
District: East Herts	Site Code: AS1882	
Approved: Claire Halpin CMIfA	Project No: 2529	
	Date: 25 April 2017

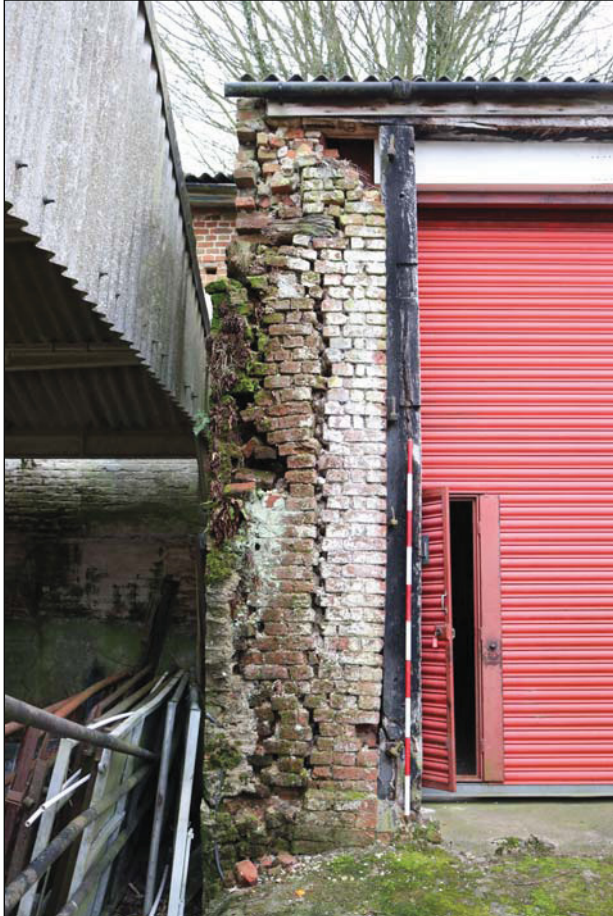
5.4 The north-west side of the porch, particularly the north-east jamb, is in very poor condition with bricks falling away and large cracks (Plate 2). The existing brick

jamb may have been rebuilt but at a relatively early date and the gate posts retain pintles for earlier double doors. Above, a timber lintel is likely original and has empty mortices that may confirm the early alteration. A modern steel roller shutter 'up-and-over' door is set behind the original portal framing. The north-east side of the porch displays render as noted above, but above this two narrow blocked ventilation slits are visible.

Plate 2 North-east brick jamb of the barn porch (Building 1) showing cracked brickwork, taken from the north-west (DP 18)

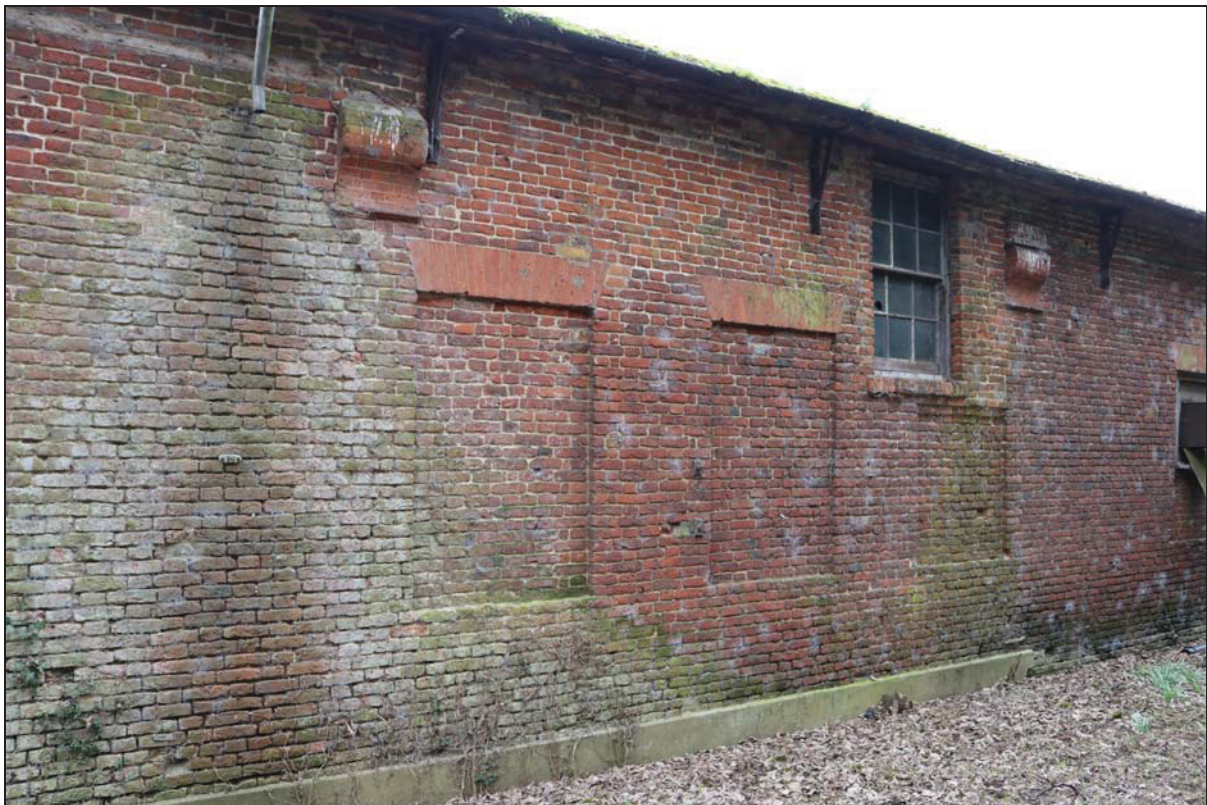
Plate 4 Detail of the south-east elevation (Building 1: barn) showing central set of blind panels framed by corbels, taken from the south (DP 79)

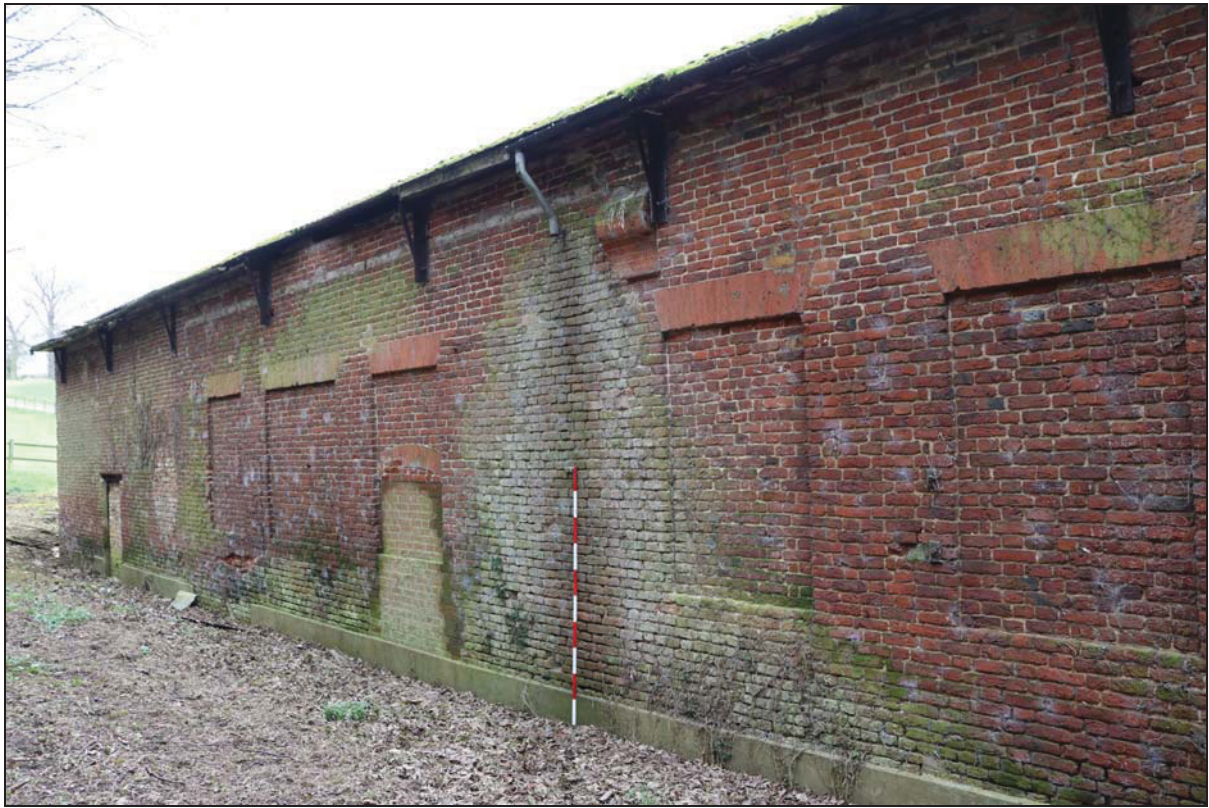
Plate 5 South-east elevation (Building 1: barn) showing blind panels with blocked apertures, taken from the north-east (DP 7)

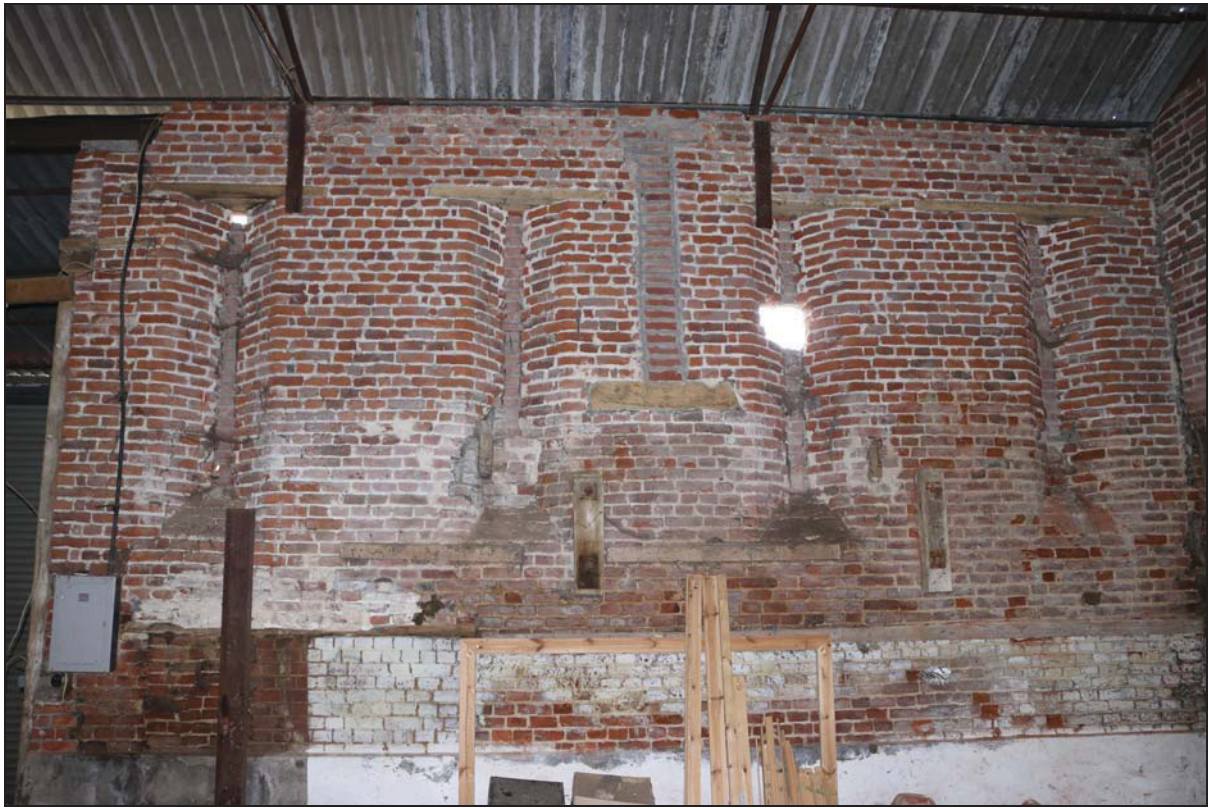
Plate 7 North-west wall of the southern unit (Building 1: barn) showing infilled wind-eyes and infilled recess in the position of a former truss, taken from the south-east (DP 40)

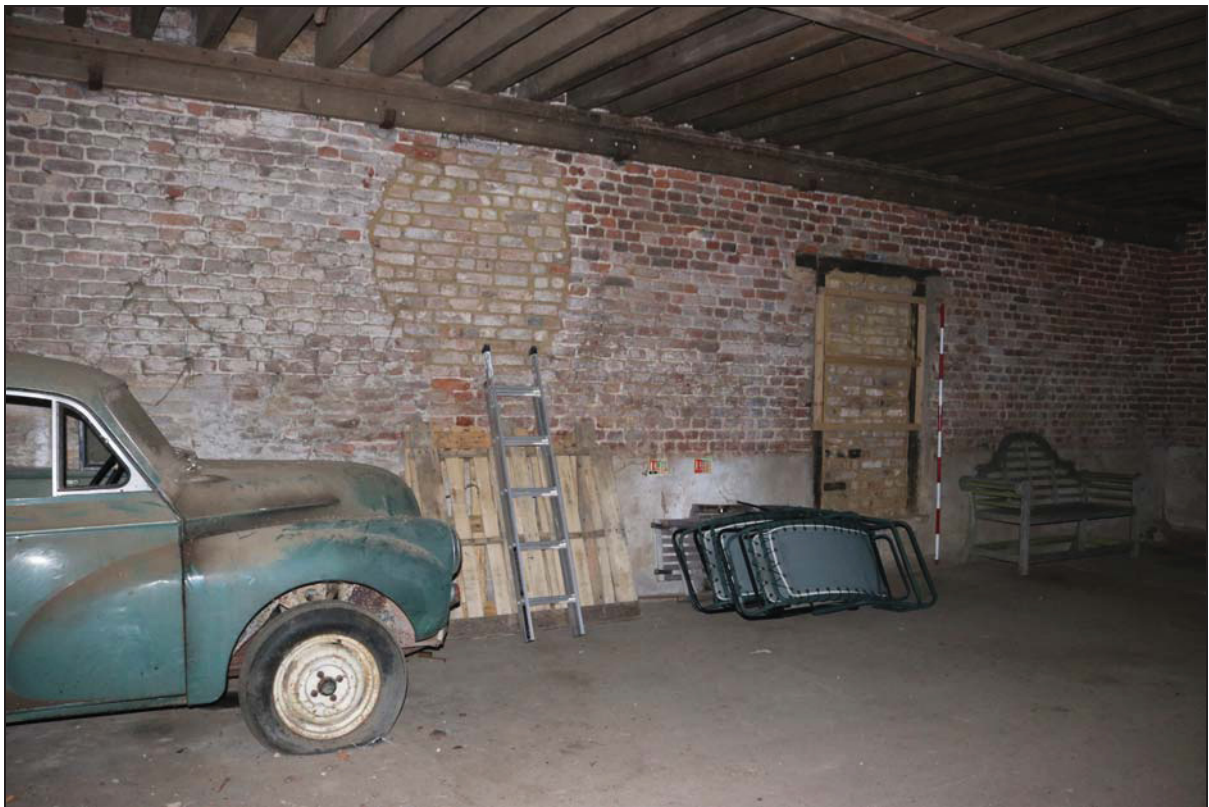
Plate 8 South-east wall of the southern unit (Building 1: barn) at the southern end with inserted circular aperture and doorway, both now blocked, taken from the north-west (DP 54)

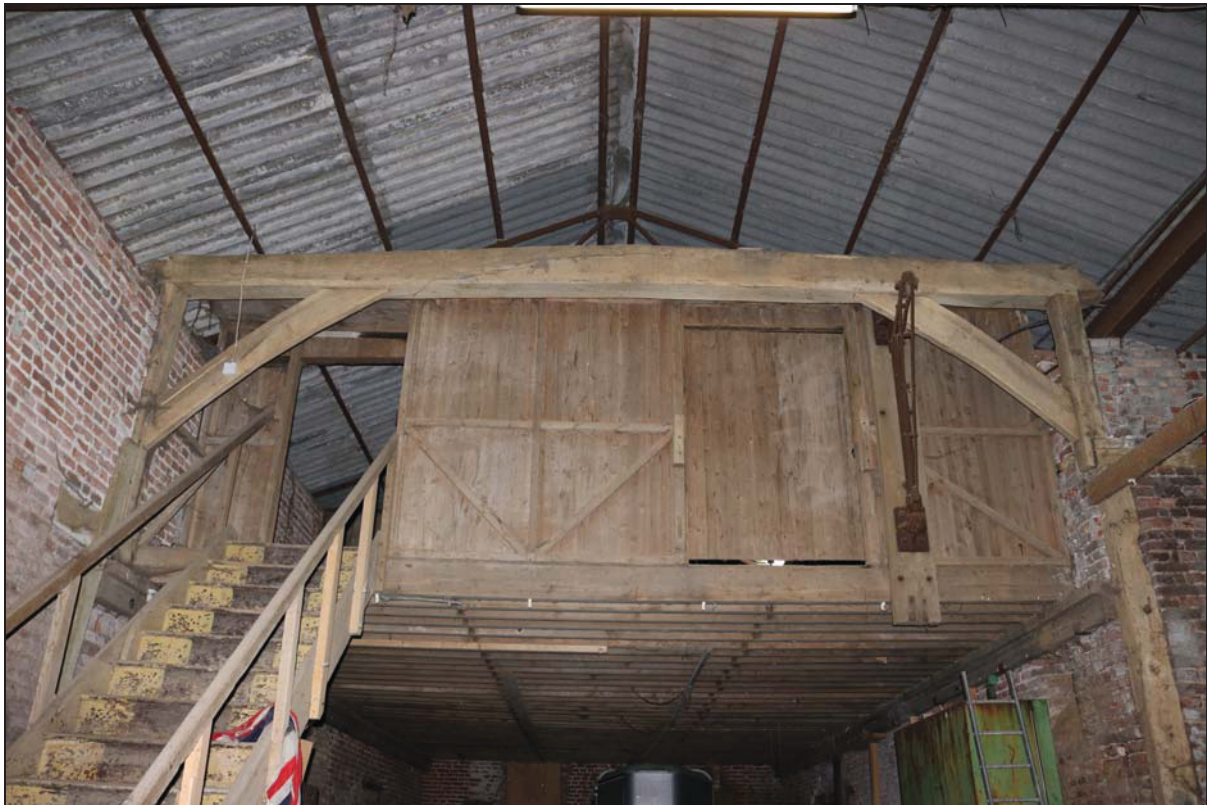
Plate 9 Detail of the surviving original truss (Building 1: barn) with inserted upper floor beyond, taken from the north-east (DP 45)

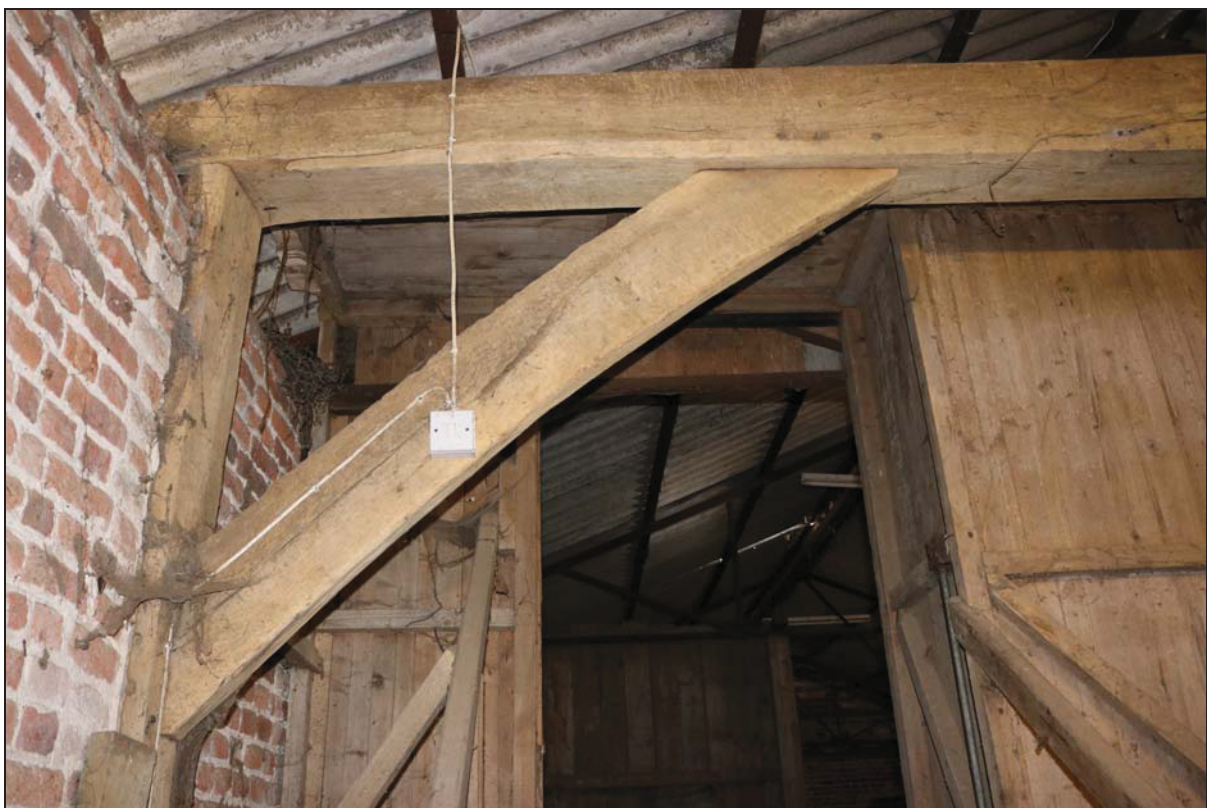
Plate 10 Detail of the surviving truss (Building 1: barn) showing pegged wall-post, tie-beam and brace, taken from the north-east (DP 50)

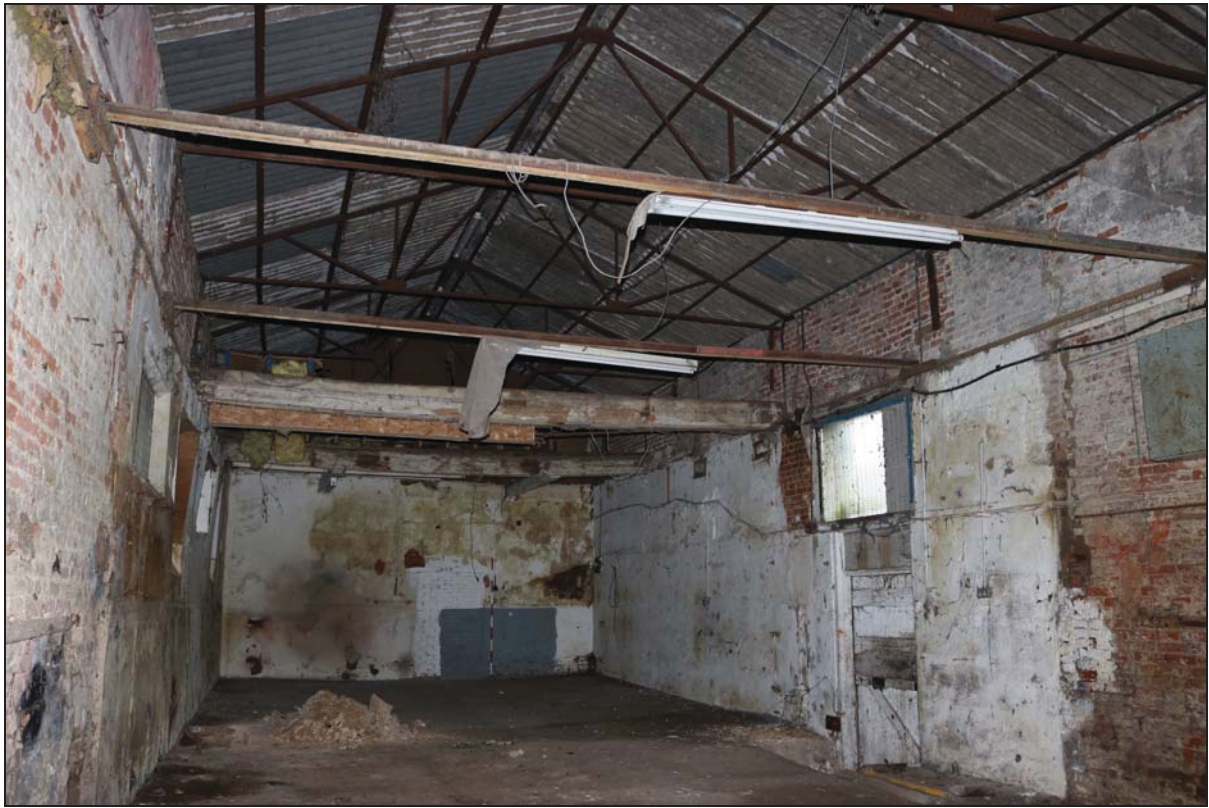
5.15 The northern unit is similar to that to the south but has been considerably altered and clearly originally fulfilled a substantially different function (Plate 11). It is entered at the north-east end which has been built forward approximately 2m from the original end wall. An inner double portal frame in timber marks the former entrance to the space, and retains some early fabric though it is unclear whether there was originally an entrance here or this simply represents an early alteration. The central post is replaced though the outer two may be early in addition to the robust lintel above.

Plate 11 Interior of the northern unit (Building 1: barn), taken from the north-east (DP 24)

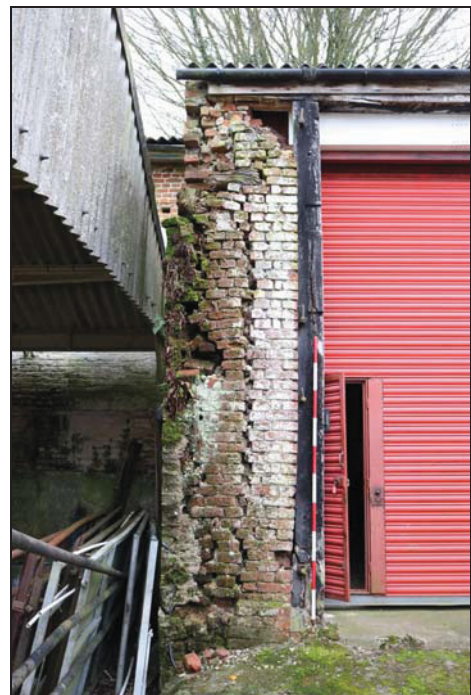
DP 18

North-east brick jamb of the barn porch (Building 1) showing cracked brickwork, taken from the north-west

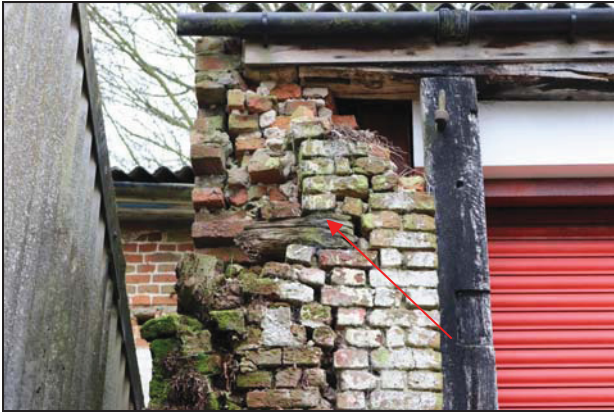
DP 19

Detail of the north-east brick jamb of the barn porch (Building 1) showing timber lintel with empty mortice above the brickwork (indicated), taken from the north-west
