ARCHAEOLOGICAL SOLUTIONS LTD

COCKHAMSTED, FRIARS ROAD, BRAUGHING,  
HERTFORDSHIRE, SG11 2NT

HISTORIC BUILDING RECORDING AND  
BUILDING MONITORING & RECORDING

Authors:	Kate Higgs MA (Oxon.) Tansy Collins MSt Kathren Henry	
NGR: TL 4193 2531	Report No: 6678	
District: East Hertfordshire	Site Code: AS1859	
Approved: Claire Halpin MCIfA	Project No: 6678	
Signed:	Date: 18 November 2016

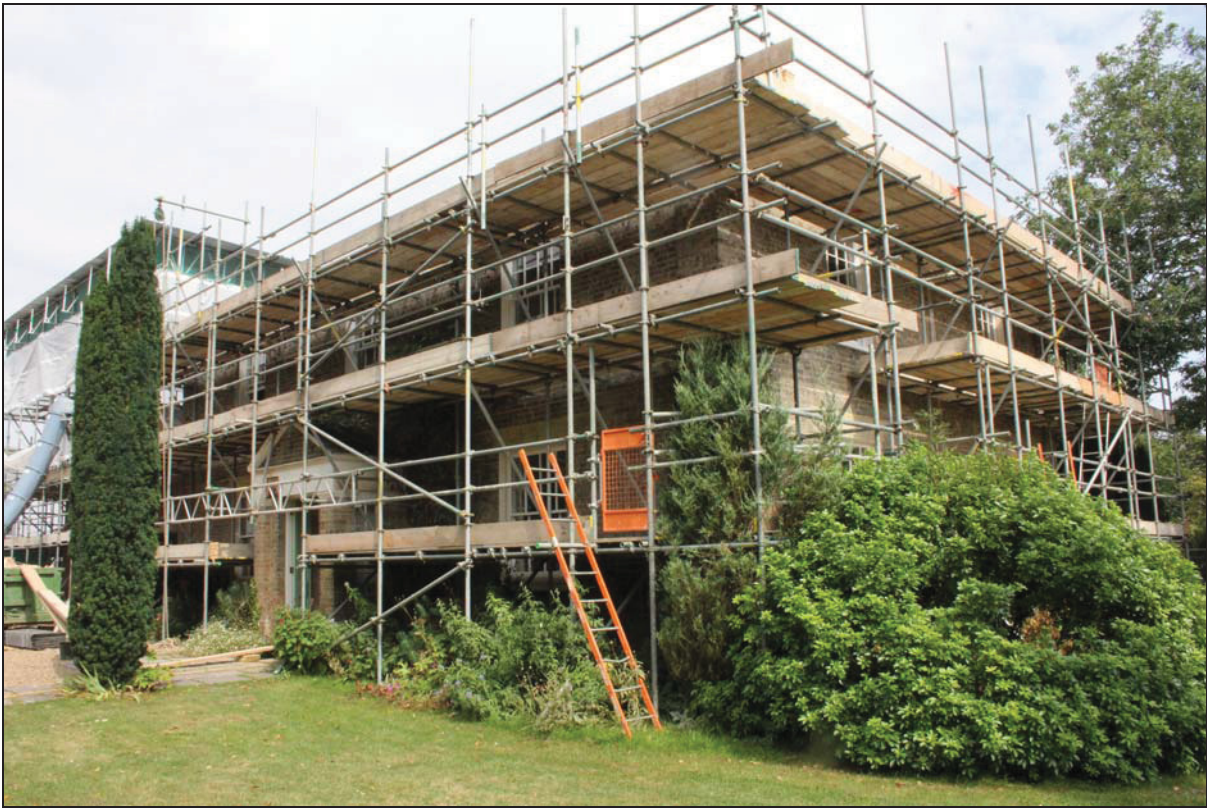
Plate 1 West and south sides of the main house, taken from the south-west (DP15)

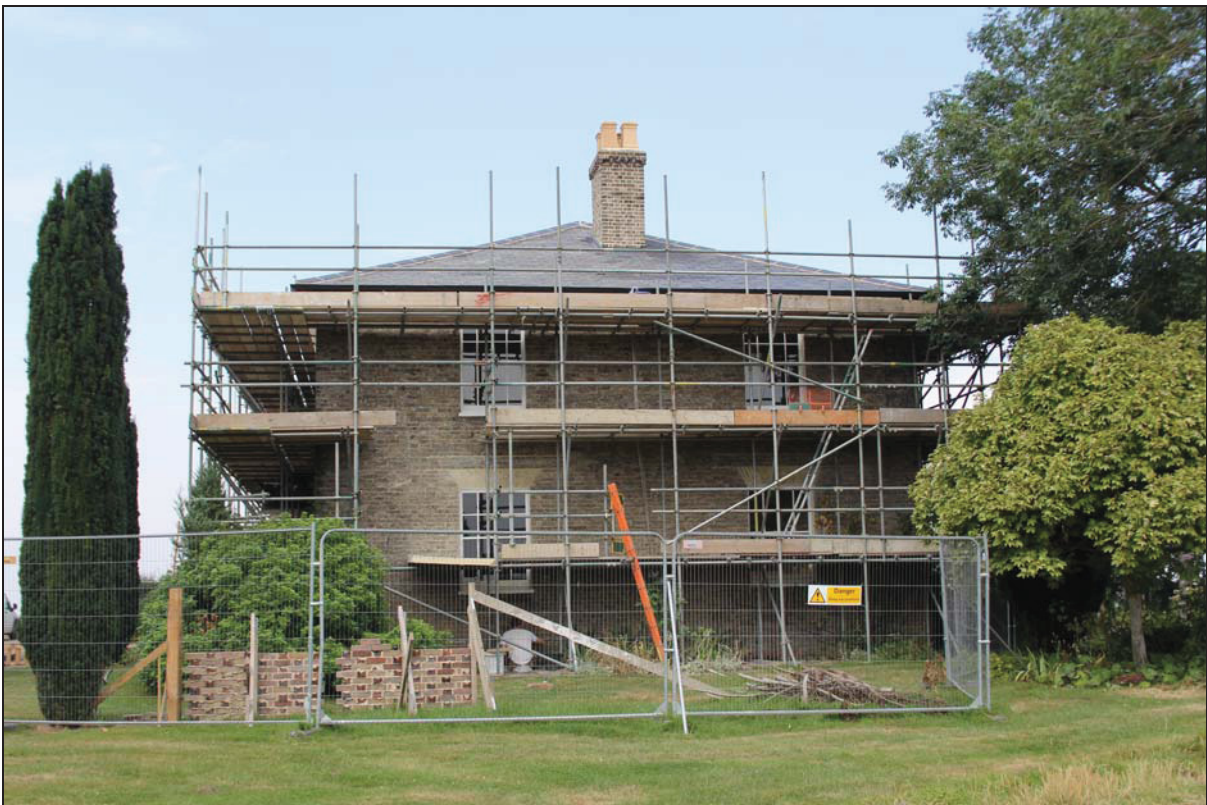
Plate 2 South elevation of the house, taken from the south (DP40)

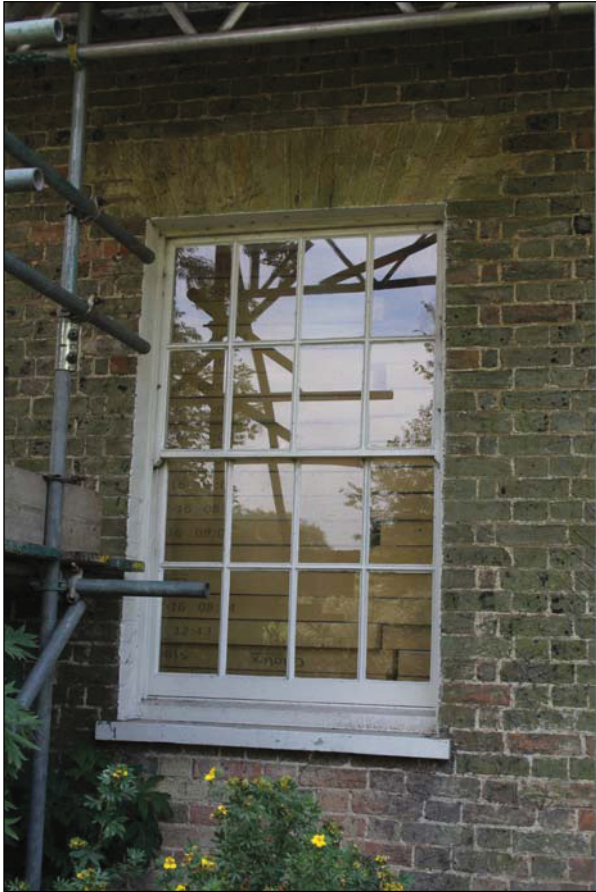
5.6 The rear, east elevation is similarly symmetrical and of good construction though here on the private side, the brickwork is less consistent though all tuckpointed as before. There has been some clear alteration and repair/rebuilding in red brick, particularly around the cellar aperture which may suggest the cellar entrance is a later insertion. At ground level, the central doorway is reached up a large stone step and has a semicircular gault brick arch with a plain infill panel, while the door itself is a glazed 15-pane door with a good, probably 1930s handle.

Plate 3 Recessed sash window on the east elevation with a flat gauged brick arch, taken from the east (DP36)

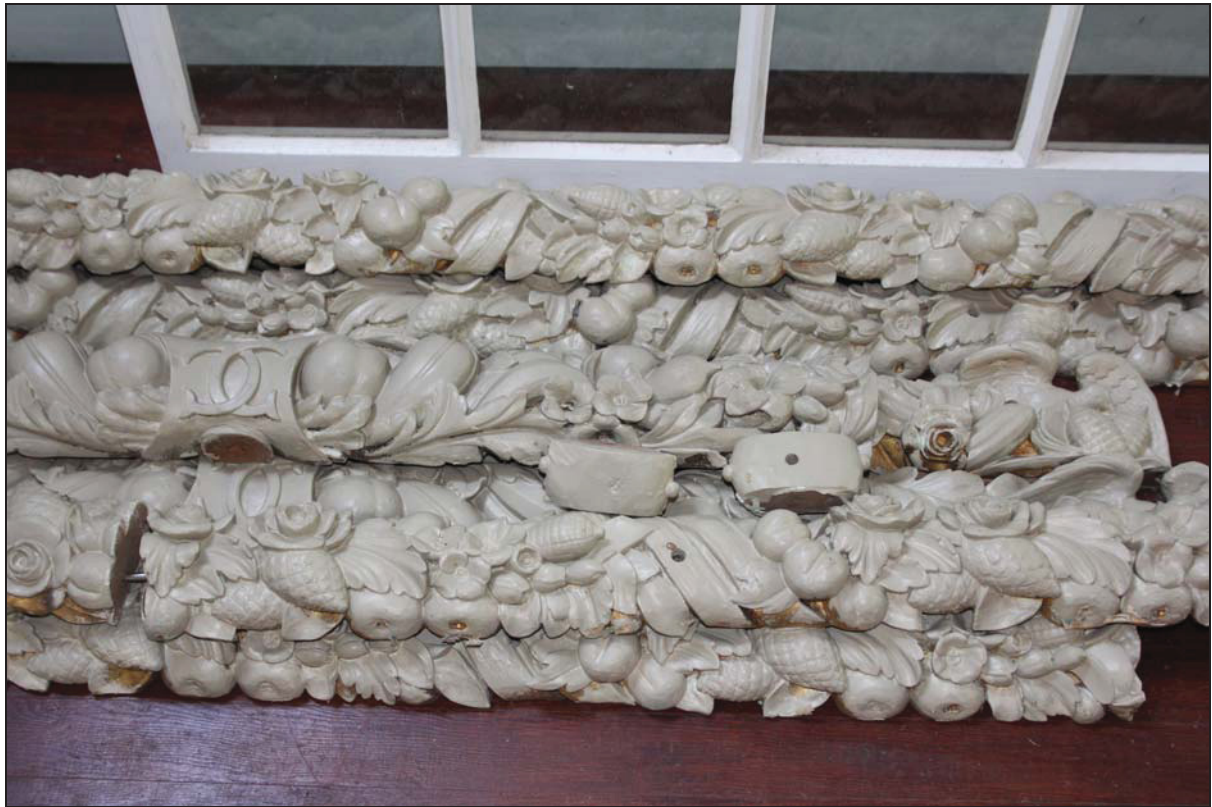
6.4 Further interest is provided by the presence of a highly decorative corning, which the listing noted as being originally from Panshanger House. The decoration was not originally corning but likely from ceiling coffering and is more consistent with a 17<sup>th</sup> century date meaning if taken from Panshanger House, it may have itself been brought in from Coles Green, the precursor to Panshanger House. There has been general upgrading in the 20<sup>th</sup> century, particularly in the service range, and the modern outbuilding was constructed in the mid-later 20<sup>th</sup> century and is of no interest.

Plate 6 Decorative cornice formerly installed in Room GF02 stored prior to reinstallation (DP106)

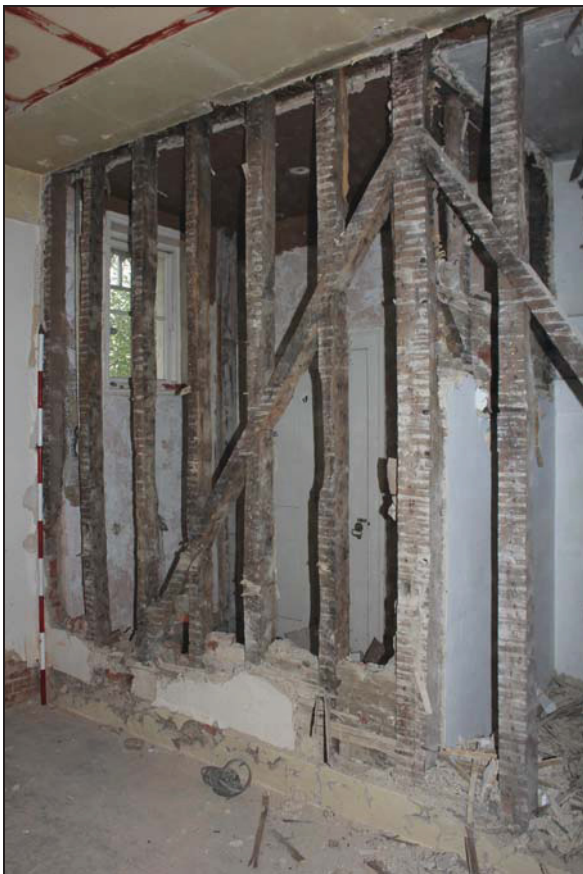
Plate 11 Primary-braced studwork partition in Room GF05 after removal of lath and plasterwork, taken from the north-west (DP01)

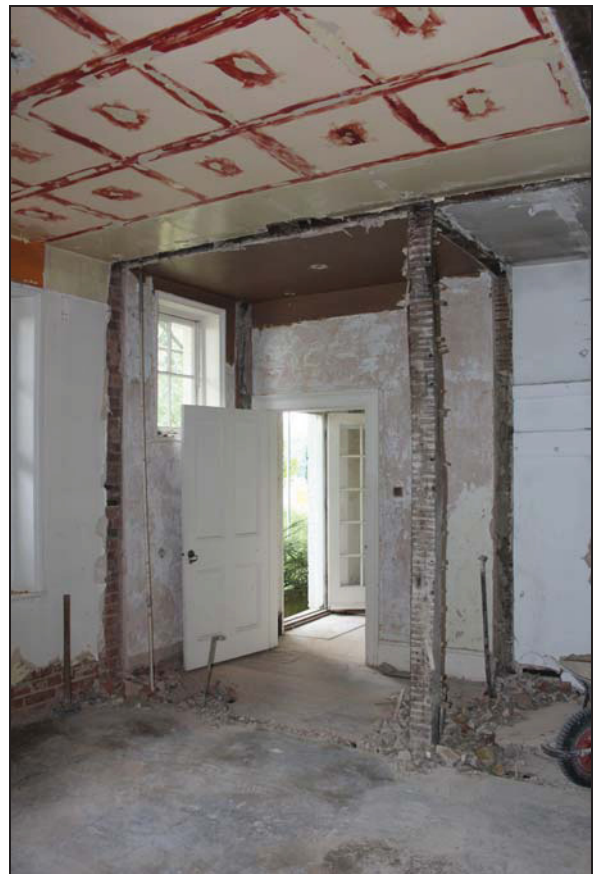
Plate 12 Room GF05 after removal of the primary-braced partition during the planned works, taken from the north-west (DP16)

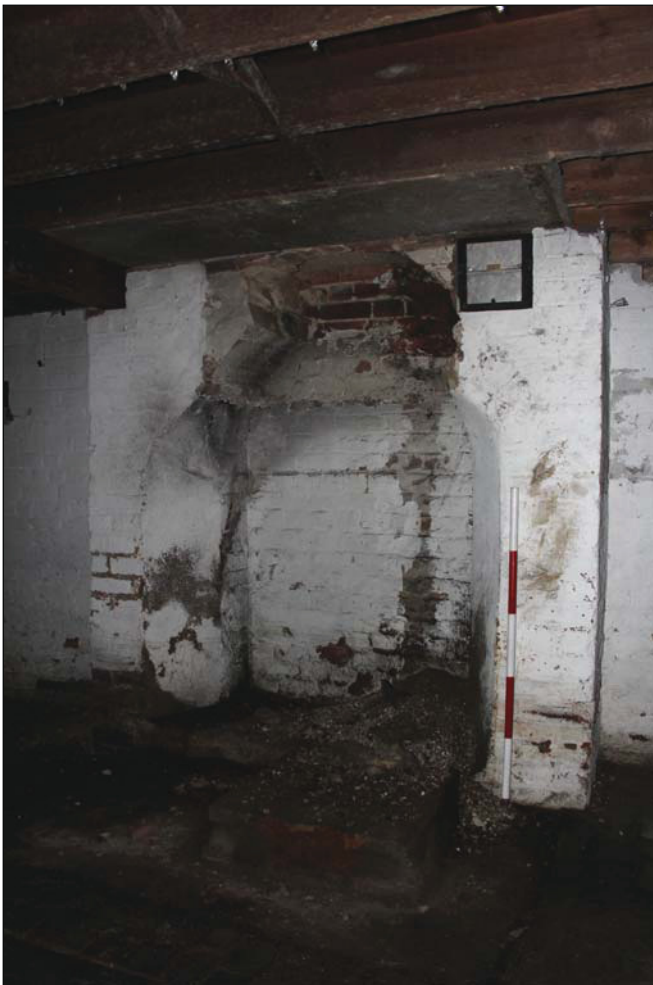
5.34 The walls of the remainder of the cellar are all of painted brickwork and there is a drainage gully in the floor. On the west side, the chimney breast has heavily chamfered jambs and the strainer arch supports the stack above, but at some point the arch has been broken through to insert a flue into the stack, likely for a stove at this level.

Plate 16 Chimneybreast on the west side of the cellar supporting the stack above (BF01), taken from the east (DP102)

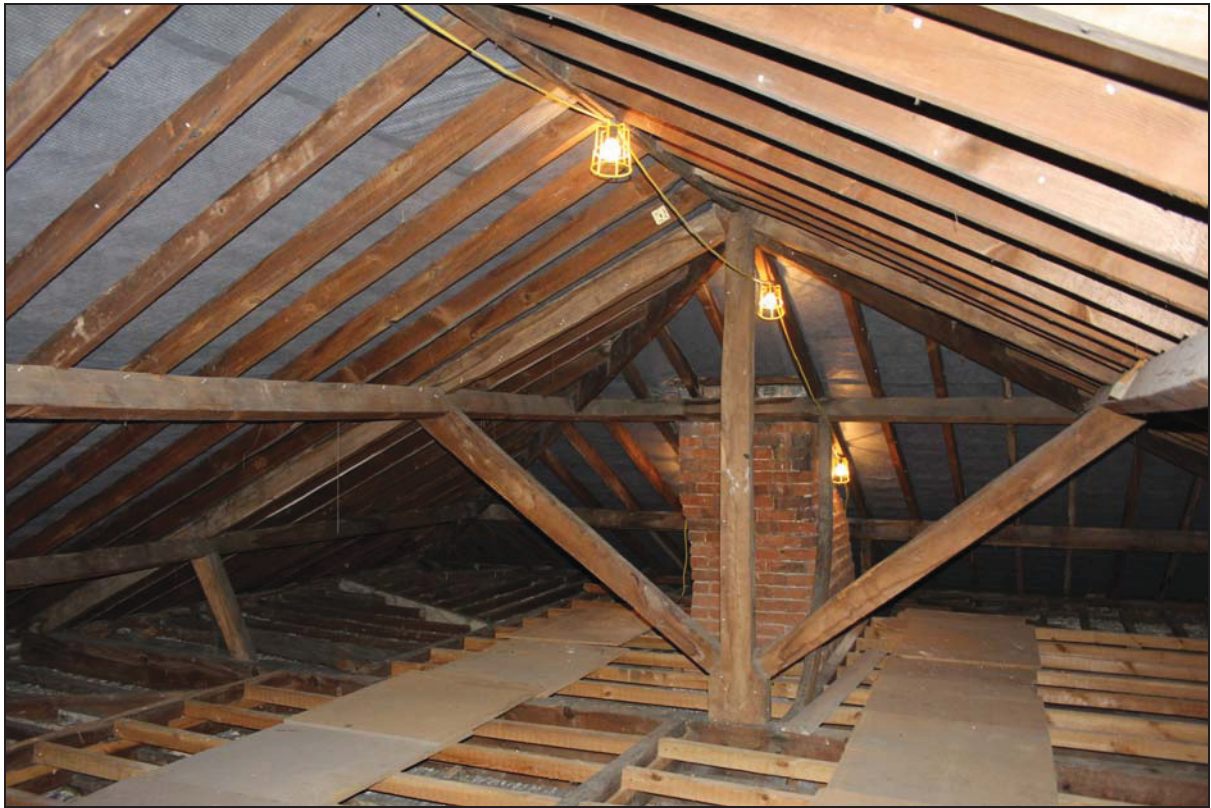
5.36 The roof of the main range was given access through a ceiling hatch in Room FF06 and is of regular and systematic construction utilising softwood of regular and slender scantling (Plate 17). The timber is notable by the presence of a number of scribed marks suggesting a Baltic origin for the timber (Plate 18), which are observed on purlins and one bridging joist to the ceiling below.

Plate 17 King-post roof structure over the house (south-truss), taken from the north (DP17)

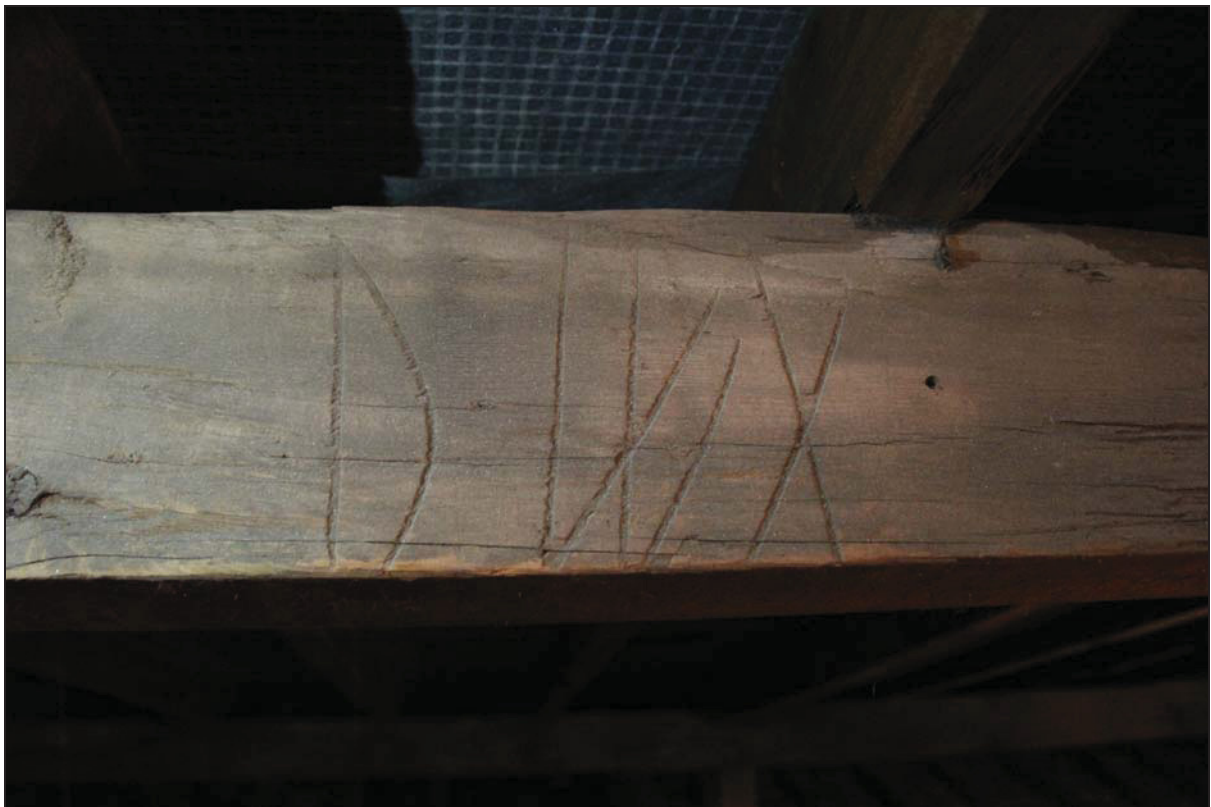
Plate 18 Scribed Baltic timber mark on a purlin in the roof structure (DP25)

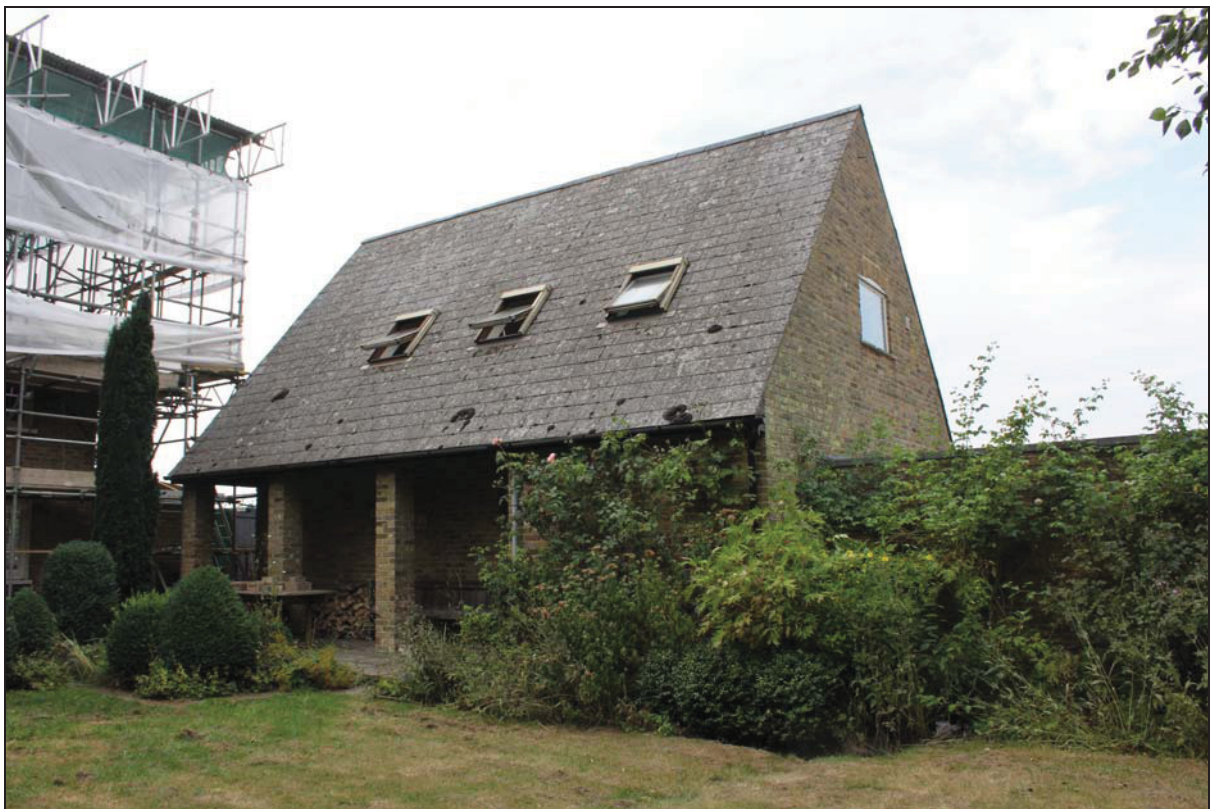
5.39 The outbuilding lying to the north of the house was also subject to consideration and was found to be of no interest (Plate 20). It is constructed of stock brick laid in raking stretcher bond rising to a steeply pitched roof covered in grey slate, though the western gable is of vertical boards. The structure is arranged with a car port at lower level, a covered aisle on the south side and a staircase and WC at the east end, the staircase leading to rooms housed in the roof space. The upper spaces are lit though modern velux roof lights and all the fixtures and fittings are modern. A single-storey flat-roofed unit extends east in part identical brick and part timber boarding. It has pine-cone finials adorning the east wall but have been added from elsewhere.

Plate 20 South side of the modern outbuilding, taken from the south (DP45)

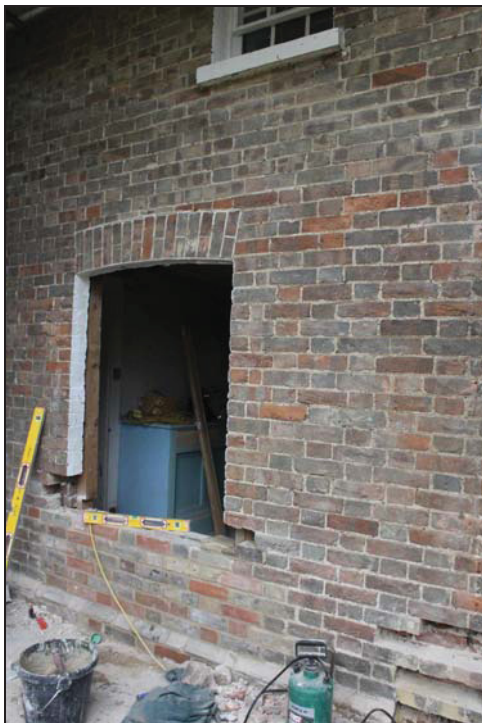
DP 47

*Former doorway on the east side of the service range currently being converted to a window, taken from the east*

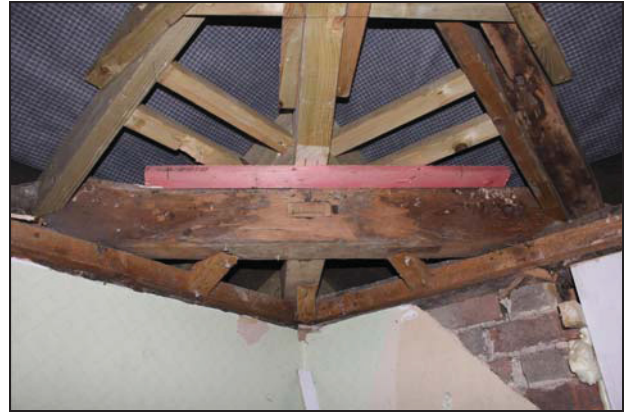
East side of Room FF12 showing new ceiling timbers inserted alongside historic fabric, taken from the west

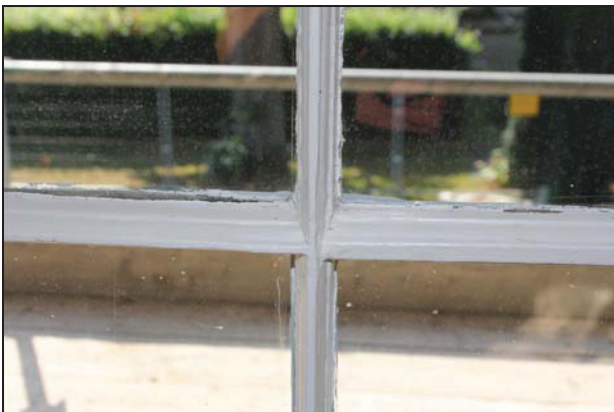
DP 95

5.26 The south-west room (FF03) has a further original eight-over-eight sash window with no horns on the west, though the bottom sash has been replaced with thicker glazing bars. The window on the south is a later 19<sup>th</sup> century sash with horns. The fireplace on the east is blocked. A small doorway on the north leads to a closet which retains the original eight-over-eight sash on the west as elsewhere. On the east side, there were formerly shelves, though their removal has exposed the lower portion of the studwork partition. This is primary-braced, but also displays an aperture in the centre now infilled with modern fabric but marking the position of the original doorway from the landing. Also of note, is that this room apparently retained a hidden area in which World War Two ammunition was found by the current owners.

*Glazing bars of the sash window on the west side of Room FF03 showing repair with the thicker glazing bar to the right, taken from the east*
