ARCHAEOLOGICAL SOLUTIONS LTD

LORDSHIP COTTAGE, DANE END, WARE,
HERTFORDSHIRE

HISTORIC BUILDING RECORDING AND BUILDING
MONITORING & RECORDING

Authors: Tansy Collins MSt Lauren Wilson MA PCIfA Kathren Henry	
NGR: TL 3358 2201	Report No: 5169
District: East Hertfordshire	Site Code: AS 1837
Approved: Claire Halpin MIfA	Project No: 6571
Signed:	Date: 18 July 2016

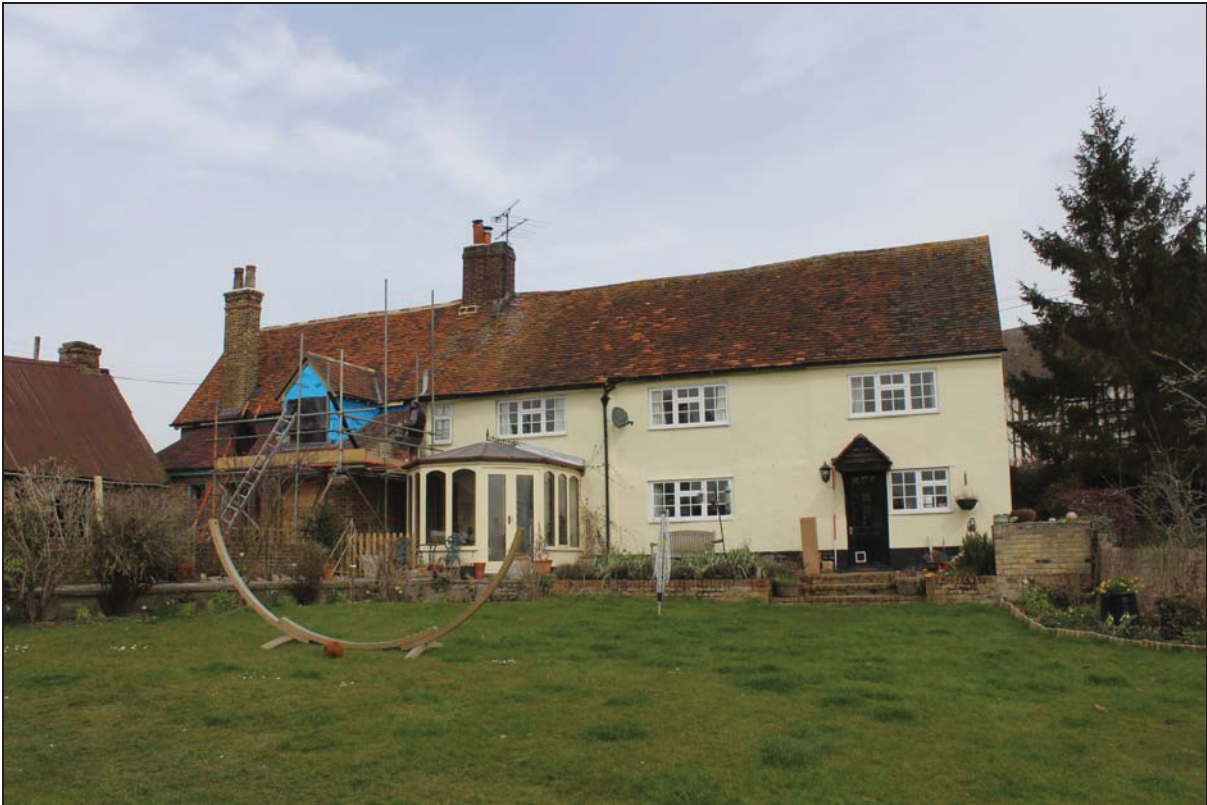
Plate 1 South-west side of Lordship Cottage with adjoining Orchard Cottage to the left, taken from the south-west (DP 01)

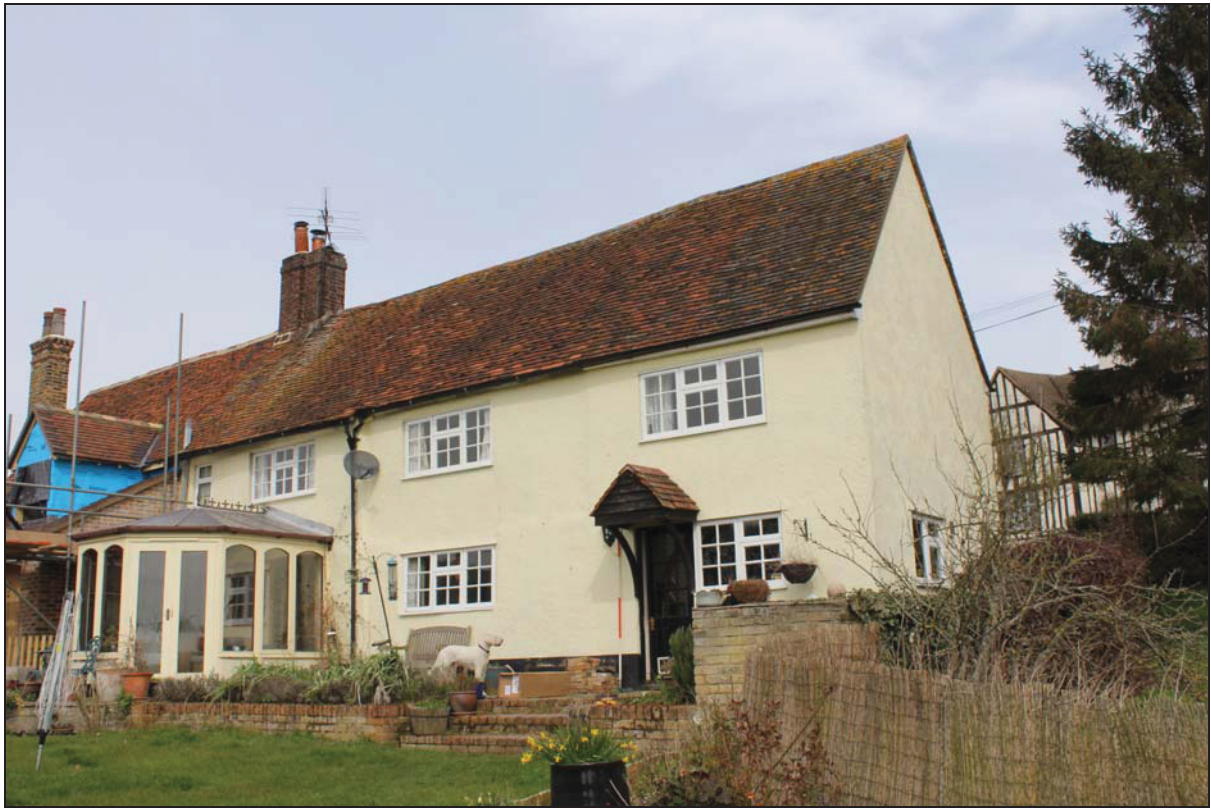
5.5 The south-west elevation fronts onto the garden and has a small raised patio area so the main garden area is slightly lower (Plate 3). This elevation is rendered as noted, while a change is visible where the north-west bay projects very slightly. The north-west bay (Range 1) is largely obscured by the modern conservatory at ground floor level with a three-light casement above. The central bay (Range 2) has two three-light casements, but also of note is a slight impression of the mid-rail between floor levels. The rafter feet are visible at eaves level; one is larger and of flat-section in the middle of the bay but is in fact a reused timber and does not coincide with any internal partitions or trusses. The final bay is all rendered and contains a doorway into the kitchen. It has an adjacent two-light casement with a three-light casement above.

Plate 3 South-west elevation of Lordship Cottage, taken from the south-west (DP 02)

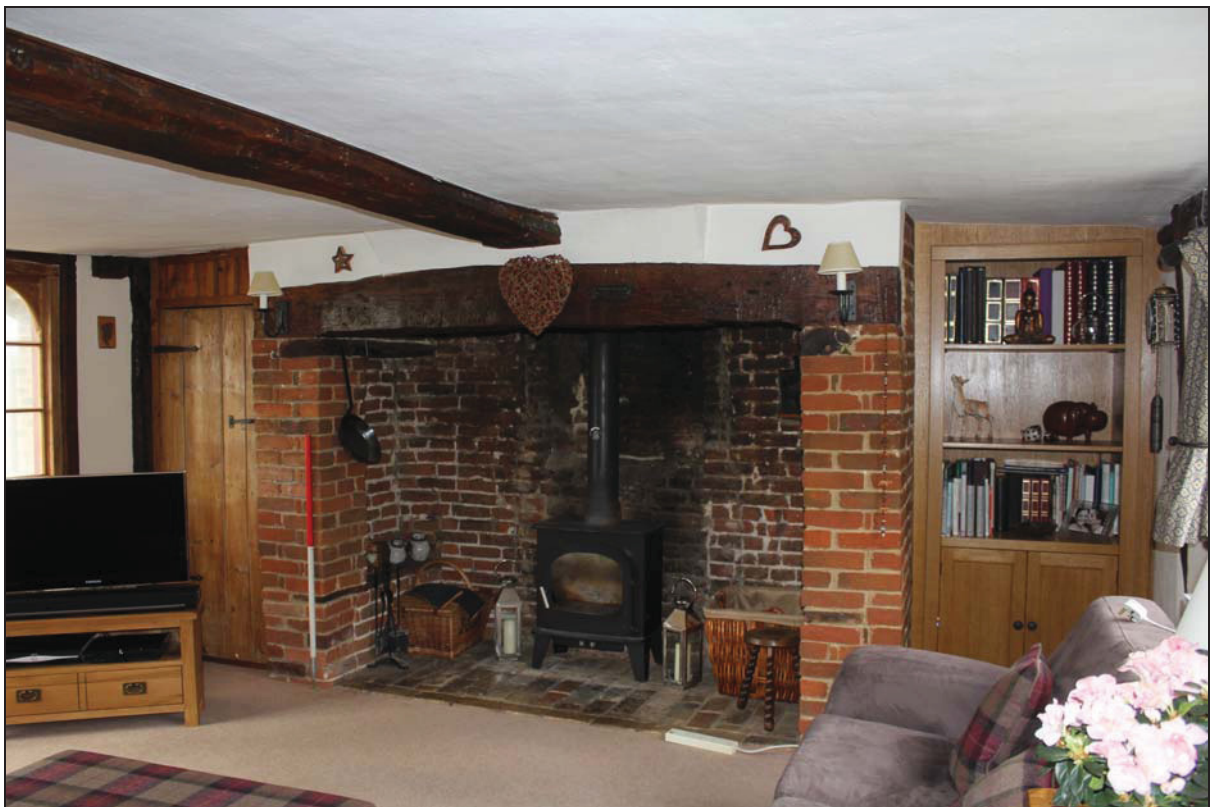
5.7 At the north-west end the living room (GF01) forms the companion bay to that in adjoining Orchard Cottage and contains a large inglenook fireplace (Plate 4). There has been some repair and rebuilding in later fabric, though the bricks at the rear are original being long slender bricks measuring 9½" x 4½" x 2¼" (241mm x 114mm x 57mm), while the bricks returning along the reveals accommodate two low seats and there are two lantern niches. The jambs have been rebuilt, possibly reusing 19th century brick, and supported the original timber bressummer which is chamfered with characteristic lambs tongue chamfer stops (Plate 5) and large peg holes at either end for a shelf. The floor of the inglenook is laid with reclaimed yellow bricks.

Plate 4 Inglenook fireplace in the historic core (GF01), taken from the south-east (DP 10)

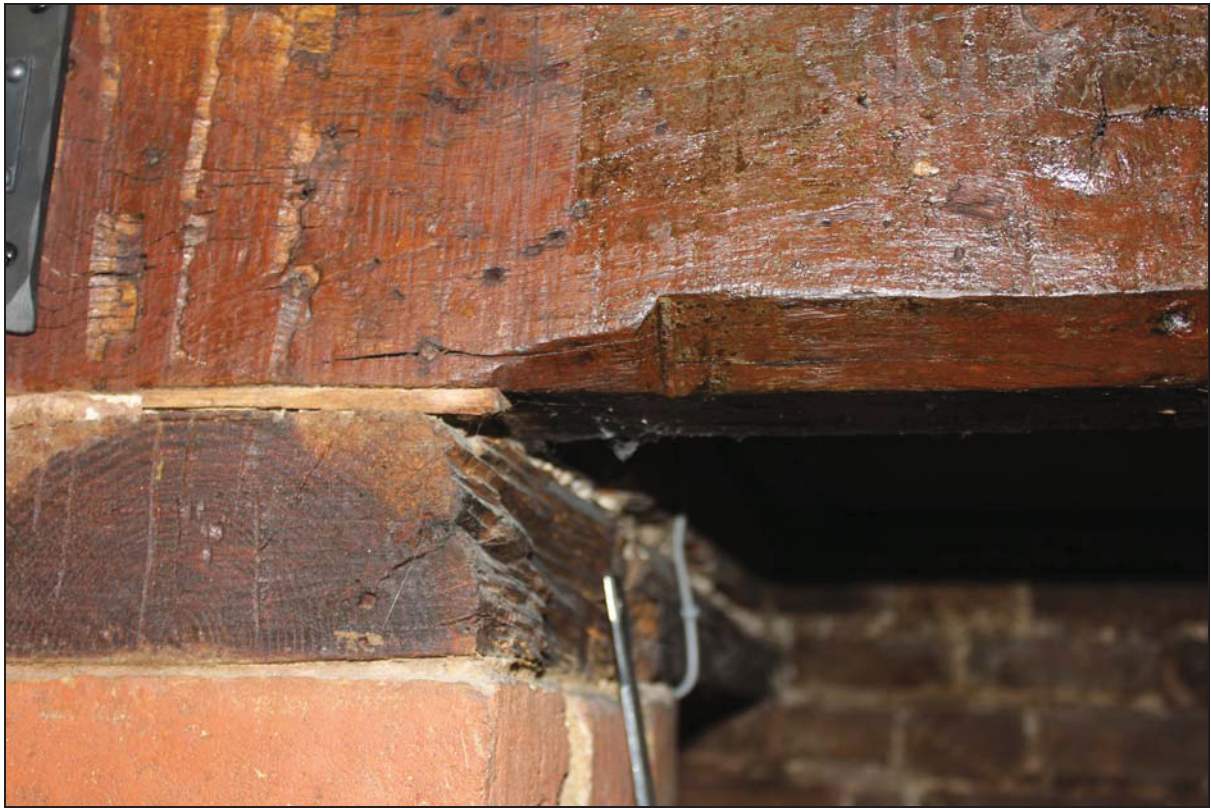
Plate 5 Lambs tongue chamfer stop on the fireplace bressummer in Room GF01, taken from the south-east (DP 11)

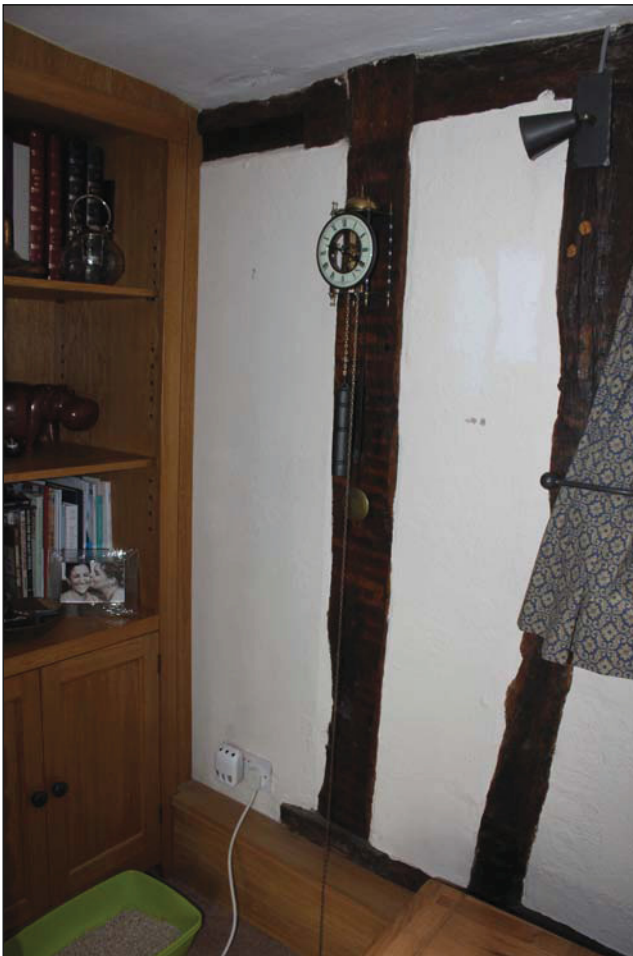
Plate 8 External timber framing on the north-east side of the chimney stack showing the possible position of the original doorway into the lobby, taken from the south (DP 14)

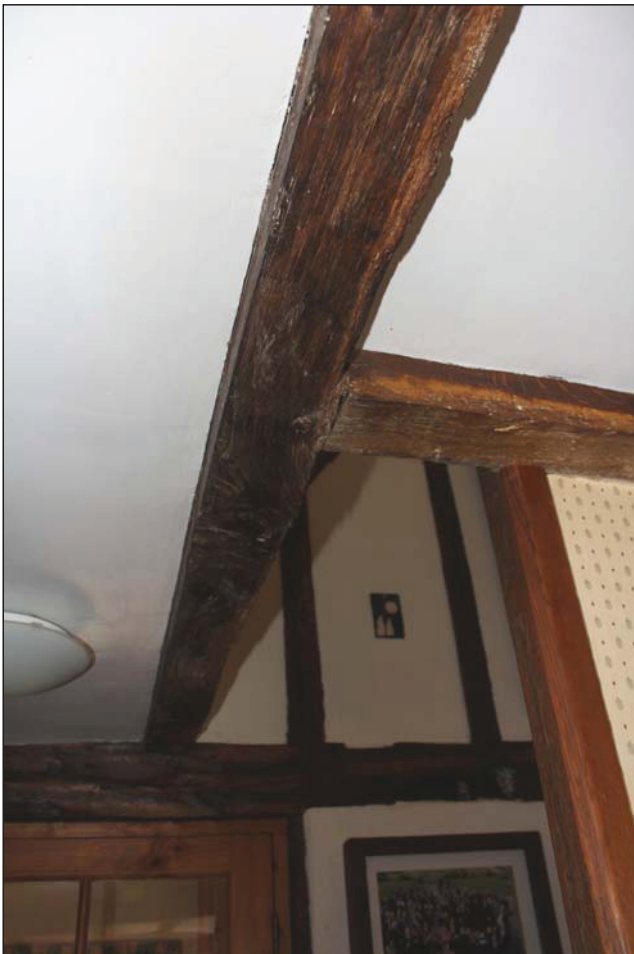
Plate 10 Common joist in the north-west corner (GF02) with pegged trimmer joist framing the staircase, taken from the west (DP 39)

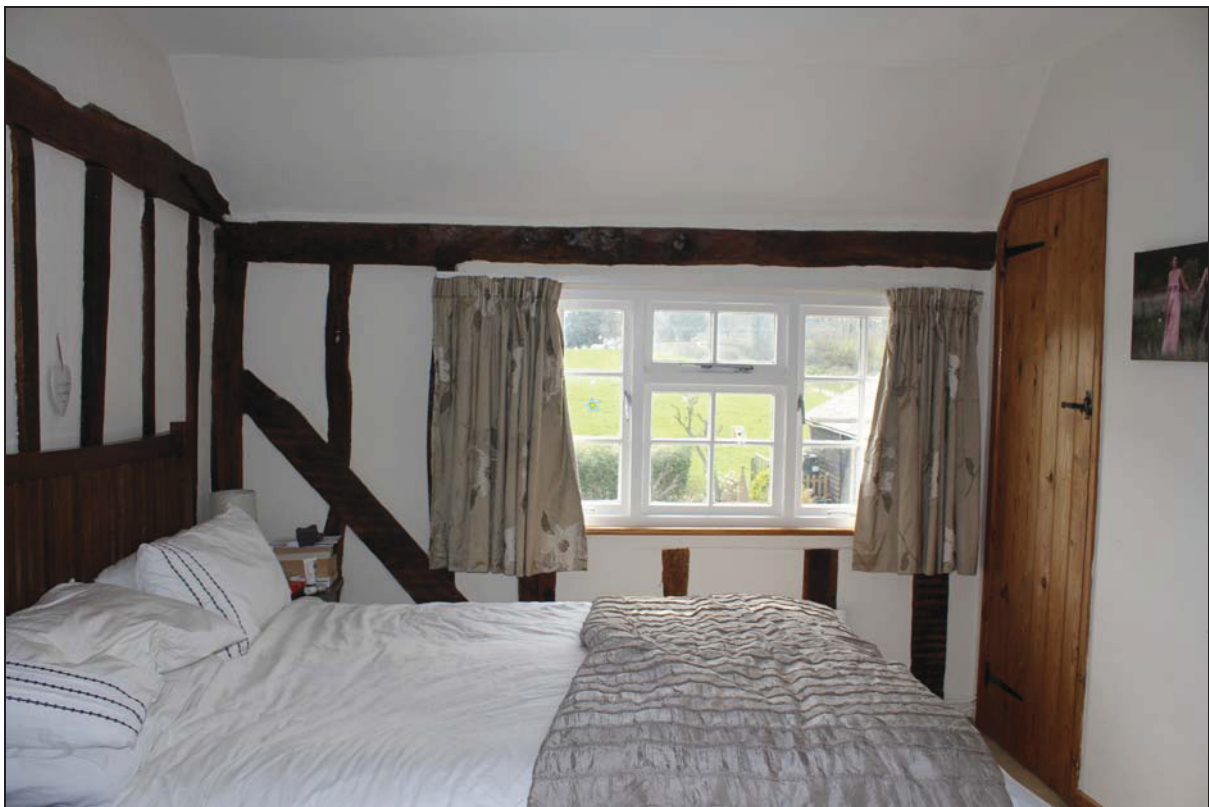
5.15 The outer walls are of the same form as seen in adjoining Orchard Cottage and include fairly robust common studs (all original examples pegged) with straight braces from the corner posts down to the mid-rail (Plate 12). The extension of the building on the south-west side necessitated the removal of the 1970s casement window on the south-east side of this room. This allowed further evidence for the character of the original building to be observed where the external plasterwork has been removed in the area of the window apron. This reveals that no original studwork infill survives in this area and that with the insertion of the existing window four original studs were truncated. Three studs are marked by empty mortices in the wall-plate above, though two mortices frame a blank area indicating the position of an original window aperture (Plate 13), likely of the same form as that surviving in adjoining Orchard Cottage. The mid-rail is partially visible below (in fairly poor condition) to which all studs are single-pegged. To the south-east the base of a brace is visible that functions in the manner of a tension brace, though is fairly robust and not notched itself so that its almost completely bisects the studs leaving approximately 1 inch (25mm) of the stud remaining (Plate 14). There is an assembly mark at the base of the brace comprising a roman numeral 'III'.

Plate 12 South-east wall of Room FF01 showing tension brace, taken from the north-west (DP 50)

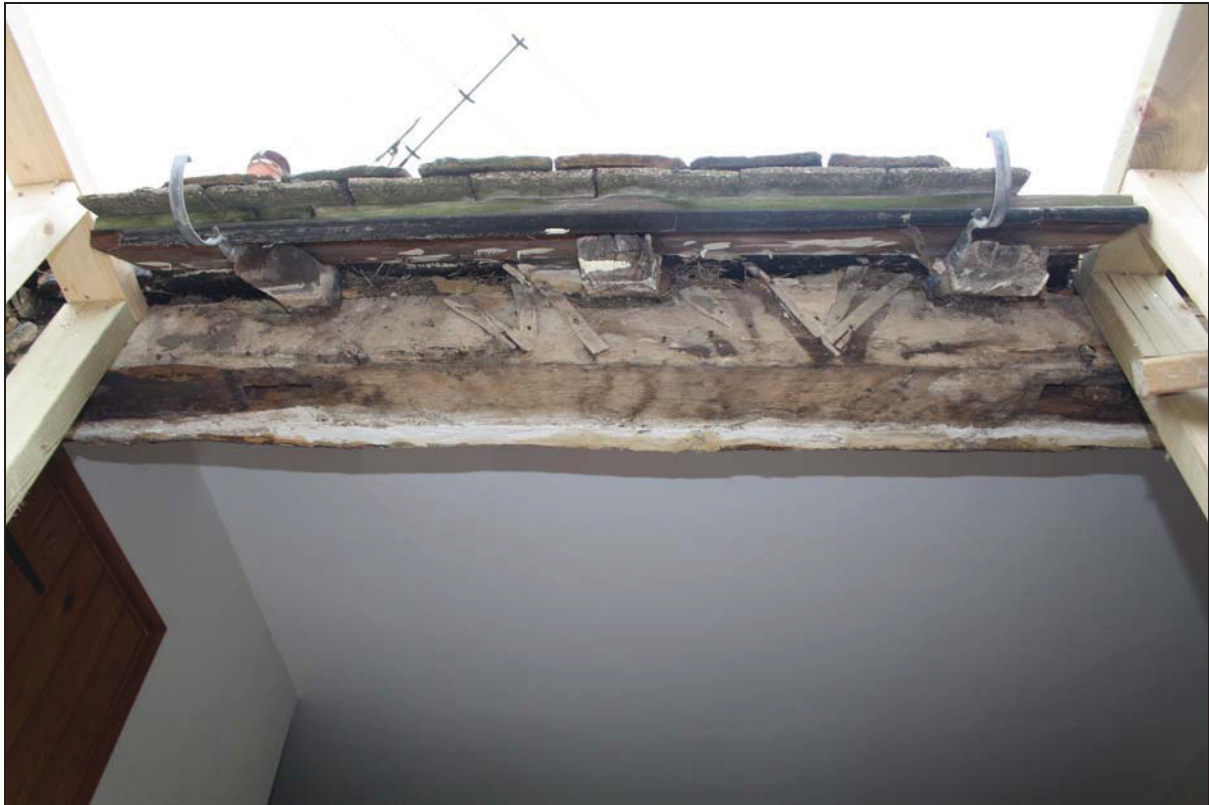
Plate 13 View of wall-plate on the south-west side of Range 1 exposed during the planned works showing stud mortices either side of a plain area, taken from the south-west (DP 77)

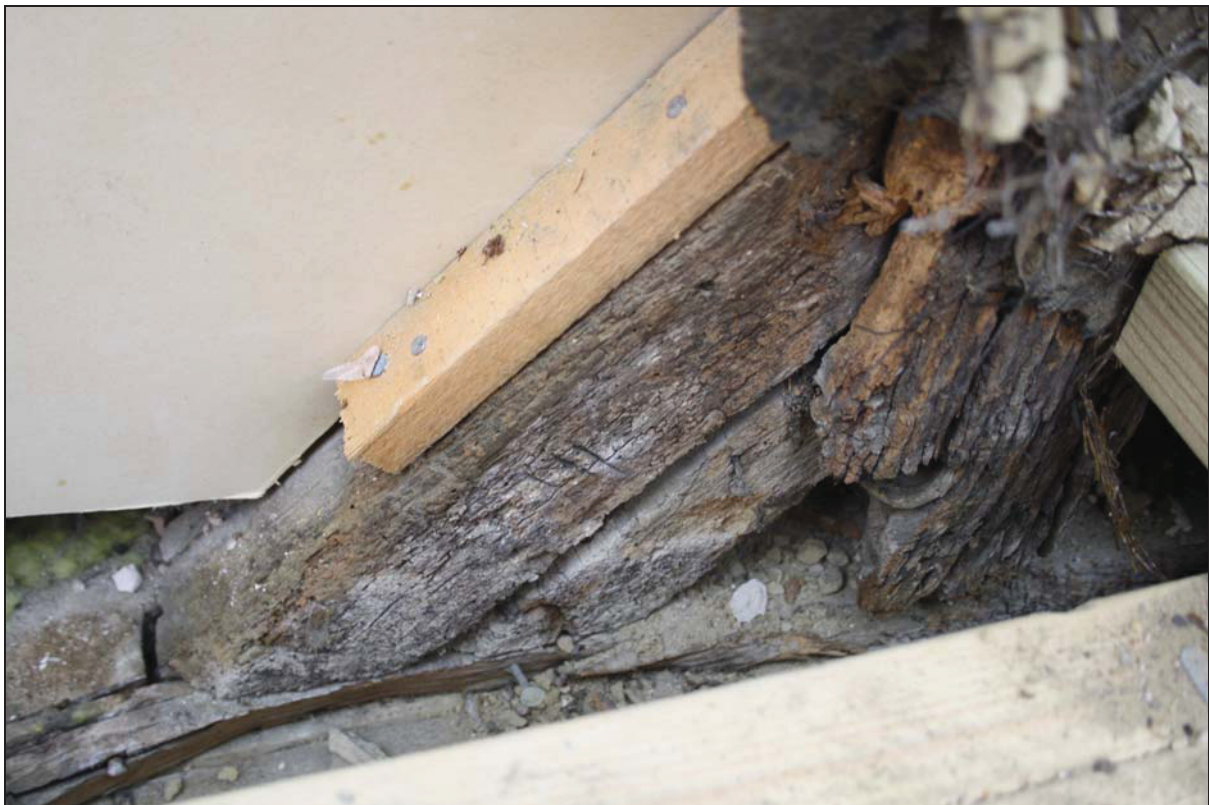
Plate 14 View of the timber-framing on the south-west side of Range 1 exposed during the planned works showing base of tension brace with assembly mark, taken from the south-west (DP 75)

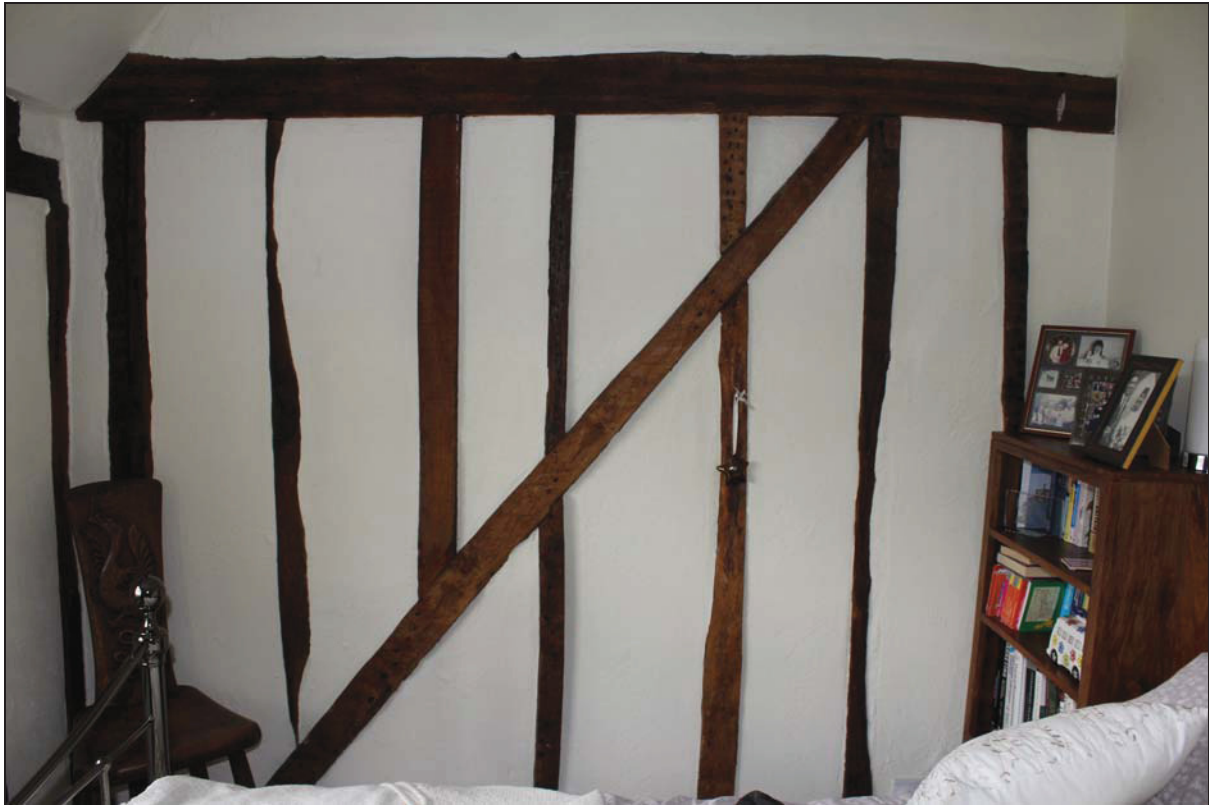
Plate 15 North-west wall of Room FF03 showing primary-braced studwork, taken from the south-east (DP 41)

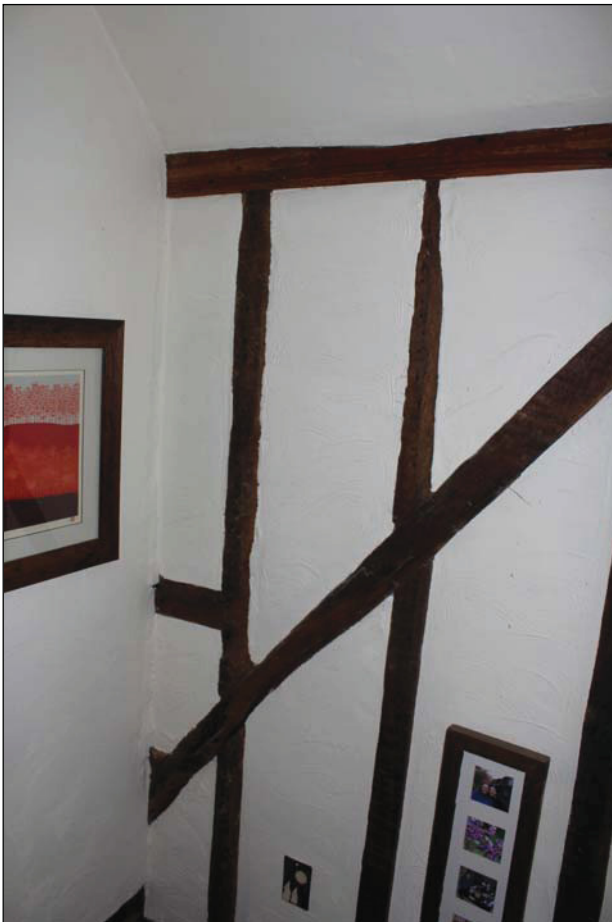
Plate 16 North-east wall of landing FF02 showing horizontal timber possibly forming the sill of a former window aperture, taken from the south-west (DP 33)

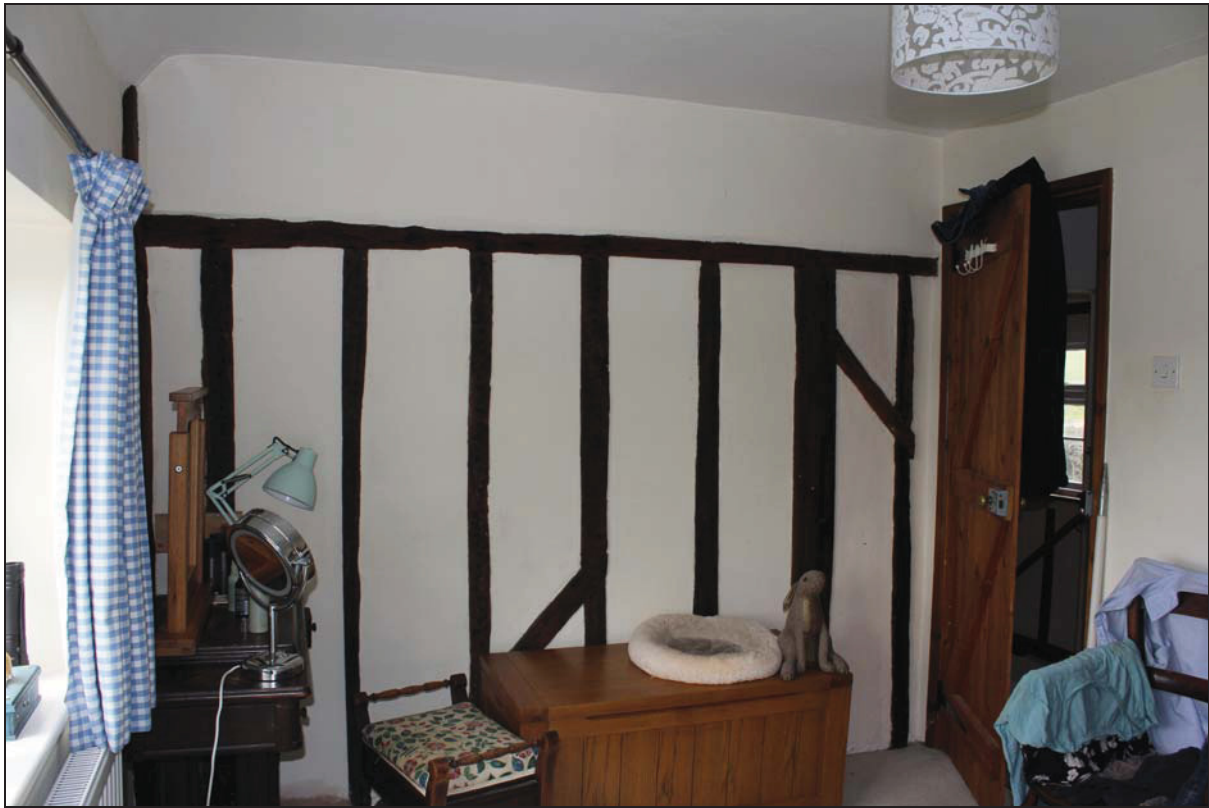
Plate 17 North-west wall of Room FF04 showing ephemeral primary-braced studwork and position of an inserted aperture later blocked, taken from the south-east (DP 35)

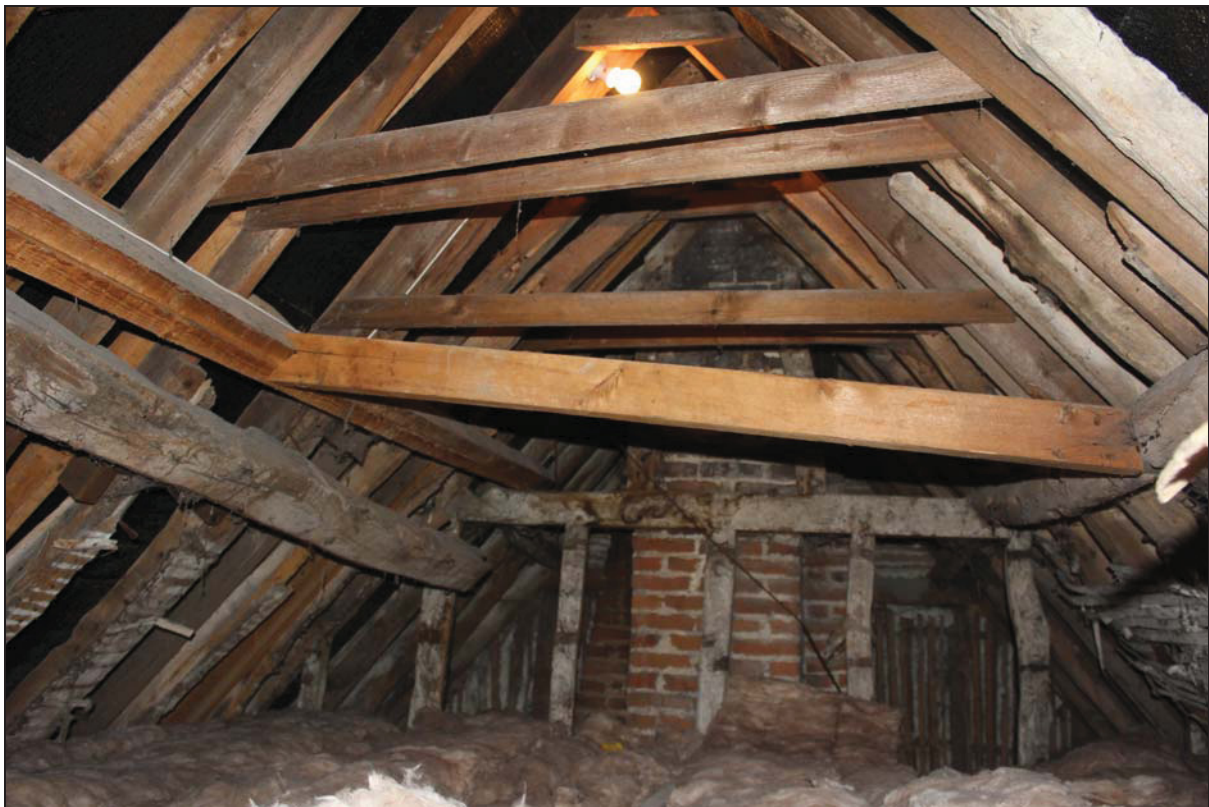
Plate 18 Roof structure over the historic core (FF01) showing clasped side-purlin form, taken from the south-east (DP 55)

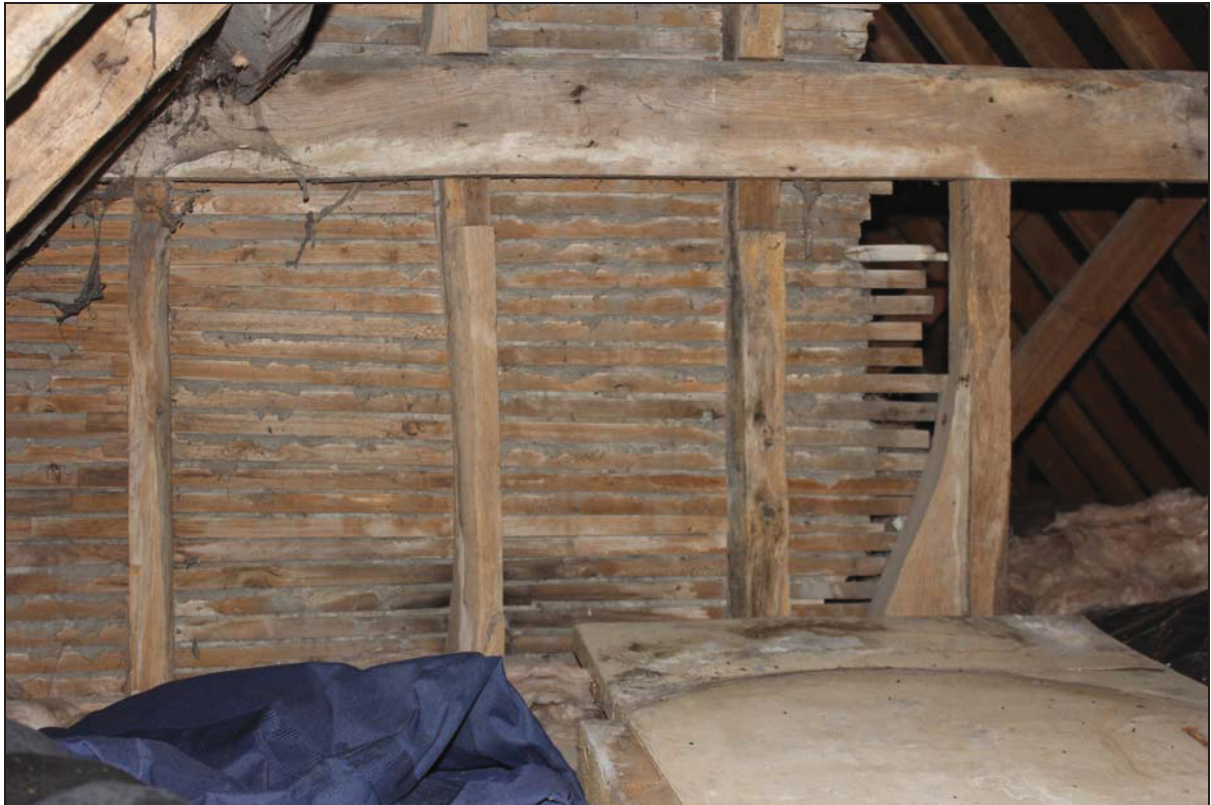
Plate 19 South-east end of the roof structure over Range 2 showing formerly external framing with external lath and plasterwork, taken from the north-west (DP 61)

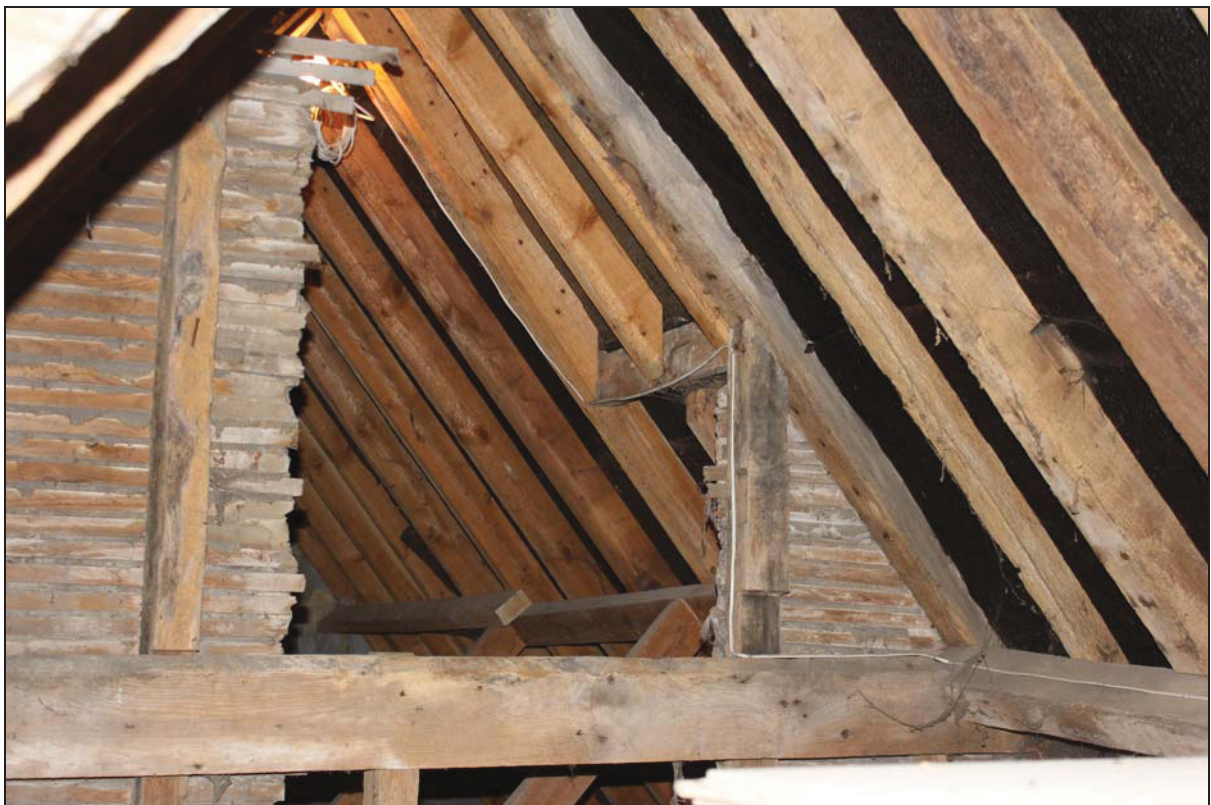
Plate 20 South-east end of the roof structure over Range 2 showing formerly external framing with external lath and plasterwork with area cut through to the modern roof structure over Range 3, taken from the north-west (DP 62)

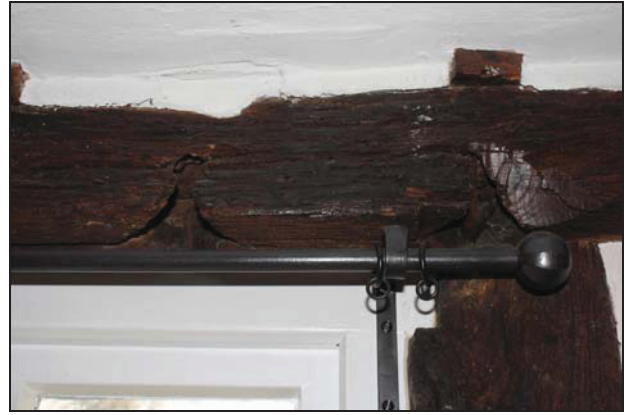
Mid-rail on the north-east side of Room GF01 showing redundant diamond mullion mortices, taken from the south-west

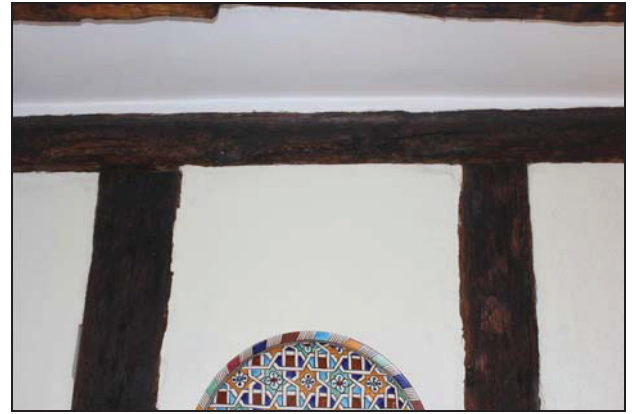
Detail of the binding joist at the north-west end of Room GF02 showing ephemeral slender studs, taken from the south-east

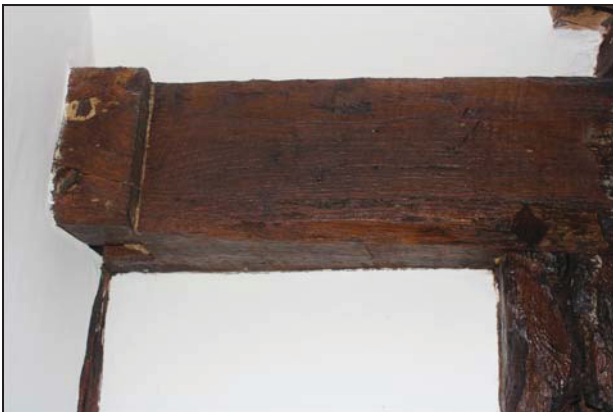
North-east wall of Room FF01 (north-west end) showing evidence for repair or reconfiguration, taken from the south-west

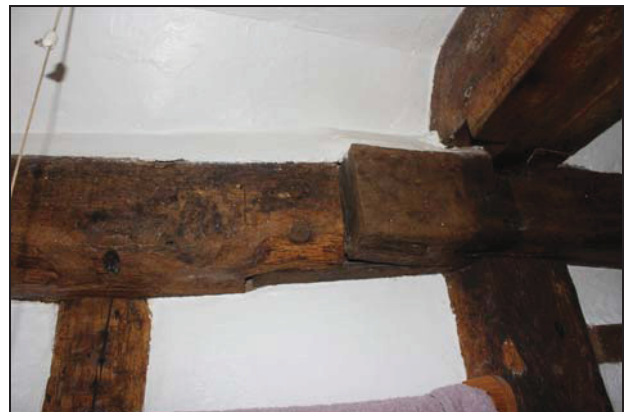
Wall-plate on the south-west side of Room FF01a showing possibly repaired scarf joint, taken from the north-east

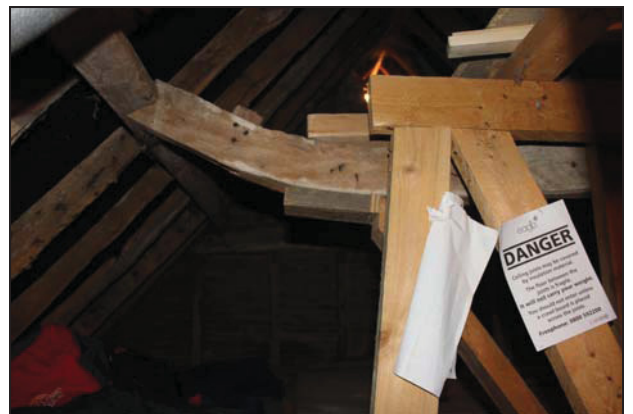
Roof structure over Range 2 showing inserted bird-mouthed collar seemingly deformed from the weight of later fabric, taken from the north-west

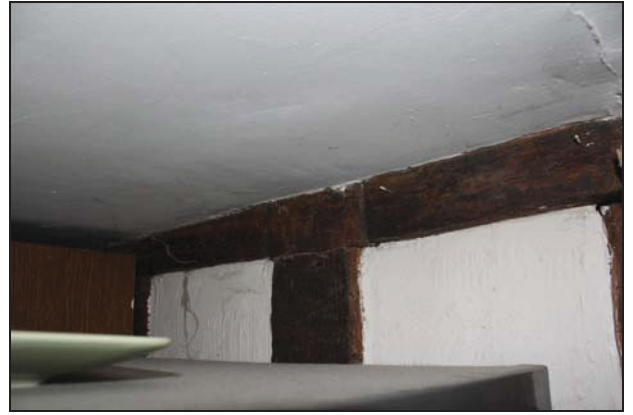
Formerly external wall of Range 2 showing truncated prick post with pegged mid-rails (viewed from Room GF03), taken from the east
