ARCHAEOLOGICAL SOLUTIONS LTD

**15 FISHPOOL STREET, ST ALBANS,
HERTFORDSHIRE, AL3 4RS**

HISTORIC BUILDING RECORDING & MONITORING

Authors:	Lauren Wilson MA PCIfA Lee Prosser PhD Tansy Collins (Photography) Kathren Henry (Graphics)	
NGR: TL 1426 0716		Report No: 5396
District: St Albans City and District		Site Code: AS1891
Approved: Claire Halpin MCIIfA		Project No: 6764
		Date: 4 July 2017

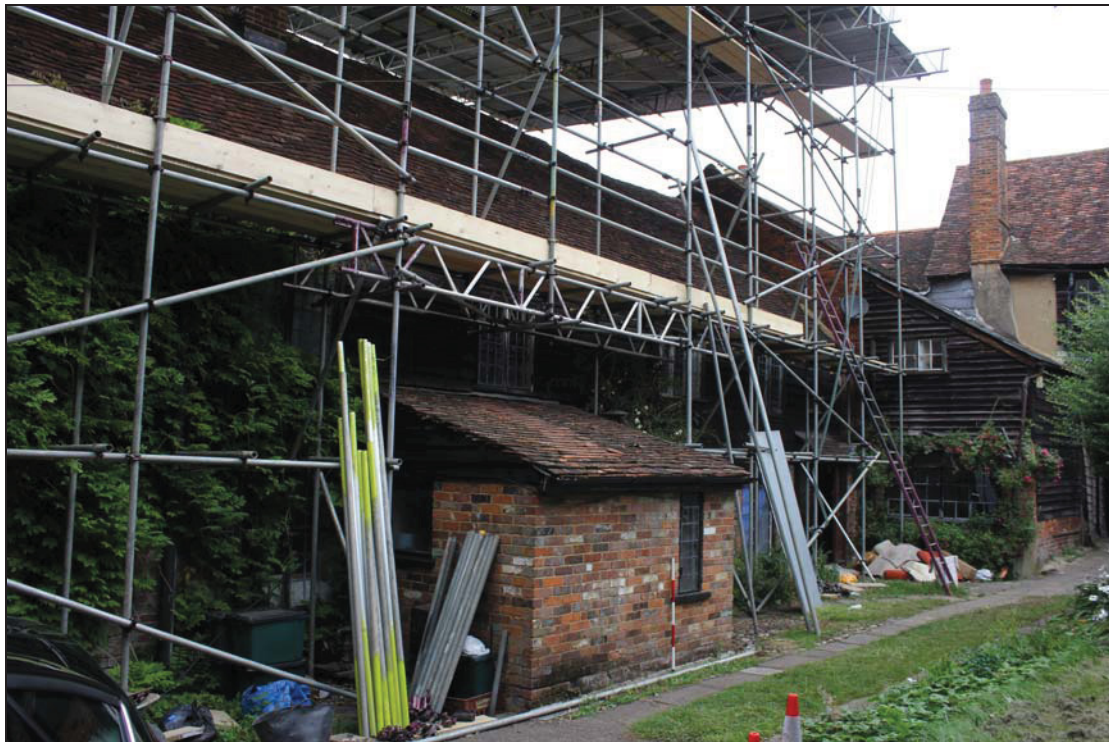
5.8 The long rear range faces into the yard with a mixture of flint and brick panels at lower level and upper weather-boarding (Plate 6). The roof is of old peg tiles. A small pent-roofed extension of 1970 provided an entrance porch and WC. The fenestration is generous and all of iron or steel casements with leaded panes, most probably inserted in the 1970s. A chimney projects through the roof pitch to the south but is clearly a replacement in modern brick.

Plate 6 East elevation of the rear range, taken from the south-east (DP 017)

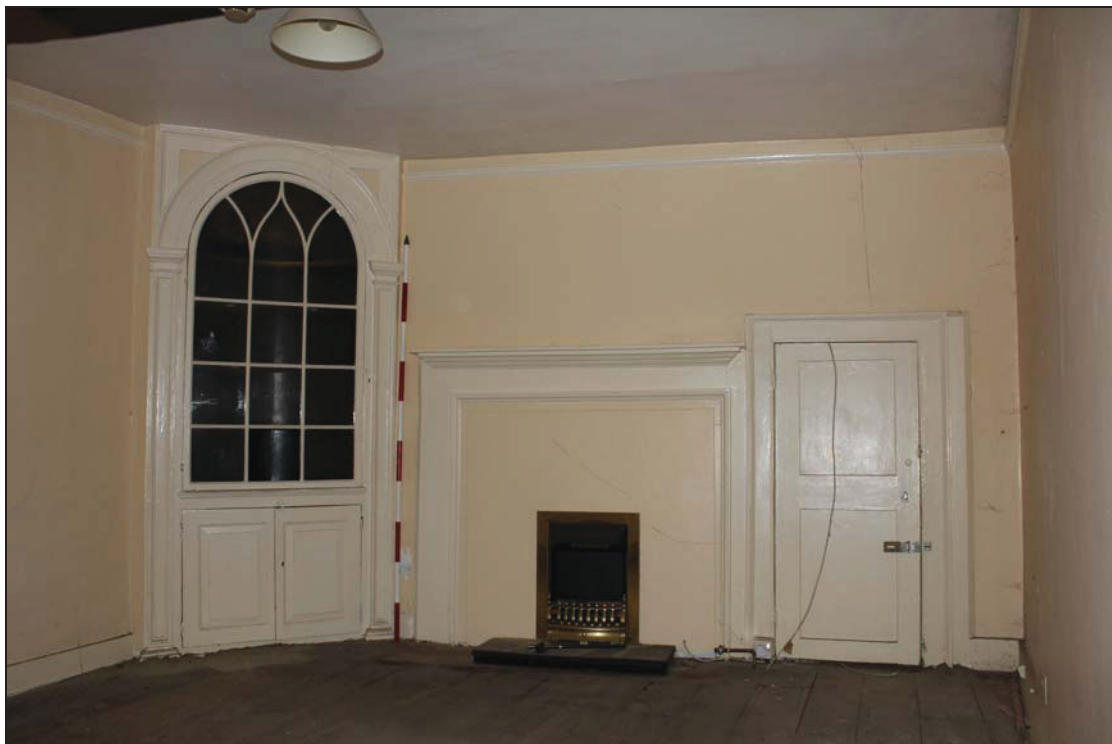
5.22 The principal decorative features include a fireplace with moulded surround, now blocked and replaced by a modern gas fire and a corner display cupboard of early 18th century date (Plate 14). This is framed within moulded pilasters, capitals and a semi-circular arch further enclosed with a fourteen-pane glazed door with elegant upper arched tracery, all except one pane retaining its original glass. A two-door cupboard with raised and fielded panels encloses the lower part, thereby preserving the original shelves and 18th century paintwork to the skirting. The upper cupboard preserves its internal configuration largely intact with a caramel colour to the rear of the door and three shaped shelves, with gilded edges and notches for the display of porcelain. The arch features a painted scallop shell (Plate 15). To the west of the fireplace, a small cubby-hole is entered via a two-panelled door. Within the room at upper level there is a continuous picture rail, a ceiling of old plaster and a distinguishable bridging joist with hollow chamfers and decorative brackets.

Plate 14 Interior of GF01, taken from the north (DP 027)

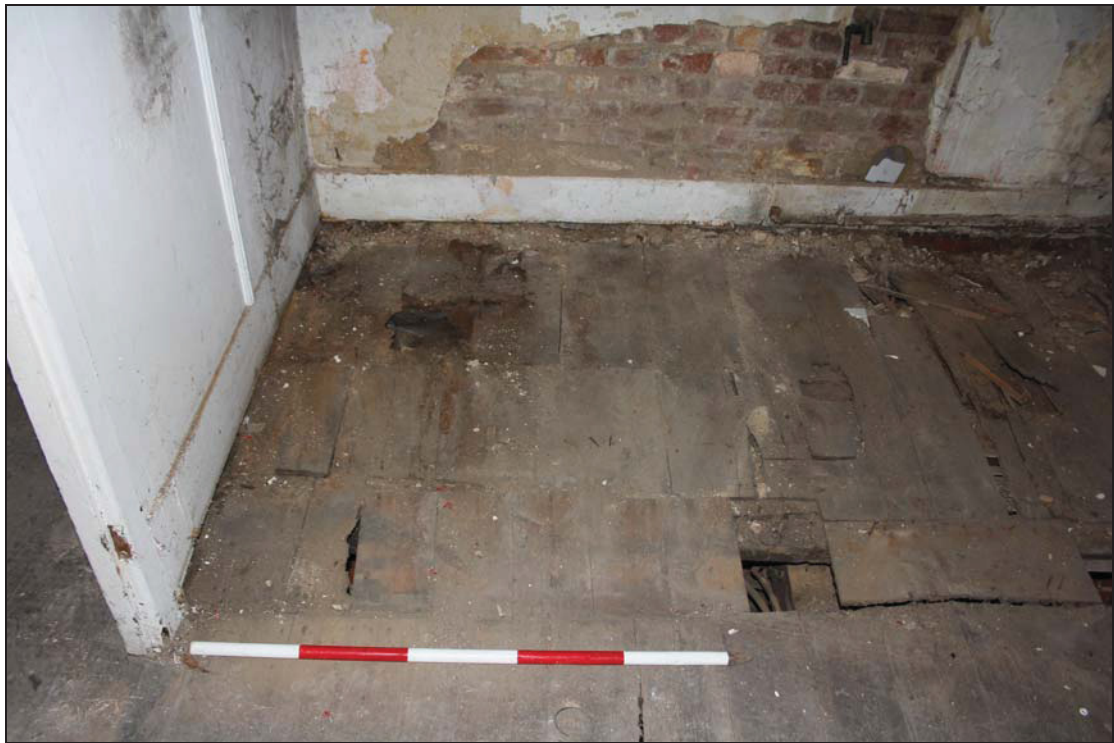
5.25 During monitoring works to the building a strip of 1-1.5m floorboards in the northern part of the kitchen were removed in order to record the underlying fabric. The floor boards themselves were laid north to south with a clear straight joint dividing them from the rest of the room (Plate 18). The floorboards laid to the south of this division were wide and consistent but those to the north were much decayed and formed ad hoc short sections in a confusing arrangement. Those nearest the north external wall are wider and those in the north-east corner of the room are modern.

Plate 18 Exposed floorboards in GF03, taken from the south (DP 262)

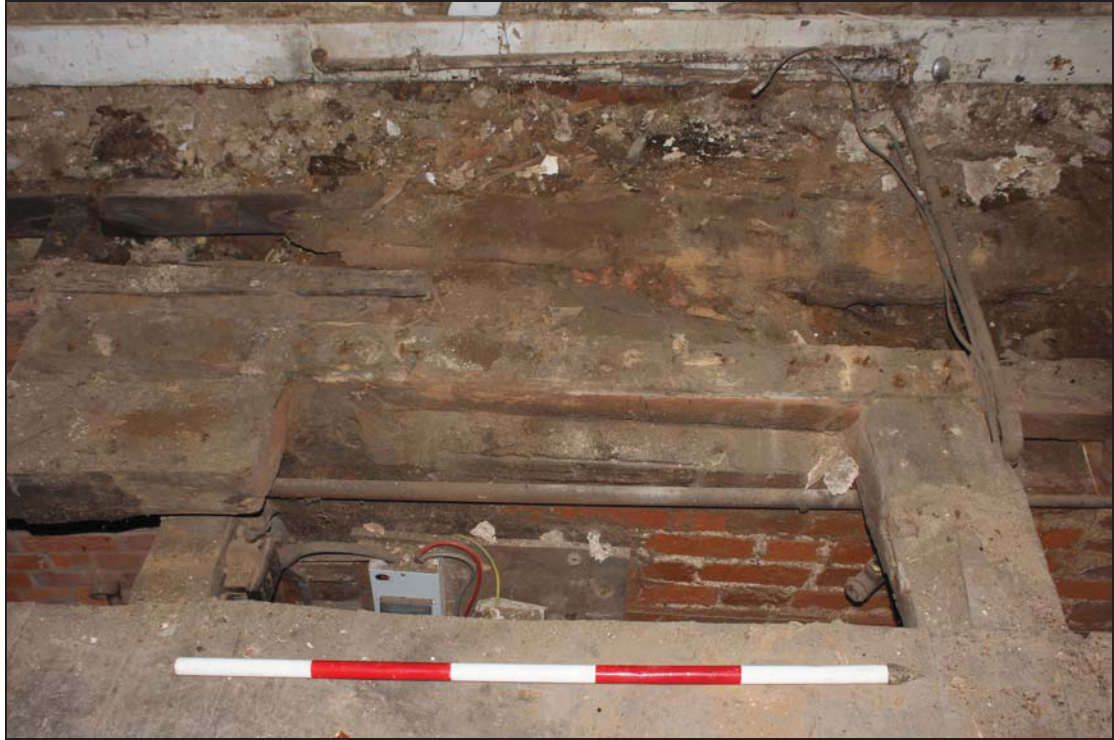
5.26 Lifting of the boards exposed joisting of variable scantling but all much decayed, making it difficult to determine the general form of the joisting (Plate 19). The division in floorboards noted above is reflected in a change in the form of the floor joists, which mirrors the line of the cellar wall at basement level.

Plate 19 Revealed floor joists in GF03, taken from the south (DP 297)

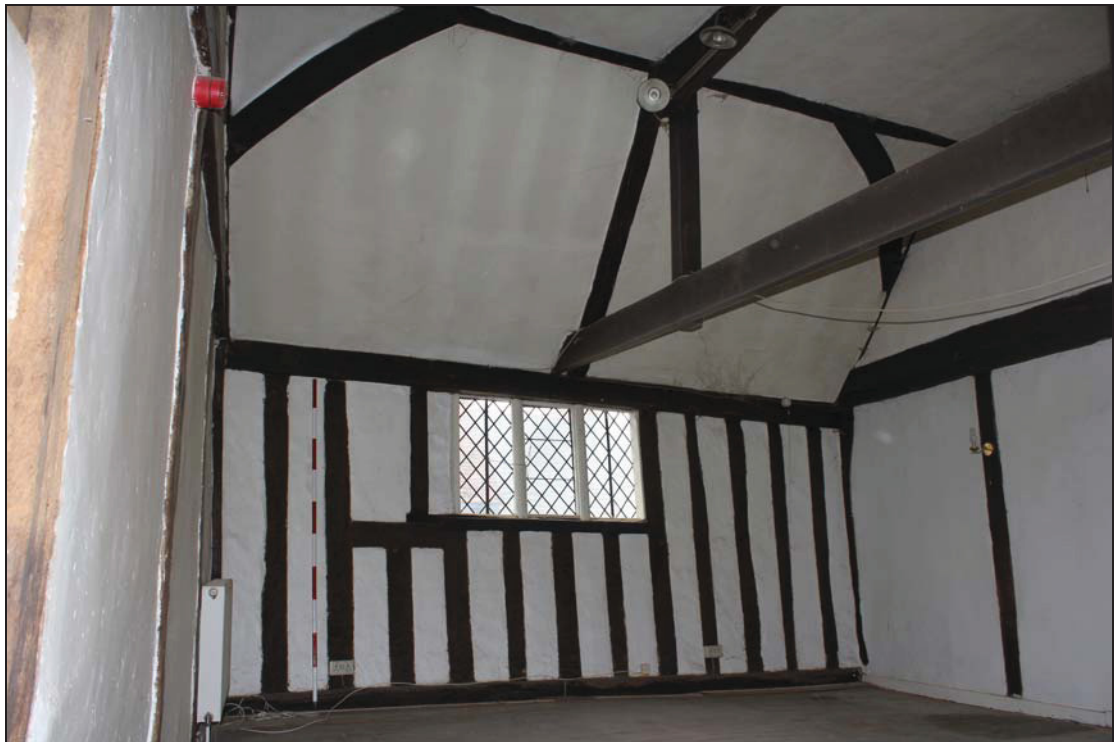
5.36 The north wall overlooking the street retains its wall plate and close studwork (Plate 28). An existing central window with iron casement and saddle bars is probably a 17th century insertion and replaces an earlier window located off-set to the west. To the rear of the building a chimney stack rises close to the south-east corner. The adjoining wall is lit by a Crittall-type window beneath a lintel which preserves pegs, but there is very little other diagnostic evidence.

Plate 28 Interior of FF04, showing timber-framing on the north wall, taken from the south (DP 142)

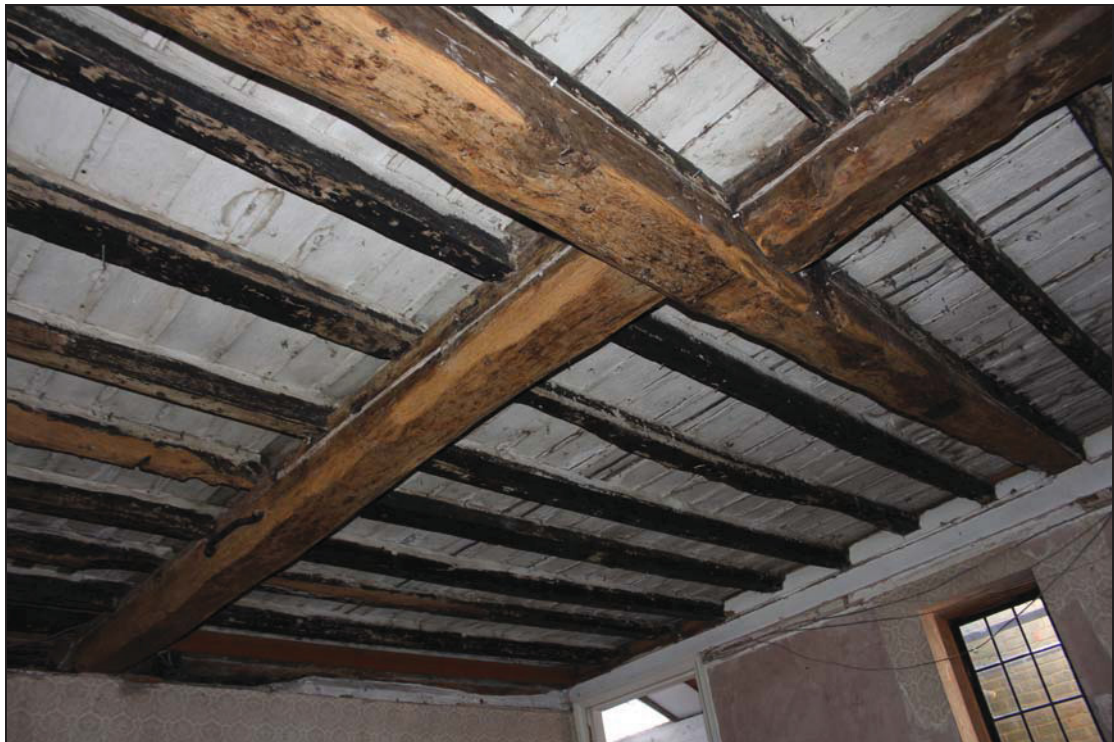
5.48 During the monitoring the newly consolidated space essentially comprised the first three bays of the rear range, displaying homogenous timberwork to the ceilings (Plate 38). The bridging joists are all double-pegged into the binder with a pendant soffit. The original common joists, once in-line had been removed in the past, but the empty mortices demonstrate that they originally had diminished haunch tenons, but these were replaced with slender joisting, notched over the bridging joists. Between the commons the underside of the floorboards of the first floor were painted white, with nailed-on riven laths concealing the joint.

Plate 38 Ceiling joists of GF08 exposed during monitoring of works, taken from the north-east (DP 245)

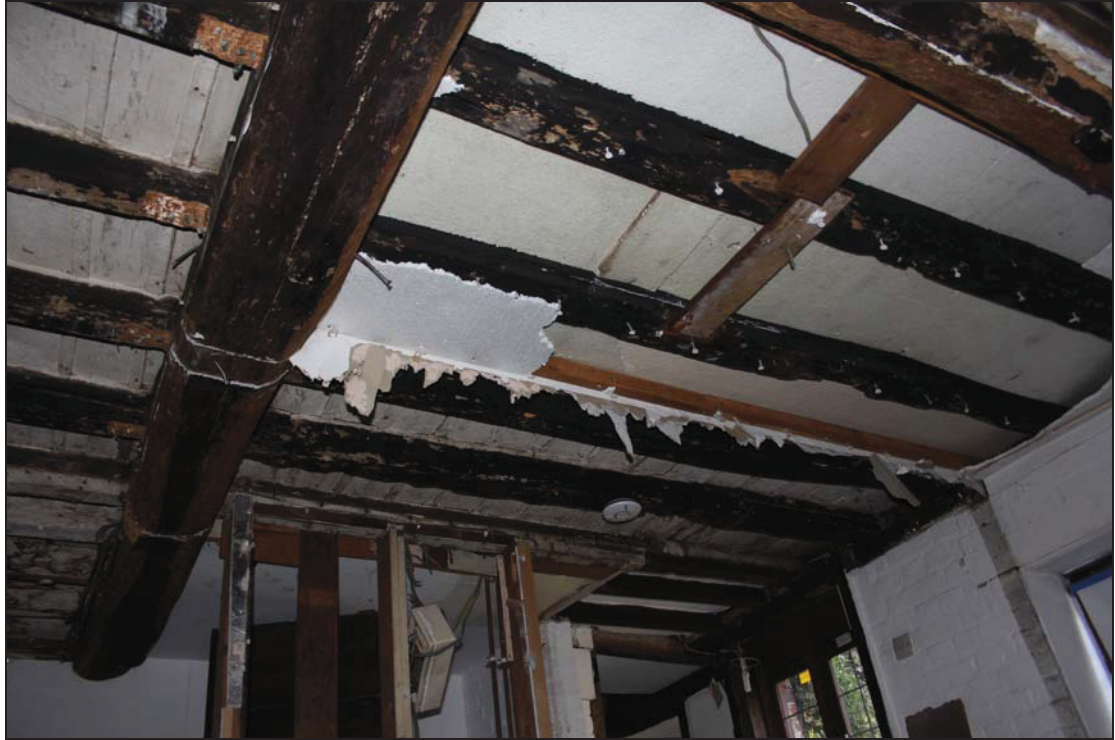
5.49 In Bay 1 the timber was extensively disturbed and suggested a level of rebuilding (Plate 39). Further investigation also confirmed that the fabric of the stair, corridor and bathroom are all modern. Some of the common joists display empty mortises, suggesting the replaced common joists were reused. Other features of note include stanchion plates between the bays, a dove-tailed mortise in Bay 2 to the binding joist of the southern edge, and a Baltic mark on one of the common joists (indicative of a 19th century date).

Plate 39 Ceiling joists in the area between GF06 and GF08, partitions now removed, taken from the south (DP 249)

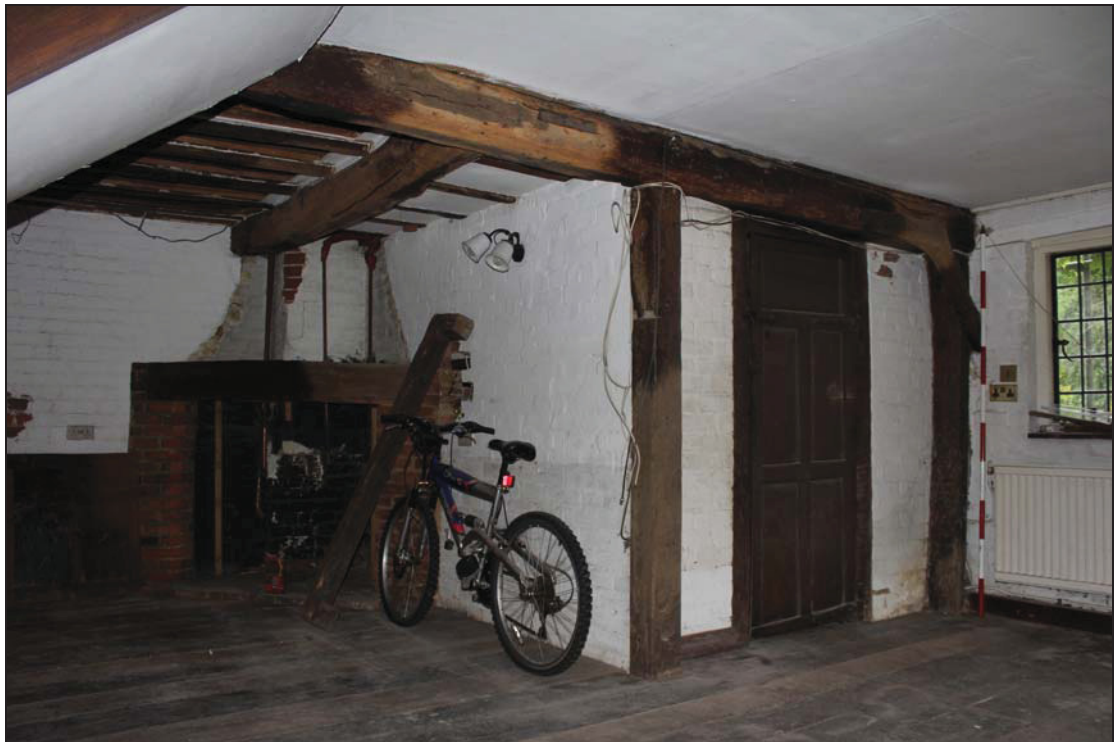
5.52 The ceiling timber continues to be expressed in a single consolidated room at the southern end of the building. The north part of the room displays a similar joist arrangement to the first three bays, as noted above (Plate 42). Common joisting is present but has all been replaced. A corner fireplace to the north-east is a cosmetic addition of a later date. The south part of the room retains timber only on the south gable end but much appears to have been reused (Plate 43). A section of old brickwork to the east has been repaired, where a small kitchen has been formed by subdividing part of the room and enclosing it with a recycled panelled door.

Plate 42 Interior view of GF10, taken from the south-west (DP 099)

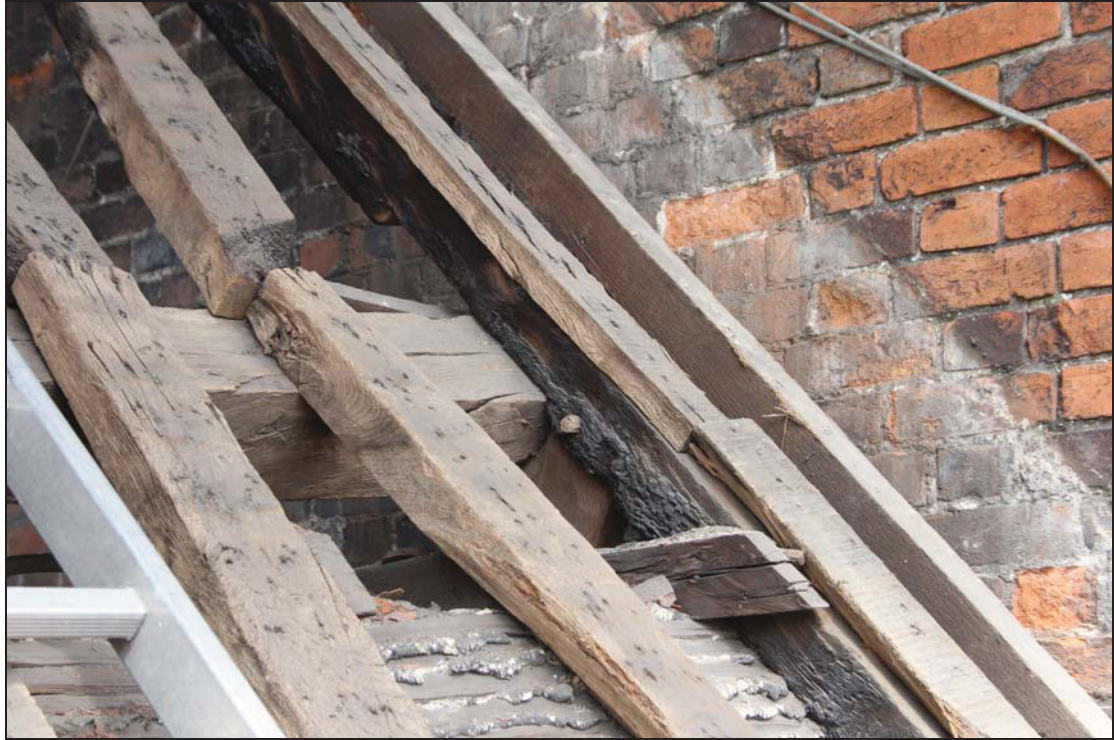
5.65 Other points of note include the presence of charred rafters distributed throughout the roof structure. This may be assumed to be the result of the fire noted in the history above and indeed there are a higher number of affected timbers at the north end. However, the burning only affects discrete members and so suggests these timbers are reused in this building. A good example of this can be seen at the north end where the principal rafter is charred but the raking strut and peg used to secure this to the rafter is clean (Plate 53), but furthermore

Plate 53 Evidence of smoke-blackening and rafter replacement in the roof of the rear range, taken from the south-east (DP 226)

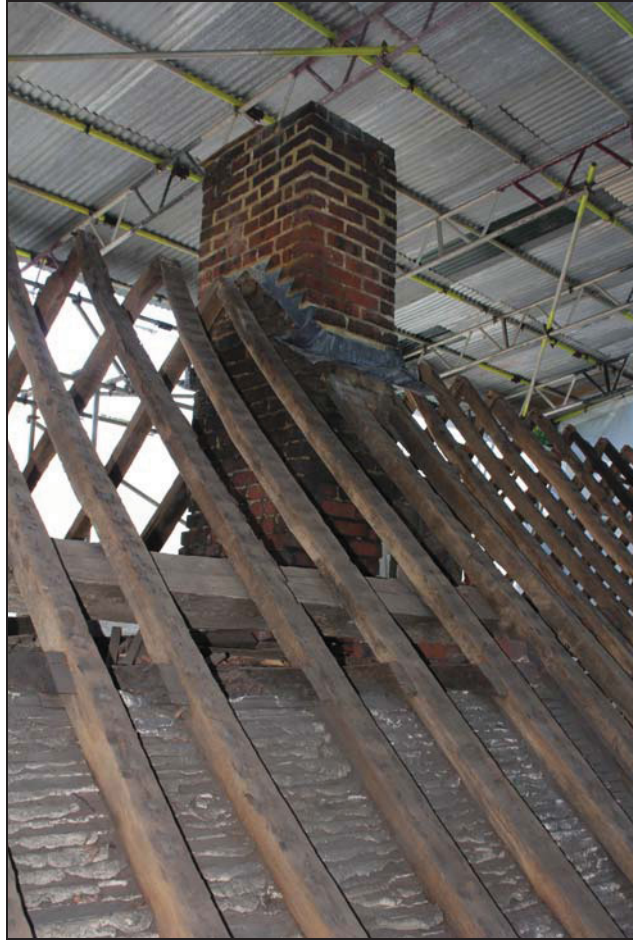
truncated below purlin level and replaced with ephemeral timbers (Plate 55). On the west side of the bay the wall-plate has a face-halved and bladed scarf joint to the north. The east side has had all its rafter feet removed.

Plate 55 Roof structure over the rear range showing replacement rafters below the chimney stack, taken from the north-west (DP 200)
