BARNHURST, ALBURY RD, LITTLE HADHAM,
HERTFORDSHIRE

HISTORIC BUILDING APPRAISAL

Authors: Tansy Collins BSc Kathren Henry	
NGR: TL 44030 22767	Report No: 4727
District: East Herts	Site Code: n/a
Approved: Claire Halpin MfA	Project No: 5788
Signed:	Date: 14 November 2014

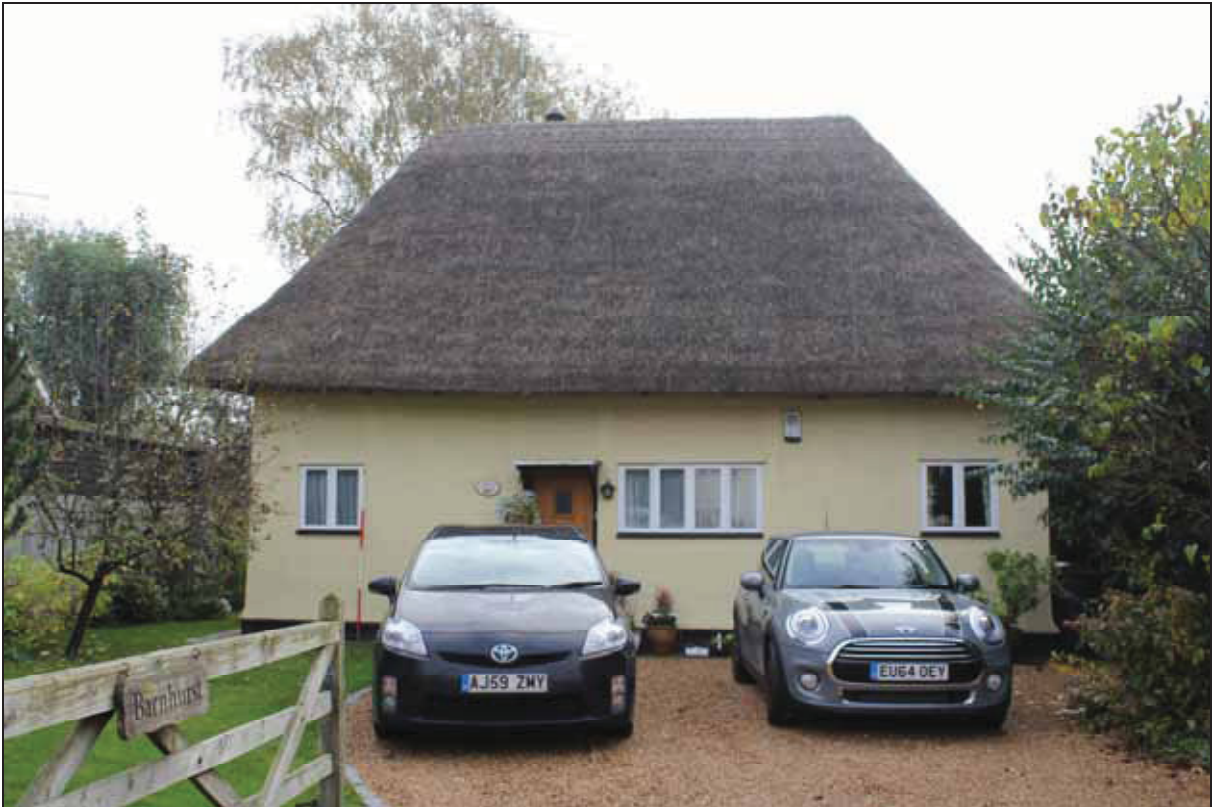
4.1 The house is aligned north-east to south-west with the existing entrance facing west towards the road from which it is set back with a gravelled drive in front (Plate 1).

Plate 1 North-west elevation of Barnhurst, taken from the west (DP 1)

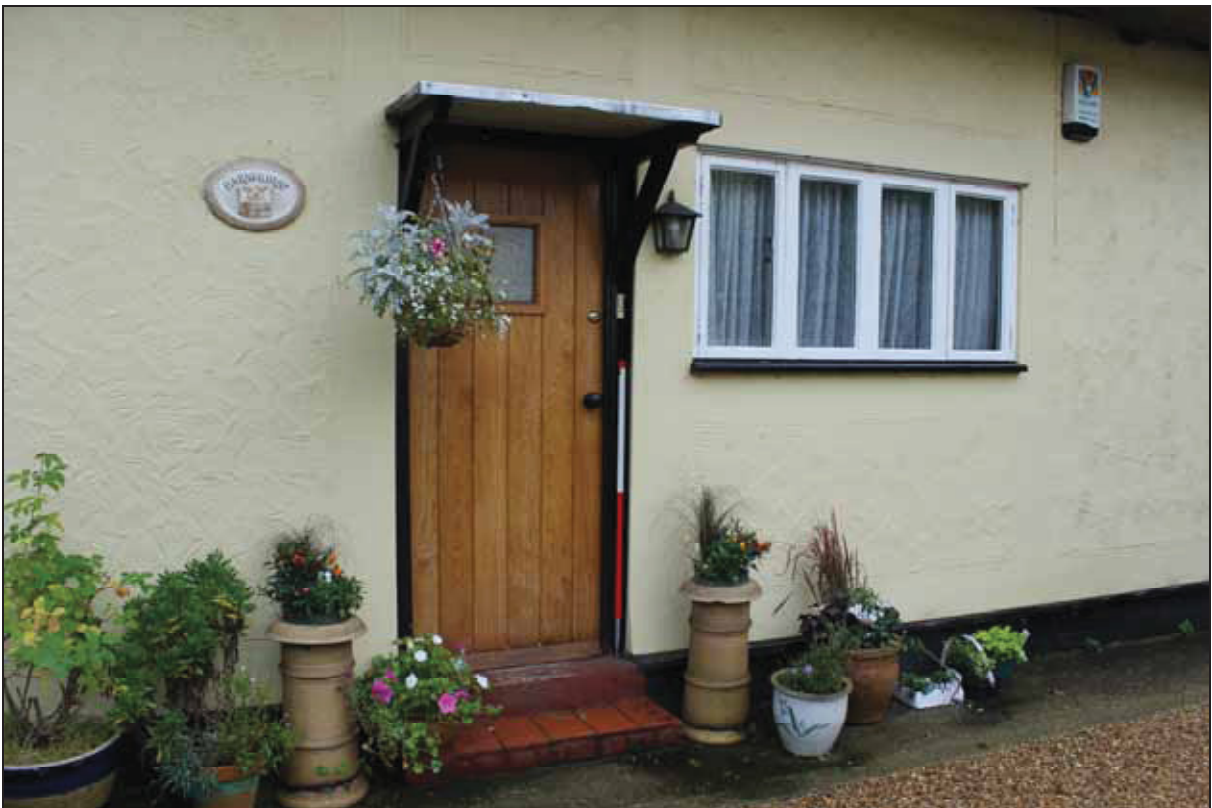
Plate 2 Entrance and adjoining window on the principal elevation, taken from the north-west (DP 2)

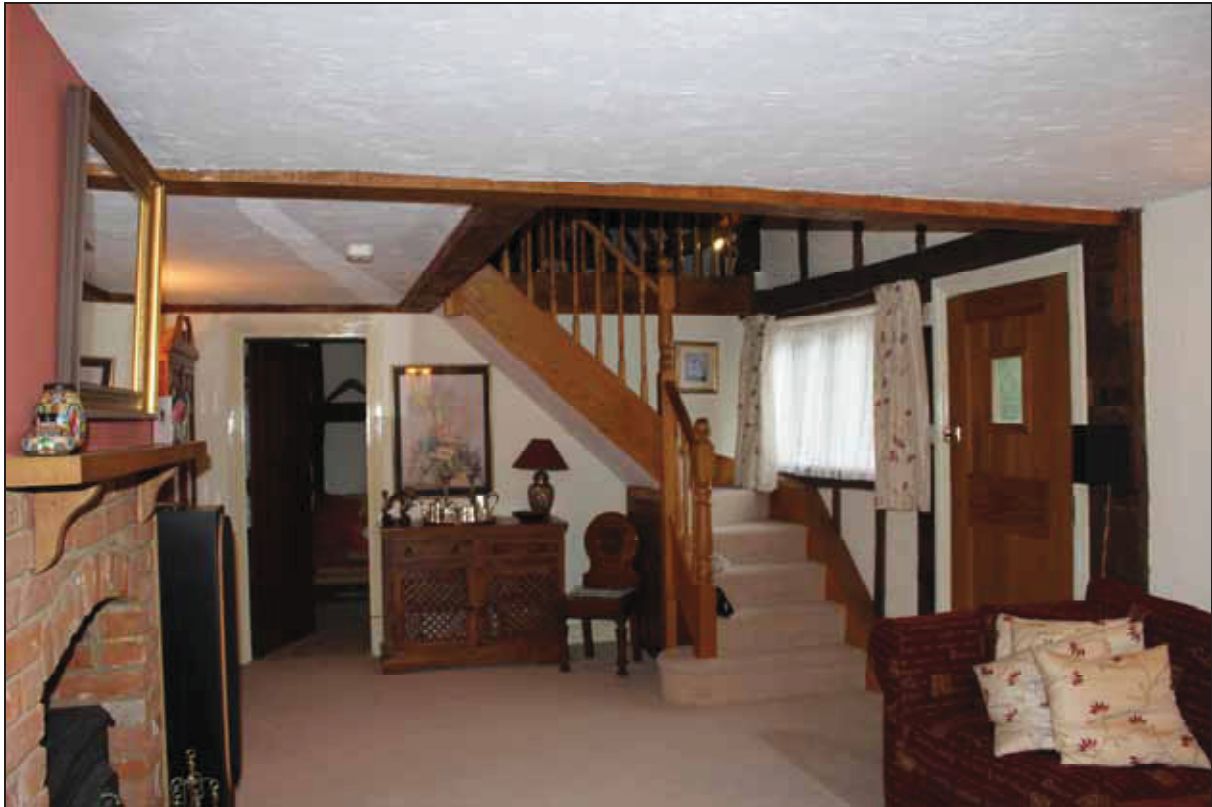
4.9 The entrance leads into the main living area which occupies the northern two bays of the original barn body (Plate 3). A study occupies the south bay with a WC on the east, while the chimney stack has been inserted on the east side of Bay 1 (the

Plate 3 View of Bay 2 from Bay 1 (living room), taken from the north-east (DP 50)

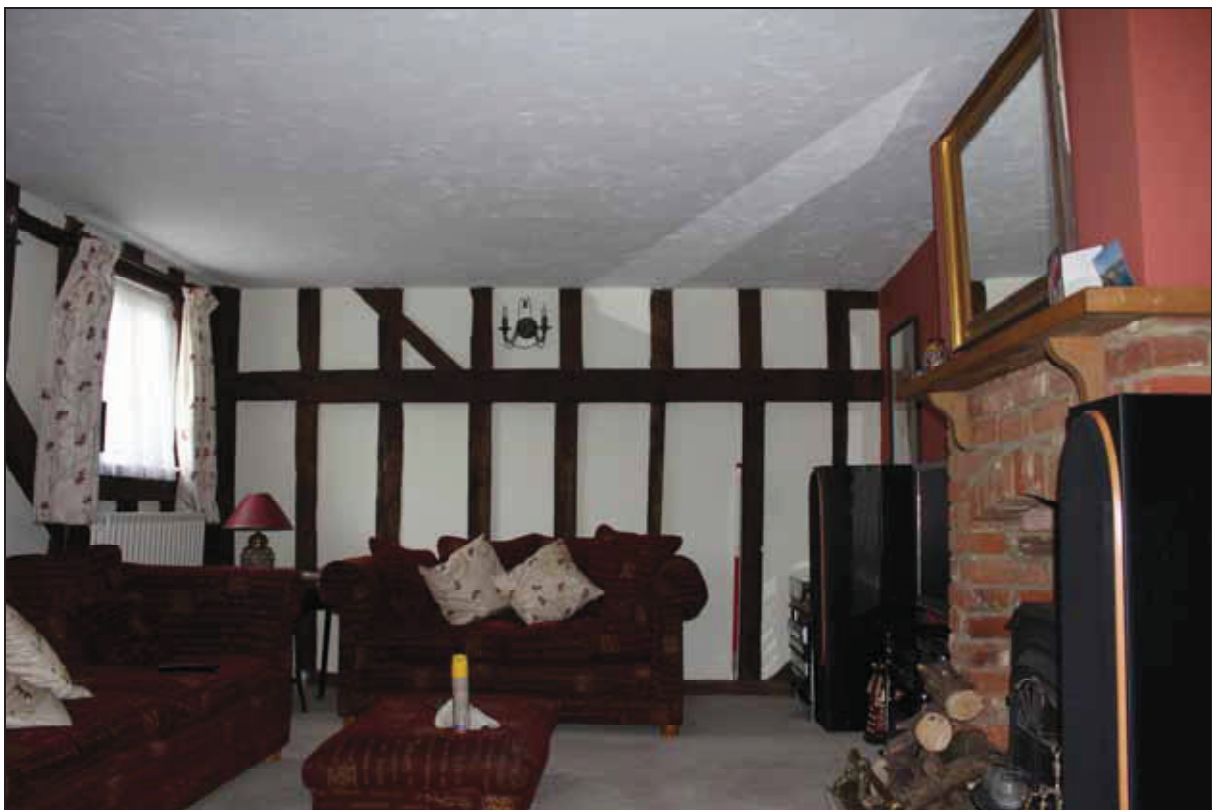
4.15 The wall panelling includes inline mid-rails or girts with regularly spaced pegged studs above and below (Plate 4). The studs are characterised by the

Plate 4 View of Bay 1 (living room) with original framing at the north end, taken from the south-east (DP 23)

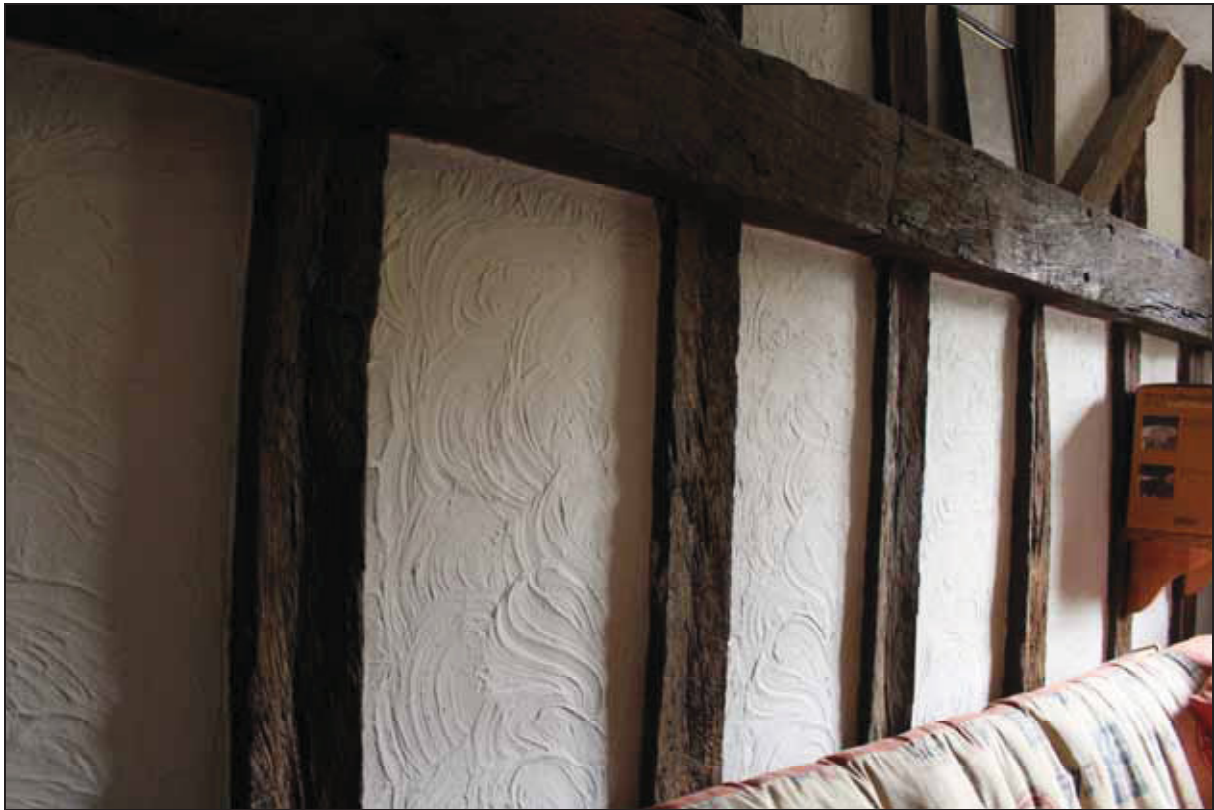
presence of shallow V-shaped depressions on the inner face of the studs (Plate 5). In the upper registers, robust downward braces extend from the bay posts to the mid-rails and are lapped over the studs. These mostly survive though one example has been replaced in the north-east corner. This pattern extends to the porch structure though this area has been more extensively modified with inserted doorways and opening up of studwork to the extensions. From within the south-east extension the outer face of the studwork is visible where a sequence of assembly marks is visible, as well as nail marks that confirm the presence of weatherboarding.

Plate 5 Detail of the studs on the south side of Bay 3 showing characteristic V-shaped depression, taken from the east (DP 17)

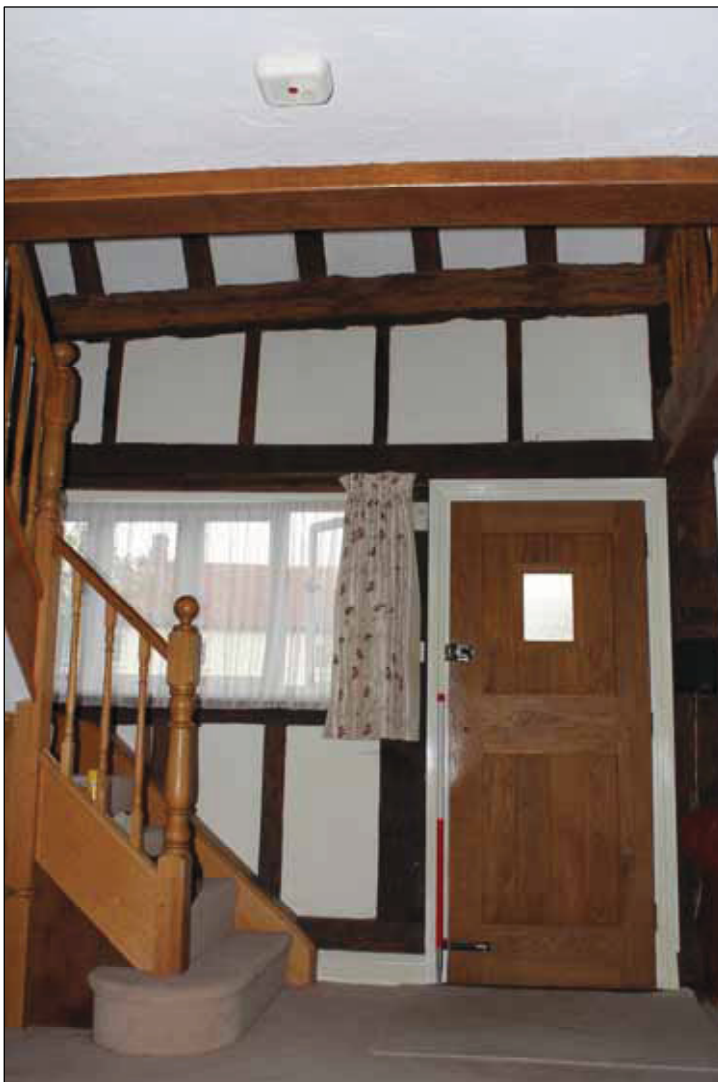
4.17 The western side of the central bay (Bay 2) has been entirely rebuilt and all the fabric is modern (Plate 6). Modern fabric includes the sole-plate, a high-set horizontal member at the door and window head height as well as slender stud infill, the door and window. The sides of the bay posts are not visible which might provide further evidence as to the original infill of the bay, while the wall-plate retains empty mortices for what appears to be lower studwork. These might comprise redundant mortices from the previous building or relate to this construction. It is likely that the original form of the barn included double doors on this side, lying opposite the porch for threshing purposes. This suggestion might be reinforced by the former presence of outbuildings on this side as it would allow access to the barn from the courtyard and road.

Plate 6 North-west side of Bay 2 showing rebuilt fabric, taken from the south-east (DP 28)

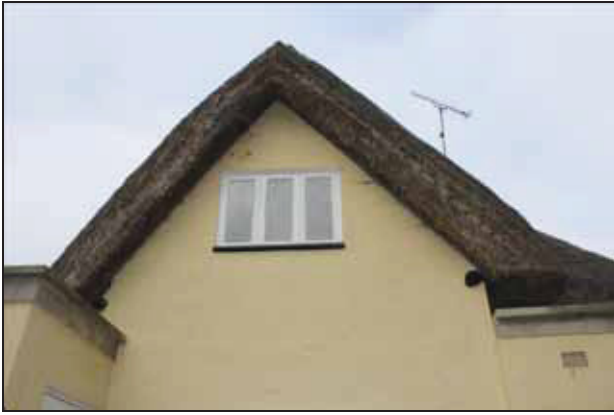
DP 7

Gable of the rear former porch showing wall-plate ends at different levels and inserted window, taken from the south-east

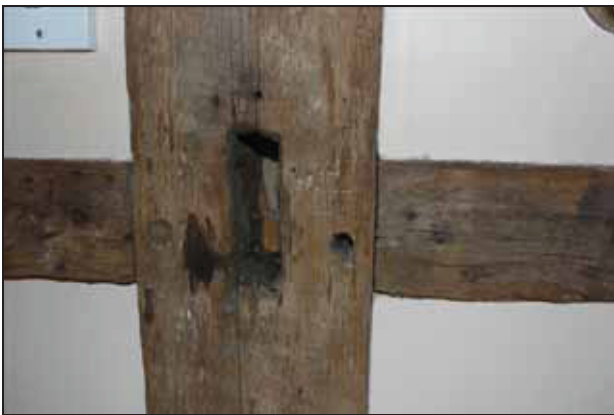
DP 9

Stud on the south-west side of the former porch showing redundant mortice and assembly marks (III), taken from the south-west

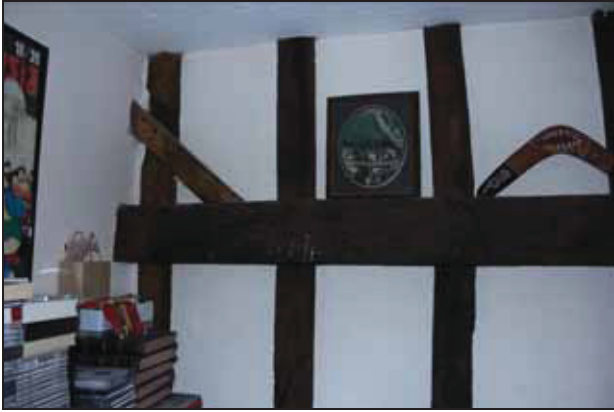
DP 19

Detail of the south wall of Bay 3 showing slender brace replacing the original lost example, taken from the north

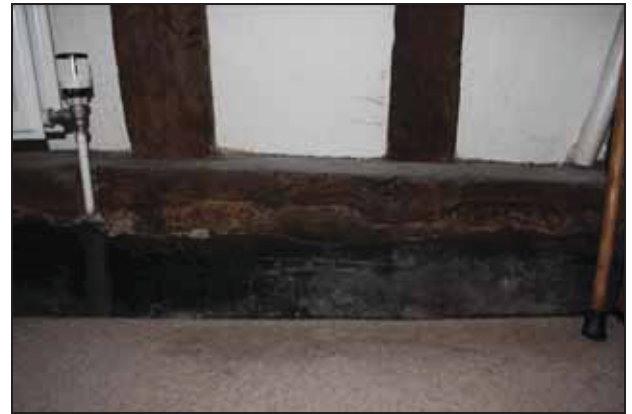
DP 22

4.13 Of the framing, the sole-plate is mostly original in the main body of the barn, indicated by the presence of pegging, while that on the west in Bay 3 appears to be a replacement though of some age.

Detail of the west replaced sole-plate of Bay 3 (study) showing unpegged studs above, taken from the north-east

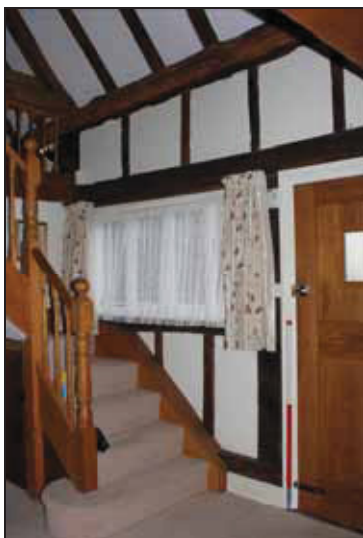
DP 29
North-west side of Bay 2 showing rebuilt fabric
including the modern window that replaced an
earlier 20th century larger example in order to
accommodate the staircase, taken from the east

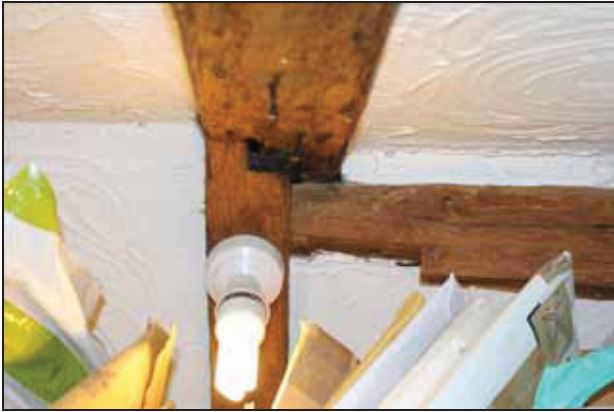
DP 37

Detail of the roof over Bay 1 showing purlin end terminating short of the end of the roof, taken from the north-west

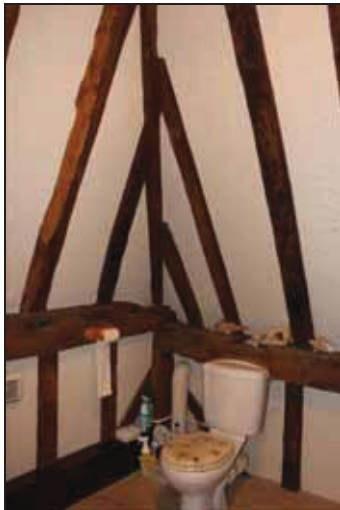
DP 39

Bathroom on the south-east side of Bay 1 at upper level showing wall-plates with redundant mortices, taken from the south-west

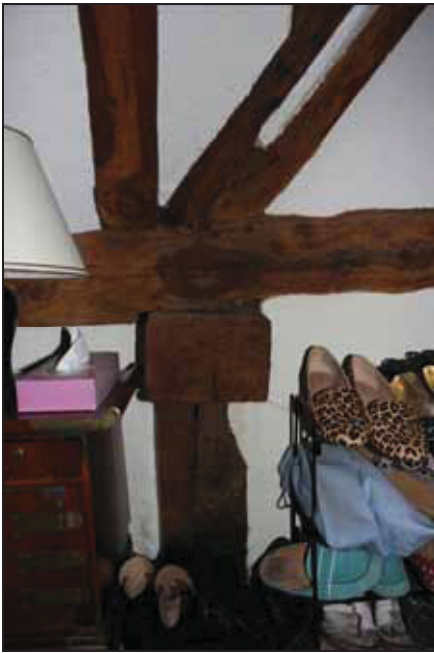
DP 45

Detail of the bisected wall-plate between the main body of the building and the former porch, taken from the north-east

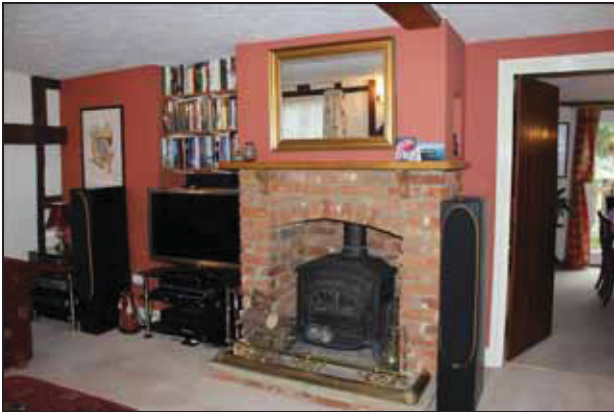
DP 49

South-east side of Bay 1 (living room) showing inserted chimney stack, taken from the west
