HISTORIC BUILDING AND ARCHAEOLOGICAL
MONITORING & RECORDING

Authors: Tansy Collins MSt Kathren Henry	
NGR: TL 1332 1444	Report No: 5490
District: St Albans	Site Code: AS 1917
Approved: Claire Halpin MCIfA	Project No: 7150
	Date: 20 November 2017

4 CHURCH GREEN, HARPENDEN, HERTFORDSHIRE

HISTORIC BUILDING AND ARCHAEOLOGICAL MONITORING & RECORDING

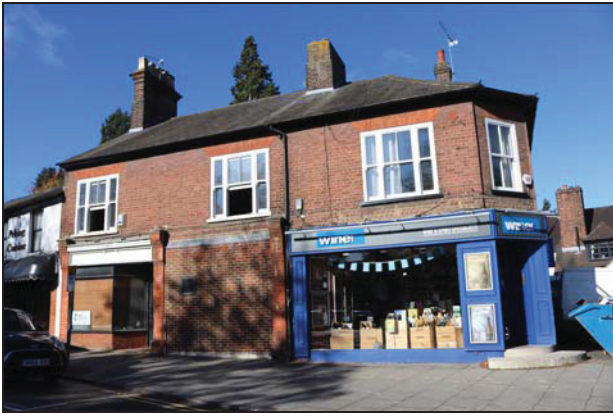
DP 1

South elevation of the assessment building (No. 4) and No. 52 High Street, taken from the south

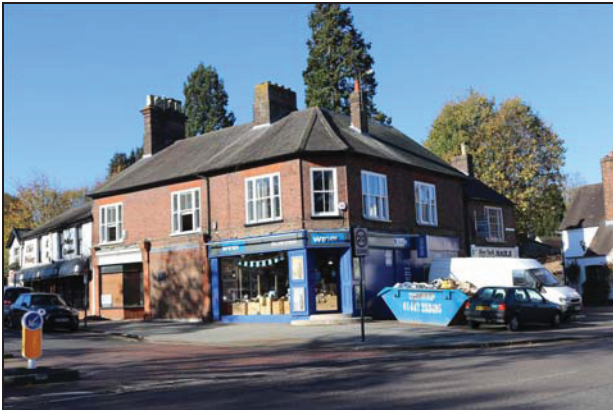
DP 3

View of the large building including the assessment building (left) and No. 52 High Street, taken from the south-east

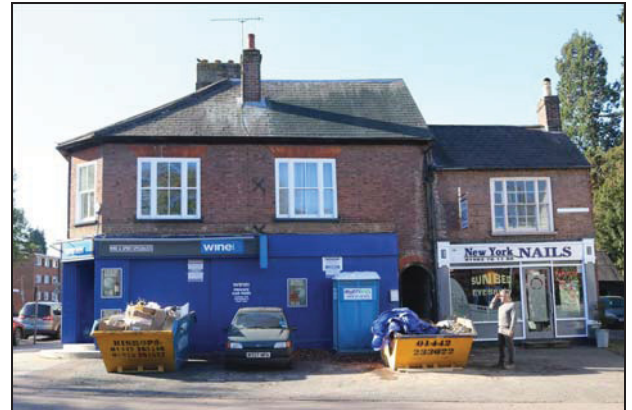
DP 4

East side of N. 52 High Street with the entrance to the rear yard on the right, taken from the east

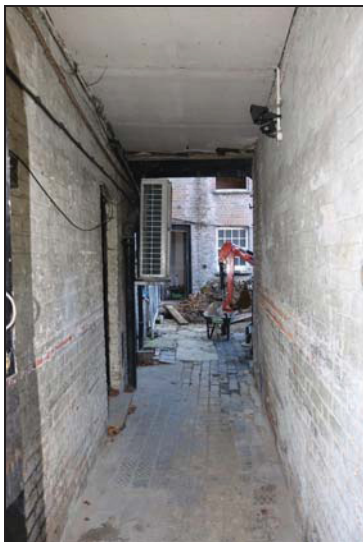
DP 5

Throughway from the east side of No. 52 High Street leading to the rear yard, taken from the east

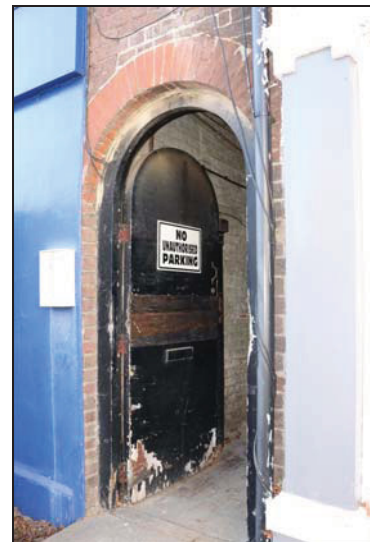
DP 6

Entrance to the throughway on the east side of No. 52 High Street, taken from the east

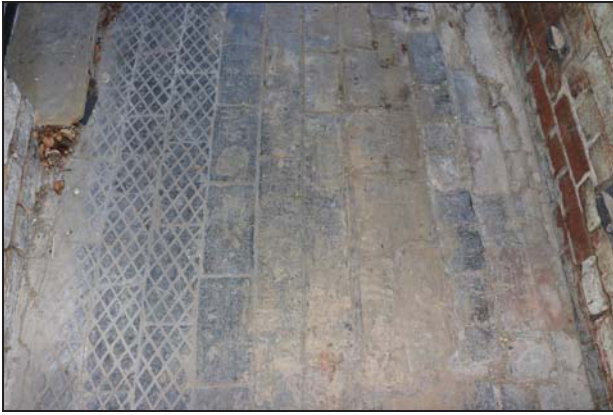
DP 7

Floor surface of the throughway to the rear yard showing mixture of earlier blue bricks and later diamond blue bricks, taken from the east

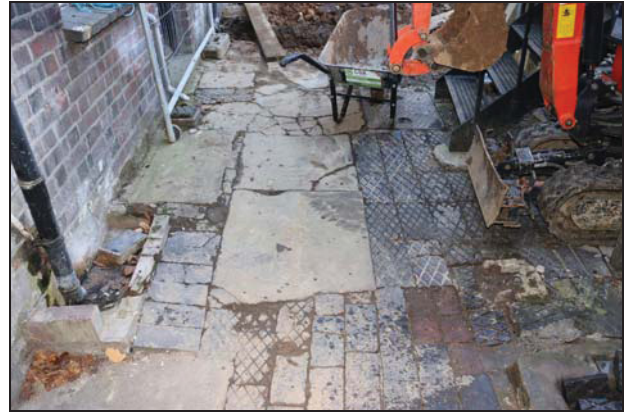
DP 8

Floor surface in the south-east corner of the yard (outside assessment) showing mix of brick paving and stone paving, taken from the east

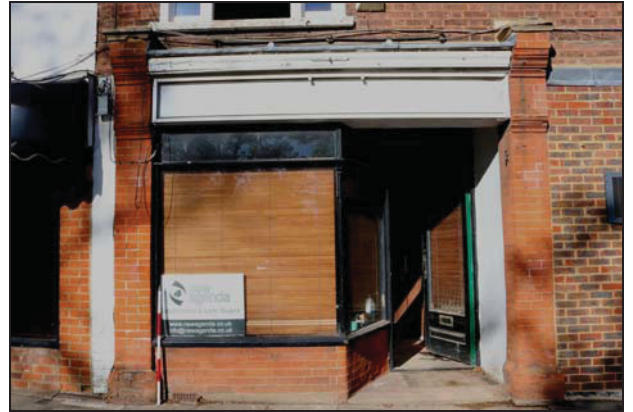
DP 20

4.1.3 The assessment building includes a single shop front at ground floor level with brick pilasters to either side built of fine red rubbing bricks with lime putty

South elevation of the assessment structure showing shop front, taken from the south

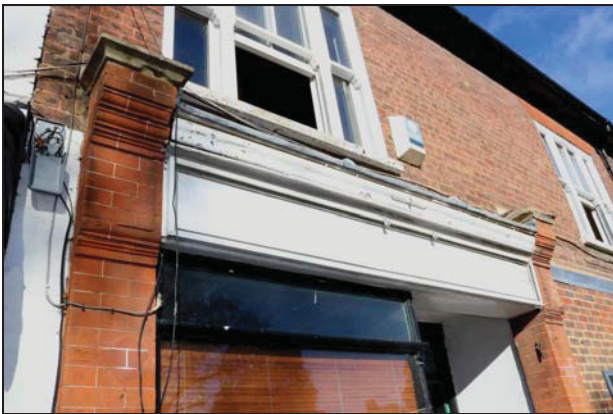
DP 21

Detail of the shop front showing rubbed brick piers and awning structure between, taken from the south-west

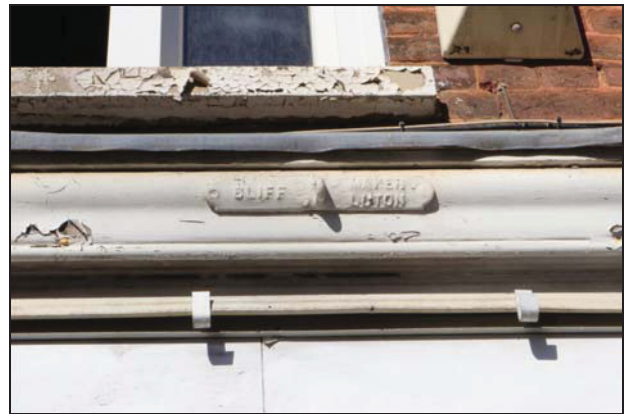
DP 22

Detail of the shop front showing awning cover with manufacturer's plate, taken from the south

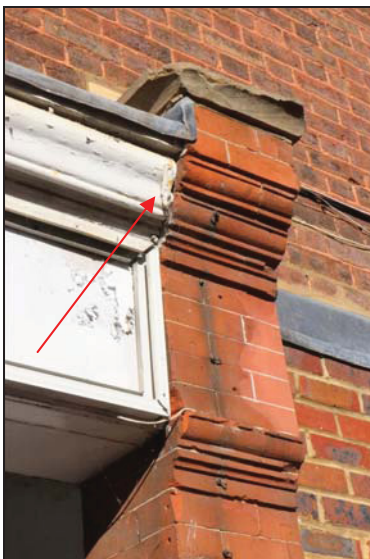
DP 23

Detail of the shop front showing rubbed brick pier and awning cover with hook (indicated), taken from the south

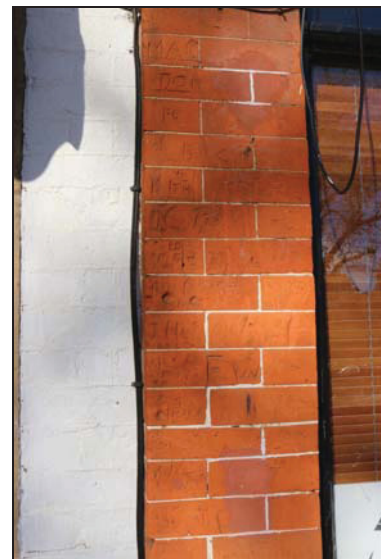
DP 24

Detail of the shop front showing west brick pier with extensive graffiti, taken from the south

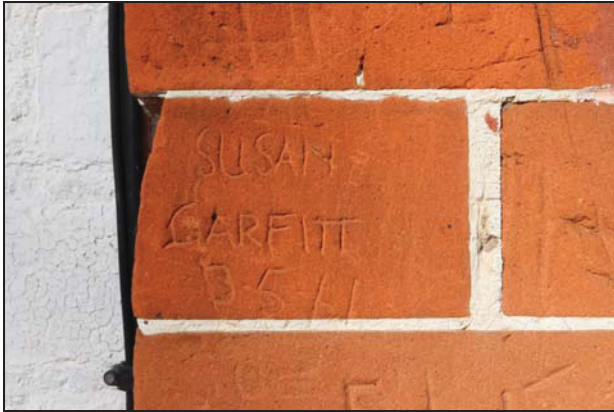
DP 25

Detail of the shop front showing west brick pier with graffiti example, taken from the south

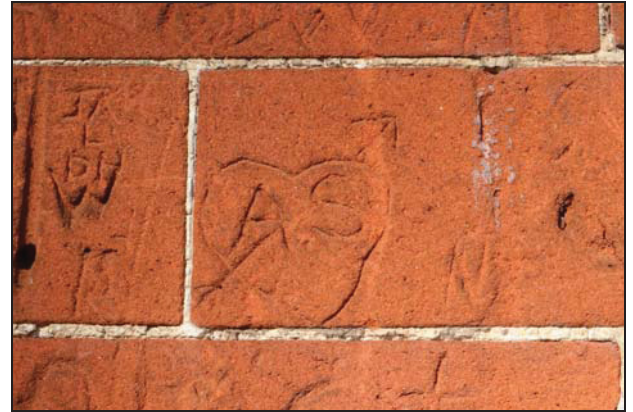
DP 26

Detail of the shop front showing west brick pier with graffiti example, taken from the south

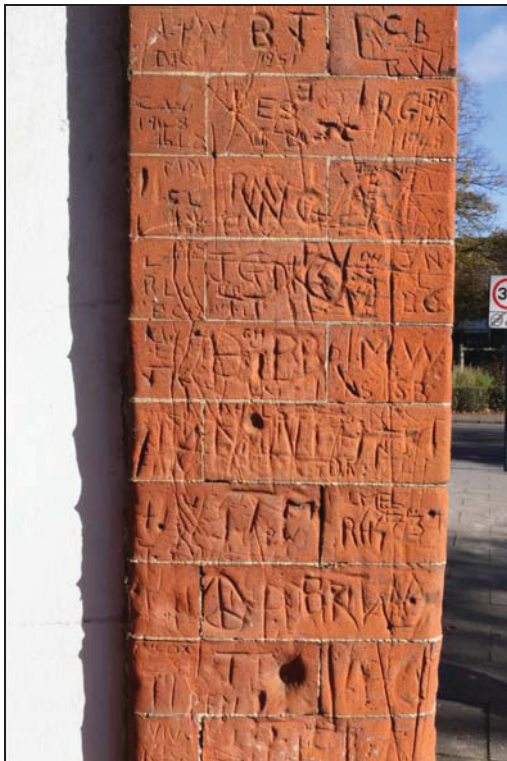
DP 27

Detail of the shop front showing east brick pier with extensive graffiti, taken from the west

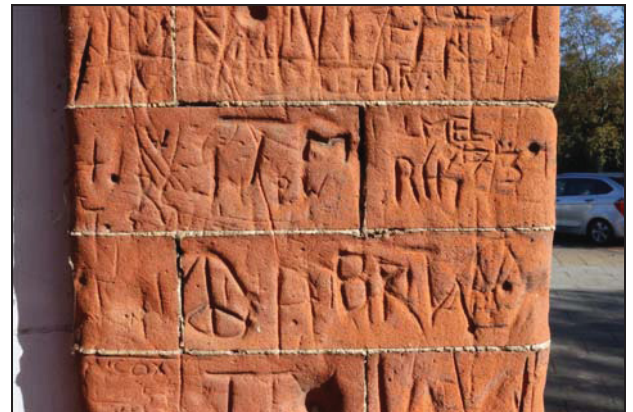
DP 28

Detail of the shop front showing east brick pier with examples of graffiti, taken from the west

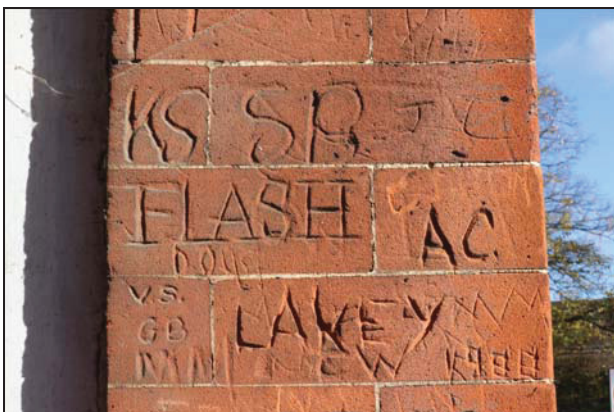
DP 29

Detail of the shop front showing east brick pier with examples of graffiti, taken from the west

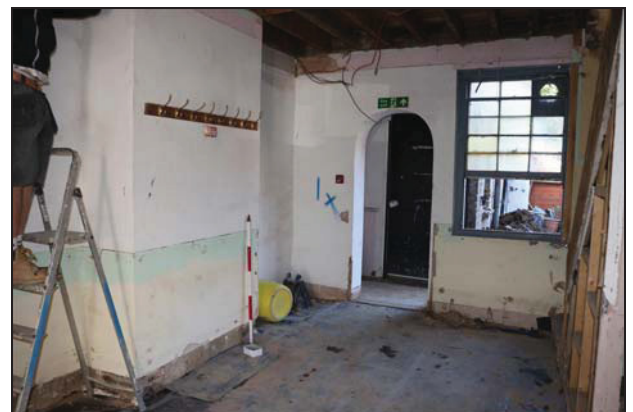
DP 30

Room GF02 with chimney stack on the west, taken from the south

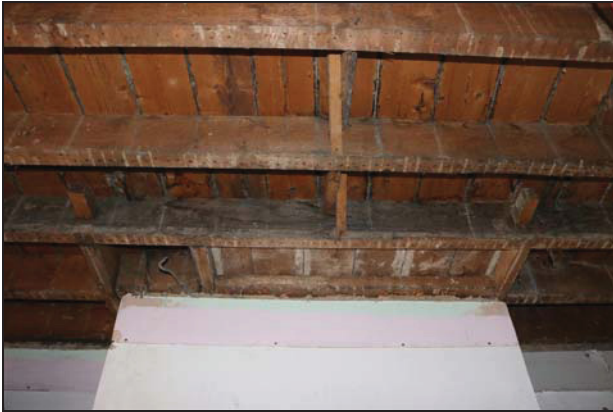
DP 31

Ceiling around chimney stack in Room GF02 showing trimmers supporting a hearth above, taken from the east

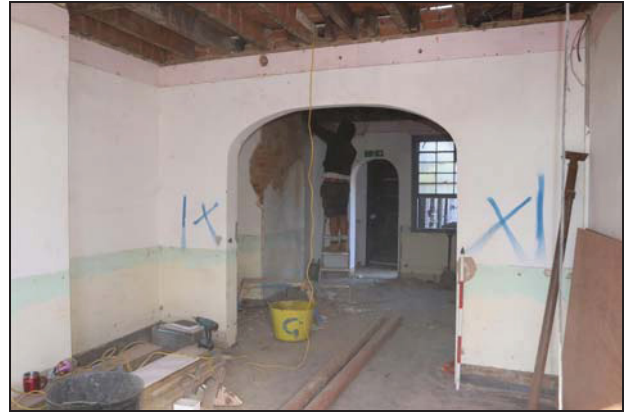
DP 32

Room GF01 showing wide archway creating an open space with Room GF02, taken from the south

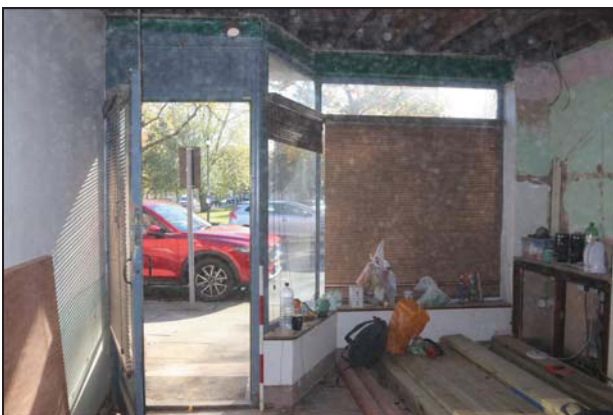
DP 33

View of the shop front from within Room GF01 during the planned works, taken from the north

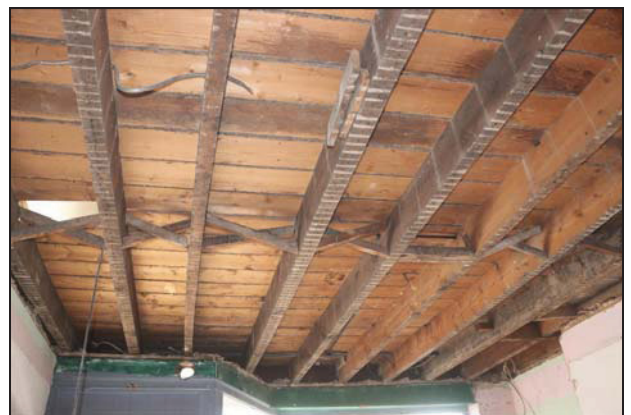
DP 34

Ceiling in Room GF01 showing thin-section joisting with x-bracing, taken from the north

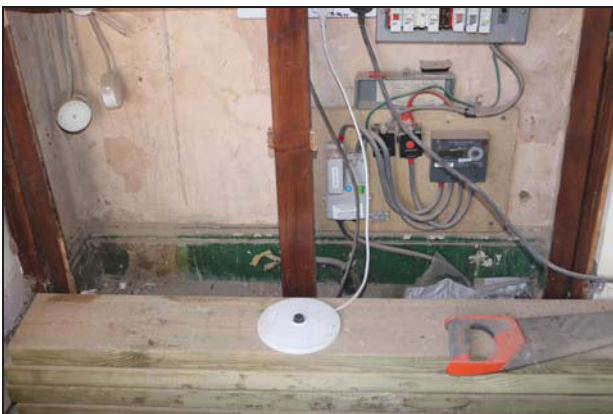
DP 35

Surviving section of simply moulded skirting board on the west side of Room GF01, taken from the east

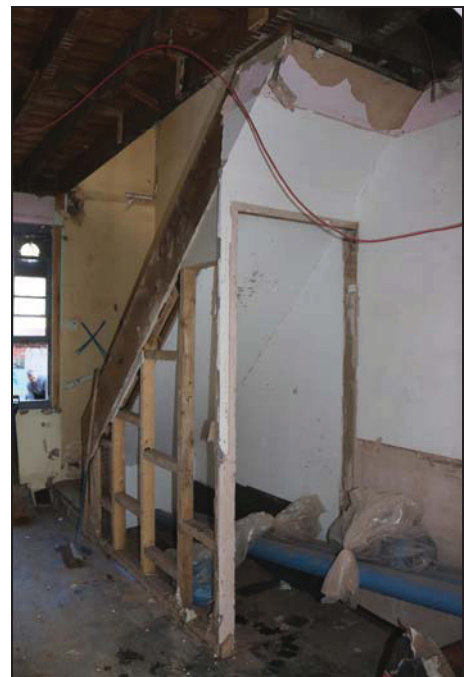
DP 36

Staircase on the east side of Room GF02 showing modern alterations, taken from the south

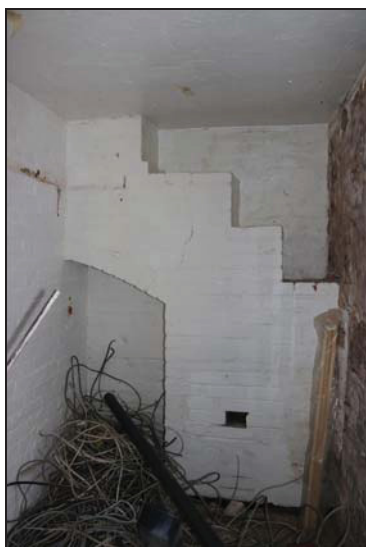
*DP 39
Room GF04 in the rear range showing blocked fireplace and stepped flue above, taken from the north*

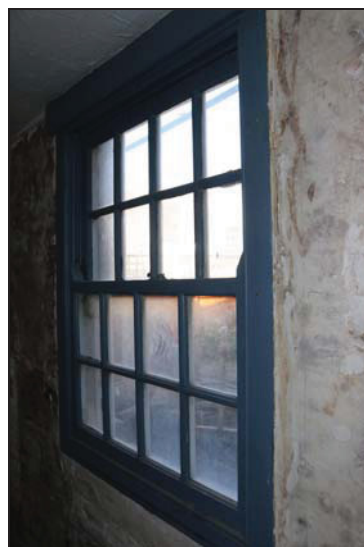
*DP 40
Room GF04 in the rear range showing sash window on the east, taken from the south*

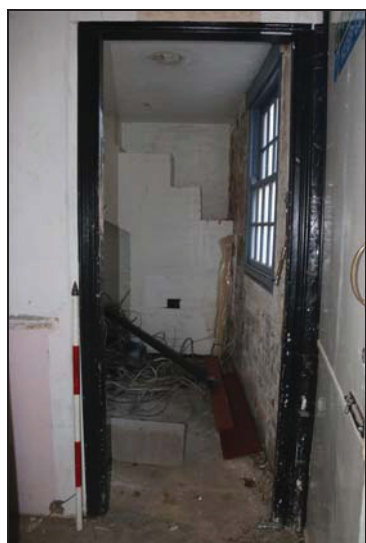
*DP 41
Lobby GF03 showing doorway leading to Room GF04 in the rear range, taken from the south*

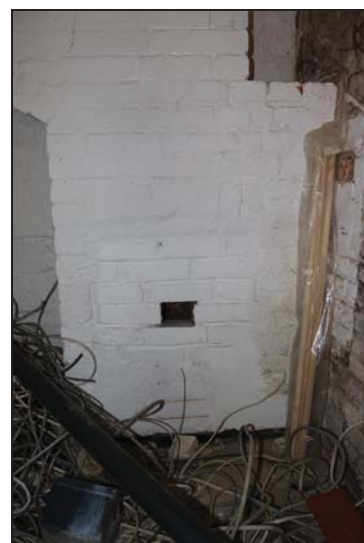
*DP 42
Room GF04 showing blocked fireplace aperture, taken from the south*

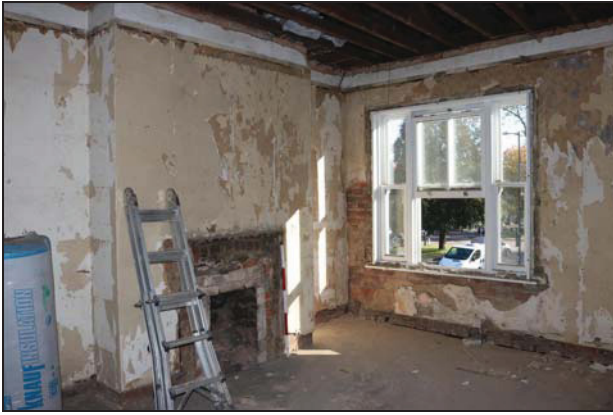
DP 43

Room FF04 showing renewed tripartite sash window, taken from the north-west

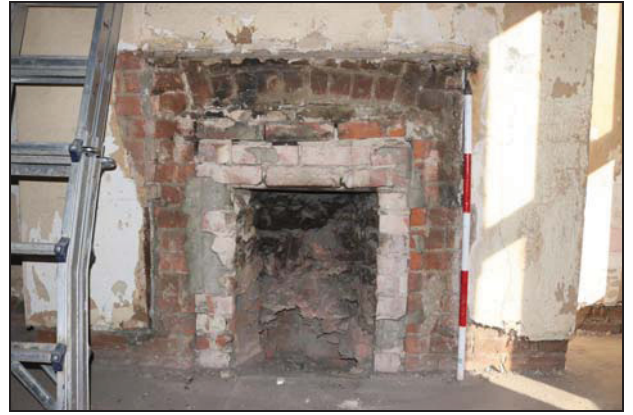
DP 44

Fireplace on the east side of Room FF04 showing original aperture with cambered brick arch and later infill below, taken from the west

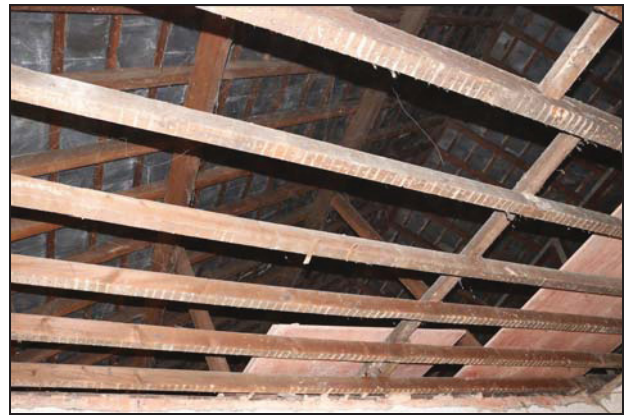
DP 46

Obscured view of the roof structure from within Room FF04, taken from the east

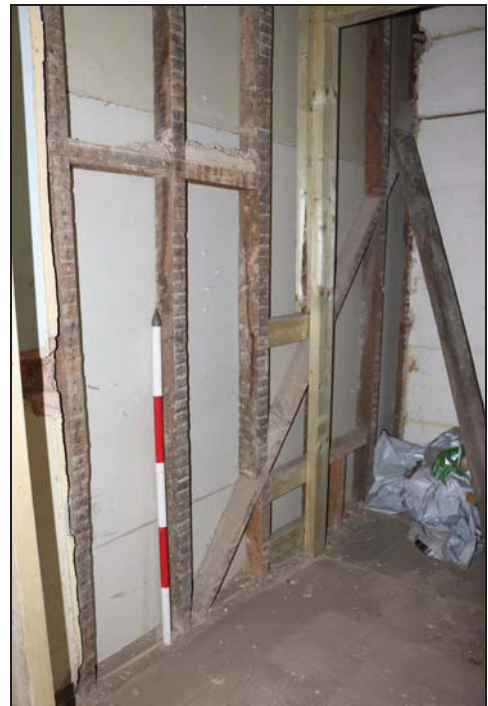
DP 48

Section of surviving primary-braced studwork in lobby FF03, taken from the south-west

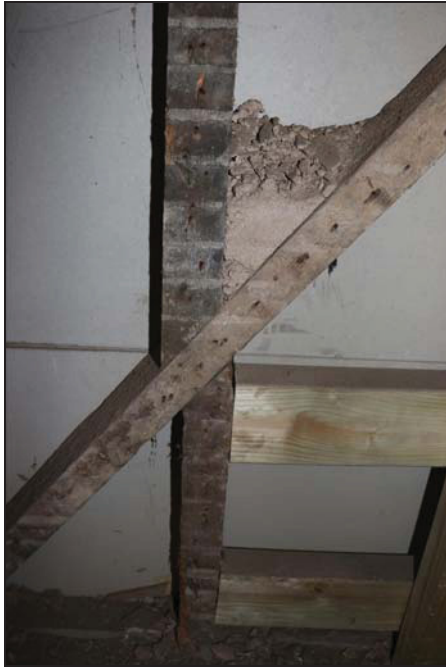
DP 49

Detail of the primary-braced studwork in lobby FF03, taken from the south

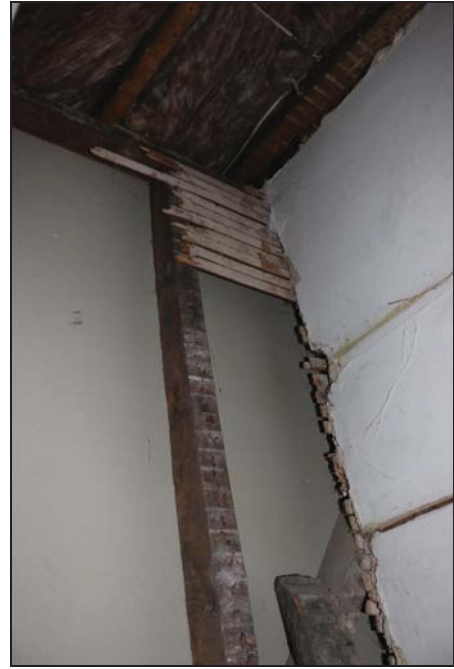
DP 50

Detail of the primary-braced studwork in lobby FF03 showing mechanically sawn laths, taken from the south

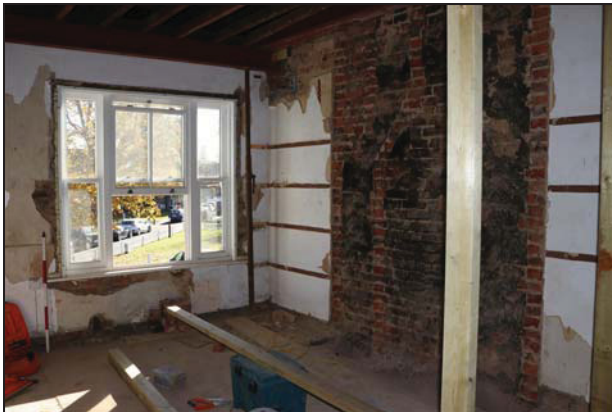
DP 51

Room FF01 after the removal of the chimney stack on the west and renewed sash window, taken from the north-east

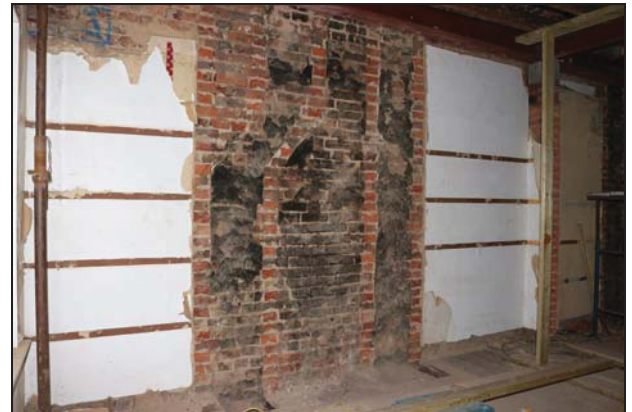
DP 52

Room FF01 after the removal of the chimney stack with evidence for flanking cupboards, taken from the east

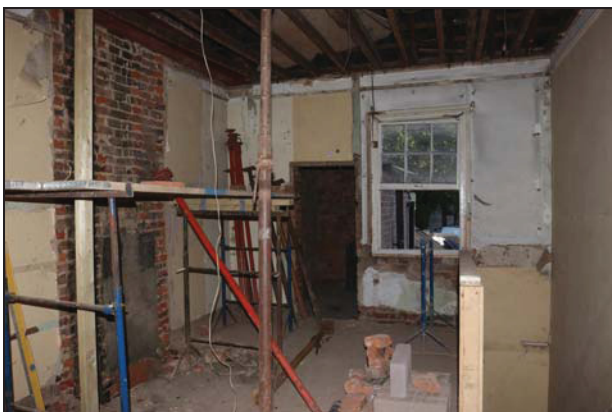
DP 53

Room FF02 after the removal of the chimney stack and the partition between this room and Room FF01, taken from the south

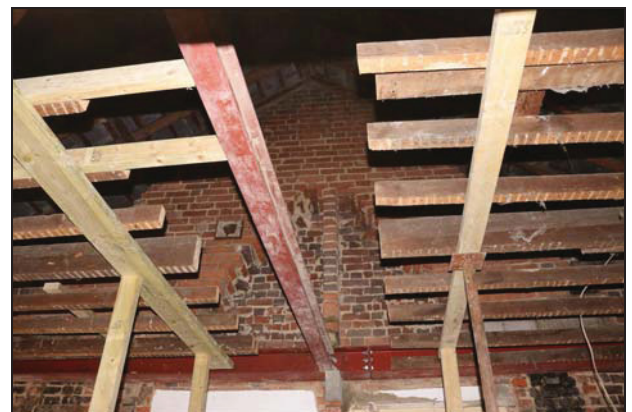
DP 54

View of the pair of chimneystacks rising at an angle to meet the central stack above, taken from the east

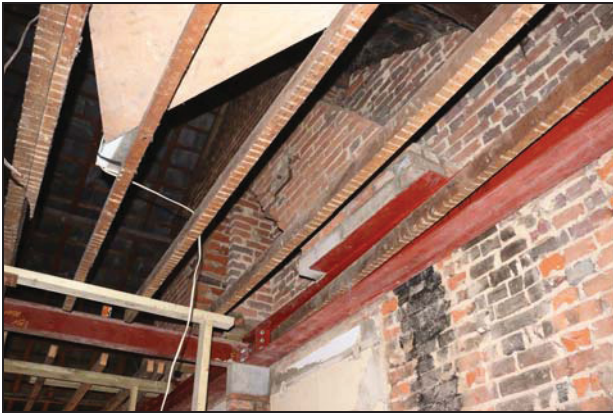
DP 61

View of the west gable end above ceiling level showing paired chimney stacks rising at an angle to meet the stack above, taken from the north

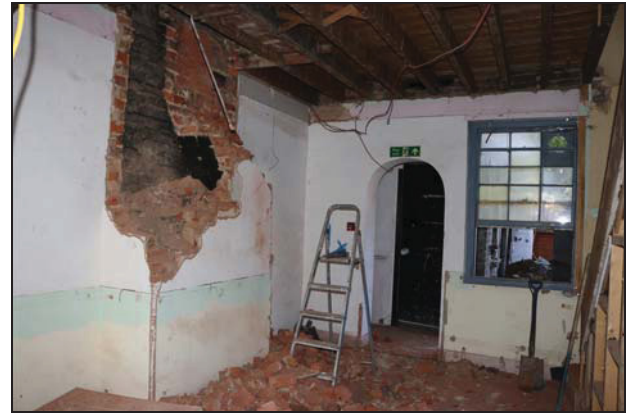
DP 62

Room GF02 during removal of the chimney stack, taken from the south

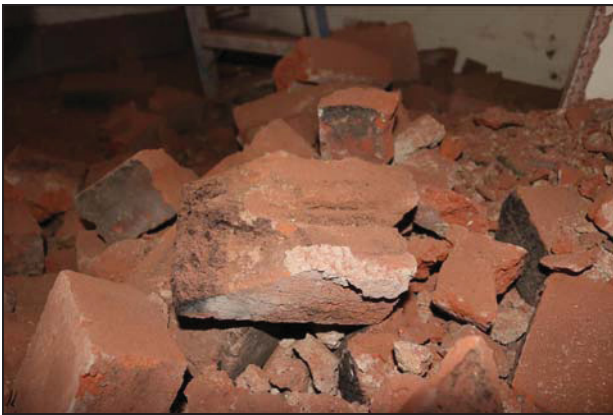
DP 63

Brick rubble from the removal of the chimney stack in Room GF02 showing a scooped frog

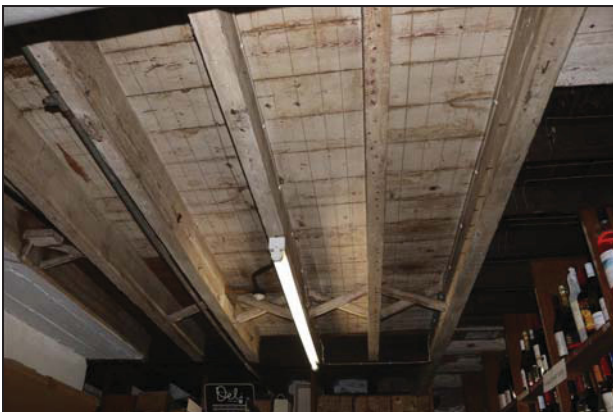
DP 65

Ceiling structures in the cellar (part of the adjoining property) showing identical thin-section joists with x-bracing

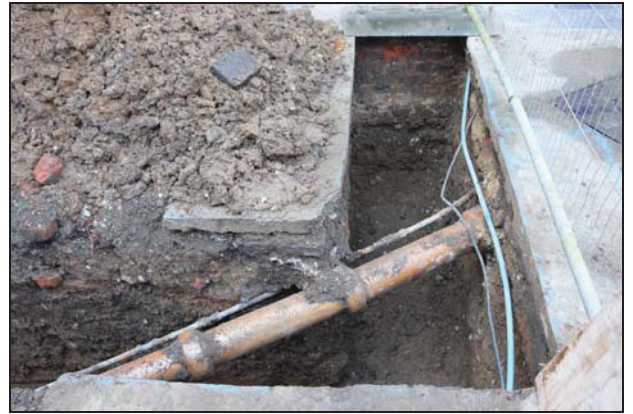
DP 69

View of the north return of the foundation trench with Victorian ceramic pipework, looking west

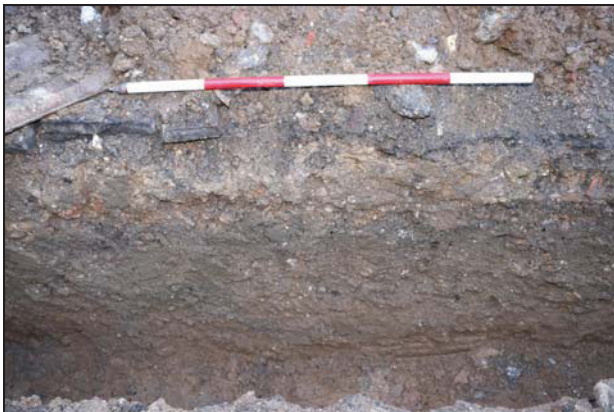
DP 70

<i>Sample section 1</i> <i>0.00 = 107.60m AOD</i>		
0.00 – 0.05m	L1000	Yard surface. Staffordshire blue brick pavers.
0.05 – 0.08m	L1001	Levelling layer. Loose black granular coke grit.
0.08 – 0.38m	L1002	Made ground. Firm, pale yellow grey mixed clay and gravel.

Sample section 1, looking west

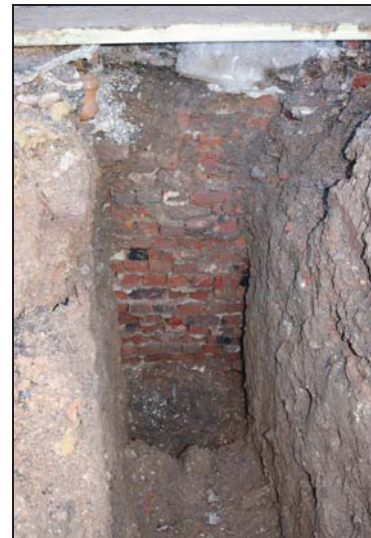
DP 71

South end of the foundation trench showing brickwork below ground level to the cellar below Room GF02, looking south
