ARCHAEOLOGICAL SOLUTIONS LTD

18-20 ST PETER'S STREET, BEDFORD,
BEDFORDSHIRE

HISTORIC BUILDING
MONITORING AND RECORDING

Author:	Tansy Collins MSt Kathren Henry	
NGR: TL 05141 50083	Report No: 5501	
District: Bedford	Site Code: AS1925	
Approved: Claire Halpin MCIfA	Project No: 6291	
	Date: 22 December 2017

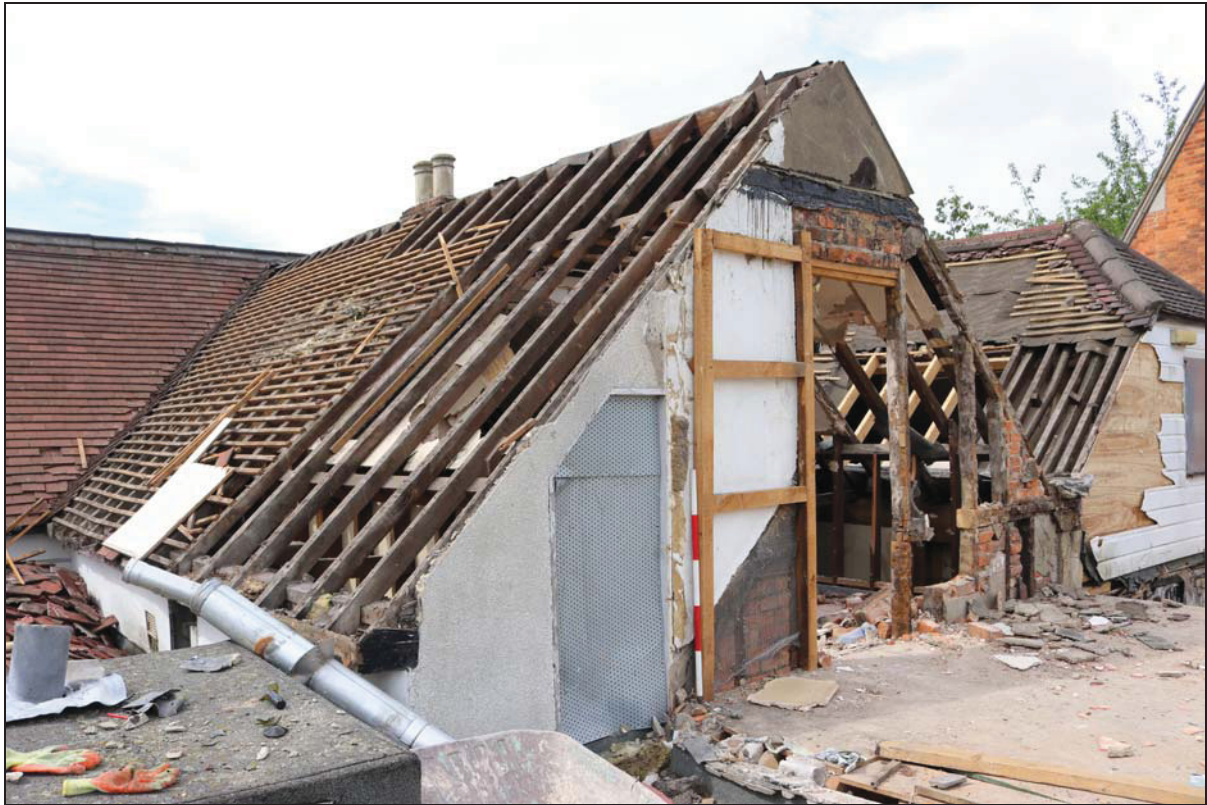
5.7 During the planned development, the roof cladding and some external fabric was removed from these ranges (Plate 3). This has revealed much repair in modern fabric, particularly with bolted softwood at the valley between the two ranges, but historic fabric remains. The north-east range roof structure is of softwood and is reciprocally sawn with rafters measuring an average of 2" x 4" (51mm x 102mm) with hand made nails to hold the original battens for tiles. Later slender rafters are mostly circular sawn and with machine made nails to secure new battens. The north, end truss has a little more fabric visible where empty mortices in the rafters demonstrate an original collar so the existing fabric is mostly later. The tie-beam has been cut for the existing doorway and due to the stripping of the roof, the tie-beam can be seen with iron strapping to the wall-plate (Plate 4).

Plate 3 View of the north-east range after removal of the roof cladding, taken from the north-east (DP 112)

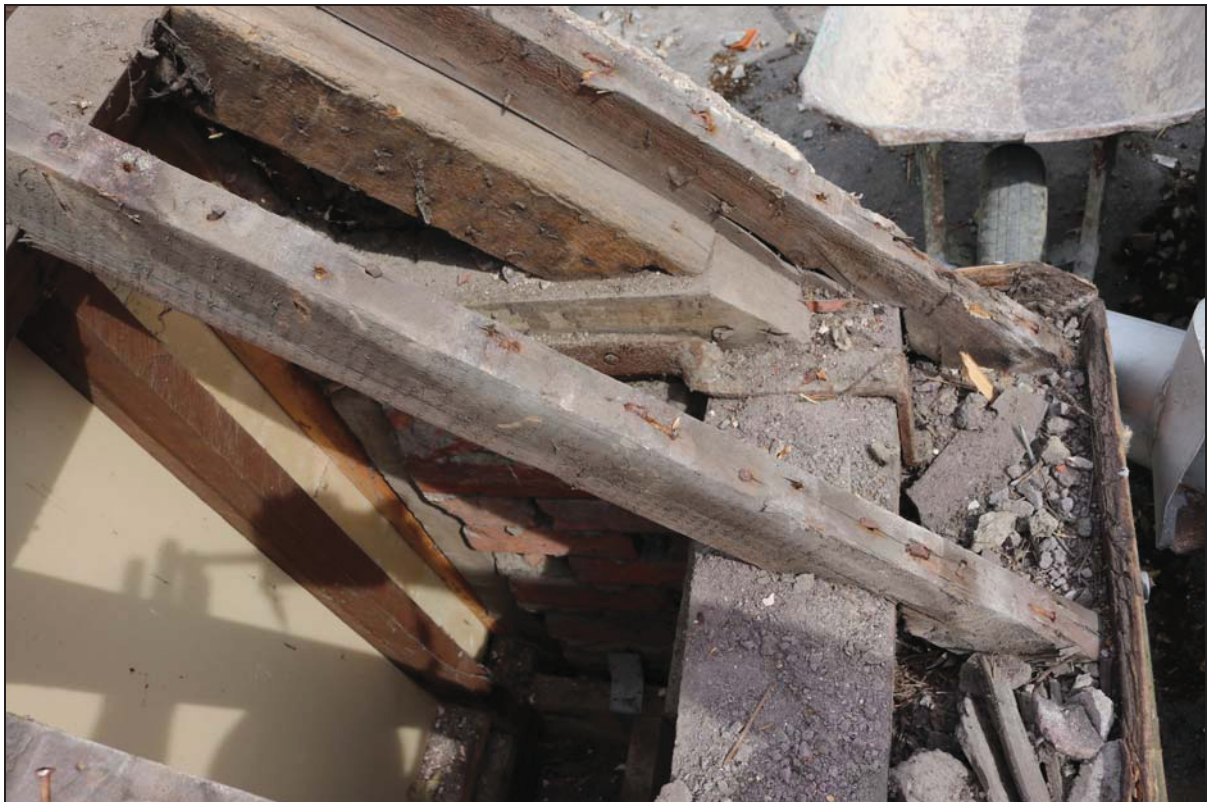
Plate 4 Detail of the east pitch (north-east range) after removal of the roof cladding showing iron-strapped wall-plate and tie-beam, taken from the east (DP 115)

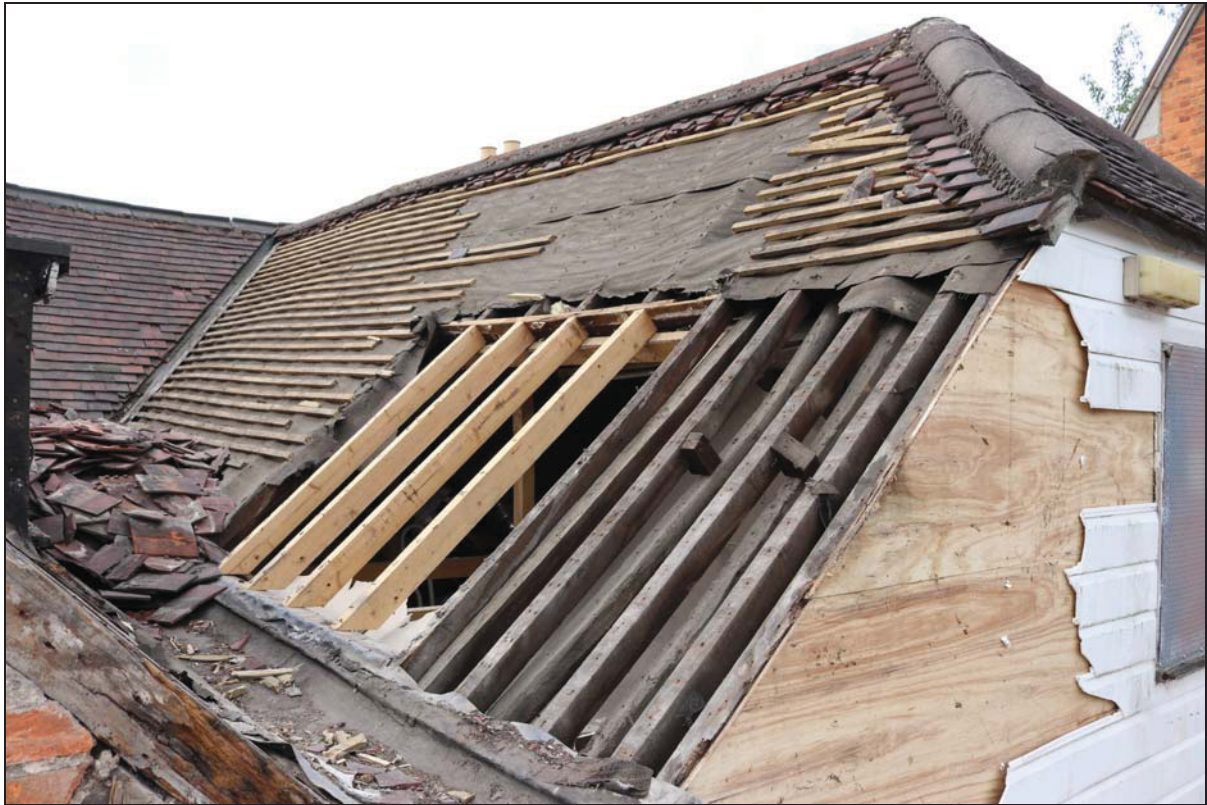
Plate 5 View of the north-west range after partial removal of the roof cladding, taken from the north-east (DP 117)

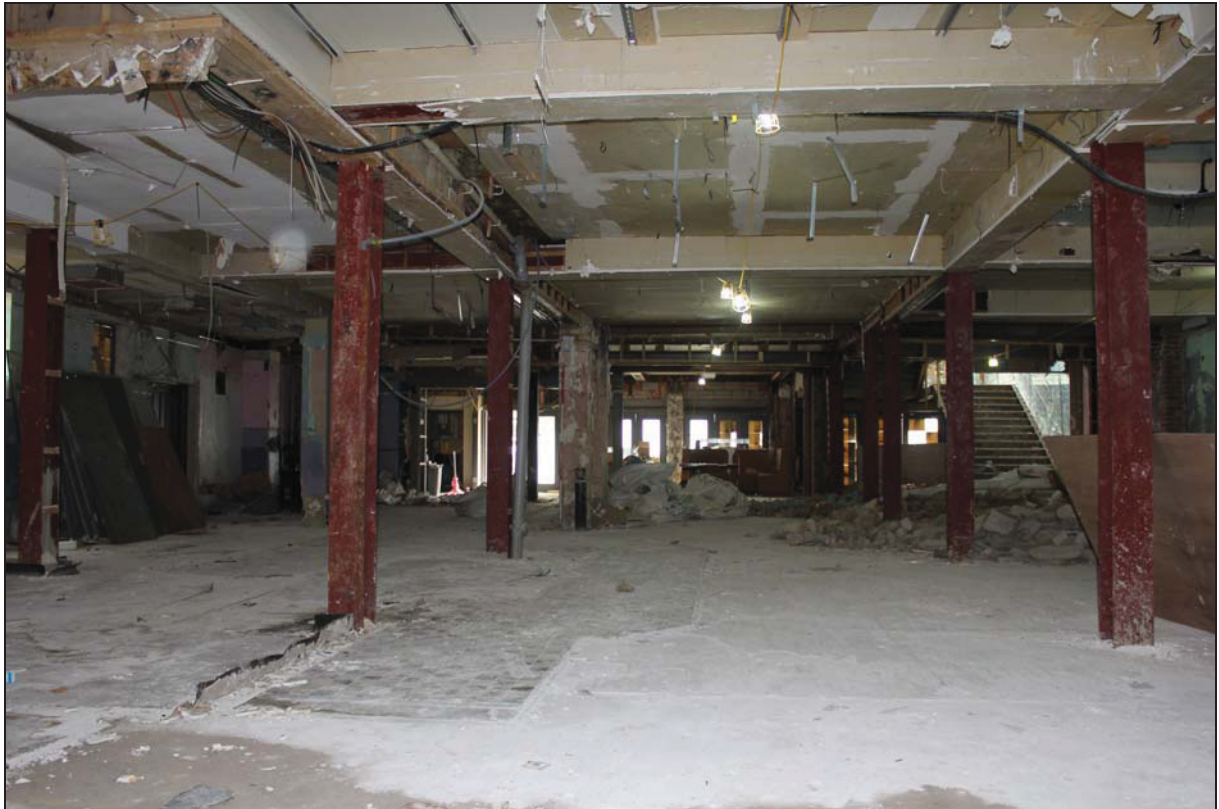
5.11 Little of interest was observed at ground floor level either during the initial assessment or the monitoring phase, the construction now comprising a framework of modern steel stanchions and joists (Plate 7). The single large open space has been soft stripped of all fixtures and fittings associated with the buildings latter use as a restaurant although tiling in the floor indicates a long bar on the east, while a staircase occupies the west element of the main range and leads to upper level (Plate 8). Exposed surviving historic fabric is limited to an isolated post that lies on the line of the former rear wall of the main range at the junction between the east and west elements so it is not clear which structural unit it is part of.

Plate 7 View at ground floor level from the rear extensions towards the street front, taken from the north (DP 92)

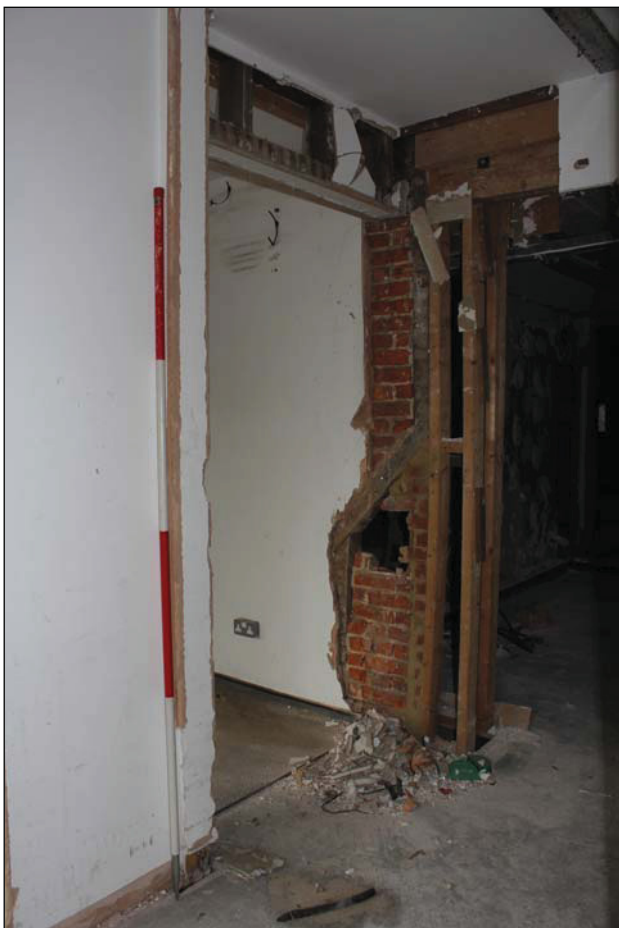
Plate 9 View of FF01 showing fragmentary surviving timber-framing and brickwork infill of the rear wall (main range), taken from the south (DP 60)

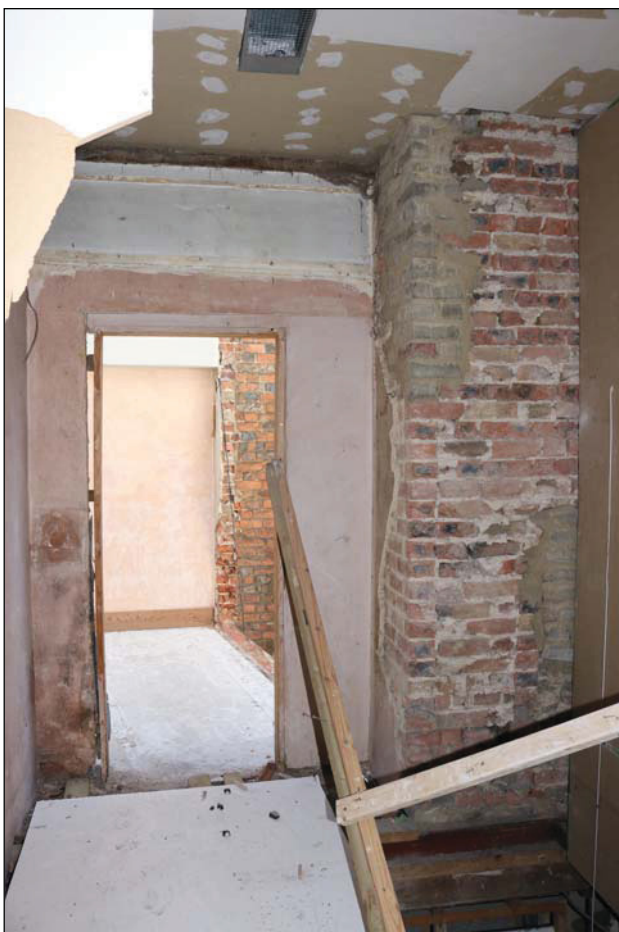
Plate 10 East end of FF01 showing inserted doorway in the east end following removal of the modern lift (main range), taken from the west (DP105)

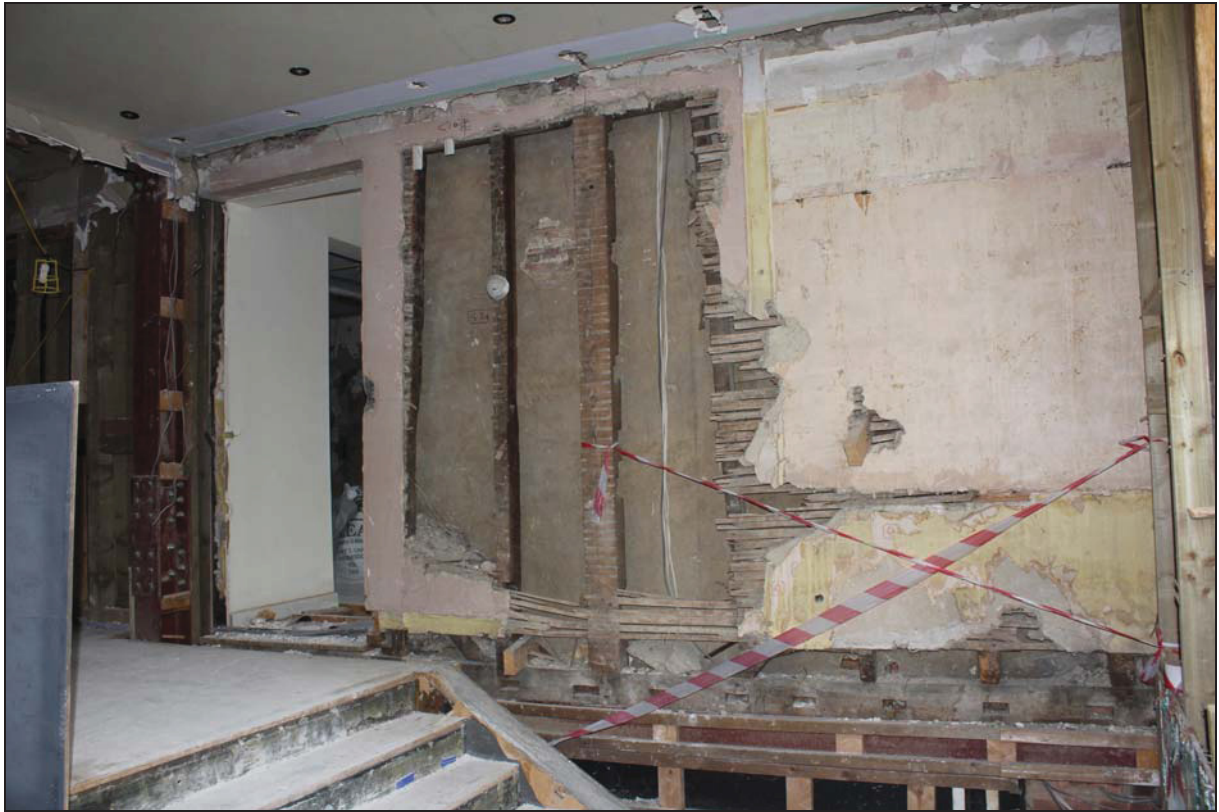
Plate 11 East wall of FF02 (west range) showing studwork constructed against pre-existing fabric, taken from the west (DP 51)

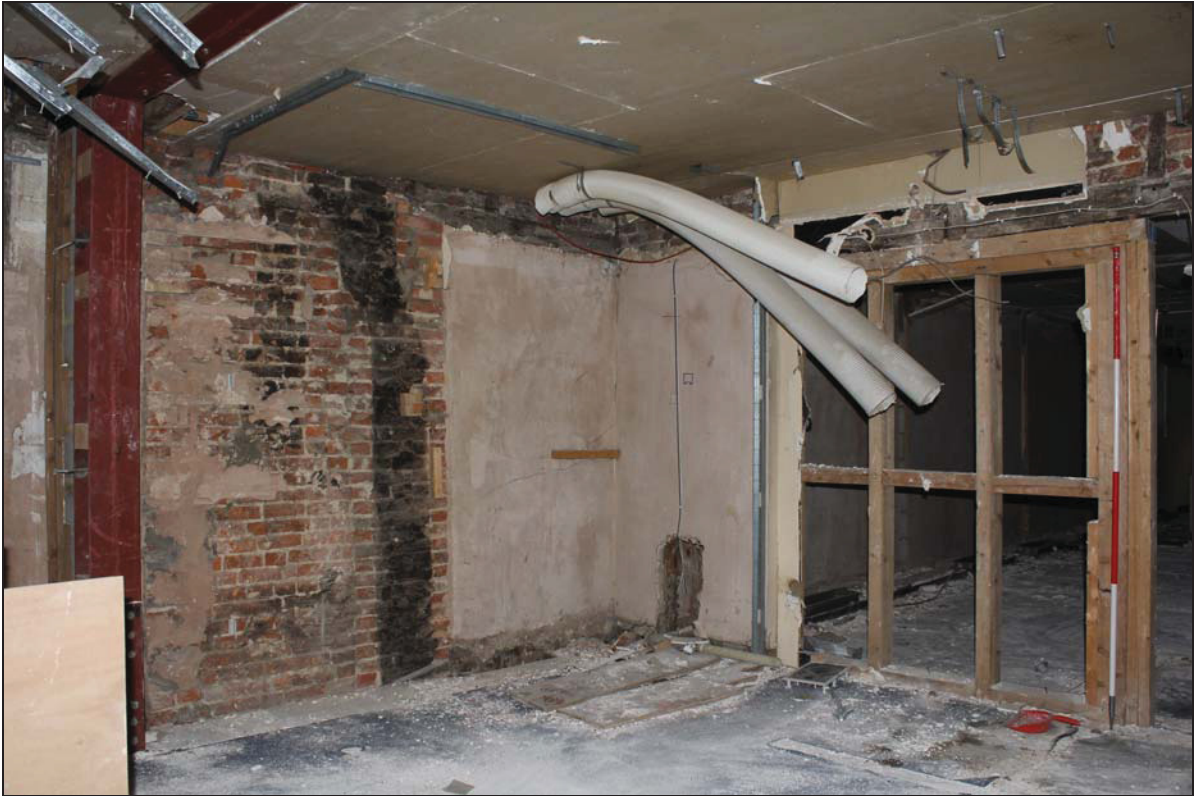
Plate 13 FF04 (north-west range) showing much disturbed fabric including brick and timber and the outline of former chimney flue, taken from the south-east (DP 63)

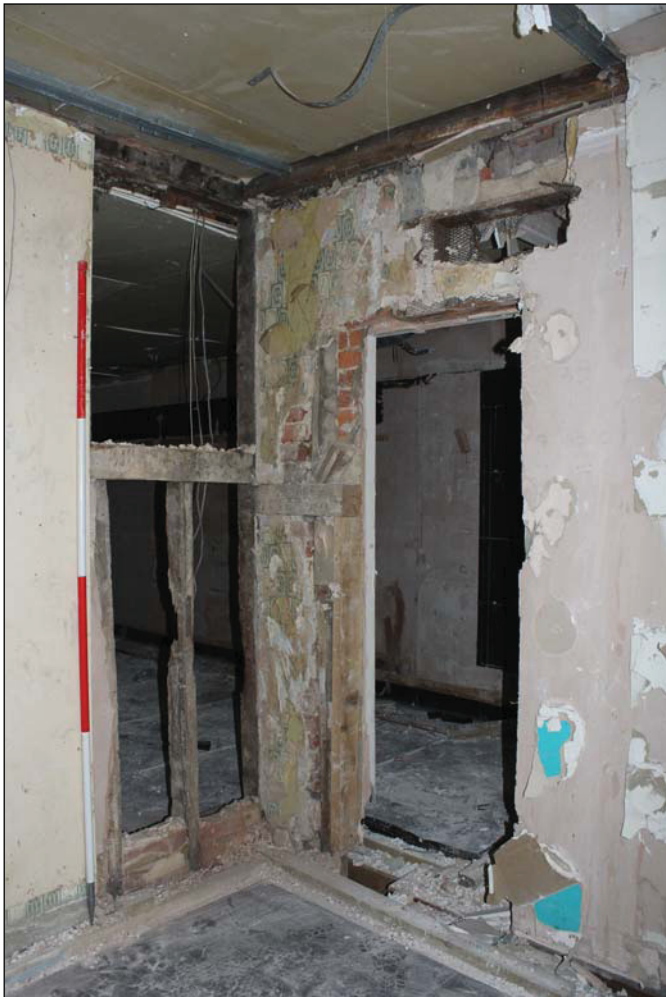
Plate 14 North-east corner of FF03 (north-east range) showing truncated original mid-rails with studs above and below, taken from the south-west (DP 72)

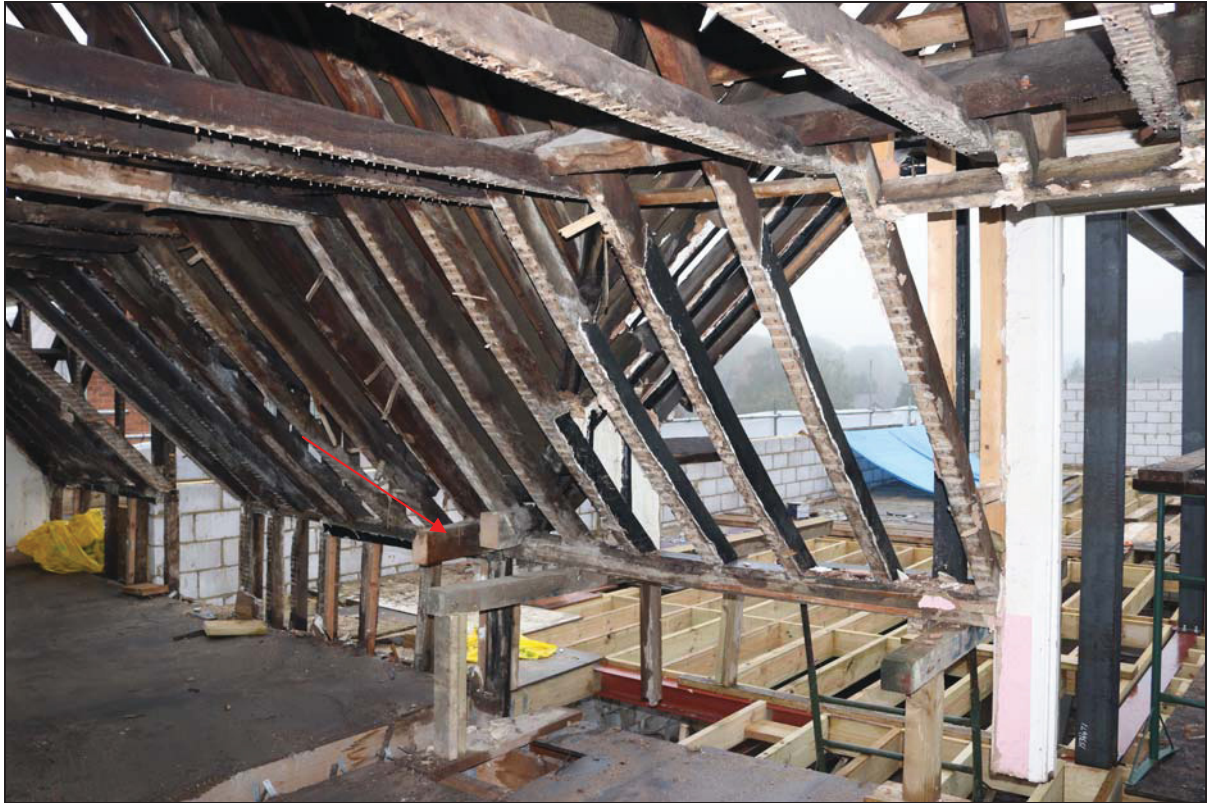
Plate 19 North roof pitch of Bays 3 and 4 (SF01) showing junction between the two with truncated adjacent trusses (indicated), taken from the south-east (DP 140)

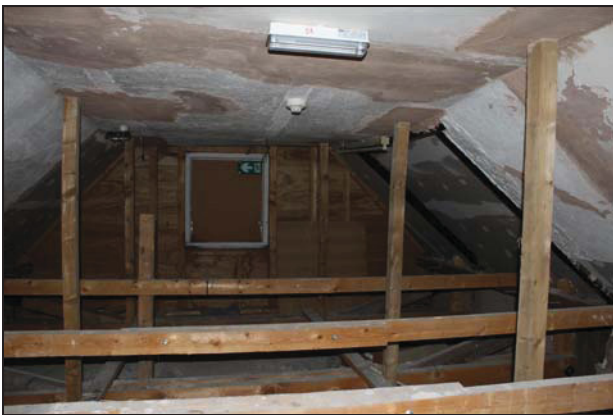
DP 45

View of Room SF04 (north-west range) showing much repair and replacement with modern supporting timbers, taken from the south

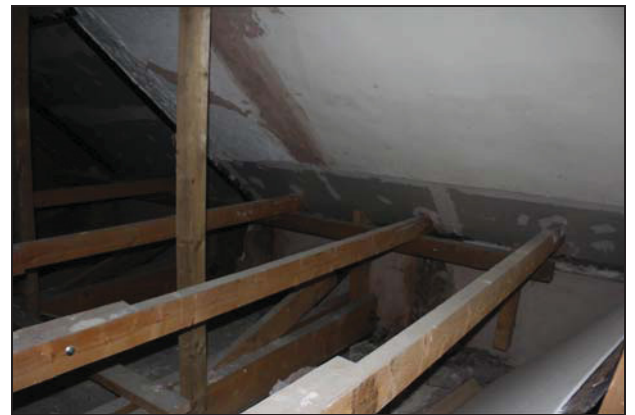
DP 46

View of Room SF04 (north-west range) showing much repair and replacement with modern supporting timbers, taken from the south-west

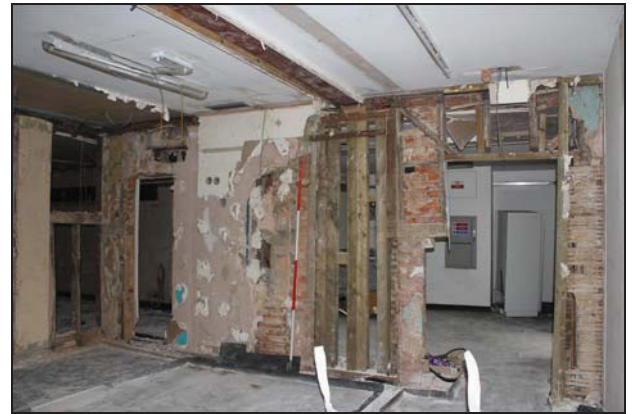
DP 70
East side of FF03 (north-east range) showing fragmentary survival of timber framing with much later replacement and removal, taken from the west

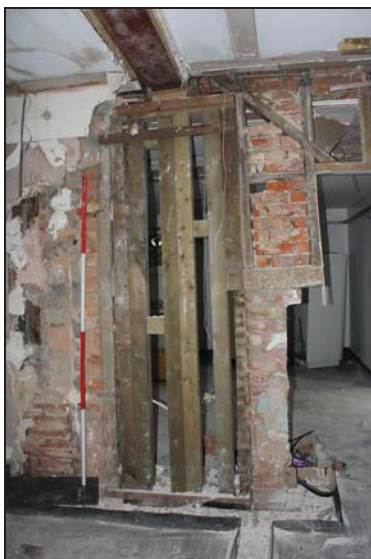
DP 71
Detail of the east side of FF03 (north-east range) showing fragmentary survival of timber framing with much later replacement, taken from the west
