**LOWER FARM, BURY GREEN, LITTLE HADHAM,
WARE, HERTFORDSHIRE SG11 2EY**

**HISTORIC BUILDING RECORDING AND
ARCHAEOLOGICAL MONITORING & RECORDING**

Authors: Tansy Collins MSt Lauren Wilson MA (Background Research) Kathren Henry	
NGR: TL 4522 2096	Report No: 5534
District: East Hertfordshire	Site Code: AS 1910
Approved: Claire Halpin MIfA	Project No: 7300
	Date: 7 February 2018

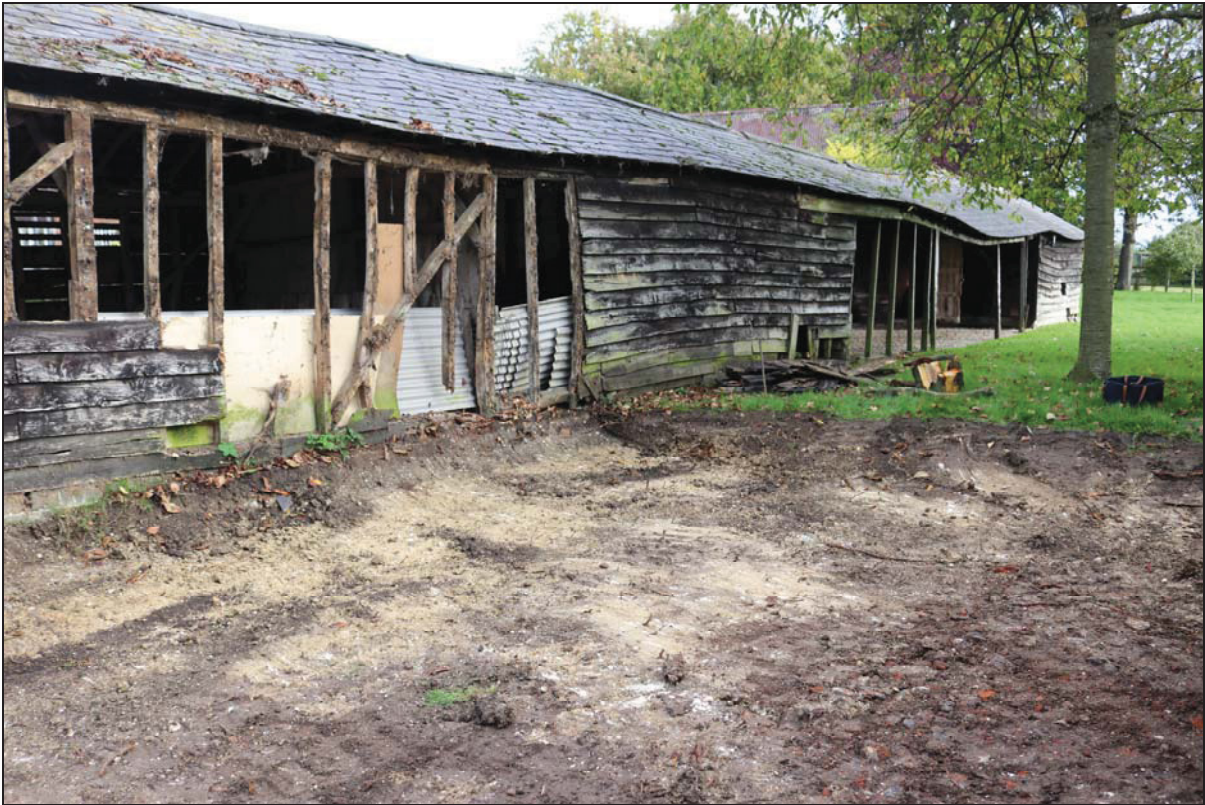
Plate 1 South-east elevation showing primary-braced framing (Unit 5) after removal of weatherboarding and open-fronted unit beyond (Unit 2), taken from the south (DP01)

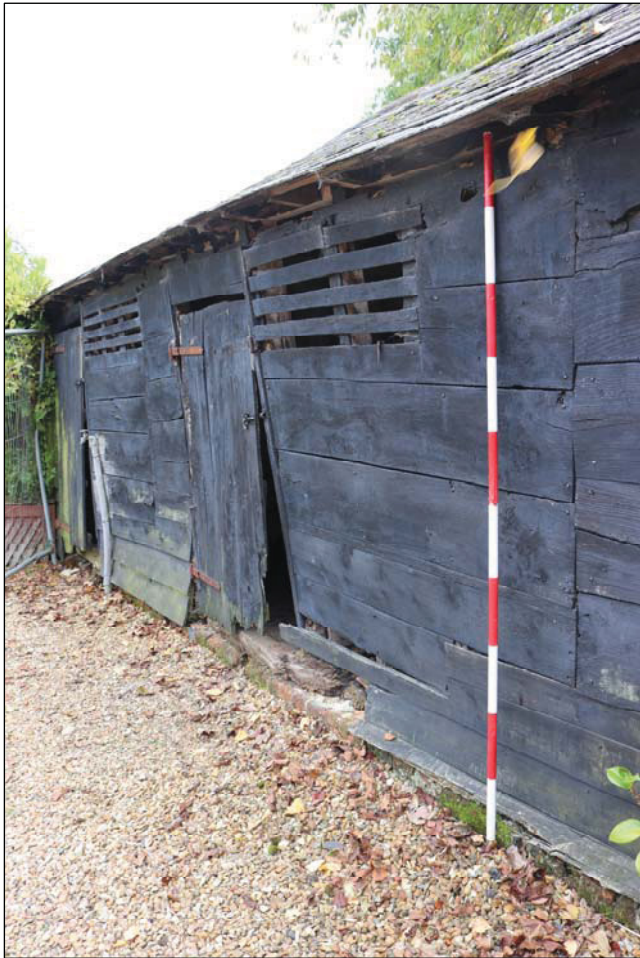
Plate 3 North-west elevation (Units 3 and 4) showing wide horizontal boarding with ventilation apertures, taken from the south-west (DP15)

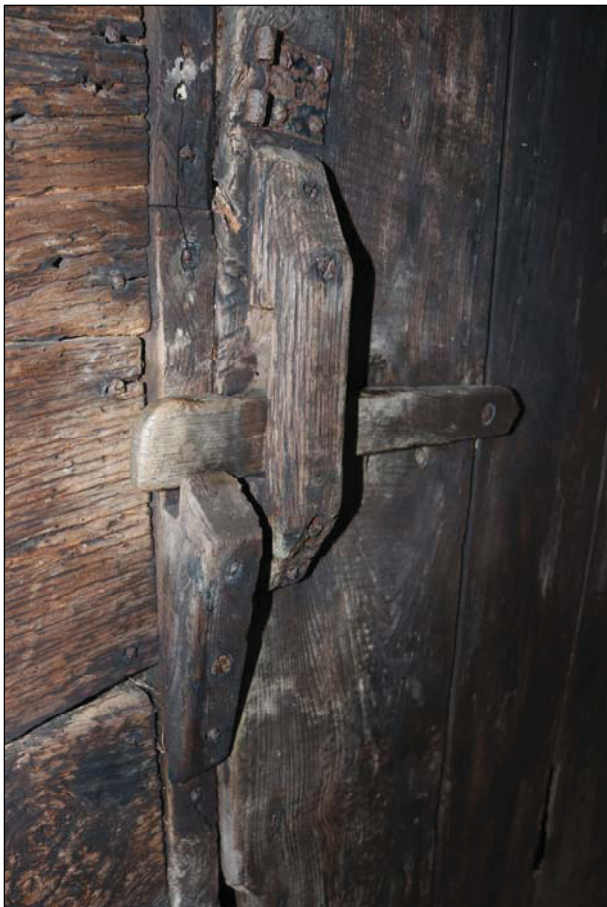
area of Unit 2 through a closed partition. The partition includes fairly wide horizontal boarding, possibly some elm with occasional softwood boards likely as replacements, and vertical boarding above tie-beam level. The doorway contains a good oak boarded and ledged door of 18th / 19th century date (Plate 9). There are four boards and four ledges to the rear, all secured with hand made nails and hung on strap hinges with round finials and pintles. Of interest is the timber latch and fastener which rarely survive (Plate 10). It is in good condition and worn through use.

Plate 10 Detail of the boarded door (Unit 1) with early timber latch, taken from the west (DP 41)

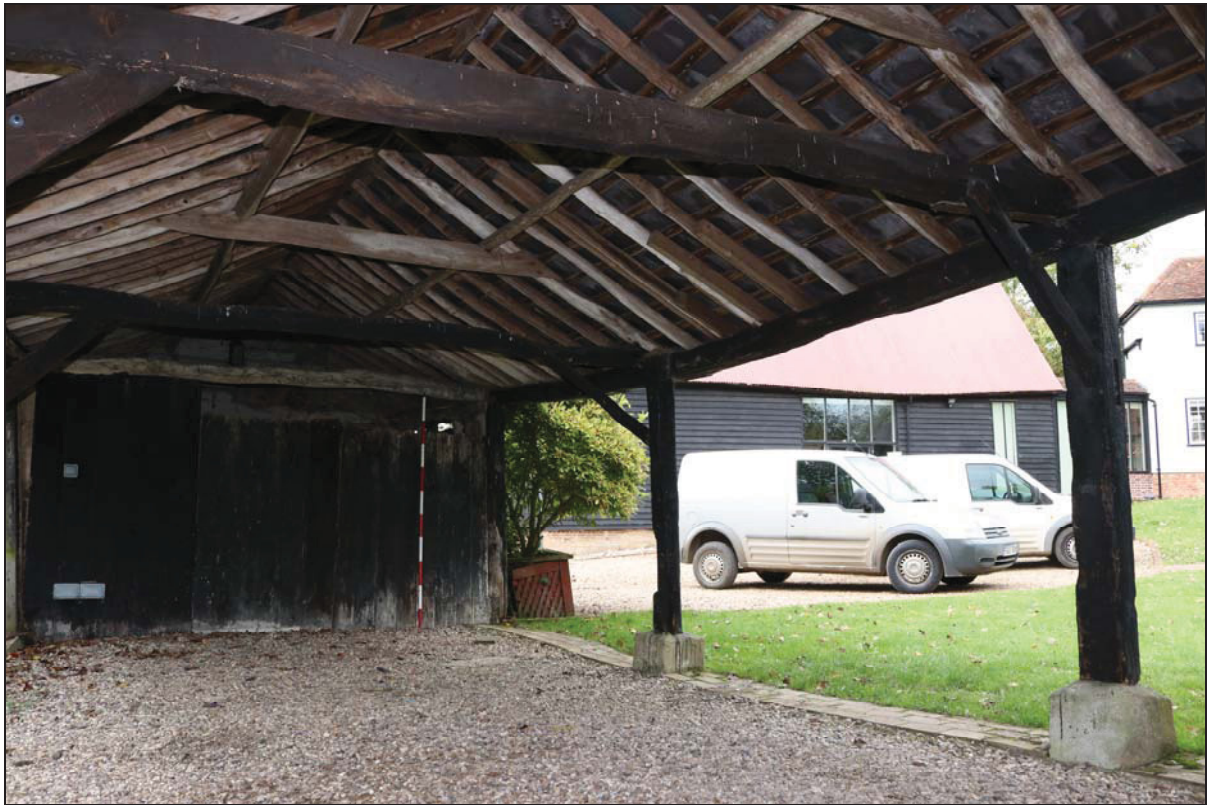
5.1.34 Unit 2 forms a much-altered cart-shed or former animal shelter, now open to either side forming a throughway and with a gravel floor (Plate 11). The two north-west bay posts are reused, as noted above from the exterior, while the south-east side is now open though was formerly closed. The truss construction includes outer bay posts pegged to the wall-plate with the tie-beam over, triangulated with short straight inner braces pegged to post and tie-beam. The roof is replaced as before with a purlin in each pitch and two slender board collars are notched into the rafters and nailed.

Plate 11 Open-fronted bays to the north-west of Unit 2, taken from the north-east (DP 43)

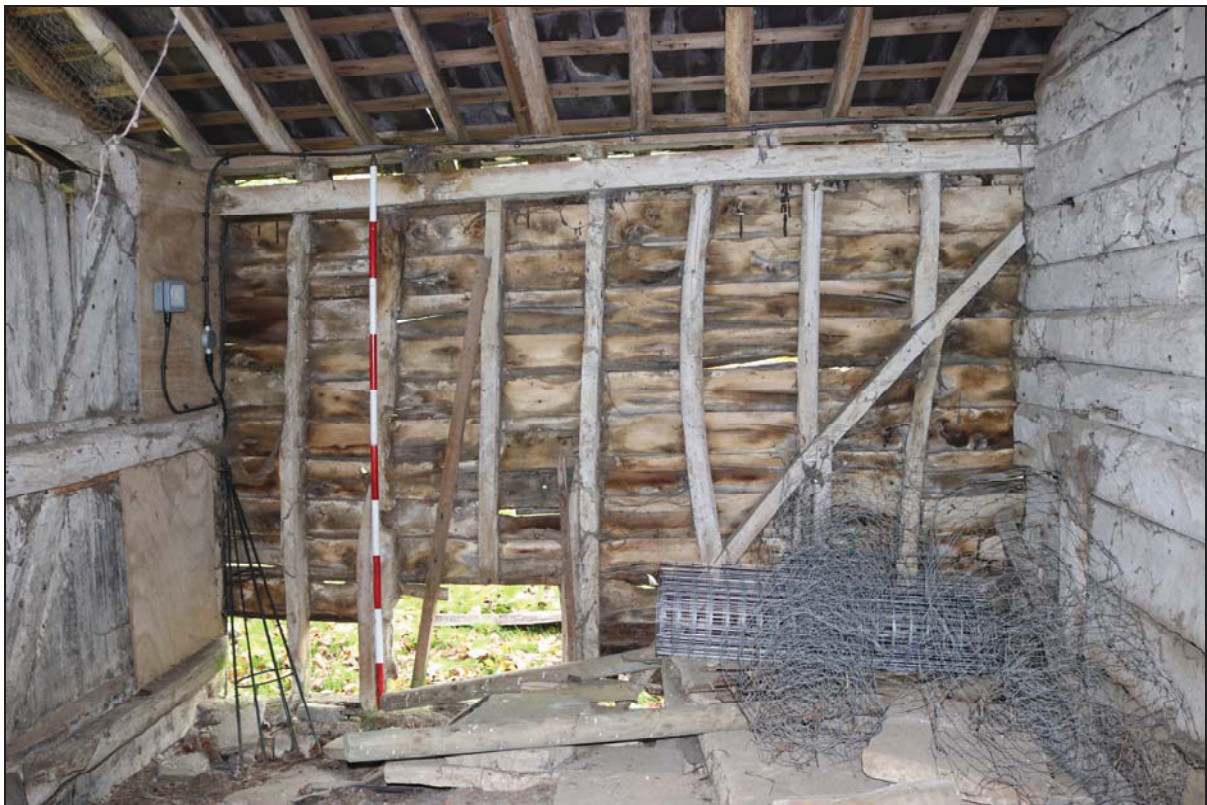
5.1.38 The south-east side includes timber-framing comprising a degraded sole-plate with primary-braced studwork above, none of which is pegged (Plate 12). The studs are all slender with a single, slightly curved primary-brace descending from the north-east bay post. The wall-plate above has a scarf joint. The north-west wall has a central doorway with primary-braced studwork to both sides and upper ventilation apertures, the primary brace fairly crude and straight (Plate 13). The south-west side is a solid partition of thick planks with chamfered edges, laid horizontally and extending to the apex. The pattern of nails demonstrate the planks are attached to studwork on the opposing side. The roof is as before with slender rafters over a single purlin in each pitch to a ridgeboard.

Plate 12 South-east wall of Unit 3 showing primary-braced framing, taken from the north-west (DP 57)

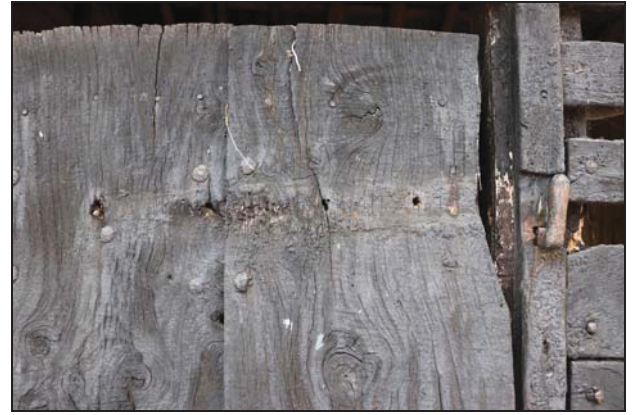
5.1.10 Of similar form, Unit 4 presents the same wide boarding, a doorway and ventilation aperture. The door has again been re-hung so that evidence for original hinges (pintles and impressions of strap hinges) lie opposite the existing, later strap hinges. Heavy nails mark the position of internal ledges within. The sole-plate is partially visible at low level, but is fairly degraded.

DP 20
Detail of the door on the north-west elevation (Unit 4) showing original pintle and impression of strap hinge, taken from the north-west

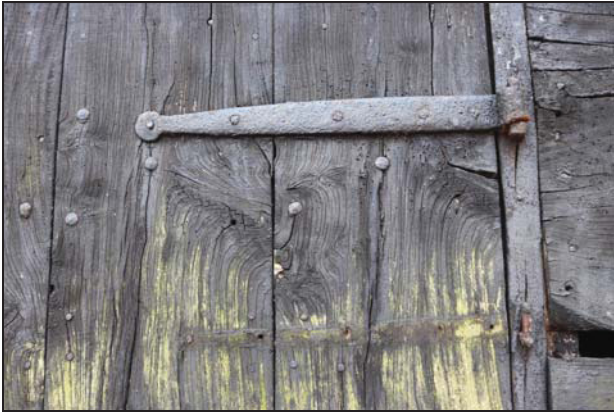
DP 25

Detail of the door on the north-west elevation of Unit 5 showing strap hinge hung on a pintle with impression below for lost example, taken from the north-west

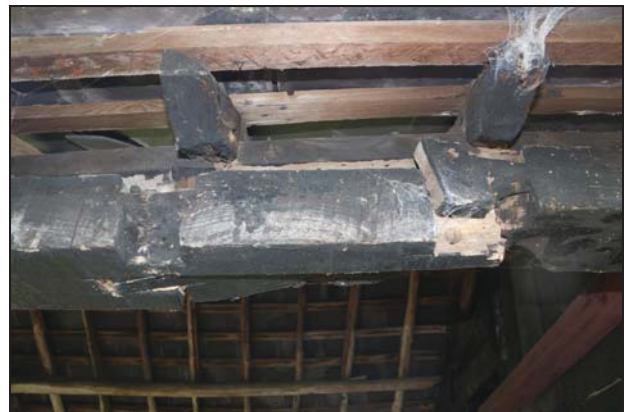
DP 48

A failing face-halved and bladed scarf joint in the south-east wall-plate (Unit 2), taken from the south-east

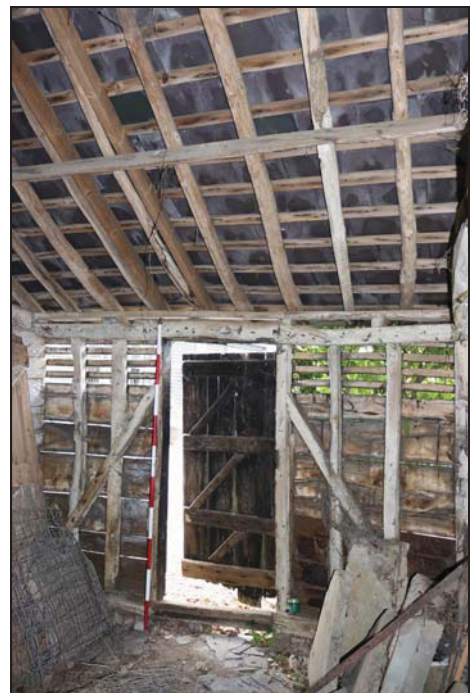
DP 60

South-east wall of Unit 3 showing decayed sole-plate, taken from the north-west

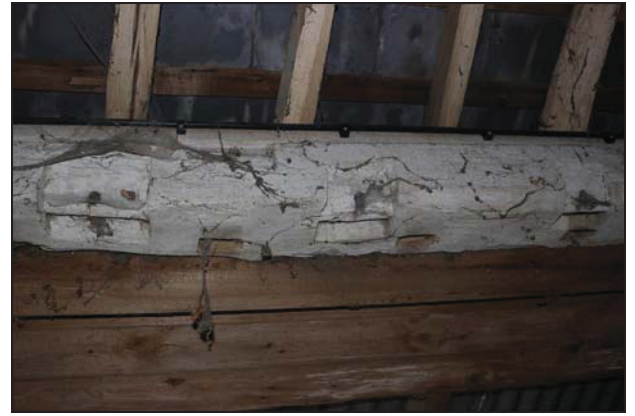
DP 104

Wall-plate on the south-east side of Unit 6 showing numerous mortices, taken from the north-west

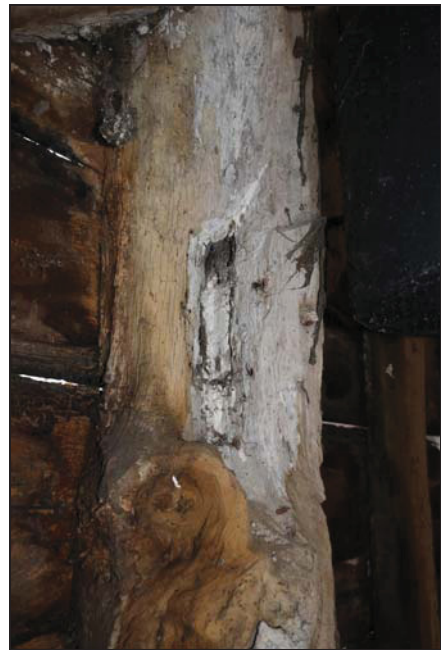
DP 118

Detail of the south-west bay post of the central bay (Unit 5) showing worn empty mortice for an inner brace, taken from the south

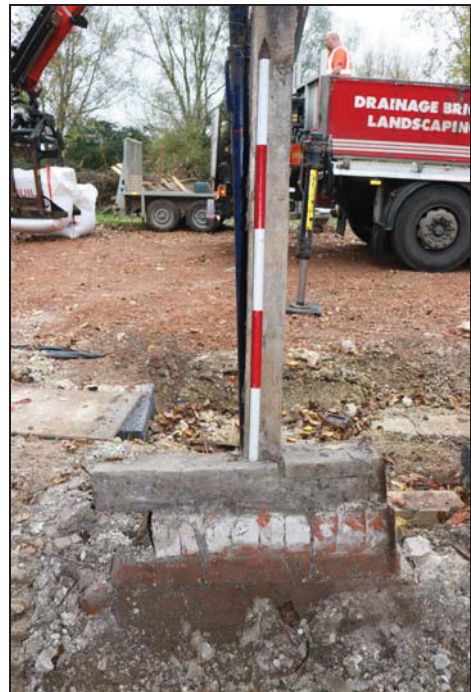
DP 124

South-east side of Unit 5 (bay division between the centre and north bay) after the lowering of the floor showing the dwarf wall and fragment of sole-plate remaining, taken from the north-west
