**BARNS AT DANE END HOUSE, CONDUIT LANE,
GREAT HORMEAD, BUNTINGFORD,
HERTFORDSHIRE**

HISTORIC BUILDING RECORDING

Level 3

Authors: Lauren Wilson MA PCIfA Kath Henry (Graphics)	
NGR: TL 40520 30120	Report No: 5372
District: East Herts	Site Code: AS 1883
Approved: Claire Halpin MCIfA	Project No: 6858
	Date: 5 May 2017

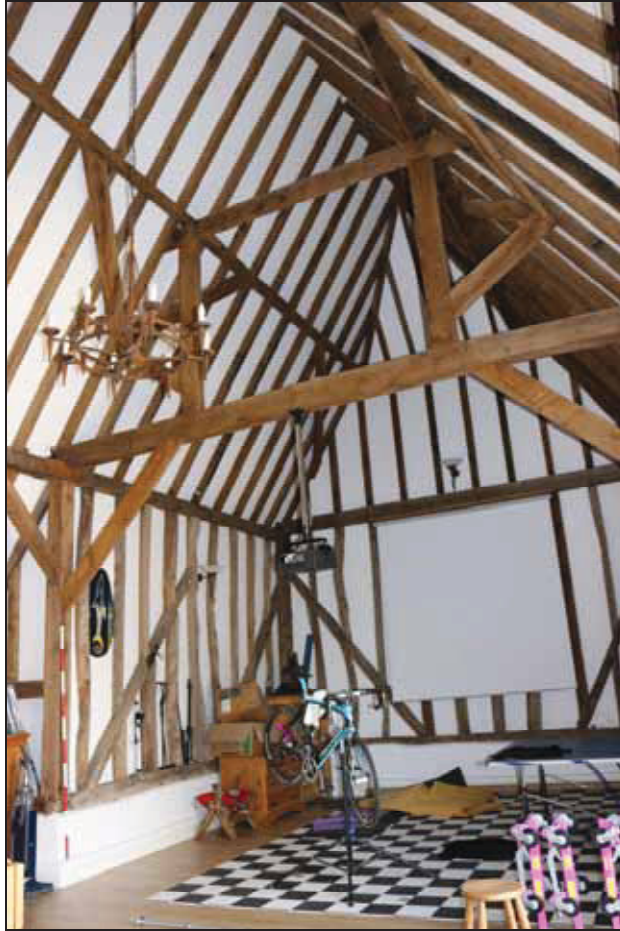
Plate 5 Truss 1 in Barn 1, taken from the north (DP 26)

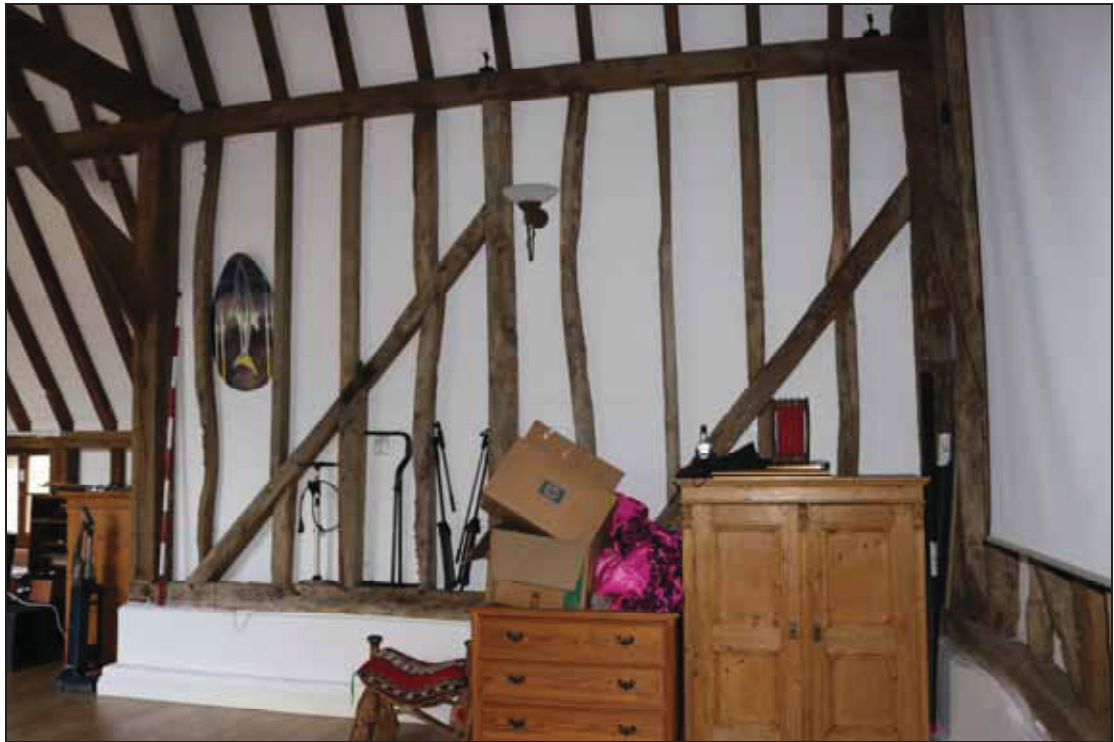
5.10 The wall-framing is of fairly regular construction with a standard nine studs to each bay and straight primary braces (Plate 7). The wall-plates have face-halved under-squinted scarf joints at the bay divisions each with a nailed-on plate to its edge (Plate 8). The original pattern of pegging is not entirely clear because the recent rebuilding has pegged every replacement, however where the original

Plate 7 South-east side of bay 1 in Barn 1, taken from the west (DP 41)

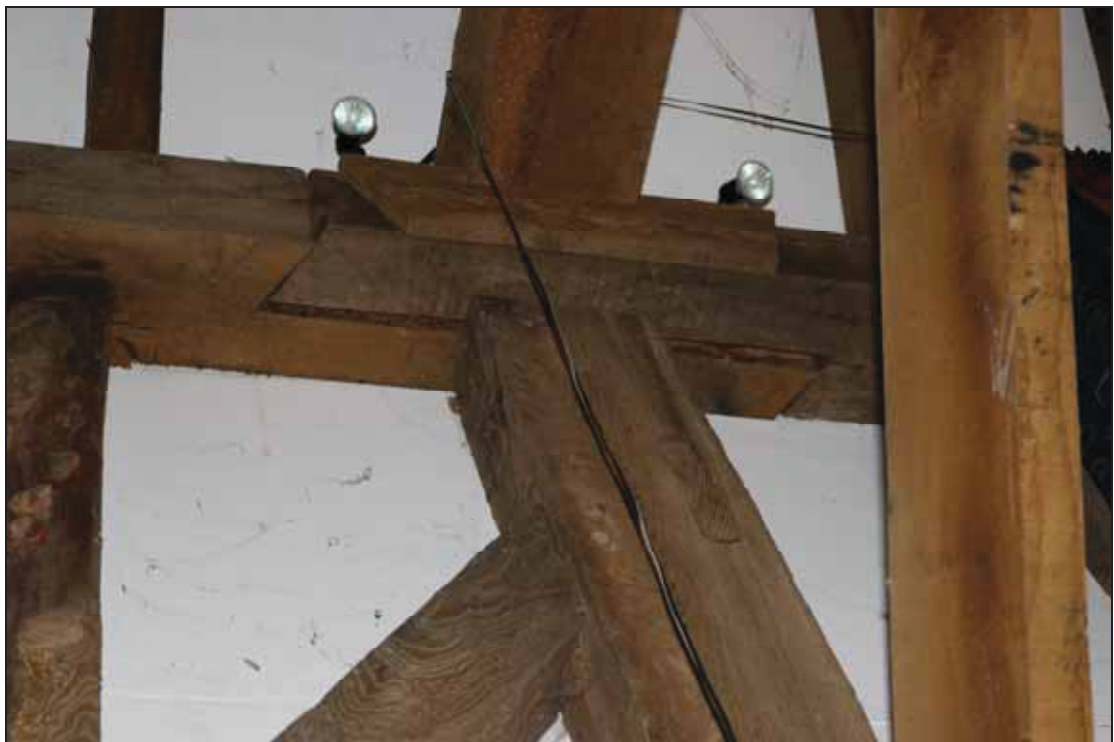
Plate 8 Scarf joint in the wall-plate at the bay divisions in Barn 1, taken from the south-east (DP 37)

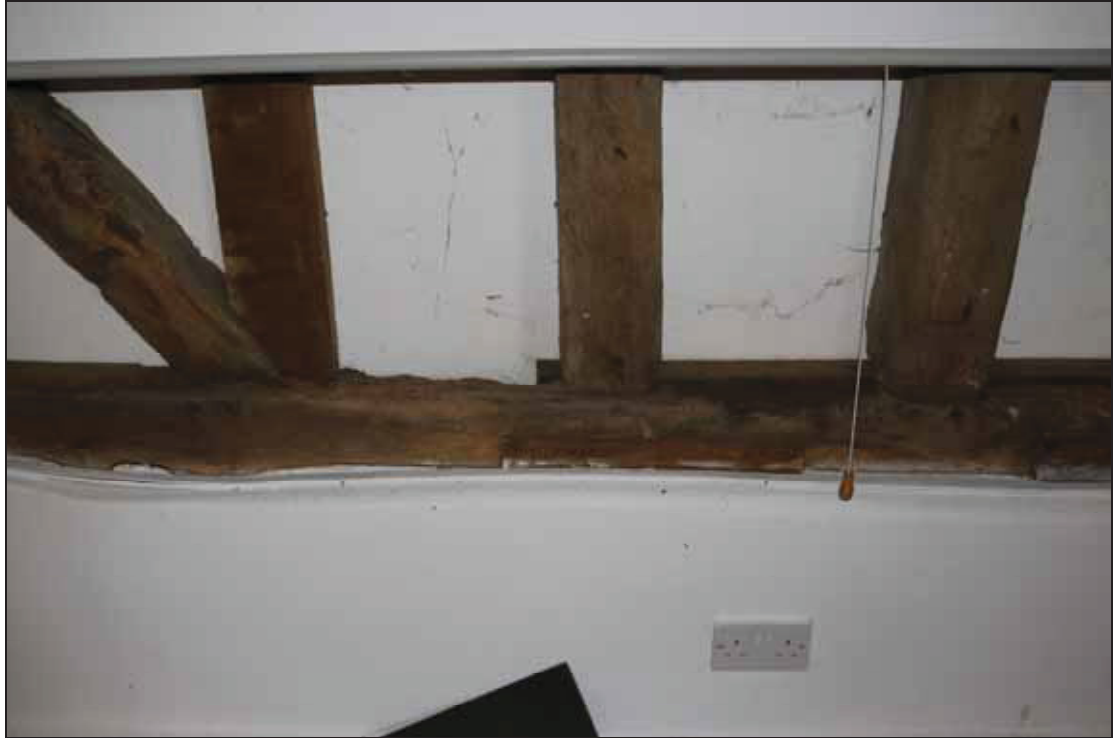
Plate 9 Studwork and sole-plate at the south-west end of Barn 1, taken from the north-east (DP 40)

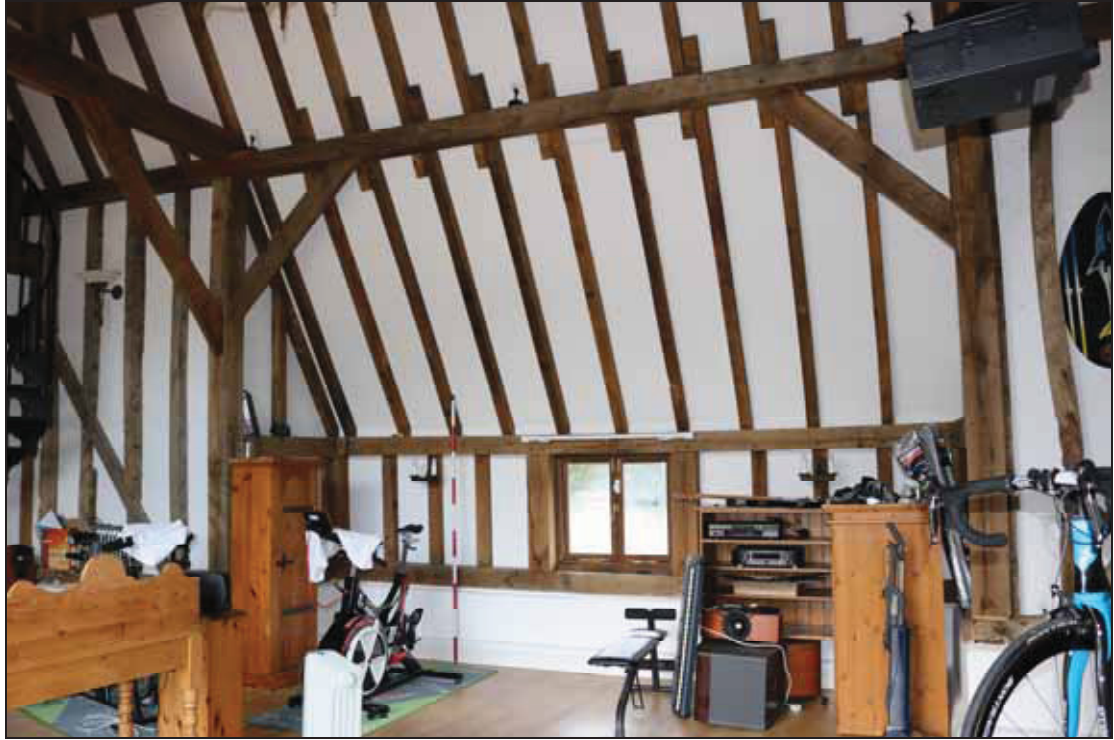
5.16 On the east side of bay 3 the sole plate is interrupted as this bay houses the catslide roof outshut, which is all modern (Plate 11). This comprises all clean-sawn timber, a sole plate and mid-rail which are both pegged. The bay division posts have also been replaced and are visibly mortised into the old sole-plate. Straight braces triangulate to the wall-plate. The rafter feet of the common rafters are visible below the wall-plate as the common rafters of the catslide roof are visible above.

Plate 11 Outshut on the south-east side of bay 2 of Barn 1, taken from the west (DP 29)

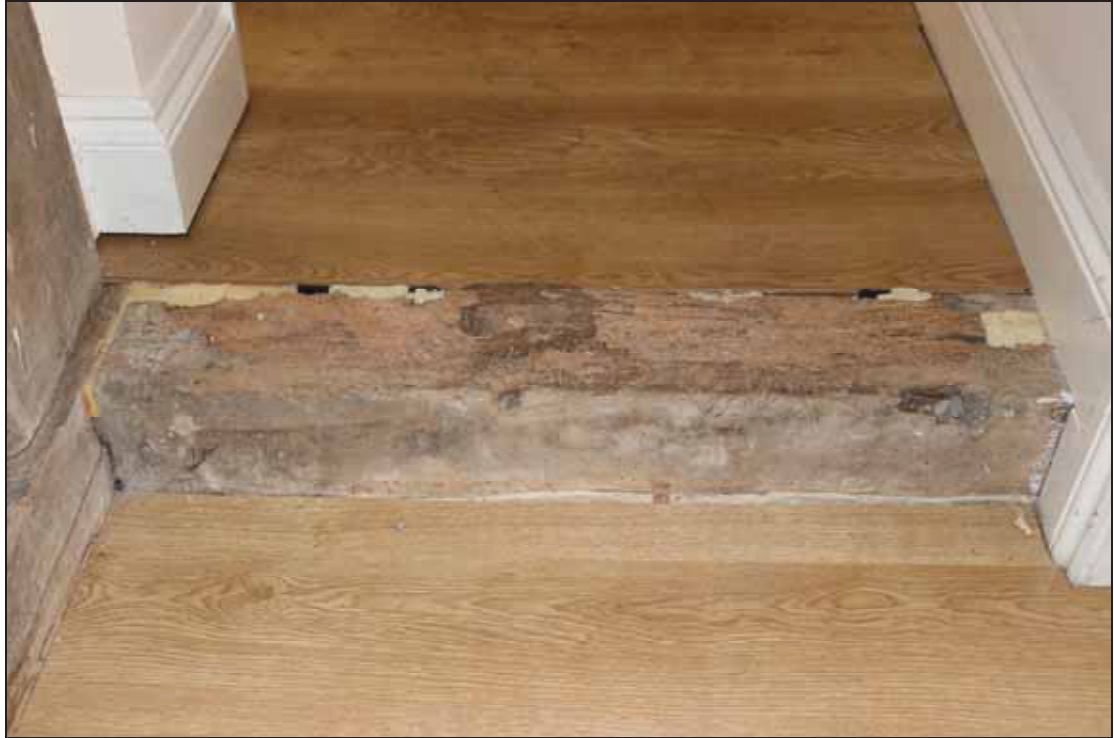
Plate 13 Surviving sole-plate of the original north-east end wall of Barn 1, taken from the south-west (DP 60)

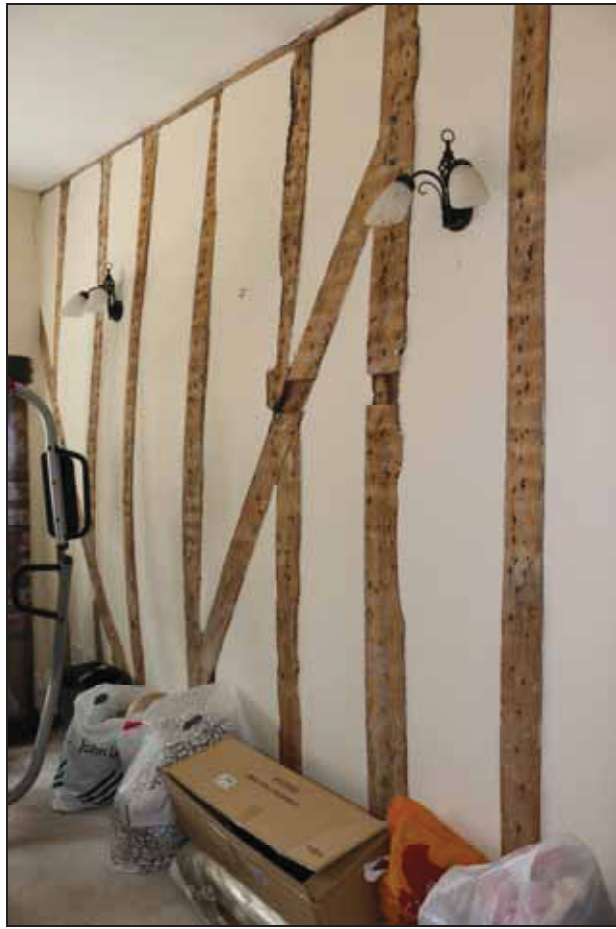
Plate 15 Original outer wall of Barn 1, taken from the north-west (DP 49)

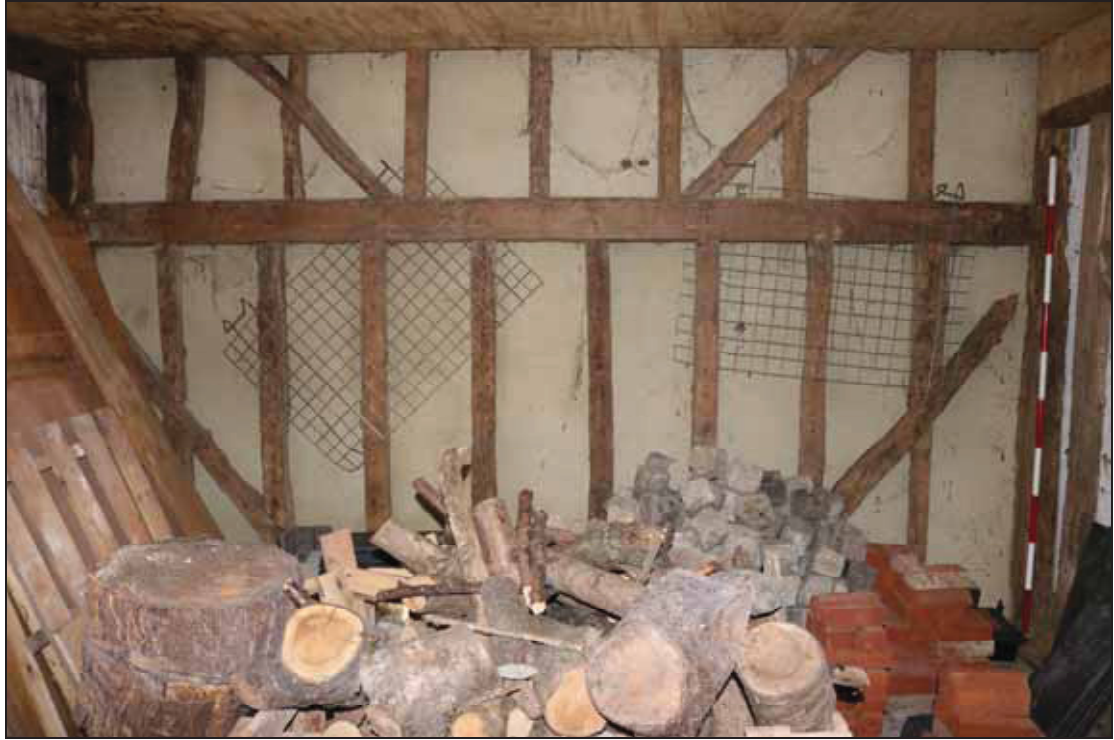
5.25 The west wall comprises two outer principal posts with upper and lower registers divided by a pegged mid-rail, where the upper and lower studwork is of the same form (Plate 17). The lower register has eight studs and the upper register seven but both display outer primary braces descending from the corners, the lower north brace decayed. The primary braces are very slightly cranked. The studs and braces are pegged to the mid-rail which has an unusual assembly marking system comprising half-crescent indentations. Behind the studs the wall has been plastered by hand with a grey lime mortar.

Plate 17 East wall of Barn 2 visible within the adjoining west room, taken from the east (DP 12)

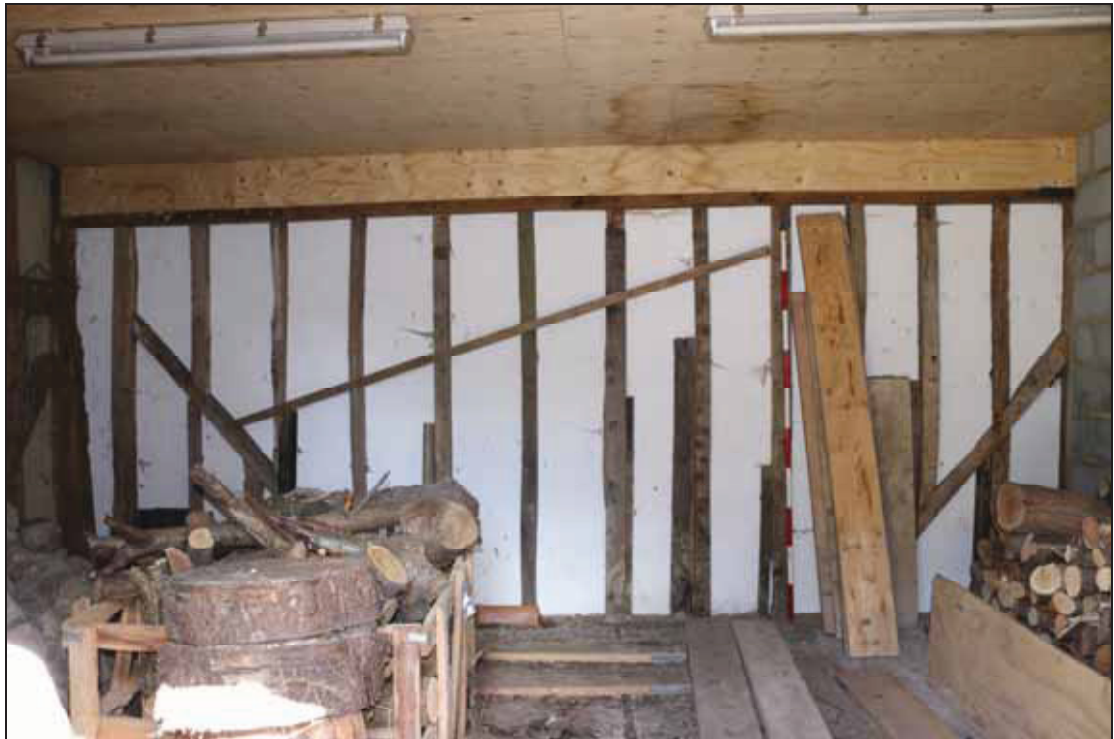
5.27 To the north the structural wall-plate of the outbuildings has been tenoned into the principal post of the main barn but is machine-sawn and is replaced (Plate 18). The original form survives in outline on the north, where thirteen slender studs rise from the concrete floor and are simply mortised and tenoned into the wall-plate, some have been additionally supported with nailed-on supports. Two primary braces descend from the two outer studs and are pegged. A single splayed and tabled scarf joint with under-squinted abutment and missing face peg is visible to the west, but is again anachronistic in this context.

Plate 18 North wall of the west room of Barn 2's outbuildings, taken from the south (DP 16)
