FORMER FLAX FACTORY, HARDWICK INDUSTRIAL ESTATE, BURY ST EDMUNDS, SUFFOLK

HISTORIC BUILDING APPRAISAL

Authors: Amy Goldsmith BA	
Kathren Henry	
NGR: TL 8570 6314	Report No. 2057
Parish: Bury St Edmunds	Site Code: BSE 274
Approved: Claire Halpin MIFA	Project No. 2243
Signed:	Date: June 2006

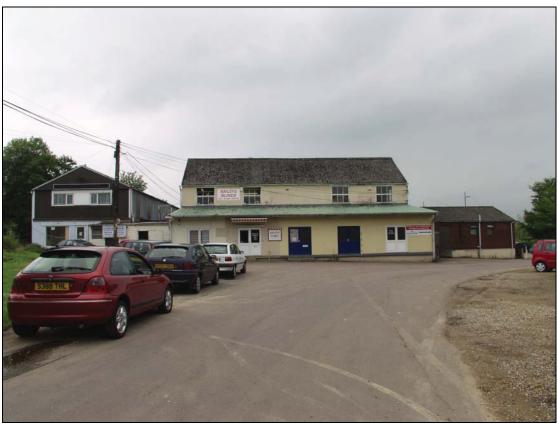
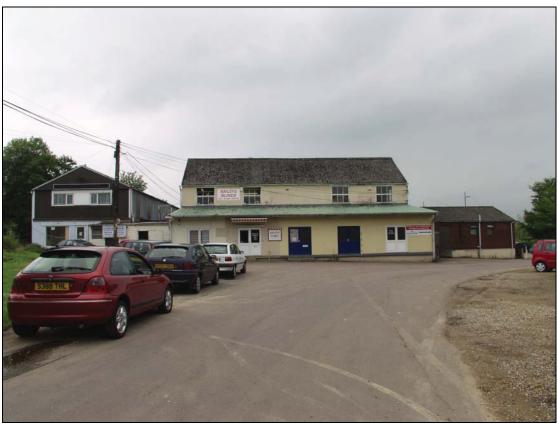
- 5.2.2 Unit 1 is a two storey structure constructed of brickwork laid in Flemish bond (Plate 1). The east elevation is obscured at ground floor level by a later lean-to structure but a photograph taken whilst the factory was in use shows its original appearance (Appendix 2.10). The east face of the lean-to has five identical modern two leaf doors with upper glazed panels, which lead to separate industrial units. The lean-to roof is covered with corrugated asbestos, rising above which is the first floor of the main build which contains four 3x2 pane windows. The roof of Unit 1 is covered with corrugated asbestos. The north elevation is adjoined by a more recent single storey Fletton brick and horizontally boarded structure. Above, the first floor has a tall window of two lights, each of 2x6 panes. The upper part of the window is now boarded over. The ground floor of the south elevation is obscured by a lean-to structure and the first floor like the north elevation has a tall window aperture, the lower part of which now contains a boarded door.

Plate 1 East elevation of Building Group 1, taken from the east (DP 77)

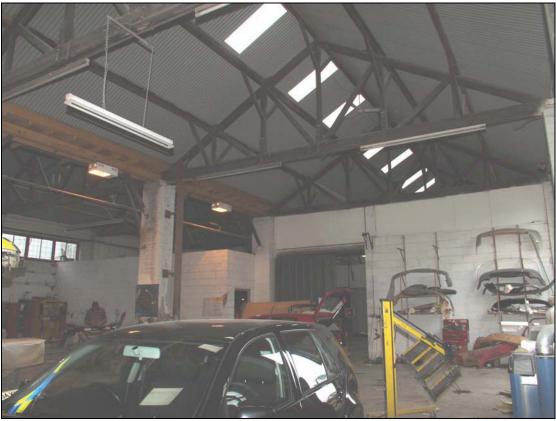
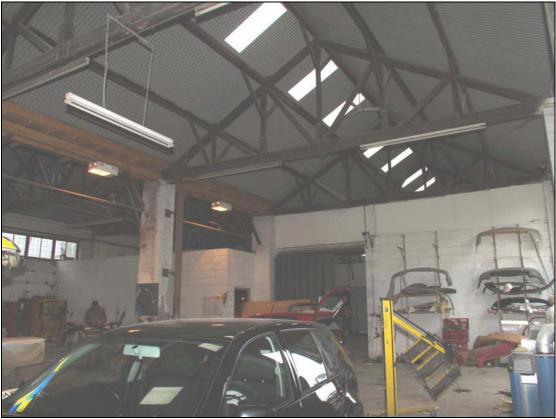
- 5.2.5 The interior comprises an open shed, now subdivided into two separate areas by a blockwork partition (Plate 2). There are two rows of roof trusses which are supported on buttresses on the outer walls and on brick piers down the building's central axis. Each roof truss is constructed of paired board-section timbers to form a tie beam with a central 'king post' and outer 'queen' and 'princess posts' secured to the tie beam by iron stirrups. Raking struts extend from these to the rafters which support two purlins in each pitch. Additional longitudinal braces extend from the trusses to the purlins and ridge board. There are several blocked apertures within the walls and an inserted doorway in the west wall leading into an adjacent lean-to. Surviving on the south face of two of the brick piers are two iron brackets which can also be seen in an old photograph of the building (Appendix 2.3).

Plate 2 Unit 2, Building Group 1, taken from the north-east (DP 85)

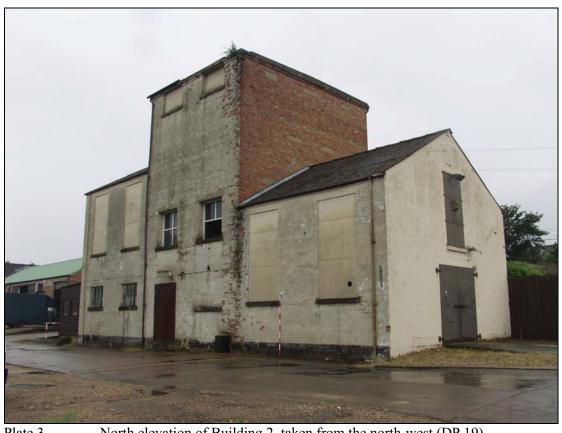
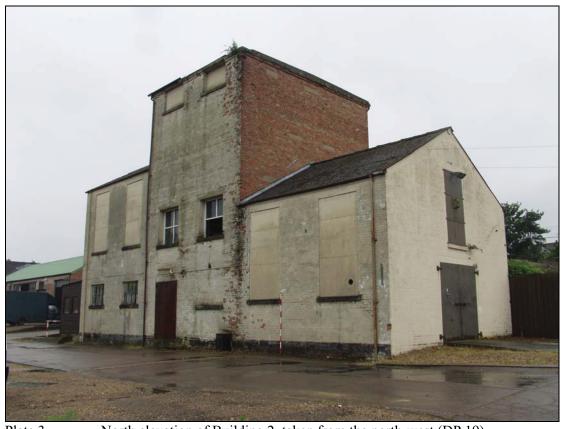
- 5.3.1 The north elevation of Building 2 comprises a tall three storey unit (Unit 2) flanked by a two storey unit to the east (Unit 1) and a single storey unit to the west (Unit 3) (Plate 3). The brickwork is painted and laid in English garden wall bond. Unit 2 has a ground floor doorway containing an iron door set off centre to the east and to its west is a blocked window aperture. Above, the first floor contains two window apertures although the windows themselves have been replaced and the second floor has two high set window apertures, now blocked. The roof is essentially flat and constructed of concrete. Unit 1 has two small ground floor windows each of three lights plus two tall first floor windows each of 4x6 panes. The west unit has two similar tall window apertures, now boarded over. The east and west units each have a corrugated asbestos roof.

North elevation of Building 2, taken from the north-west (DP 19) Plate 3

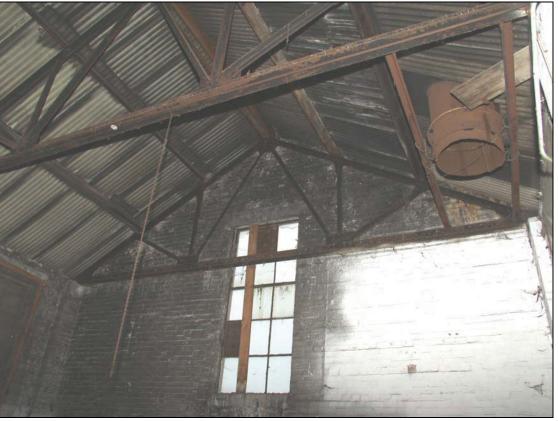
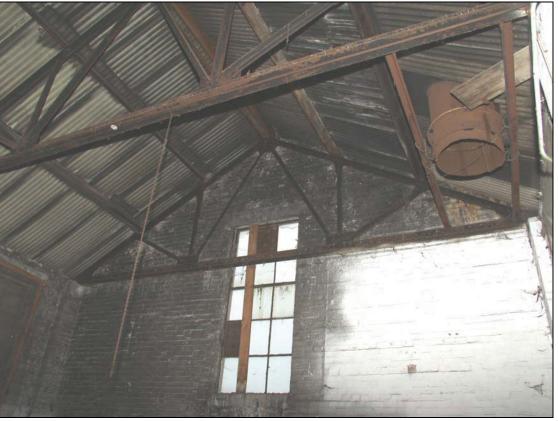
- 5.3.5 The ground floor comprises three rooms. Unit 1 comprises a ground floor and first floor room although it is clear that the floor is a later addition and that the room was once open to the roof. The floor is supported by three axial 'H' girders which have been inserted into the east and west walls. There is also a buttress in each the north-east and south-east corners and one on each the north and south walls. An old photograph taken when the factory was in production, shows two coal fired boilers situated on the south side of the room (Appendix 2.11). Two doorways now exist on the south side of the room which lead into the modern additions and a door at the north end of the west wall leads into Unit 2. Room 2 on the upper floor is reached by an inserted stair on the south side of the room. The buttresses seen on the ground floor continue to the wall head and support two roof trusses of angle iron and gusset construction. Each truss comprises a tie with two 'queen struts' on either side of which raking struts extend to the rafters and apex. Three timber purlins resting on cleats on the rafters are present in each roof pitch. High up on the west wall are two large down-flow pipes, the bases of which can be seen in Appendix 2.11 and within the roof is the remnant of a former chimney flue (Plate 4).

Room 2, Building 2 showing remnant of chimney flue from coal fired boiler, taken from the south-west (DP 6) Plate 4

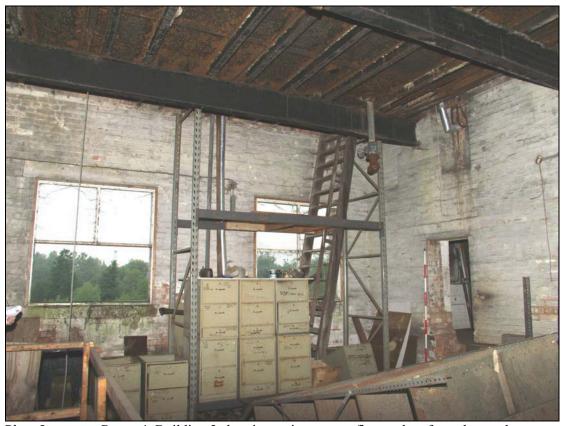
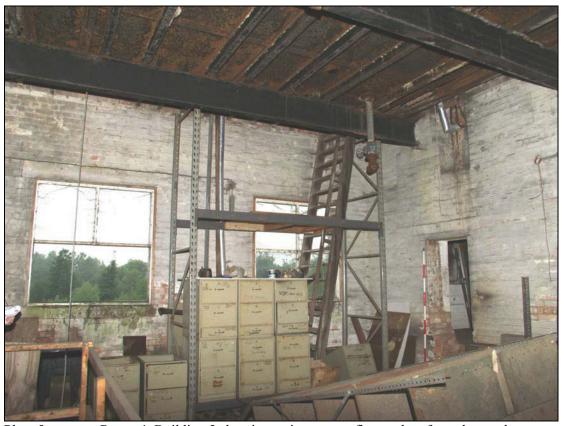
Plate 5 Room 4, Building 2 showing stair to upper floor, taken from the south-west (DP 10)

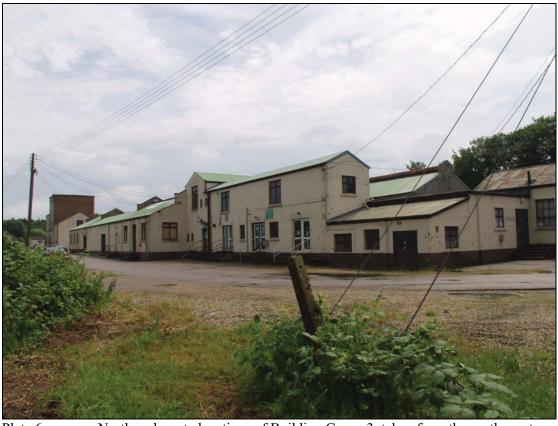
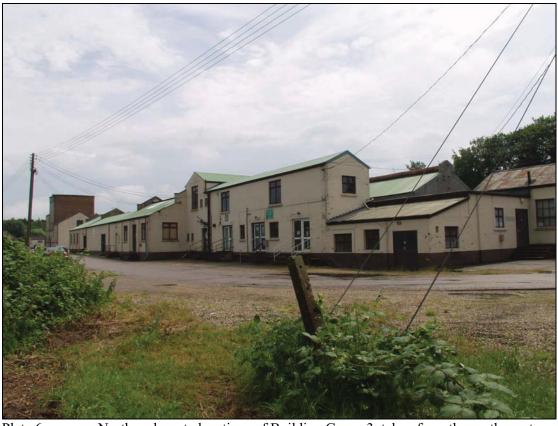
5.4.1 Building Group 3 comprises twelve adjoining units forming an east to west range (Plate 6). They are organised roughly back-to-back to either side of a lean-to unit which forms a central communication route. All units, unless otherwise stated are constructed of Fletton brickwork laid in English garden wall bond, which is now painted and have corrugated iron roofs.

Plate 6 North and west elevations of Building Group 3, taken from the north-west (DP 24)

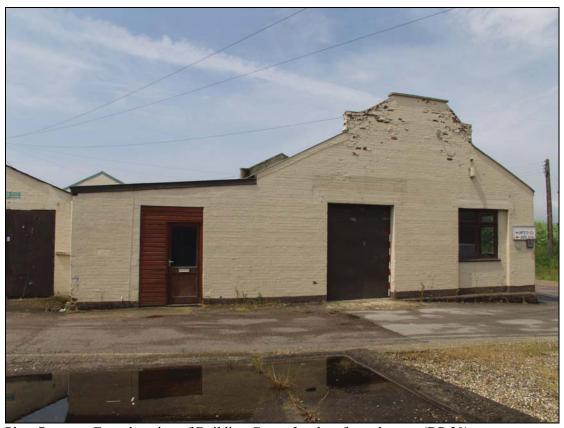
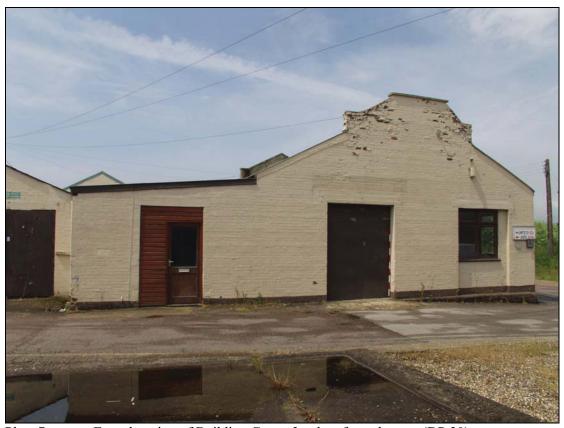
- 5.4.2 Unit 1 lies at the east end of the range and has shaped gables at both the east and west ends (Plate 7). All the windows are modern wooden framed replacements of two lights. The north elevation is defined by three pilaster buttresses and contains three windows. The east gable end contains one window inserted within a former wide doorway aperture and to the south is a modern sliding steel door. Adjoining to the south is the central lean-to unit which contains a modern doorway within a former window aperture.

Plate 7 East elevation of Building Group 3, taken from the east (DP 30)

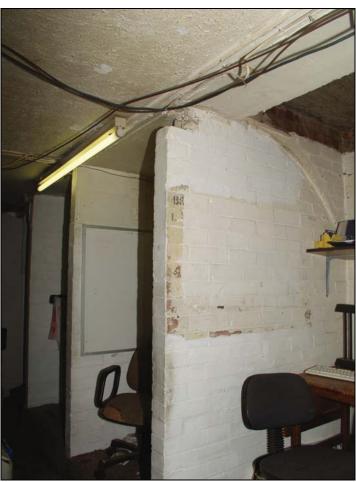
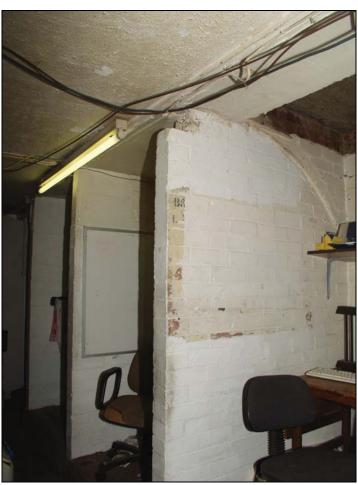
Plate 8

Unit 2, Building Group 3, taken from the north-west (DP 48)

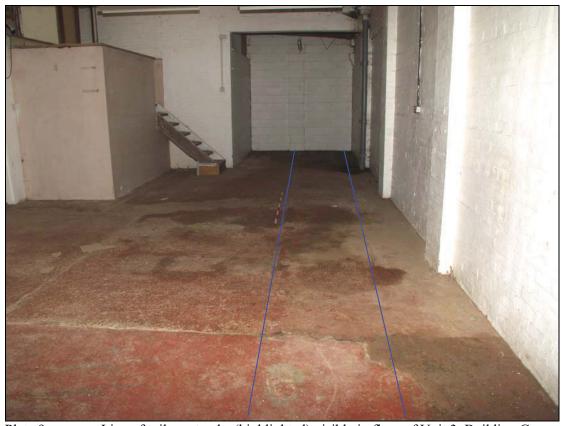
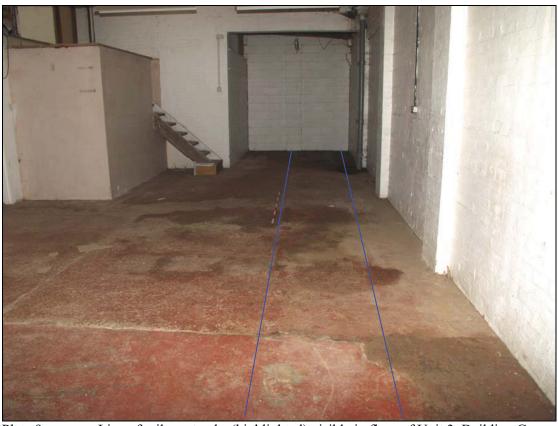
5.4.7 The interior has three roof trusses similar to those in Unit 1. Faint lines of railway tracks can be seen within the concrete floor running down the south side of the building (Plate 9) which may be those which are visible in the old photograph reproduced as Appendix 2.12. There is a blocked doorway to Unit 7 at the south end of the west wall..

Plate 9 Line of railway tracks (highlighted) visible in floor of Unit 3, Building Group 3, taken from the west (DP 51)

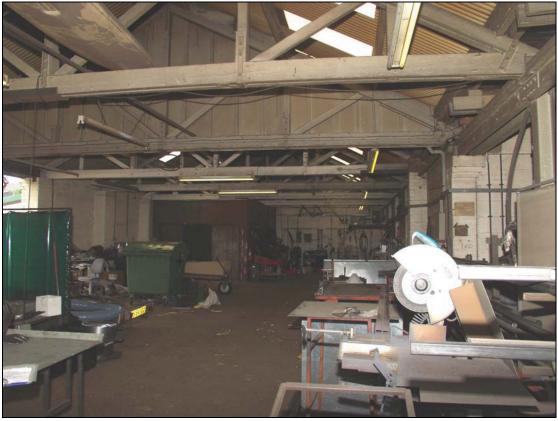
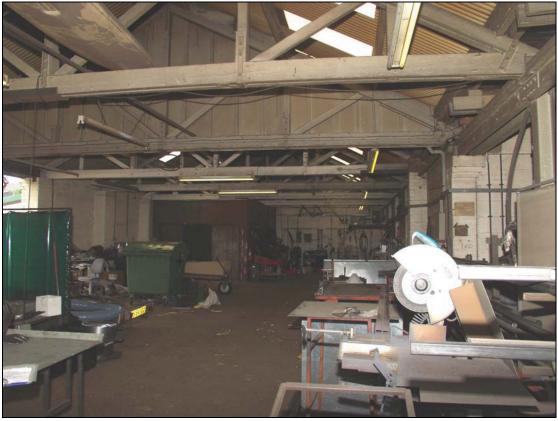
- 5.4.13 The interior comprises a large open shed with seven roof trusses supported on brick buttresses (Plate 10). The roof trusses are of similar construction to those in Units 1 and 3. The north wall of the easternmost three bays open into the lean-to unit which runs between the buildings. The roof at this point is supported as in Unit 1 by an 'H' girder which is in turn supported on corbelled brick piers and an 'H' iron stanchion. The east wall contains a wide inserted doorway and to the north a smaller original doorway, both of which are now infilled. Between the two is a 4x3 pane iron window. There is a doorway on the north wall in the fifth bay from the east, now boarded over and an inserted doorway on the south wall in the sixth bay from the east. The west wall contains a very wide blocked aperture with a central iron stanchion which can be seen in an old photograph of the building (Appendix 2.2). The large concrete lintel above the aperture has a decorative chamfer.

Plate 10 Unit 6, Building Group 3, taken from the south-west (DP 39)

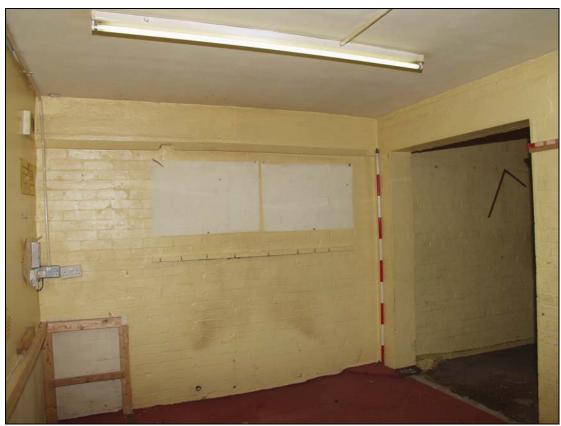
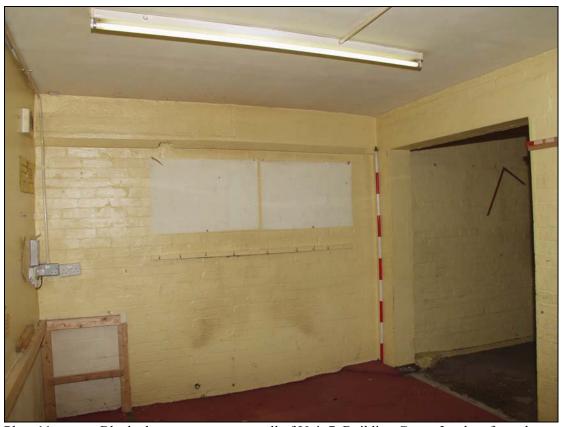
Plate 11 Blocked aperture on west wall of Unit 7, Building Group 3, taken from the south-east (DP 55)

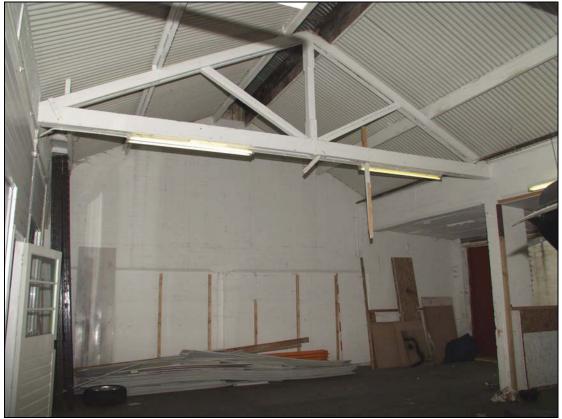
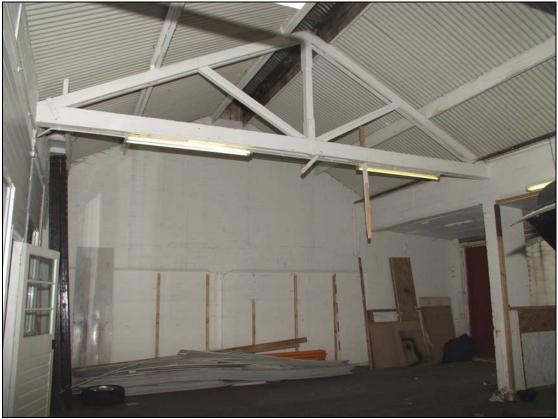
Plate 12 Blocked apertures at the west end of Unit 8, Building Group 3, taken from the south-east (DP 65)

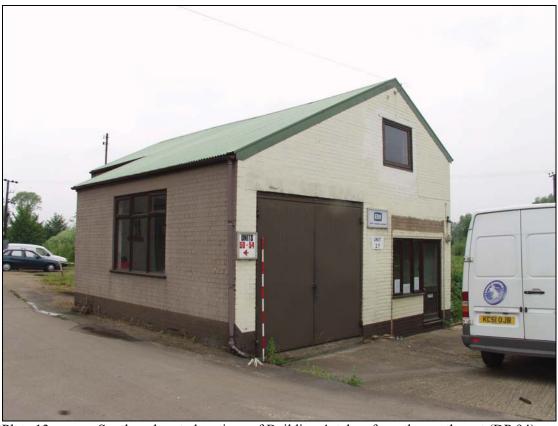
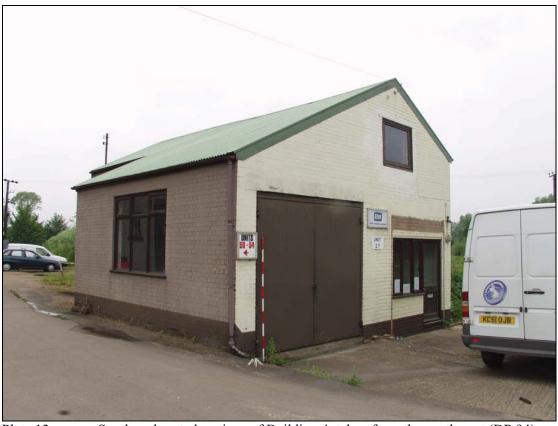
Plate 13 South and east elevations of Building 4, taken from the south-east (DP 94)

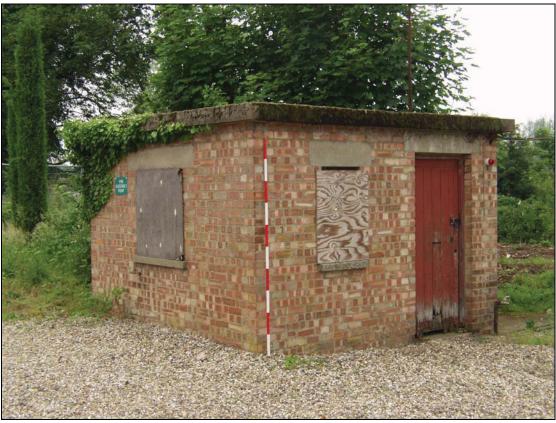
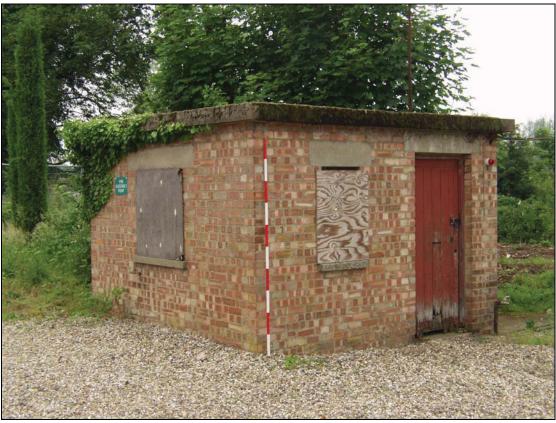
Plate 14 South and east elevations of Building 5, taken from the south-east (DP 95)
