AMWELL END, DOWN GREEN LANE,  
WHEATHAMPSTEAD, HERTFORDSHIRE  
HISTORIC BUILDING MONITORING AND RECORDING

Authors:	Tansy Collins BSc Kathren Henry	
NGR: TL 16762 13340	Report No. 4951	
District: St Albans	Site Code: n/a	
Approved: C. Halpin MCIFA	Project No. 5679	
Signed:	Date: 28 September 2015

## HISTORIC BUILDING MONITORING AND RECORDING

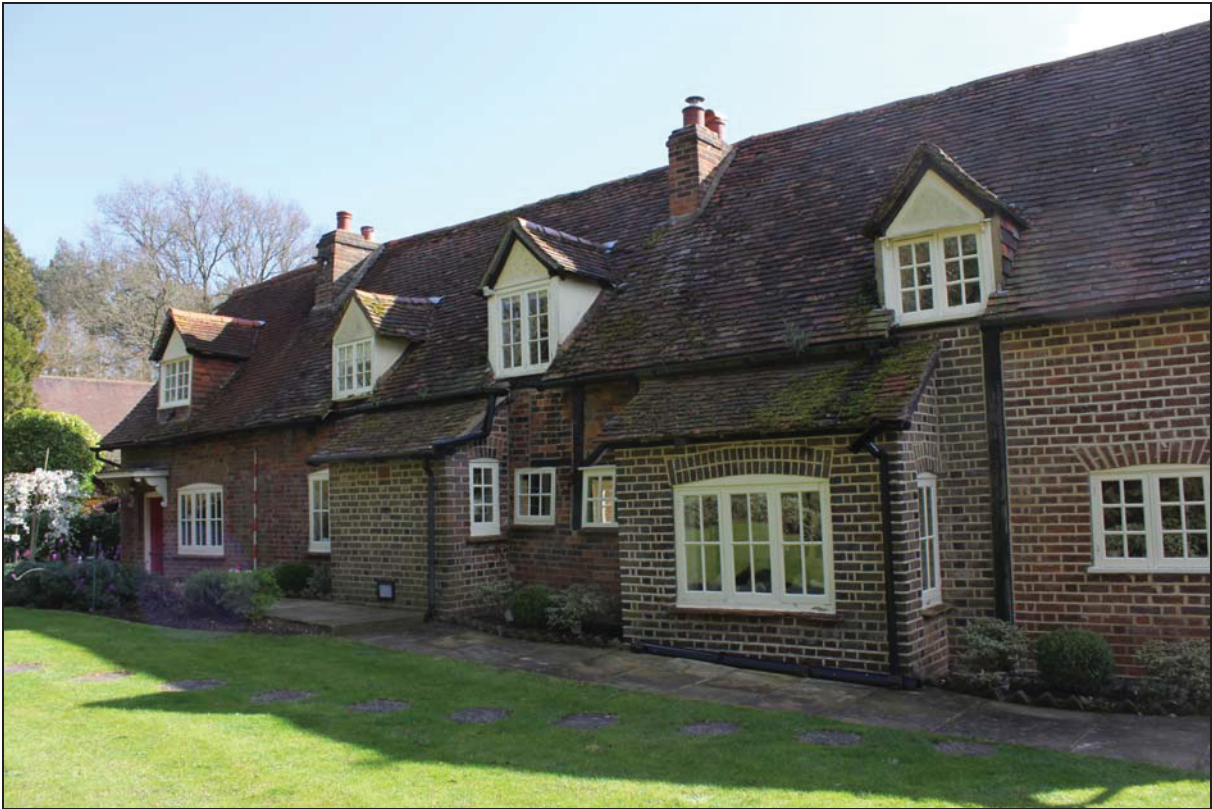
Plate 1 Principal west façade, taken from the south-west (DP 01)

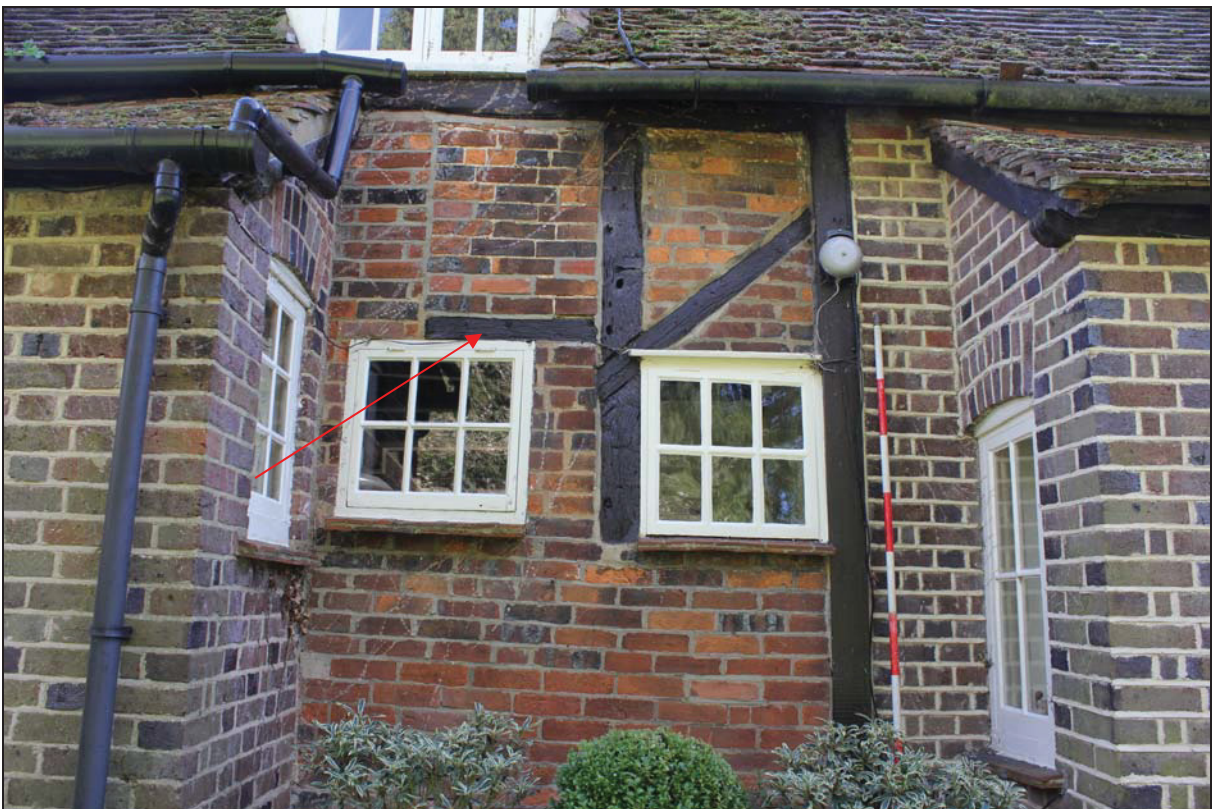
Plate 2 Section of the west elevation showing timber-framing infilled with brick and position of possible early window (indicated), taken from the west (DP 04)

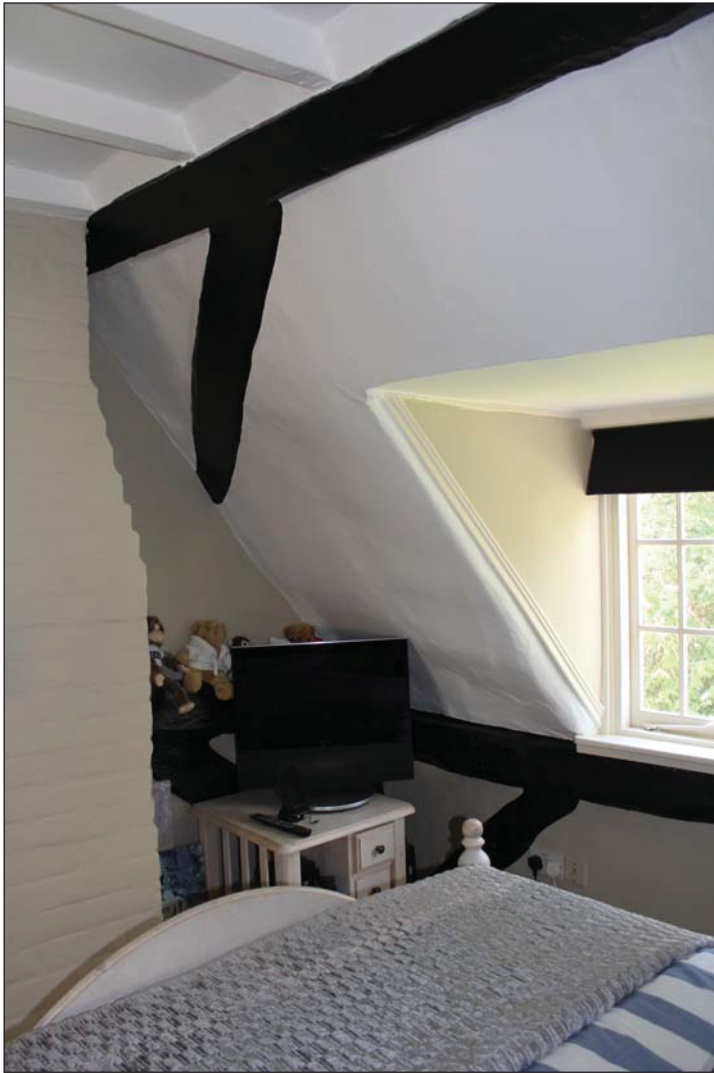
Plate 3 West side of Room FF07 showing exposed timber elements including a wind brace and lower inner brace, taken from the north-east (DP 24)

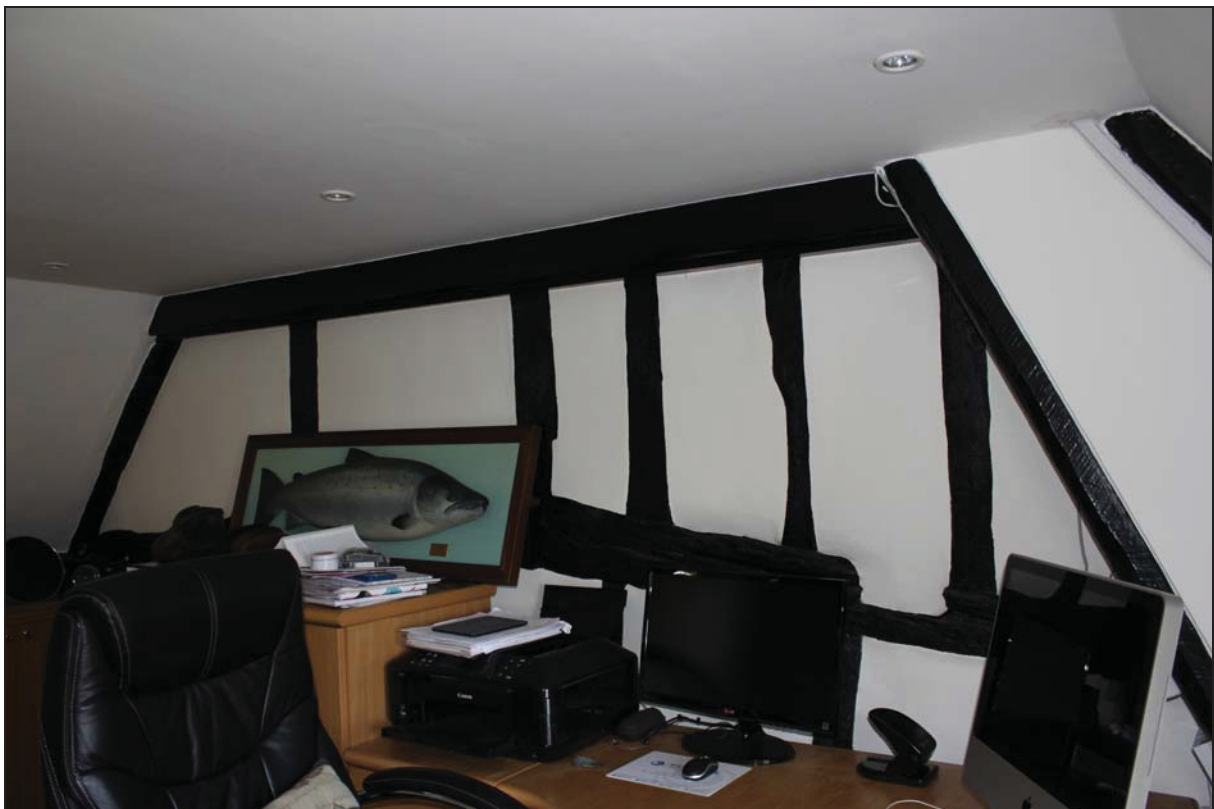
Plate 4 View of the south gable end of Range 1 exposed within Range 2 (FF08), taken from the south-east (DP 22)

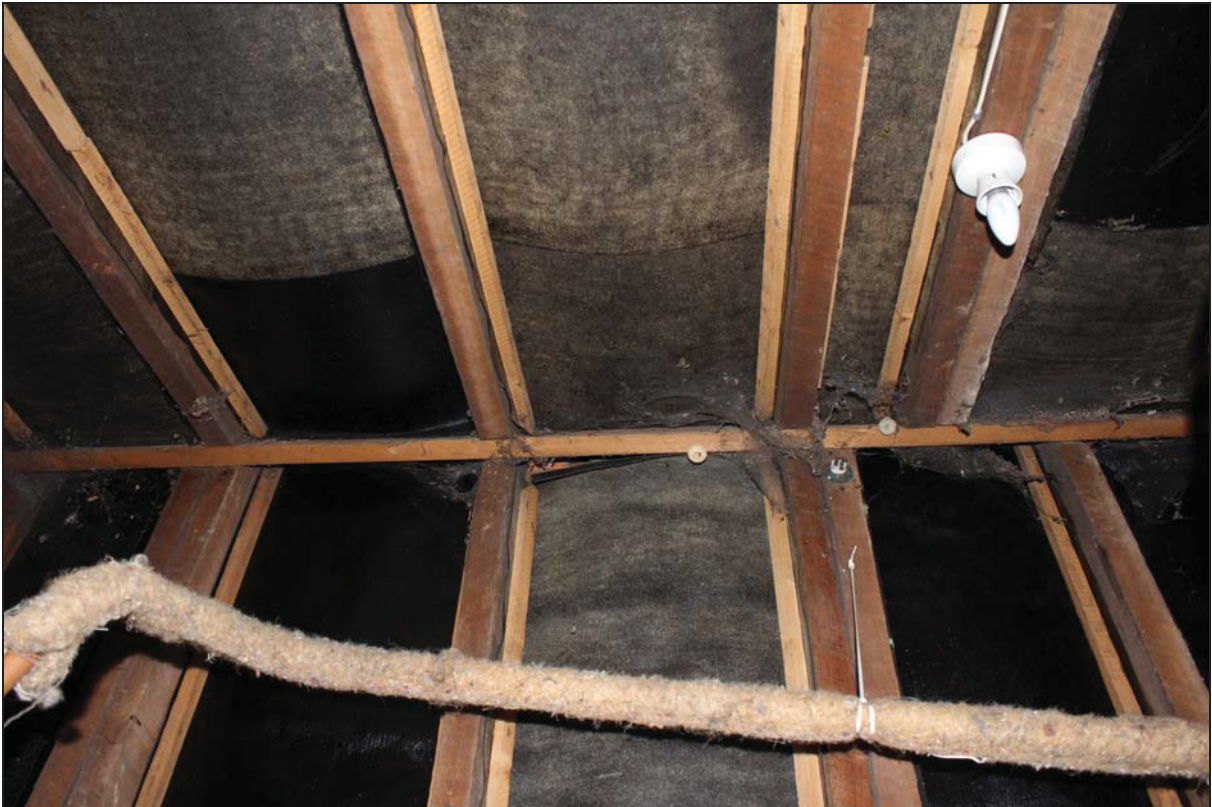
Plate 5 View of the roof apex in the south end of the main range, taken from the west (DP 14)

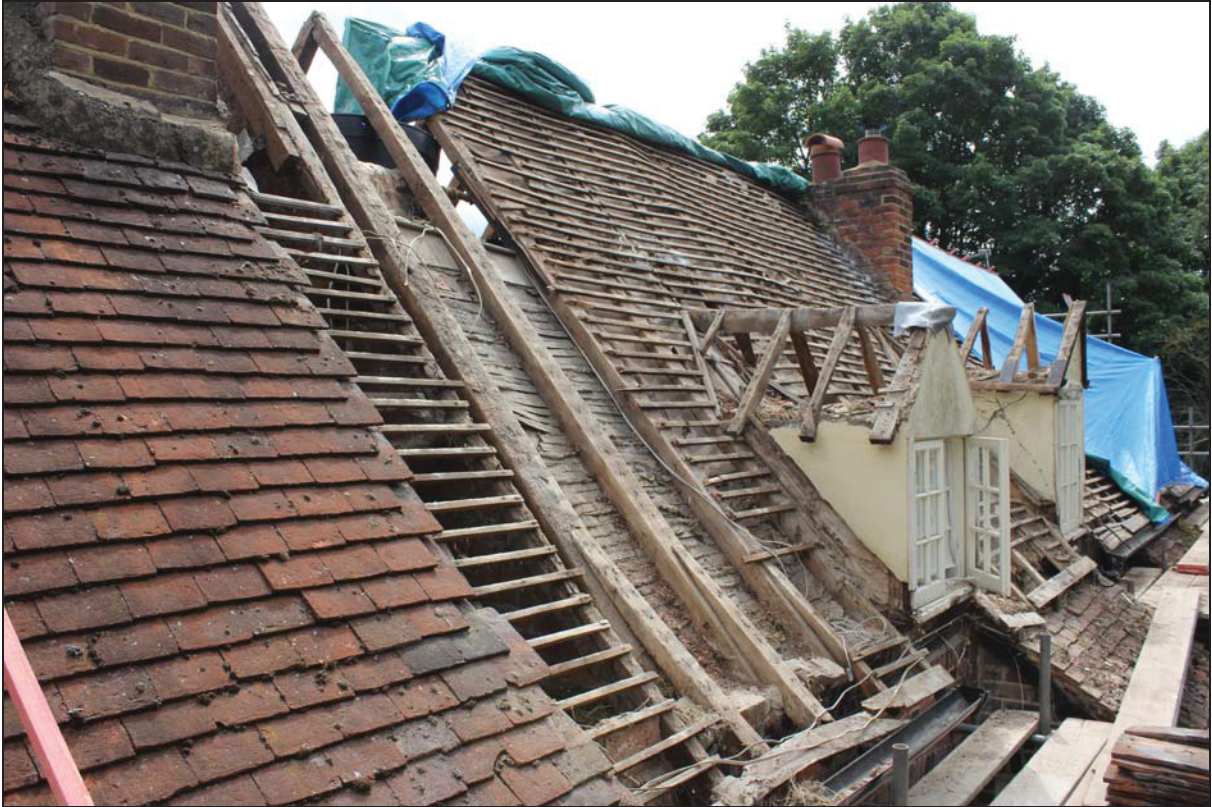
4.26 The roof is constructed of side-axed oak members that all survive in good condition, although a number have been truncated for the insertion of dormer windows or chimney stacks (Plates 6 and 7). Truss 1 (labelled on Fig. 4) forms the north gable end of the historic core and the north side of Bay 1. This presents the clasped side-purlin form of the roof as noted from within and includes a tie-beam with principal rafters to a pegged bridled joint at the apex. Robust purlins are visible clasped by a single-pegged collar. The principal rafter on the west displays an assembly mark of a I with a tag. There are three studs below the collar and a single upper stud to the apex. Below the collar is infilled with large orange bricks, one or two were accessible and measure 8" x 2" (203mm x 51mm). The east side is obscured where it is adjoined by Range 5.

Plate 6 West roof pitch of the historic core showing exposed rafters and dormer windows, taken from the north-west (DP 47)

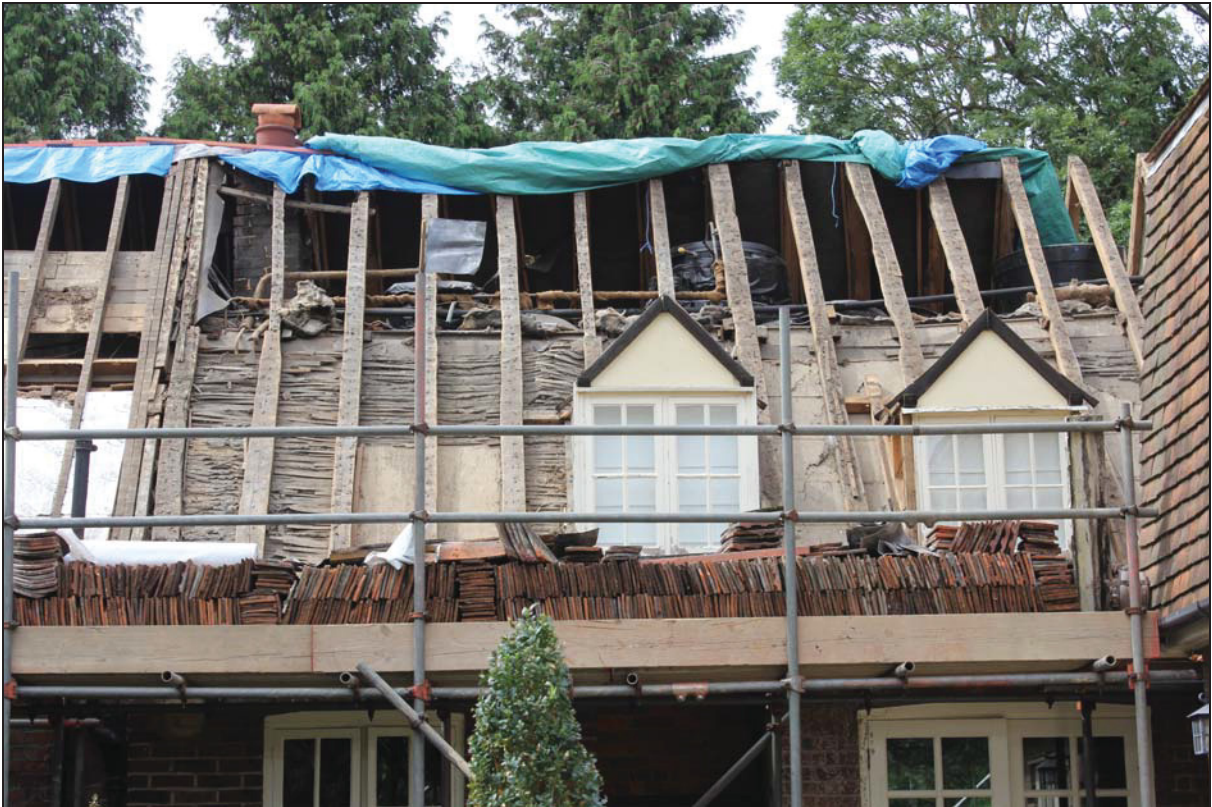
Plate 7 View of the east roof pitch of the historic core, taken from the east (DP 86)

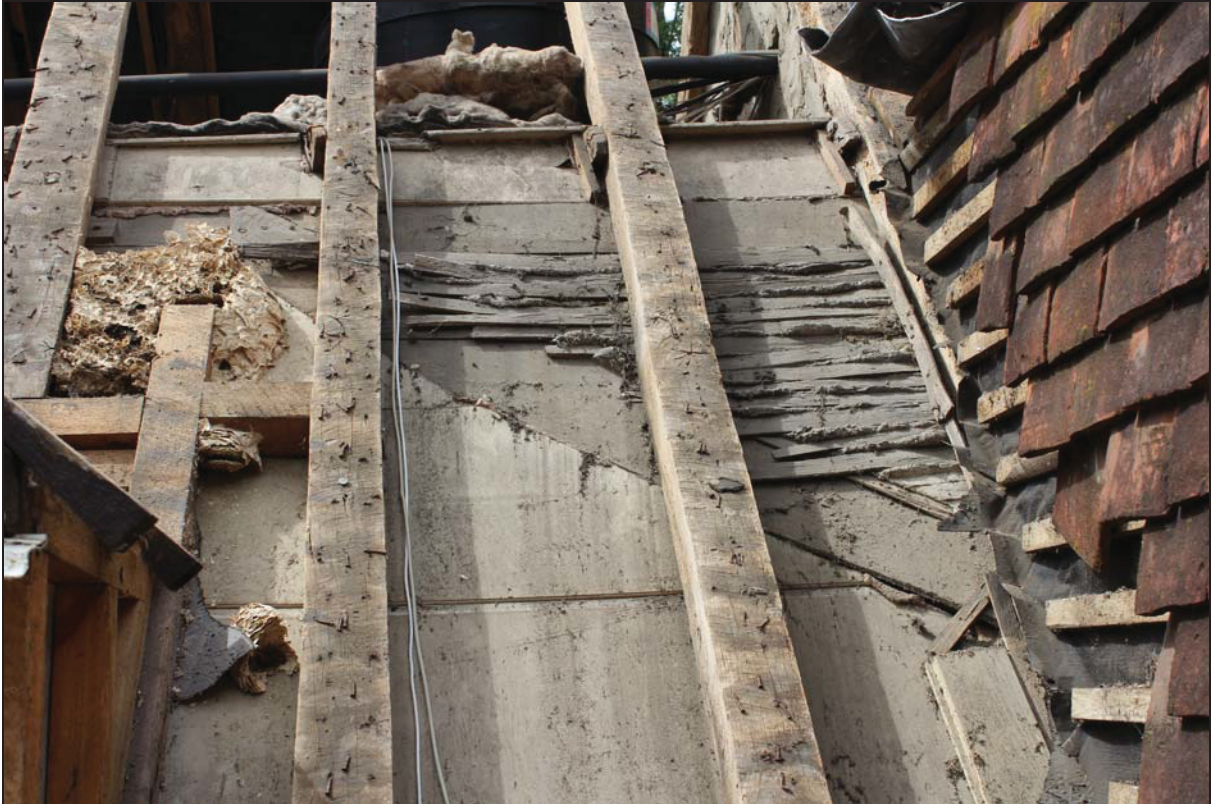
Plate 8 East roof pitch of the historic core (Bay 1: north end) showing wind brace with lath and plaster above and replacement boarding below, taken from the east (DP 77)

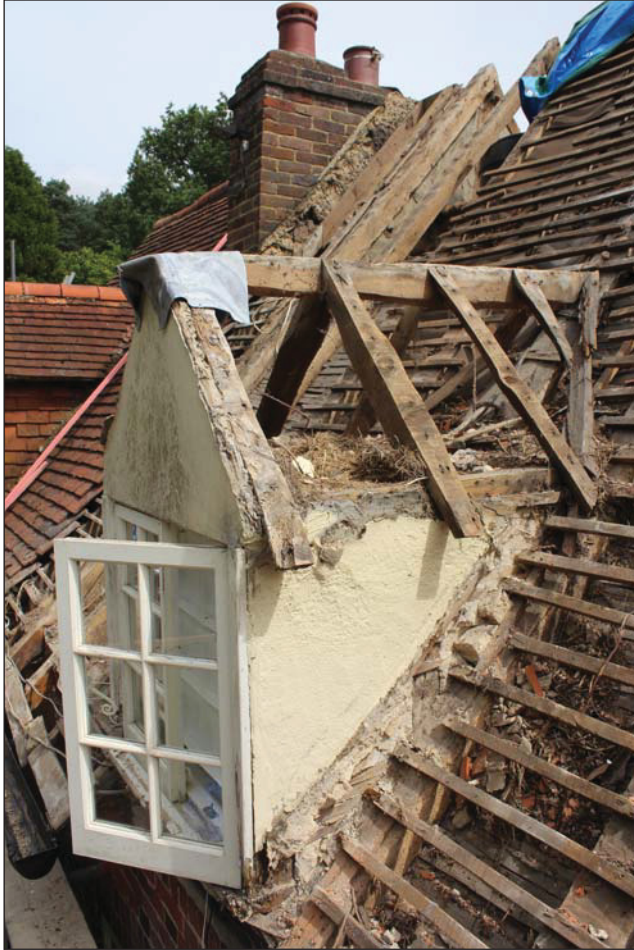
4.30 The dormer window on this west side is a later, probably 19<sup>th</sup> century insertion and truncated the fourth rafter from the north (Plate 9). The tiles have been removed exposing waney slender rafter couples of probable oak to a ridgeboard to which they are nailed with hand made nails. The casement itself is modern, but the cheeks of the dormer, where the lead flashing has been removed, appear to be of contemporary studs with lath and plaster over. The north side appears to have been repaired. On the opposing side, an inserted modern dormer window truncated two of the original rafters.

Plate 9 Dormer window (Bay 1: west side),  
taken from the south (DP 56)

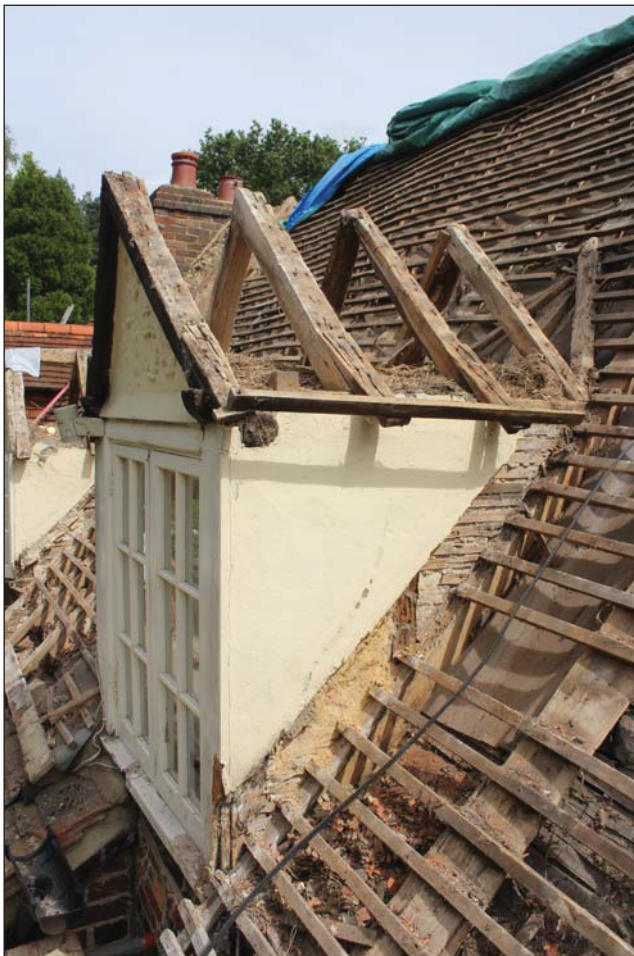
4.33 The dormer window on the west side, however, is much earlier than those noted above, and includes four rafter couples rising to an apex with no ridgeboard (Plate 10). The principal rafters framing the gable end are bridled and pegged at the apex, while the remaining three are halved at the apex and unpegged. Sprockets are present to the rafter feet. The wall-plates project to either side and are simply shaped. The infill of the gable end is modern and consists of modern steel mesh with cement render. A date of 1756 is picked out in the cement render with impressed pebbles (Plate 11). The form of the roof structure is consistent with an 18<sup>th</sup> century date and although the existing date is modern, it is not unreasonable to suggest this replicates a previous date in this position and reflects the date this dormer was added.

5.5 The dormer windows were inspected as part of the assessment of the roof. All were found to be of limited interest with one exception. This comprises the dormer on the west side of the southern bay (Bay 2) of the historic core. It was constructed with no ridgeboard and instead comprised oak rafter couples halved at the apex with the principal pair bridled and pegged. The cheeks retain some early fabric, while the gable and casement itself are modern. A date of 1756 is marked in the gable infill and although the fabric is modern, the structural fabric of the dormer is consistent with that date and it is likely that the date replicates an earlier incarnation. The remaining dormer windows are either earlier 20<sup>th</sup> century or modern.

Plate 10 Dormer window (Bay 2: west side),  
taken from the south (DP 61)

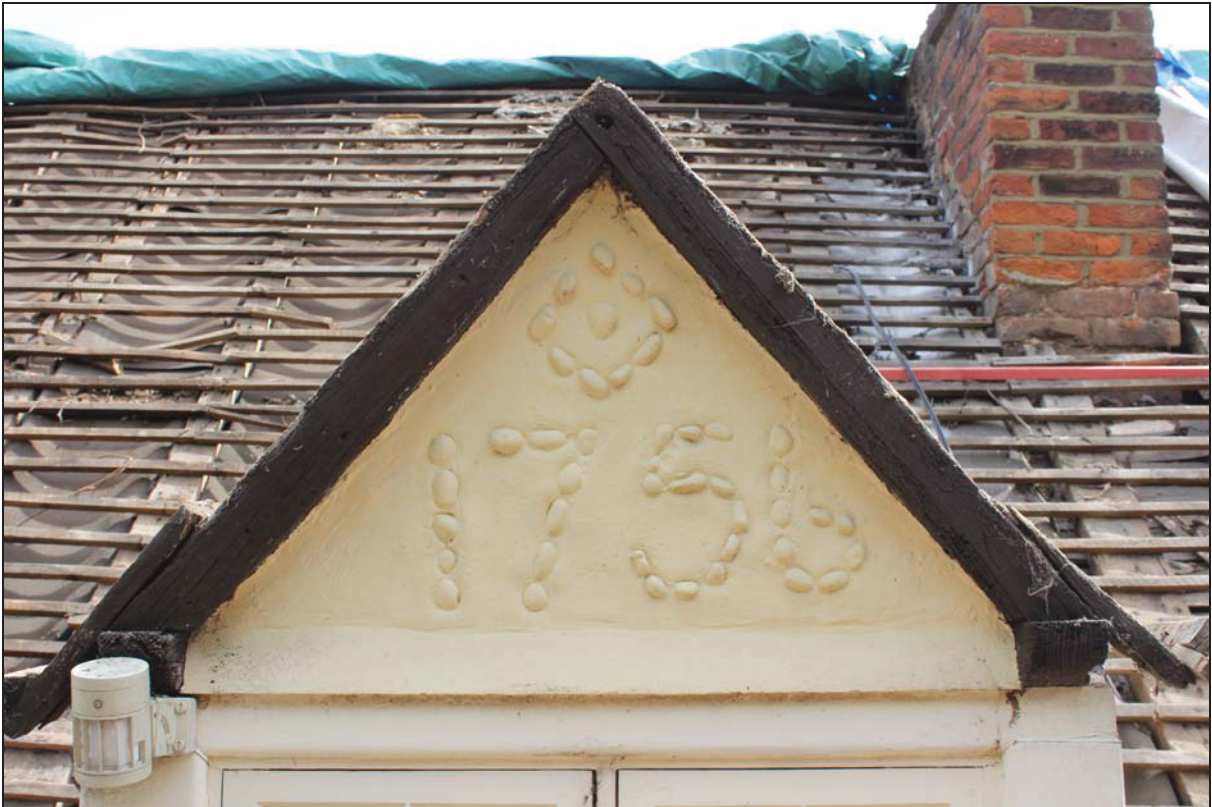
Plate 11 Detail of the dormer window (Bay 2: west side) showing gable with modern cement render infill and an early date, taken from the west (DP 59)

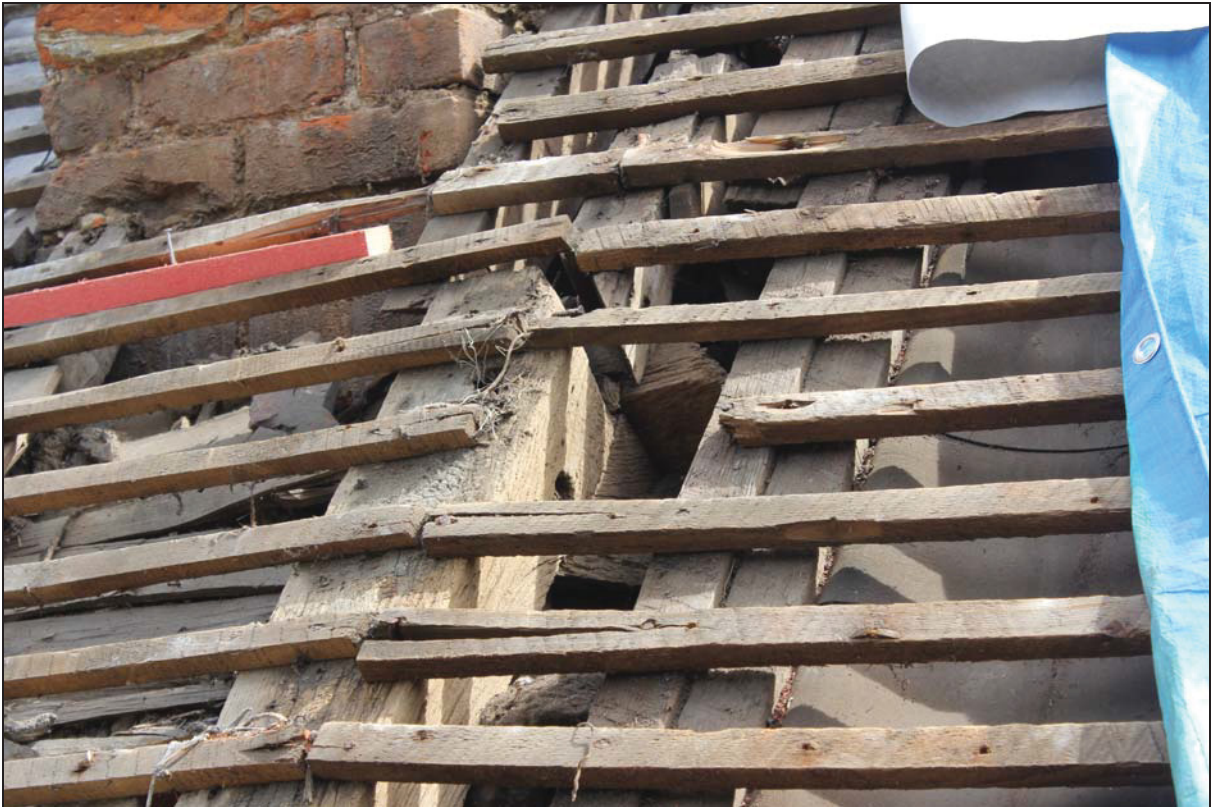
Plate 12 West roof pitch of the historic core (Bay 1: south end) showing principal rafter with pegged collar and weathered projecting purlin end, taken from the west (DP 67)

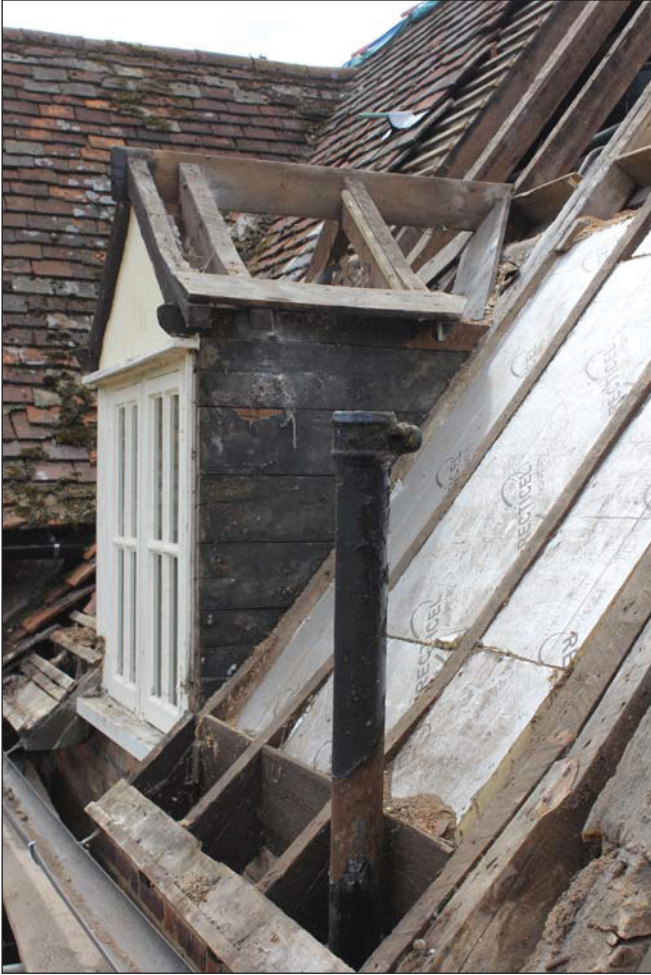
4.36 Inspection of the exposed roof structure over the southern ranges reveals that the entire roof structure over Range 2 was replaced in the early 20<sup>th</sup> century and appears continuous with the roof over Range 3. It is all of slender, circular sawn softwood construction consisting of rafter couples to a ridgeboard. These rafters measure 2" x 4" (51mm x 102mm). A dormer on this side is likely contemporary with the roof structure and of early 20<sup>th</sup> century date with horizontal boarded cheeks (Plate 13).

Plate 13 View of the east roof pitch of the historic core, taken from the east (DP 86)

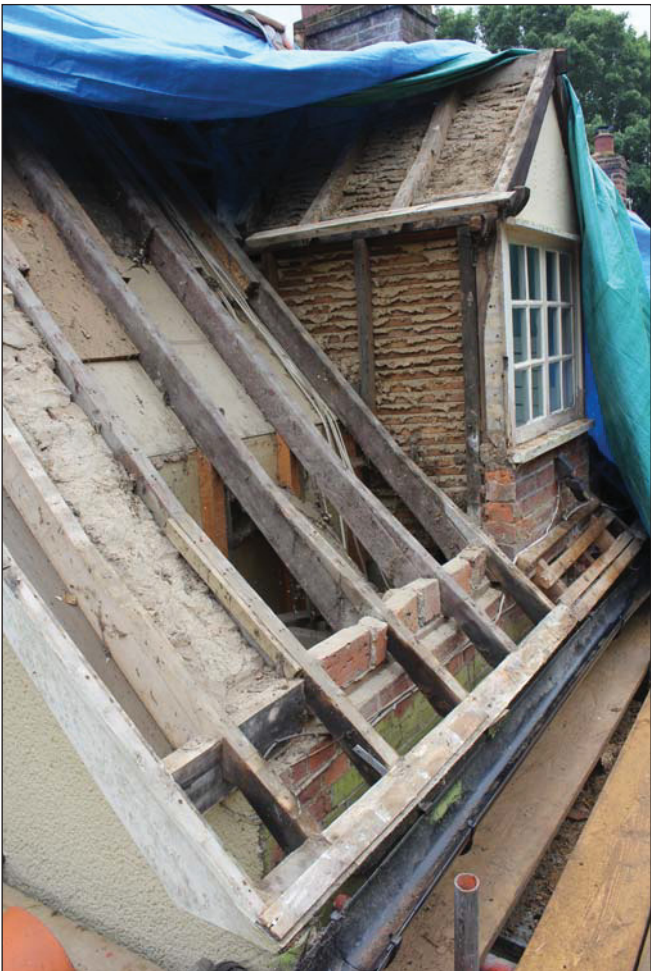
Plate 14 West roof pitch of Range 4 showing dormer window, taken from the north-east (DP 89)
