CENTRAL MALTING, NEW ROAD, WARE,  
HERTFORDSHIRE

HISTORIC BUILDING APPRAISAL

Authors: Matthew Williams MA MSc Lee Prosser BA PhD	
NGR: TL 3603 1433	Report No. 3149
Parish: Ware	Site Code: AS 1163
Approved: Claire Halpin MIFA	Project No. 3260
Signed:	Date: September 2008

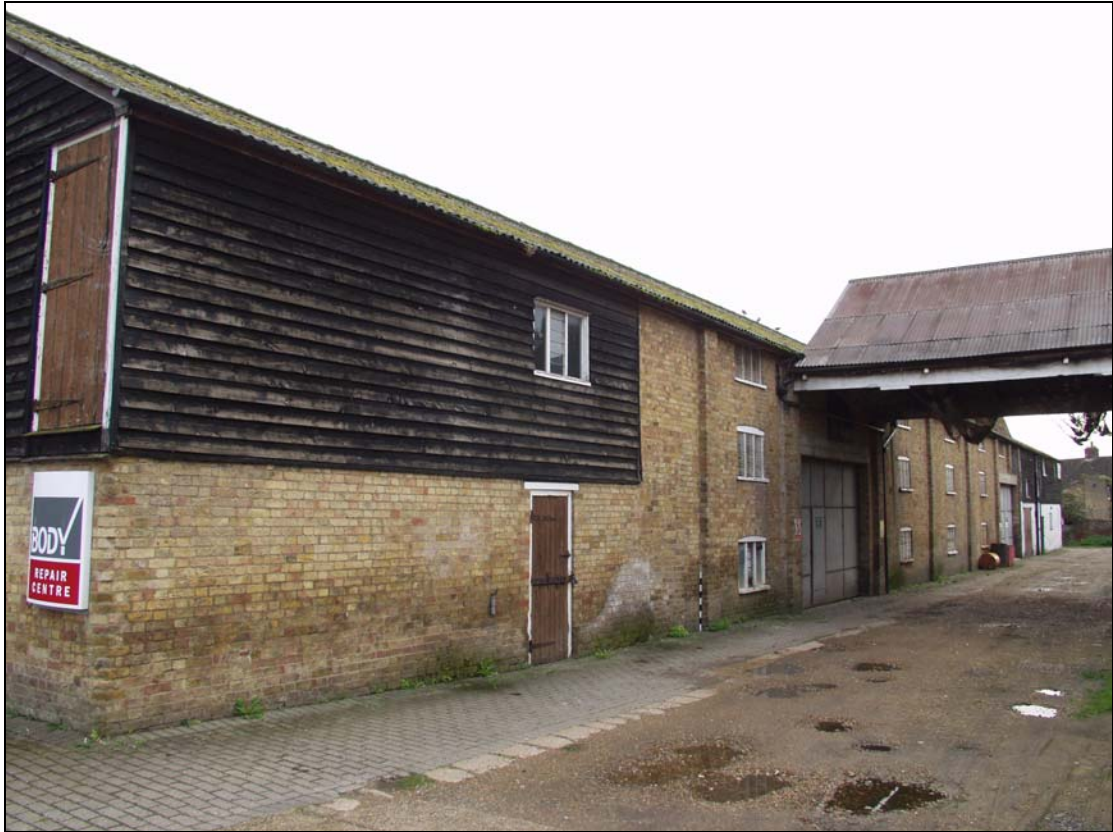
pink, but the south façade has been pressure-washed, leaving the bricks pitted and porous.

1 Southern elevation taken from the south-west (2)

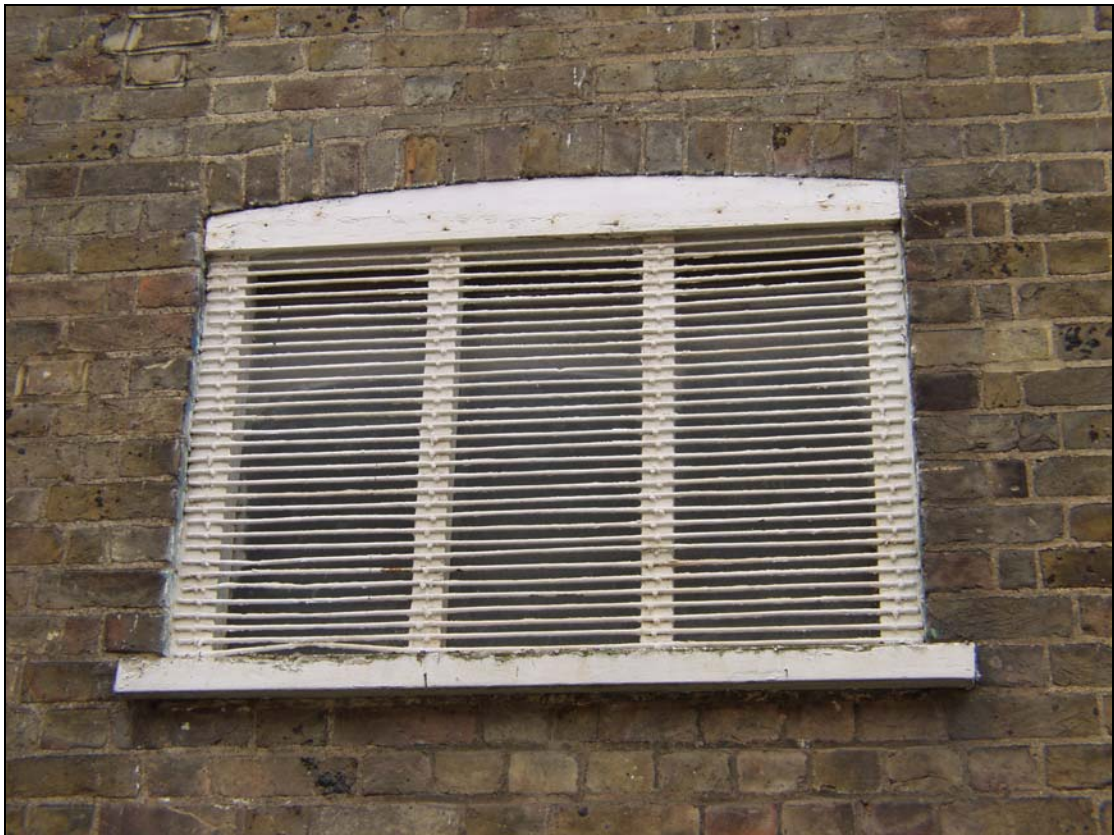
5.2.3 The original window form survives through much of the building with wide apertures in the typical malting pattern; with cambered voussoirs and timber sills, divided into three lights by simple mullions. Many preserve fine, closely-spaced horizontal bars, though a few have been replaced with glass (Plate 4). On the south elevation, the original mid-section loading bays have been modified by expanding the apertures to full bay width and inserting a concrete lintel, but the original upper loading doors survive.

4 Typical central section window taken from the north (39)

7.2 Externally, several historic features would be affected. The window joinery and bars of the typical malting windows would disappear and be replaced by glass, though the overall appearance would be unaffected. The north loading doors and their corresponding position on the south would be replaced by windows. Pressure washing of the brickwork on the north elevation (as has occurred on the south) is inadvisable (if it is advocated as part of the proposal), as this removes the fire-face of the brick, and exposes the fabric to accelerated decay. A number of new windows are proposed, though these are few, and not considered to be detrimental.

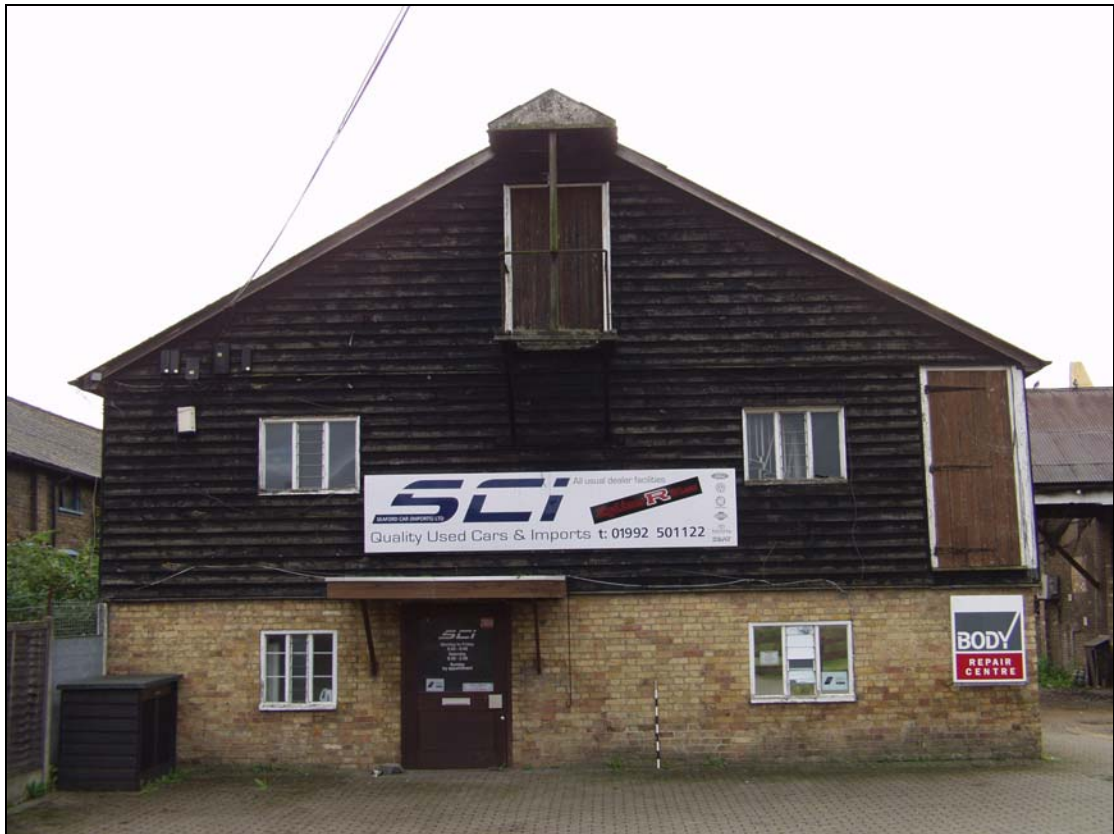
5.2.4 The west gable is weatherboarded and retains a small roofed loading platform as on the flanking maltings; these are clearly later, but at the south-west corner an original loading door with three strap hinges on pintles survive, also matched on the companion buildings (Plate 5).

5 Western elevation taken from the west (1)

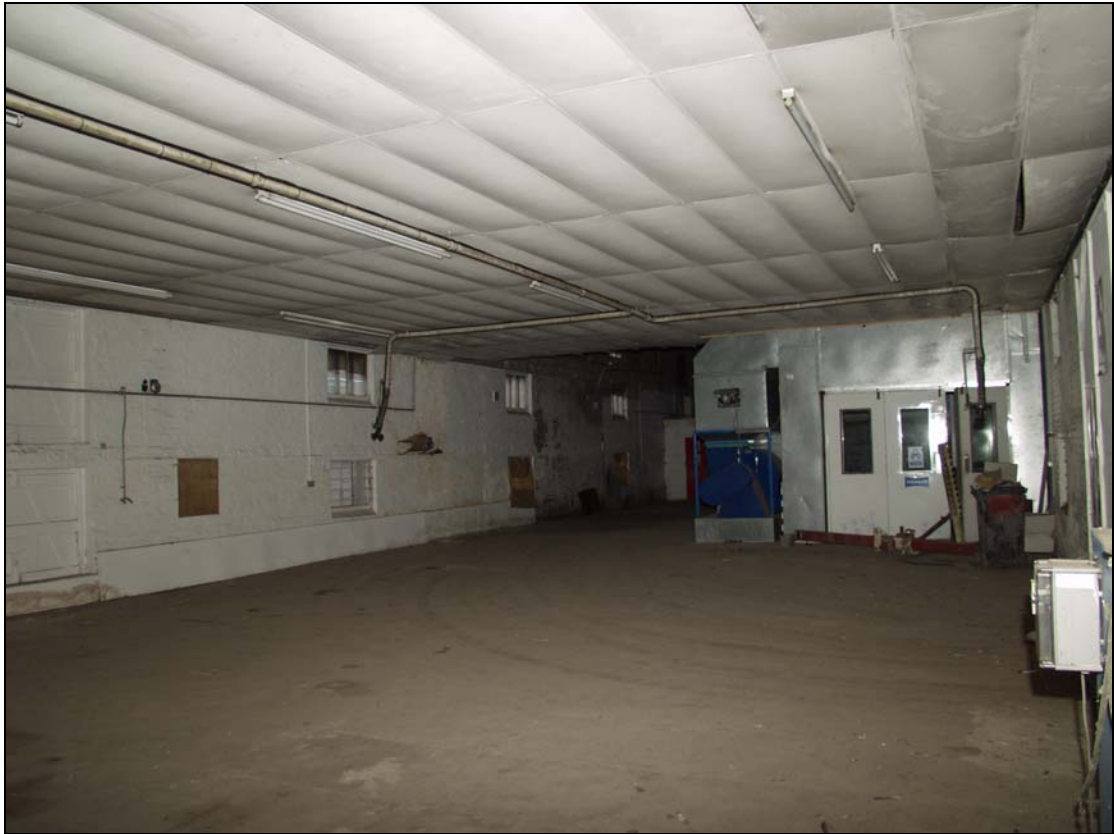
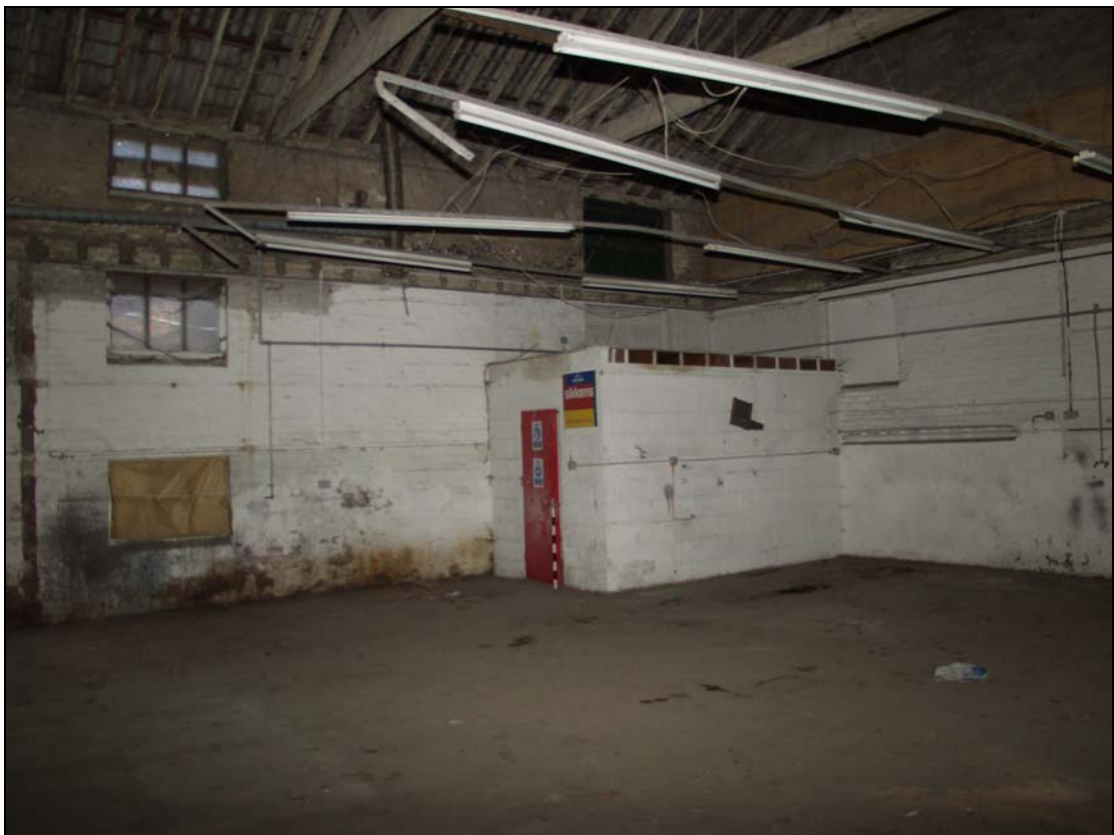
5.3.2 The central nine bays are now open to the roof, though partly obscured by a flimsy modern suspended ceiling in parts (Plates 7 and 8). The window configuration survives and the blocked sockets of closely spaced former floor joists are visible on two levels indicating the position of the floors. The exposed brick walls retain some traces of limewash at the upper level. Interestingly the windows are not spaced symmetrically with respect to the roof, so that trusses occasionally rest at points of structural weakness on window heads. The south central bay, as noted on the exterior, has lost its lower loading doors but these survive on the north side. Similar doors at the east end are partially obscured by a later store room but those at the west end are easily accessible (Plate 9). They are double braced and ledged with original iron bolts. Their small size suggests that the upper and middle floors had very little headroom.

7 Internal view of central area taken from the south-west (6)

8 Internal view of eastern section of central area, taken from the south-west (11)

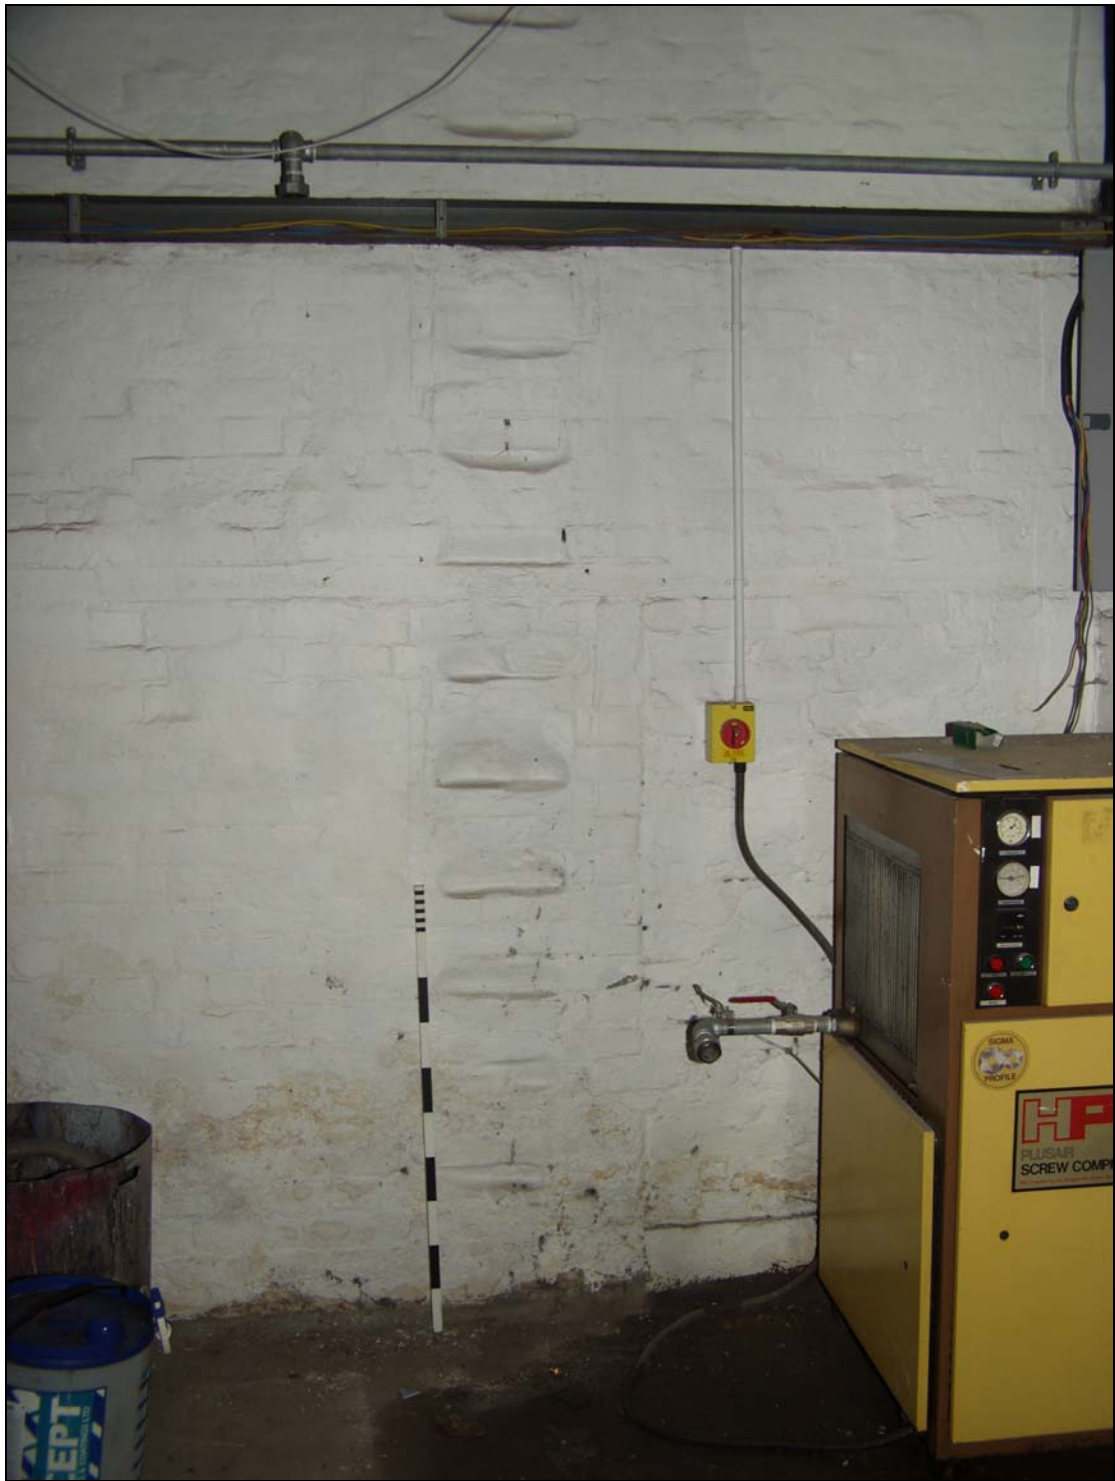
5.3.3 Among a few distinguishing features, two blocked shovelling apertures remain visible on the east wall which formerly gave access from the central floor into the adjacent kilns. It is also possible to discern the sawn-off stumps of many former cast iron stanchions in the floor which once supported the upper levels in two rows. Their spacing varies, but have been noted in Figure 3. A further surviving detail is a series of indentations in the wall at the south-west corner, caused by abrasion from the use of a vertical ladder formerly attached to the wall at this point (Plate 10). The space

10 Detail of former position of ladder (41)

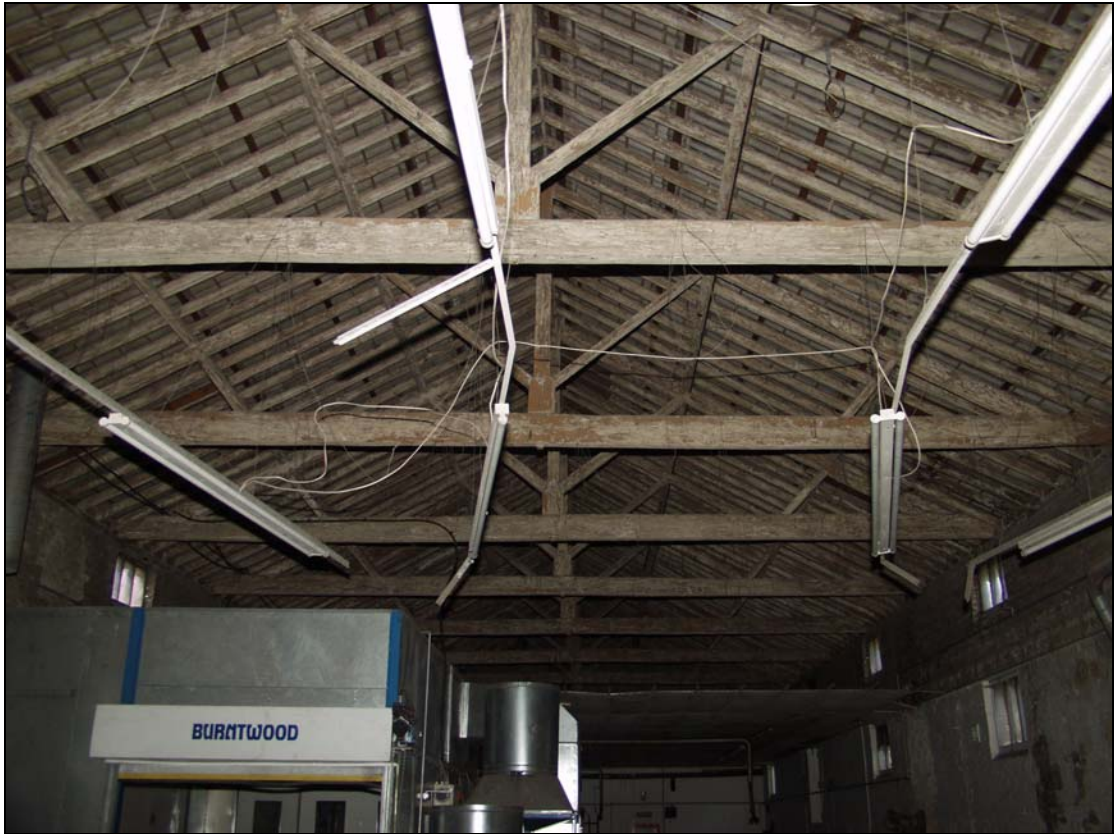
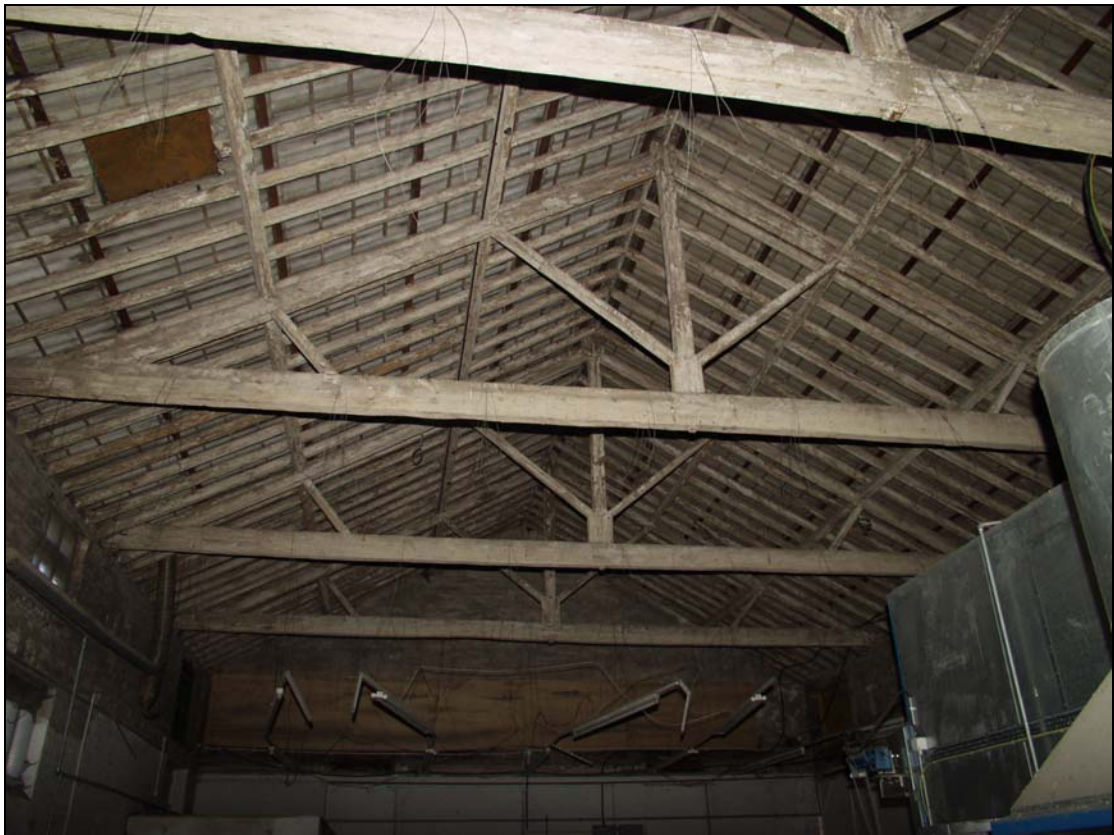
5.3.5 The roof is of typical early 19<sup>th</sup> century form, comprising relatively slender softwood trusses (Plates 11 and 12). Each truss has a robust tie-beam with king posts and shaped shoulders with raking struts. Subsidiary raking struts also link the tie beam directly to the principal rafters. The king post is held to the tie-beam by a coach-bolt and housed nut. Occasional strapping to the sides is visible, but this is uncommon. There are two purlins per pitch, coggled over the principals with common rafters to a ridgeboard, also coggled over the purlins in eight common rafters per bay. This essentially forms a typical double-framed roof, typical of barns and other agricultural buildings of the date. Scarfing and other jointing is not visible. The original battens for the former pan tiles survive.

11 Roof trusses in the central section taken from the east (14)

12 Roof trusses in the central section taken from the west (13)

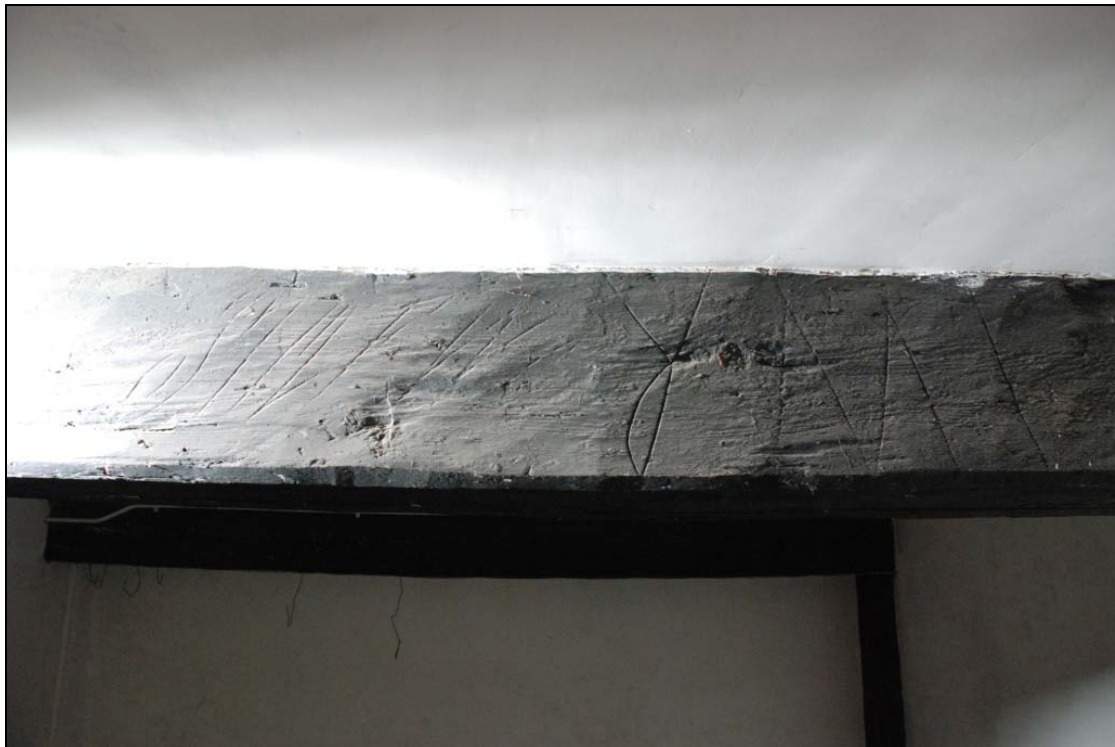
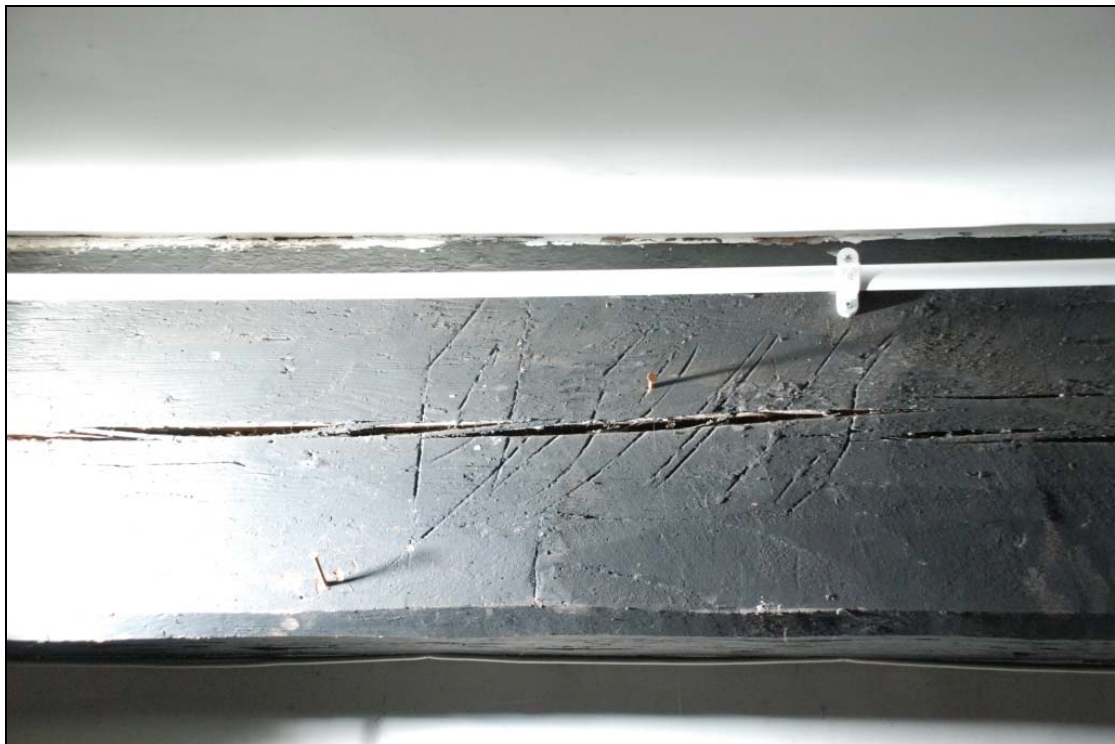
5.3.7 The structure of the western unit is supported by three robust principal east-west joists, measuring approximately 11" x 11" (279mm). Two additional cast-iron stanchions also survive in the south-west, while a mortice on the north indicates a third, removed example (Plate 13). The southern two timbers extend into adjacent Store Room 1 now given access from the main central area. These both retain Baltic bracking marks on their south faces (Plates 14 and 15).

6.6 Elements of particular interest and historic value include the Baltic bracking marks, which are typically found on early 19<sup>th</sup> century industrial and agricultural buildings where good quality Baltic softwood was utilised, and the fairly low impact that conversion in the 1980s had to the overall integrity of the building. Though dilapidated, the three maltings also preserve much of their original external appearance in outline, complete with kiln cowls, and thus their value as a group is an important historic asset to the town.

14 Detail of Baltic mark in store room (46)

15 Detail of Baltic mark in store room (47)

7.3 The interior has been much compromised, particularly with the removal of the malting floors, though the end-sections are well preserved. The main historic loss would be the sense of space, which is otherwise rarely avoidable when buildings such as this are altered from their original purpose. The cowls and roof trusses would be retained with little alteration, while the suggested layout of the new residential units would make use of existing divisions within the building (with two exceptions on the ground floor). In the east section, the ground floor timber partition would be removed, while the two remaining stanchions in the western ground floor area would also be removed. An expansion of the south-west area into adjacent Store Room 1 would affect the timber joists containing the Baltic marking.

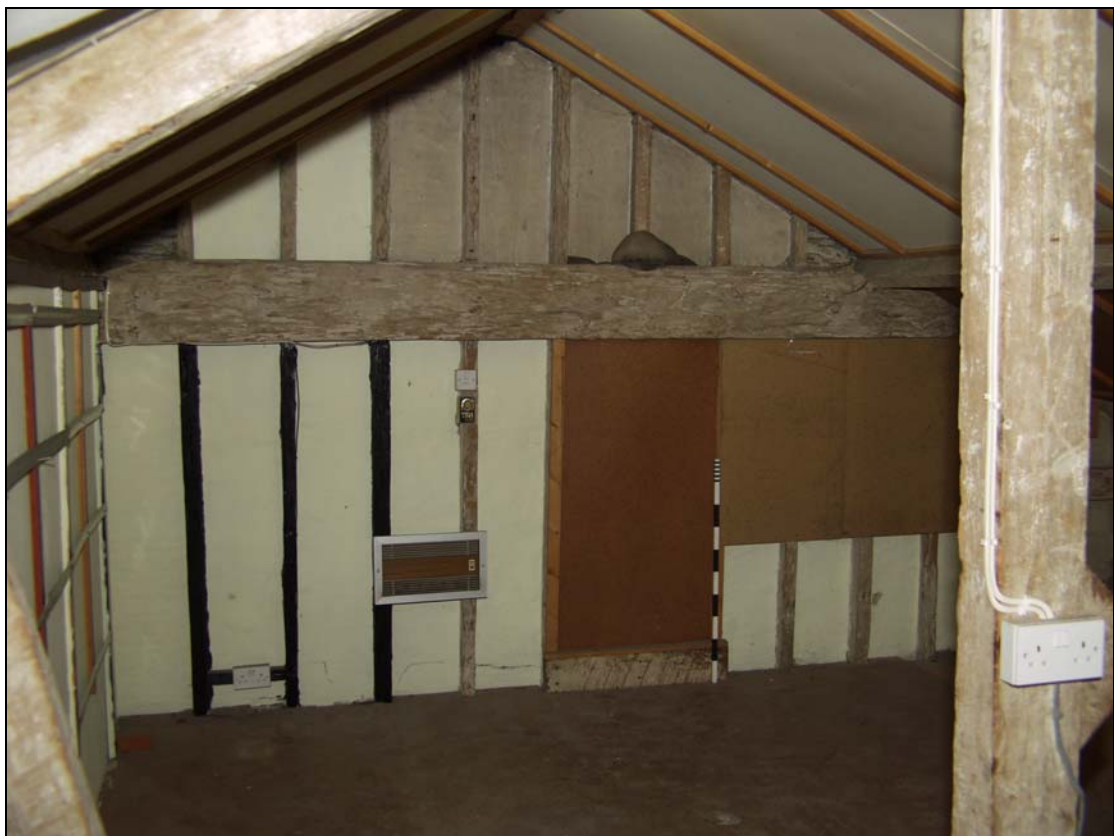
5.3.9 Access to the surviving loft area is given by a modern modular spiral staircase. This occupies 1½ bays, and preserves one original, modified roof truss. The tie beam, king post and principal rafters are all intact but the original raking struts have been removed and replaced with nailed-on struts to facilitate access on either side. The partition wall to the east which encloses this area has a very wide plank-collar, which retains side-axe and Baltic marking. The studs to the rear are coggled over with lath and plaster infill (Plate 17).

17 Loft area taken from the north-west (44)

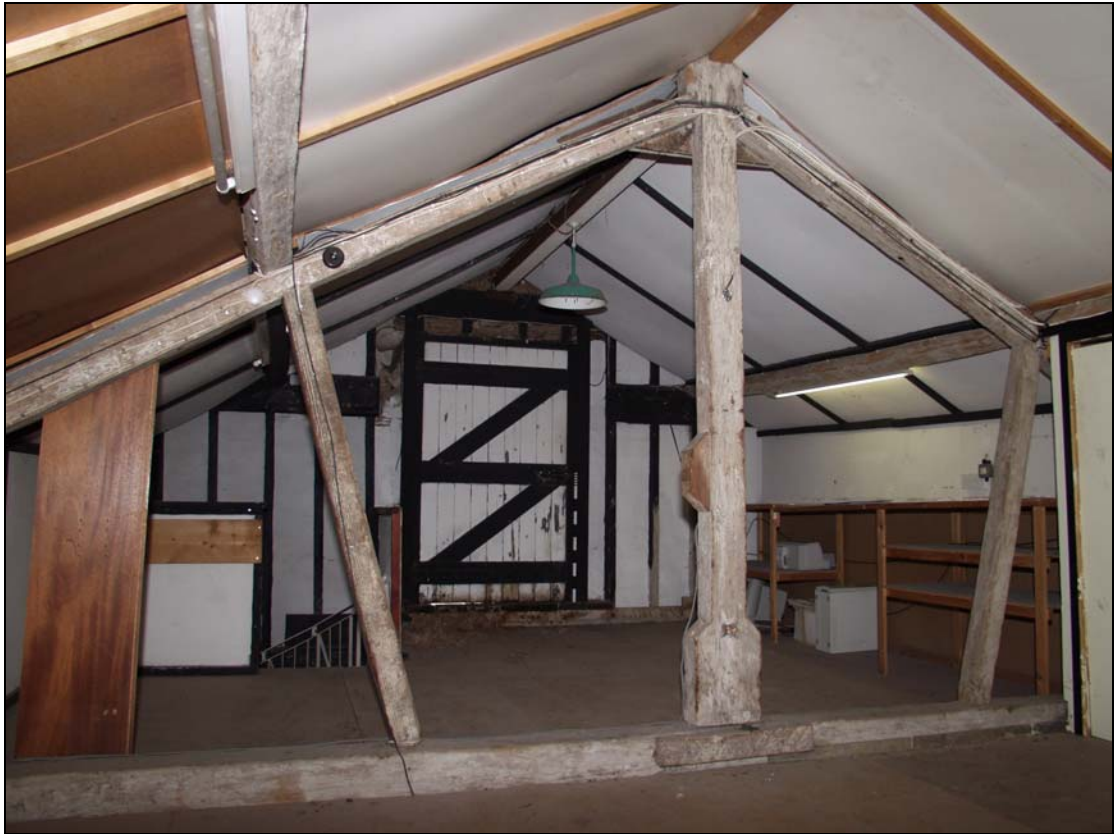
5.3.10 A similar arrangement formerly existed on the west gable end but the plank collar has been cut to accommodate a later loading door (Plate 18). The associated mechanised loading arrangement was supported by a reinforced steel joist, bolted to a yoke piece next to the truss, which protrudes from the gable.

18 Loft area taken from the east (45)

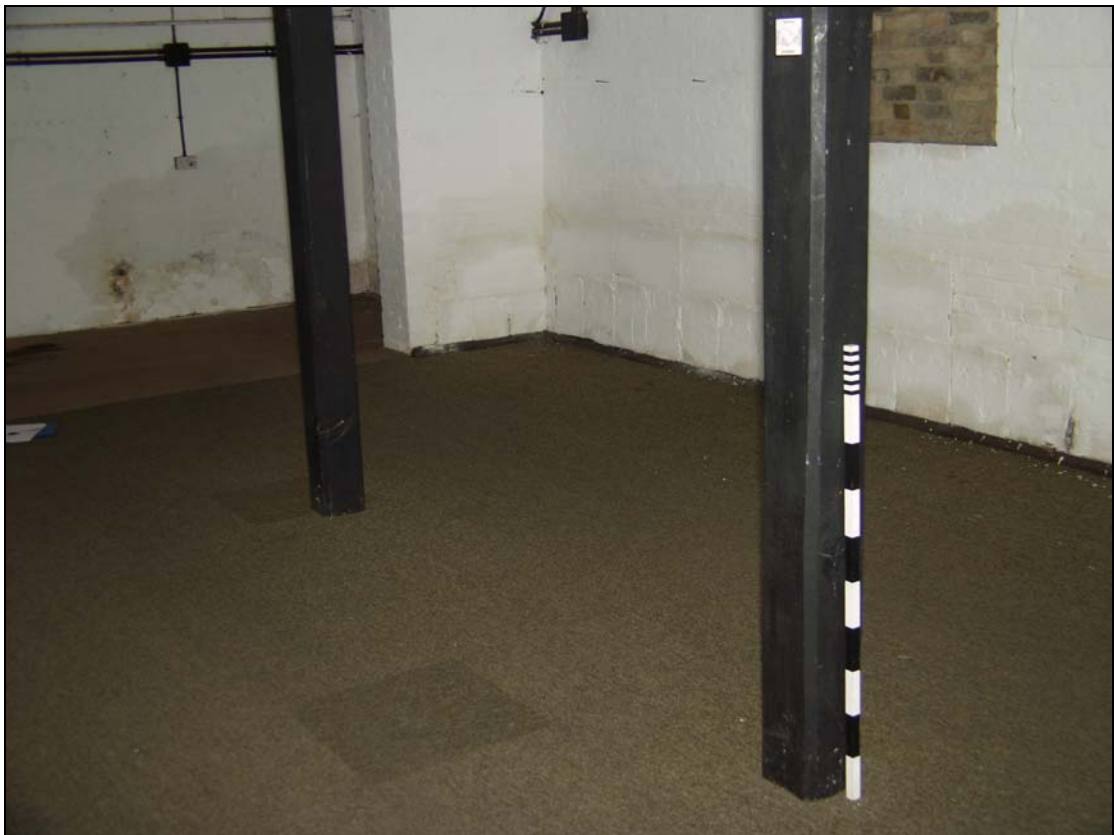
5.3.13 The brick outer walls contain bearer timbers, and have a row of vertical slates mortared and nailed to the lower brickwork as a damp-proofing barrier (Plate 19). Originally furnaces served the kilns, and on the western internal wall, a blocked, semi-circular aperture remains (Plate 20).

19 Wooden columns and slate damp proof course to ground floor of eastern section, taken from the south-east (32)

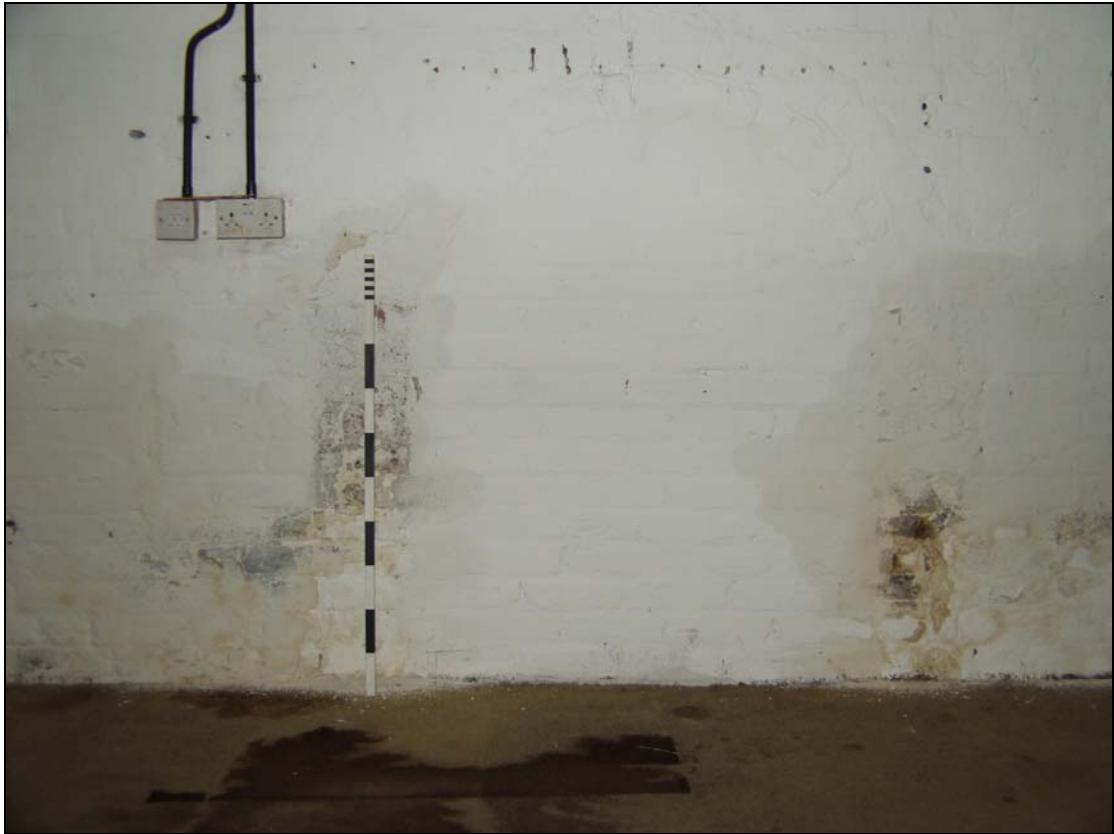
20 Blocked archway to west wall of ground floor of eastern section, taken from the east (31)
