**BARNS AT WOODS FARM, WOOD ROW,
HATFIELD BROAD OAK, ESSEX**

HISTORIC BUILDING RECORDING

Authors:	Tansy Collins BSc Lee Prosser PhD Charlotte Davies BA Kathren Henry Kate Higgs BA	
NGR: TL 5365 1824		Report No. 3260
District: Uttlesford		Site Code: HBWF09
Approved: Claire Halpin MIFA		Project No. 3397
Signed:		Date: March 2009

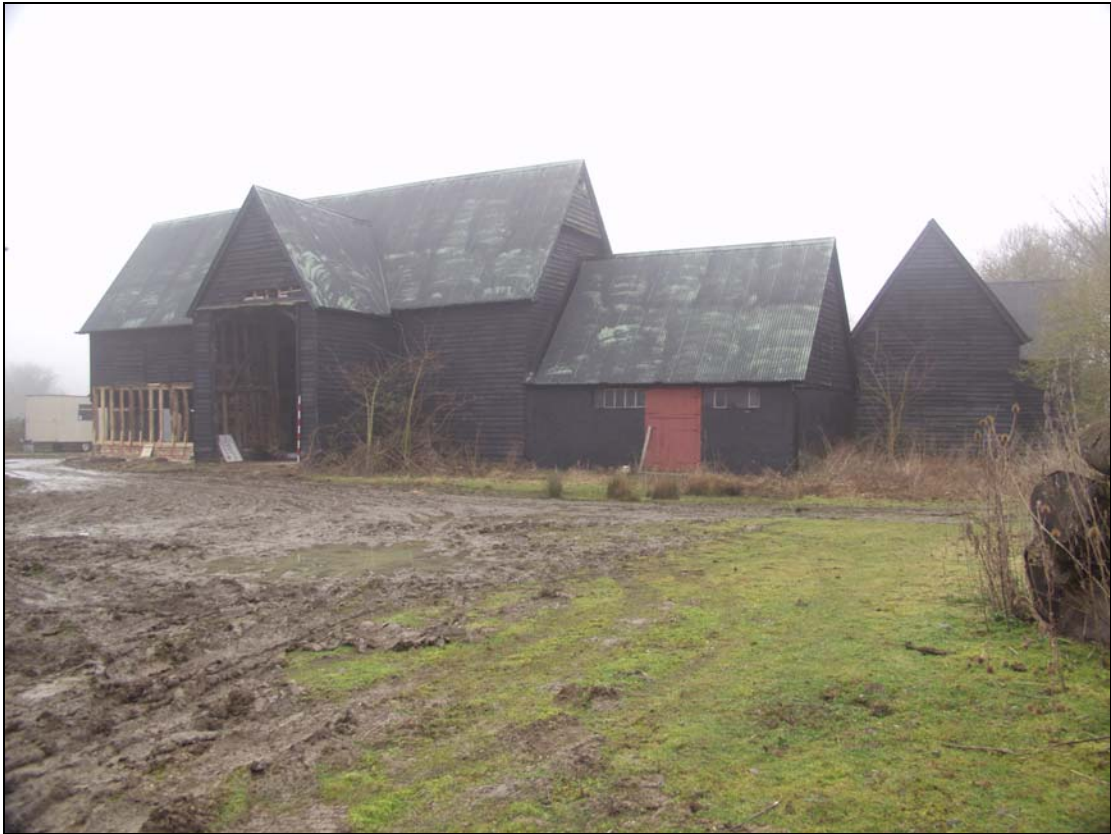
5.2.1 Building 1 is a four-bay, timber-framed and weatherboarded barn orientated north–south with a porch set off-centre to the north on the east side (Plate 1), the whole structure measuring some 62 feet x 21 feet (18.5m x 6.35m). The frame sits on a brick dwarf wall of orange/red bricks of late 19th or early 20th century date, laid in random bond with later patching and repair in evidence. The weather boarding is all of modern softwood (probably larch), now coated with a bitumen finish. The roof, which is steeply pitched, is clad in modern corrugated sheet repair. At the time of survey the barn was undergoing repair on the east side.

Plate 1 East elevation of Buildings 1 and 3, taken from the north-east (11)

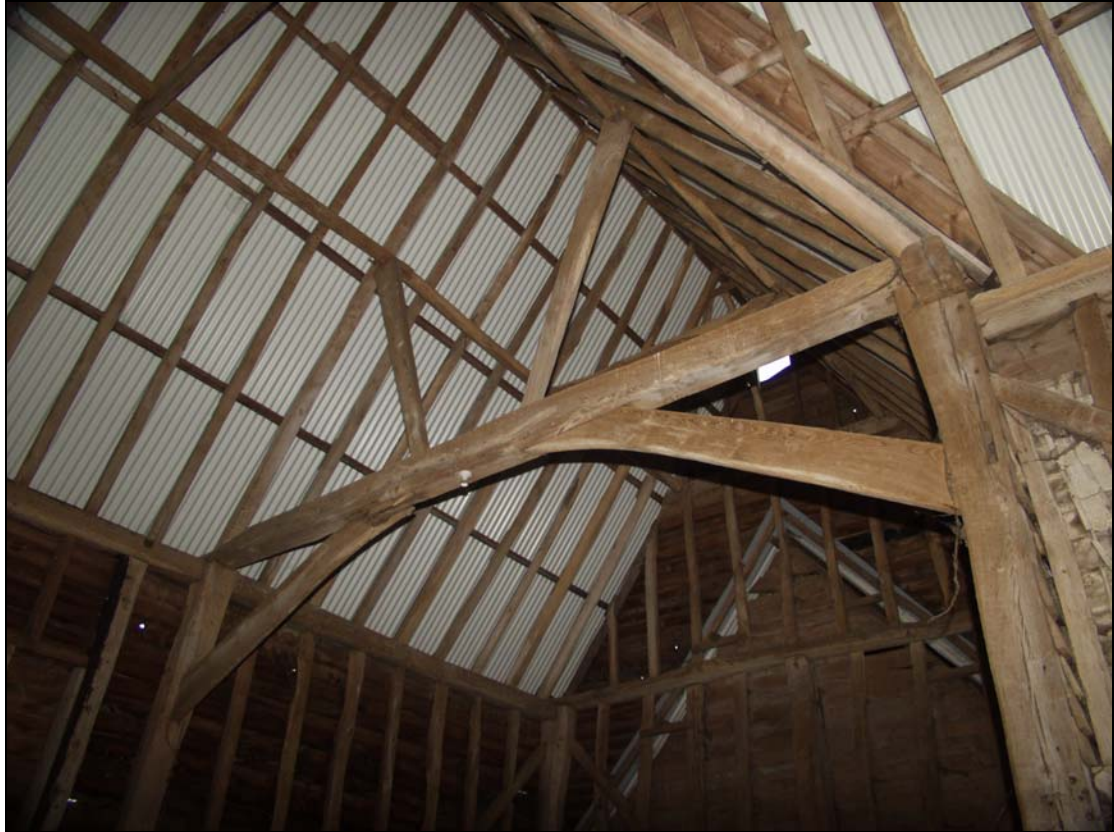
5.2.11 The first truss comprises principals with gentle jowls and rudimentary chamfering, the tie-beam having a very waney upper edge. Long and elegantly sweeping braces spring from the principal posts to the tie-beam. Most are secured by two pegs, but here, the west brace is secured by three, presumably to off-set a weakness in the timber, which has fractured nonetheless. The struts engage the purlins, which are scarfed at this point. The south face of the truss preserves a gently scratched assembly mark, II on the west brace and a II with tag on the east brace and adjoining post. The tie-beam and strut display a III on the west and III to the east.

Plate 3 View of Truss 1 (Building 1), taken from the south-east (28)

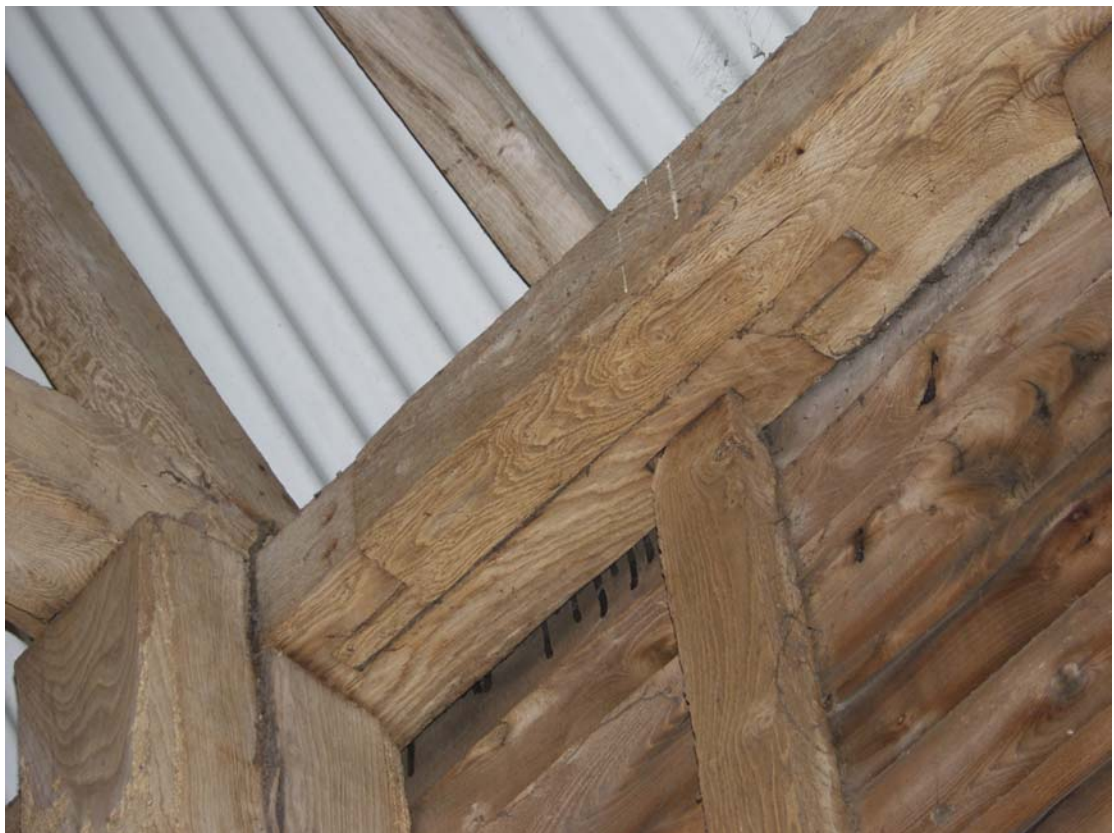
5.2.9 The west panel sill is much decayed, but preserves a short, simple bladed scarf. The seven lower studs are pegged top and bottom, but now partially encased in cement. The mid-rail profile and camber is exactly as its east companion and is clearly halved from the same timber. Seven corresponding upper studs remain, the north pair cut by a straight downward primary-brace as on the east. The wall-plate displays a face-halved and bladed scarf joint with four edge pegs (Plate 4).

Plate 4 Face-halved and bladed scarf joint in west wall-plate of Building 1 (Bay 1), taken from the north-east (88)

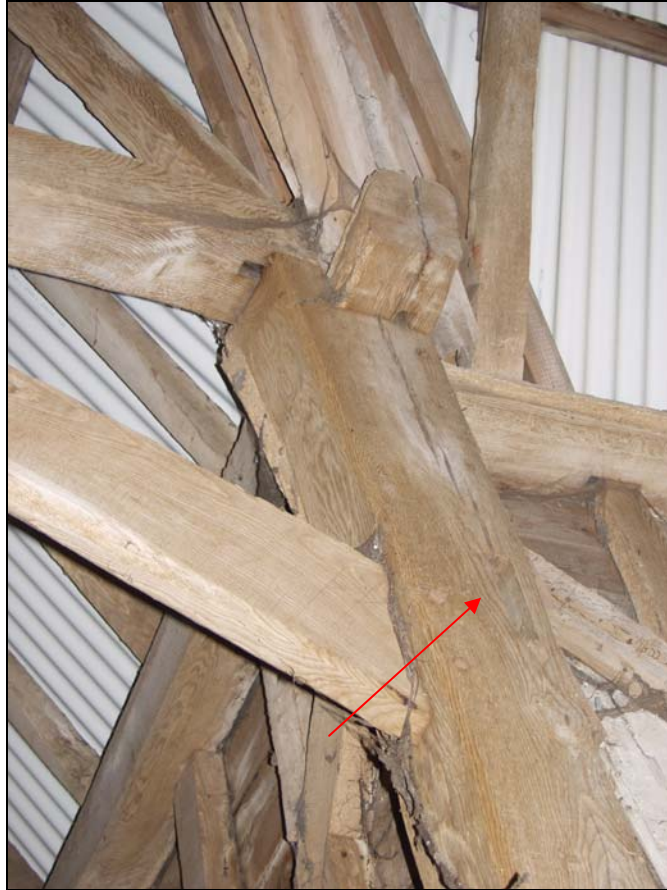
Plate 5 Truncated wall-plate at the head of Truss 1, with mortice (indicated) in the principal post for a former upward brace, taken from the south-west (87)

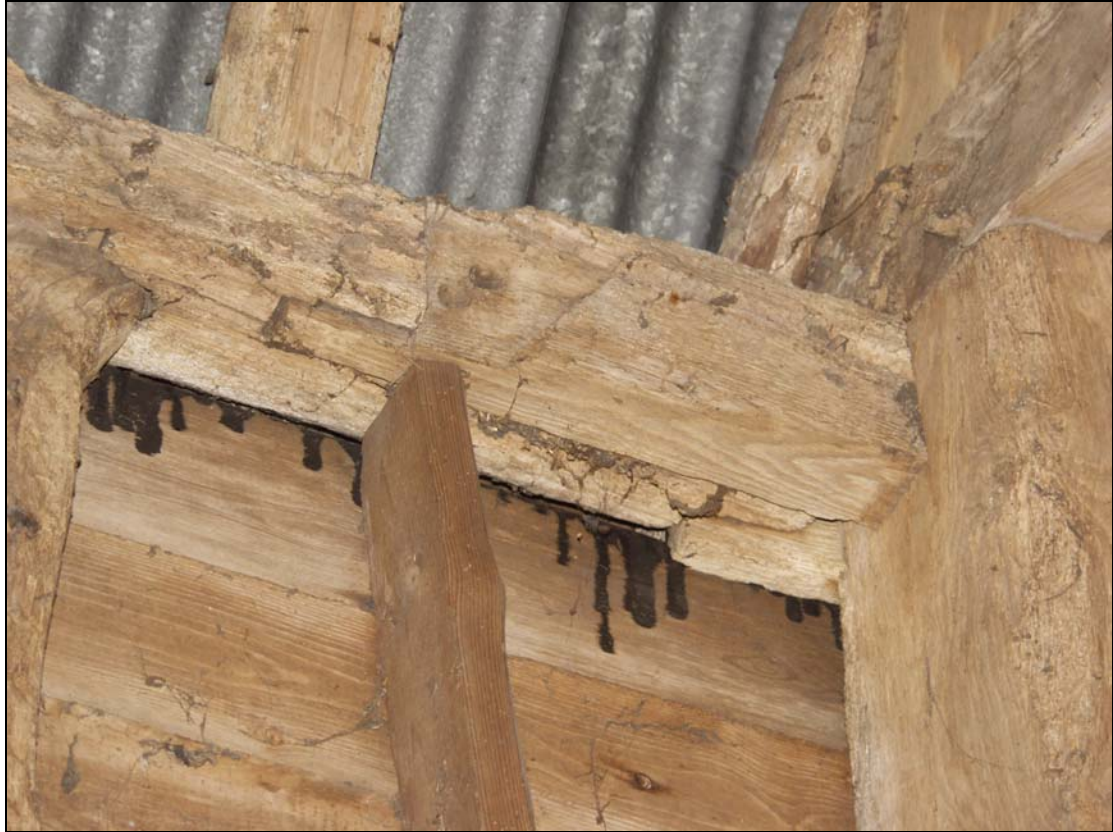
Plate 9 Face-halved and bladed scarf joint in the north wall-plate of Building 2 (Bay 4), taken from the south (96)
