**COLE GREEN WORKS, COLE GREEN,
HERTFORDSHIRE**

HISTORIC BUILDING APPRAISAL

Authors: Amy Goldsmith BA (Historic building appraisal) Lee Prosser BA PhD (Historic building appraisal) Kate Doyle BA (Historic background)	
NGR: TL 2822 1134	Report No. 2883
Parish: Cole Green	Site Code: AS 1056
Approved: Claire Halpin MIFA	Project No. 2897
Signed:	Date: May 2007

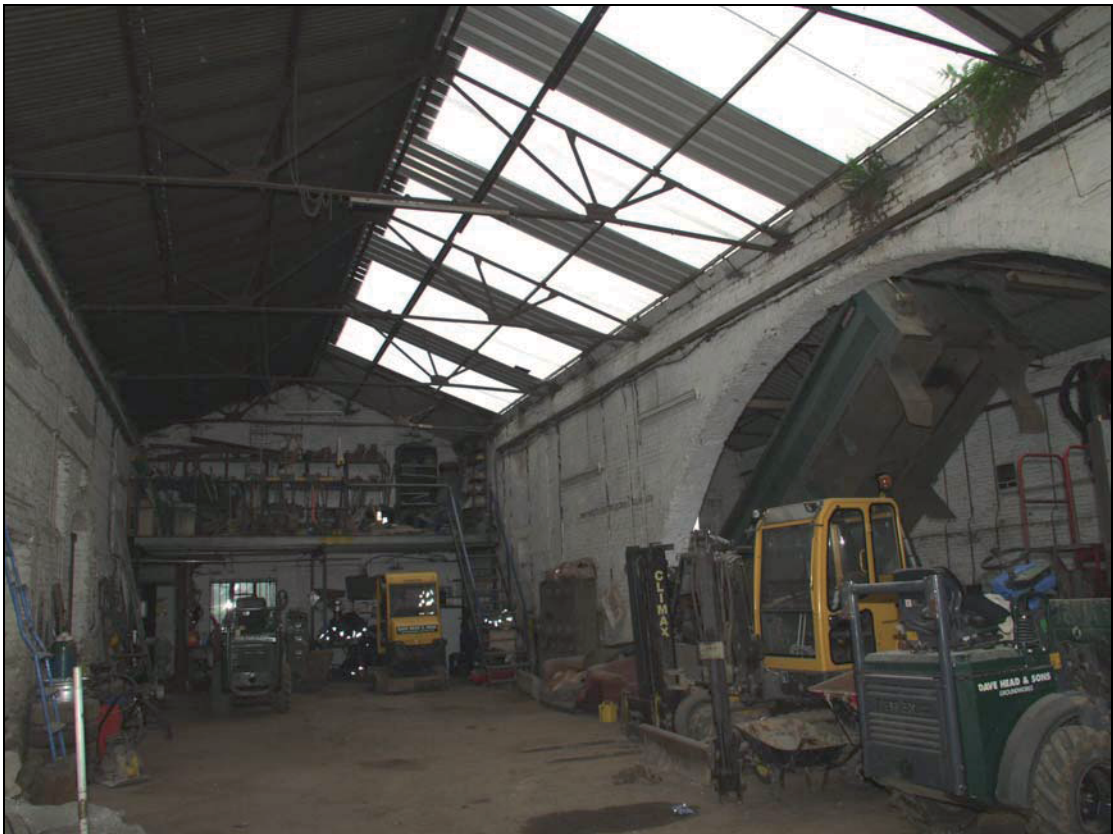
4.1.4 The interior of the building comprises two large open bays divided at the north by a very wide semicircular arch (Plates 2 and 3). The brickwork is laid in English bond with an offset at approximately 2m in height extending around the external walls. There is clear disturbance of the brickwork at eaves level where the wall head and probably the roof have been rebuilt. The roof over each unit comprises five tension trusses constructed of L-section iron / steel bolted to joining plates. Each truss comprises a tie rod with 'raking struts' and 'principal rafters' supporting two flights of 'purlins' and a double 'ridge piece'. At the end walls, the roof is stapled and strapped to the brickwork.

2 Building 1 – east bay, taken from the north (17)

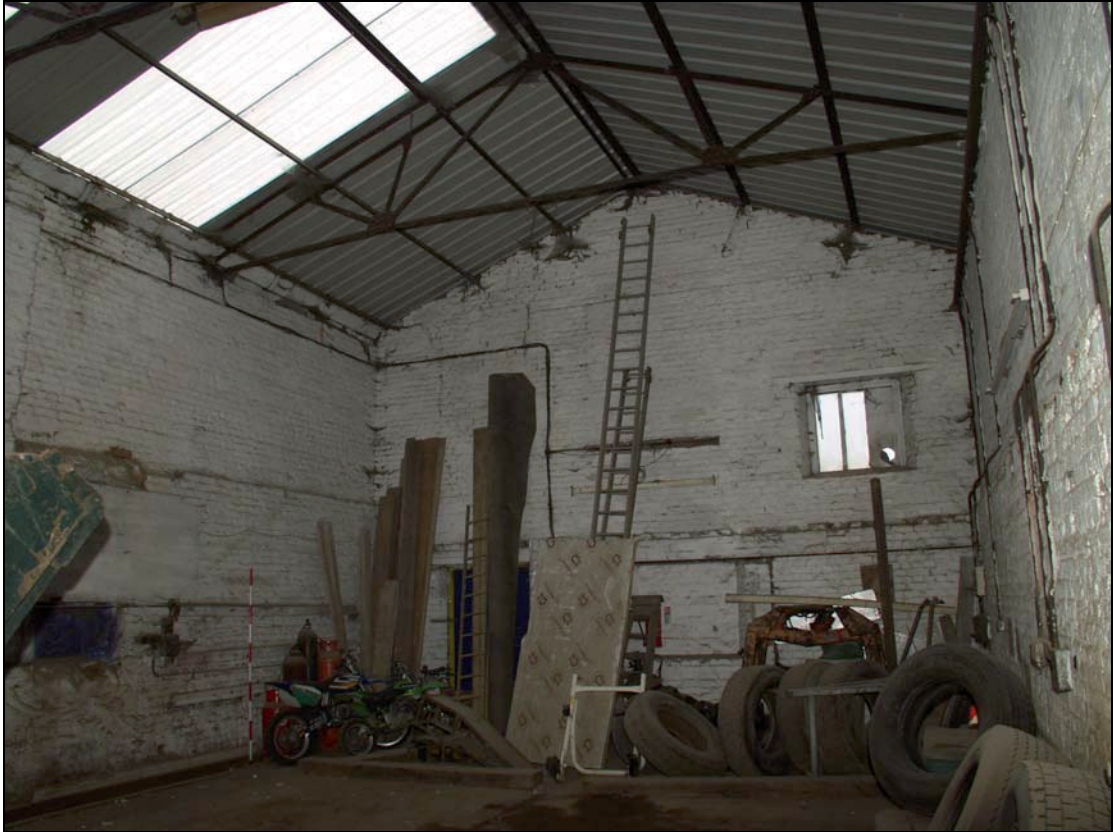
3 Building 1 – west bay, taken from the north-west (18)

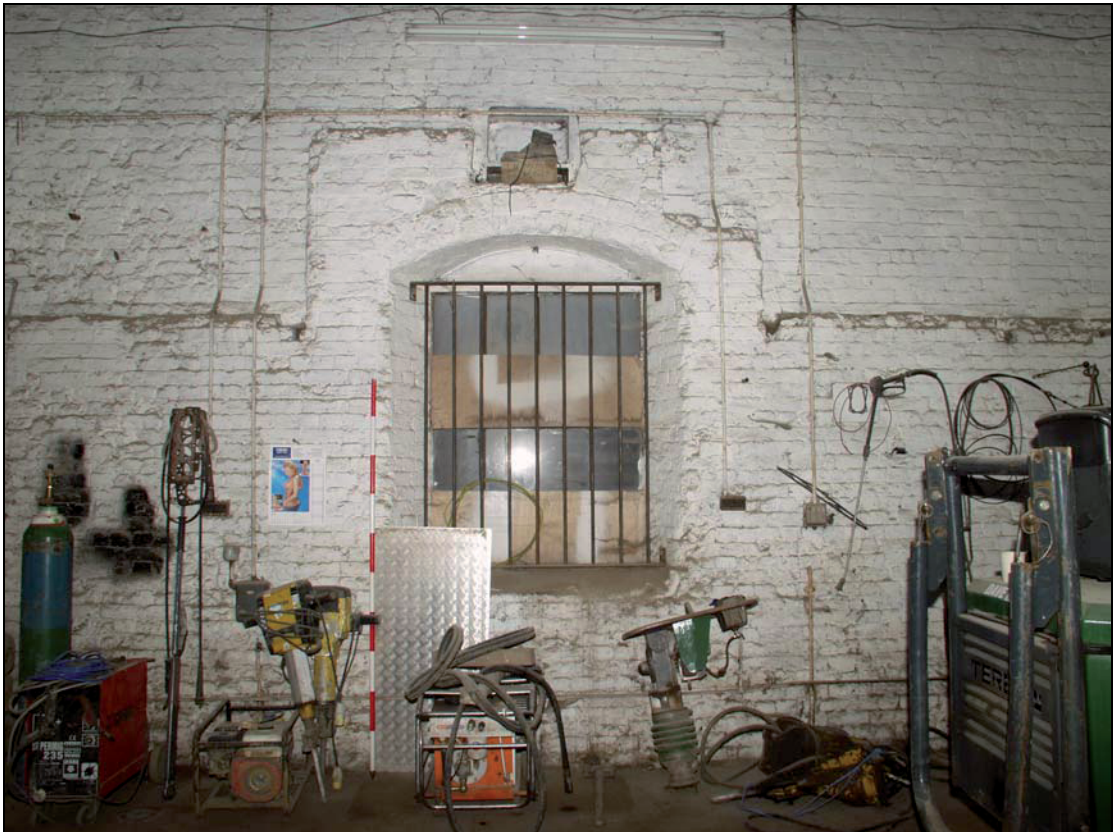
4.1.5 The door and window apertures on the east wall have wide splays. The brickwork surrounding the middle window is built out in a more robust way and has an iron framed aperture set above to support machinery (Plate 4). At the south end of the east bay, is an inserted mezzanine with a blocked window at the upper level. Below, is an inserted 1950s casement window and to the east is a modern WC, with similar later window. To the west an arched aperture gives entrance to a small office which projects at the rear of the building.

4 Robust brickwork surrounding window in Building 1 – east bay, taken from the west (22)

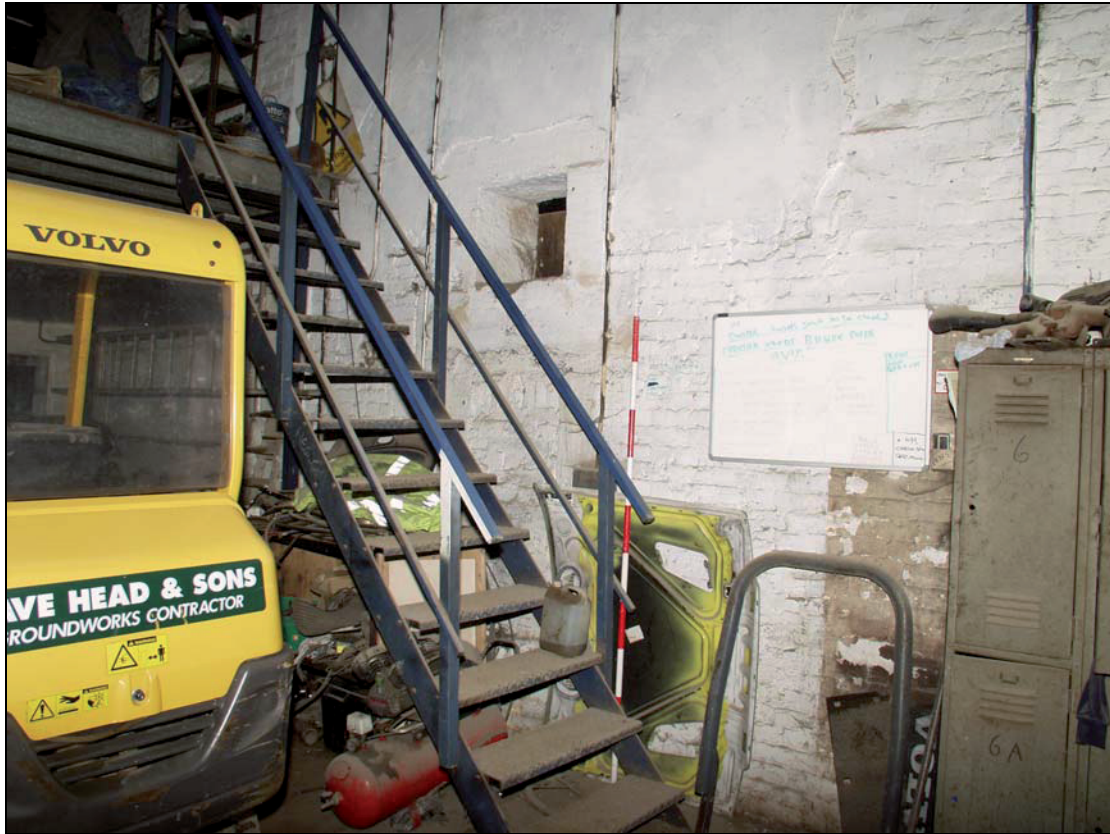
4.1.6 The dividing wall between the two bays contains two original square apertures, presumably for the transmission of machine components or drive shafts from one side to the other (Plate 5). These are set one above the other and surrounded by roughly dressed stone for additional strength. To the east of these the floor contains a movable rectangular stone slab, presumably covering a pit below. The west face of the partition wall has two distinct sections, divided by a brick pier; the north part adjacent to the wide arch is plain whereas the south section has an offset at a different level to the external walls and contains the stone lined apertures described above.

5 Stone-lined apertures in division wall in Building 1, taken from the north-east (23)

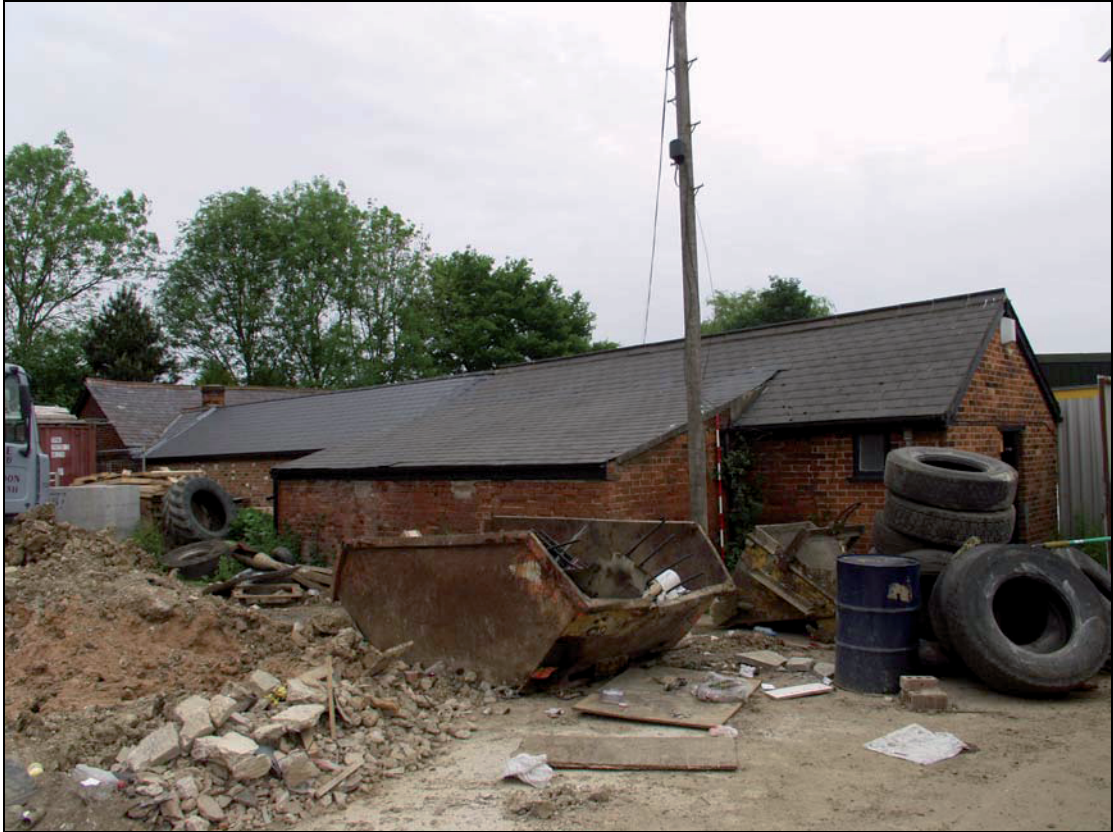
4.2.5 The south section of the building has been extended to the west by a secondary lean-to structure (Plate 7). It is constructed in Flemish bond but has the same cement mortar as the lavatory addition. To the north of the lean-to, the brickwork of the north section has been recently rebuilt in a mixture of reclaimed 19th century brick and modern textured Flettons.

7 West elevation of Building 2, showing lean-to extension, taken from the south-west (10)

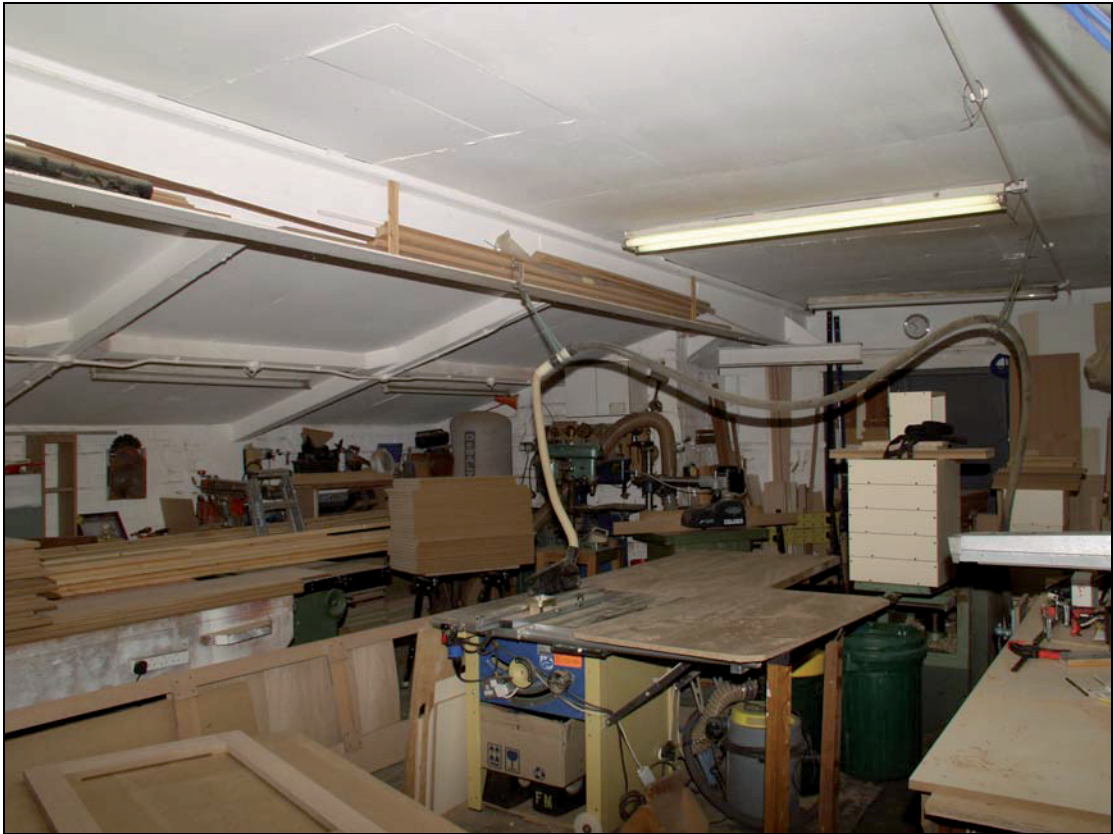
4.2.7 The south section is currently occupied as a workshop and most of the surviving fabric, including the roof is obscured (Plate 9). The west side of the building has been opened up to form one large space with the adjoining lean-to and the original west wall is supported by an RSJ. The lean-to roof is of simple construction, comprising widely spaced rafters with purlins and triangular chocks or supporting pieces at the junction of the timbers.

9 Interior of Building 2 – south section and lean-to, taken from the south-east (13)

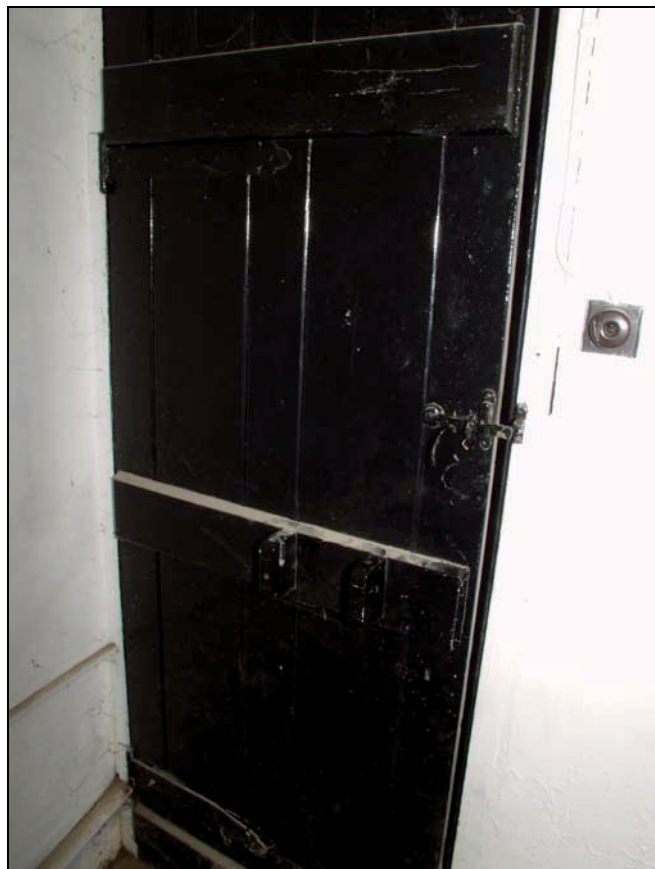
4.2.8 The south section comprises a small lavatory compartment which has an early 20th century boarded door with contemporary latch (Plate 10).

10 Early 20th century boarded door within lavatory addition, Building 2, taken from the west (8)

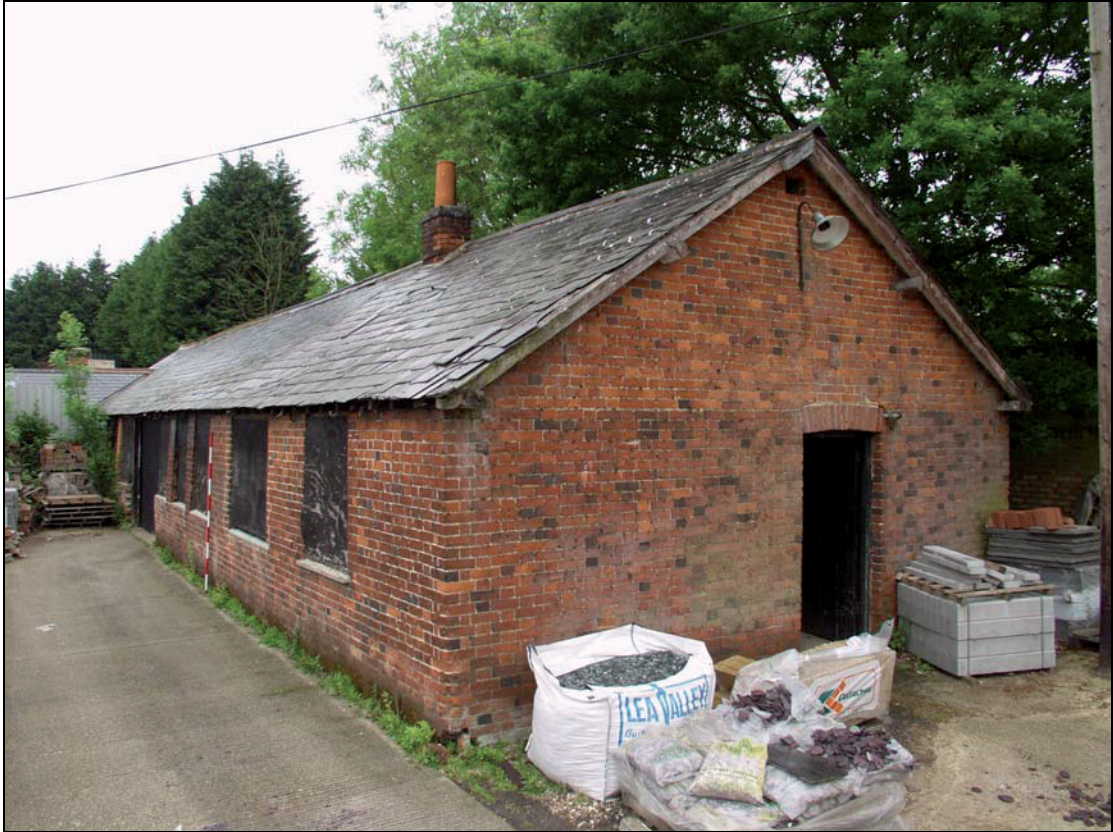
4.3.1 Building 3 is of similar constructional form to Building 2, comprising orange-red brickwork in Flemish bond laid in a lime based mortar (Plate 11). It has a modern slated roof and towards the east end of the building a red brick chimney rises through the roof apex. The south elevation faces onto the yard and has been much reworked. It contains a wide doorway set off-centre to the west, which has softwood jambs with mortices for removed butt-hinges and now contains modern makeshift doors. The doorway is flanked on either side by a series of window apertures that appear to have been created, as the brickwork of the dividing piers is different to that which lies below the level of the sills. It is possible that the upper part of the elevation was once open or even continuously glazed. The eastern two window apertures appear to be original, although the westernmost of the two has been widened. Building 2 adjoins the building at the west end.

11 South and east elevations of Building 3, taken from the south-east (26)

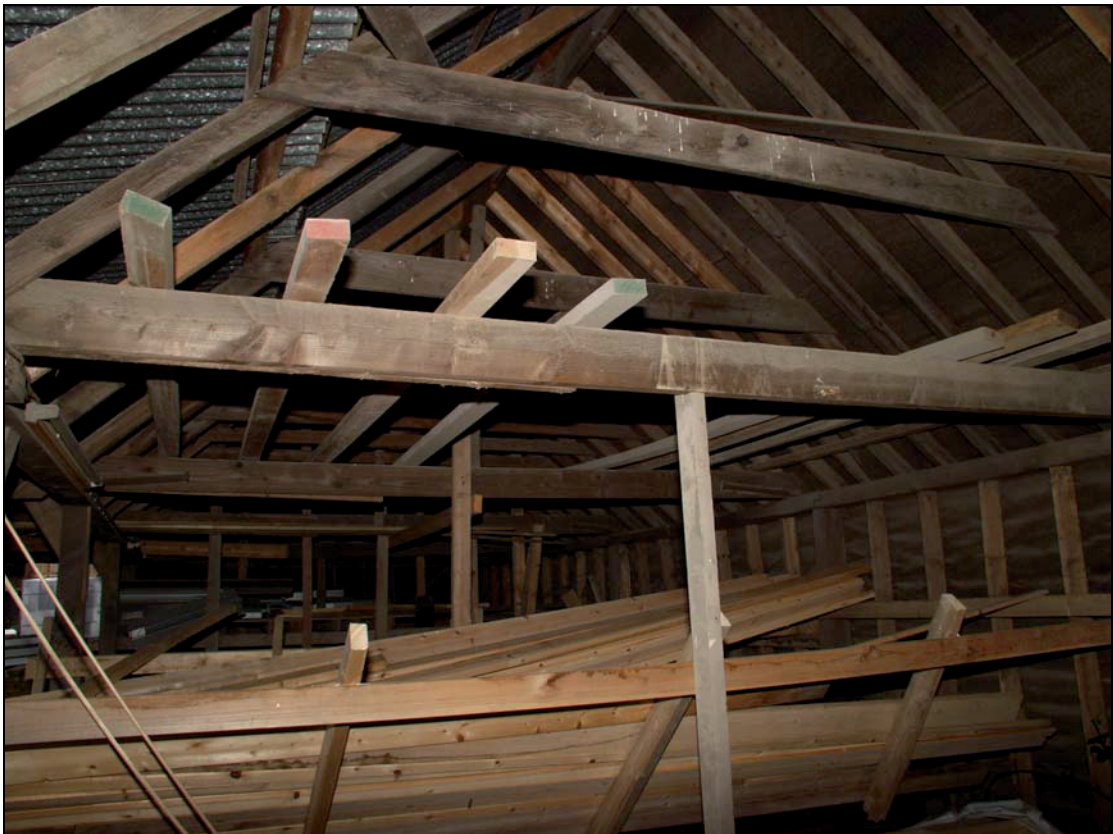
4.4.5 The framing is similar to that of the south section. The interior comprises five bays of simple, circular-sawn softwood framing (Plate 20). On the west side, pine uprights are supported on cement stylobates, and reinforced by secondary lower buttressing timbers. Straight, nailed braces extend to the wall plate on the north side of the posts of Bays 2 and 3 from the south. The wall plate is scarfed above the posts and the tie beams are strapped and stapled to the wall plate. On the north and east sides, the panels are infilled with later studding, with five studs per bay. The roof structure is independent from the tie beams, comprising slender rafters cogged over the back of the wall plates, thin board-section collars nailed onto every fifth rafter pair, and a ridge board at the apex. There is also a nailed-on rafter brace at the south end. The roof extends to the west with a flying pent roof clad with corrugated galvanised steel.

20 Building 4 – north section, taken from the south (35)

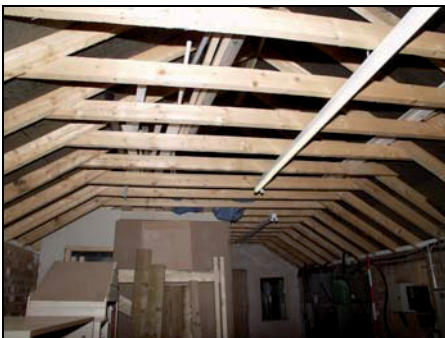
5

4.2.2 Building 2 was considerably rebuilt following a fire approximately three years ago and the roof over this section is covered with modern slates. The east elevation of the building survives relatively intact and comprises two sections (Plate 6). The north section is constructed of orange-red bricks essentially in Flemish bond laid in a lime based mortar. It contains three doorways; the doorway at the north end is partially blocked and is now a modern window. A thin chimney stack rises through the roof apex above. The two doors to the south are each accompanied on their north side by an early to mid 20th century window with tiled sill.

Modern roof above Building 2 – north section, taken from the south

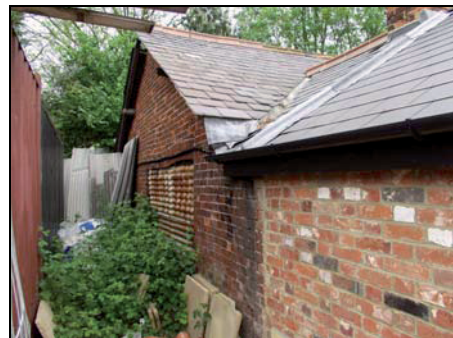
12

4.3.2 The west gable end of Building 3 contains an original doorway with segmented head, which has been extended to the north to create a wide aperture. The

wall plates and purlins protrude by approximately 150mm, and those in the south pitch are partially burnt.

West gable end of Building 3 and section of rebuilt west wall of Building 2, taken from the south-west
