**THE BARN, OLD PARK FARM, PERRY GREEN, MUCH
HADHAM, HERTFORDSHIRE**

HISTORIC BUILDING RECORDING

Authors:	Tansy Collins BSc Lee Prosser PhD Matthew Williams MA MSc Charlotte Davies BA Kathren Henry	
NGR: TL 44299 16773	Report No: 3233	
District: East Hertfordshire	Site Code: AS 1182	
Approved: Claire Halpin	Project No: 3296	
Signed:	Date: December 2008

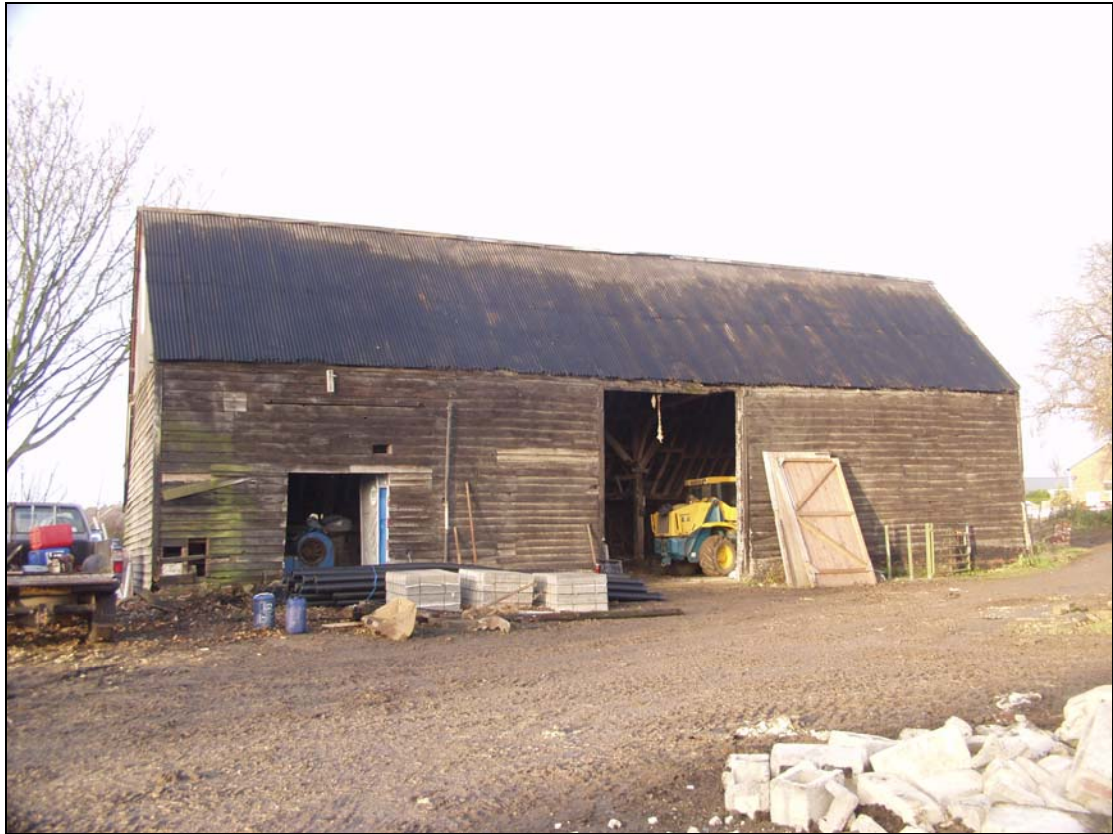
5.2.1 The barn is timber-framed and weatherboarded, with an aisle on the west side, all resting on a red brick dwarf wall. The roof is covered in corrugated metal sheeting. The east elevation (Plate 1), facing Buildings 2-5, is entered by a central bay-width opening which formerly had double doors, though these are no longer *in situ*. The flanking walls are clad in a mixture of old and replacement weatherboarding; the older being predominantly 8" (203mm) oak and elm boards with some replacement in softwood. Latterly, all has been given a coat of thick bitumen preservative, carelessly applied, which now covers much of the brickwork also. A second doorway has been inserted into this elevation towards the south end. Surviving boarding on the west appears to be all of oak and elm and of some age, while the two gable ends are substantially replaced in softwood. There is some later piecemeal cladding in metal sheeting on the west, and in places the dwarf wall has been rendered in cement. The only notable features are the terminals of the arcade and wall plate at the north end, which are finished with a large quarter-round moulding. The corresponding members to the south are simply sawn, by contrast. This may be due to the earlier presence of a building which formerly abutted the barn, now demolished. The brick, where visible, is of a fairly sandy, soft red fabric averaging 9" x 4" x 2" (229mm x 102mm x 51mm) in size, all of variable quality and much degraded. Many display diagonal skintles and appear 18th century in date.

Plate 1 East elevation of Building 1, taken from the south-east (34)

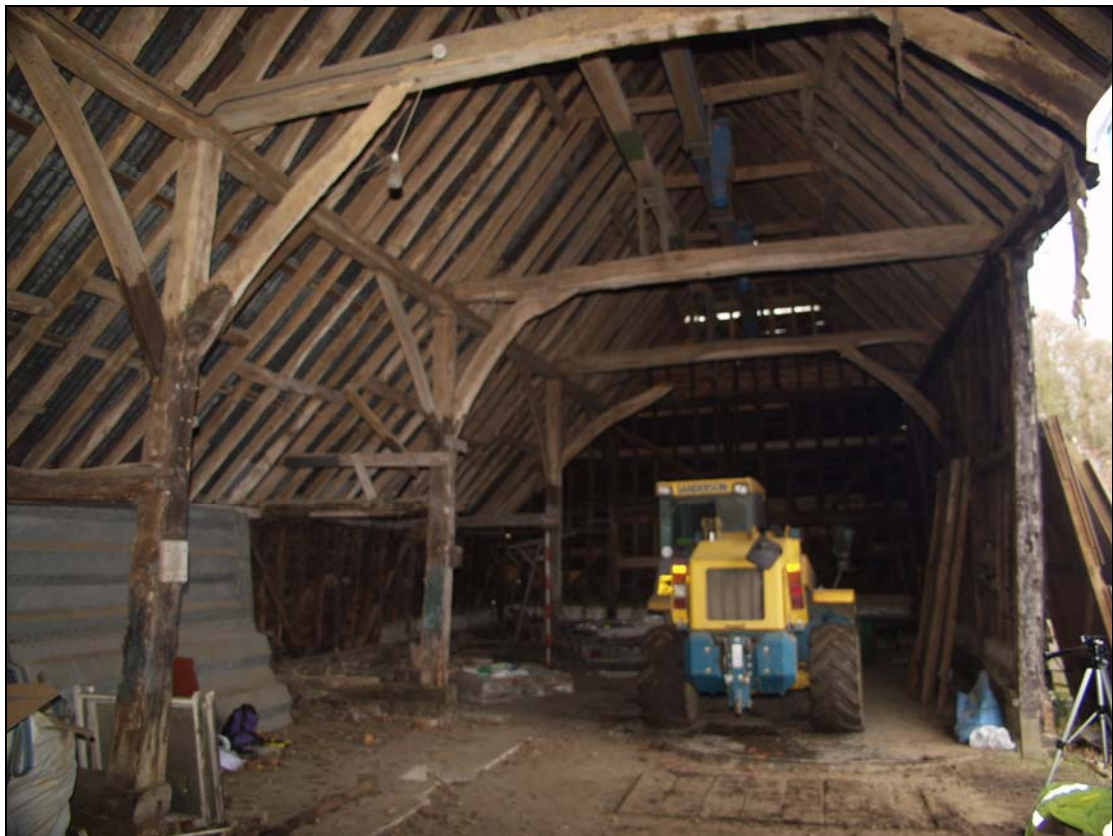
Plate 2 Interior of Building 1, view towards the north end, taken from the north-west (44)

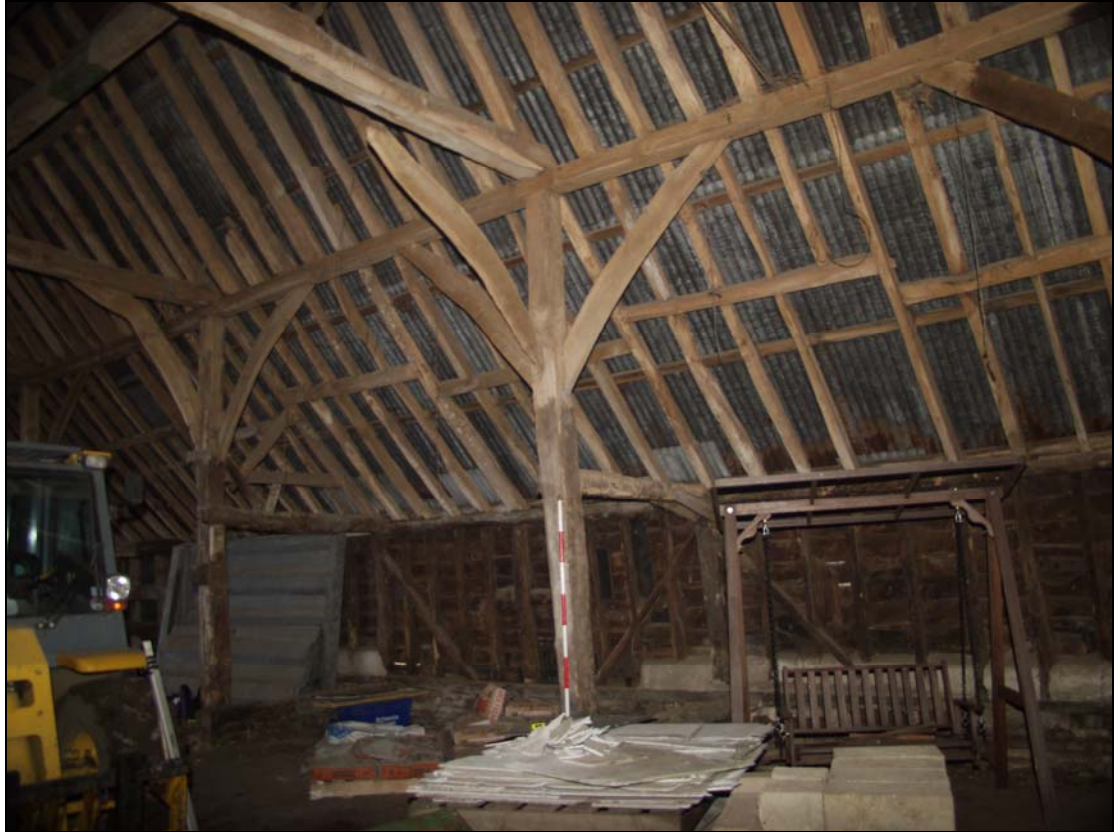
Plate 3 West side of Bays 1 and 2 (Building 1) showing truss configuration, taken from the north-east (51)

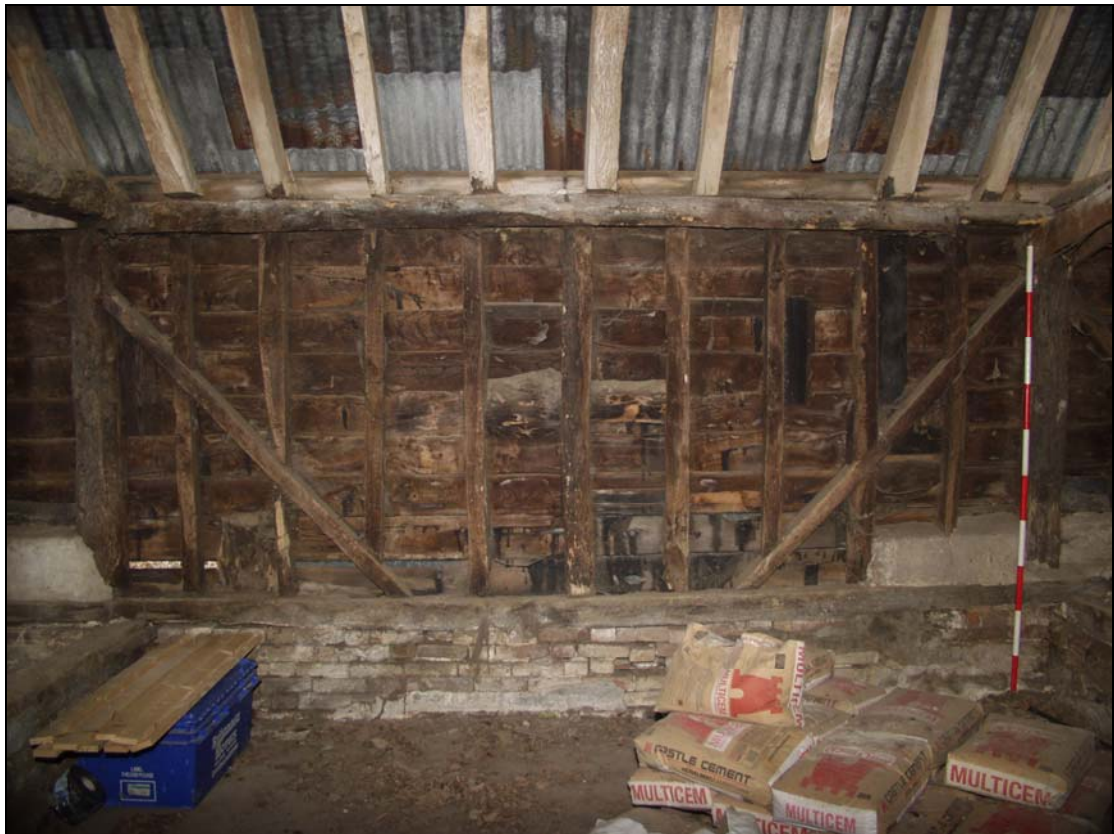
5.2.13 The dwarf wall on the west is poorly preserved. Water ingress has probably washed out much of the mortar, leading to partial collapse. The sill-beam is in variable condition but the wall-plate is well preserved. All nine studs are preserved, with a slightly larger central stud and primary-bracing at either end.

Plate 4 West wall of Bay 2 (Building 1), taken from the east (49)

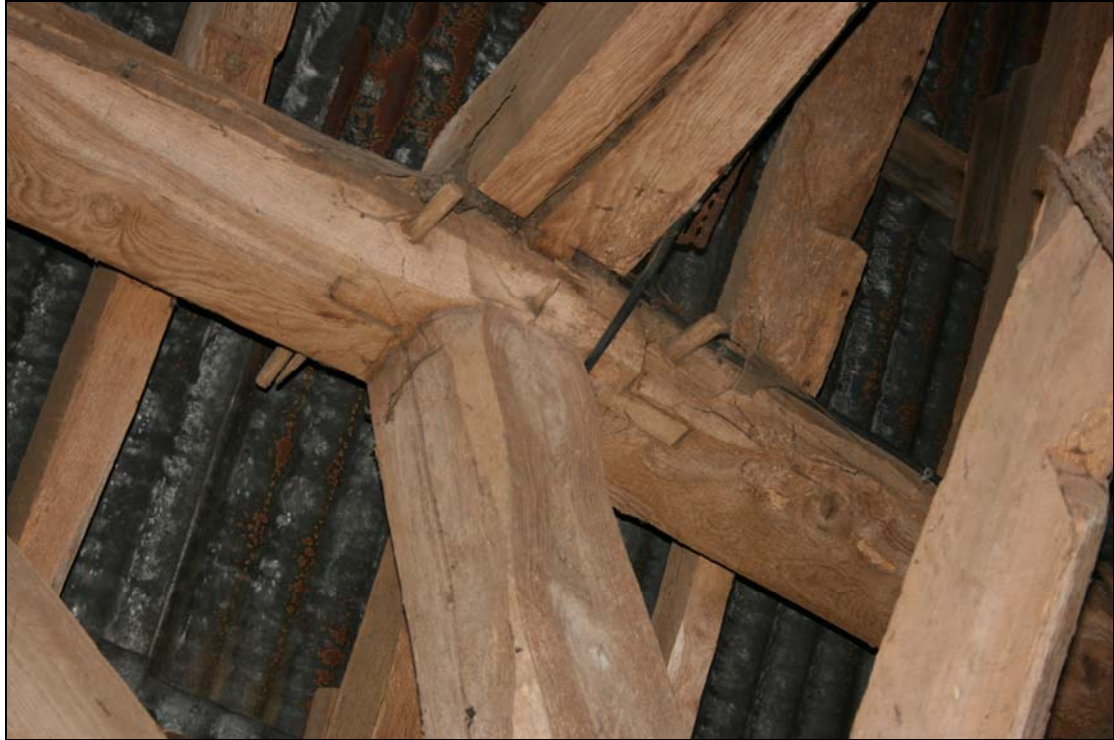
Plate 5 Detail of face-halved and bladed scarf joint in the arcade plate (west side of Truss 4, Building 1), taken from the south-east (62)

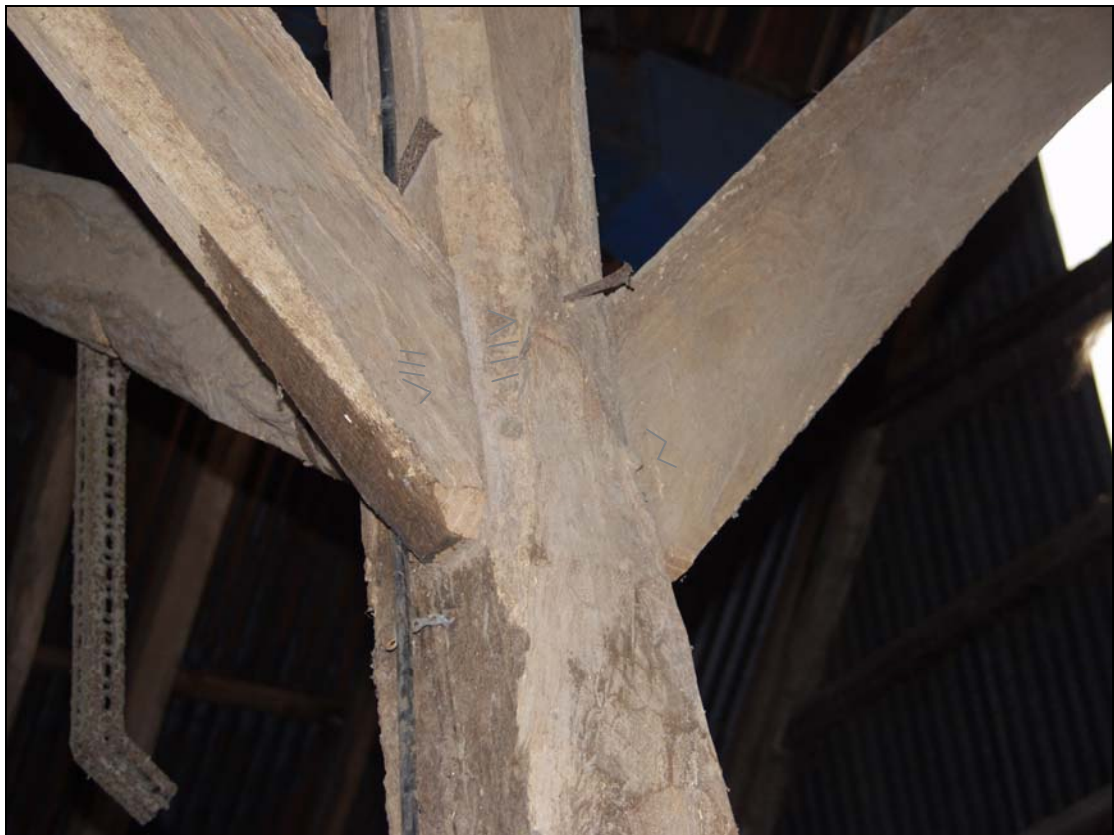
5.2.10 Small, chiselled assembly marks seen on the west side of the barn show that the bays are numbered from north to south (shown on Fig. 12). These appear in a coherent sequence on the west tie-beam brace and arcade post. The east side also displays numerals with tags, but with less frequency and not in any comprehensible sequence as on the west. Additionally each lateral arcade-plate brace on the west is sequentially numbered 1 – 10 from north to south. Assembly marks are noted below for each truss. The roof is not described in greater detail, as its construction is almost completely uniform, and covered by the general description, above.

Plate 6 Assembly marks (emphasised) on west side of Truss 4, (Building 1), taken from the north-west (56)

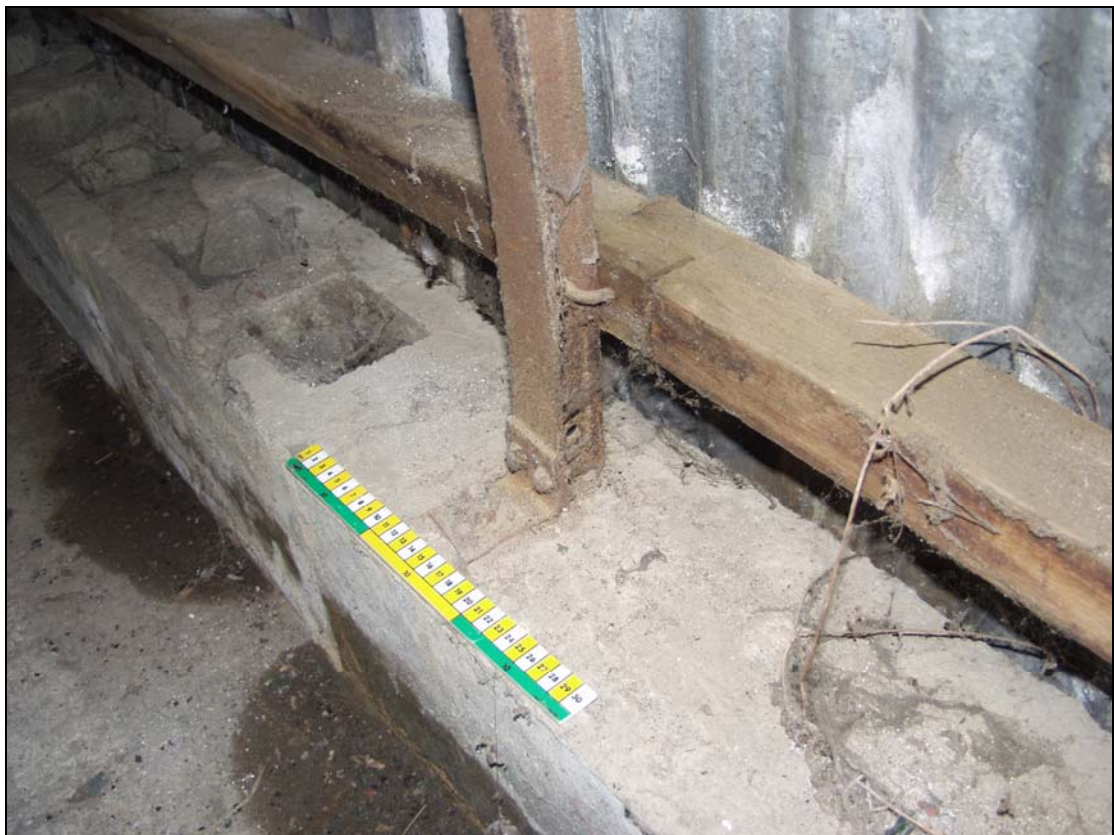
Plate 8 Construction detail of Building 2 at base of a truss, taken from the west (29)

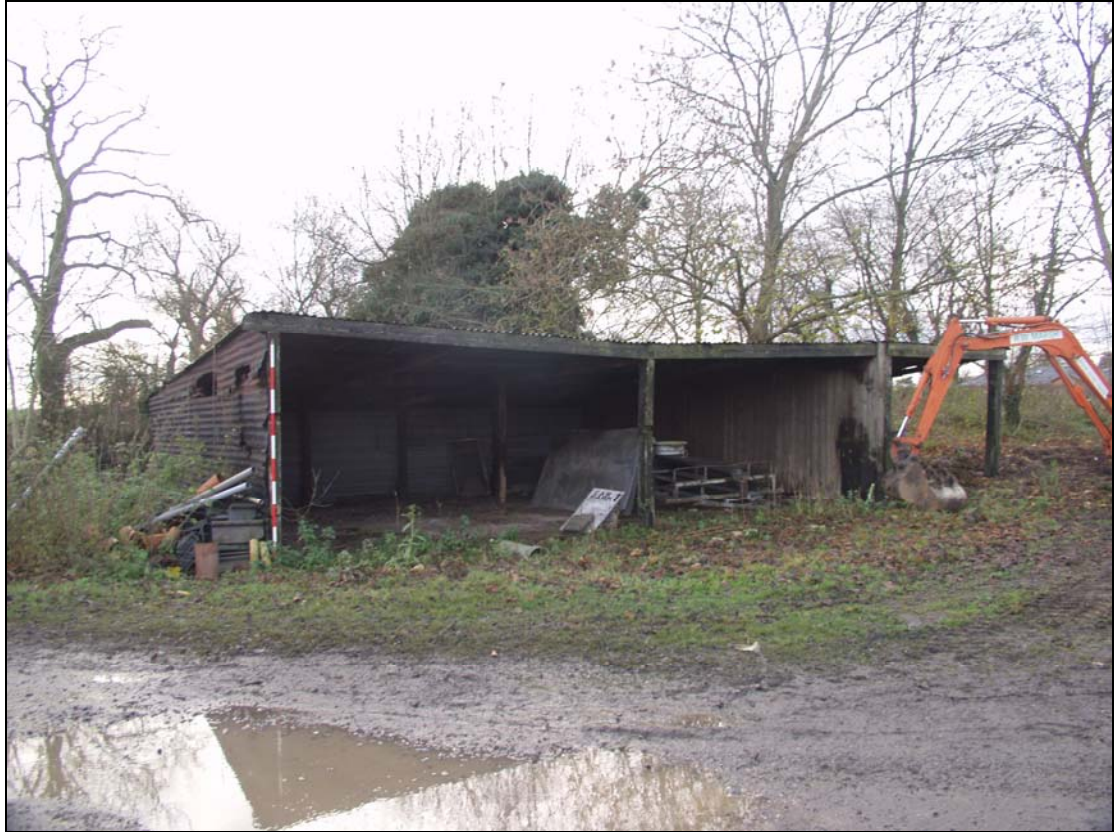
Plate 9 View of Building 5, taken from the north-east (11)
