**BARN AT GREEN FARM,
BOVINGDON GREEN, HERTFORDSHIRE**

HISTORIC BUILDING RECORDING

Authors: Tansy Collins BSc Lee Prosser PhD Andrew Peachey BA AIFA Kathren Henry	
NGR: TL 0110 0278	Report No: 3331
District: Dacorum	Site Code: AS1211
Approved: Claire Halpin	Project No: 3394
Signed:	Date: June 2009

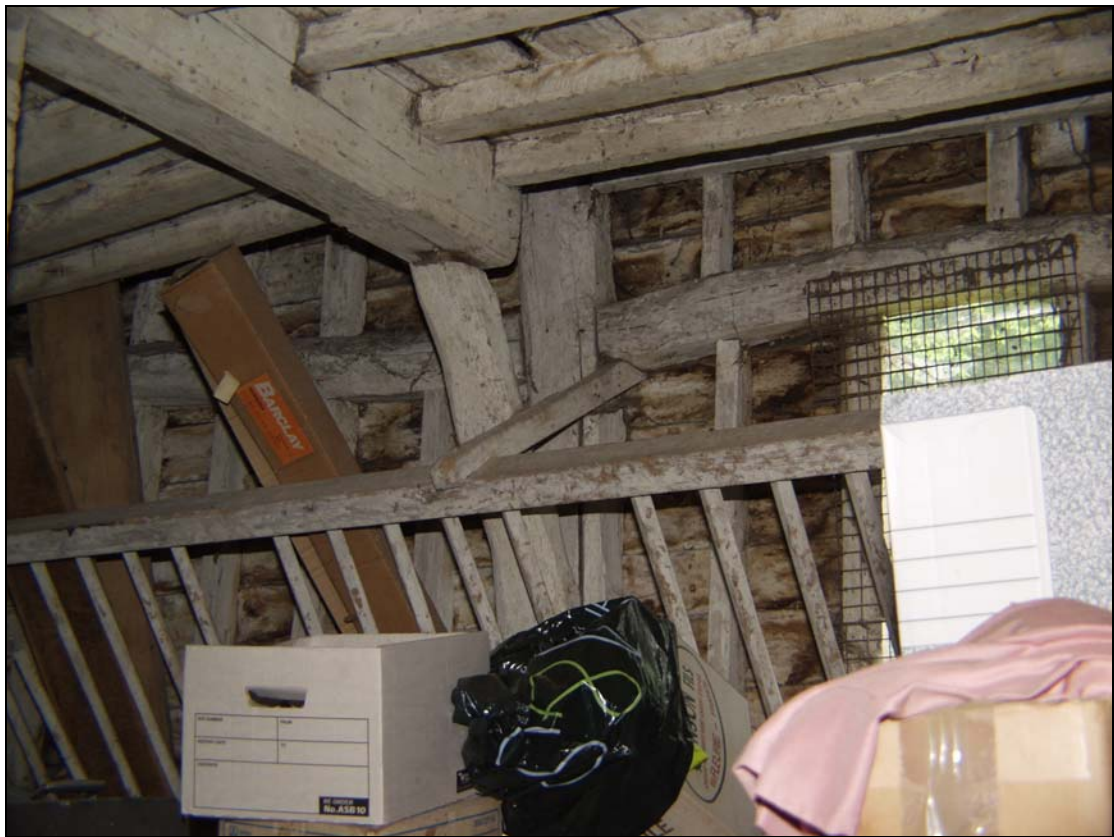
Plate 4 Detail of the east wall of Unit 1 showing floor joist and crude brace, taken from the west (15)

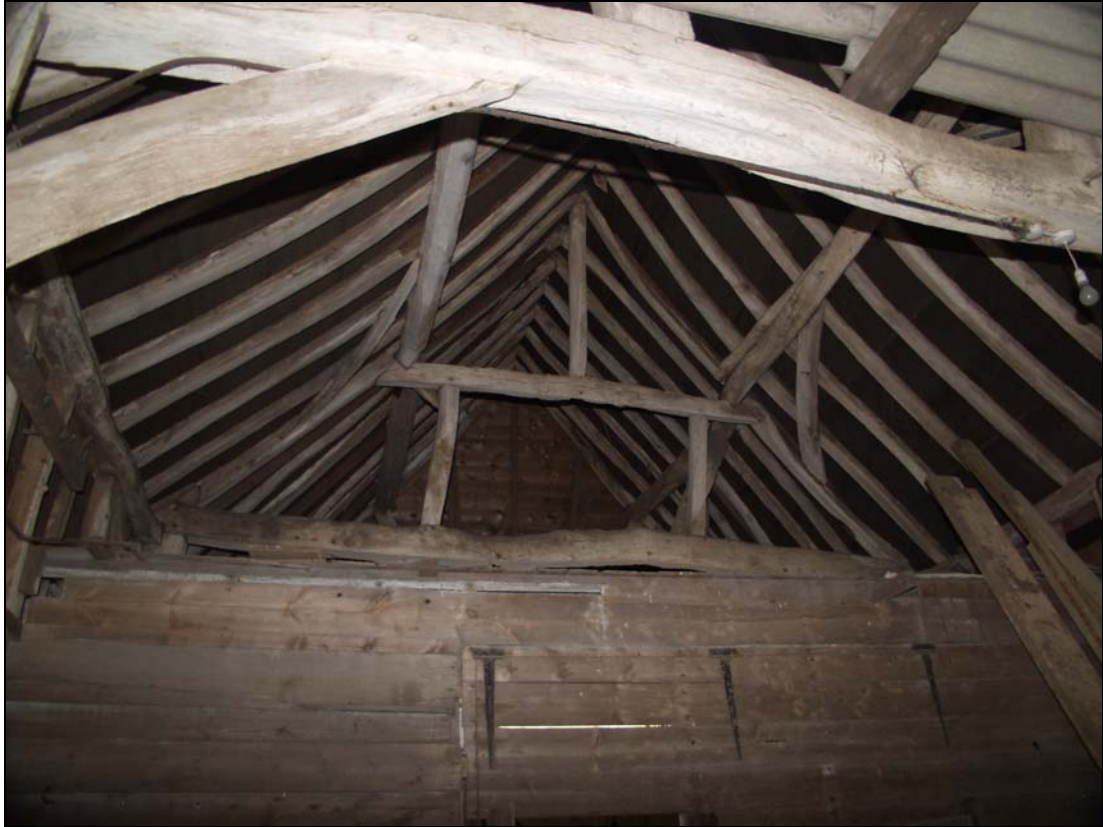
5.3.14 Two tie-beams lie above the ceiling, characterising a division of date and construction detail. The north truss (Section G-G1, Fig. 12), marking the division with Unit 2 has a central prick post below the tie-beam, noted above, with slightly cranked braces to principal posts with splay-cut jowls. Raking struts from the tie-beam are birdmouthed to the purlins. The weatherboarding to the rear and Unit 2 is of modern softwood, supported by additional radiating struts applied to the frame.

Plate 5 View of roof structure over Unit 3, north outer truss of the 15th century barn, taken from the south-west (21)

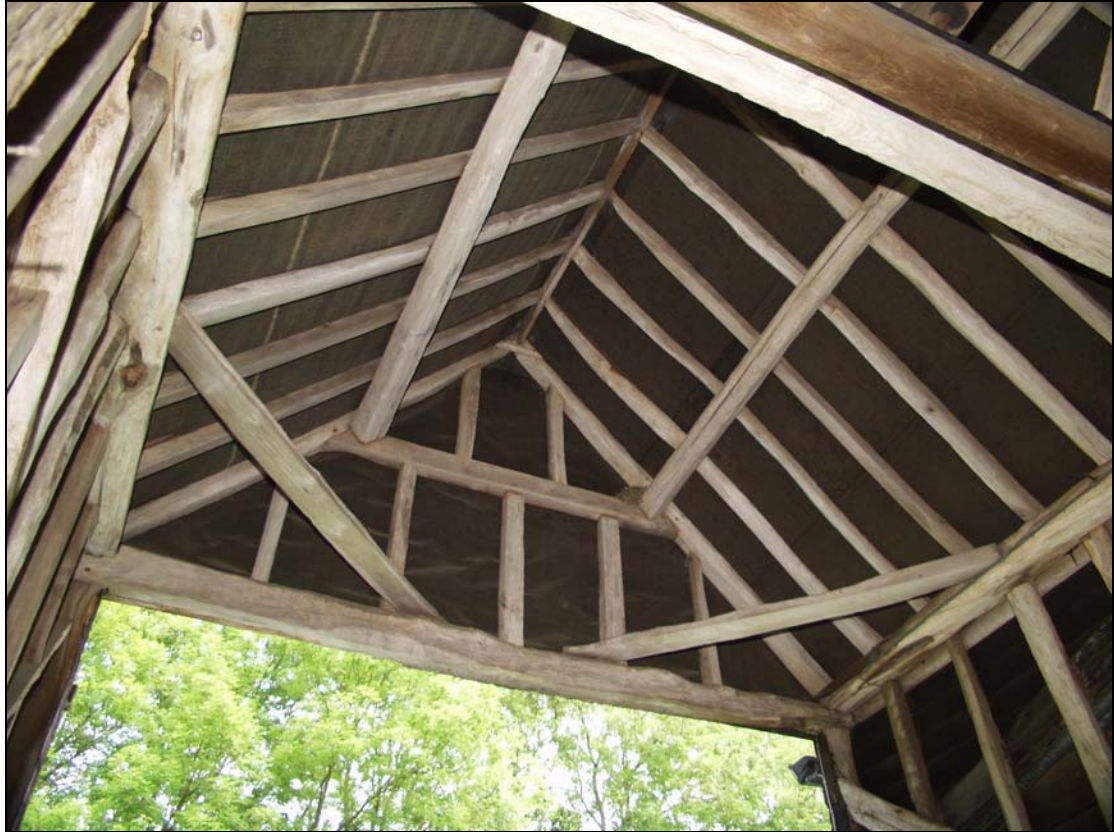
5.3.19 Many timbers within the porch have also been renewed. A few appear to be of some age, such as the door lintel on the west. The current form of the north and south walls is of primary-braced panels above mid-rails with simple studs (six in each register) below. One primary-brace on the south is notched over and pegged in an earlier manner. The walls appear to make use of some older timber but careful repairs of a different date are also visible. The roof is conventional, of side-purlin form with lap-dovetail joints visible at the junction with the barn. Additional support is given by two angle-ties extending from the outer wall-plates to the lintel on the east side (Plate 7).

Plate 7 Roof form of the porch on the east side of Unit 4, taken from the north-west (25)

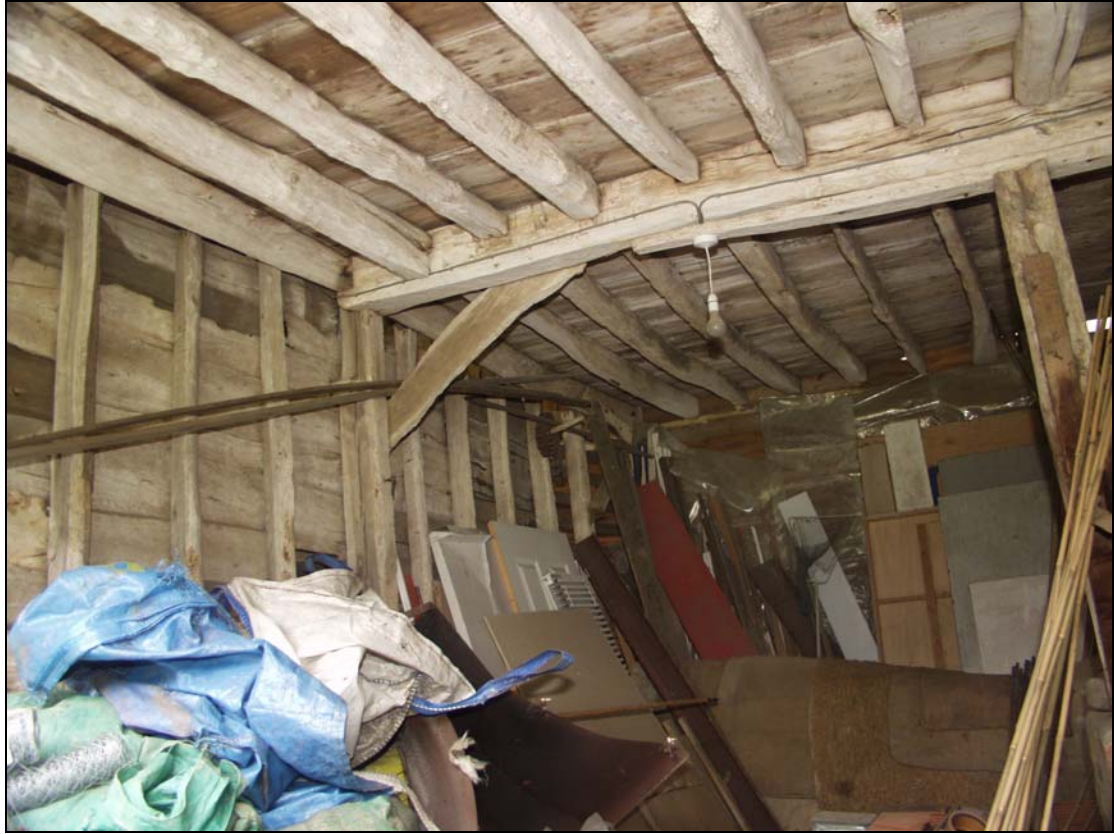
5.3.26 The hay loft floor (Plate 9) is fairly rudimentary and clearly a later addition with a central bridging joist cogged over a post at the bay division with a nail-on brace and supported at the south end by a shaped, nailed-on timber bracket. The floor boards measure 7" (178mm) and are supported by close-spaced floor joists comprising quarter-sawn timber properly morticed into the bridging joist with diminished haunch and pendant soffit joints although simply cogged over the mid-rails on the east. This was formerly the case on the west except here the entire mid-rail has been replaced in softwood and the joists now simply rest on this timber. The insertion of the new mid-rail on the west has facilitated the truncation of the bay division post, but above we see a redundant mortice for a brace to the tie-beam and the loss made good at lower level by a cushion capital and new robust post. Similarly, the south-west corner post has been truncated but remains at lower level.

Plate 9 Ground floor of the central bay of Unit 5, taken from the west (29)

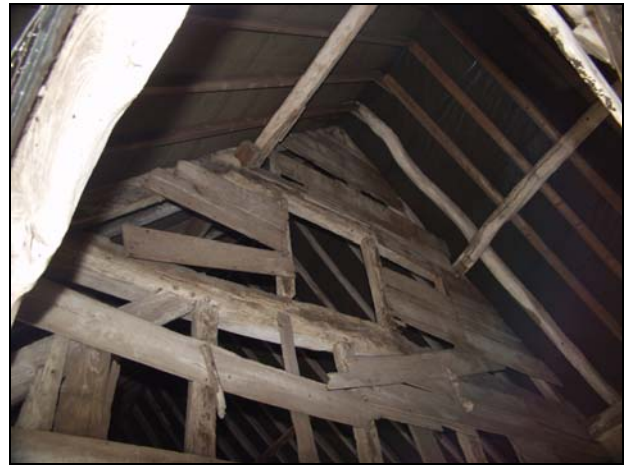
DP 26

North side of the open-bay of Unit 5 showing some weathering to timbers, taken from the south-west

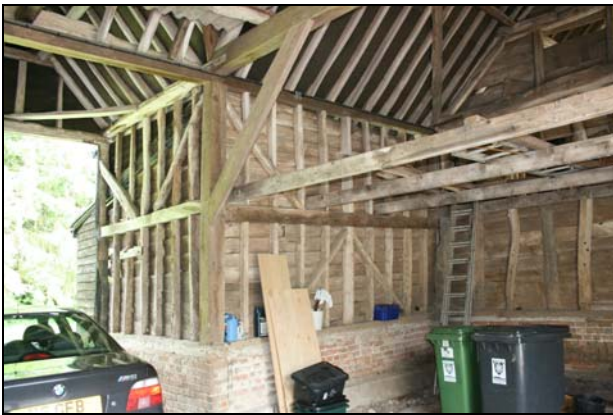
DP 39

South-east corner of Unit 5 showing later repairs to the earlier core, taken from the north-west
