**23 BALDOCK STREET,
WARE**

HISTORIC BUILDING APPRAISAL

Authors: Dr Lee Prosser BA PhD Tansy Collins Bsc	
NGR: TL 3558 1455	Report No. 3400
District: East Herts	Site Code: n/a
Approved: Claire Halpin	Project No. 3569
MIFA	Date: October
Signed:	2009

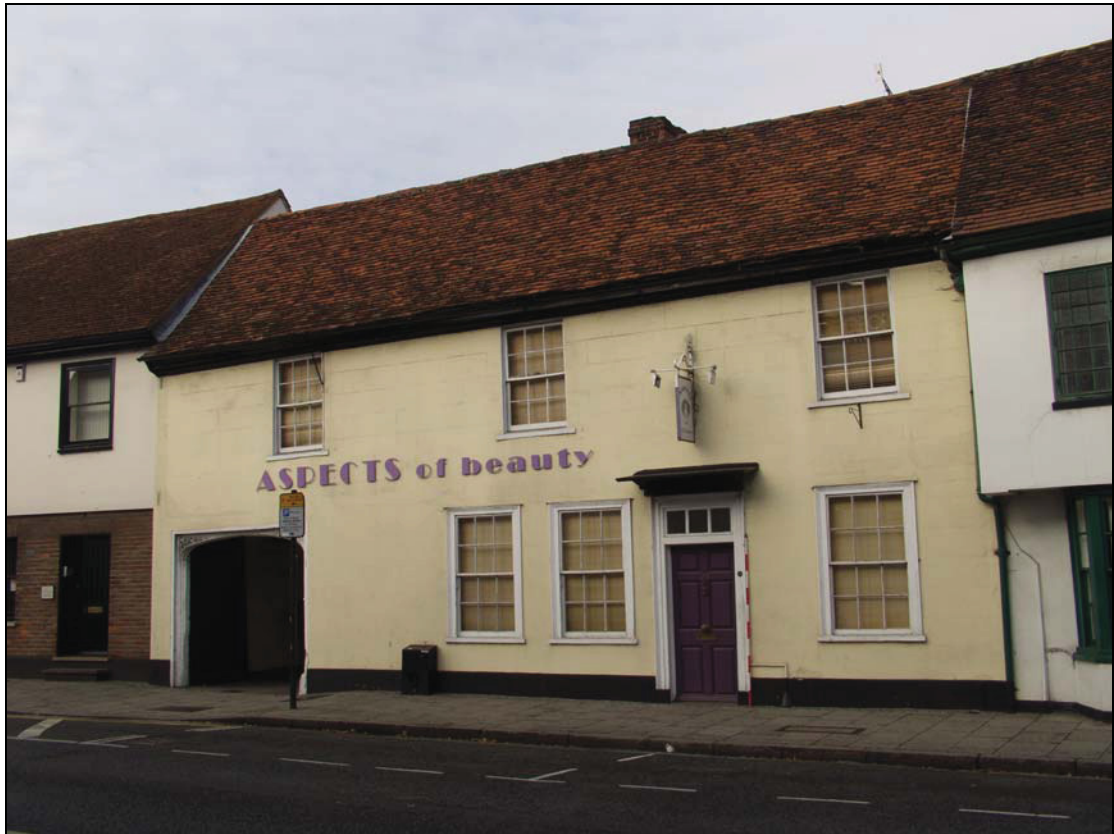
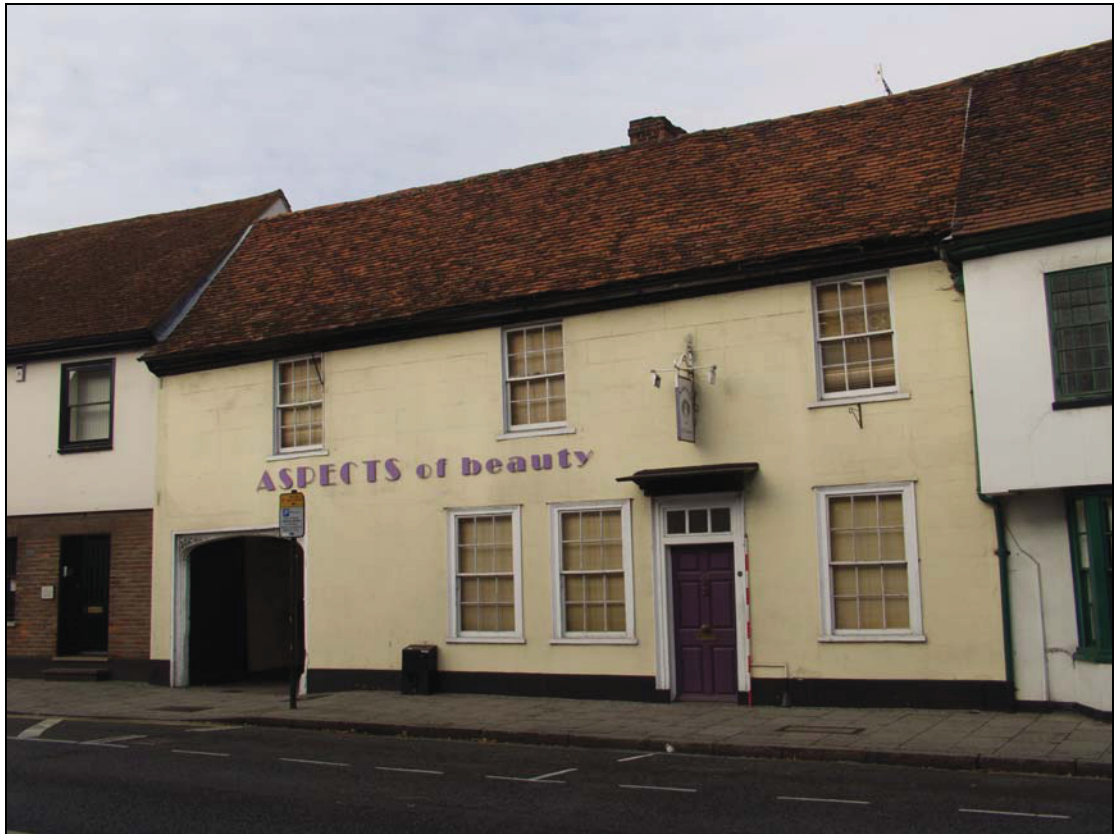
4.1.1 The principal range is aligned north – south, fronting the street (Plate 1), with a rear wing extending to the west adjoining the former yard, which is given access from the street by the carriageway on the south.

4.1.2 The building was originally of timber-framed construction but appears to be much replaced in brick and is now rendered and ashlar-lined in the 18th century style. The main entrance is flanked by a pair of windows to the south and a single window on the north. All three are six-over-six sashes in flush boxes with moulded surrounds and plain sills. The door is a well-preserved 18th century specimen, with six deep raised and fielded panels, in a contemporary surround and a three-paned overlight, protected by a deep moulded hood on shaped brackets. The door appears slightly shortened at its base. All the door furniture is modern. To the south at ground floor level a wide four-centred carriageway arch preserves moulded jambs and spandrels of carved foliage, of 16th century style as noted in the listing description, but now partly obscured with many layers of paint. The wide double doors survive and hang on upper pintles, but are permanently fixed open as progressive resurfacing of the carriageway has wedged them in their current position. They are nonetheless of some significance, of early 18th century date, robustly framed with ovolo moulding to a single flush panel on each leaf, constructed of four wide vertical boards. The north door is pierced by a wicket. Limited visibility to the rear reveals ledges with good surviving security arrangements such as locking bars, bolts etc.

4.1.3 The upper floor of the street elevation has three widely spaced six-over-six sash windows, off-set to the lower arrangement; only the north window corresponding to its lower companion. These have no architraves and all are slightly recessed, while the heads abut a deep boxed timber cornice. The roof is covered in hand-made peg-tiles.

Plate 1 East elevation of the building fronting the street, taken from the east (DP 05)

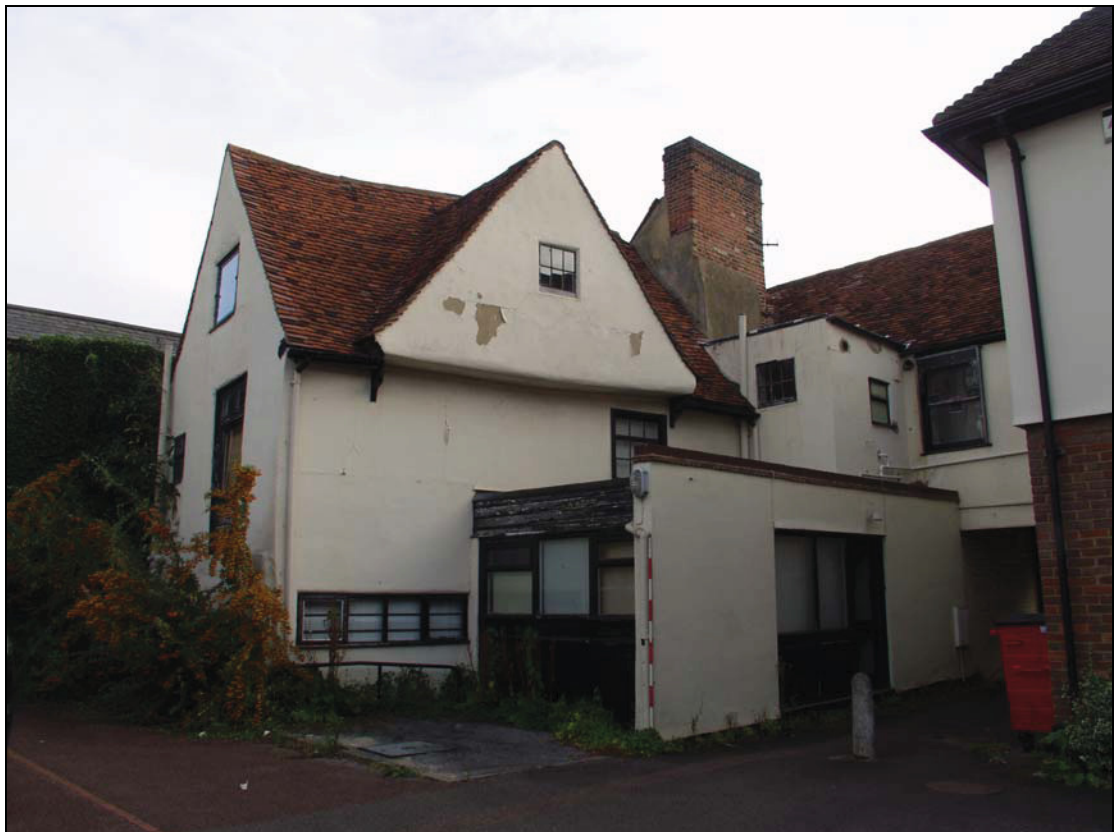
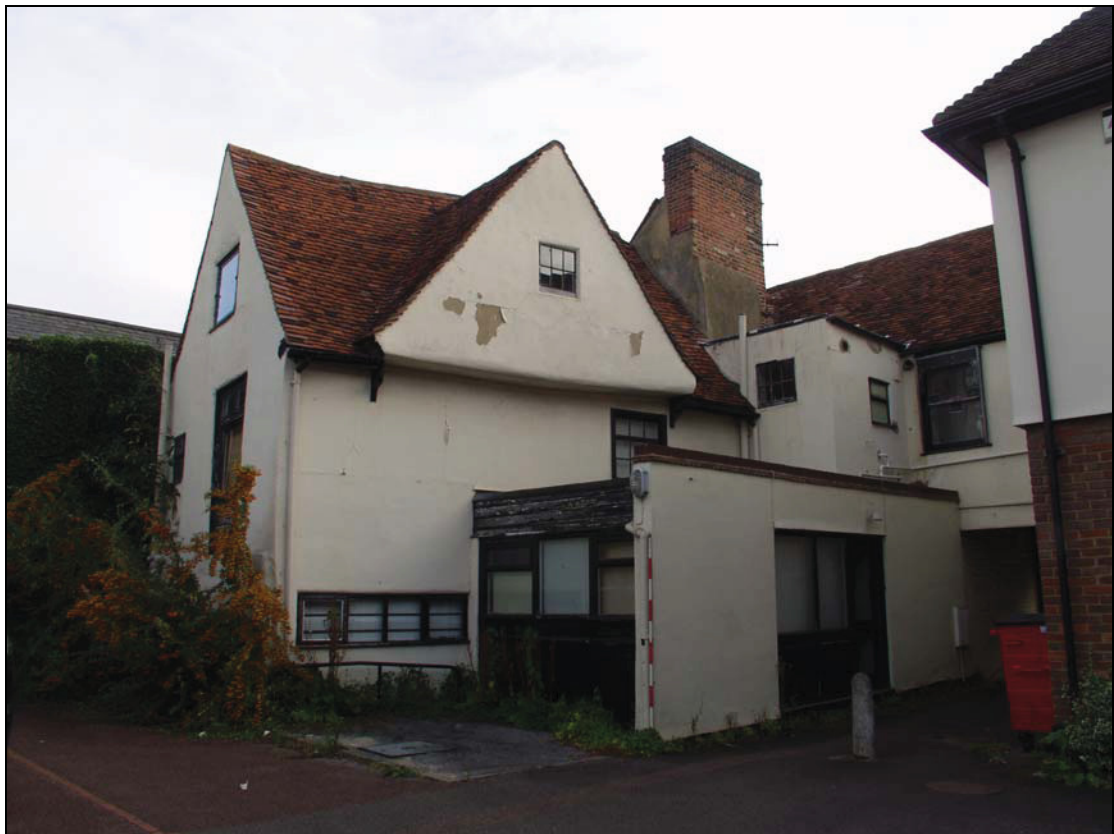
4.1.4 The rear wing has been extended on several occasions (Plate 2). The main structure lies to the north, where it shares a composite chimney stack with the main range. It has a short contemporary return to the south, jettied out at gable level, where it is supported on shaped brackets and lit by a small window. Just visible beneath later render at the corners, a short section of moulded bressumer survives (Plate 3) – the rest may survive, but is obscured by slap-dash repair. The rear wing may have extended further west as it is pierced by a high-set doorway on the west gable, latterly converted to a window. Such a door may alternatively have given access to a balcony or rear stair, as a small offset of brick remains at the base.

Plate 2 View of the rear range with south gable and later extensions, taken from south-west (DP 01)

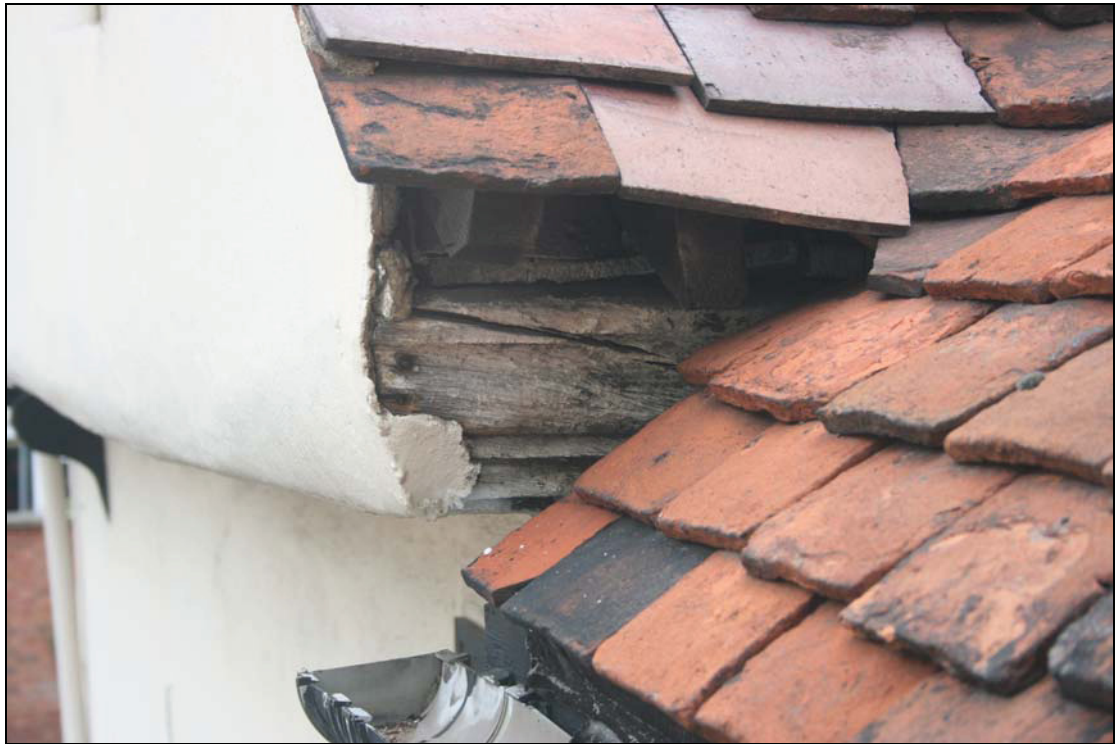
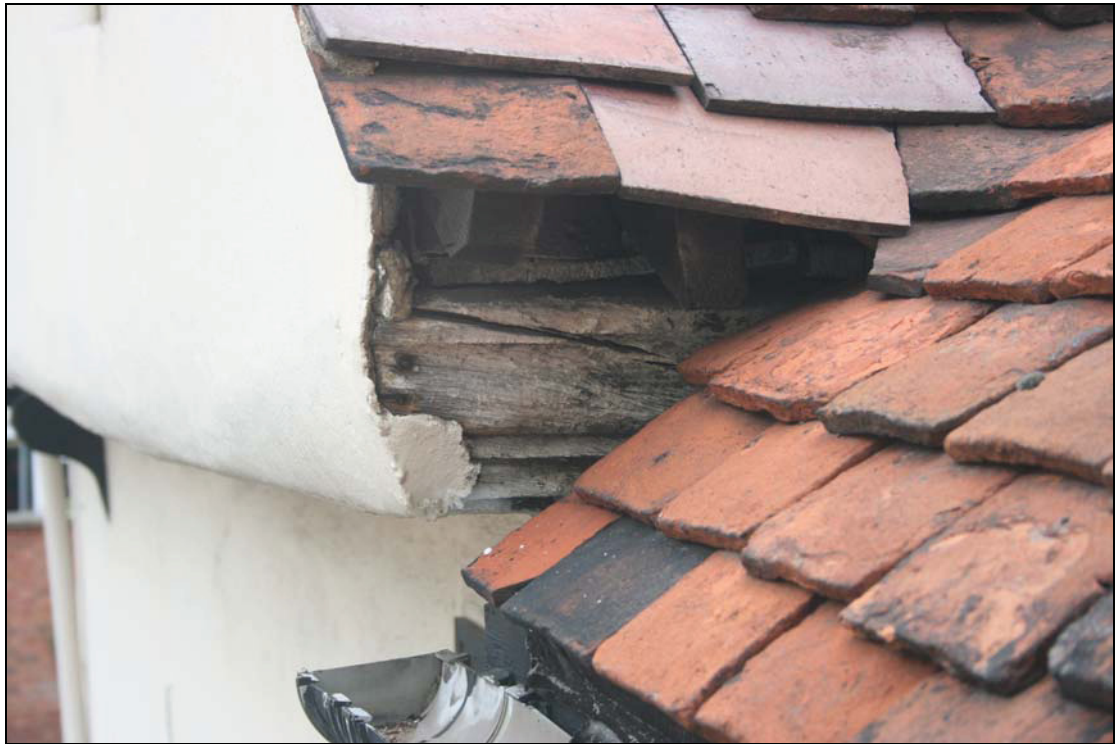
Plate 3 View of the jettied south gable of the rear range with moulded bressummer, taken from the east (DP 52)

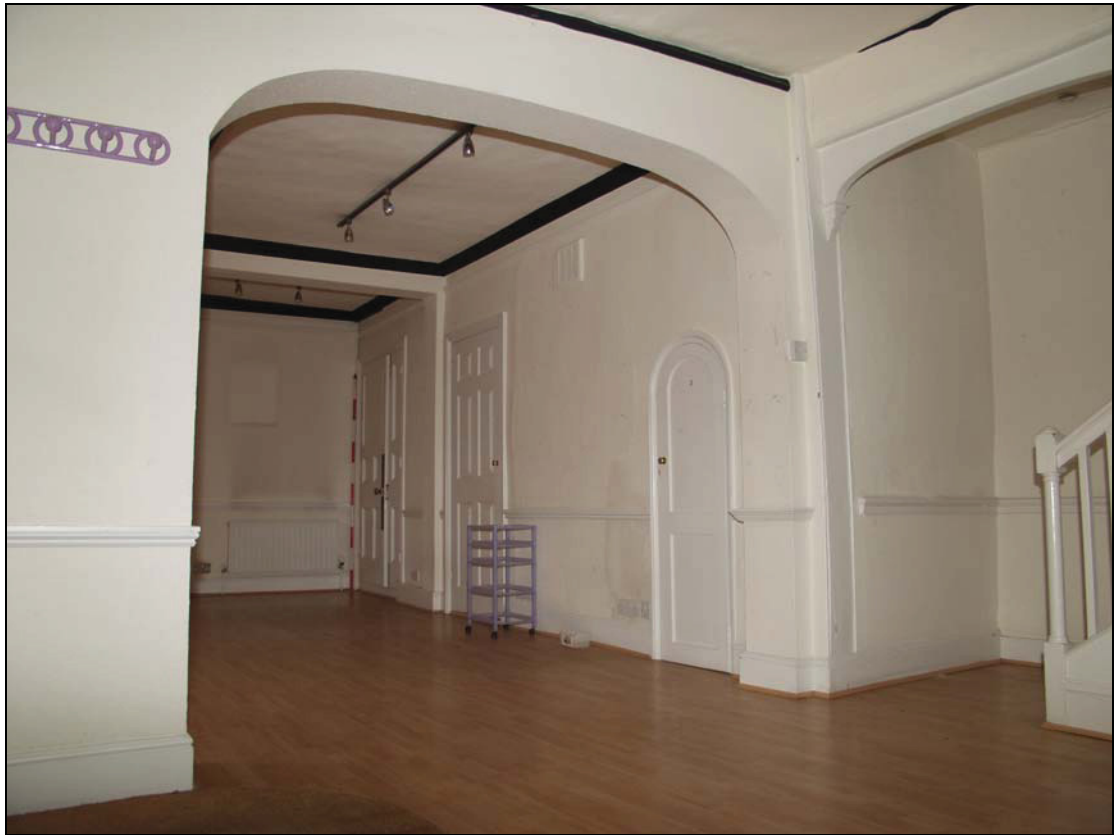
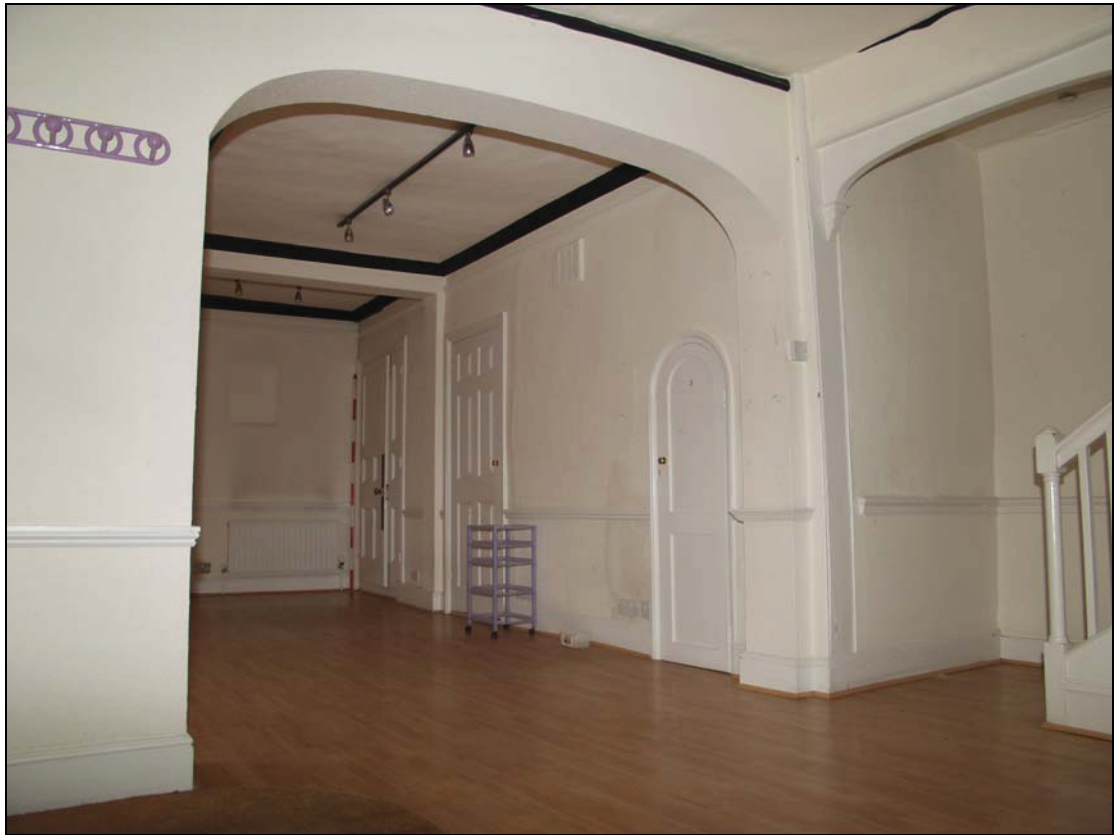
4.2.3 The front ground floor rooms have been consolidated into a single space (Room 1) with an open stair at the rear (Plate 4). Only the front door remains enclosed in its own protective lobby, of modern date. However, the former subdivisions remain in part expressed as piers or arches, and in most cases framed with decorative ceiling mouldings so that we still discern the earlier arrangement. The rear range is no longer accessible from this side. The former connecting passage has been partitioned and now forms Room 2. The staircase gives access to the upper floors of the entire complex, while a separate flight off the first floor landing leads to the attic of the rear range. The floor levels of the front and rear ranges are notable as they lie at different heights.

Plate 4 Room 1, ground floor, taken from the north-east (DP 09)

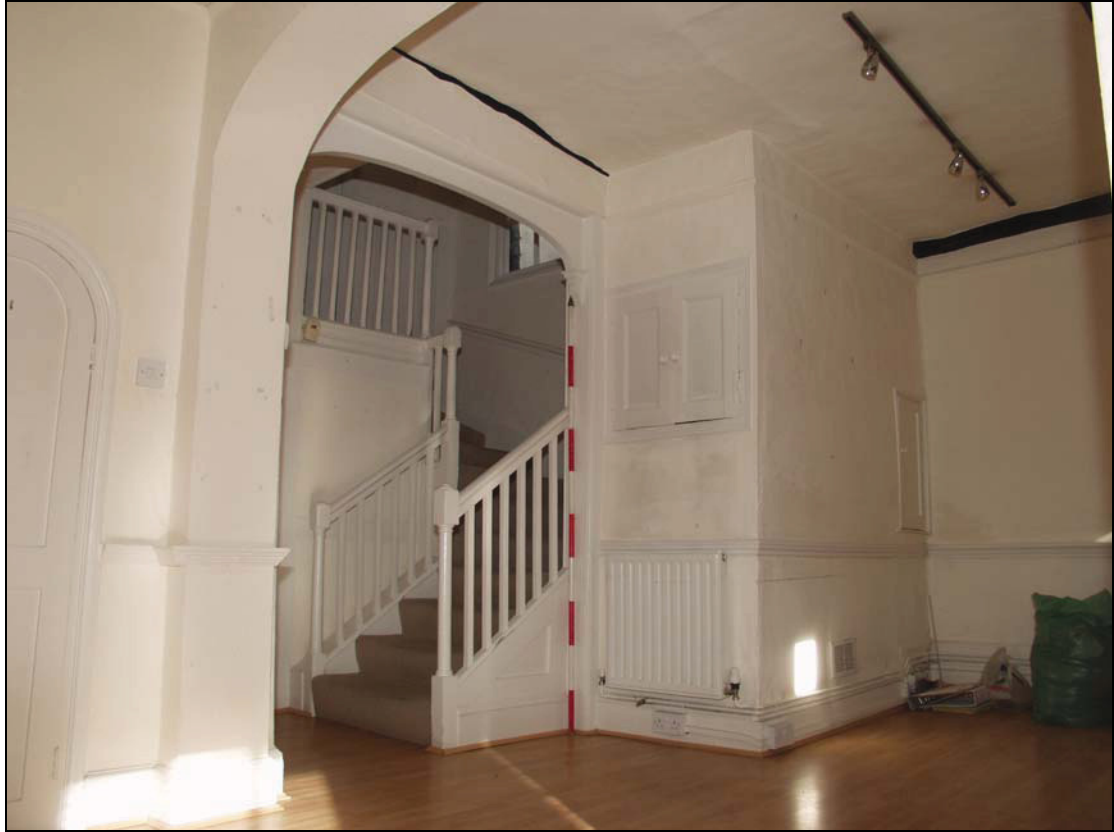
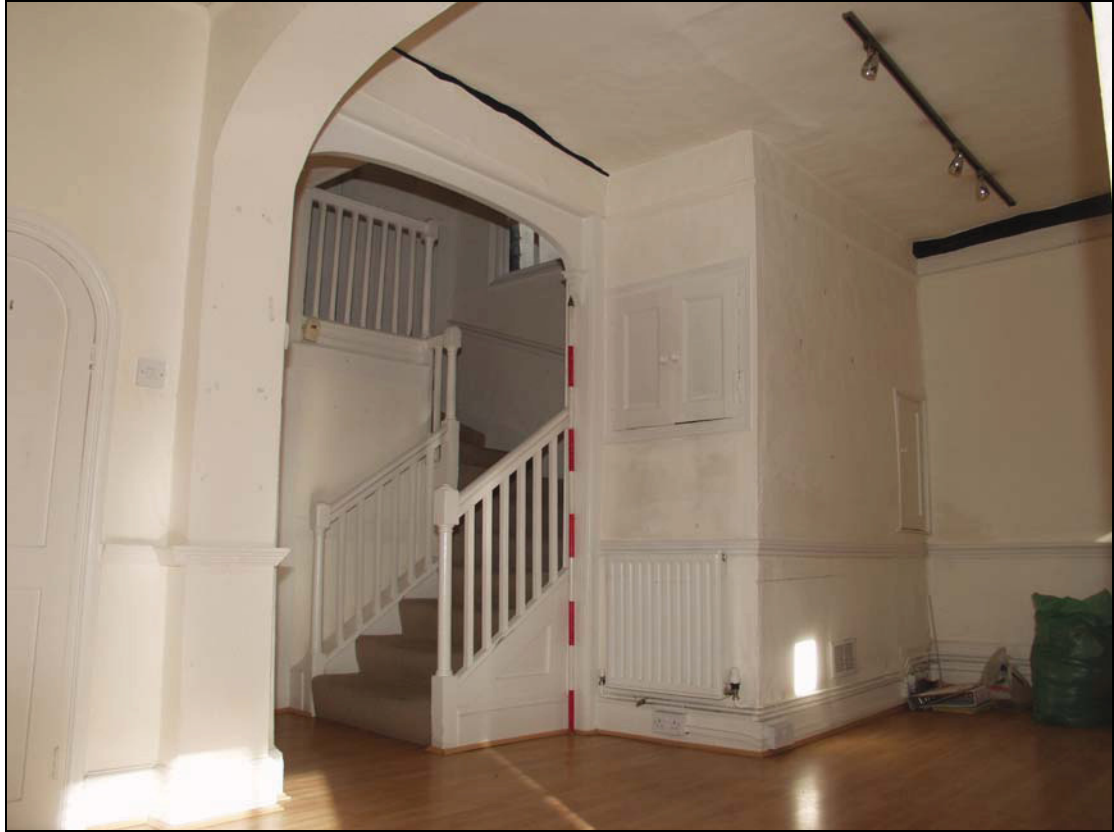
4.2.11 The staircase has been squeezed into a turret which may have been created by extending the building slightly to the north (Plate 5). It is framed at the base by a large elliptical arch on shaped brackets of late 19th century date. The staircase itself rises in dog-leg form to first floor level, and is constructed in softwood on a closed, moulded string with turned Doric column newels and thick stick balusters. A plain shaped handrail continues the first flight as a dado rail along the outer wall. When probed the stair shows an extensive paint history which seems to combine 18th and 19th century elements. Superficially it appears to be an early 19th century stair, but elements such as the heavy mouldings of the string and thickness of the sticks might suggest remodelling of an earlier structure. It is lit from the north by a six-over-six sash with characteristic early 18th century glazing bars with ovolo mouldings and fillet

Plate 5 View of the staircase and chimneystack in north-west corner of Room 1, taken from the south-east (DP 12)

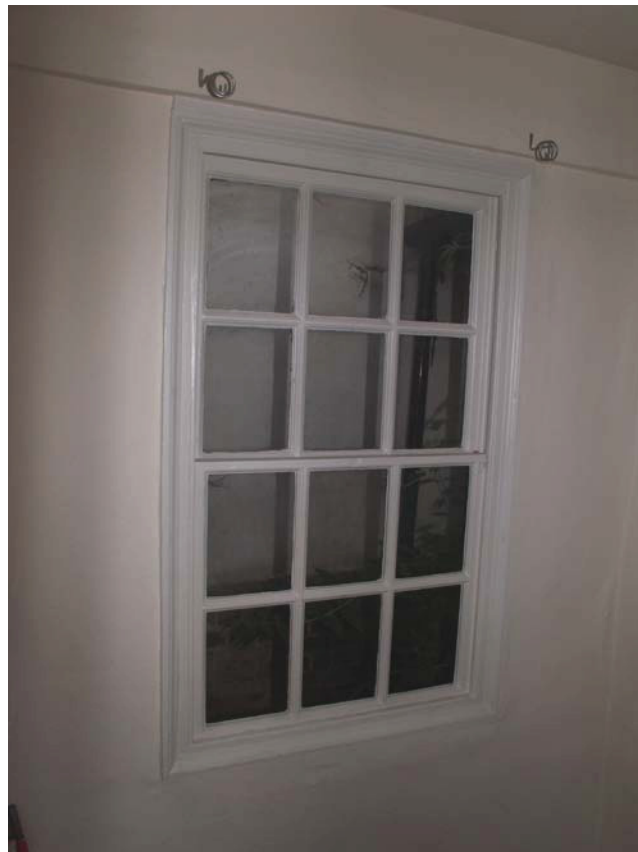
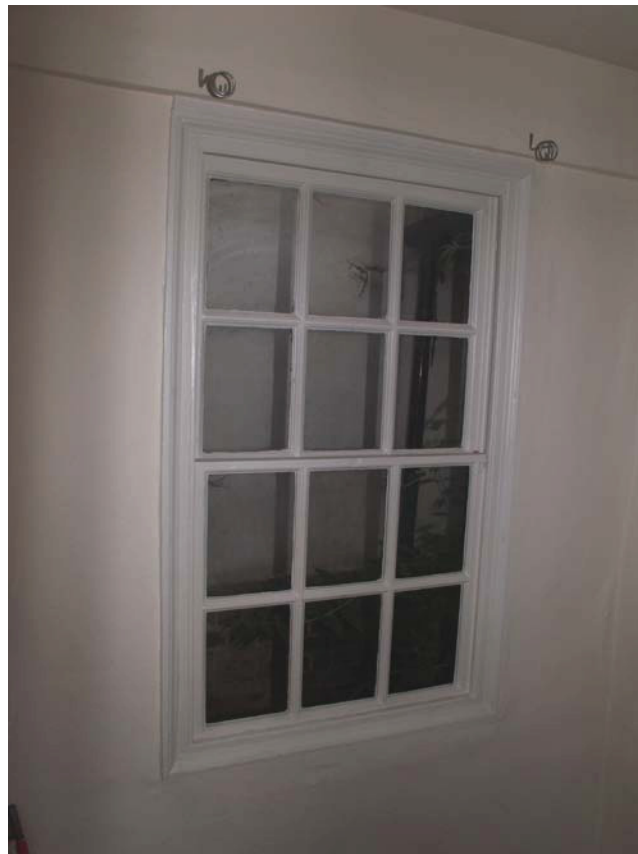
(Plate 6). This retains its early architrave and some original crown glass with characteristic threading.

Plate 6 Early 18th century window on the north side of the stair, taken from the south-west (DP 28)

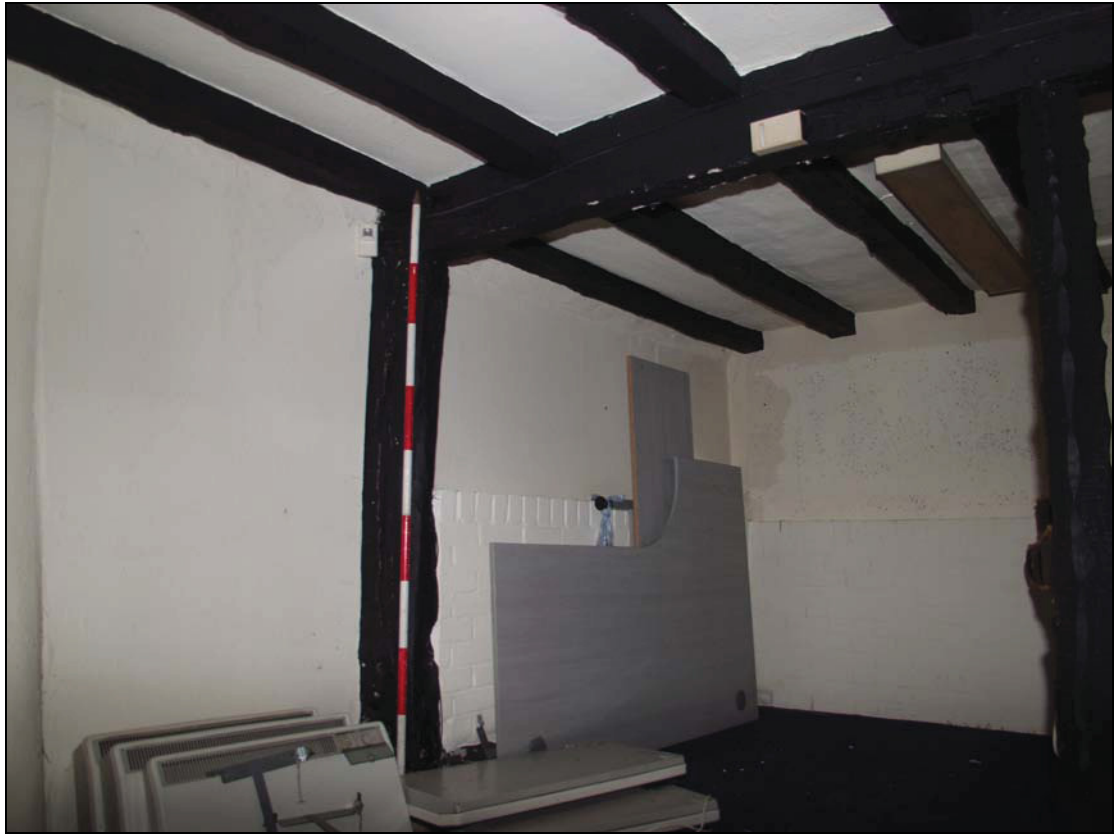
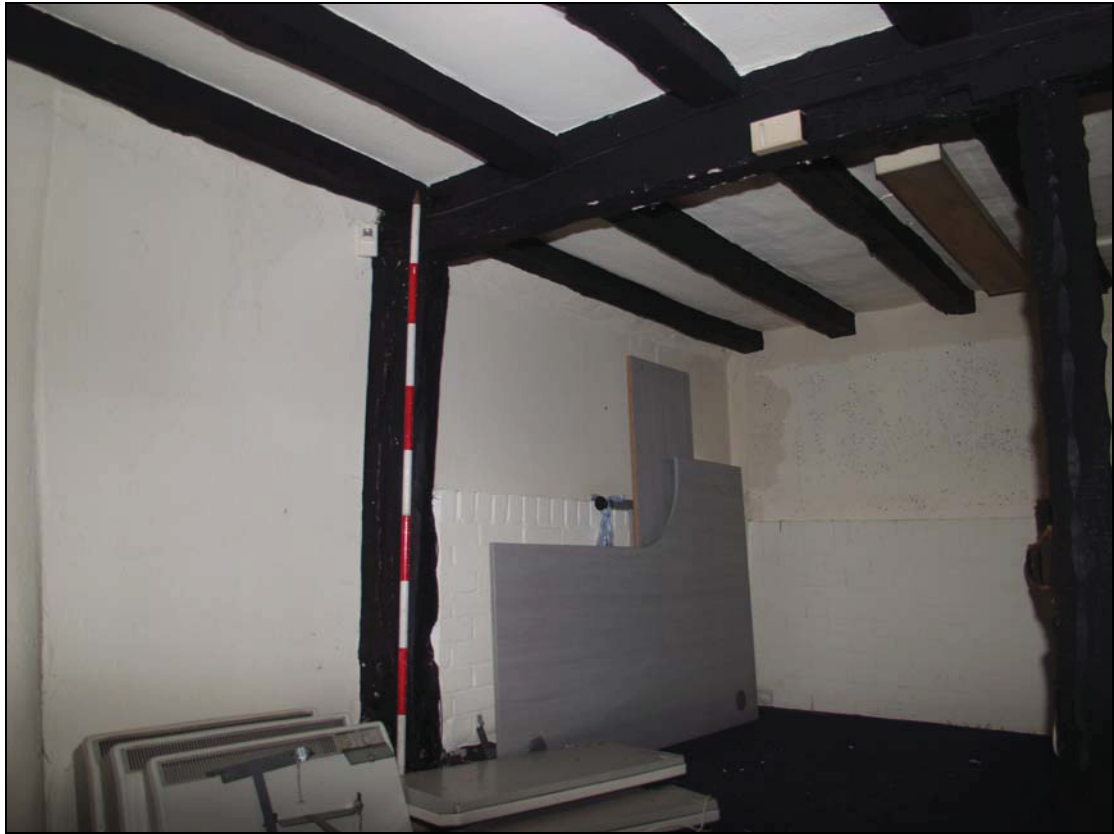
4.2.17 Room 4 appears to have been consolidated from two discrete chambers (Plate 7). The subdivision is expressed by a small step in the floor along the line of a

bridging joist and three modern timber studs. The joist is supported on the west by a post, where it is strapped and stapled on the south. It retains peg-holes for three studs to the east but is blank along its remaining length. Common joists, laid on their sides, simply sit or ride over this timber, both north and south. They are simple with no chamfers or stops. The outer walls are either of painted brick or obscured with paint and no historic fabric is visible.

Plate 7 View of Room 4, ground floor, taken from the north-east (DP 36)

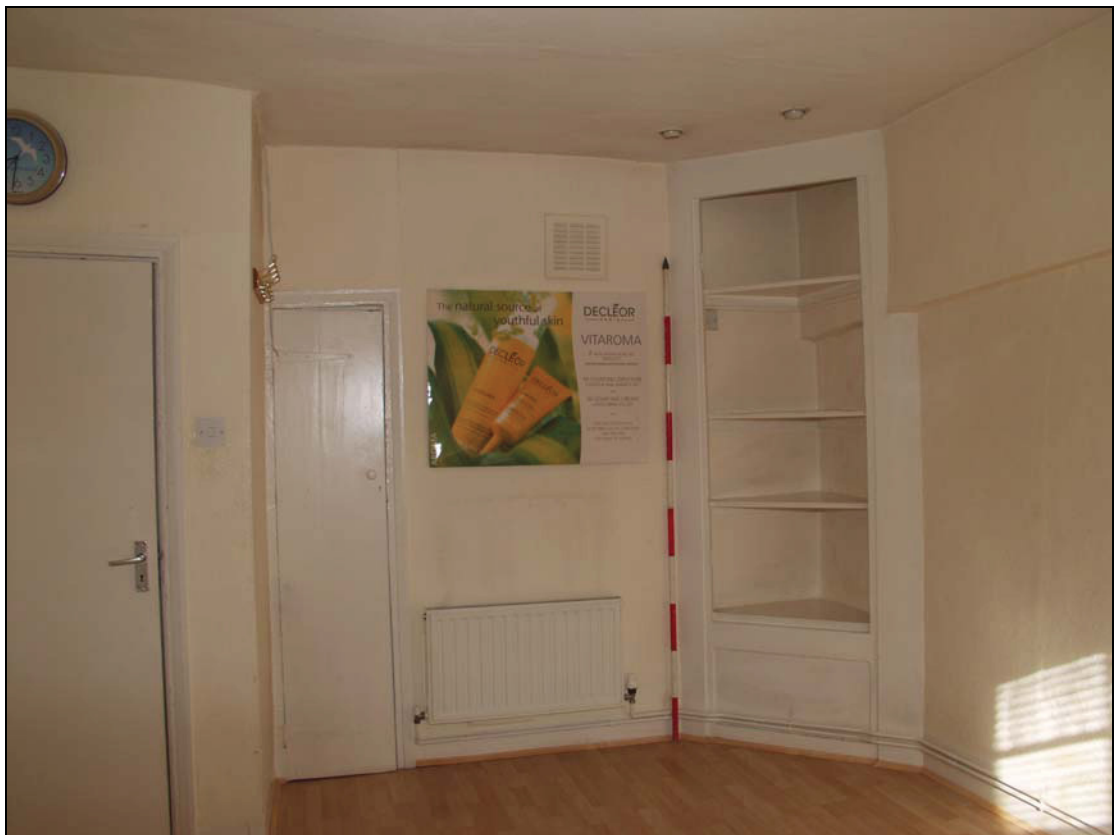
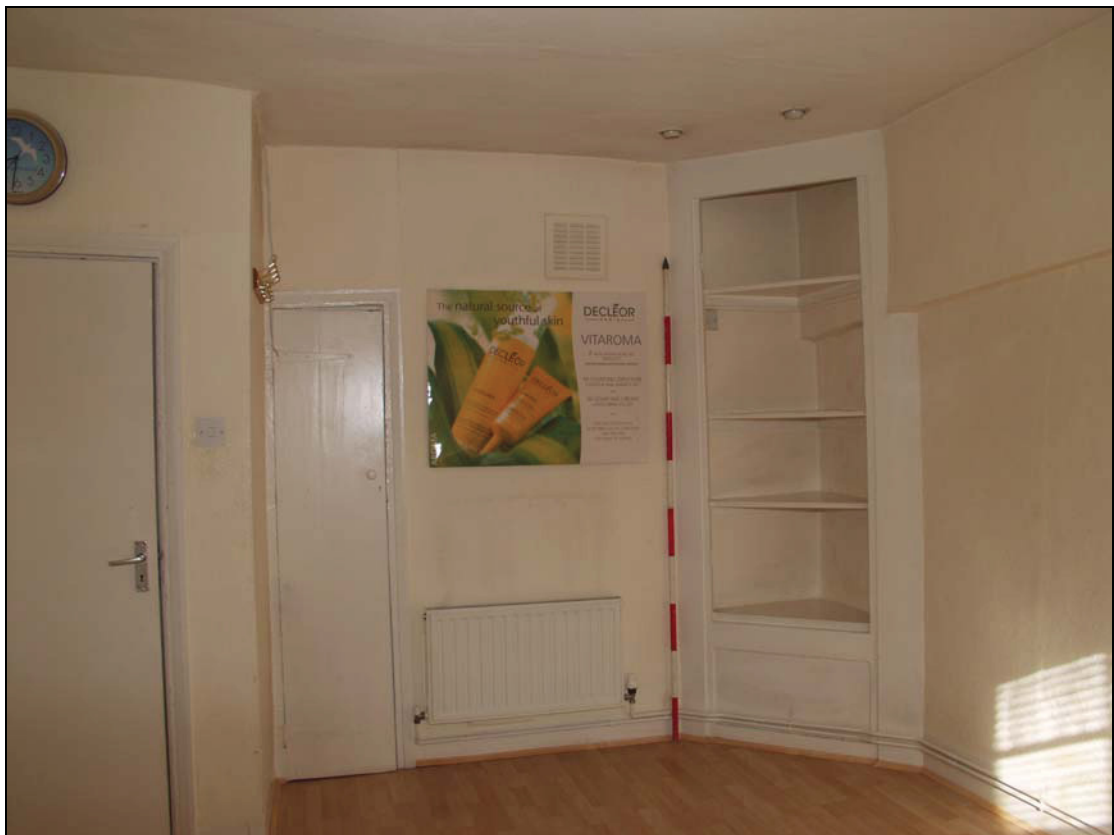
Plate 8 West side of Room 6, first floor, taken from the east (DP 15)

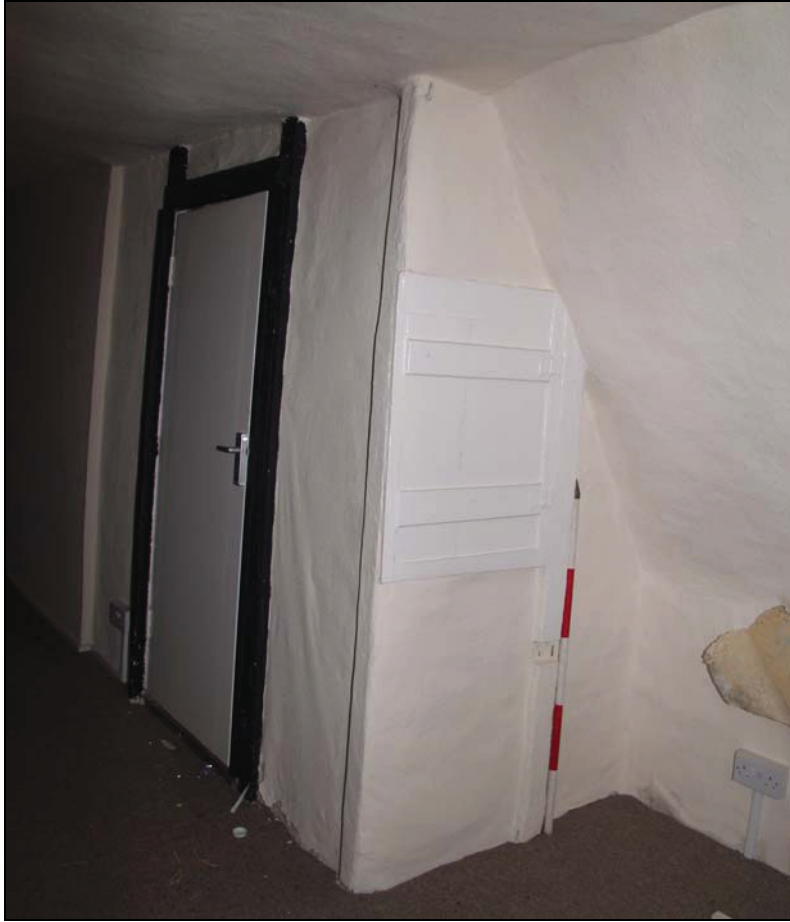
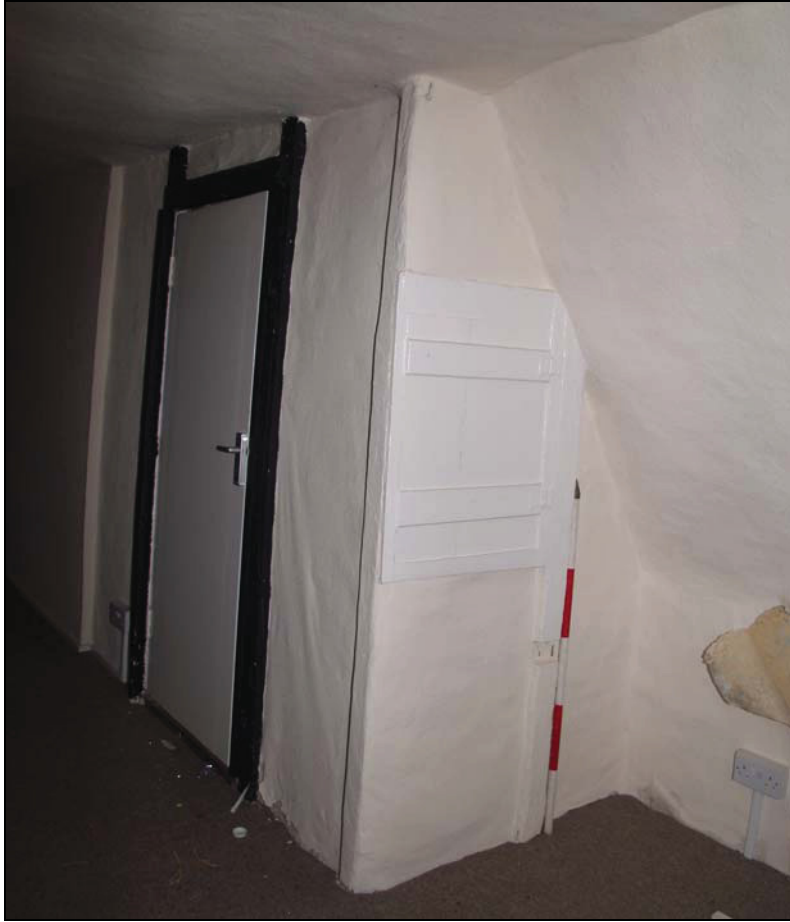
Plate 9 Exterior of Room 12, second floor, on the south side of Room 11, taken from the north-west (DP 24)

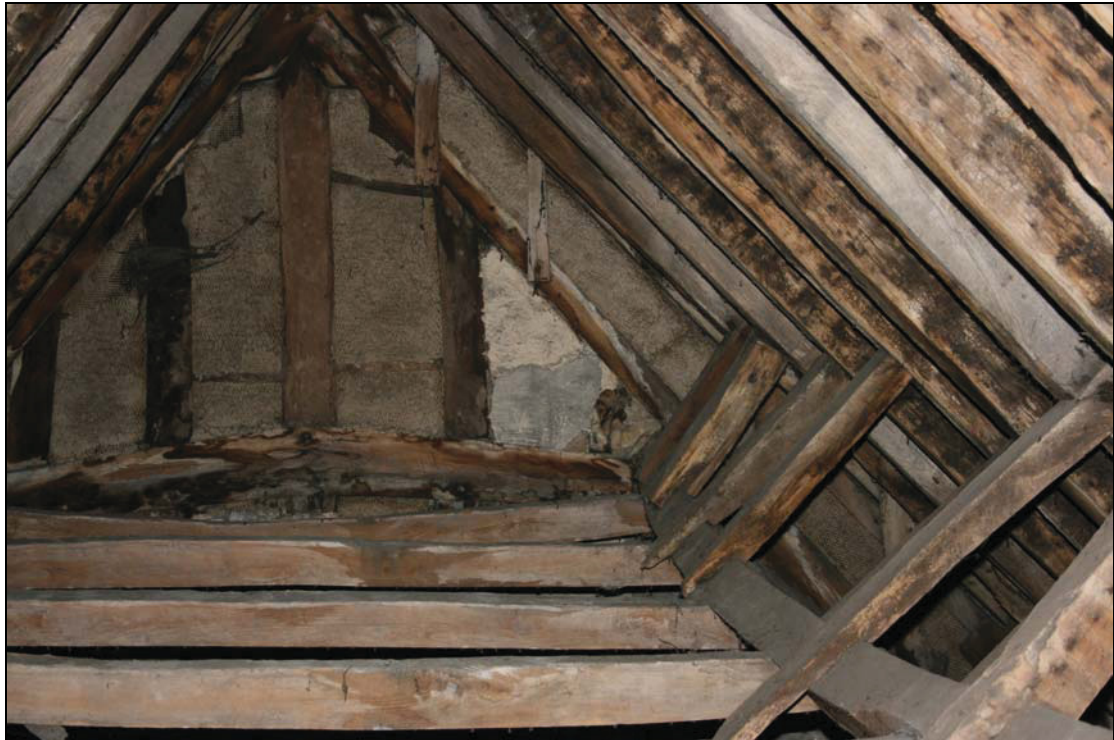
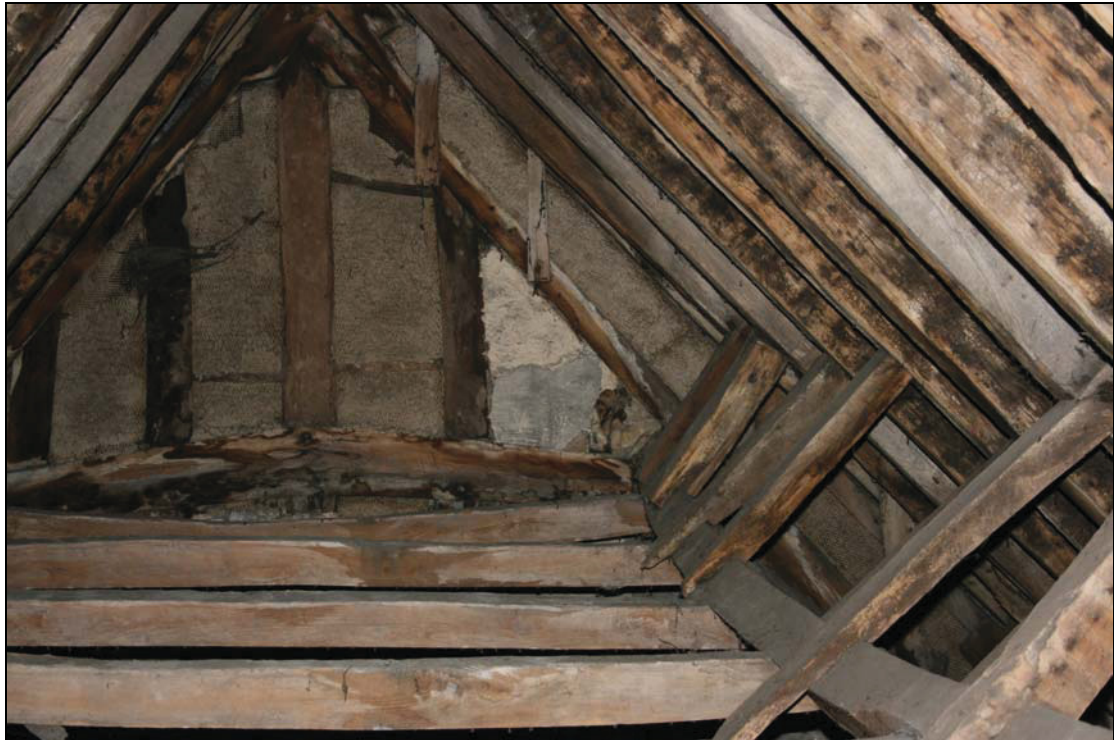
Plate 10 View of south gable in the roof space, main range, taken from the north (DP 42)

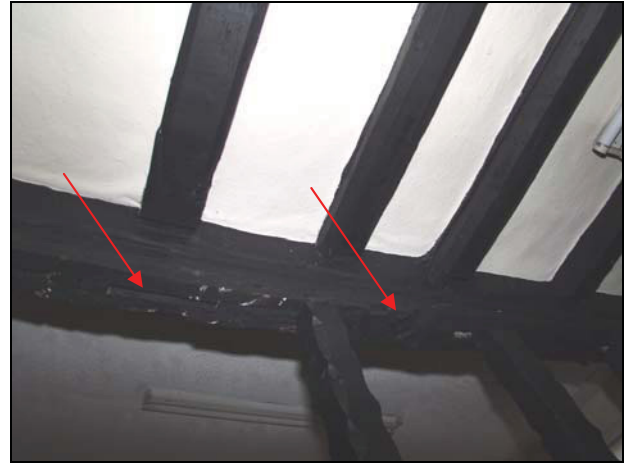
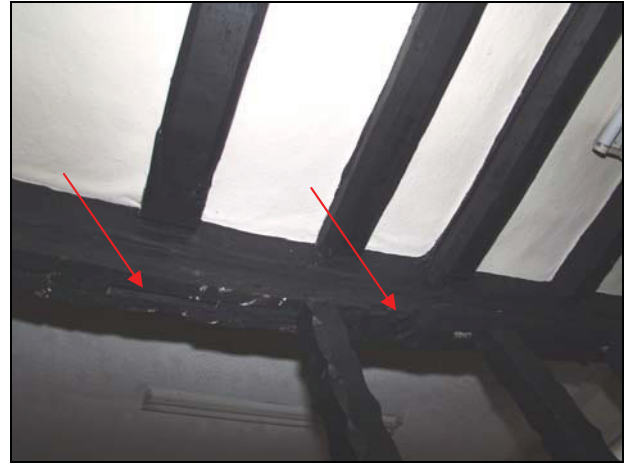
DP 32

4.2.16 This southern mid-rail, if not *in situ*, is a reused timber of some age as we see shallow mortices for diamond mullions and traces of shutter grooves, although all subsequently remodelled with studwork. Four studs of modern rusticated oak have been inserted and rest on a modern brick wall, all of no interest. At the west end, close to the partition wall a single upright survives, preserving mortices for timber but similarly it is not known if this is *in situ*.

Soffit of the south mid-rail in Room 3, showing shutter groove and diamond mullion mortices, taken from the north
