**OUTBUILDINGS SHEERING HALL, BAMBER GREEN,
TAKELEY, ESSEX**

**HISTORIC BUILDING RECORDING AND ARCHAEOLOGICAL
MONITORING AND RECORDING**

Authors:	Tansy Collins BSc Lee Prosser PhD Matthew Adams BA Peter Thompson MA Kathren Henry	
NGR: TL 5760 2288		Report No: 3480
District: Uttlesford		Site Code:
Approved: Claire Halpin		Project No: P3310
Signed:		Date: February 2010

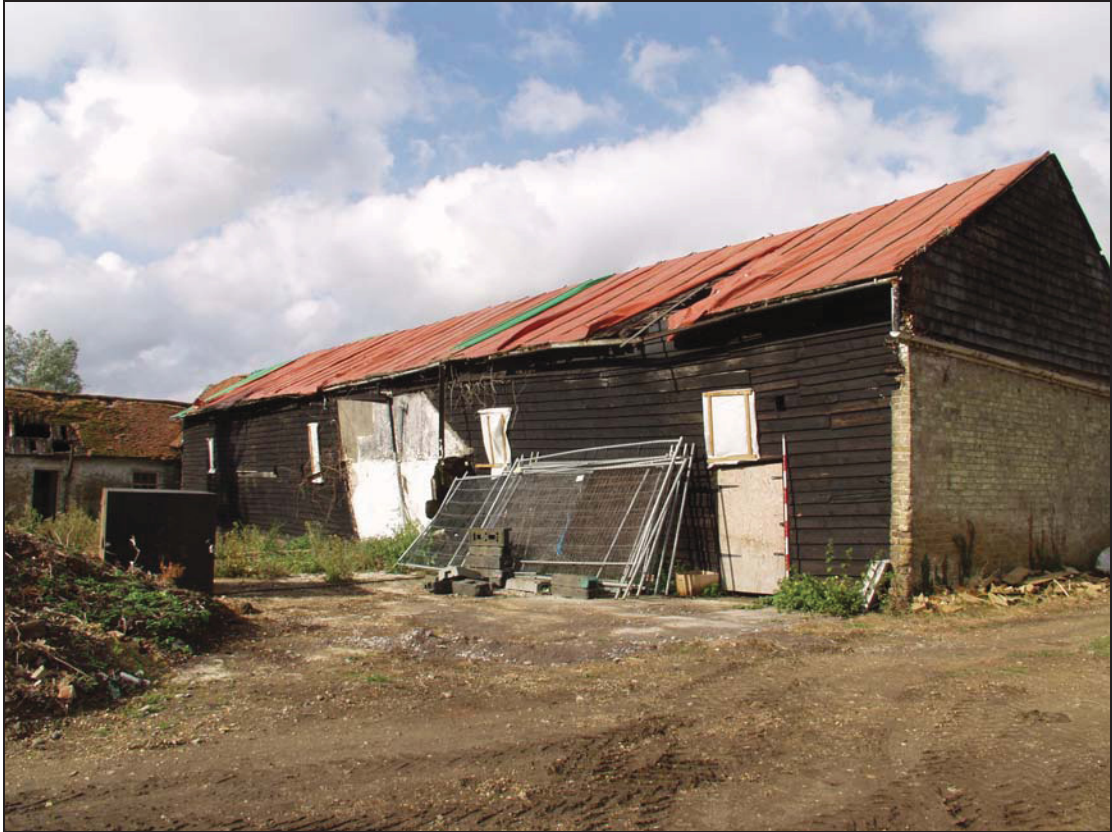
6.2.2 The whole building is suffering from racking and partial structural failure evident in the bulging profile of the external surviving fabric, while the north gable end has been given additional support with an applied brick skin rising to tie-beam level. Above this the gable is hung with shingles.

Plate 1 East façade of Building 1, taken from the north-east (DP 31)

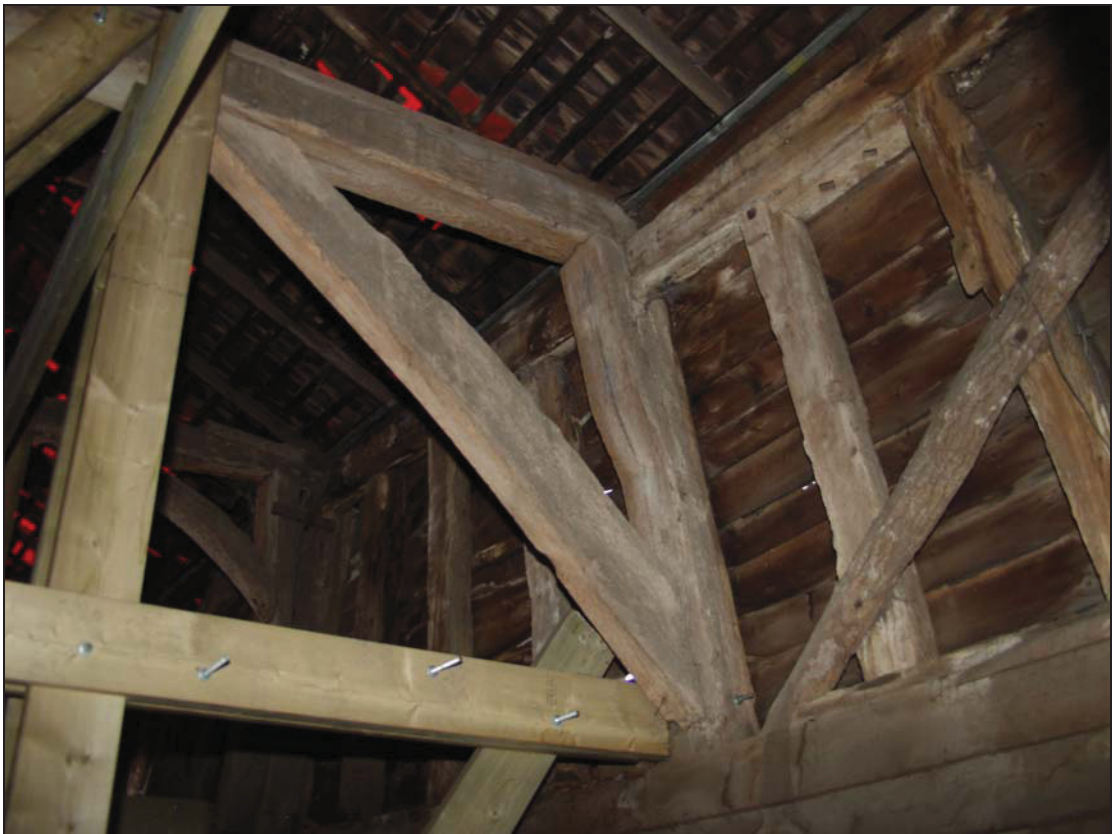
Plate 2 Detail of truss construction on the east side of Truss 6, Building 1, taken from south-west (DP 61)

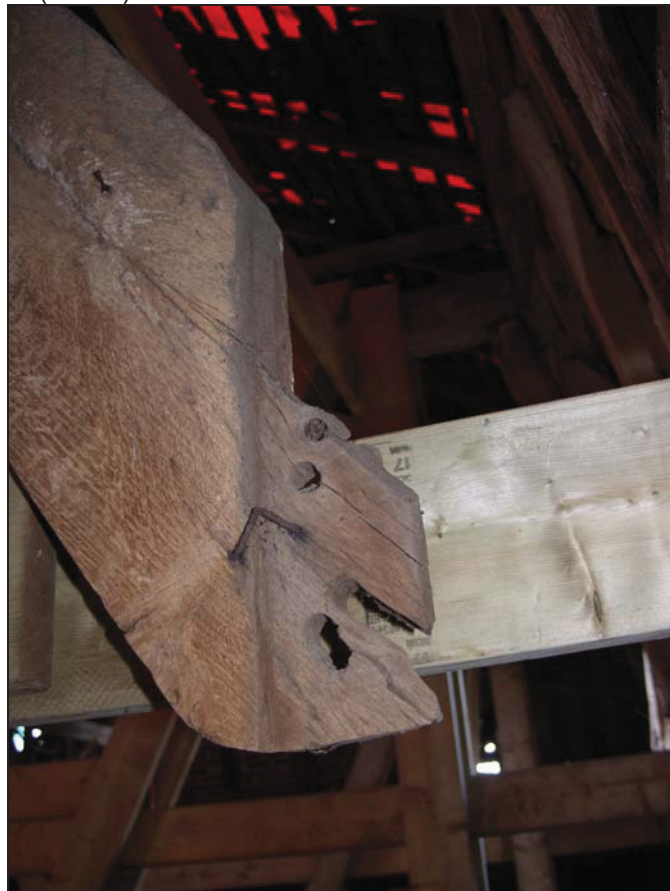
Plate 4 Disengaged west brace of Truss 6, Building 1, taken from the north-east (DP 87)

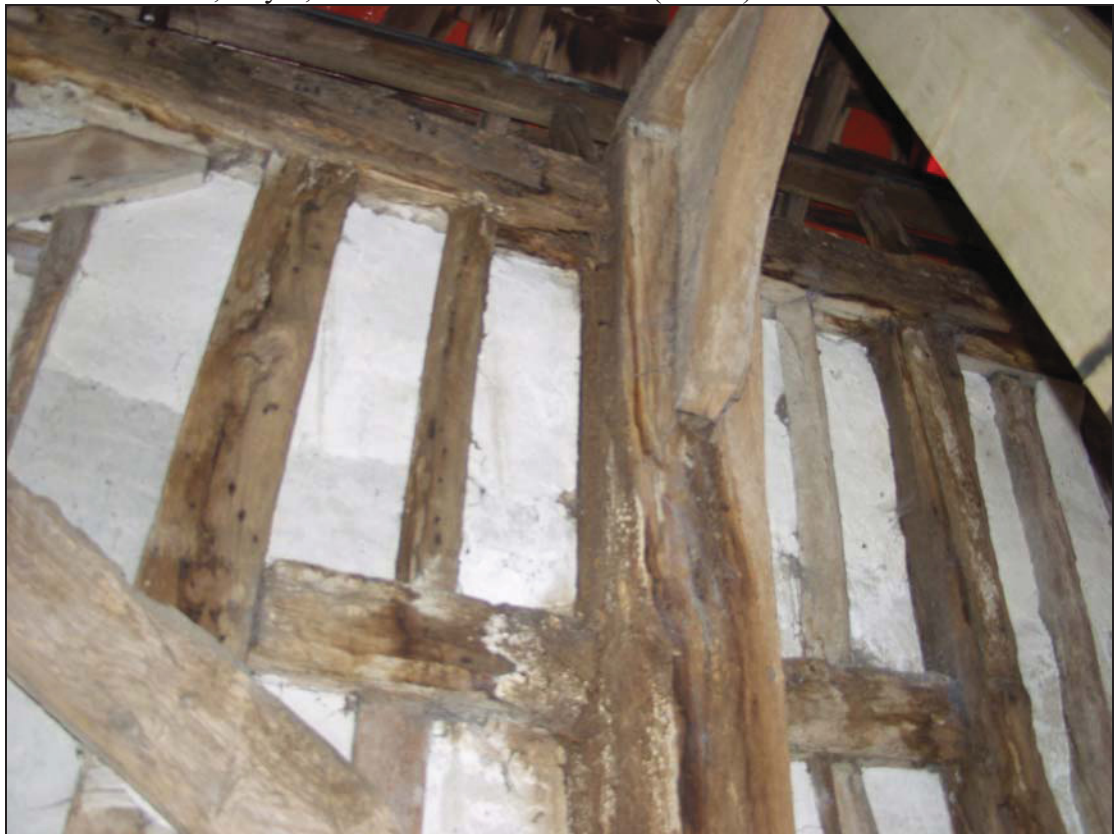
Plate 6 Detail of former window on the east wall of Bays 8 and 9 of Building 1, taken from the east (DP 84)
