**TIMBER-FRAMED BARN AND GRANARY,
HILL FARM, LOVE LANE, KING'S LANGLEY,
HERTFORDSHIRE**

HISTORIC BUILDING RECORDING

Authors: Tansy Collins BSc Lee Prosser BA PhD Kathren Henry	
NGR: TL 0651 0287	Report No: 3343
District: Dacorum	Site Code: AS 1090
Approved: Claire Halpin MIFA	Project No: 2990
Signed:	Date: July 2009

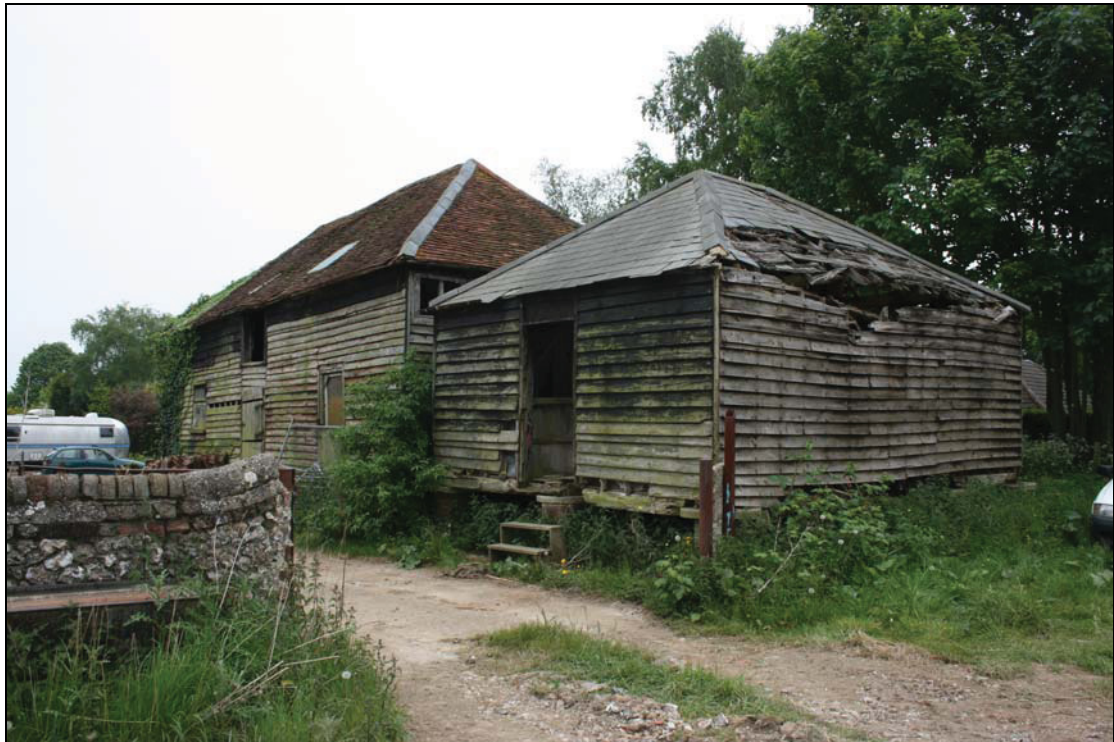
5.1.1 This element of the project comprises recording of the barn and granary. The buildings are orientated east – west fronting the trackway and south boundary wall of the yard on the north (Plate 1).

Plate 1 View of the barn and granary, taken from the north-west (DP 23)

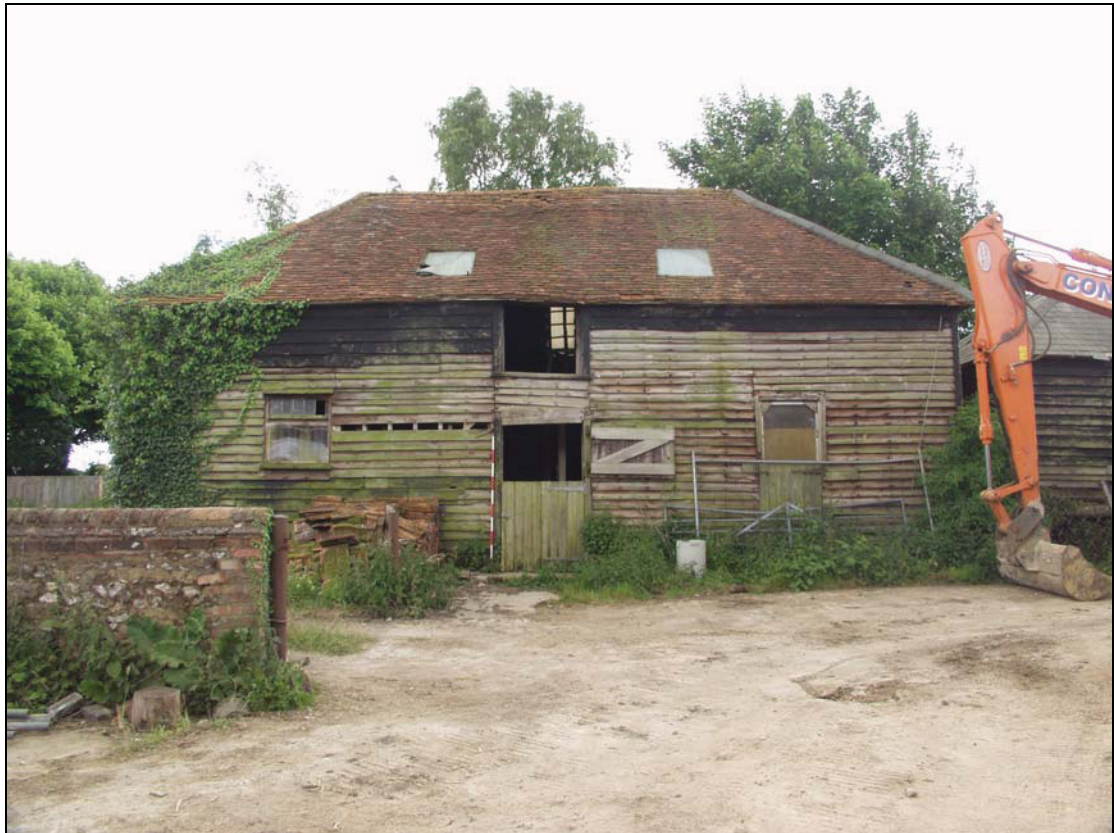
5.2.2 The building is entered through a central 19th century stable door on the north façade (Plate 2). This is a rudimentary plank door, ledged and braced to the rear with an original iron latch. It is flanked by a door to the west set on the dwarf wall, the lower leaf only remaining, ledged and braced to the rear, with a decorative iron latch. A third door lies at the eastern extent of this façade, also set on the dwarf wall. It is a small boarded loading door, ledged to the rear, with robust strap hinges on pintles. A window lies between this and the entrance, with metal bars at lower level and six fixed panes in the upper section. The upper façade is pierced by an open loading aperture, directly above the entrance.

Plate 2 North façade of the barn, taken from the north (DP 15)

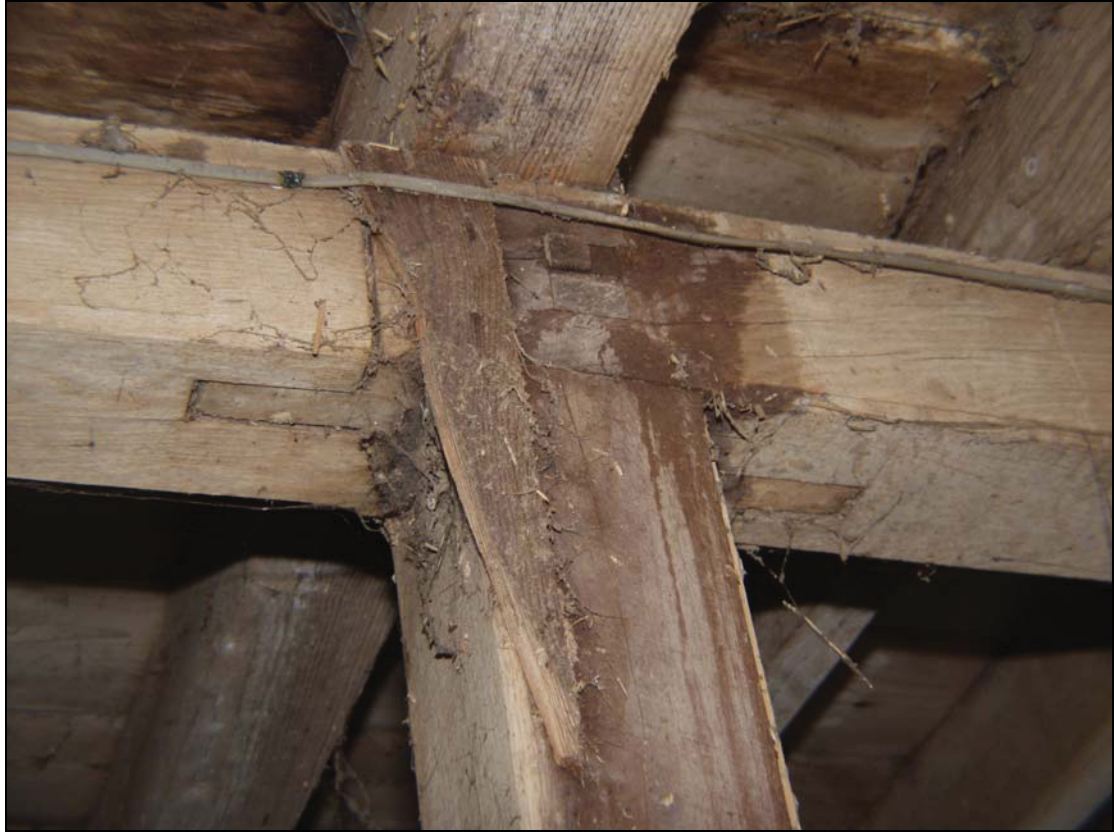
Plate 3 Detail of scarf joint in bridging joist in the barn, taken from the north-east (DP 11)

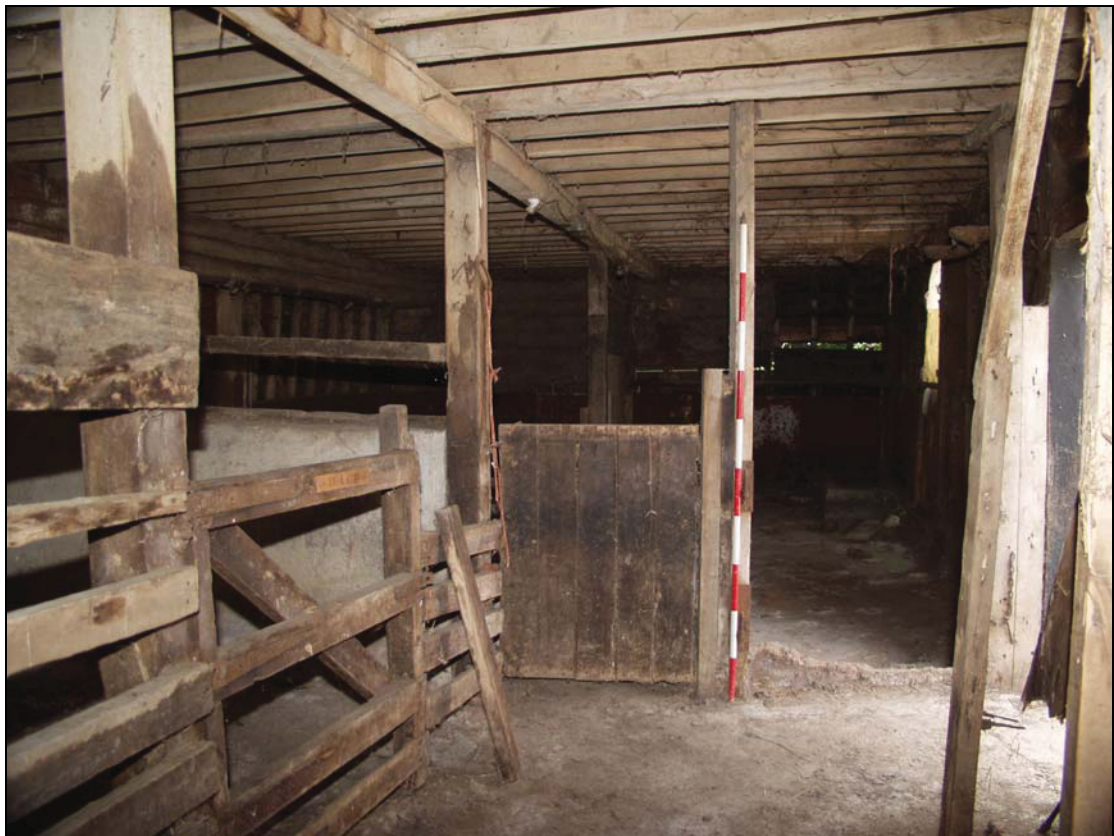
Plate 4 Contrived vestibule in the barn, taken from the north-east (DP 2)

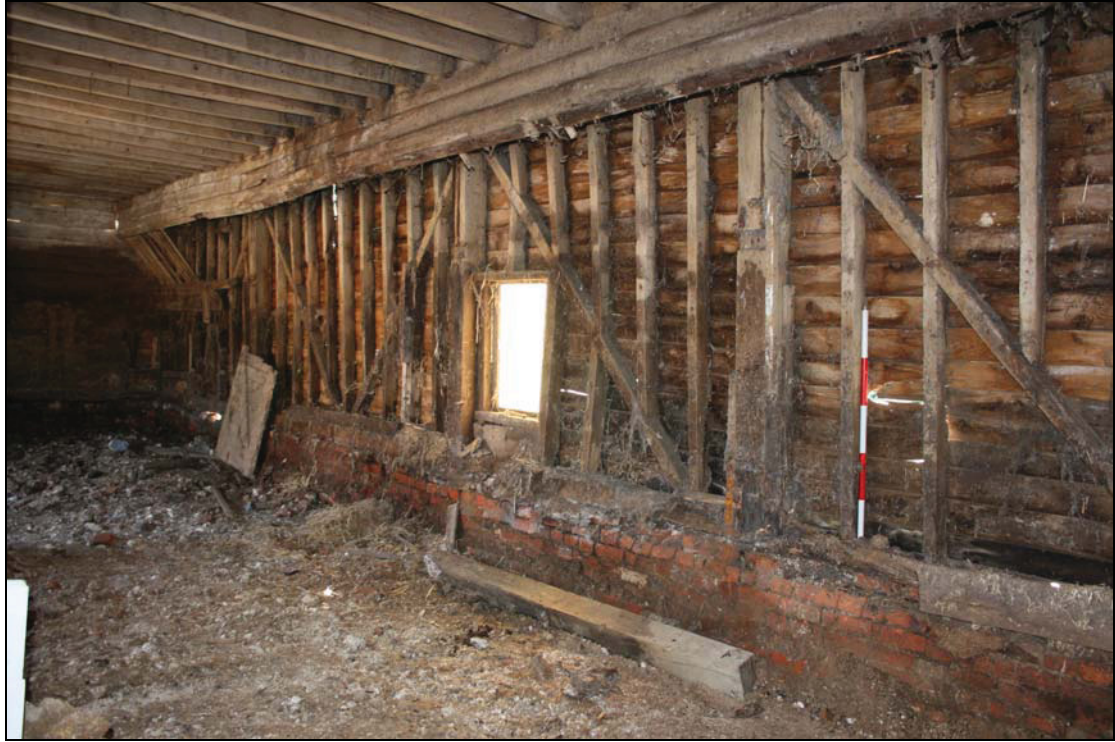
Plate 5 South wall of the barn (after stripping out), taken from the north-west (DP 45)

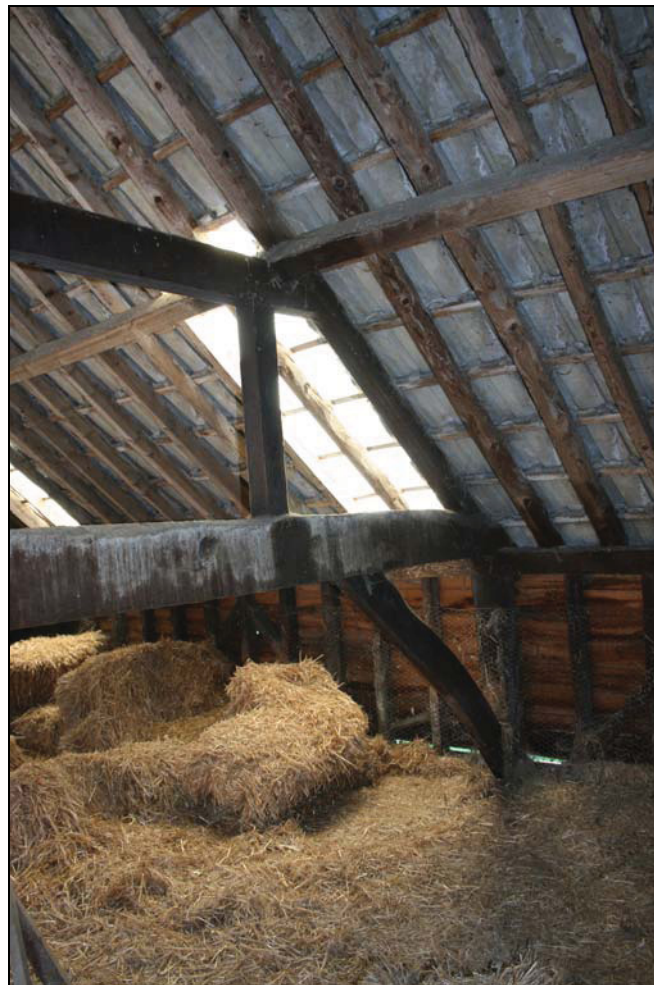
Plate 6 South side of the central truss of the barn at upper level, taken from the north-west (DP 50)

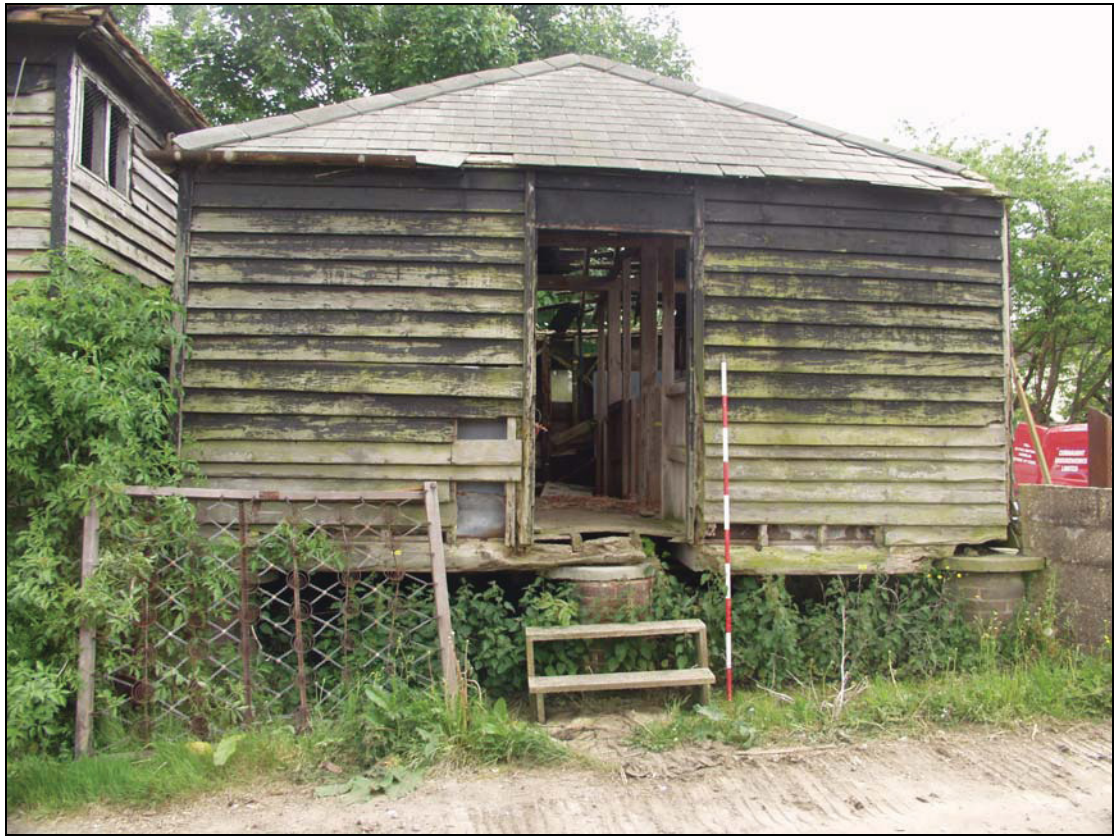
5.3.2 The building is in poor condition where water ingress has caused extensive decay and partial collapse on the west side. The weatherboarding is of softwood and fairly robust, latterly covered in bitumen. One or two oak or elm weatherboards survive in places. The building is entered from the north by two modern free-standing timber steps and a central door.

Plate 7 North façade of the granary, taken from the north (DP 20)

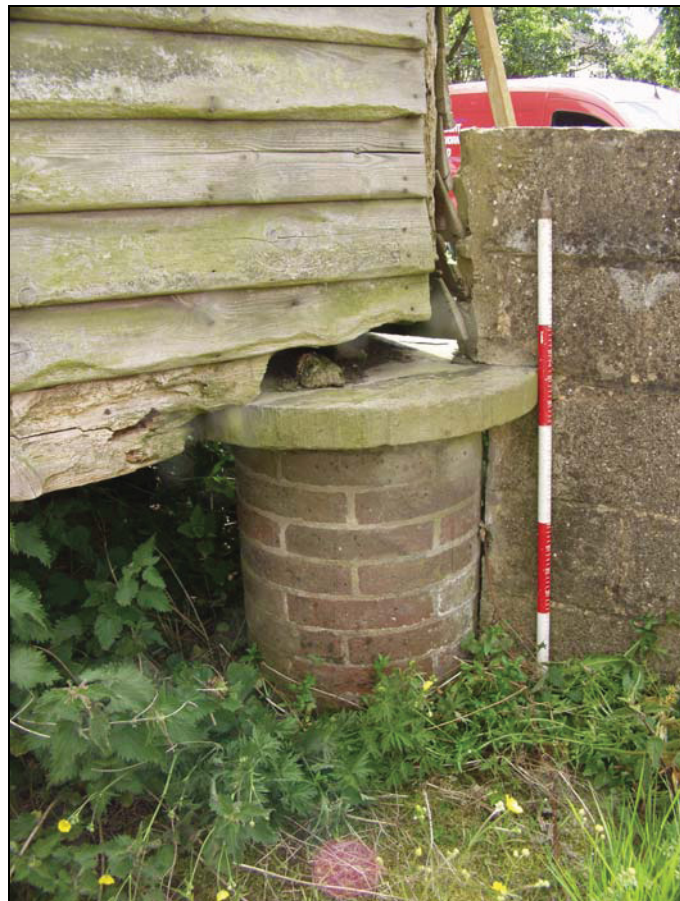
Plate 8 Brick stylobate and sandstone pad, taken from the north-east (DP 24)

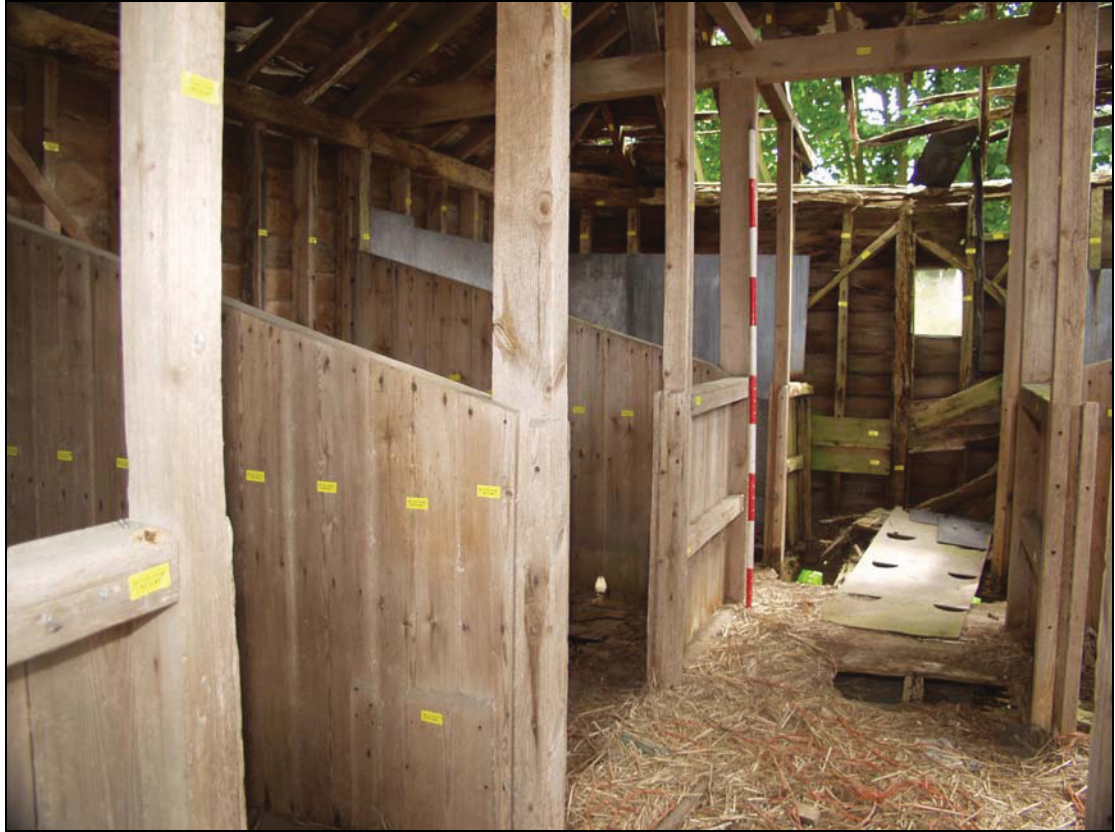
5.3.4 The floor is supported by deep-section joists with well-set 9" (229mm) floorboards, many heavily decayed, over an outer supporting frame of 7" (178mm) beams which sits directly on the stylobate caps, and is fixed with large iron bolts at the corners. The wall framing is of primary-braced panels, and is entirely systematic, with five widely-spaced slender studs per bay, bisected by a single, straight brace.

Plate 9 Interior of the granary, taken from the north (DP 25)

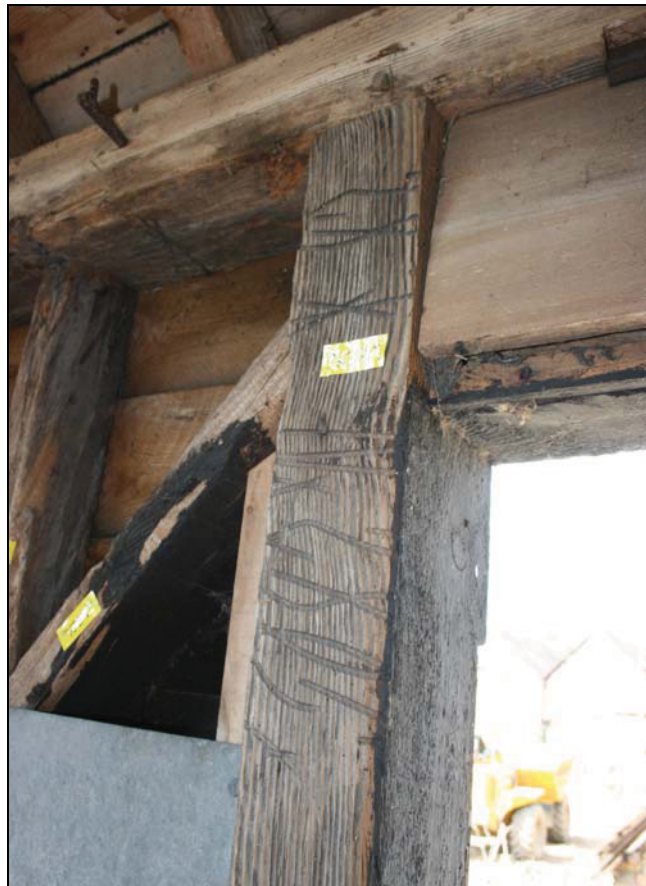
Plate 10 Baltic bracking mark on west door jamb to the granary, taken from the south (DP 33)
