# BRICK AND MILLING BARNS, HILL FARM, LOVE LANE, KING'S LANGLEY, HERTFORDSHIRE

HISTORIC BUILDING RECORDING AND ARCHAEOLOGICAL MONITORING AND RECORDING

Authors: Tansy Collins BSc	
Lee Prosser BA PhD	
Kathren Henry	
Sophie Unger MA	
NGR: TL 0651 0287	Report No: 3326
District: Dacorum	Site Code: AS 1090
Approved: Claire Halpin MIFA	Project No: 2990
Signed:	Date: June 2009

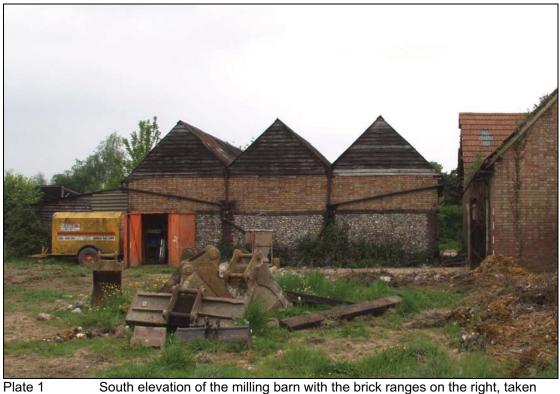
South elevation of the milling barn with the brick ranges on the right, taken from the south (3)

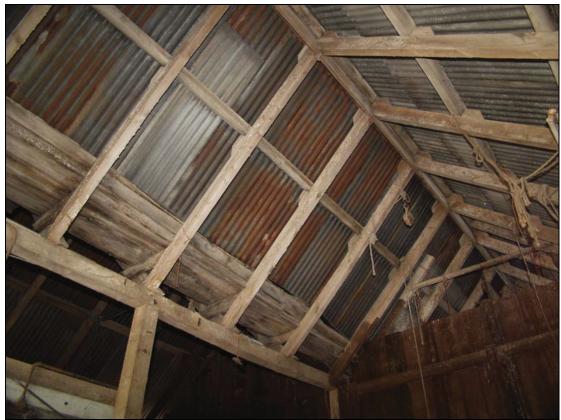
Plate 2

6.2.5 The roof structure is formed of strong, but widely-spaced rafter couples clasping a ridge-board (Plate 2). There are two purlins in each pitch but the upper forms a double-ridge purlin with the adjoining member. These are supported by heavy cleats and ride over the backs of the rafters. At the valley intersections, each adjoining pair of rafters overlap in a short scissor section, with additional nailed-on supports and three softwood boards, most probably forming an external drainage gully or walkway.

Detail showing roof construction of the milling barn, taken from the north (32)

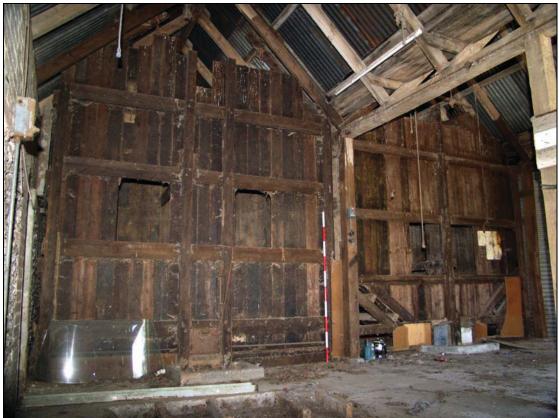
6.2.6 The timber grain stores have been framed around the original construction, and so are clearly a later addition (Plate 3). Robust softwood members with braced supports at lower level allow for a sloping floor within the store, sufficient to retain the full weight of the grain and allow the seed to be funnelled through a small chute into sacks. Sliding trapdoors survive at the base above shallow concrete pits. Both grain stores are of similar construction, with only minor differences. The west store does not display lower bracing, for example, and has a single sliding door, while that to east is divided into two cells. Various pulleys and mechanisms with residual lengths of rope survive to illustrate the carriage and movement of the sacks within the barn.

Plate 3 Timber grain stores on the south side of the milling barn, taken from the north (30)

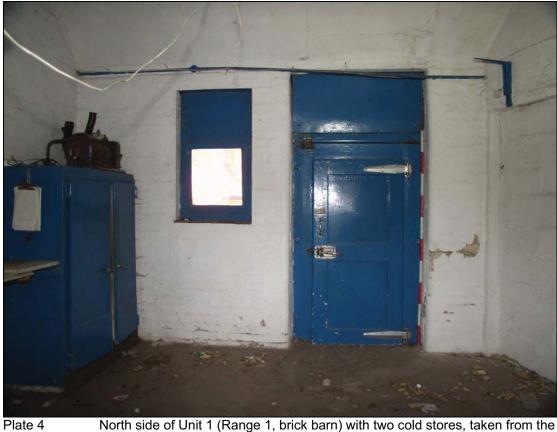
North side of Unit 1 (Range 1, brick barn) with two cold stores, taken from the south (27)

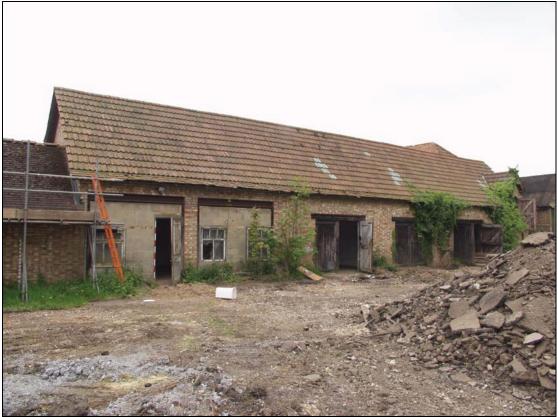
Plate 5 North elevation of Range 2 (brick barn), taken from the north-east (8)

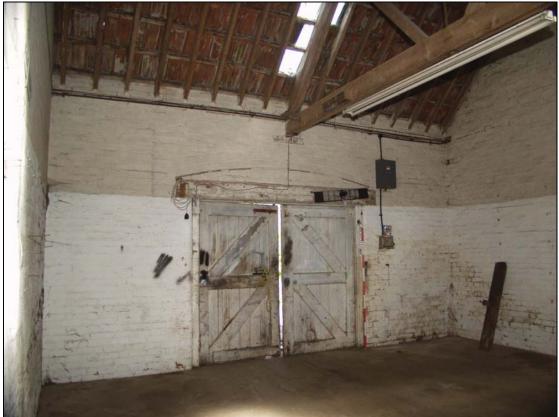
North side of Unit 2 (Range 2), taken from the south (22)

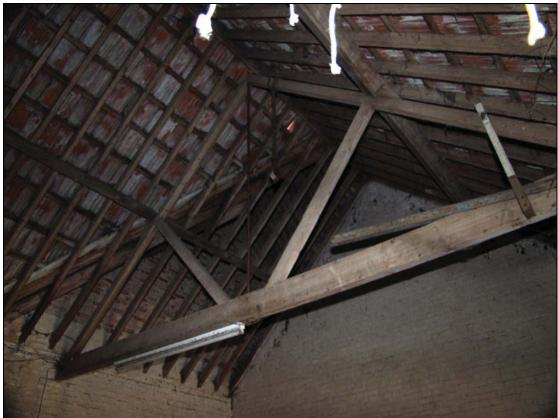
Plate 7 Roof structure of Unit 4 (Range 2), taken from the north-east (21)

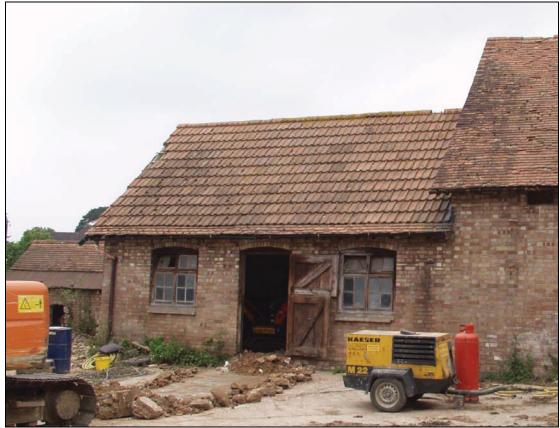
Plate 8

East elevation of Range 3 (brick barn), taken from the east (10)

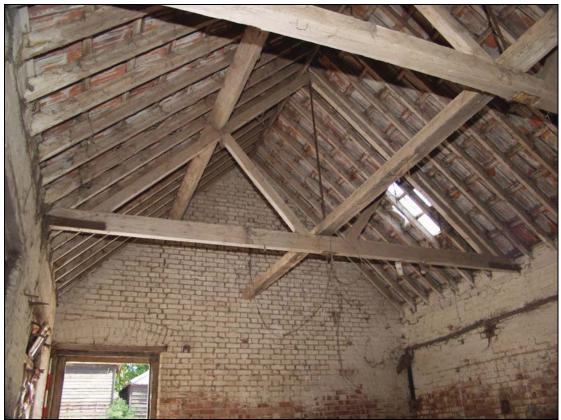
Plate 9

Roof structure of Range 3, taken from the north-east (15)

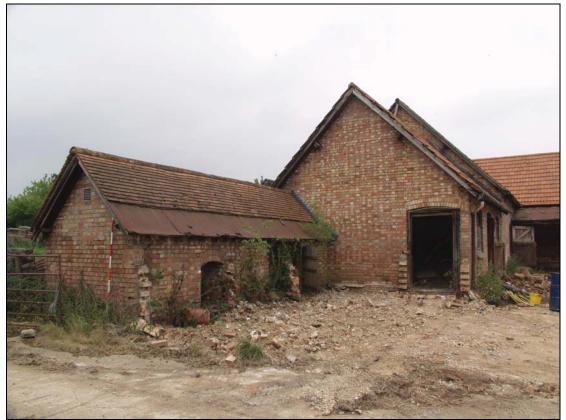
Plate 10

6.3.32 The final range adjoins, but is not integral to, Range 3. This comprises a series of low pigsties of contemporary date, formerly enclosed on the east with low retaining walls for small yards, but these now mostly demolished (Plate 10). The structures have peg-tiles to the roofs, as elsewhere, with some sheet metal replacement. They comprise three sties, each with its own low doorway with bevelled jambs. The interiors are plain with painted brickwork all round. The roofs are exposed, comprising slender common rafters resting on timber wall-plates rising to a ridgeboard at the apex.

South and east sides of Range 4 (brick barn) adjoining Range 3 (right), taken from south-east (01)

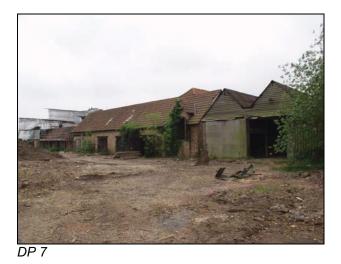
North elevations of Ranges 1 and 2 (brick barn) and the milling barn, taken from the north-west

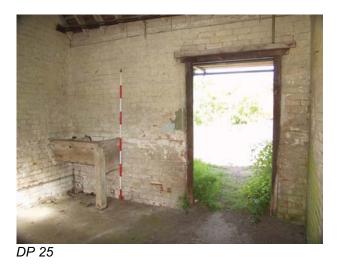
North side o Unit 3 (Range 1), taken from the south

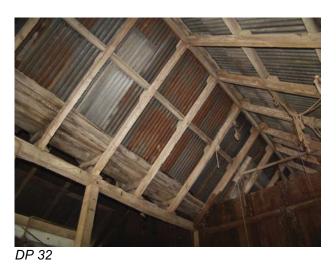
Detail of the roof structure of the milling barn, taken from the north
