FARM BUILDINGS AT SIBLEYS FARM, CHICKNEY ROAD, HENHAM, ESSEX

HISTORIC BUILDING RECORDING

Authors: Lee Prosser BA PhD	
Lisa Smith BA	
Kathren Henry	
NGR: TL 565 297	Report No. 3514
District: Essex	Site Code: SFHN10
A survey of Olaina I lake in	Ducie et Ne. 2040
Approved: Claire Halpin	Project No. 3816
MIFA	Data: March 2010
	Date: March 2010
Signed:	
Ũ

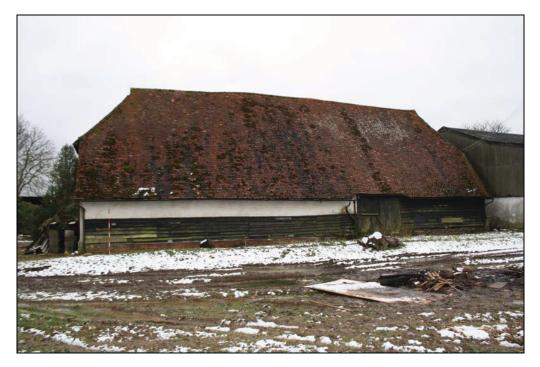
5.2 On the northern face, a doorway with double doors offset to the west pierces the elevation (Plate 1). The doors are boarded with mass-produced strap-hinges, but all in poor condition. To the west the wall is completely weather-boarded in oak with modern softwood repairs; to the east the upper portion is rendered, with modern softwood weather-boarding below. Long spurs carry the eaves beyond the wall face for added protection from the elements.

Plate 1 The barn, northern elevation, taken from the north (DP 7)

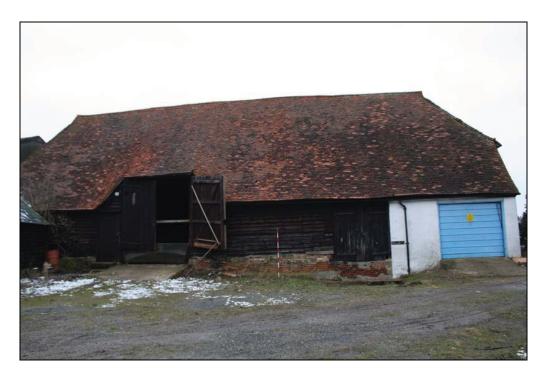
5.4 The south elevation shows much modification and repair. A taller dwarf wall compensates for the fall in ground level and comprises different phases of repair (Plate 2). Some original 16th or 17th century brickwork remains exposed to the east of the main doors but the majority has been repaired with 19th century fabric and even 20th century pink flettons, all in turn poorly re-pointed and patched.

Plate 2 The barn, southern elevation, taken from the south (DP 1)

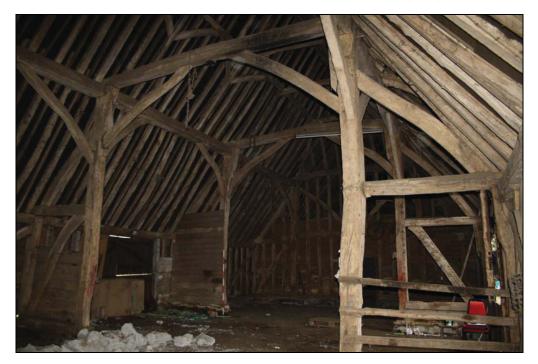
5.6 The barn is constructed in two phases. The primary build is of three bays given access via the main doorway into a narrower central bay, with wider flanking bays (Plate 4). Two narrow bays form the later extension to the north. These are now given access by the modern external openings, and from the earlier range through a doorway formed by removing two original studs. The original roof hip of the earlier range survives at the junction of the two elements, as does the majority of the original timber.

Plate 4 The barn, trusses 2 and 3, taken from the south-west (DP 37)

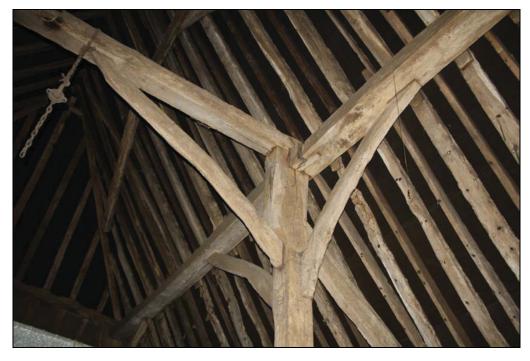
5.7 The barn is aisled with a series of principal arcade posts with splay-cut jowls braced to the tie-beams and arcade plate at the bay divisions (Plate 5). The lower outer wall posts are also similarly jowled. The arcade plates are of heavy scantling jointed at the bay divisions with half-faced and bladed scarfs. Subsidiary bracing is also used within the aisles above and below the aisle tie. The wall panels are regular in construction with long studs and slightly curved bracing. Almost all retain wattle grooves and holes for earlier infill, which also serves to confirm the extent of survival. The principal bay divisions are not framed to the apex; instead slightly larger rafter-couples at the half-bays have collars clasping a single purlin in each pitch. Common rafters rise in two continuous flights. The central couples have delicate, curved wind-bracing to the purlin, but these are not present in the outer bays where the hips already provide sufficient support.

Plate 5 The barn, interior, Truss 2, jowled arcade post and associated members (DP 41)

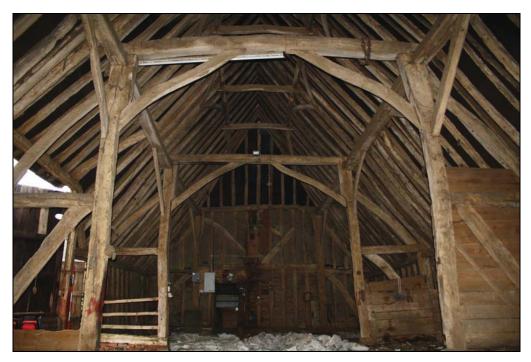
5.15 Truss two divides the western and central bays and comprises two robust arcade posts with splay-cut jowls resting on aisle plates and dwarf walls (Plate 8). The posts support a slightly cambered tie-beam triangulated by long slender braces. Similar braces extend from the posts to the arcade plate. A lower aisle brace is missing on the south.

Plate 8 The barn, trusses 2 and 3, taken from the east (DP 31)

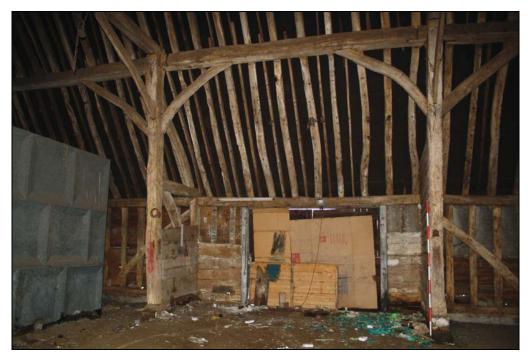
5.17 The central, narrower bay accommodates the main entrance to the barn, with a second opposing double door to the north, clearly inserted at a later date (Plate 9). The wall panel on this side is much disturbed as a consequence. Eight studs were formerly present, pierced by a central aperture approximately four feet wide, but this was subsequently widened with the loss of five original studs. Three studs still survive, now partially obscured by wide oak or elm board

Plate 9 The barn, bay 2, taken from the south (DP 12)

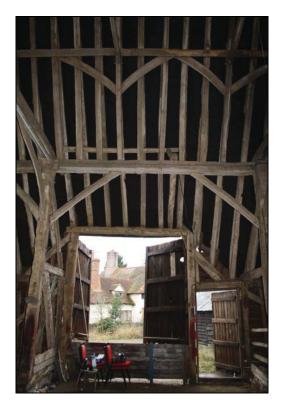
5.19 The south panel frames the main doorway, which is offset to the east to accommodate a smaller adjoining door (Plate 11). It is framed by two substantial jambs; the member to the east sits on a stump of sole-plate protruding from the adjacent bay and preserves a robust threshing leap slot (Plate 12). The western jamb extends to full height directly from the earth and retains a mortice for a locking bar. The height of the doorway has been raised and modified though both jambs have been retained, braced from the wall-plate by short, nailed-on braces of heavy scantling.

Plate 11 The barn, main entrance, bay 2, taken from the north (DP 29)

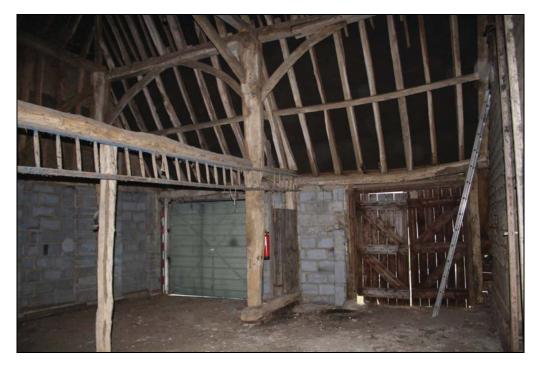
5.28 The south wall has been has been modified with the insertion of large double doors and modern cement blockwork (Plate 15). The wall-plate survives with two original studs retained as door jambs. Peg-holes indicate the position of three removed studs and a small doorway off-set to the west. The jowled outer post retains a redundant mortice for the lost brace.

Plate 15 The barn, bays 4 and 5, taken from the north-west (DP 21)

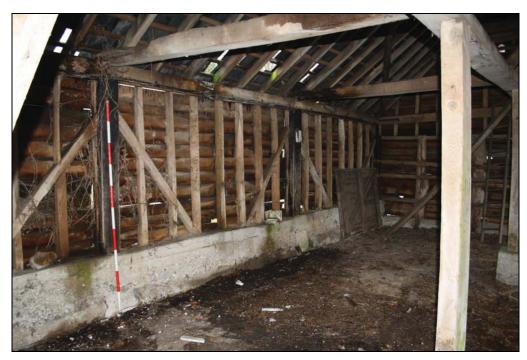
5. 41 The cart shed is timber-framed and weather-boarded, standing to the south of the barn and aligned north-west and south-east. It is laid out on a simple plan of three by two bays, open-fronted to the south-west, constructed of oak and elm with a slate roof (Plate 19). The external boarding is probably original, good quality hand-sawn oak and elm boards with very little modern replacement. Internally, the frame is highly regular and systematic, having primary-braced wall panels of seven studs per bay, with even scantling extending throughout, though the lower elements have been replaced with cement or embedded in concrete, which has caused some decay (Plate 20).

Plate 20 The cart shed, internal, eastern elevation, taken from the north-west (DP 10)

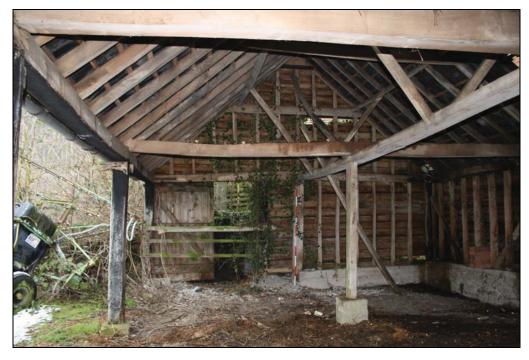
5. 42 Of the end-walls, the north-western elevation is the best preserved with a robust central prick-post supporting a tie-beam (Plate 21). Six unbraced studs rise to the tie-beam in the eastern register while a large double door occupies a similar position to the west framed by a jamb and corner post. The doors are vertically boarded, ledged and braced to the rear, though now in poor condition. Above the tie-beam studs notched over a collar continue to the apex.

Plate 21 The cart shed, internal, northern gable end, taken from the south (DP 9)
