**DOWN GREEN HOUSE, HARPENDEN ROAD
WHEATHAMPSTEAD**

HISTORIC BUILDING APPRAISAL

Authors: Dr Lee Prosser BA PhD Tansy Collins Bsc	
NGR: TL 1657 1378	Report No. 3435
District: St. Albans	Site Code: AS 1256
Approved: Claire Halpin	Project No. 3350
MIFA	Date: November 2009
Signed:

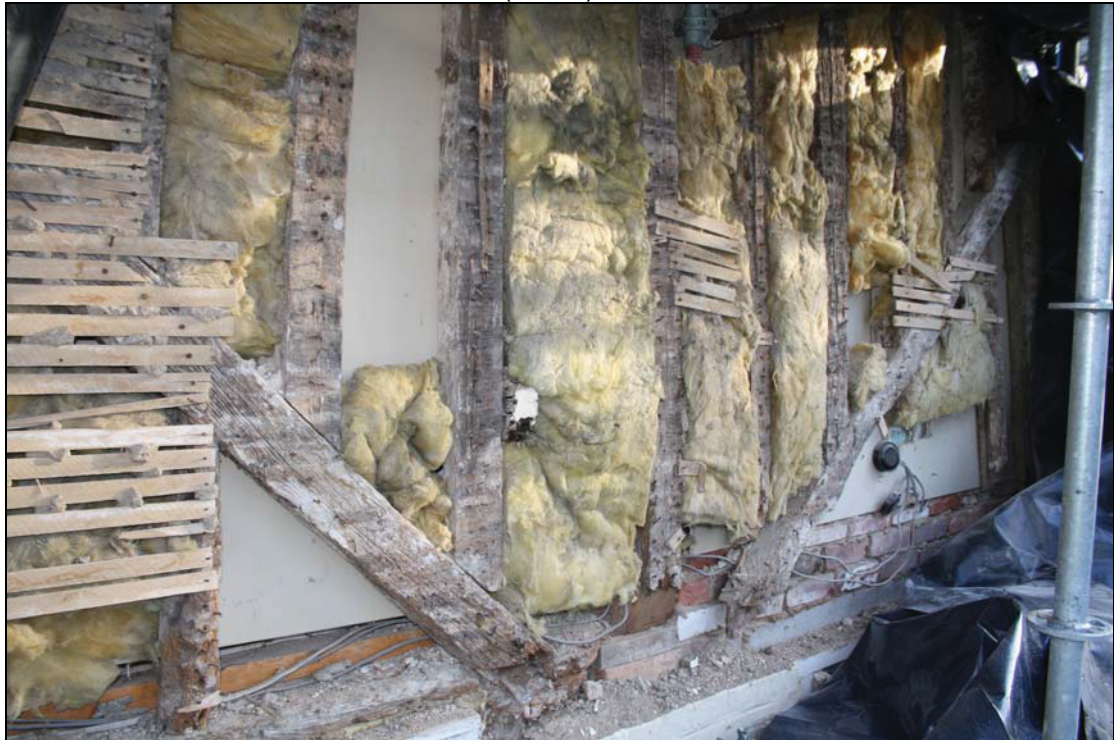
4.11 The west façade has primary-braced panelling with two downward braces descending from the corner posts, bisecting four or five studs, to the mid-rail (Plate 2). The corner posts are only partially visible but appear to be original. The mid-rail, however, is substantially lost and only survives in part at the north end, where it is very degraded. The brace is properly pegged at its head. Despite the primary bracing, we see structural pattern in the soffit of the tie-beam indicating a slightly different arrangement and suggesting this end wall has been substantially rebuilt. Mortices indicate a system of fairly robust studs, flanked by wattle poles or staves, no trace of which can be seen on the braces below. Most of the existing studs are simply notched into the tie-beam, leaving the earlier mortices now redundant and only in one or two cases do they actually survive.

Plate 2 Timber-framing on the west gable at first floor level (historic range), taken from the north-west (DP 33)

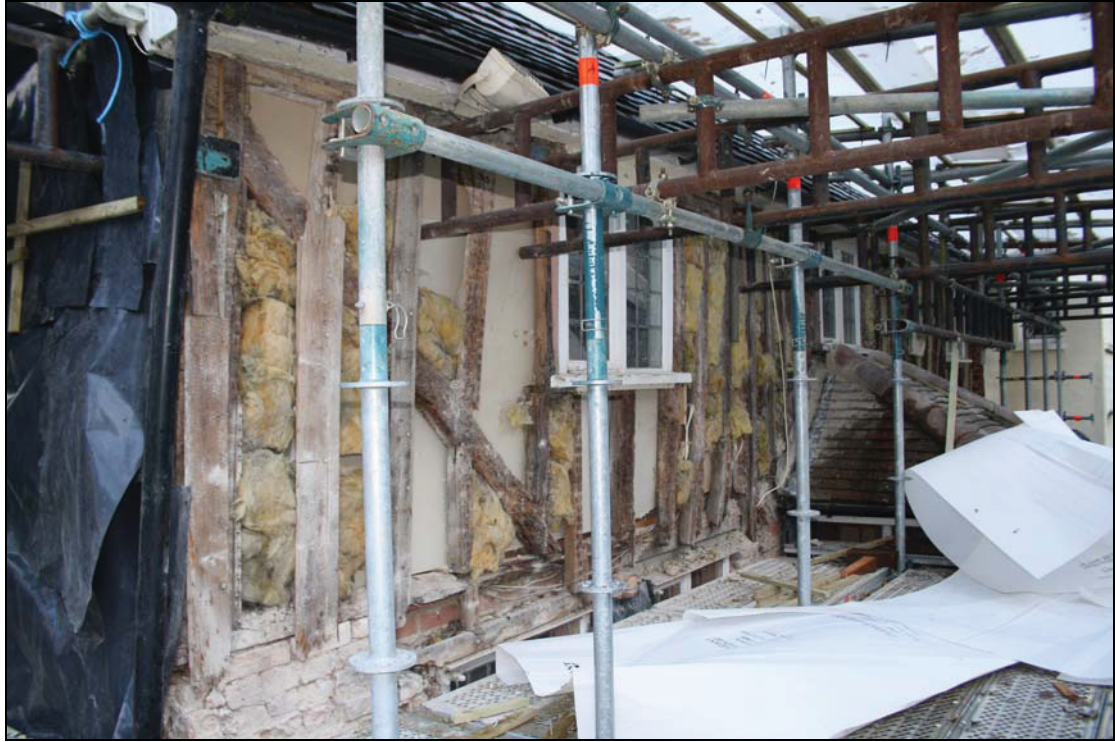
4.14 In the west bay (Plate 3) the wall-plate is mostly visible, jointed into the post of the chimney bay to the east, apart from the area above the existing window. In the soffit of the wall-plate we see a pattern of mortices indicating a series of robust studs flanked by staves or wattle poles with a further intermediate wattle pole. This is a characteristic also seen on the opposite side, now internal, and noted below. Occasional original studs survive, pegged at the head, although very degraded at the base where the mid-rail has been lost with the bricking-in of the lower facade. The west section of the bay is primary-braced as on the west gable, along with a reconfiguring or insertion of secondary studs. Again we see the redundant wattle holes in the soffit of the wall-plate, confirming the secondary nature of the primary-bracing (Plate 4). Some of these timbers perhaps reuse members from the earlier framing.

Plate 3 Timber-framing of the west bay at upper level, taken from the south-west (DP 38)

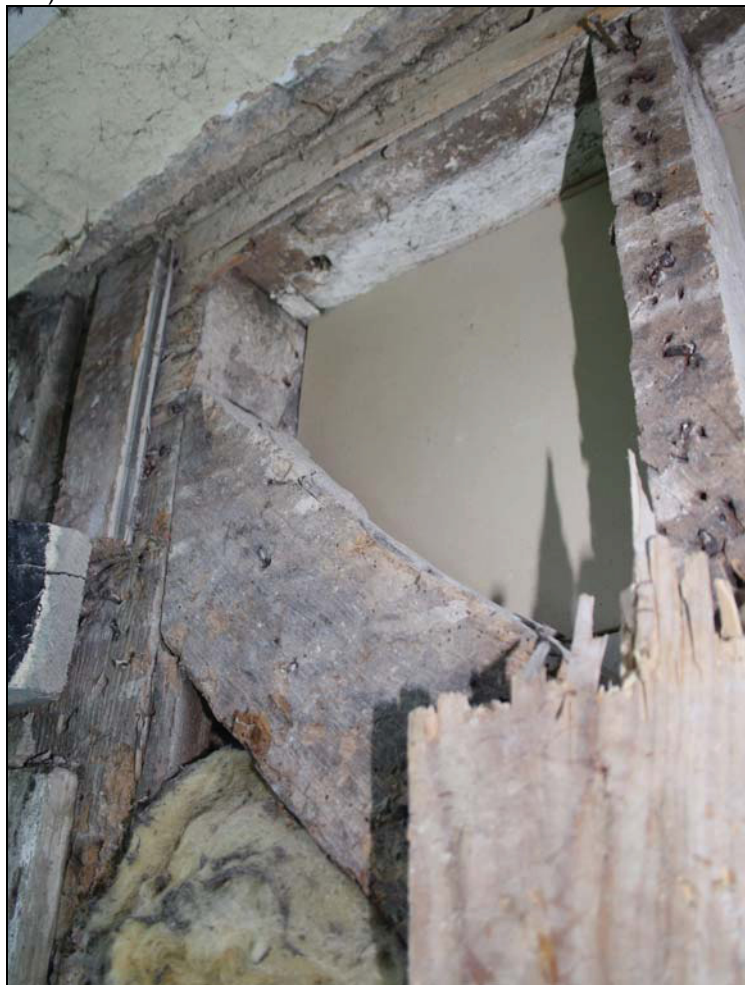
Plate 4 Detail of later primary-brace and redundant wattle hole in the wall-plate of the west bay, taken from the south-east (DP 39)

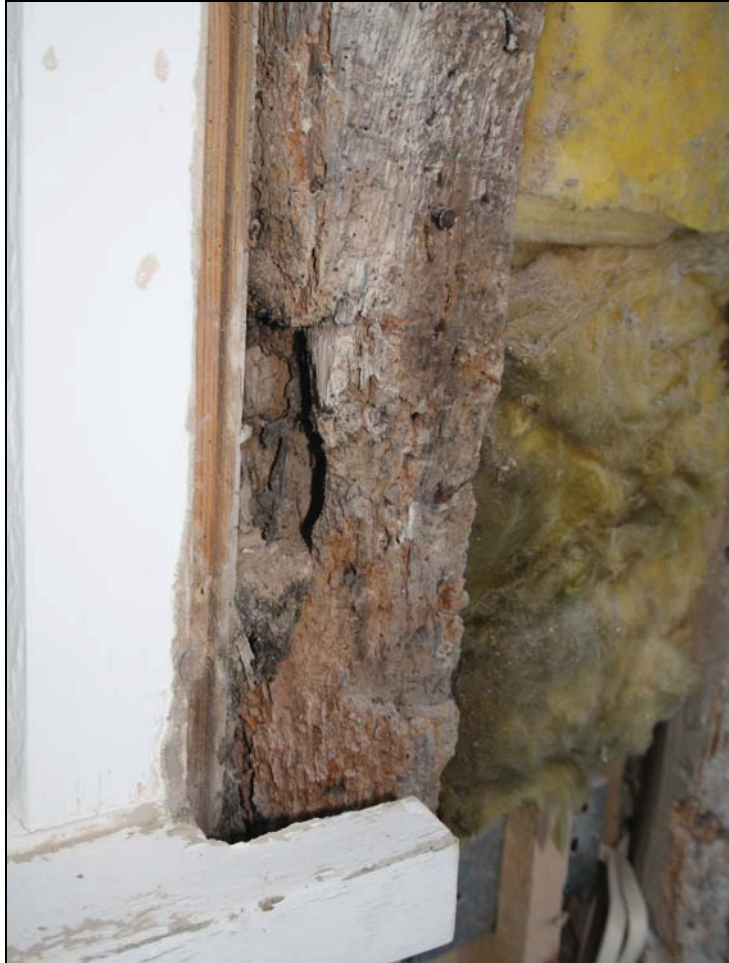
4.15 A noteworthy historical survival is an original window aperture, implied in the location of the existing window. The soffit of the wall-plate is obscured and the original stud to the west of the window is lost, but the east stud retains a redundant mortice for a sill piece typically found on frames of this nature where windows occur (Plate 5).

Plate 5 Mortise for the sill piece of an original window in the west bay of the upper floor, taken from the south-west (DP 40)

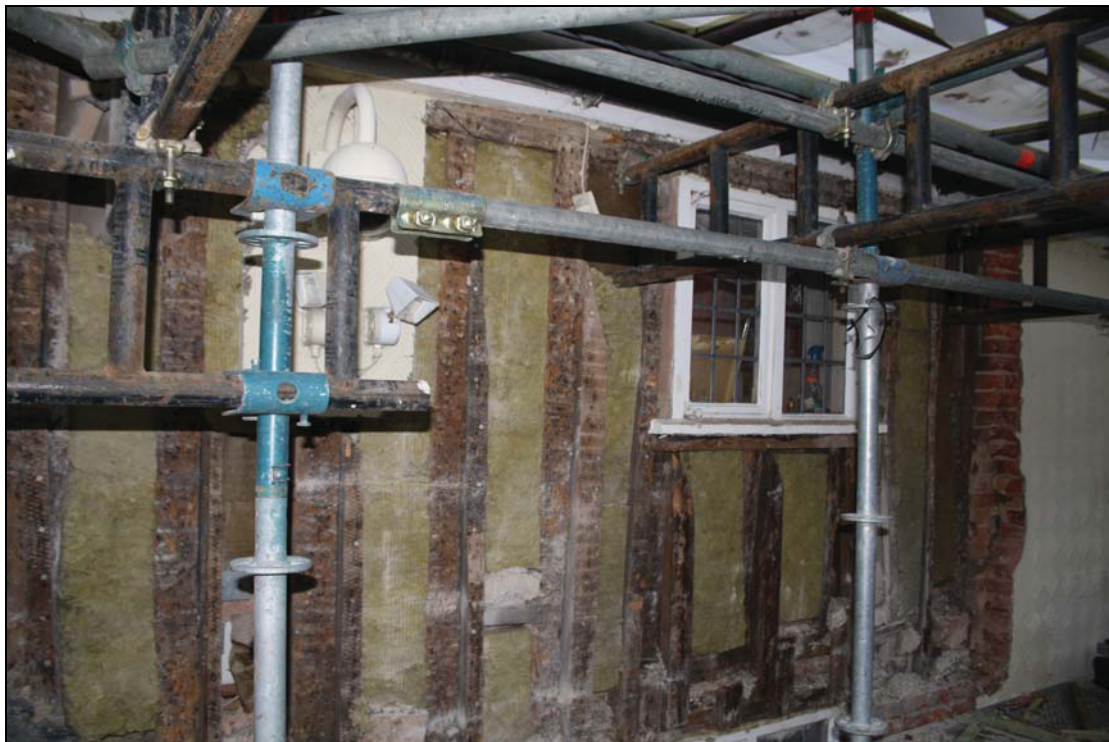
4.17 The east bay (Plate 6) is divided from the chimney bay by the robust post noted above, while the wall-plate is continuous from the adjoining area, where we see the same pattern of redundant mortices for studs flanked by holes for wattle staves or poles. The east corner post is original, although the remainder of the timberwork is later, but which utilises the redundant stud mortices. This post displays a mortice for a tension brace which originally would have extended inside the common studs, as seen on the west post of the chimney bay. A further common feature of the two studs is the presence of the through-mortice at lower level. In this instance it perhaps indicates the building formerly extended further to the east. A further peg above lies towards the outer edge, but its purpose is unknown. In this bay the mid-rail survives to some extent, although very degraded and encased by brick in places. Little else is visible and the current studs are nailed to this member. A short section of timber lies immediately above, but its purpose is unclear. It may, perhaps be a simple bolstering piece.

Plate 6 Timber-framing of the east bay at upper level, taken from the south-west (DP 47)

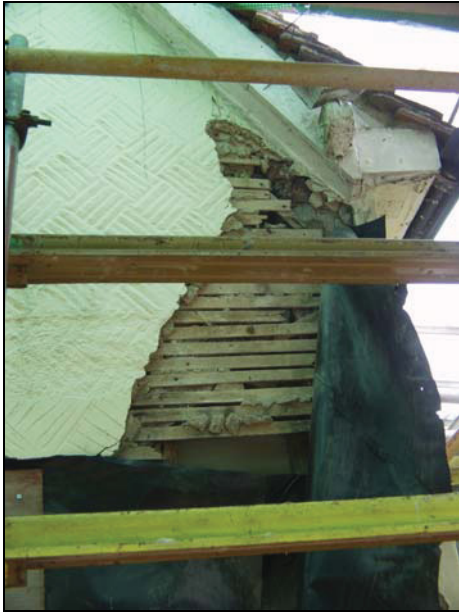
DP 31

Detail of removed render on the west gable end of the historic range, taken from the west

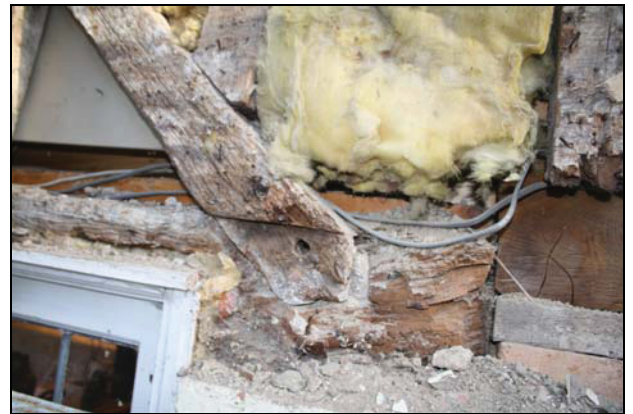
DP 34

Tenon at the base of a primary brace, west gable at first floor level (historic range), taken from the west

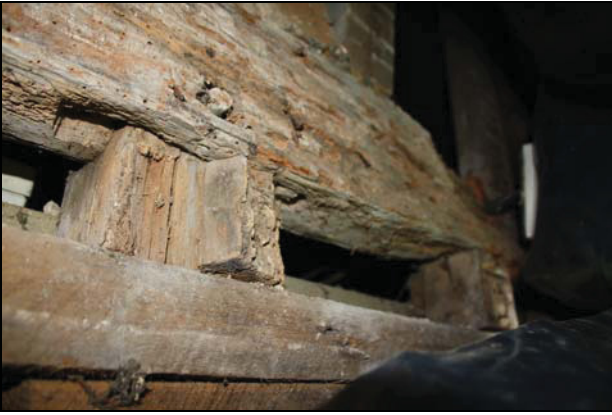
DP 37

4.12 The gable above the tie-beam is only partially visible although a wide collar jointed to principal rafters all appear to be original. The collar retains two lower peg-

holes clasping the stumps of original studs, below which a mixture of later insertions and modern reworking is visible. A central peg-hole lies to the upper side of the collar, although no stud survives.

Detail of collar and truncated studs on the west gable of the historic range, taken from the north-west

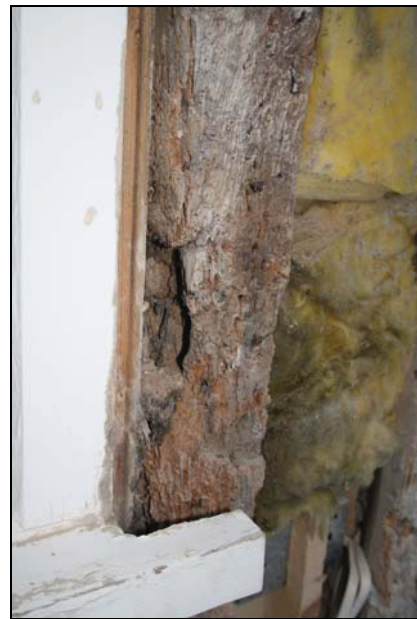
DP 40

Mortise for the sill piece of an original window in the west bay of the upper floor, south side of the historic range, taken from the south-west

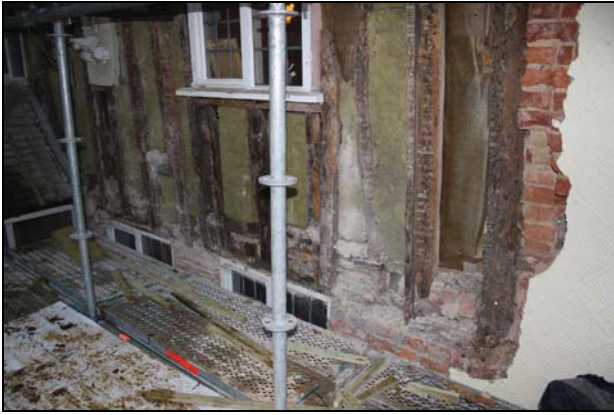
DP 49

Base of studs in the east bay at upper level showing fragmentary mid-rail, south side of the historic range, taken from the south-east

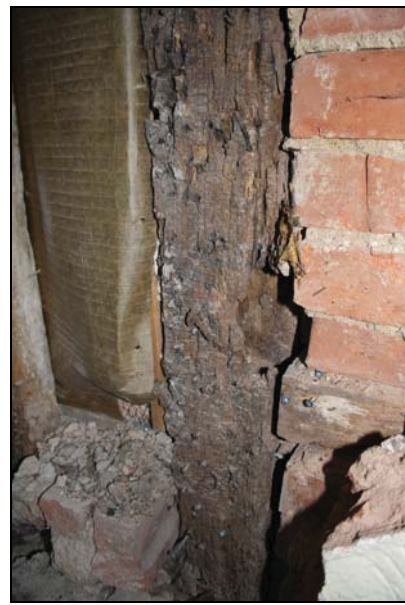
DP 52

Detail of redundant mortice in the east corner post, south side of the historic range, taken from the south-east
