**BUILDINGS ON LAND OFF FOLLY ROAD,
GREAT WALDINGFIELD, SUFFOLK**

**An Archaeological Desk-Based Assessment and
Historic Building Recording**

Authors: Peter Thompson MA Lisa Smith BA	
NGR: TL 9080 4349	Report No: 3515
District: Babergh	Site Code: WFG 041
Approved: Claire Halpin	Project No: 3325
Signed:	Date: March 2010

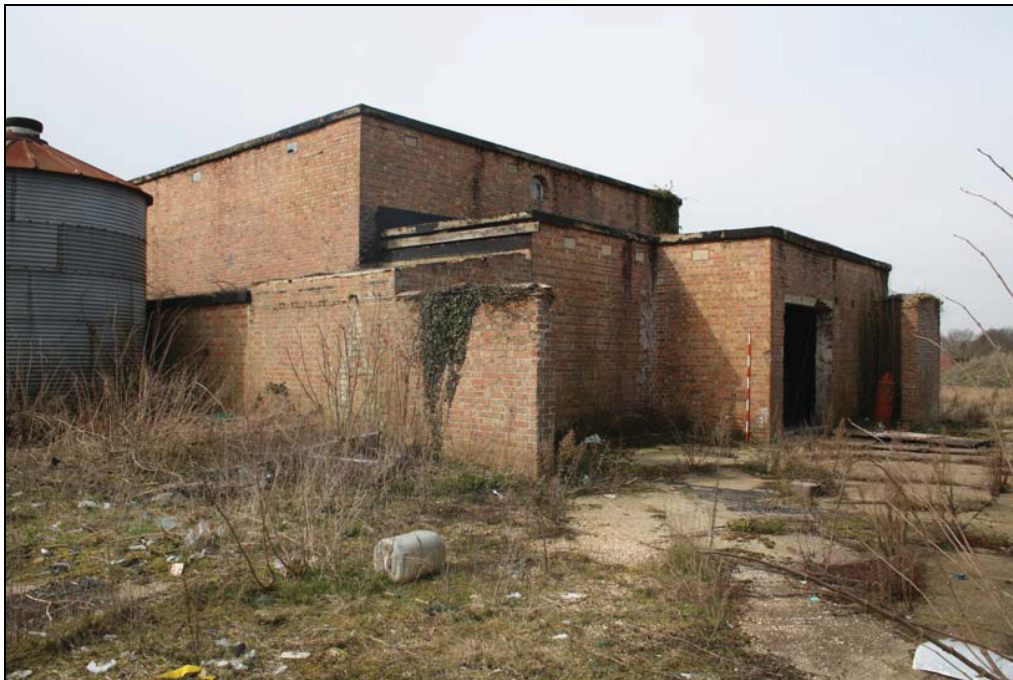
6.3 Building 1 stands as an imposing brick built block on the north-eastern outskirts of the site (Plate 2). Identified as a Stand-by Set House the building is structurally sound showing little modification for agricultural use, however, no machinery remains from its former use. The building comprises a large square central chamber flanked to the south-east by a contemporary single storey range. Three smaller chambers extend to the north-east. The brickwork is all of pink Flettons laid in English bond in fairly good condition rising to flat roofs of reinforced concrete slabs originally covered in a layer of asphalt.

Plate 2 The stand by set house, taken from the north-east (DP 4)

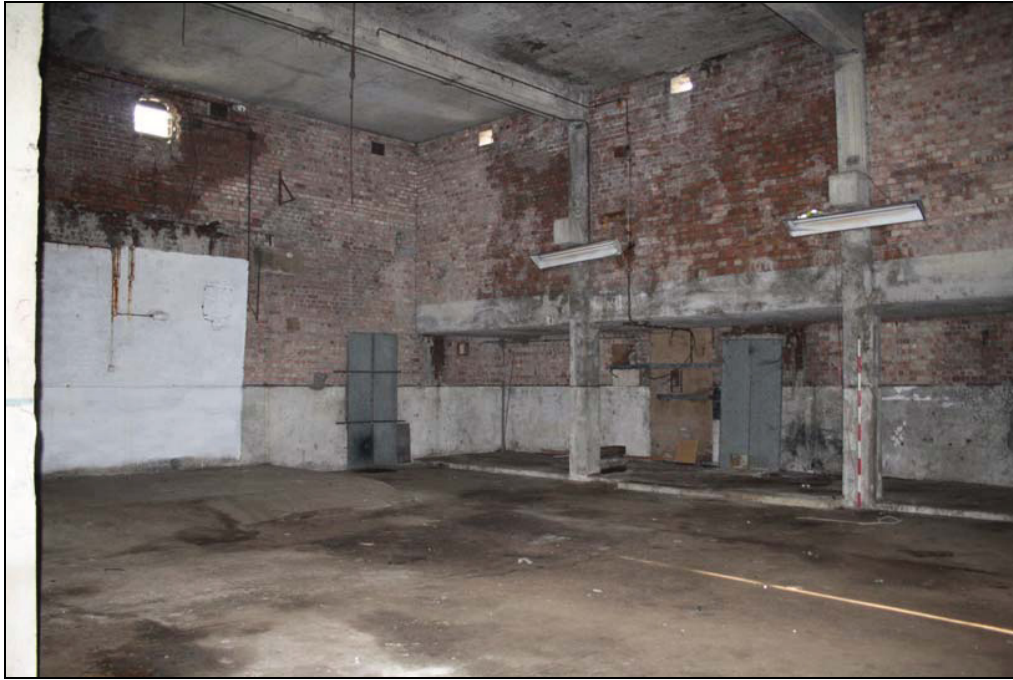
6.17 The main chamber is a large open space with a single storey range to the south-east loosely divided into three bays by two massive re-enforced concrete trusses supporting a flat concrete roof (Plate 3). To the east the concrete pillars are set into the brickwork though not visible from the exterior. To the west the concrete pillars fall short of the external brickwork creating an aisle along the north-western extents of the building. A lateral concrete beam extending between the external walls and supported by the two central pillars bears the weight of a mezzanine floor occupying the upper portions of the aisle.

Plate 3 The stand by set house, main chamber, taken from the south-west (DP 10)

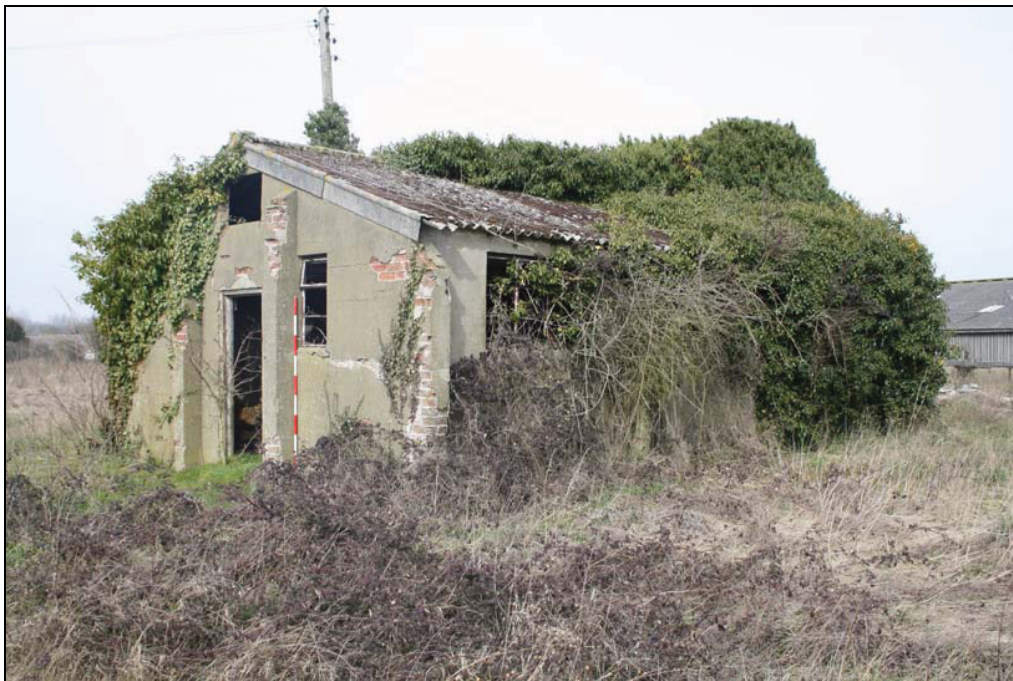
6.22 The building identified as the airmen's latrines is in extremely poor condition, being rapidly consumed by vegetation from the north (Plate 4). The building is brick-built and completely rendered with a shallow gabled roof clad in corrugated asbestos. The external elevations are divided into even bays by short narrow buttresses, also seen on each of the gable ends framing the central doorways.

Plate 4 The airmen's latrines, taken from the south-east (DP 15)

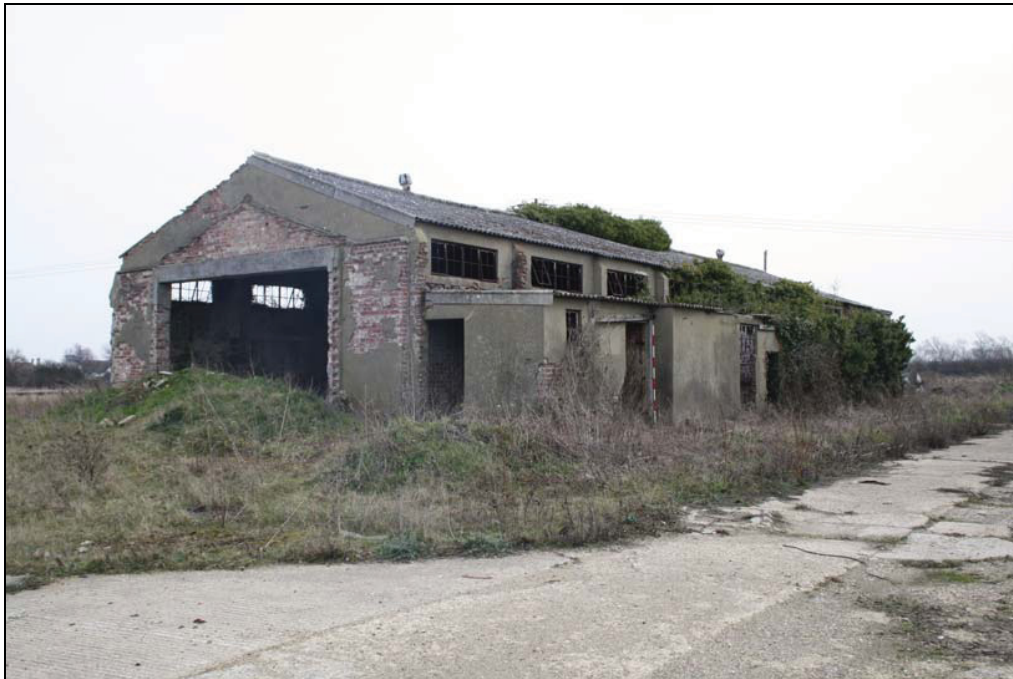
6.30 The main building is constructed of brick laid in a mixture of English and stretcher bond completely rendered over rising to a shallow asbestos covered gable roof. As with all the other buildings on site the building is in a poor state of repair partially taken over by vegetation. In places where the render has come away from the wall the brickwork beneath shows signs of decay (Plate 7).

Plate 7 The gymnasium and south-west range, taken from the south-west (DP 31)

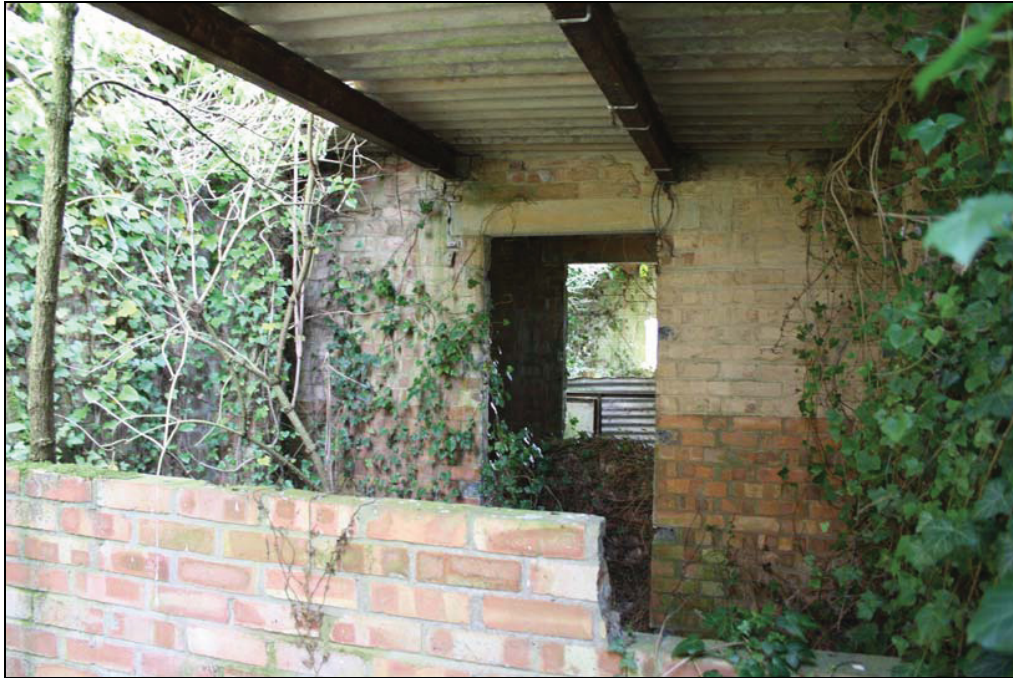
6.49 The unit to the east has been white washed and is now partially divided by a brick wall and metal framed pens (Plate 9). Two apertures pierce the east wall although no lintels, fixtures or fittings survive to suggest that these openings were original windows. The southern wall retains a metal framed window mirroring those of the main building and a small aperture which has been broken through at lower level to form a narrow doorway. The original external wall of the gymnasium preserves buttresses at the bay divisions with a wide blocked doorway framed by a concrete lintel giving access to the main building. Two large 'I' beams tied into the brickwork at the unit divisions carry the corrugated sheet metal roof.

Plate 9 South-west range adjacent to the gymnasium, interior, taken from the west (DP 44)

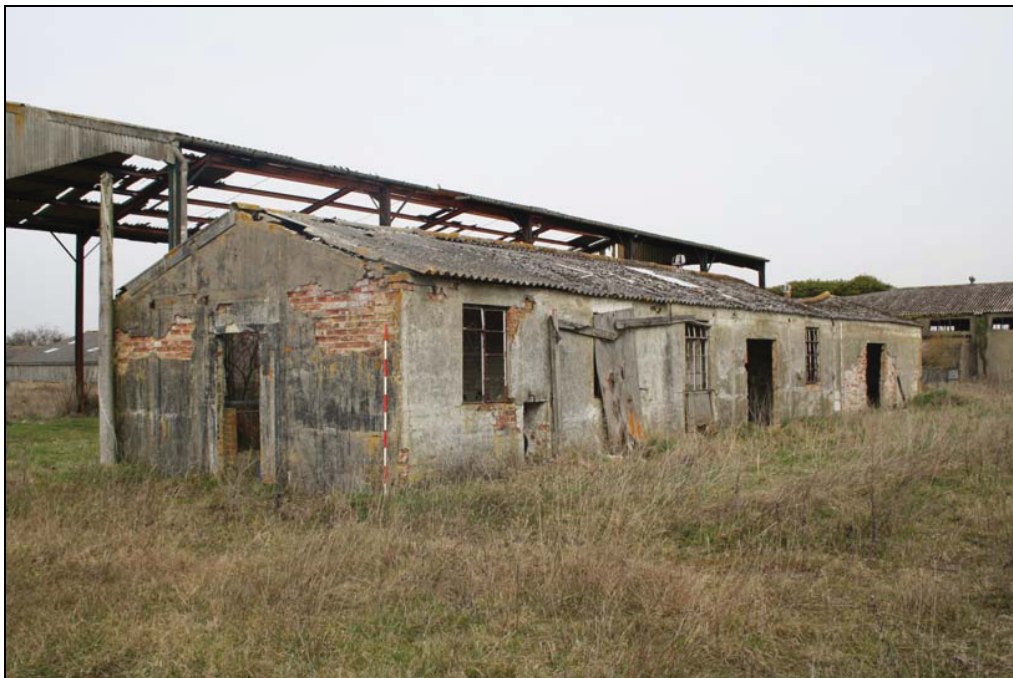
6.53 A shabby looking rectangular building now very much derelict and much altered for agricultural purposes has been tentatively identified as the meat and ration store (Plate 10). The building itself is constructed of salmon pink Flettons originally completely rendered although over time this has failed in places leaving the brickwork below vulnerable to subsequent decay. At present it is divided into four with the northern most unit almost certainly a later addition. Vegetation has

also caused a large amount of damage encroaching on the roof and interfering with the structural integrity of the building.

Plate 10 The meat and ration store, taken from the south-east (DP 58)

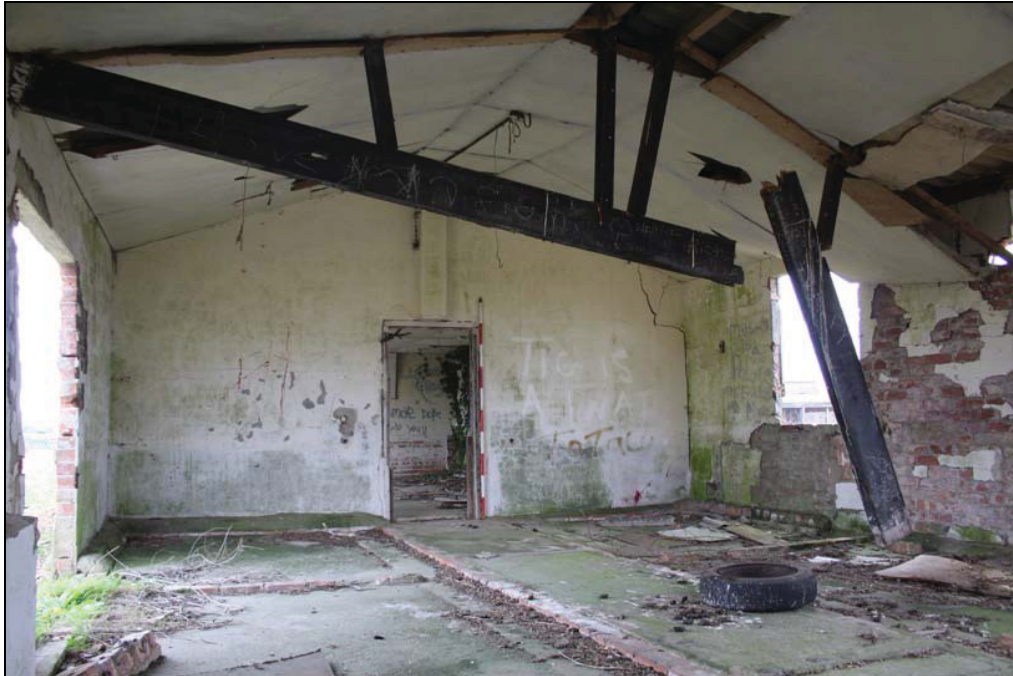
6.64 The roof is constructed of timber as opposed to metal seen elsewhere. A single truss originally supporting the roof at the mid point between the two brick gables has failed causing a partial roof collapse (Plate 11). A slender bead moulded tie-beam now disengaged from the brickwork and in two pieces maintains two sets of steep raking struts rising to the principal rafters. Each strut clasps a crude purlin notched in and scarfed at the bay division and tied into the brickwork at the gable ends. A rudimentary frame of rafters nailed to the underside of the purlins carries a plaster board ceiling following the roof line. The outer asbestos sheeting is also nailed to the purlins.

Plate 11 The meat and ration store, interior, bay 4, taken from the north-east (DP 63)
