**MALLOWS GREEN FARM BARNs,
MANUDEN, ESSEX**

HISTORIC BUILDING RECORDING

Authors: Dr Lee Prosser Lisa Smith BA Kathren Henry Kate Higgs BA	
NGR: TL 472 266	Report No. 3591
District: Uttlesford	Site Code: MAMG10
Approved: Claire Halpin MIFA	Project No. 3926
Signed:	Date: July 2010

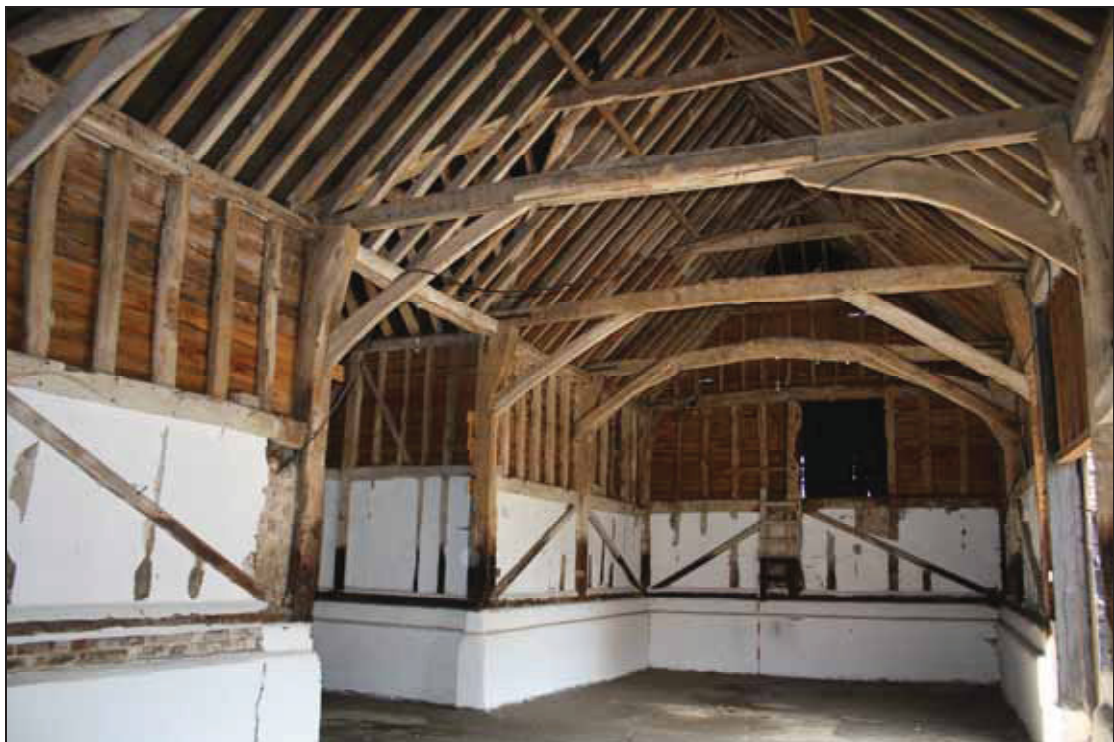
Plate 2 Building 1, interior, taken from the south-west (DP 5)

6.7 The general construction form is of five regular bays with a robust exposed timber-frame supported on high, rendered dwarf walls, with a modern concrete floor (Plate 2). The frame is defined by large oak principal posts with swelling jowls, tie-beams, some cambered and triangulated by variable bracing. There is no sign of pegging for queen or king-posts. The roof is a later replacement, but conventional, with collars offset from the bay divisions clasping a single purlin in each pitch. There are nine rafters per bay. The bay panels are regular with in-line mid-rails and five regular wide studs per panel pegged top and bottom (six in the western bay). The lower

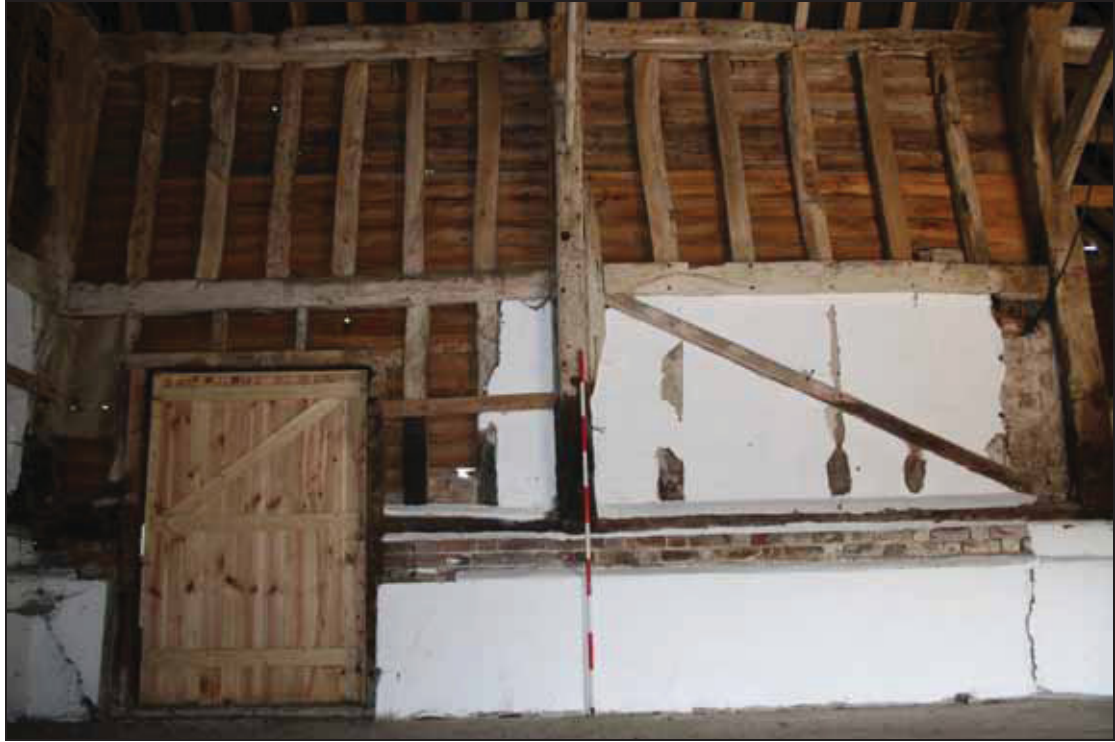
Plate 3 Building 1, interior, northern elevation, bays 4 & 5, taken from the south (DP 12)

6.27 The mid-rail and four original upper studs survive on the north; the eastern stud is probably a replacement (Plate 3). This regular pattern is reflected in the lower register behind the diagonal brace and render at the eastern end. The mid-rail falls short of western post to Truss 5 where a short timber has been added. This is itself a reused member retaining wattle grooves and is pegged to the mid-rail, so possibly an adjustment contemporary with the construction phase.

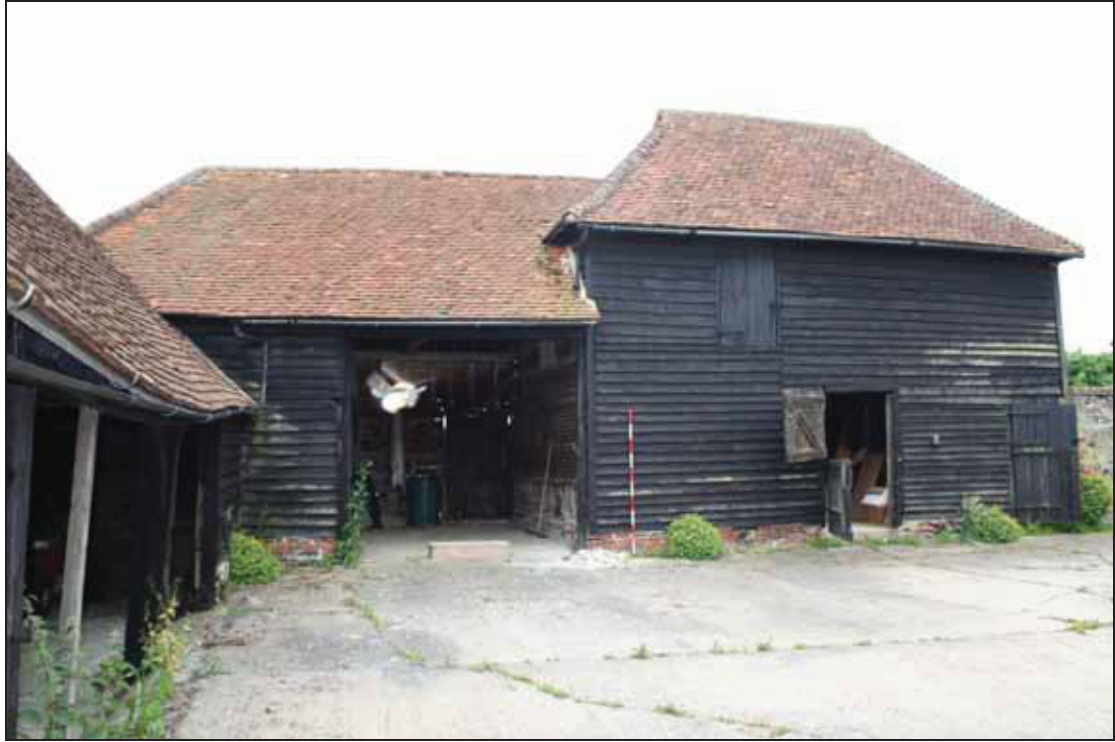
Plate 7 Buildings 3 & 4, northern elevations, taken from the north-east (DP 46)

6.49 Building 3 is of three bays, constructed in the same manner as its companions but with many signs of piecemeal modern repair (Plate 7). The roof is hipped and pushed beyond the end wall-plate as an outshut. A large, bay-width doorway opens to the courtyard with a second 19th/20th century vertically boarded door, ledged and braced to the rear, inserted into the southern elevation.

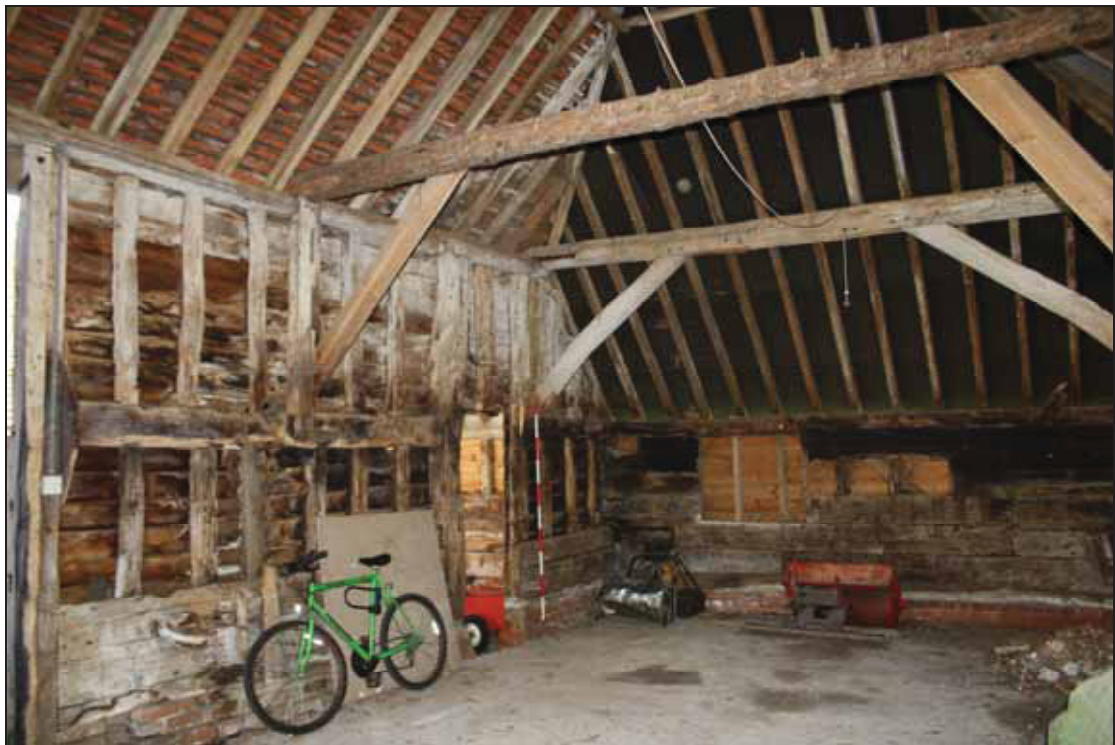
Plate 8 Building 3, interior, taken from the south-west (DP 24)

6.50 The frame is a confused assemblage of re-used timbers; principal posts do not respect notional bay divisions and braces spring from the mid-rail instead of the principals (Plate 8). The whole structure sits on a low dwarf wall much repaired at the east end with modern brickwork. Much of the southern elevation is obscured by wide boarding (up to 25" wide) similar to those seen in Building 2. The whole form makes the building difficult to describe coherently.

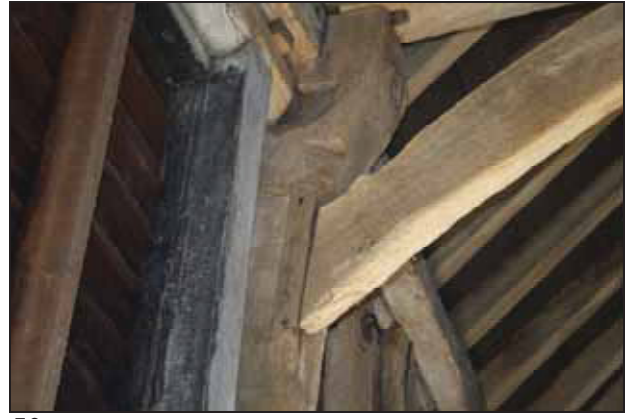
50

6.26 Truss 4 frames the west side of the entrance and midstrey and comprises jowled principal posts with a slender tie-beam strengthened by nailed-on and pegged cleats on both sides to counteract racking. Strapping has also been applied to the east face. The southern brace is original, slightly cranked and pegged to the tie-beam; the northern brace is straight and likely to be a replacement. An assembly marked Roman 'IV' is scratched onto the east face of the south post.

Building 1, interior, principal post of truss 4 displaying assembly mark 'IV', taken from the north-east
