**CHURCH OF ST BOTOLPH,
IKEN, SUFFOLK**

HISTORIC BUILDING RECORDING

ARCHAEOLOGICAL SOLUTIONS LTD

Authors:	Tansy Collins BSc Lee Prosser PhD Peter Thompson MA Kathren Henry	
NGR: TM 0265 6235		Report No: 3592
District: Suffolk Coastal		Site Code:
Approved: C Halpin MIFA		Project No: 3499
Signed:		Date: July 2010

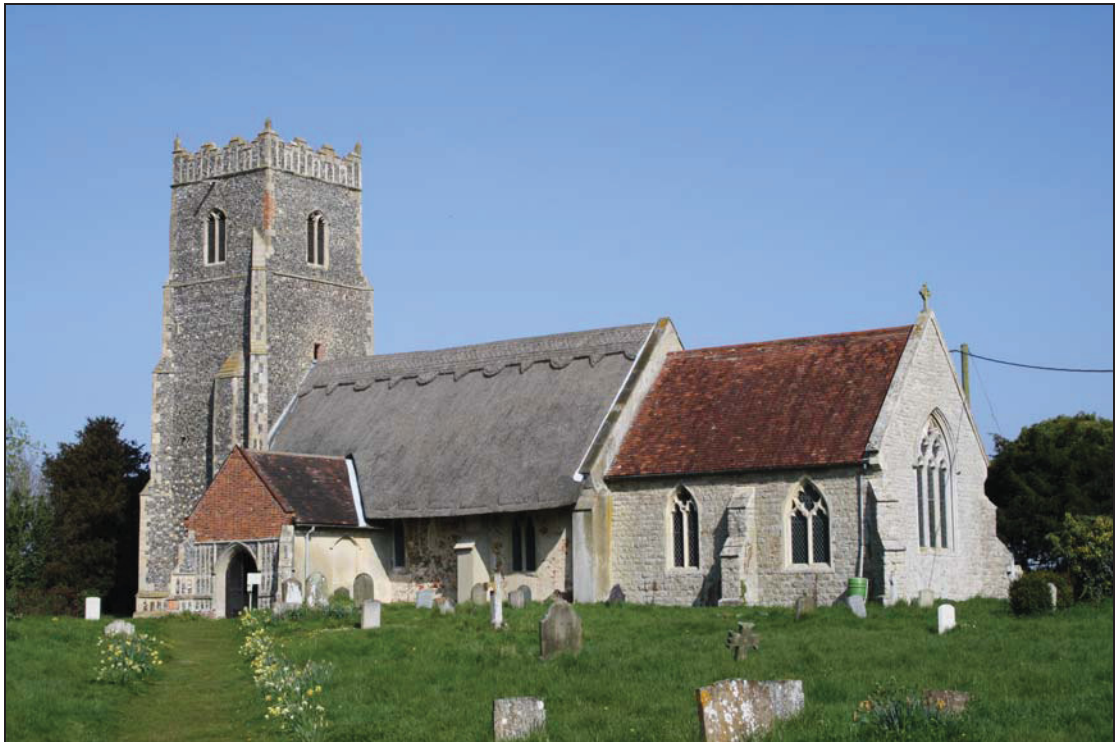
5.1 The church (Plate 1) as it now stands is the result of several periods of rebuilding, restoration and repair. The nave is the most ancient element and is rendered over a masonry core with a steeply pitched thatched roof. This was replaced in the late 1980s after a fire, following which the building lay roofless for a period. More recent interventions are also present in the form of crudely applied cement rendered buttresses, one of which is known to obscure a Romanesque window. The south porch and west tower date from the late 15th or early 16th century, constructed of knapped and coursed flintwork with limestone dressings, and having a plinth, parapet and buttresses decorated with flushwork. Bricks present in the porch are typically Tudor in form, measuring 9" x 3½" x 2¼" (229mm x 89mm x 57mm), though the gable above the door was rebuilt in the 19th century. The chancel was rebuilt in

1 General view of the church, taken from the south-east (48)

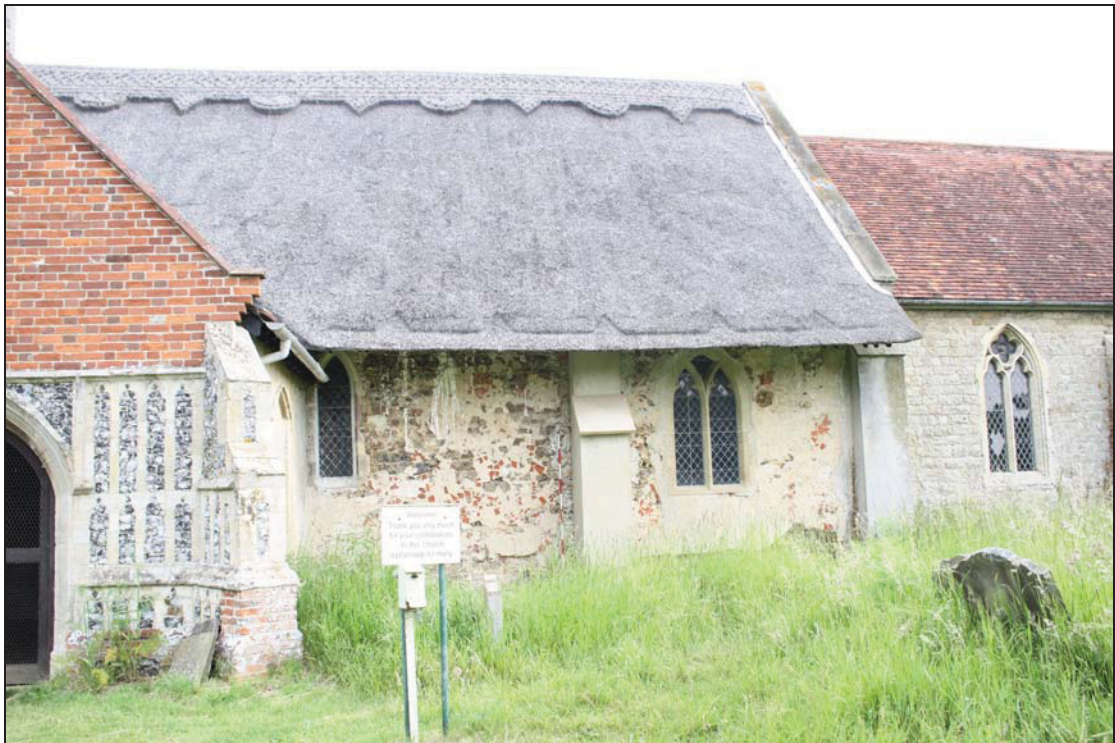
5.2 Decay and exposure to the elements following the unroofing of the nave has affected the north and south external walls, exposing the underlying masonry in places and requiring repair (Plate 2 and 3). The original construction appears to comprise large dressed and coursed blocks of Septaria, interspersed with courses of rounded flint cobbles. It is unclear how prevalent this was as there is little discernible regularity. The Septaria blocks have suffered from frost damage, and are extensively cracked and fractured, making them difficult to trace in some areas.

2 Detail of south nave wall, Bay 1, taken from the south (37)

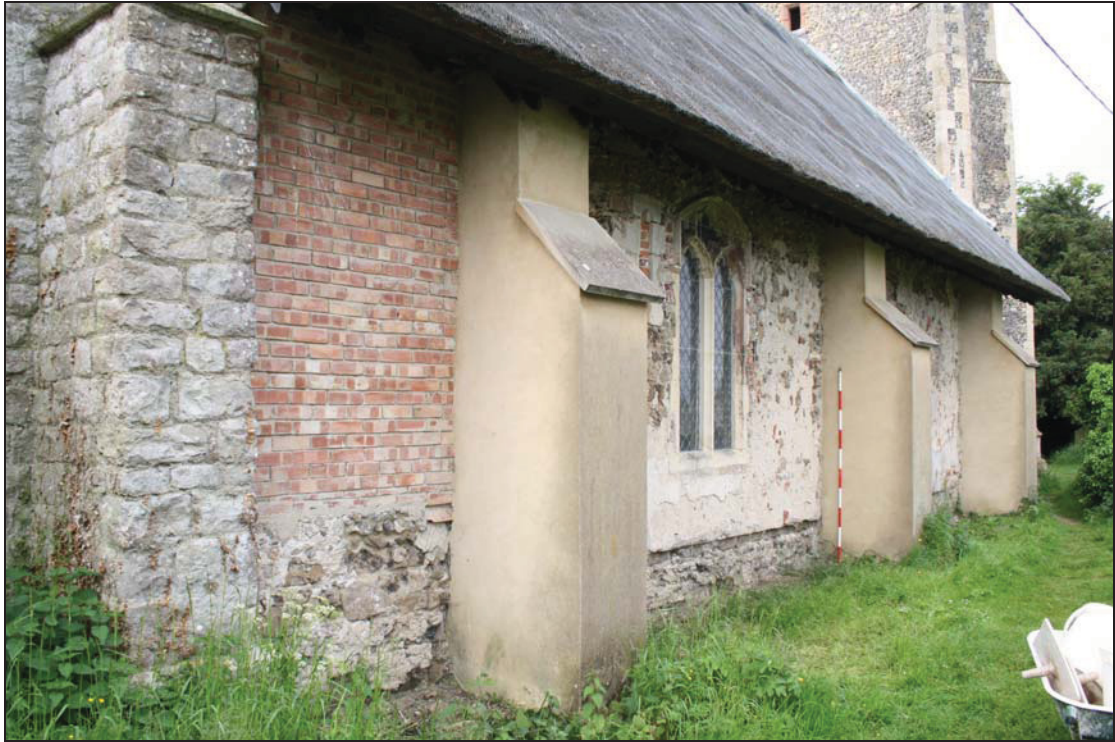
3 General view of the north elevation of the nave, taken from the north-east (39)

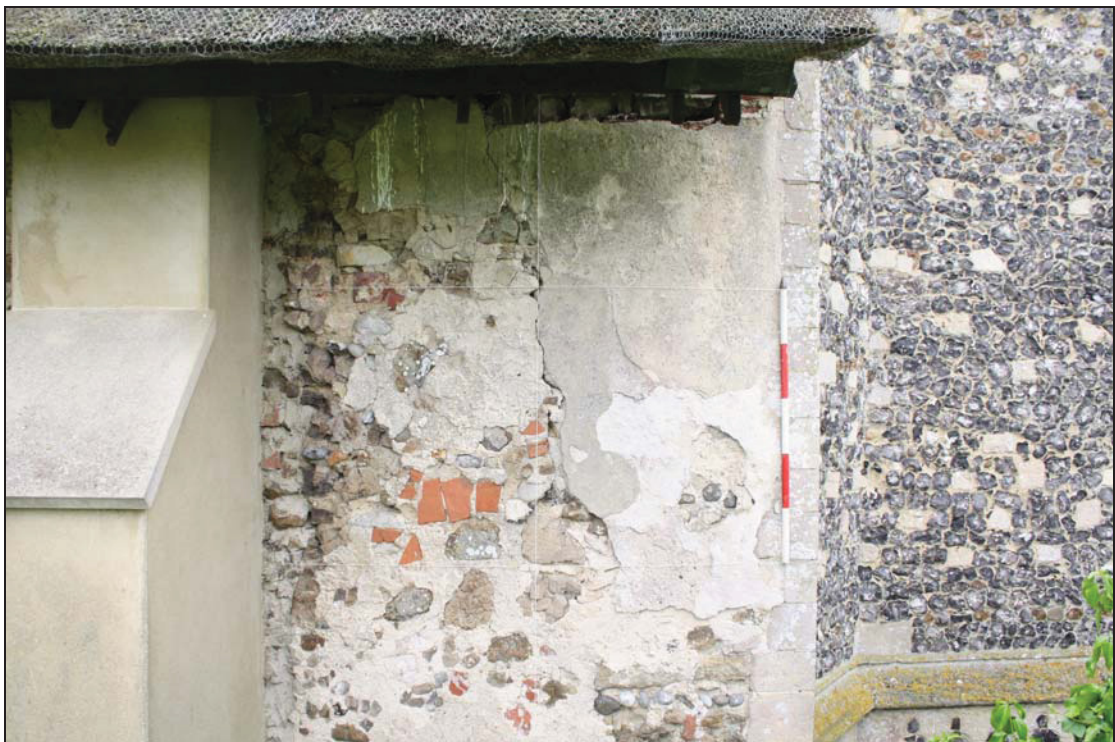
5.13 At least three layers of render can be discerned with occasional areas of repair. Little of the primary mortar is visible and the earliest layer appears to comprise the pure white lime render (Phase 3) adjoining one of the lower quoins. Phase 4 render covers much of the panel from approximately 1.2m in height and includes fragments of roof tile pressed into the surface. This is overlain in places with the fine Phase 5 finishing coat. An area of repair in the upper corner appears to comprise Portland cement containing flint pebbles, most probably a Victorian or later repair. At upper level is a distinct break which may reflect the earlier presence of a timber fascia board, which has been inadequately replaced with cement over expanded steel mesh, and falls short of the original covering.

4 Detail of north nave wall, Bay 1, taken from the north (12)

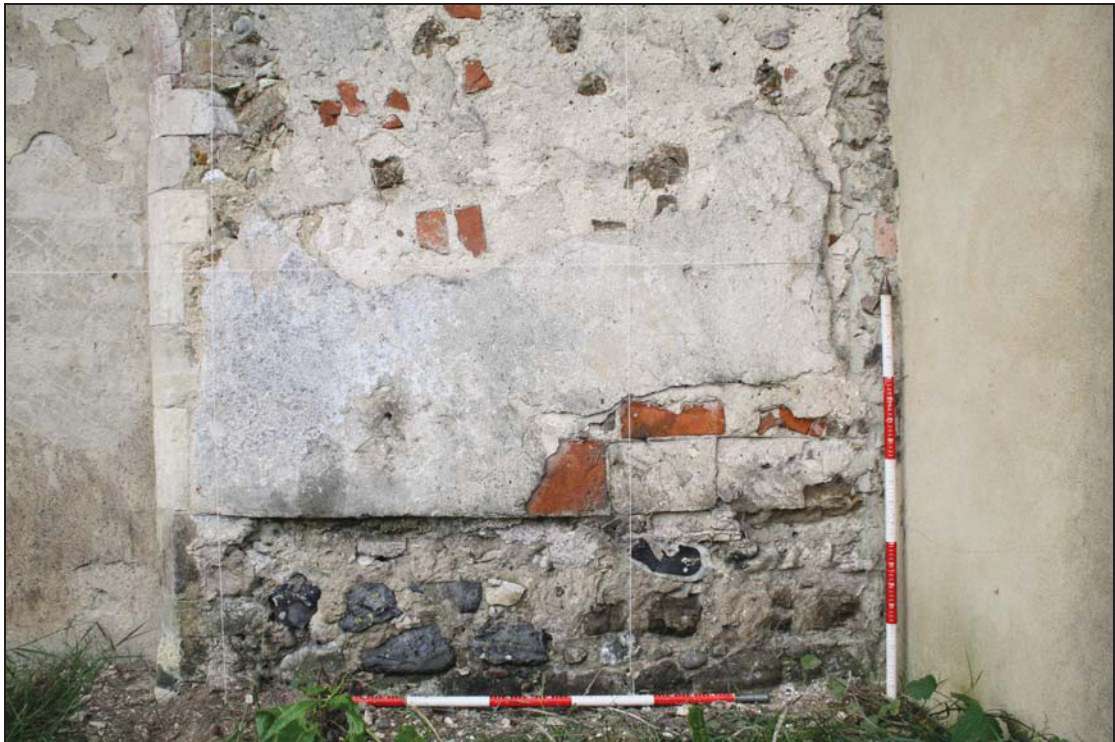
5.16 The wall structure is similar to the adjoining area, with the removal of the later brick plinth exposing courses of squared *Septaria* and flint. This is most coherent to the east of the doorway (Plate 5). Above this, some coursing is discernible, but without systematic regularity. However, this lack of coherence could be attributed to the various stages of repair along with the limited visibility caused by the surviving render layers. The render is well preserved to a level of approximately 1.6 m, consisting of the Phase 5 finishing coat over Phase 4 render. The base layer survives well, with a series of complete roof tiles, which were pressed into the wet render, and then obscured behind the final coat. This stands proud of the door dressings and at lower level appears associated with the application of the plinth. The tiling course appears to continue for two or three courses above the height of the plinth, and this has perhaps facilitated the high survival in this area. Above, much more fragmentary tiles have been pressed into the render as a key but little of the finishing coat survives. In the upper area, render survives in recesses in the wall fabric.

5 Detail of north nave wall, Bay 2, taken from the north (36)

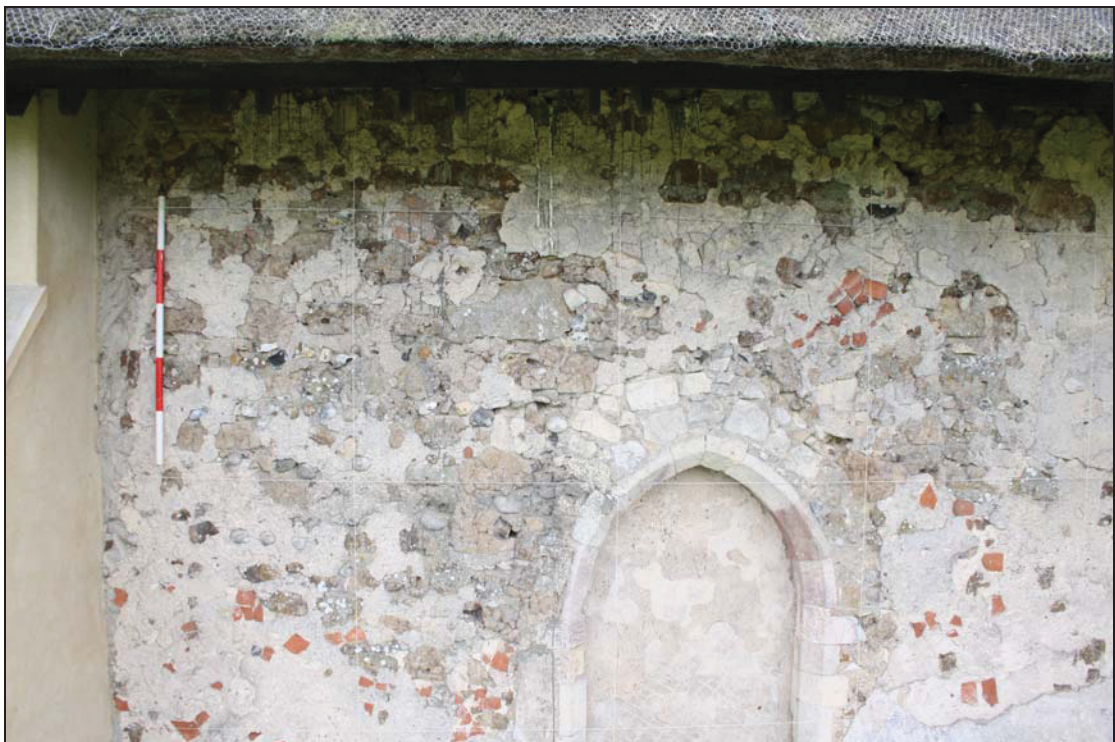
5.17 At upper level (Plate 6) the exposed masonry is coursed with *Septaria* and flints, with Phase 1 primary mortar. In addition 17th or 18th century brick has been used in places as a repair.

6 Detail of north nave wall, Bay 2, taken from the north (09)

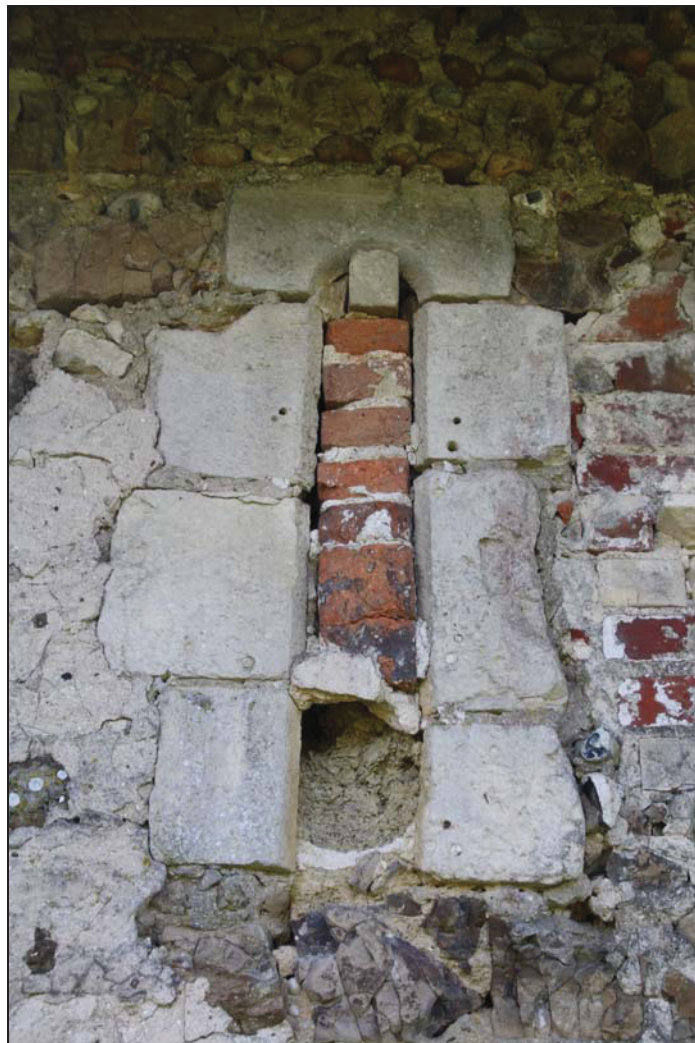
5.19 This bay frames two windows; a small, single-light Romanesque lancet and a large 15th century window with two lights and trefoil head to a four-centred arch with a drip-mould. The window is constructed of Caen stone, all elements with hollow chamfering, although the central mullion has been replaced in a shelly limestone. Immediately below the sill is a course of three or four yellow Flemish bricks which measure 4¼" x 2" (108mm x 51mm). The jambs, particularly to the west, are packed with fairly small fragments and some 15th or 16th century brick, suggesting insertion into the surrounding masonry.

7 Detail of original lancet window in Bay 3, north nave wall, taken from the north (43)

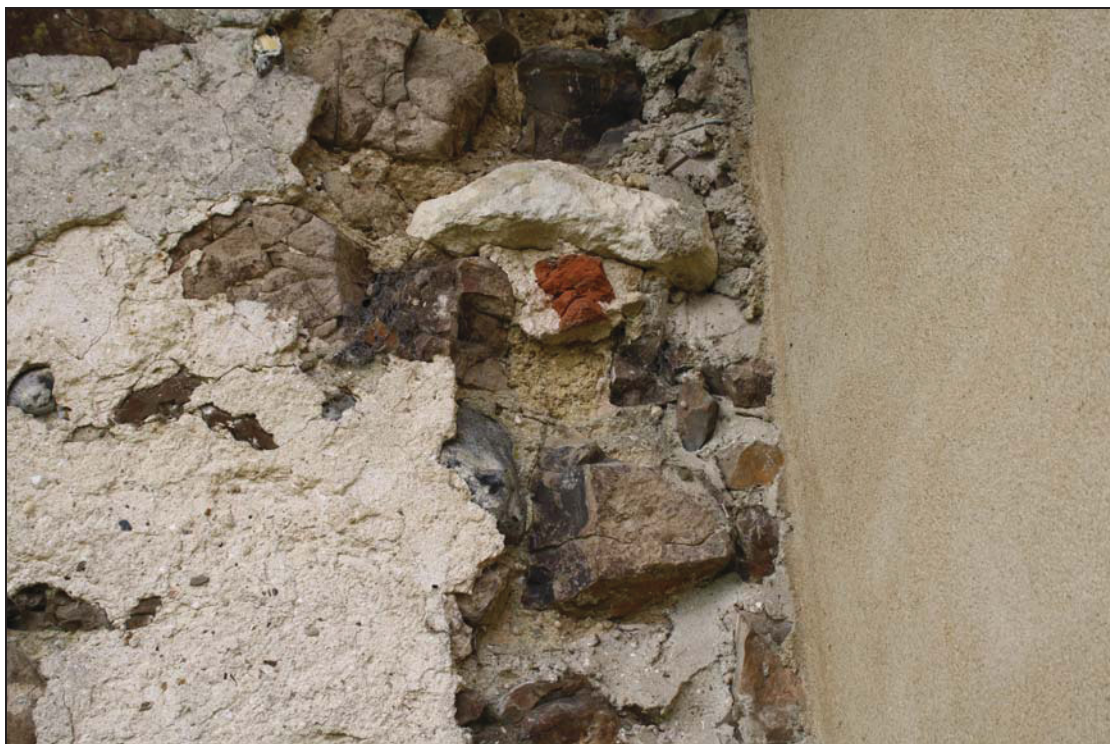
8 Putlog hole (P2) in Bay 3 north nave wall, taken from the north (41)

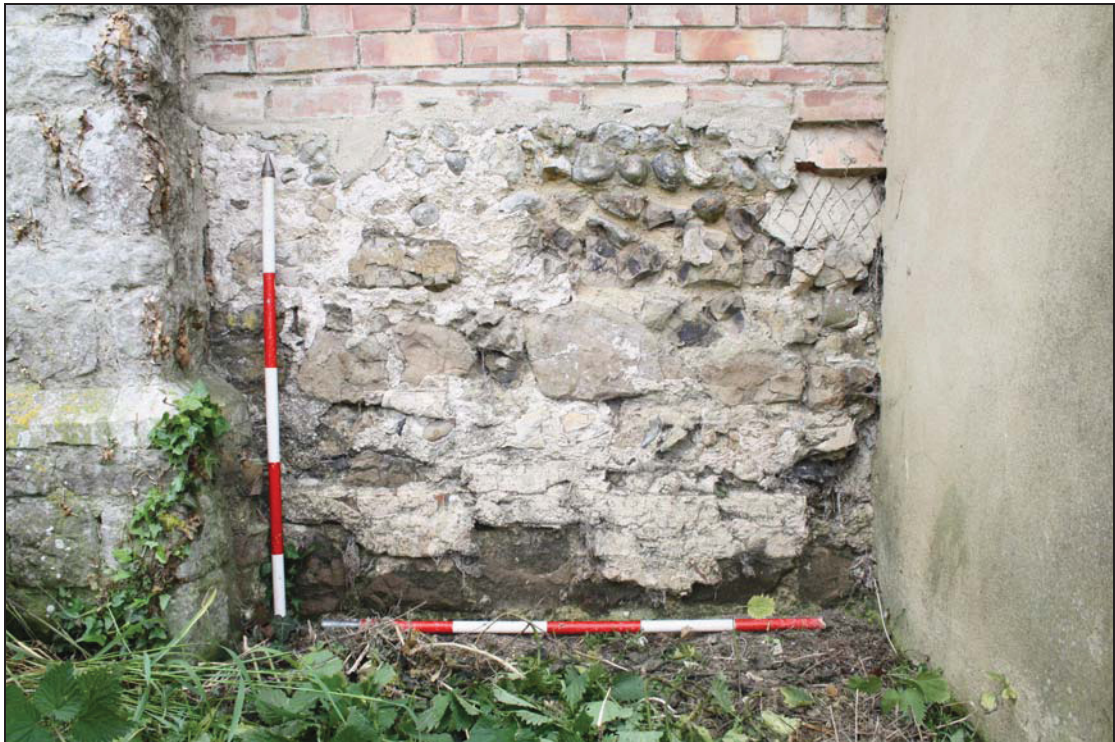
5.23 This is a final short section of the nave terminating at a ragstone buttress contemporary with the chancel. Only c.1m of the wall fabric survives at lower level (Plate 9) as the upper area has been entirely replaced with 20th century pink Fletton bricks laid in stretcher bond immediately behind the former rood stair, which survives within the church. The lower courses are of

9 North nave wall, lower Bay 4, taken from north (01)
