**BARN AT TILE KILN FARM, A1017,
SIBLE HEDINGHAM, ESSEX**

HISTORIC BUILDING RECORDING

Level 3

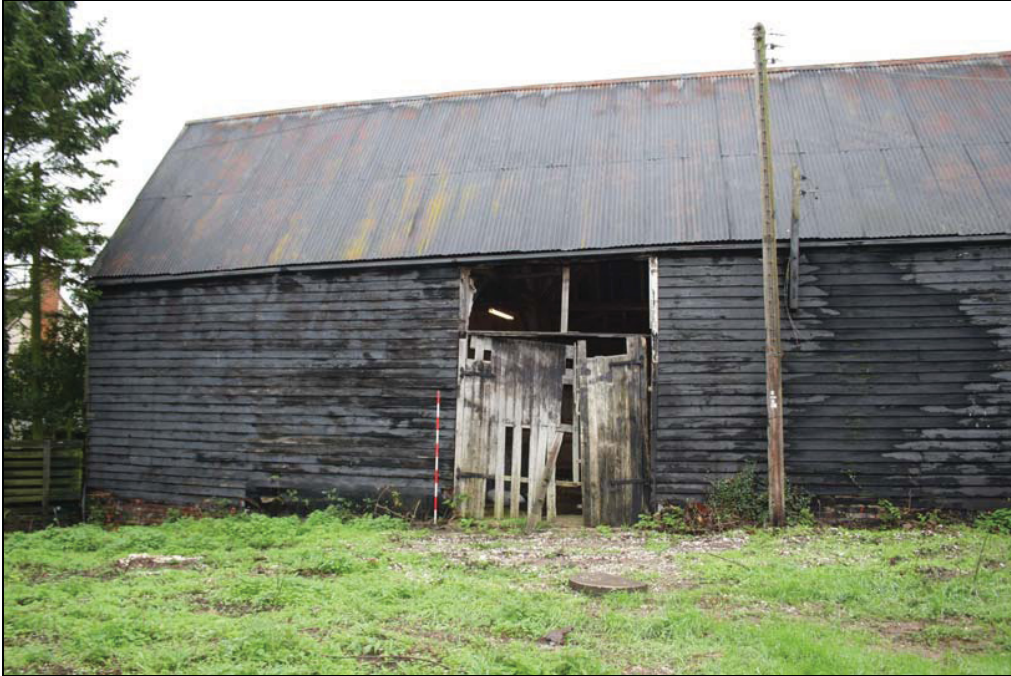
6.1 The barn stands in a dilapidated state on a small plot of land including a yard with modern farm buildings associated with the farm house (Plate 1). It is orientated north-west to south-east, but for ease of description, is considered to be east-west in the description below. The building has five bays with a central porch on the north and an adjoining outshut to its west, all weather-boarded (Plate 2). A large central entrance on the south now forms the principal access. The original roof has been replaced with corrugated

Plate 1 Barn, Tile Kiln Farm, south-western elevation, taken from the south-west (DP 1)

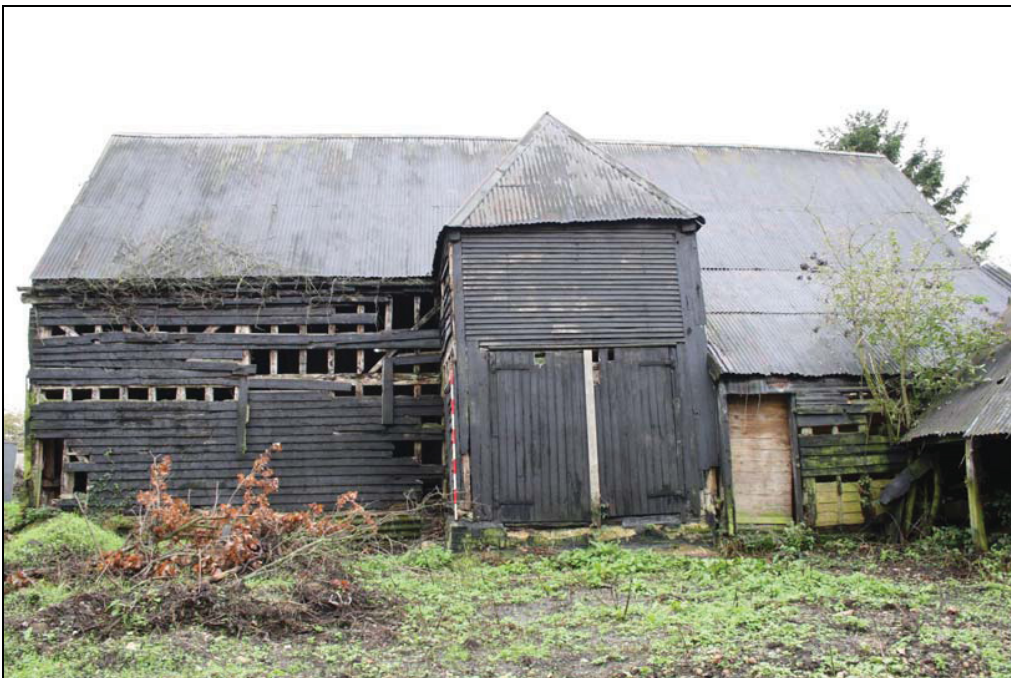
Plate 2 Barn, Tile Kiln Farm, north-eastern elevation, taken from the east (DP 4)

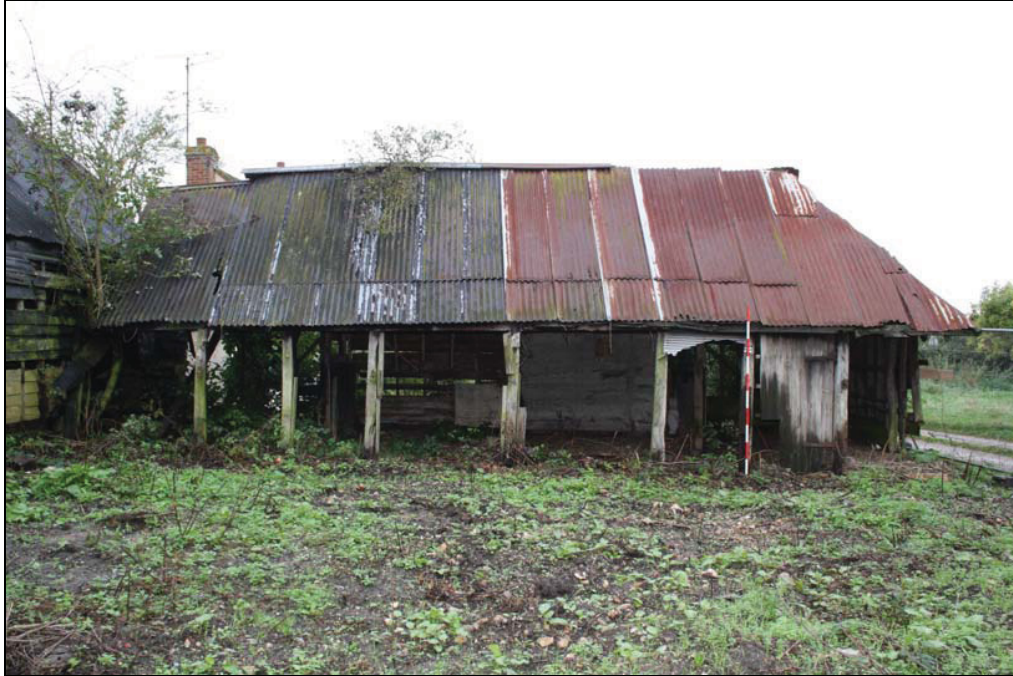
6.31 The animal byre abuts the outshut and is partly ruinous, but it remains open-fronted on the east with much modification elsewhere. Internally it retains fragments of a coherent five-bay structure, probably of 19th century date, with a fairly slender frame of oak and softwood, especial care having been taken to use the best timber for the wall-plates and principal posts (Plate 9). The rear wall panels are in poor condition. Two have partially collapsed while a third has been replaced by brick and concrete. One panel is complete, and has slender, primary-braced slender studwork. Internal stall partitions with horizontal boarding survive and are most probably original.

Plate 3 Adjacent animal byre, taken from the south-east (DP 8)

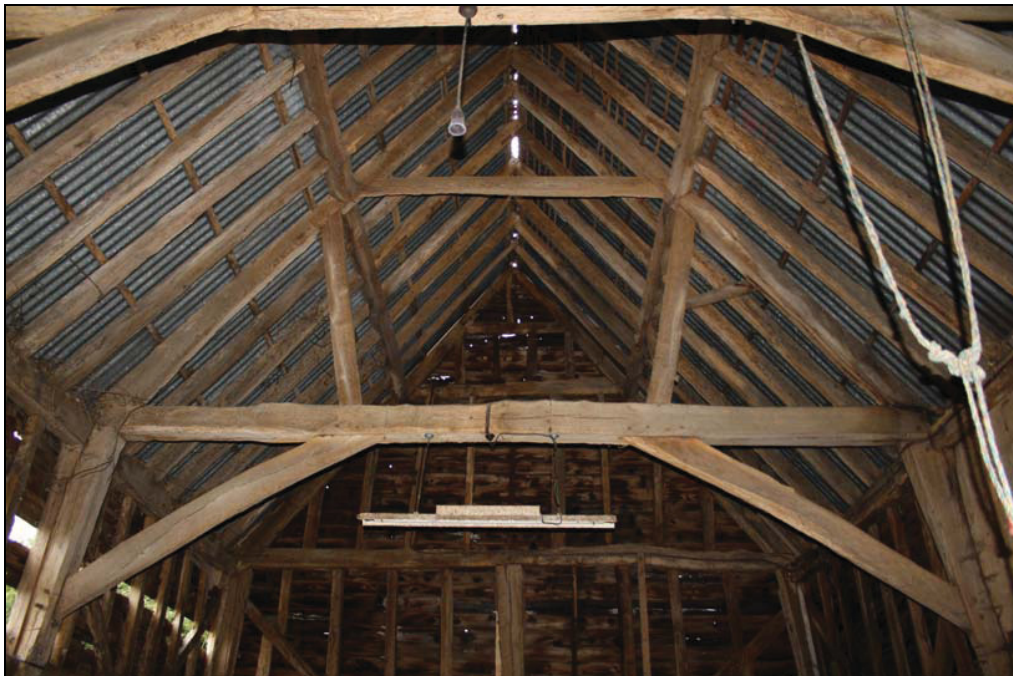
Plate 4 Truss and roof structure, taken from the north-west (DP 21)

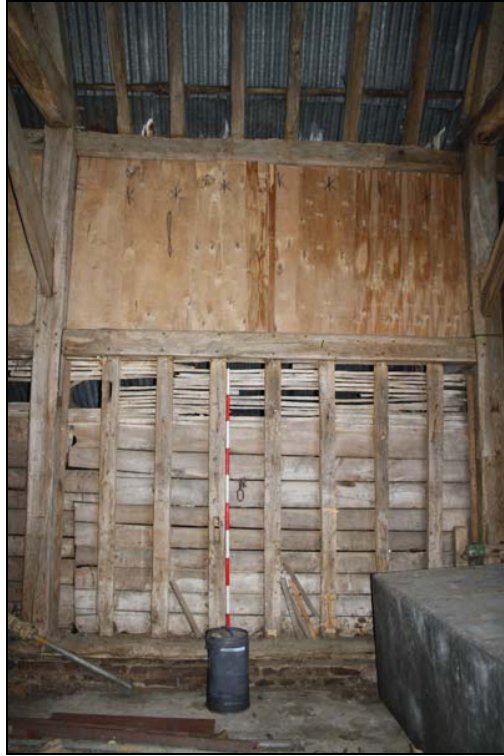
6.12 The south panel has been much modified, with the sole-plate lost or entombed in modern concrete. Six original studs survive but the mid-rail shows some signs of decay. The upper register is obscured as before though the peg holes indicate in-line members as elsewhere. The wall-plate is scarfed, as above.

Plate 5 Bay 2, north-eastern panel, taken from the south-west (DP 25)

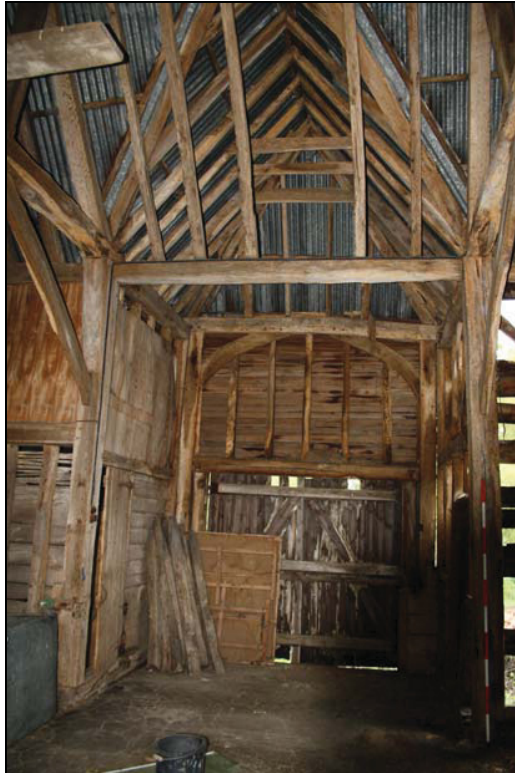
Plate 6 Porch interior, taken from the south-west (DP 13)

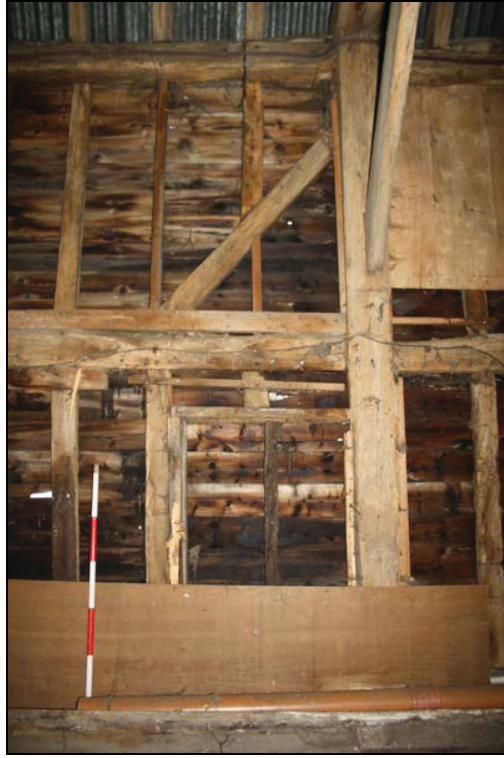
6.23 The south wall is similar but in poor condition with the sole-plate encased in cement like the adjoining area. This has accelerated decay to the studwork, though the western stud has been truncated to accommodate a doorway which is now blocked (Plate 7). The upper register is regular with primary-braced studwork; a single member has been replaced. The roof is as before, having all well-preserved members with pegged wind-braces on the south.

Plate 7 Bay 5, south-western panel, taken from the north-east (DP 24)

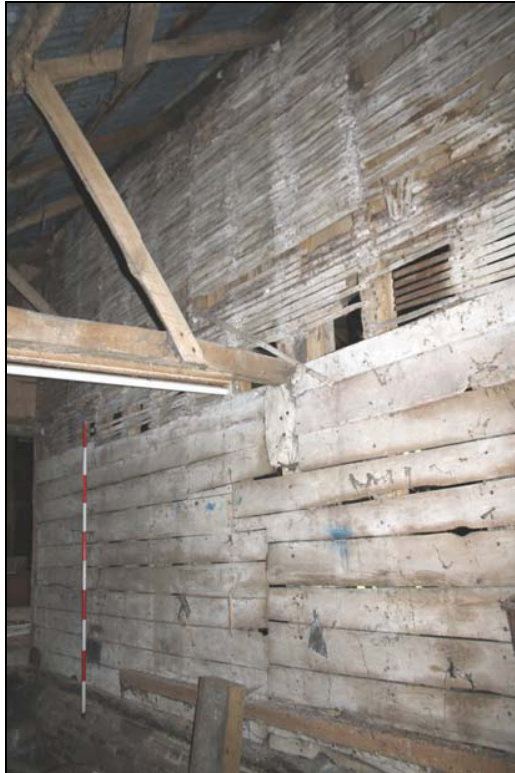
to the mid-rail. As this panel is protected by the outshut, original oak and elm weather boarding with some lath and plaster cladding is preserved to the external face. The upper register is obscured by plywood boarding but the pattern of peg holes in the mid-rail suggests a similar bracing system.

Plate 8 Upper laths and lower weather boarding, original external barn elevation seen in the outshut, taken from the north (DP 19)

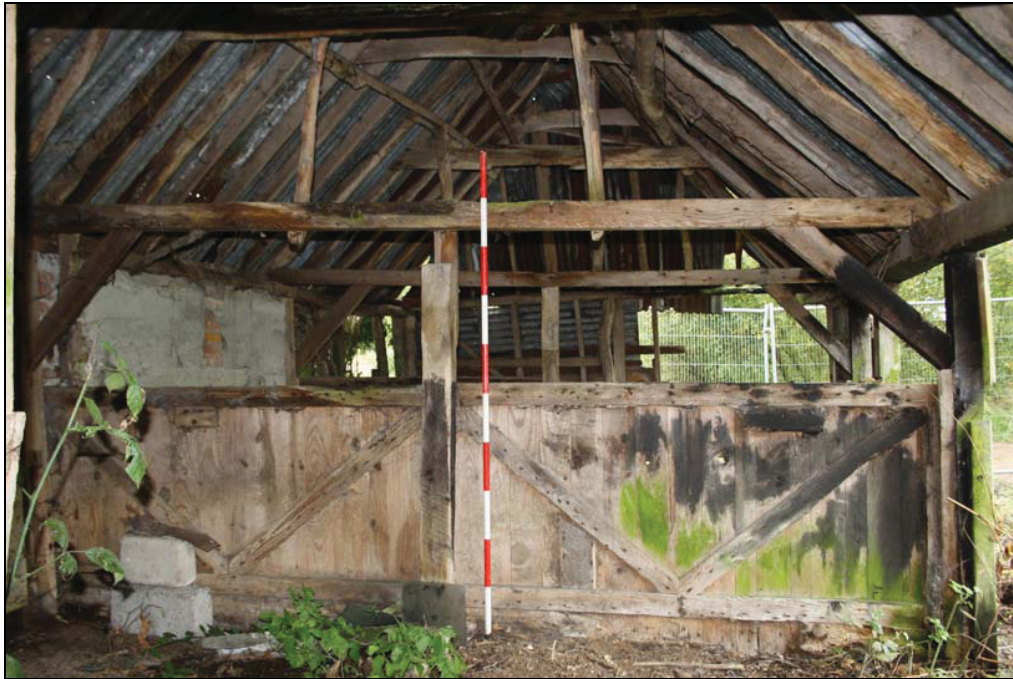
Plate 9 Stall partition, animal byre, interior, taken from the south-west (DP 11)

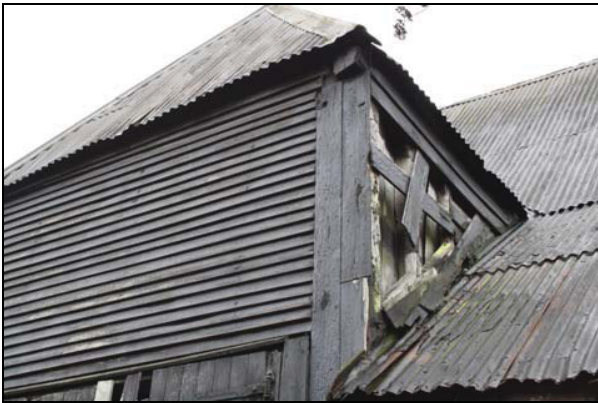
9

Damage to the porch, north-western elevation taken from the north-east

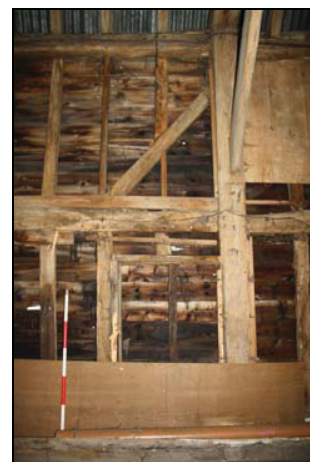
24

Bay 5, south-western panel, taken from the north-east

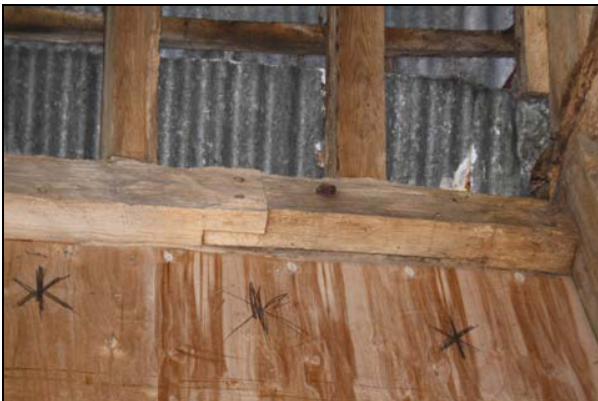
27

Bay 2, scarfed wall-plate, taken from the west
