**SELLANDS FARM BARN, HEMPSTEAD ROAD,
RADWINTER, ESSEX**

HISTORIC BUILDING RECORDING

Authors:	Tansy Collins BSc Kathren Henry Lee Prosser PhD Peter Thompson MA	
NGR: TL 6180 3772		Report No: 3675
District: Uttlesford		Site Code:
Approved: Claire Halpin		Project No: P4040
Signed:		Date: October 2010

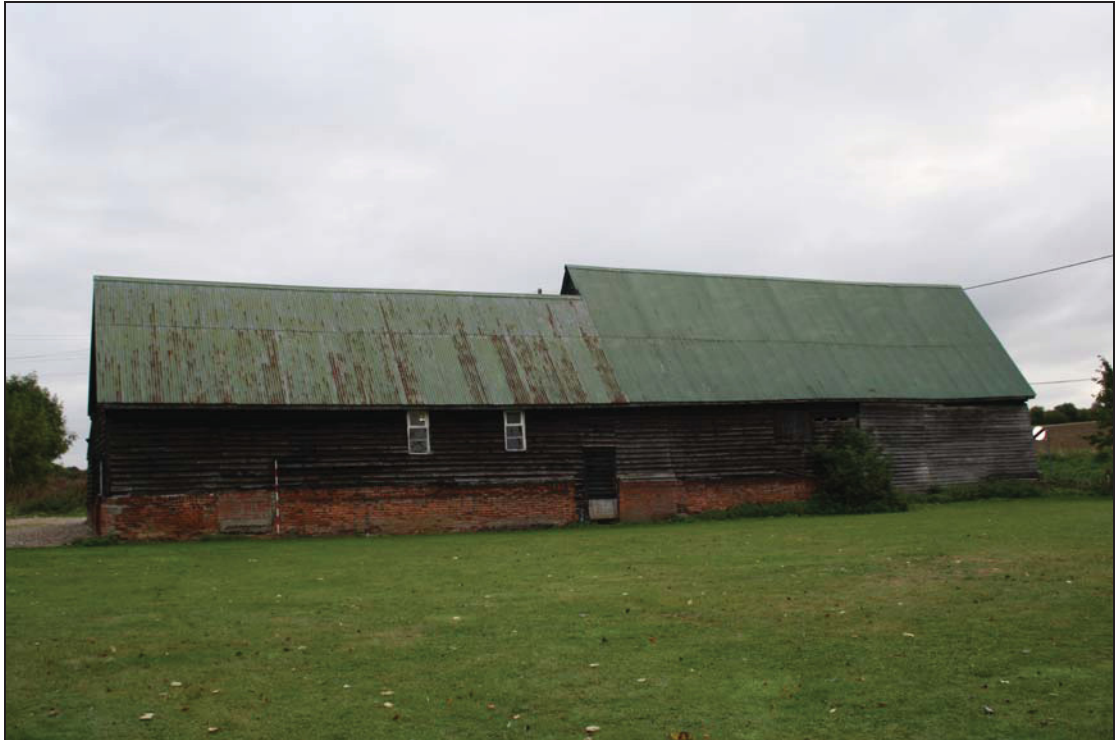
5.3 The south-west façade (Plate 1) displays a number of interventions. A doorway lies off-set to the north but is itself set in a distinct panel of brickwork which clearly infilled a much wider bay-width aperture. The door is modern, boarded, ledged and braced while the adjoining infill is of 20th century brickwork with cement mortar. At the north end a former doorway has been infilled with red brick although a small area of yellow brick repair is visible. The façade is also pierced by a high-set pitching door with hand-made strap hinges on pintles. There are two windows, each of three panes with the upper pane forming a top-hung casement.

1 South-west elevation of the barn, taken from the south-west (01)

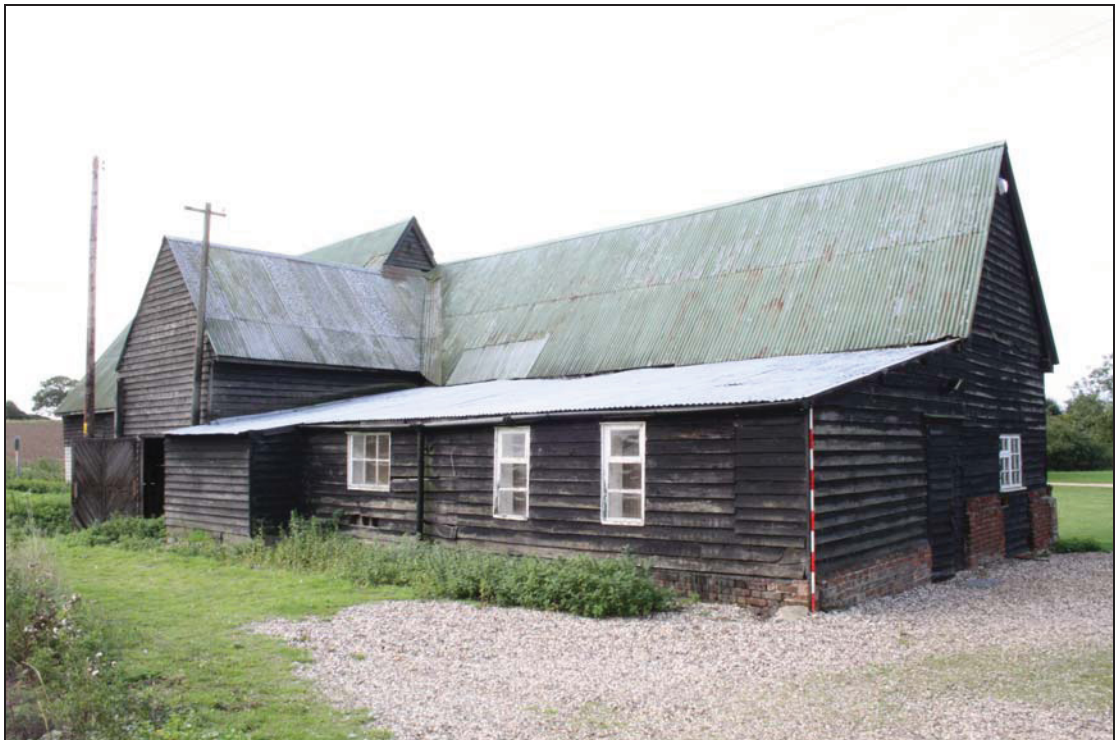
5.5 The north-east elevation includes the central midstrey and outshuts to the north-west (Plate 2). The weatherboarding has been replaced as before. Here, the dwarf wall is laid in an unresolved Flemish bond, but the fabric is consistent with that seen elsewhere. A former high-set pitching door was located to the south-east. This is now obscured, but its position is indicated by marks in the weatherboarding and a surviving pintle. The porch and adjoining outshuts are similarly clad although the porch has no dwarf wall. There is a small doorway aperture on the south side, infilled with weatherboarding. The porch now frames a wide, modern door. To the north-west, the outshut consists of two elements. The south element breaks forward slightly with the frame resting on a low wall of cement block-work, while its companion to the north has a stock brick wall. This section is pierced by two casements, each of three panes with an upper top-hung casement. A third window is a six-pane fixed light and appears to be a reused sash. A single weatherboard has dislodged revealing the underlying timber-framing which is of softwood of slender scantling.

2 Rear outshuts, taken from the north (04)

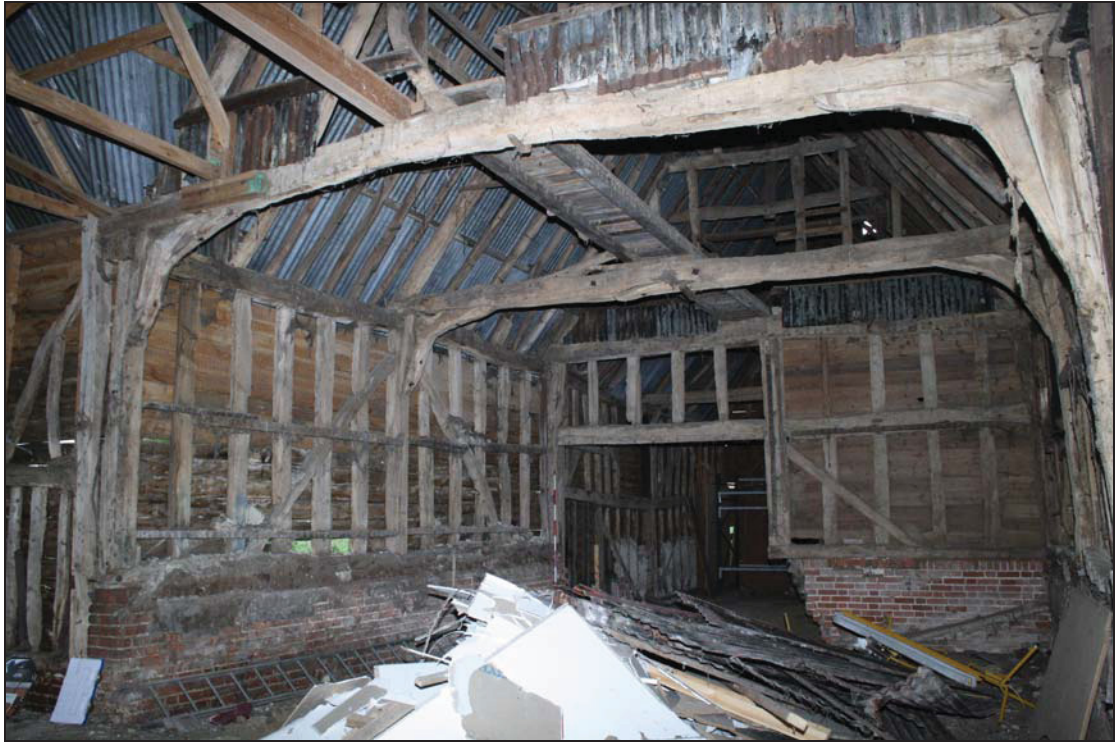
5.8 Bays 3 and 4 form the historic core where a high proportion of the original timber survives (Plate 3). The brickwork of the 18th century dwarf wall is exposed on both sides, and originally returned to close the former south-east gable end, though this became an internal wall when the eastern element was added. Latterly, this has been broken through on the north-east side to consolidate the space, with some loss of the wall and frame.

3 Bays 3 & 4, taken from the north-west (10)

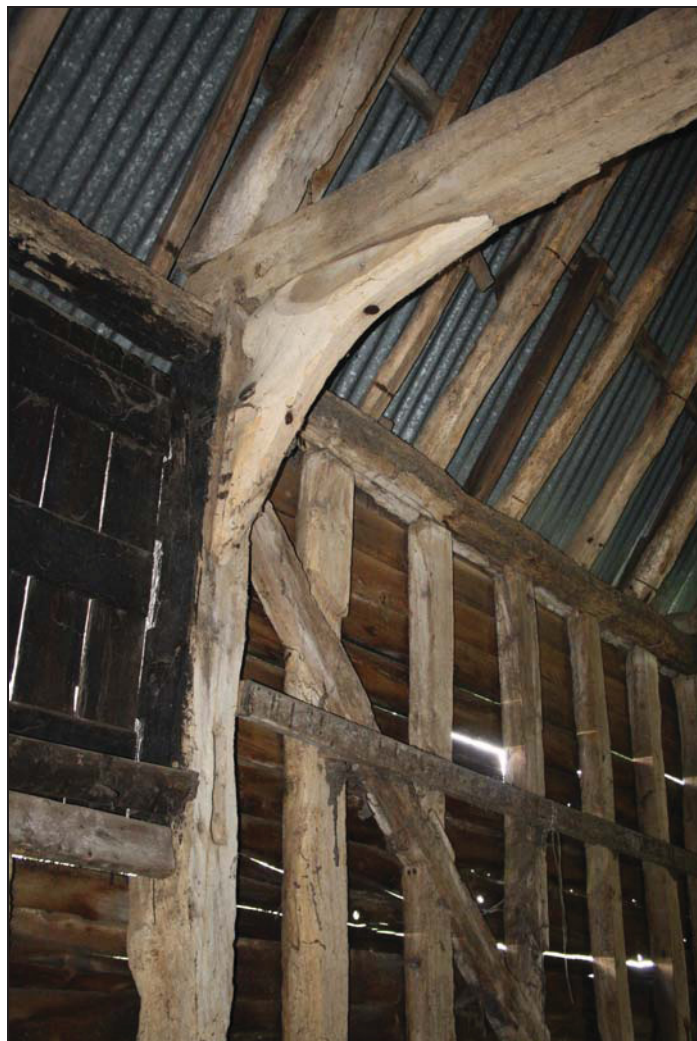
4 South-west end of the truss between Bays 3 and 4, taken from the east (37)

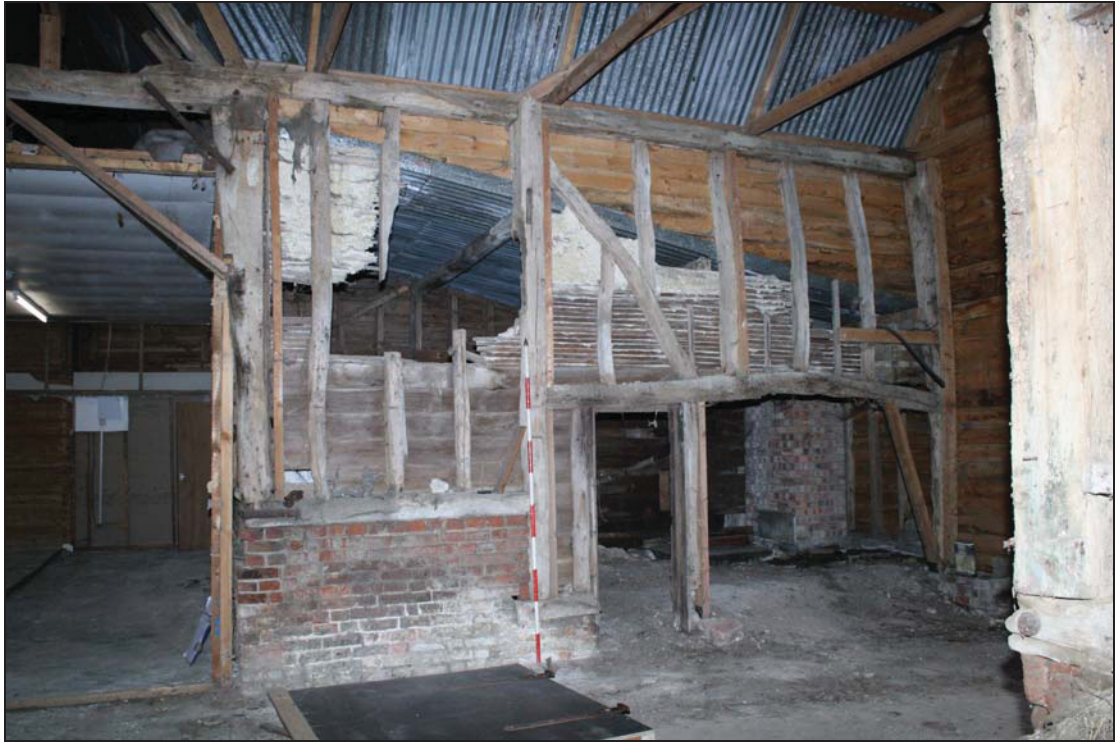
5 Midstrete (Bay 5), north-west wall panel, taken from the south (14)

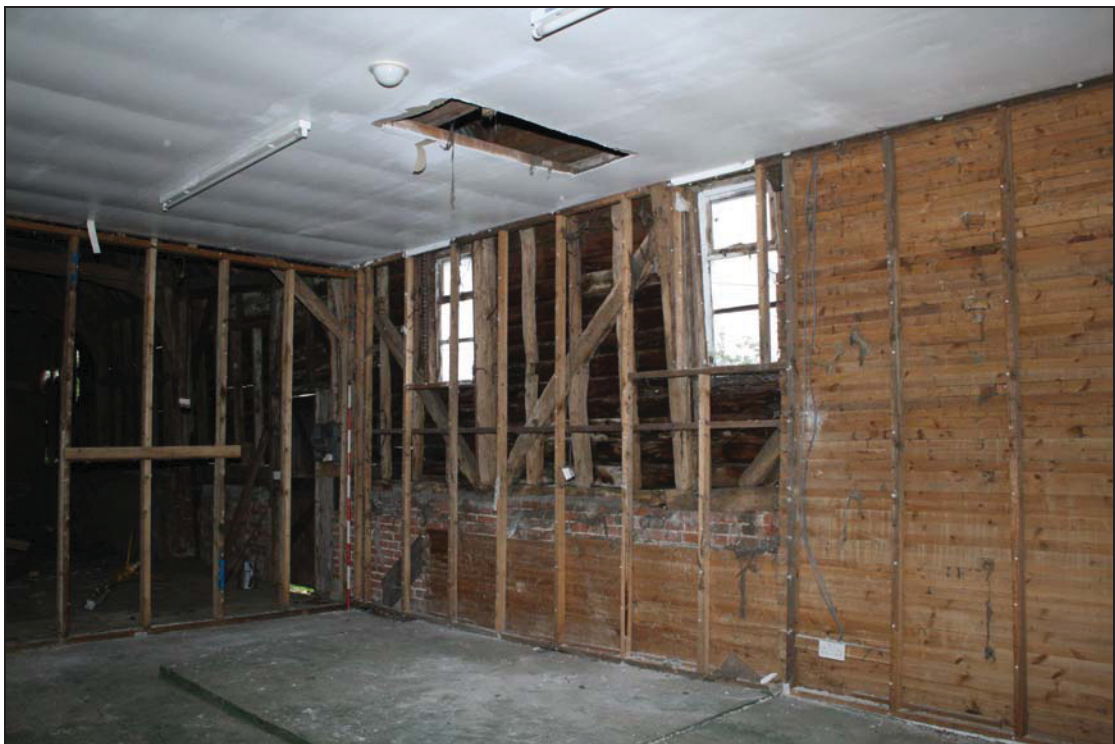
5.19 Visibility in the north-western range is hindered by modern timber and plasterboard lining (Plate 6), partitioning and a suspended ceiling, but it is clear that nothing historic above tie-beam level survives, except at the northern gable end. Bay 6 is the most clearly exposed and is defined on the south by a pair of slightly jowled principal posts set on a high, well-preserved sole-plate on the 18th century brick dwarf wall. Slender braces triangulate the uprights to a waney tie-beam. The west brace is a reused timber of some age with redundant notch-lap joints, while the east example is modern. Similar posts define the northern side of this bay but their braces have been sawn off and the tie-beam is only partially visible above a modern suspended plaster

6 Bays 6 & 7, western wall panels, taken from the north (17)

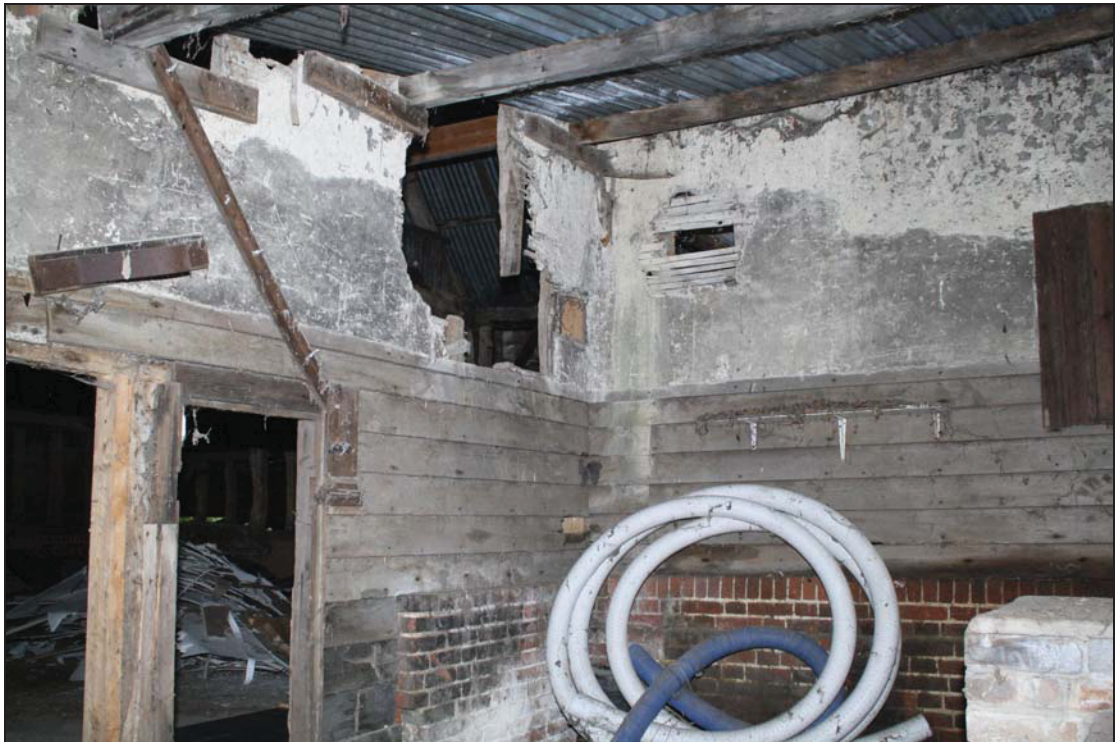
Plate 7 South-east outshut showing formerly external walls of the midstrey and barn, taken from the north (16)

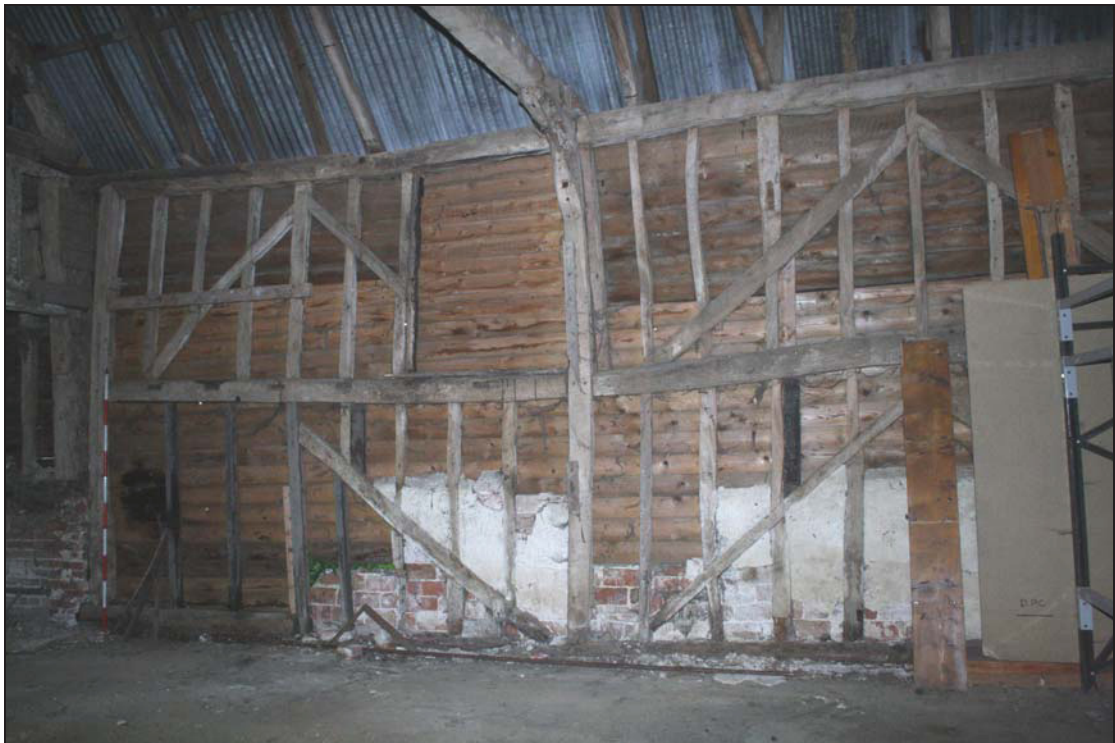
Plate 8 Bays 1 & 2, eastern wall panels, taken from the south-west (07)

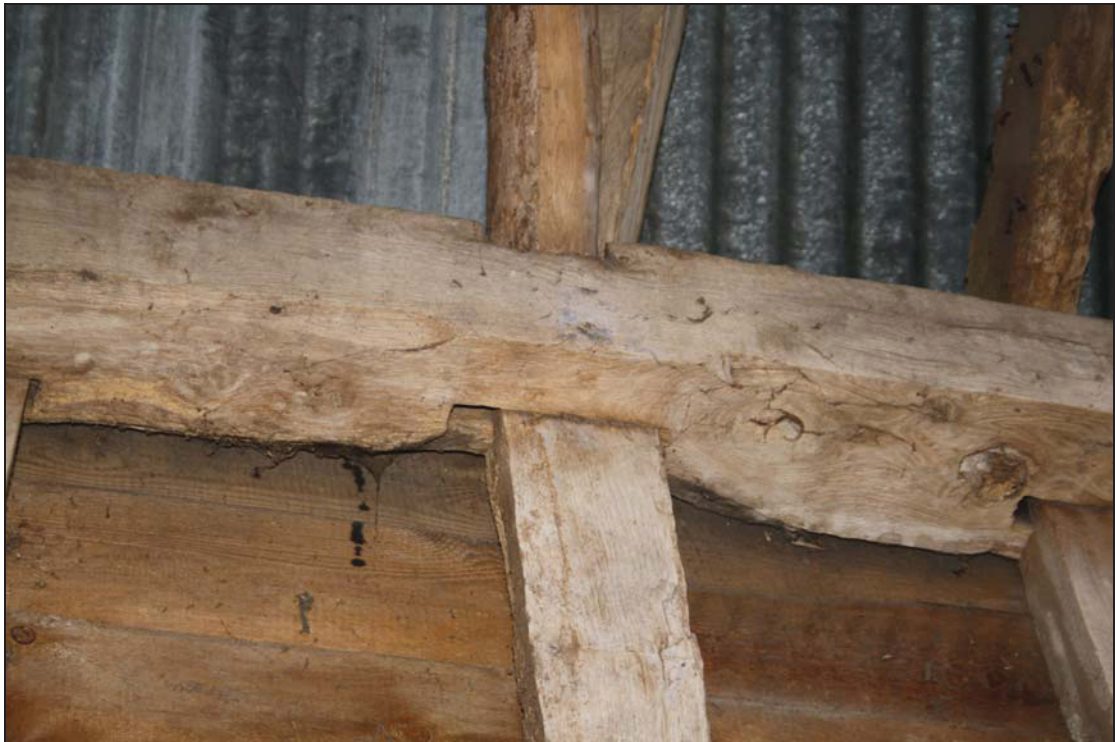
5.25 The wall-plate is noteworthy as it retains chamfering and distinct but plain stops to the south of the bay division post (Plate 9), where an unused mortice for a principal post and a notch in the upper face suggest that this was originally the bay division, but that a change occurred during construction, necessitating the lengthening of the plate with a face-halved and bladed scarf joint to the north-west. This is confirmed by similar evidence on the corresponding wall-plate to the south-west. The south-west wall is less well-preserved though the sole-plate is in better condition and has been scarfed at the point where the wall-plate has similarly been extended. The mid-rail of Bay 2 retains the same mortices for a loft as noted above. The lower registers of both bays have lost all original studwork and bracing, but some fragments of the brick nogging remain at the south end. The upper register of Bay 2 has only a single brace but this may mark the position of a pitching door as there is extensive decay in the wall-plate at this point. One or two of the studs here are clearly reused from a building contemporary with the historic core, as they retain wattle stave notches.

Plate 9 Unused configuration for a bay division on the north-east wall of Bay 1, taken from the west (26)

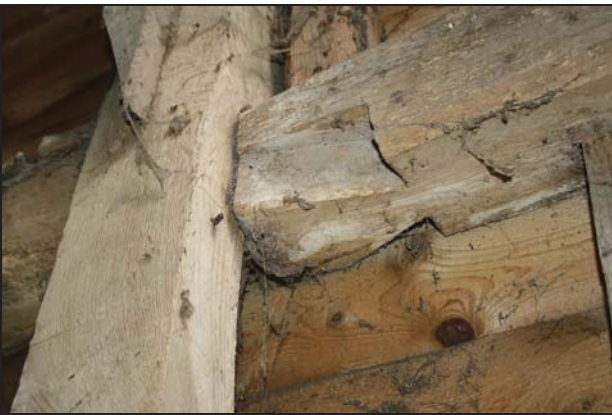
27

Former tie-beam reused as a mid-rail on the north-east wall of Bay 1, taken from the south

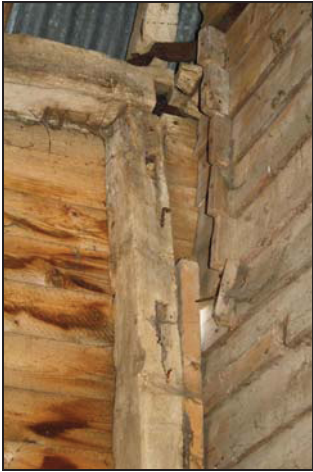
31

Former tie-beam, reused as the west post of Bay 2, taken from the south-east

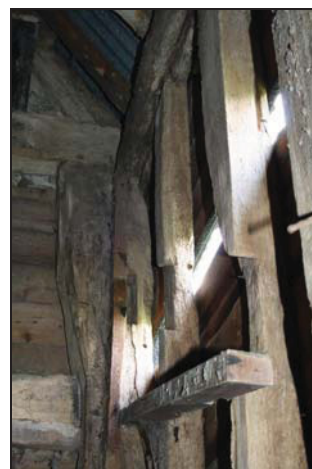
36

North-east wall of Bay 3 showing mortices for the lost brace, taken from the north-east

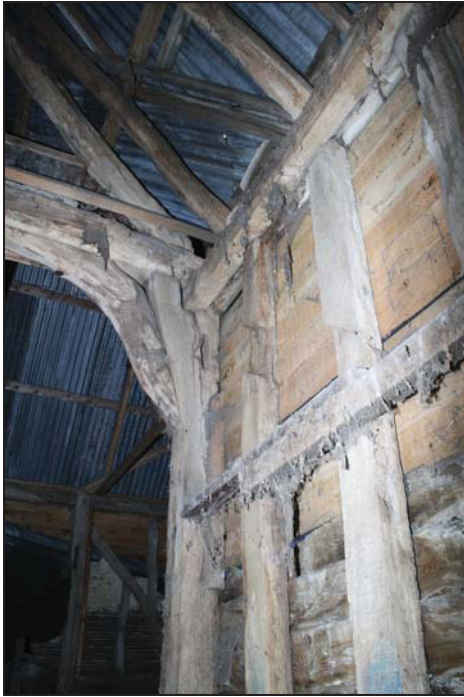
43

Redundant notch lap joints for a brace, north-east side of Bay 4, taken from the south
