Humber Field Archaeology

Archaeological Building Recording at Rectory Farm Usselby Lincolnshire

Watching Brief Report Number: 1278 November 2011

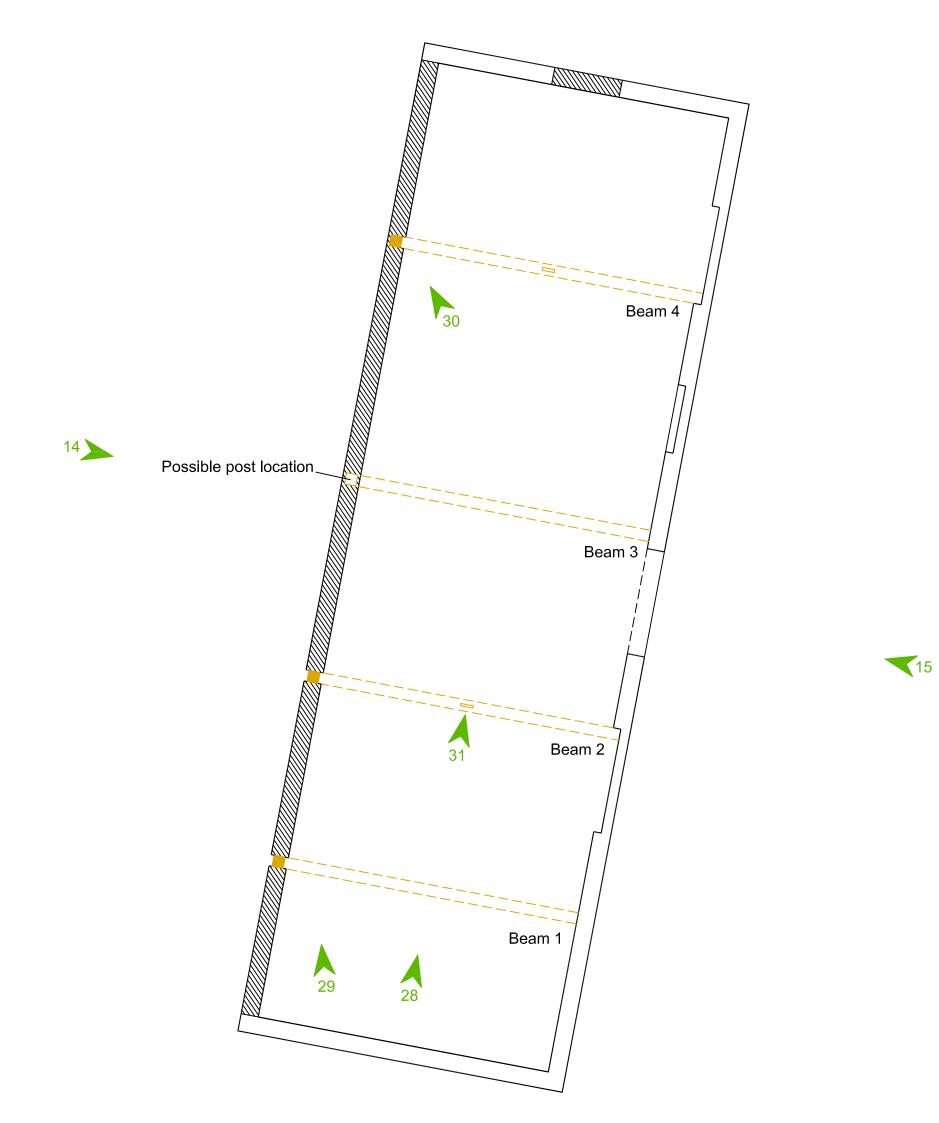
Figure 6 Plan of Building D

Two timber posts were visible in the south part of the elevation, each being of square section and 150mm (6") in diameter (*Figure 6, Plate 14*). A further post to the north was only visible internally (see below). The brickwork in this elevation appeared to be large of a smooth, reddish-orange modern type and infilling what originally would have been an open elevation with the roof supported on posts.

This building had had a ceiling inserted, though at a height some way above the level of a series of east-west running beams (*Figure 6, Plate 28*). Presumably the ceiling concealed the familiar arrangement of collars and clasped purlins. The beams appeared to have been less crudely converted than those in building C, though beam1 had a waney edge on its north side. Beam 1 also had a slot that would have carried a diagonal brace on its south-west side (*Plate 29*). Beam 2 had such a brace *in-situ* on

its north-west side (*ibid*) and a 170mm x 30mm mortice in its underside (*Figure 6*, *Plate 31*). Beam 3 had slots for former braces on its south side, whilst beam 4 had such a slot on its south-east side and a 160mm x 40mm mortice in its underside. The relationship between the timber posts mentioned earlier during the exterior description, and the beams, was best seen with regard to beam 4 (*Plate 30*).

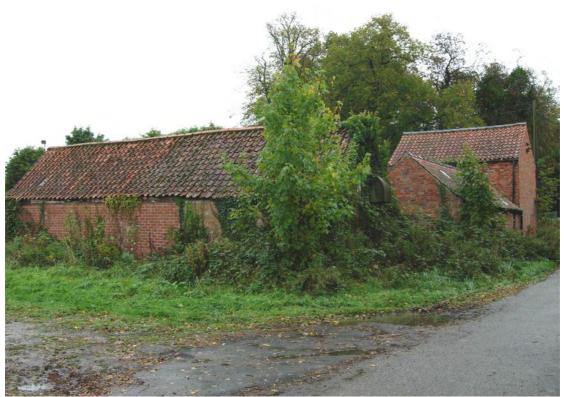
Plate 1 General view of the site from the south-west

With the exception of building E, which was of corrugated iron and asbestos, all the other buildings were of brick, with gabled, pantile covered roofs (*Plate 1*)

With the exception of a substantial cowling in the upper part of the gable, any detail was obscured by vegetation (*Plate 1*).

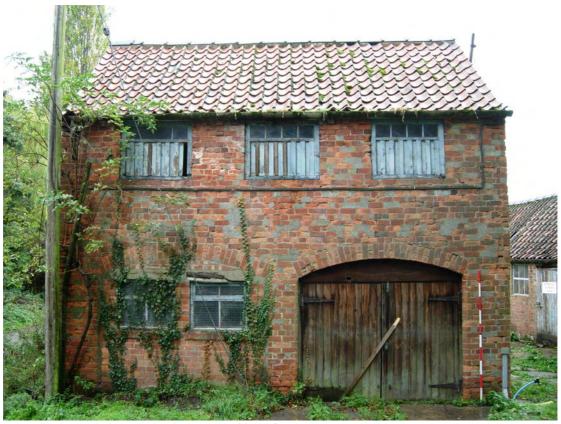
Plate 2 East (principal) elevation of building A

This was the principal elevation. Originally there would have been two substantial openings at ground-floor level, each with a segmental brick arch (*Plates 2 and 3*). The one to the north retained its double-leafed doors whilst that to the south had been brick blocked with two windows also being inserted (*Figure 3*). The bricks were similar to those throughout the building though of slightly different size, being 220mm x 100mm x 70mm ($8^{3}/4^{"}$ x 4" x 2 $^{3}/4^{"}$). Both the windows had concrete lintels and brick sills.

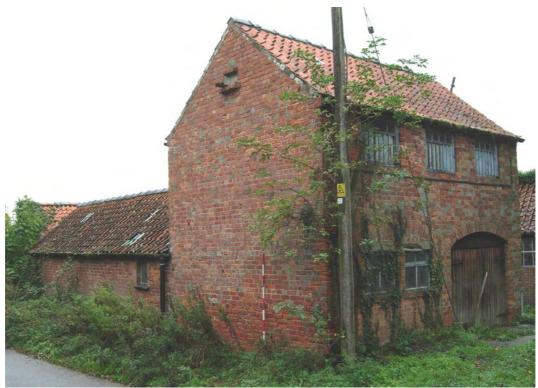
Plate 3 West elevation of building A, together with the south elevations of buildings A and B

Devoid of features save for a small recess high up in the gable, from which protruded a short section of iron or steel 'I'-beam (*Plate 3*). Given that there was no loading bay door beneath, it presumably did not function as a hoist.

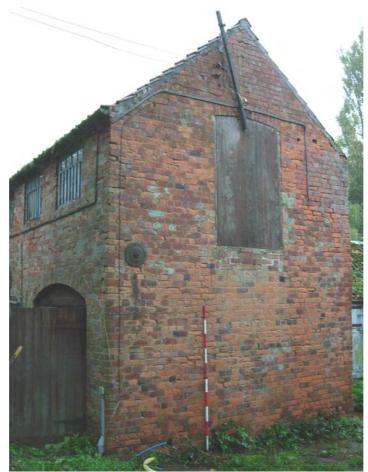
Plate 4 North elevation of building A

This was dominated by what would originally have been a first-floor loading bay door, but which in recent times had simply become a boarded-over opening (*Plate 4, Figure 4*). A little lower, and to one side, there was a single circular cast-iron tie plate.

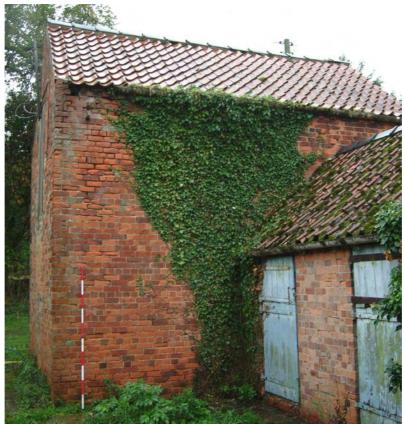
Plate 5 West elevation of building A and part of the north elevation of building B

Devoid of features and abutted by building B (Figure 3, Plate 5).

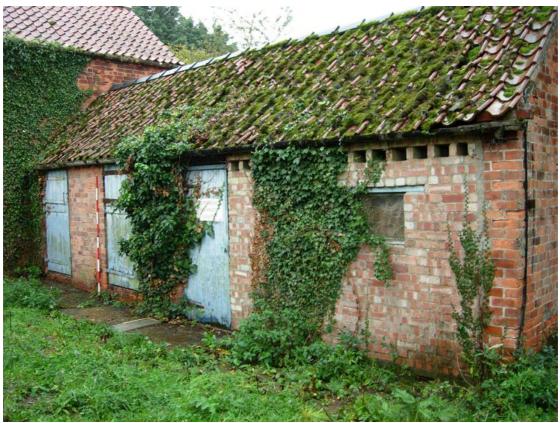
Plate 6 North elevation of building B

This was the principal elevation. Although the orange brick had been used in the eastern part of the elevation, the western part contained a substantial blocking of quite modern (dating to the second half of the 20th century) pink bricks (*Figure 3, Plate 6*). A long and largely obscured window had been included in the blocking, and below the eaves, alternate bricks had been removed from a course – presumably for ventilation purposes.
